Re: 1850's Unitarian Church Exterior Restoration
Project No. 96072

Re: Circa 1851 Unitarian Church
Project 96072

Re: Circa 1851 Unitarian Church
Project No. 96072

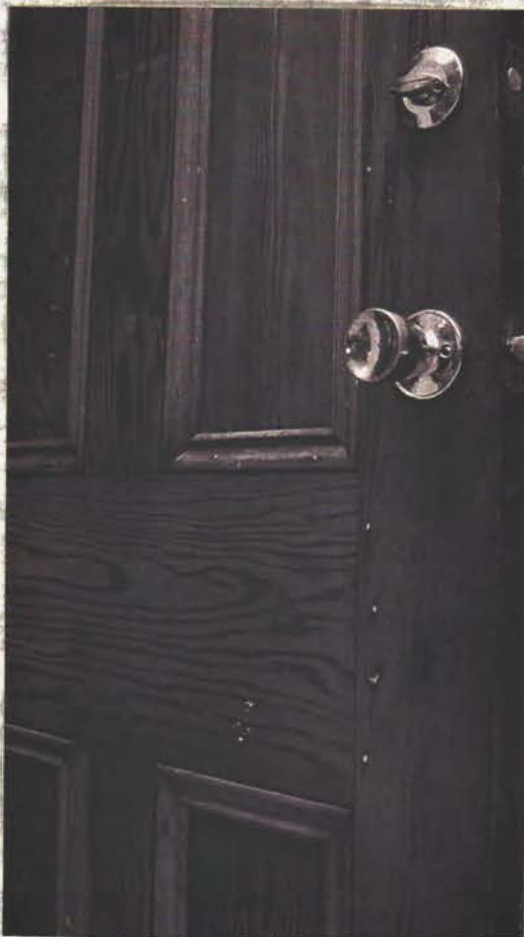
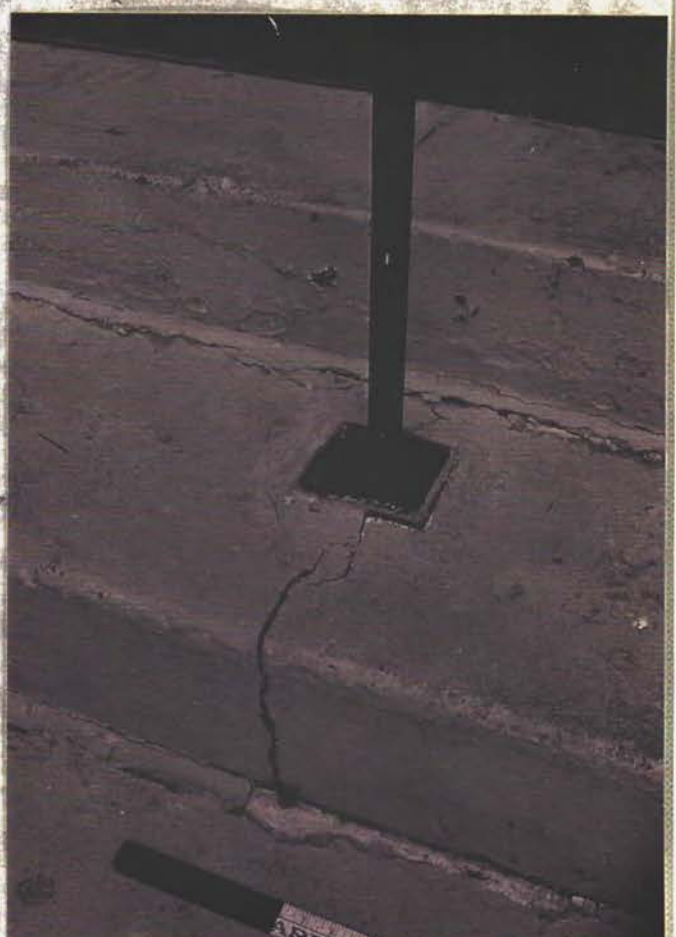
post has broken the stone step

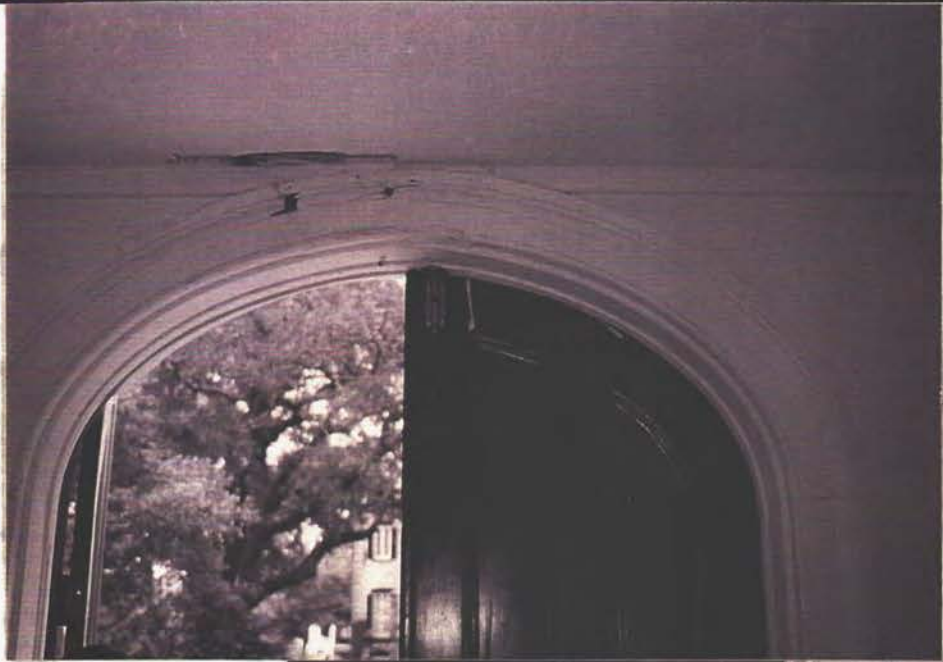
ORIGINAL
DOOR LOC (open in)
removed 1851
C.I. fast-pin
hinge (one in
with door,
rest - mod.)

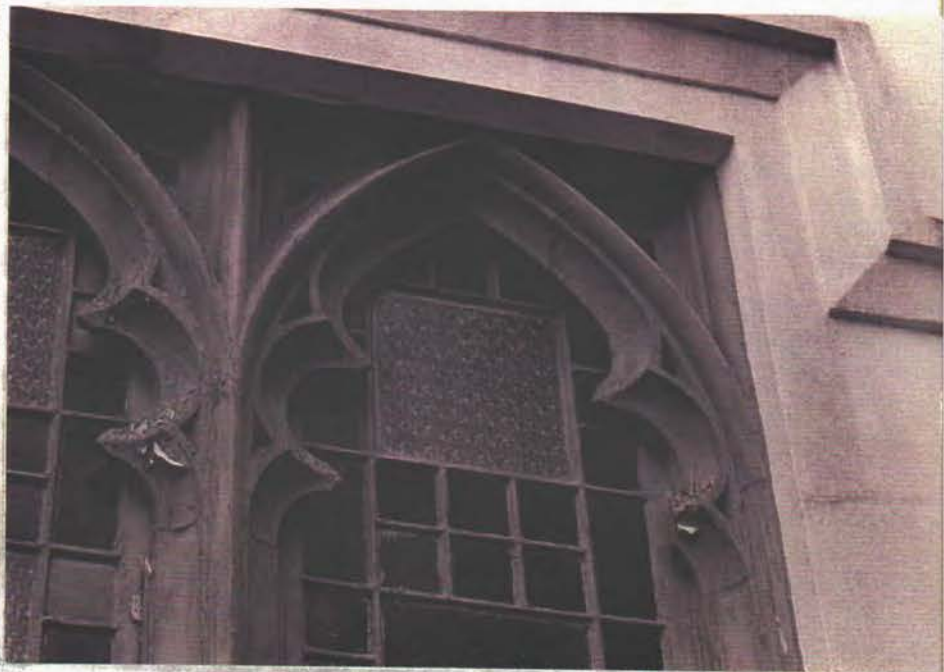
S. Window, east fac.
 Sashes = c. 1870-1920 (see hist. photo + p. 12 Sash w/ diamond - panes, upper rt.)

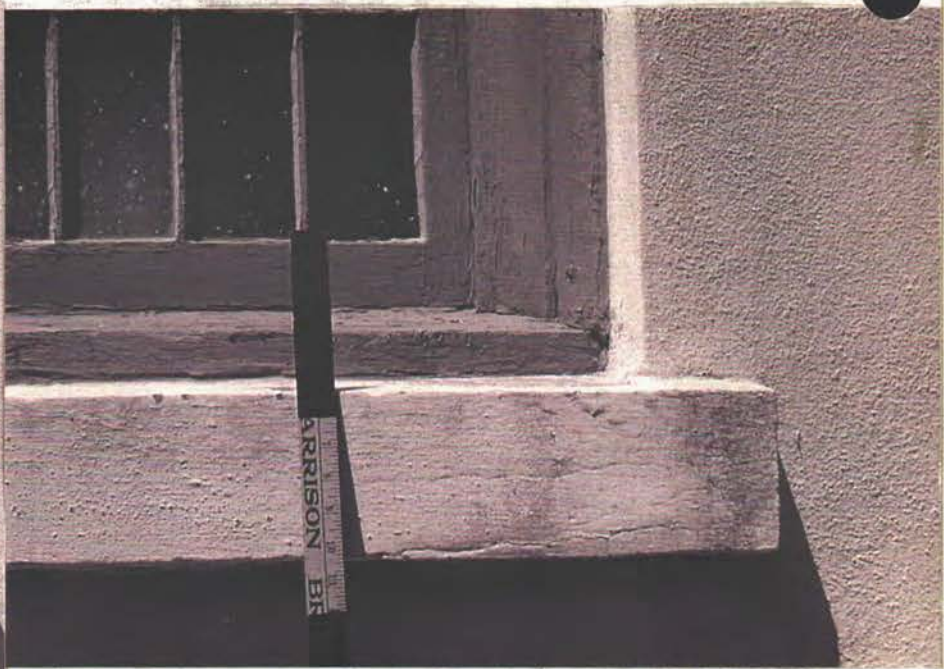
Limits of S. Mo =
 red-brown sandstone w/ white c.
 cem. patches of stress cracking & paint

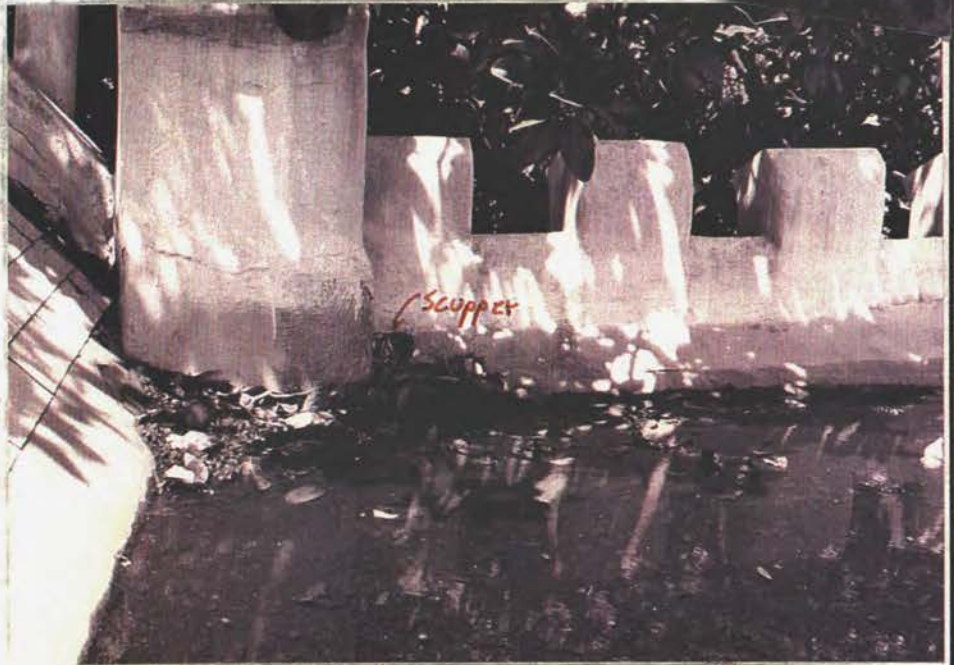
Both of these near-flat roofs have ponds of up to 2" deep. The apparent cause is the deflection of the wood joists discussed at paragraph 15 below. More study will be needed, in conjunction with paragraph 15, to try to solve this. Some ponding at the N.E. roof is due to blockage of the scupper by fallen magnolia leaves.

pond $\pm 2'$ d. (suggestion)

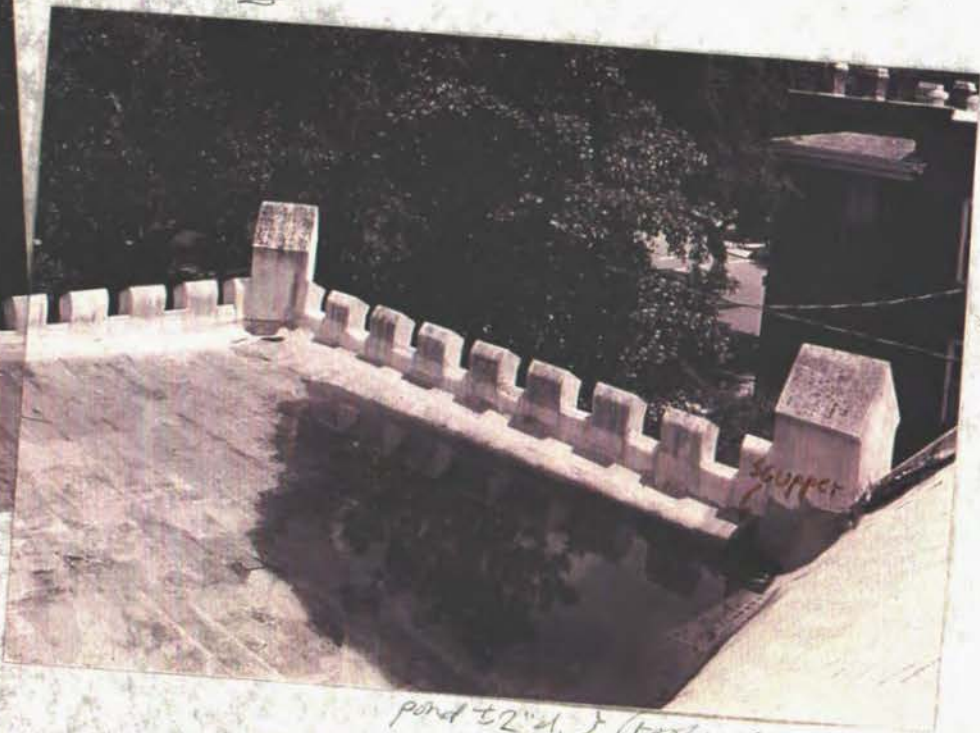
pond 22" d. J (Frog to Scupper)

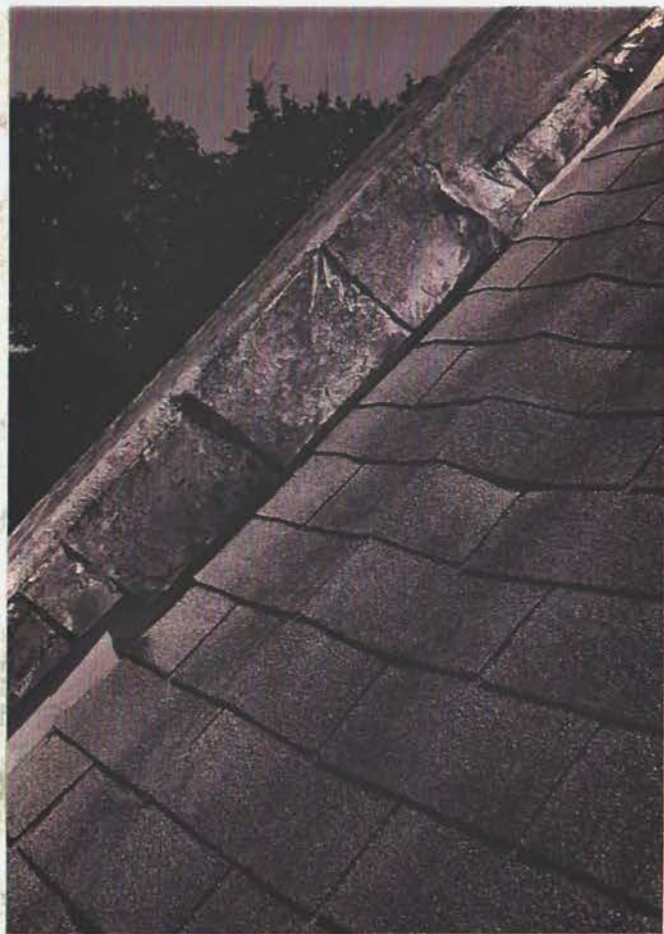
→ Rusty galv flash. - typical

Shingles look to 10 yrs old
↓
(14 yrs. max. life)

1. The galvanized metal counterflashing at the parapets is rusted-out and must be replaced by a more rust-resistant metal.
16. A look in the attic reveals that the original ceiling was rotary-sawn wood lath and plaster painted a pinkish off-white. The present ceiling is board-and-batten wood of a type I have seen at several mid 19th century soffits. Probably the roof-framing described at Item 15 caused early, extensive and repeated plaster damage, resulting in a decision to install the wood ceiling. This approximately doubled the weight of the ceiling and probably accentuated the sagging to its present 4"-6".

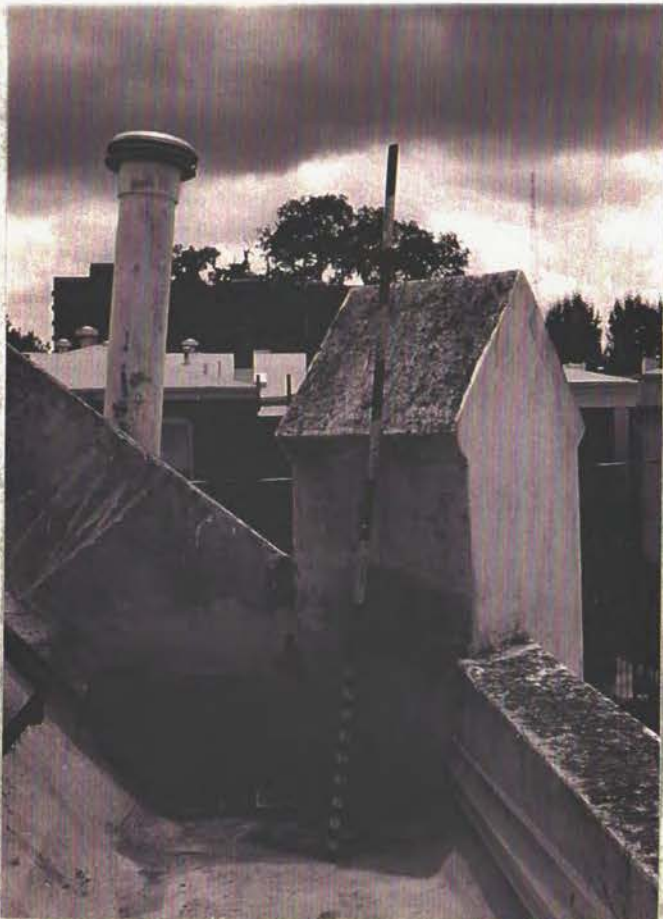
rusty
gutter
flash

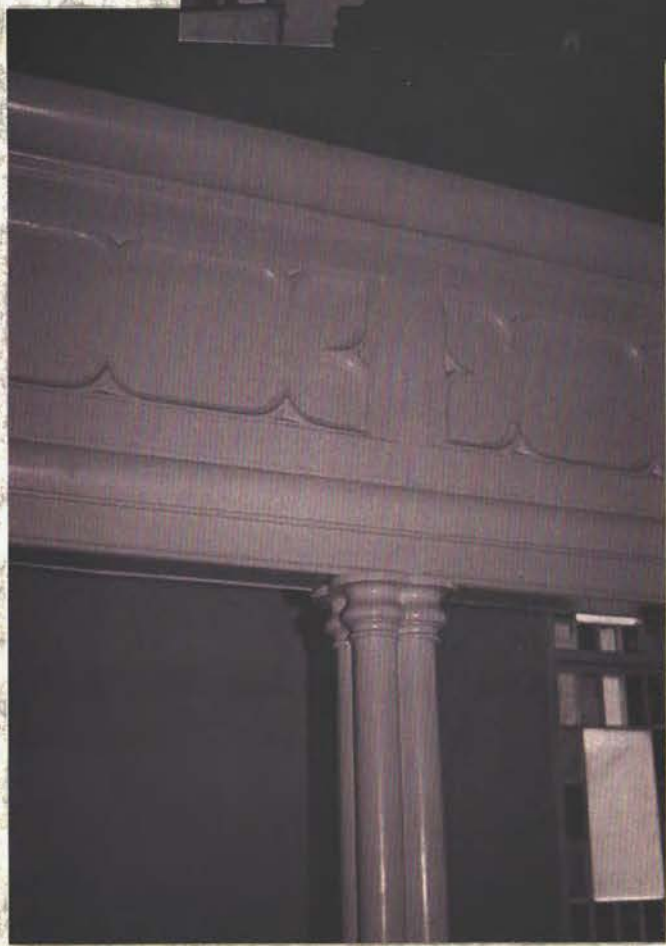
↑ Arch over balcony was to
 support the "tower" described
 in 1851 newspaper article,
 now gone
 Also is a ridge on roof where
 the tower penetrated!

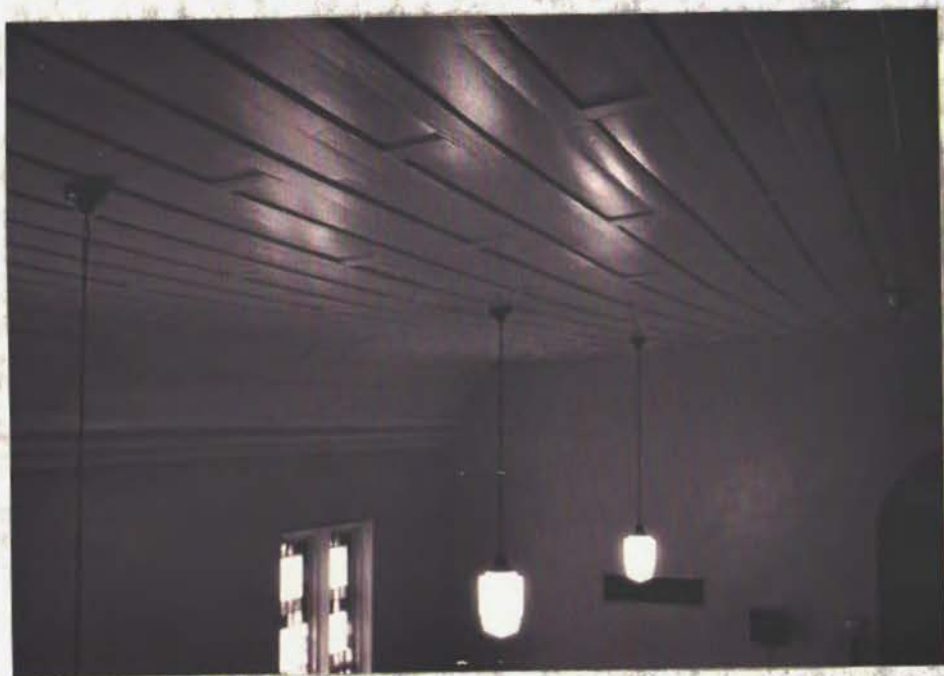
15. The structural engineer should examine the roof framing in the attic. The roof structure and ceiling is deflected 4 to 6 inches at the bottom of the valley intersections of the cruciform gables. Due to the way the roof is framed a heavy load-concentration exists on the mid-spans of the ordinary ceiling joists under these two points, causing the deflection. About 130 square feet of

NOTE
 $\pm 3'' - 5''$
 SAG
 ↙

roof-load is concentrated at and near the mid-span (weakest point) of two 24' long ceiling joists. Some of the load could be transferred back to the central East-West main roof truss with appropriate bracing.

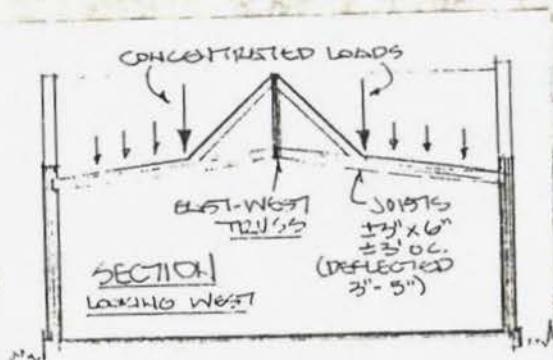
Orig. ceil. was plaster of rotary - some lath, pale pink paint
 (STW in place in attic).
 This cell perhaps ca 1870. Plaster ceil. probably cracked
 soon & repaired due to way roof was framed.

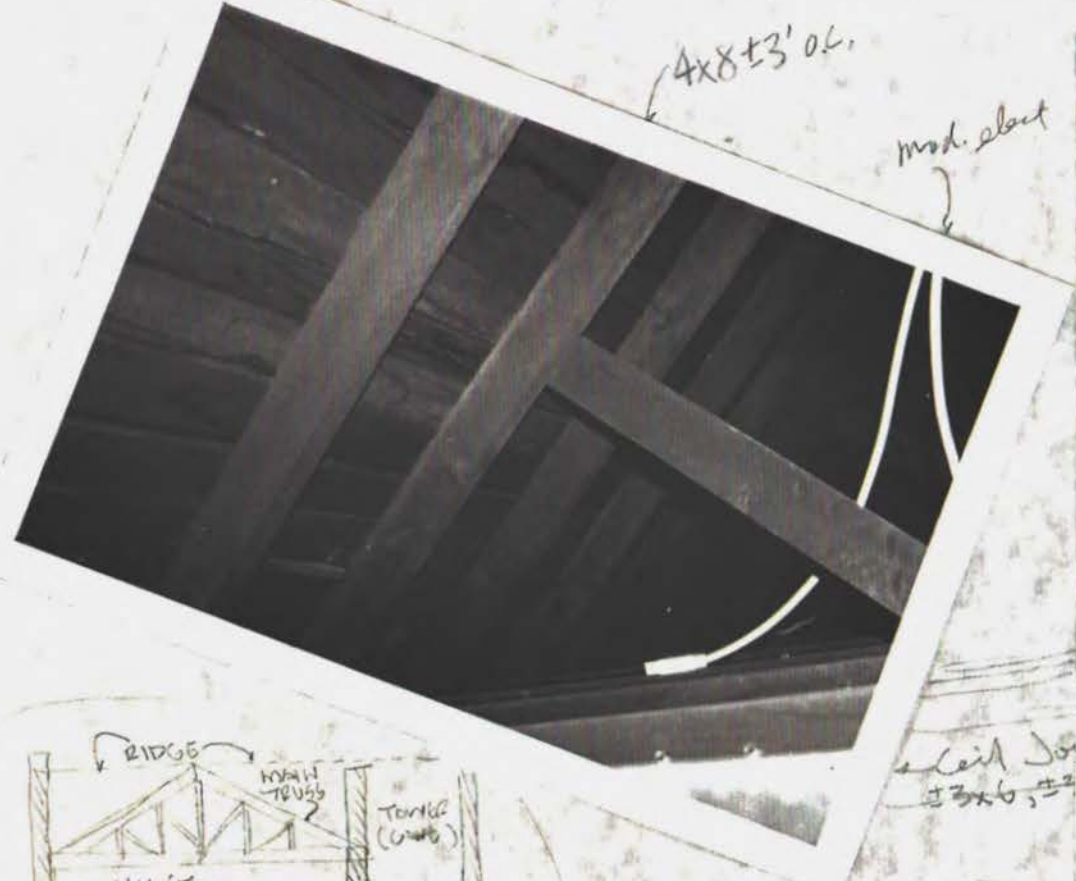
Ceiling Joists
2x6 @ 12"

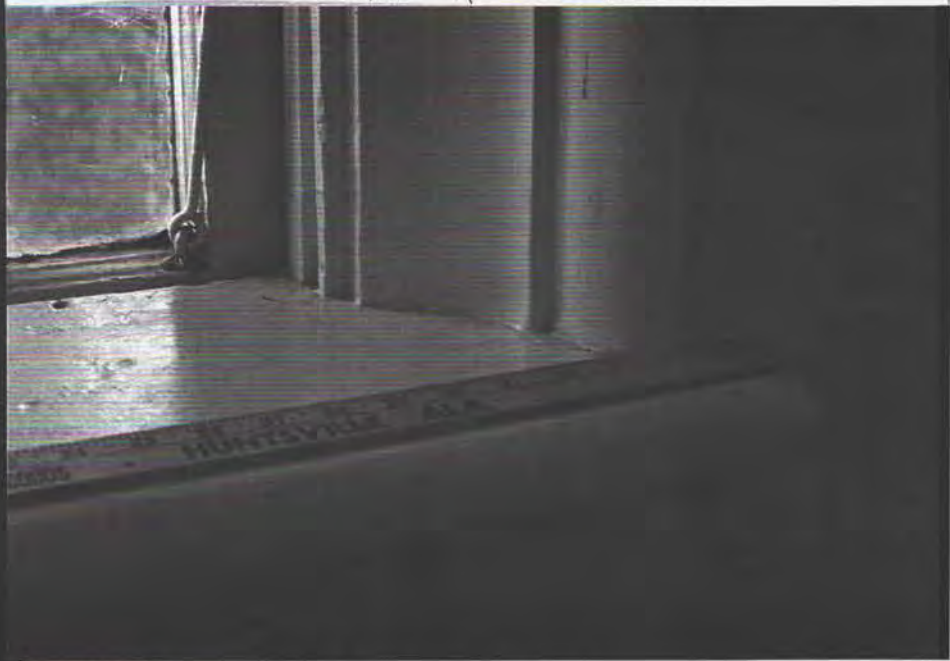
Later sash, perhaps c. 1800-1810, in sand.
See hist. photo for orig. 60°-120° diamond pane
sashes. N.W.M. Typical in Sand.
