## Borders-Blackmon House Offers Important Record of Slave Artistry

CIRCA 1840 BORDERS - BLACKMAN HSE, ANNISTON, AL.  
 H.A.B.S. RESTOR. + ADDN. 1990 DR. GEORGE & SUSAN GIBBS.  
 JONES & HERRIN, ARCHITECTS - H.P. JONES, F.A.I.A. - HUNTSVILLE, AL.

c.1840 Borders - Blackman Hse, Anniston, AL (HABS)  
after restoration in 1990 by Jones & Kerrin, Arch.  
Harrie P. Jones, FARA, Huntsville, AL  
Owner - Dr. George Gibbins, Anniston  
Photos H. Jones, June 1993

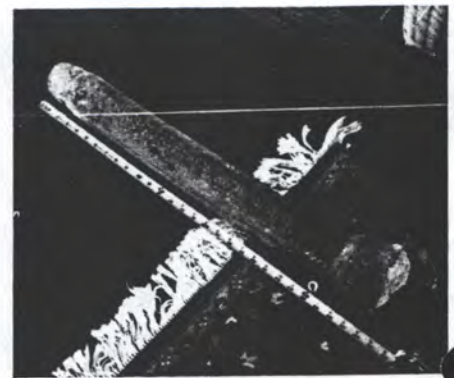
Glazed ceramic bell-joint water supply lines, probably 1840-1860, found at Borders-Blackman house.

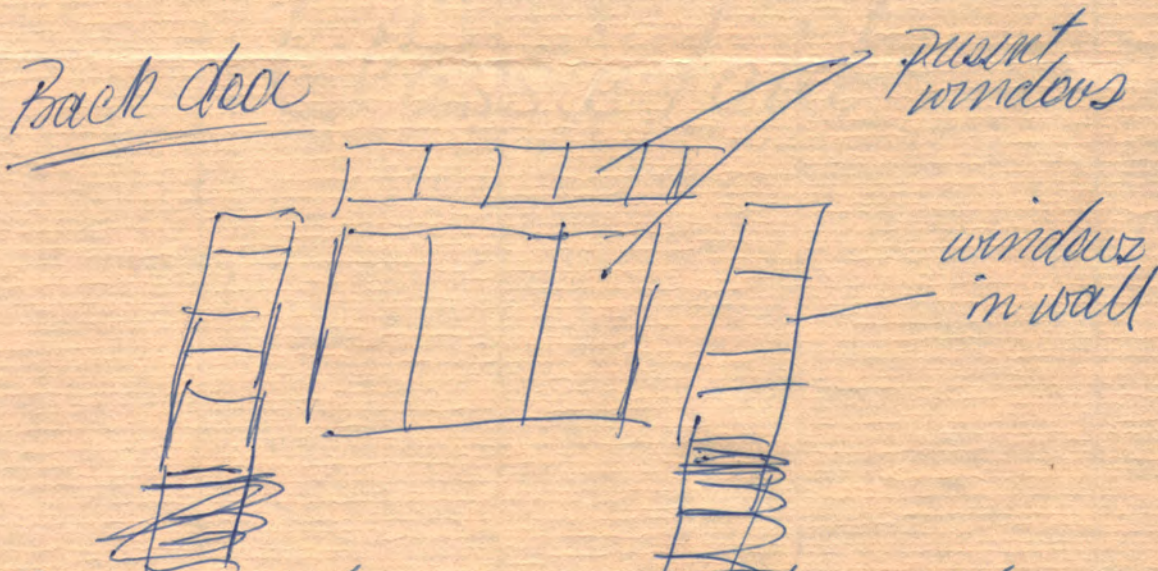
Yesterday we found windows  
in the wall where the old  
back door had been. Windows  
look like those on both sides  
of the double front doors.  
Also appears that lap siding  
on the back was been replaced -

Siding joints appear fairly random -

so I think most of siding  
has been replaced or used  
when door closed.

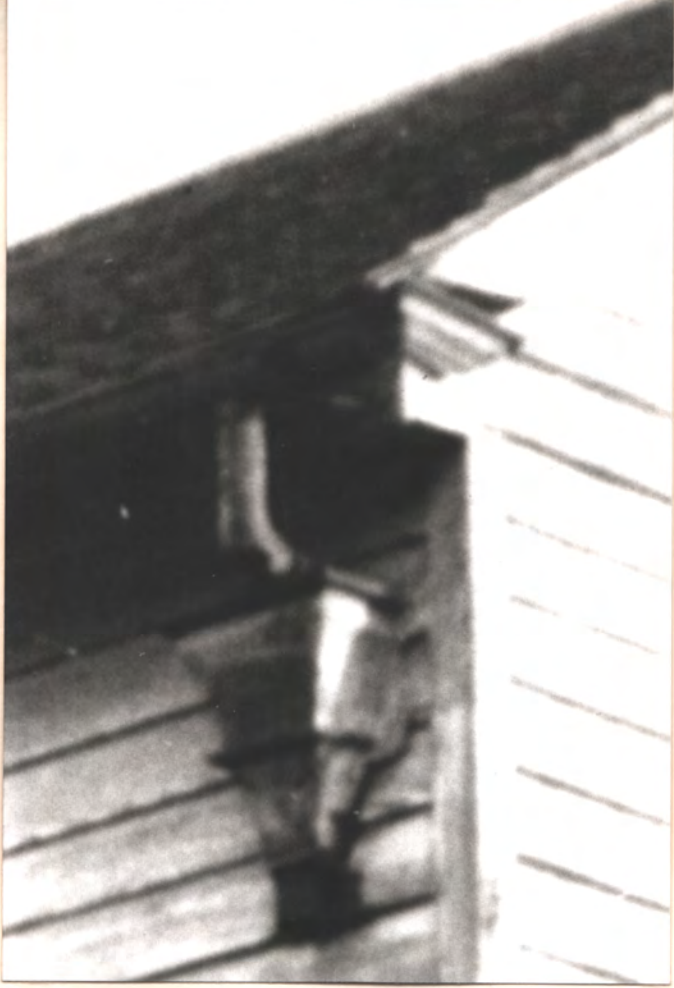
FOUND IN  
ATTIC OF  
FRONT PORCH.  
PROBABLY IS  
THIS CORNICE  
MOULD

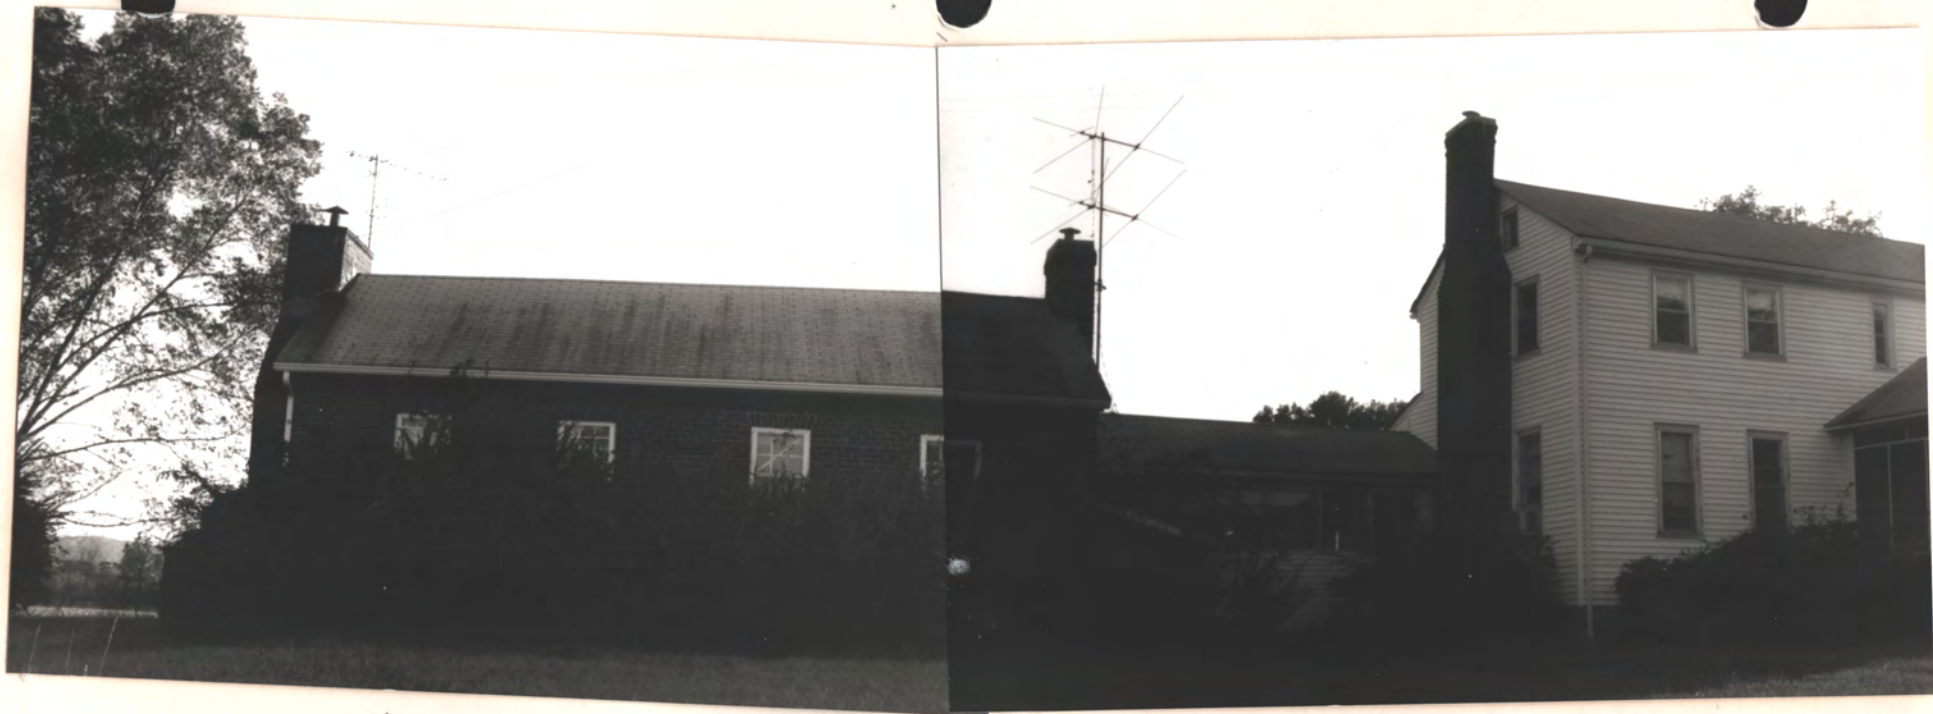
K17.  
orig. crow-step gables gone.  
See HABS 1936 photos

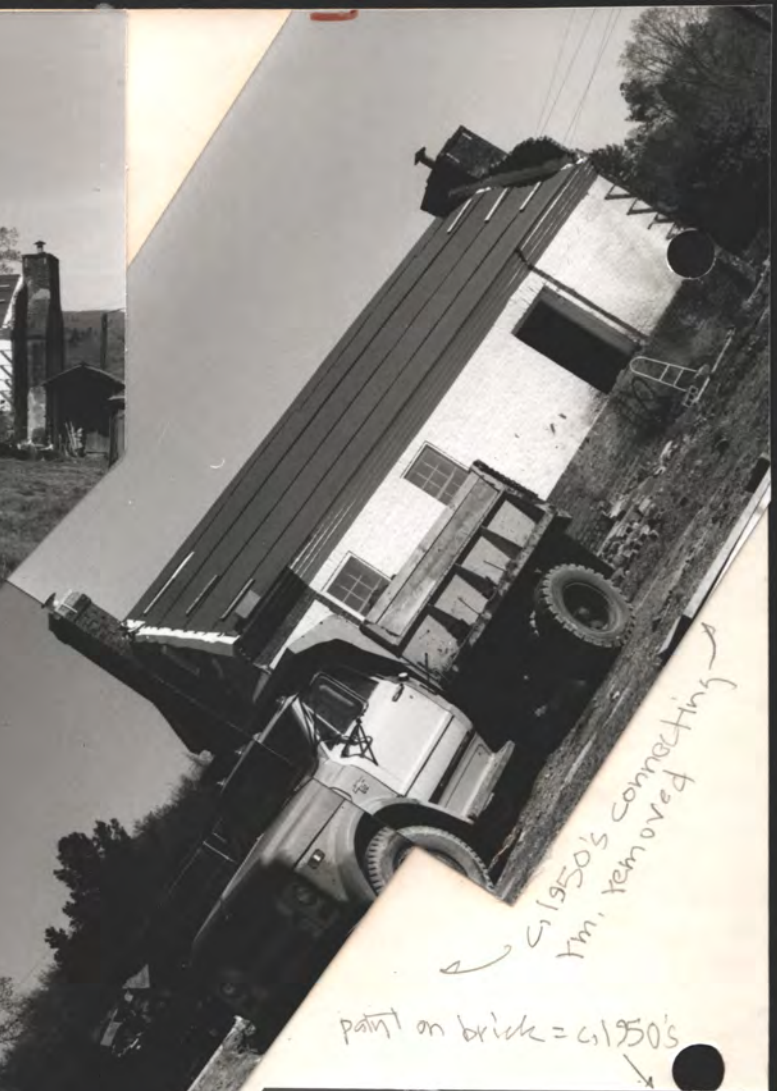
1950's connecting  
fm, removed  
paint on brick = 1950's

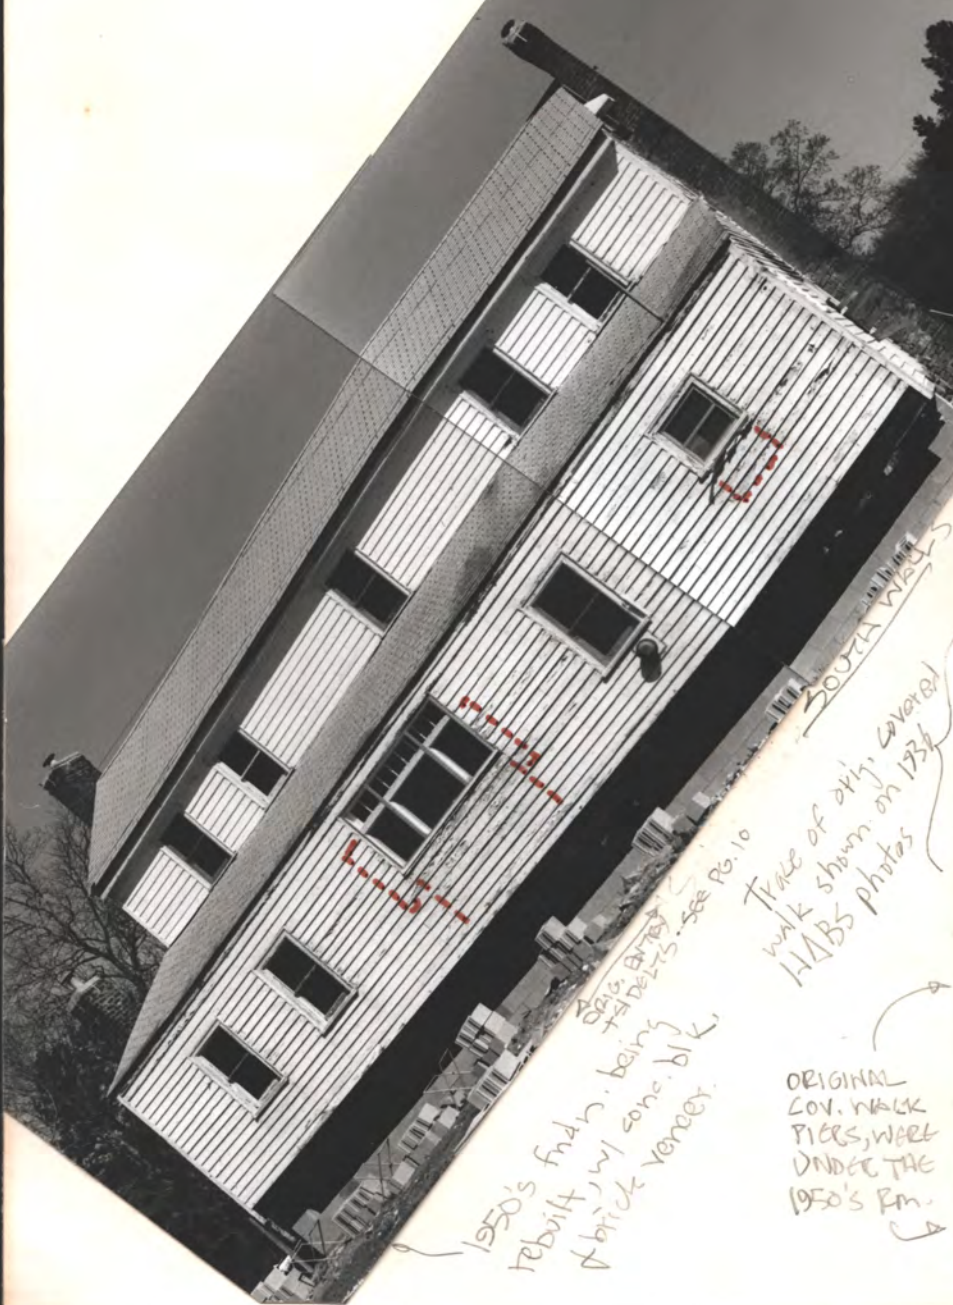
1950's finish being  
rebuilt w/ some blk  
& brick veneer.  
SAYS BRICK  
TIE BELTS - see Pg. 10  
SOURCE: WALK  
Trace of old, covered  
walk shown on 1934  
HABS photos  
ORIGINAL  
COV. WALK  
PIERS, WERE  
UNDER THE  
1950'S FM.

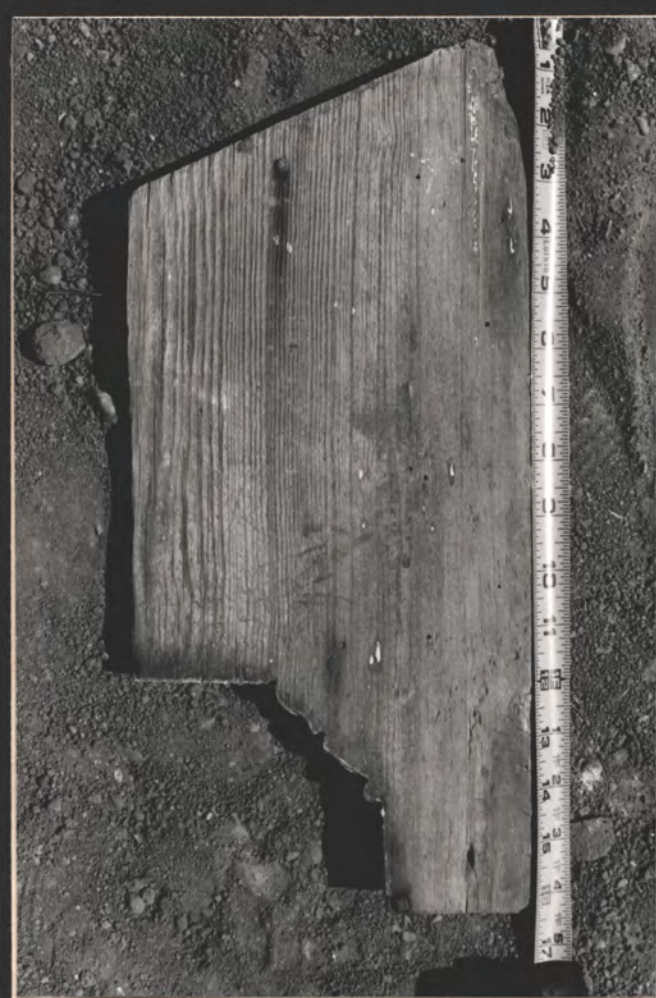
Big cornice end - cap of the original c. 1840 covered walk to the kit. Found in crowd sp. of base. This exactly fits a paint outline by the west door of the kit. bldg., next to the D.P. Chim., This piece would have been the S.E. eave-cap; the only cornice-end exposed on the walk roof. Note faint traces of white paint

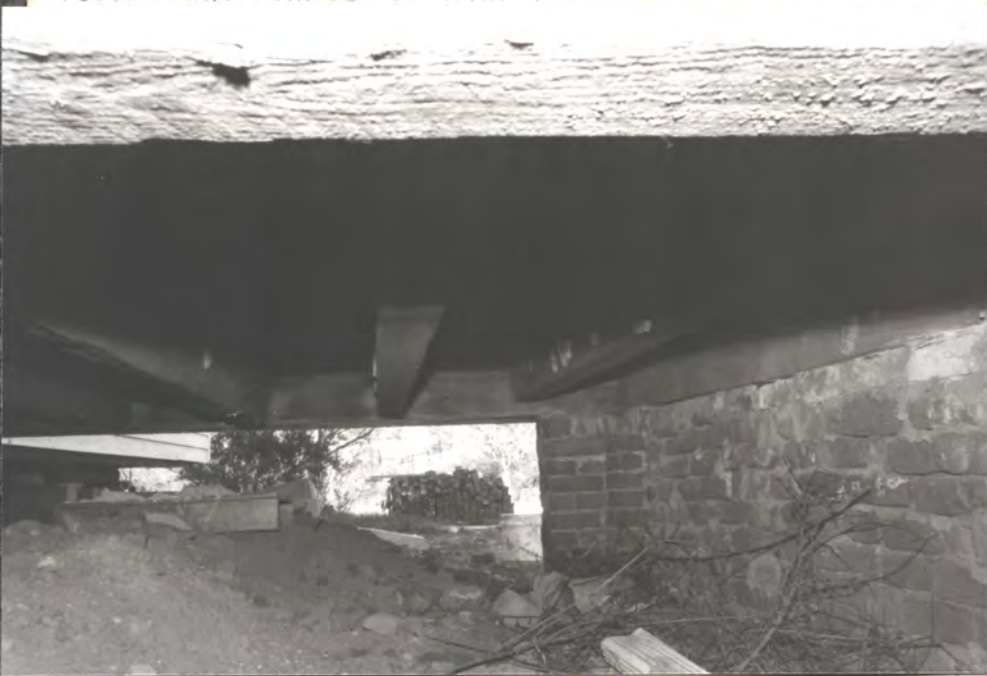
Heavily rotted (red.) Fram. under portico fl. → N

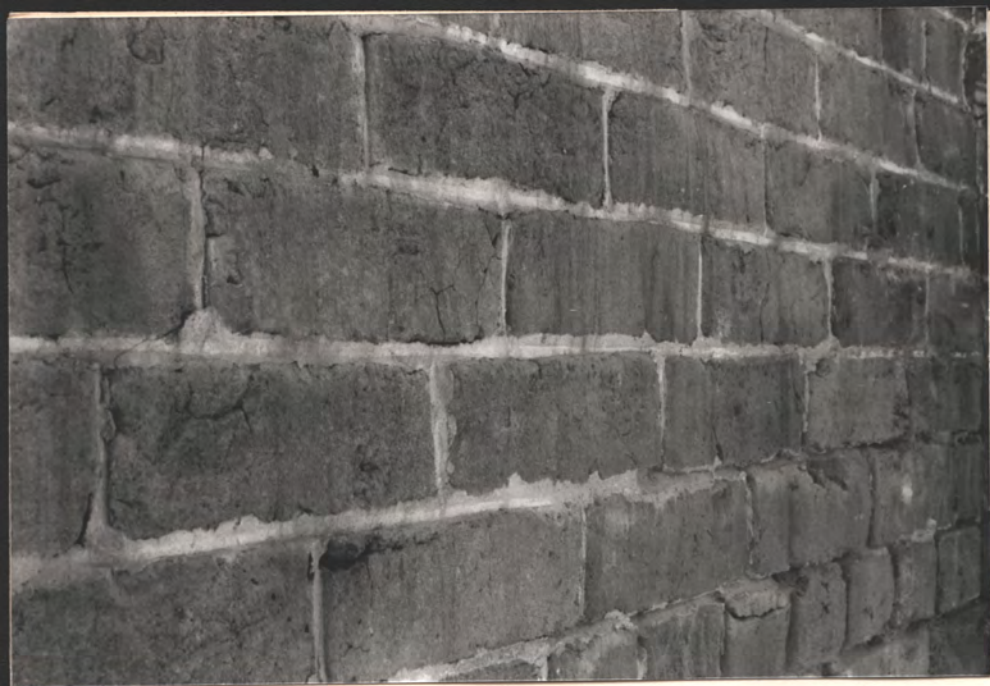
Brick that was under  
the pent roof & protected  
from weather.

Note the "periced" joints  
( $\pm 1/4"$  white paint stripes on  
jts) = typical of 1800-1860  
(Most has weathered off, but  
can usually be found under  
roof eaves etc)

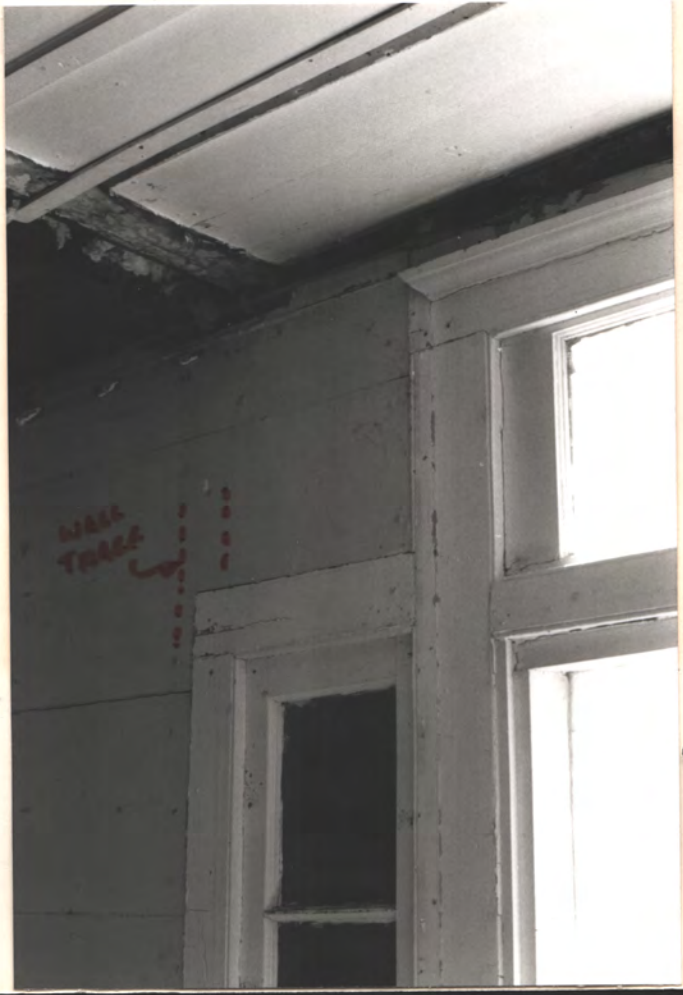
These bitterns were put on when the rock-wool  
 insul. was blown into the shed-rm attic,  
 probably 1950's. Moisture condensed in the insul.  
 ↓ bowed these ceil. boards. When insul. is not  
 above bd. cell. the boards aren't bowed.

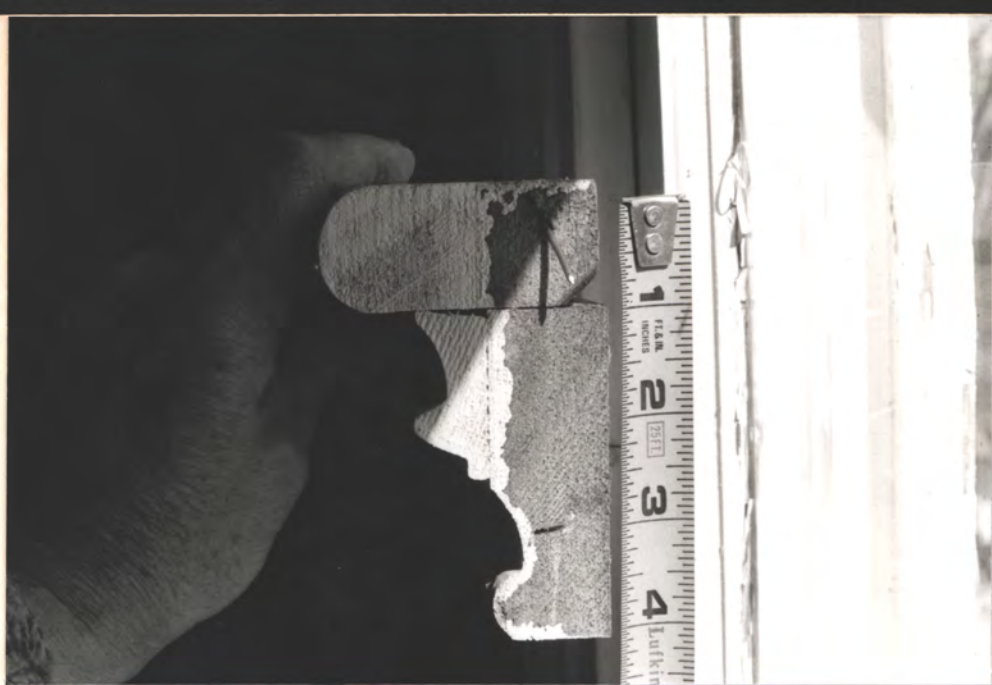
loose c. 1840 chair rail  
 piece that was removed  
 when the c. 1950's closets  
 were installed in the  
 2nd fl. rooms

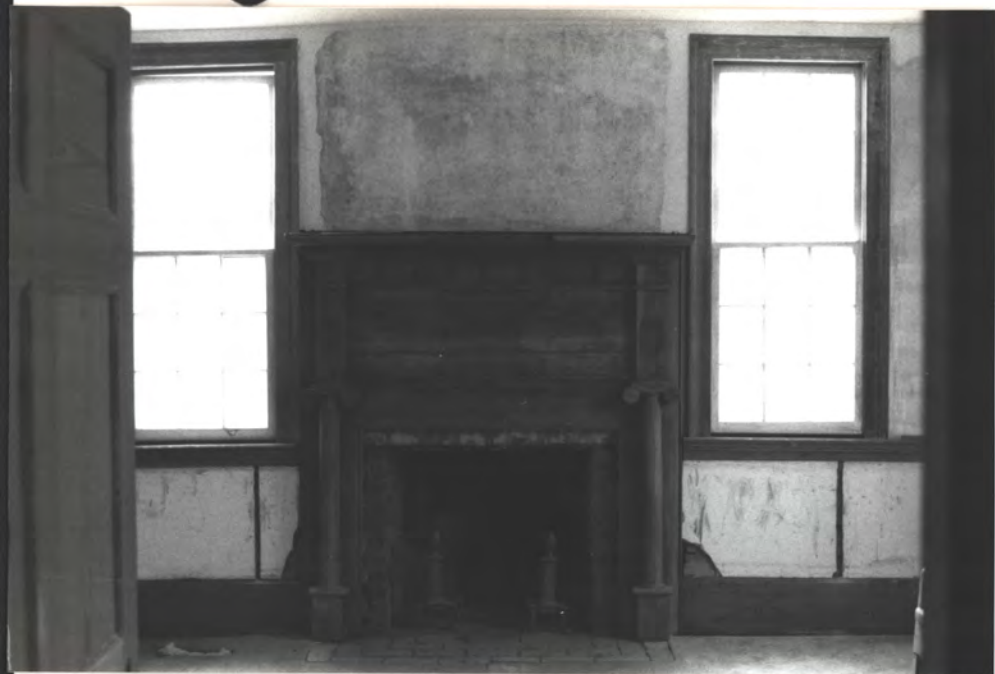
West Parlor. Note traces of missing decor. elements (side oval = sunburst, probably)

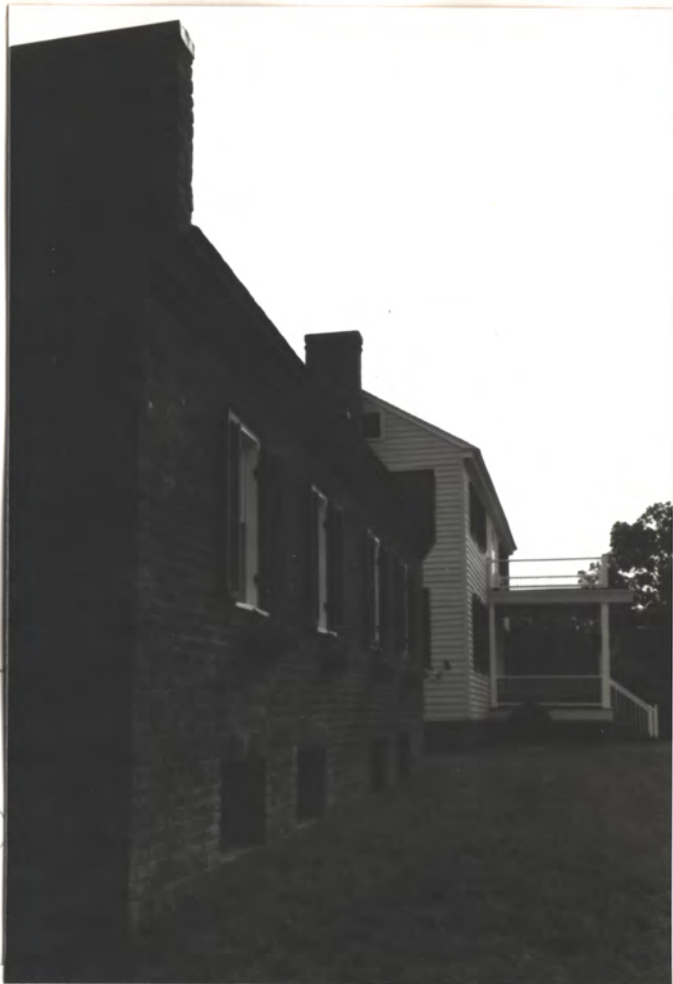
6/6 of 9/9 photos put back per 1930's HABS photos  
Also blinds put back per HABS if a few swimmers found in barn.  
Vinyl siding removed.

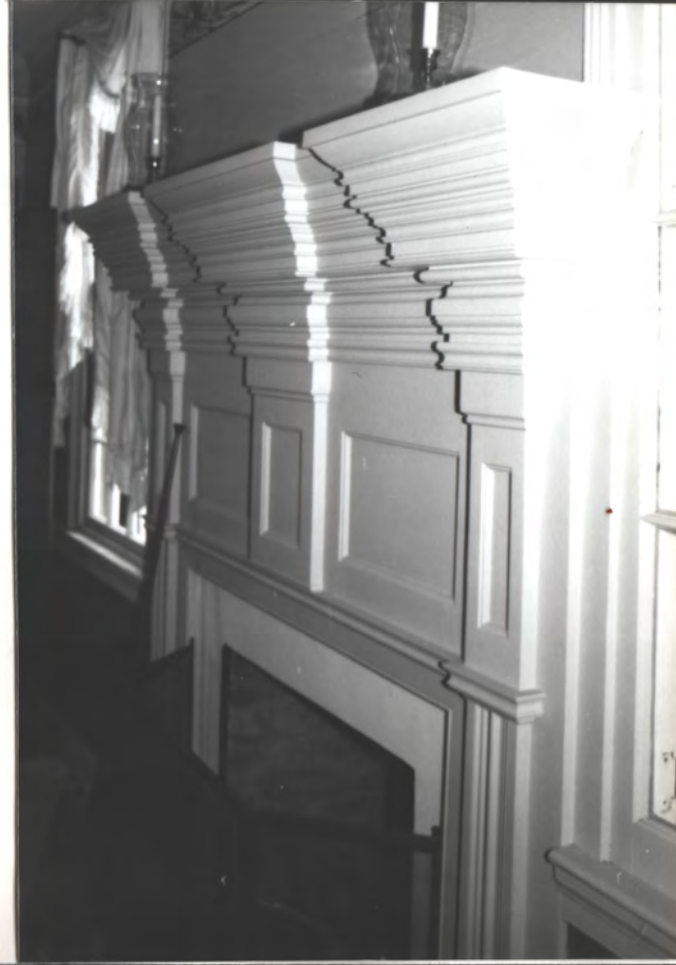
Fl. 1 N.E. Parlor  
This mantel is  
a replica of the  
original. Owner  
apparently  
discarded the  
original because  
it had some  
minor damage!  
(against wiring  
of H.S.)
