**ST. MICHAEL'S AND ALL ANGELS CHURCH
(EPISCOPAL)**

ANNISTON, ALABAMA

PROJECT NO. 93049

PRESERVATION & RESTORATION PRELIMINARY OUTLINE NOTES

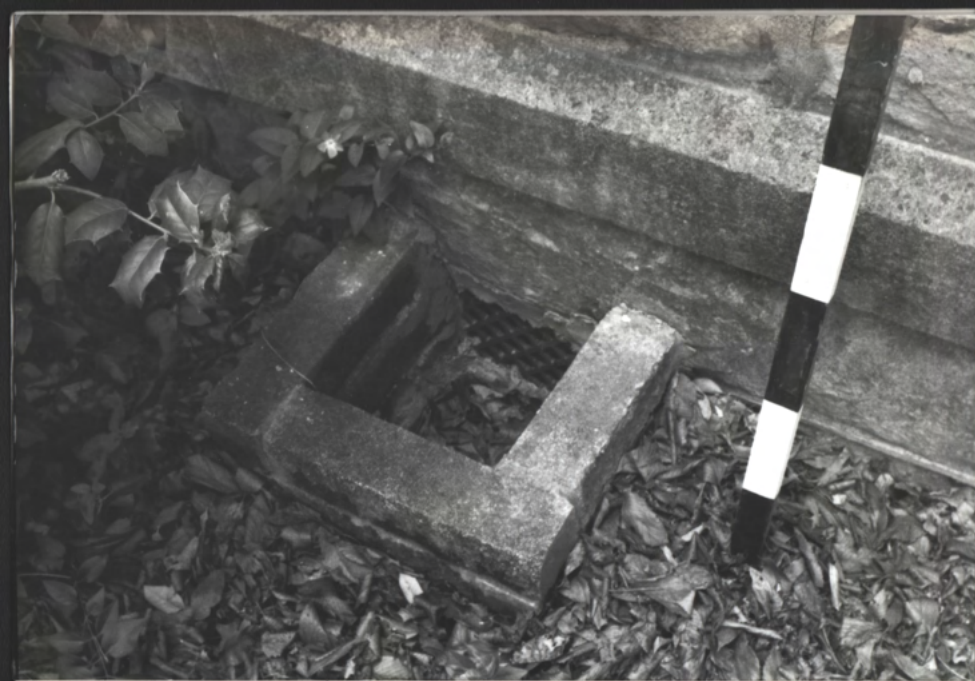
Vent buried by later fill. Congrats w/ arch. domg. post
N. Central wall → N

The raised soil has left the originally-exposed foundation vents buried in the soil, in small "wells", limiting their venting capacity. In at least some cases these vents have in addition been stopped-up in an attempt to keep gutter-overflow water out of the crawlspaces. All these vents need to be reopened, and the drainage corrected.

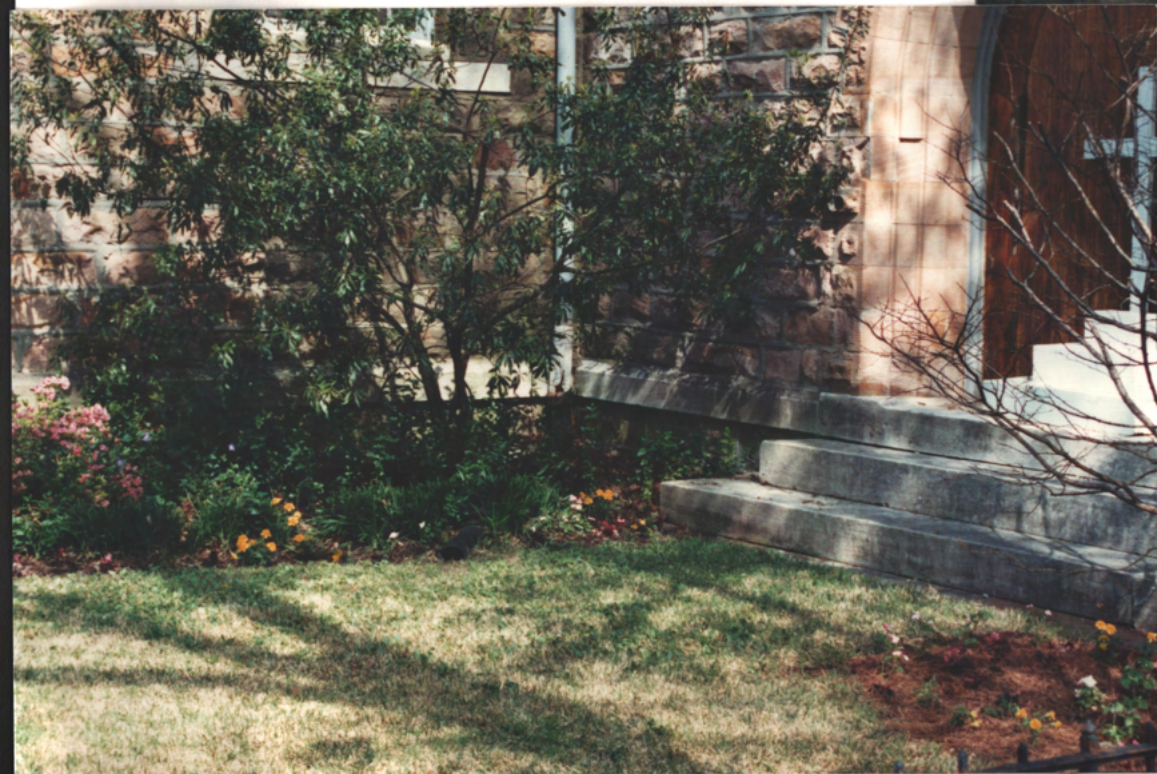
← E. Cent. Wall
 Spalled
 sandstone
 (common)
 sloppy repointing

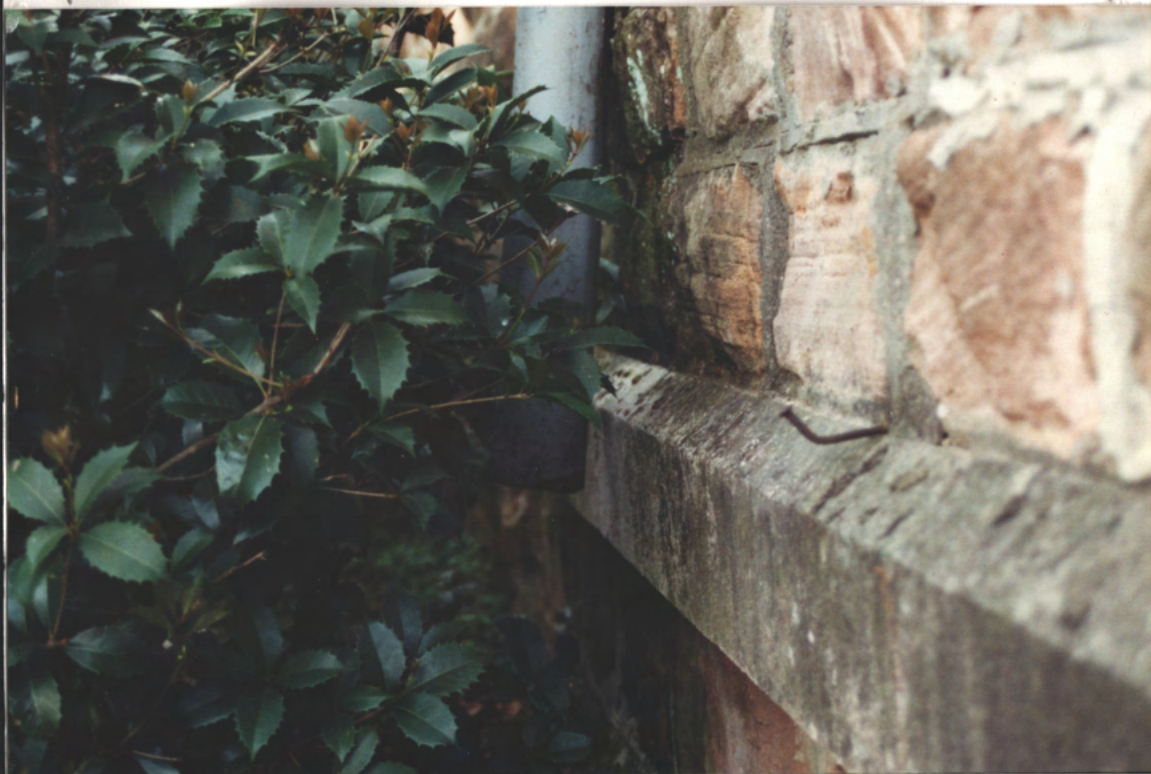
Spilled stone → → N.E. Corner of S.E. Ambulatory

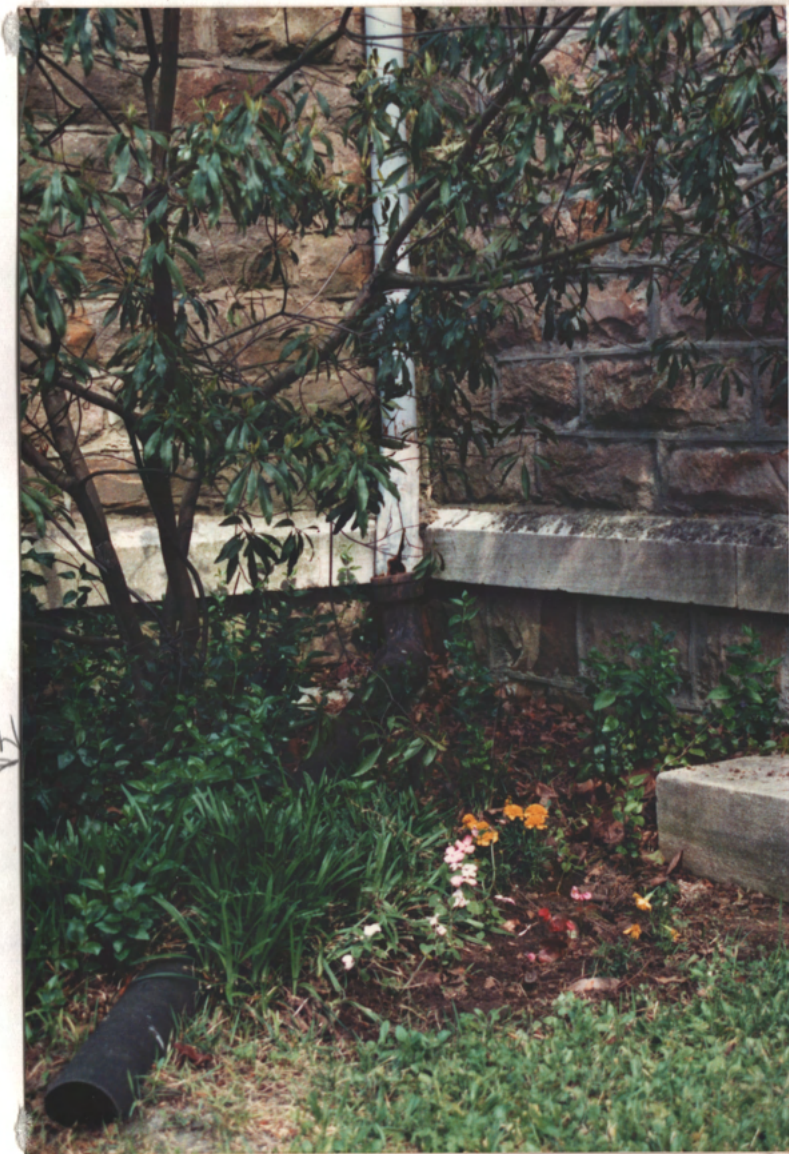
#CENT. WALL - dm spoil dumps on fndm. →

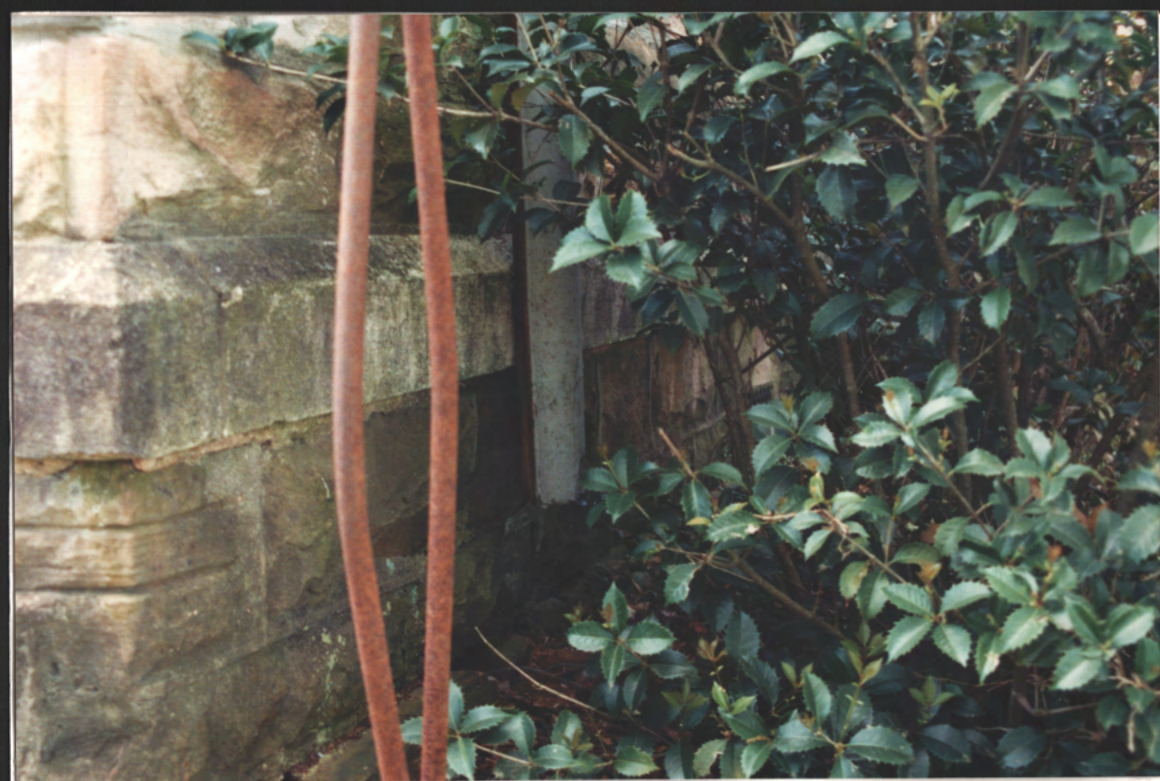
↳ plastic drain
(soil forms a dam
around bdy.)

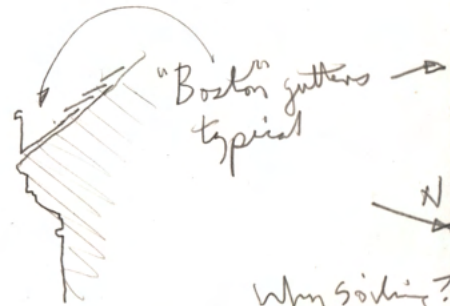
Why soiling?
See photo for
roof behind.
May be due to
old leaks

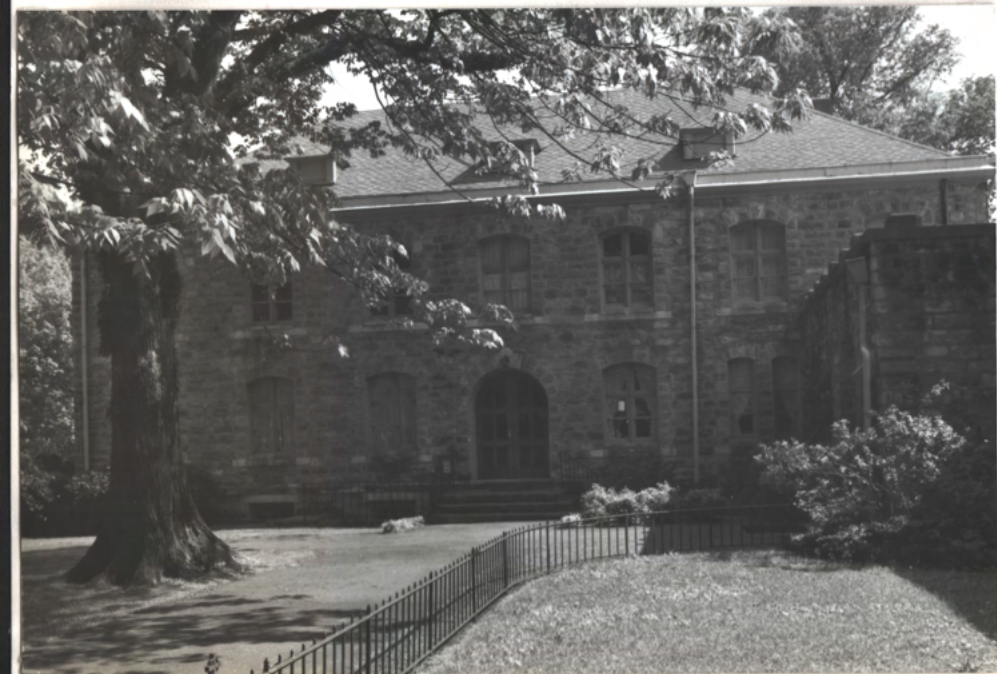
† drain spout not joined to
C.I. storm drain
Loc.?

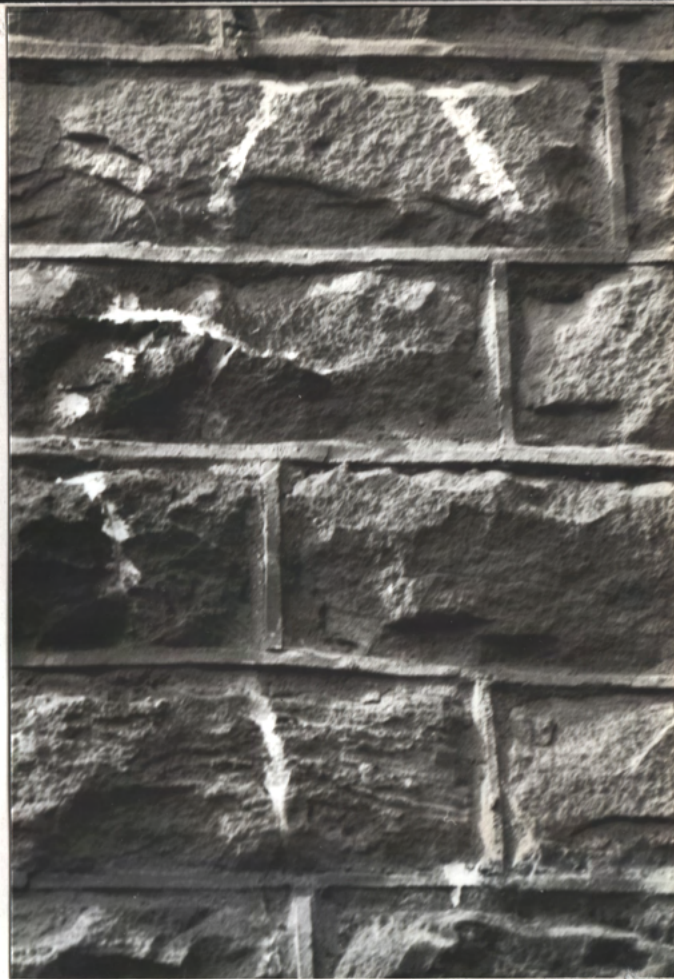
PN Tower south face,
about 20' up
(telephoto)

←
White streaks
are oxidized
"sealant" put
in cracks
years ago

Hard Portland
cem. put in
±20 years ago
(not good).
Gray color.

6. In some areas, the tower in particular, hairline cracks in the sandstone were apparently filled with a sealant, perhaps silicone, at some point in the past 20 or 30 years. Some of the sealant was smeared onto the stone faces. This material has now oxidized to a bright white color, defacing the stone. Perhaps gentle hand-sanding can also remove this surface material without altering the stone (except for temporarily clean spots).

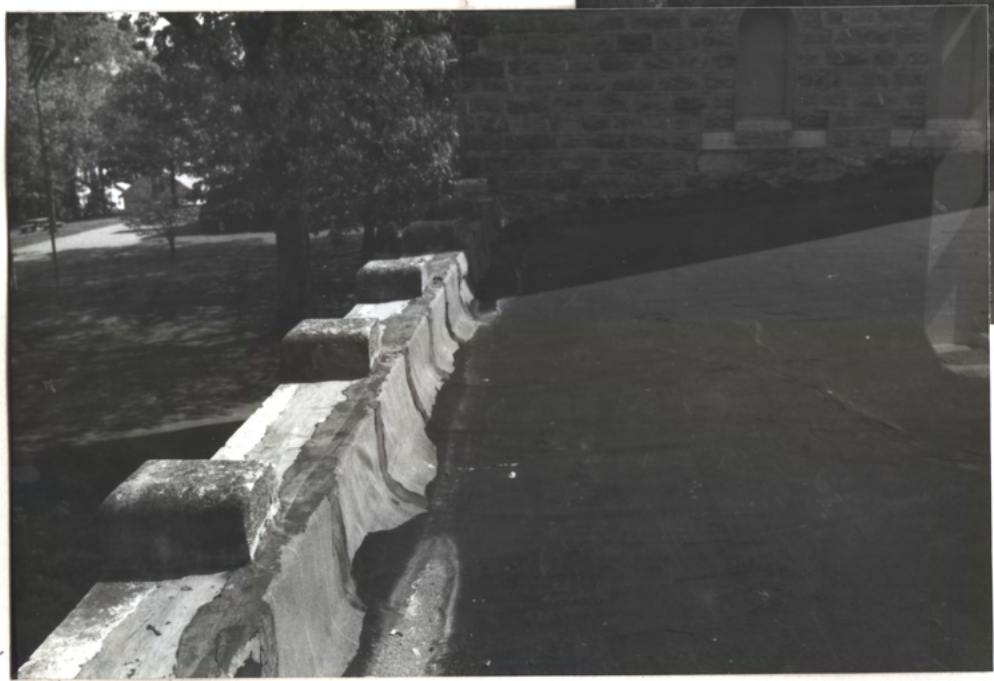
"Crickets" shed
(later?) w/
con. asbestos tile
on walls

Grp timberline asphalt
shingles (not shed)
SHEET.
(CARRIAGE)
ROOF

Orig. roof = gray slate
(found pieces in attic)

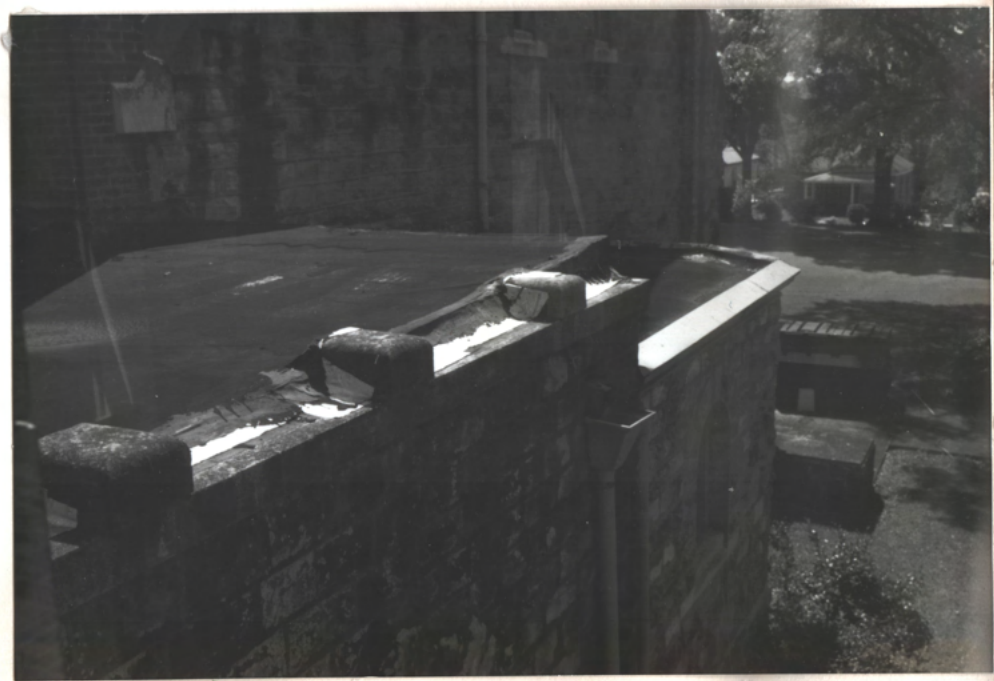
Looks like single-ply roof (type?)
said installed in recent years

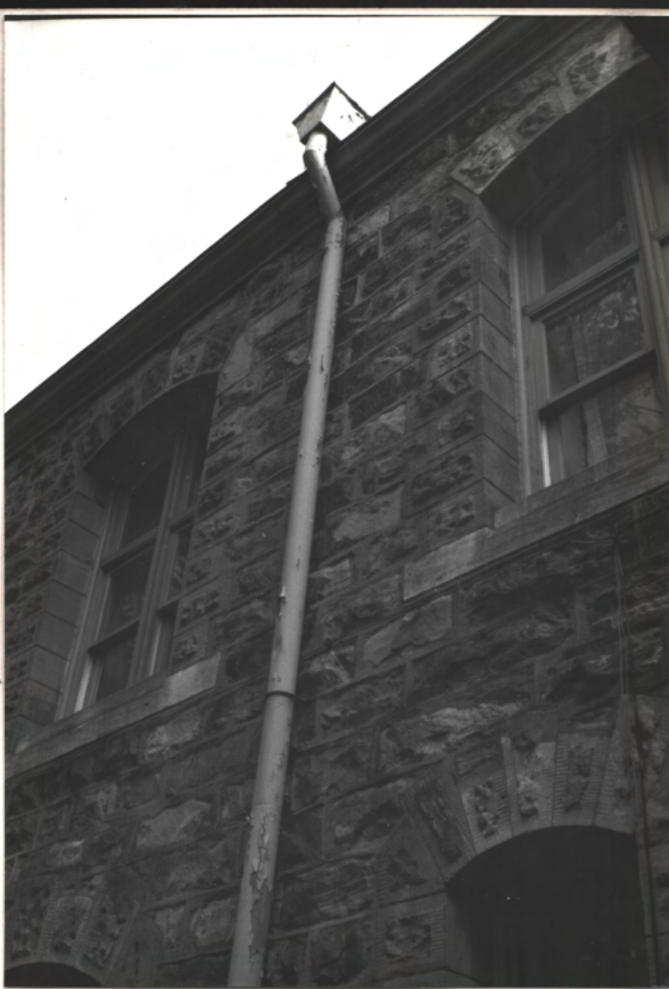
W. wall of S.E. - CR wing

peeled
paint =
gals. not
cleaned
first, or
wrong paint
or both
(typical)

Paint has generally peeled at the galvanized gutters, leader heads and leaders, indicating the probable lack of proper cleaning of the mill-oil film from the new metal, and perhaps also the use of an incorrect metal-primer. There is now no cure for this except to keep on (proper) painting until all the old paint is finally off. The gutters also, I seem to recall, are not painted on the inside. If not, they typically rust-out in only 12 to 14 years. They should be cleaned and properly primed and painted 3 coats of (1) galvanized primer (2x3) oil base rust-resistant "long-oil" paint.

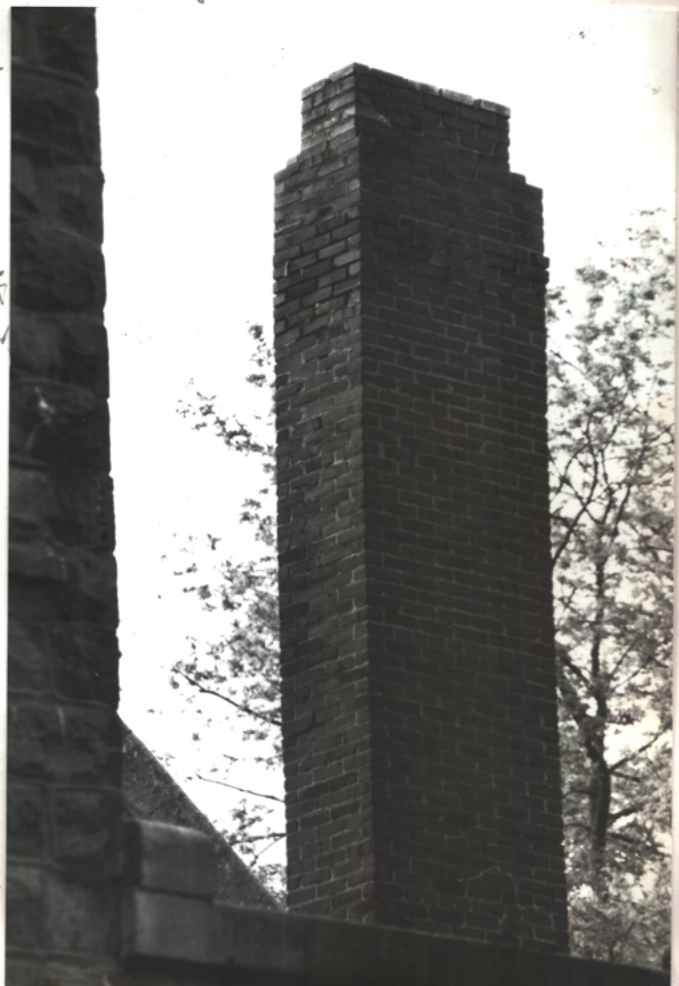
Chim. north of tower. Top 16" not like arch. drwg

Telephoto views of the brick chimneys show many deteriorated mortar joints and no cap-flashings. The joints should be neatly and properly raked, cleaned and tuck-pointed with lime mortar, and the caps completely topped with flashing if the flues are no longer active (flushed if active).

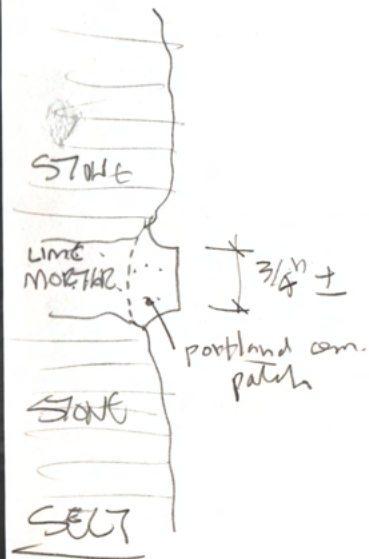
PN
 LM. mortar = original lt. buff color
 lime mortar.
 Dark mortar = c. 1960
 portland cem.

Since the hard modern mortar is apparently merely plastered onto the face of the original eroded mortar there is a chance that it can be removed without significant further damage to the stone and replaced with mortar of the original color, softness and profile. This seems worth an experiment in an inconspicuous location.

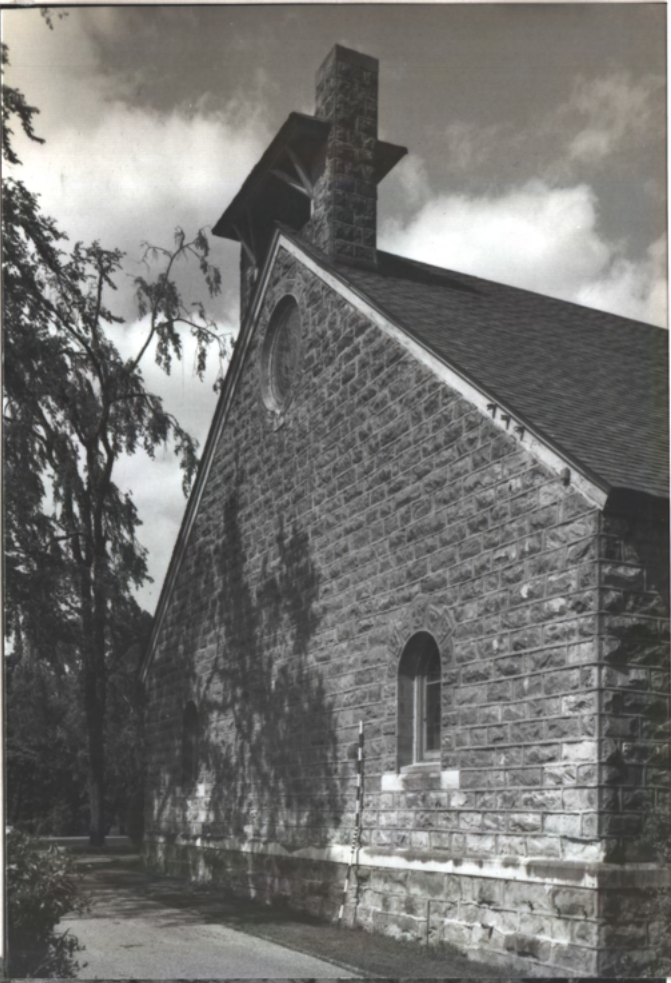
Parish Hall W. W. M.

At S.W.
Corner:
entire face of
stone spalled
1/2" ± 1/2" deep

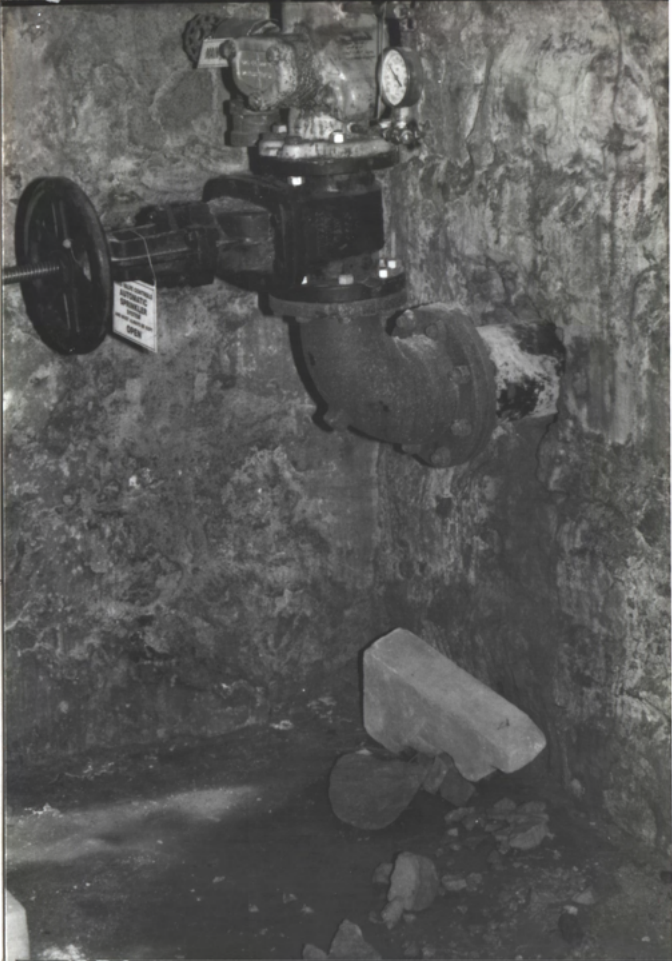
a copious water
leaks in tower
E well (bsmmt)
at recently
installed fire-
sprinkler water
supply

Water evidence in
bsmmt fl.
