**ARCHITECTURAL COLLECTION
OF
HARVIE P. JONES, F.A.I.A.**

**1933 DeSoto State Park
1892 Clanton Hse.,
701 Adams St.
c1900 Coffman Hse.
1888 St. Michael's,
Anniston, AL
1920's Erskine Tomb
Braham-Goldsmith Hse.,
206 Gates Ave.
1887 Goldsmith Hse.,
506 Franklin
c1900 Wm. Pepper Office,
Athens, AL
1994 Wm. Pepper Res.,
Athens, AL
c1818 Murphy Hse.,
Decatur, AL**

Re: DeSoto State Park Renovation

Photos Nov. 20, 1986
Harvie P. Jones FOLA
James L. Harvin Arch. - Huntsville, AL
DeSoto State Park cabin (1930s)
5188
North Ave, AL
Cabin 12

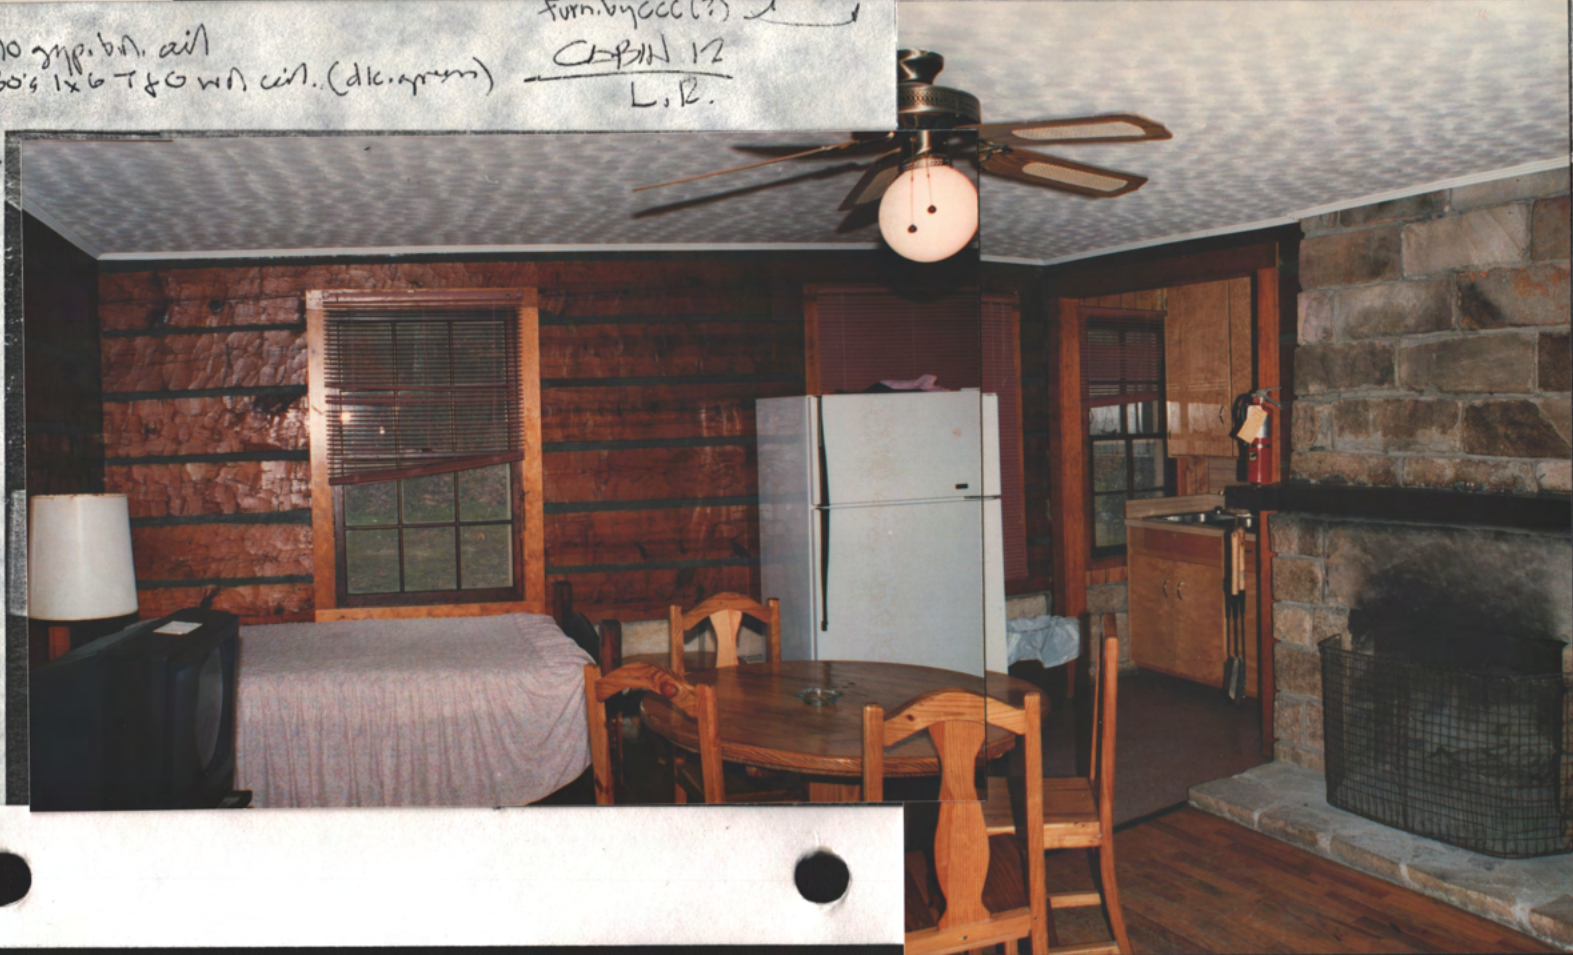
Furn. by CCC (?)
CABIN 12
L.R.

c. 1960-70 ypp. brn. cil
over 1930's 1x6 T&G w/ cil. (dk. green)

All f.p.'s smoke.
No smoke-shelf

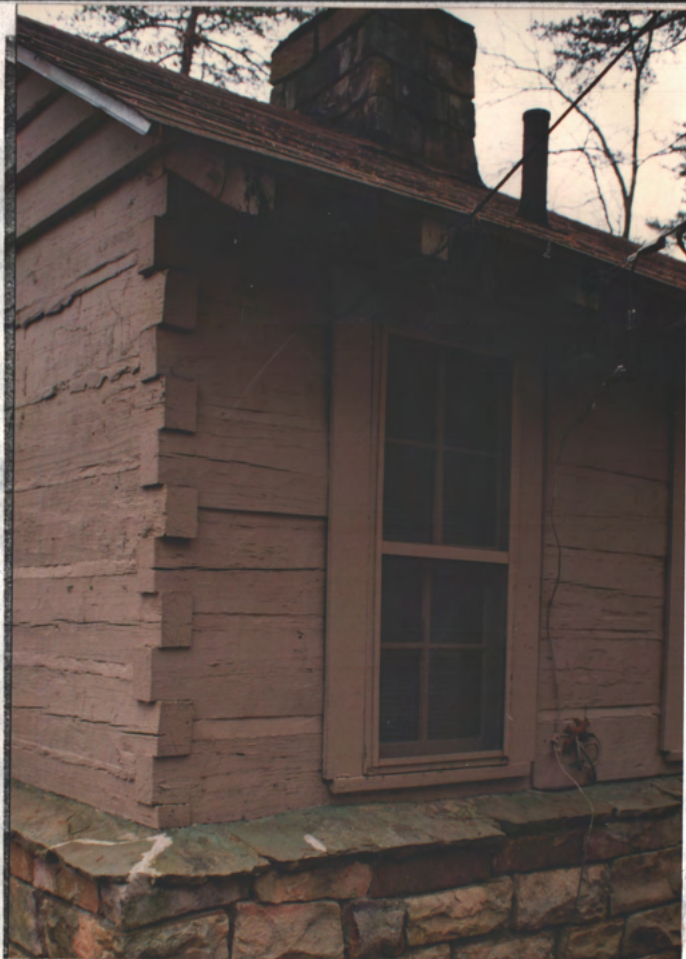
Cracked
jts. - damp
(Portland Cem)

Both the stone and the logs have hard, brittle, gray Portland cement grout. Broken grout is to be removed from the log joints and new daubing of mostly-hydrated-lime is to be installed.

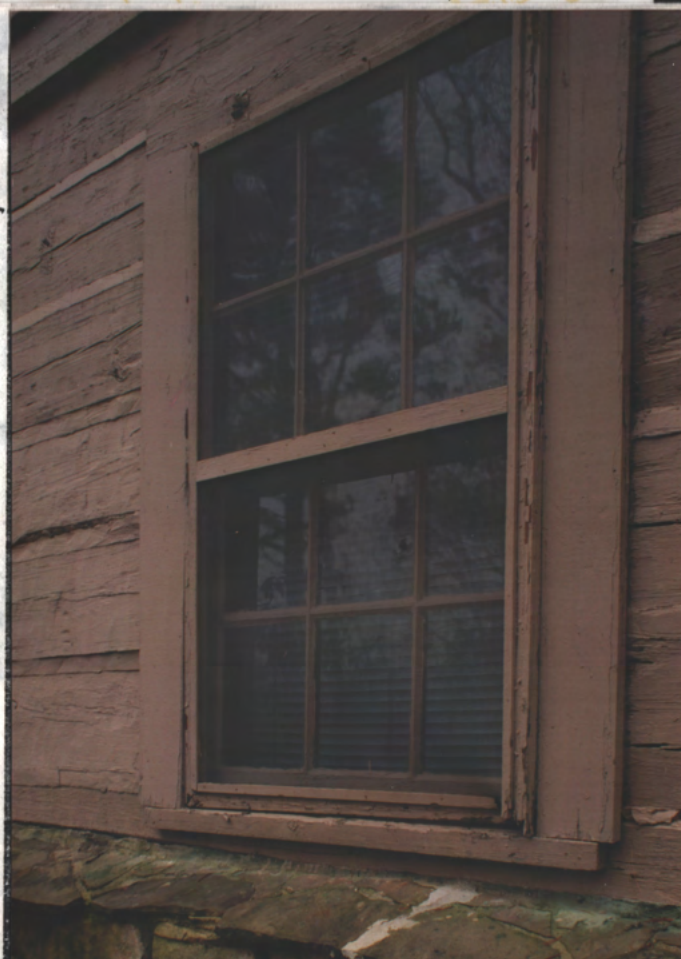
Cracked
jts. damp
(Portland
Cem)

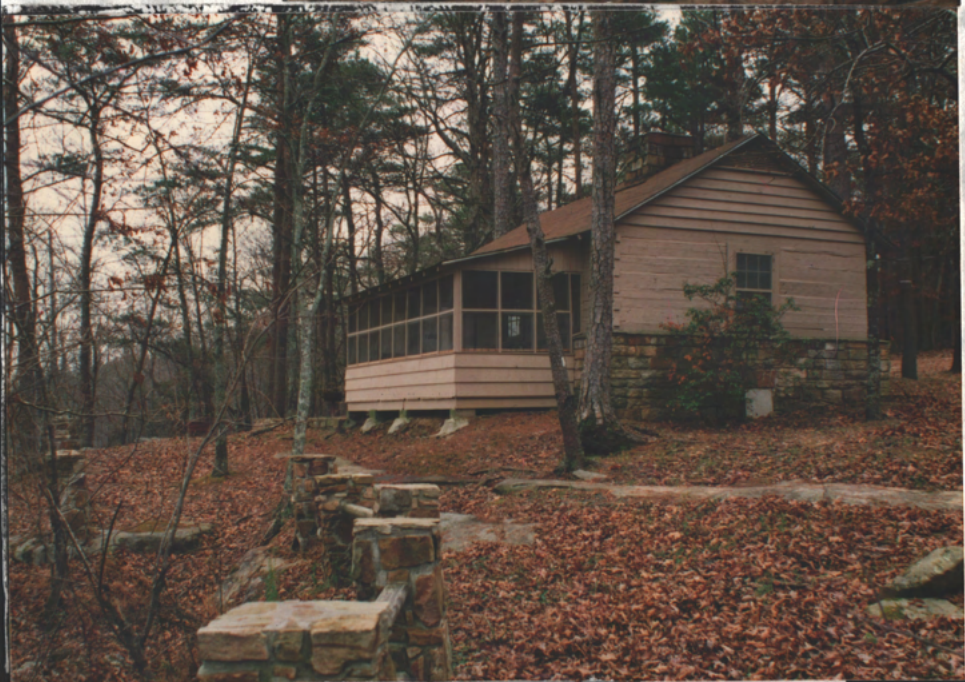
deterior.
Screen frame

The window-screens are aluminum, with approximately 3/4"x2-1/2" wood frames and 1/2"x3/4" batten-strips. Many need repair.

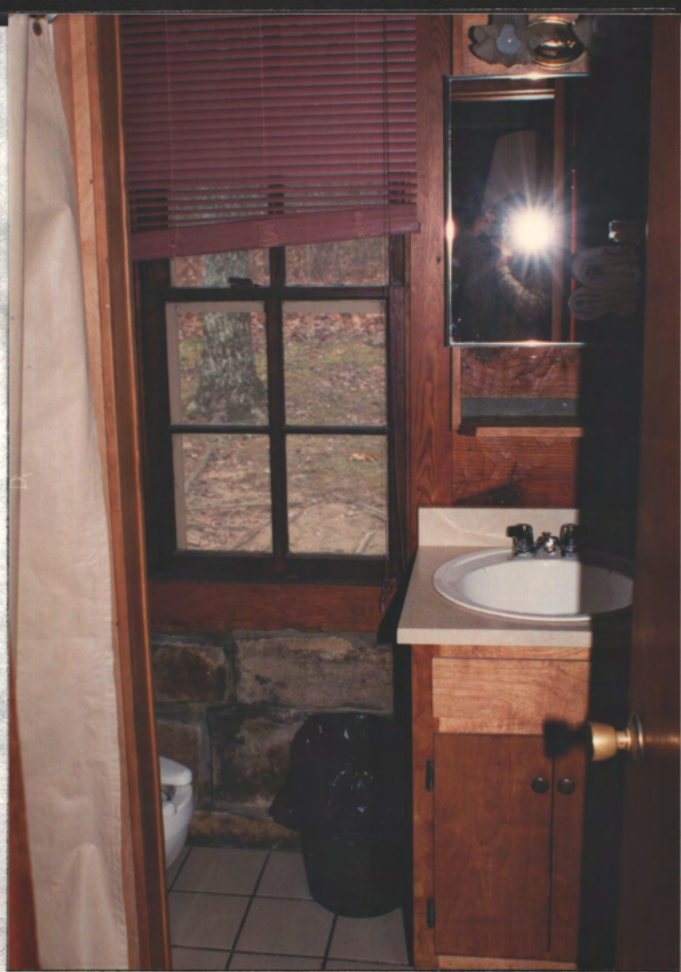
B.R.

↑ c. 1960-70
door block

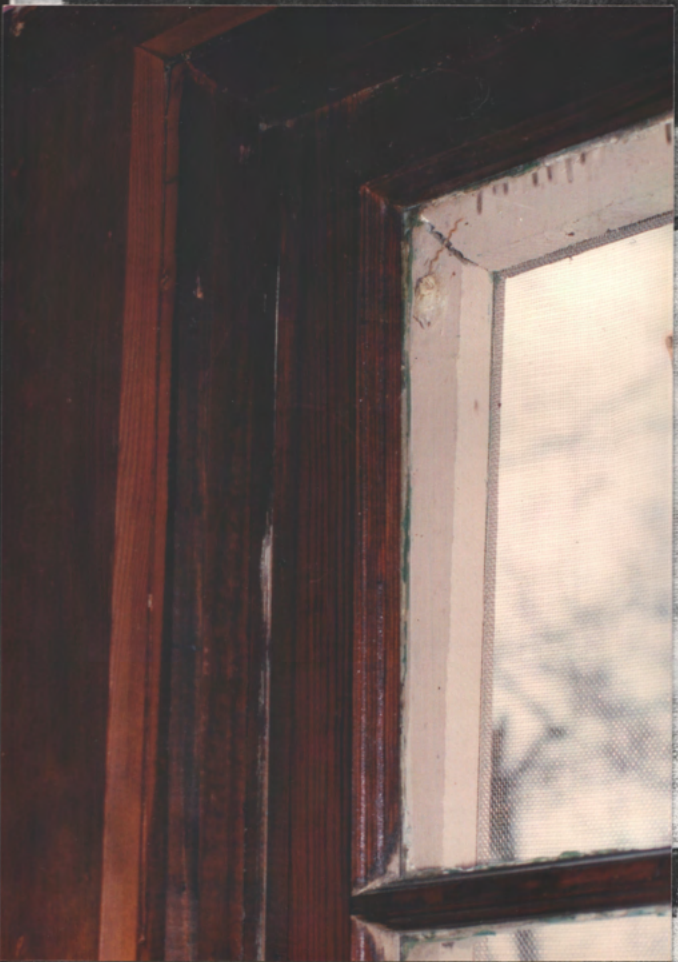
no evidence of ropes or pulleys.
No weatherstrip

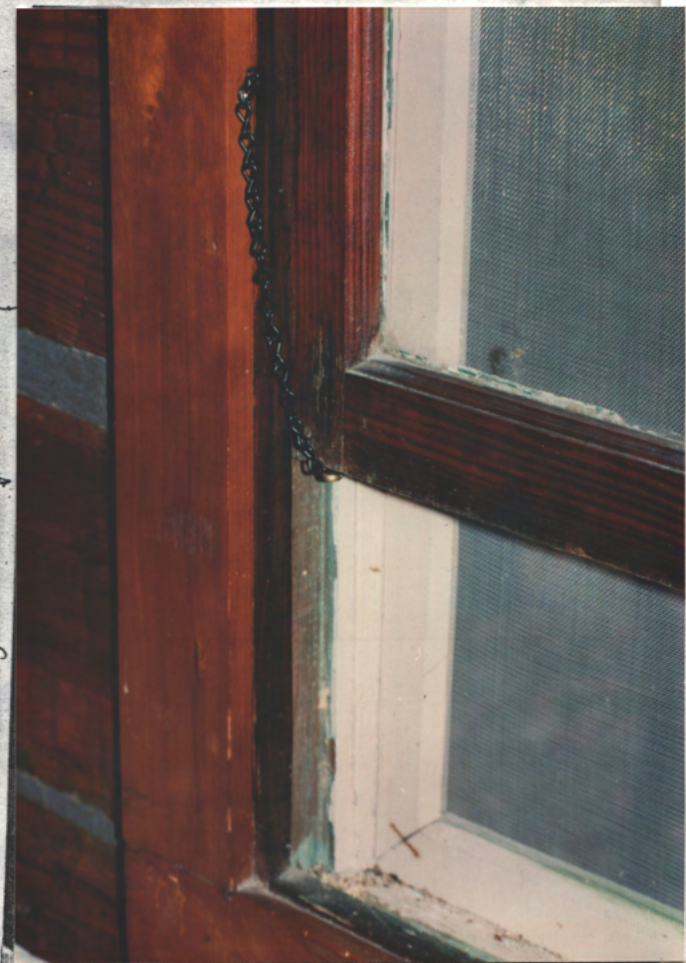
There is no evidence of sash-pulleys, so the sashes apparently always were sliders. One cabin (No. 12) has an early 1800's type holdopen, a series of drilled holes in one jamb and a 1-1/2" brass cotter-pin clamped to a metal toilet-float chain. The pin is inserted in a hole in the jamb to hold up the sash. All the sashes are to be similarly equipped. See photo Page 4.

metal chain

STGH
HOLDUP
brass
copper
pin in
drilled
holes in
joints

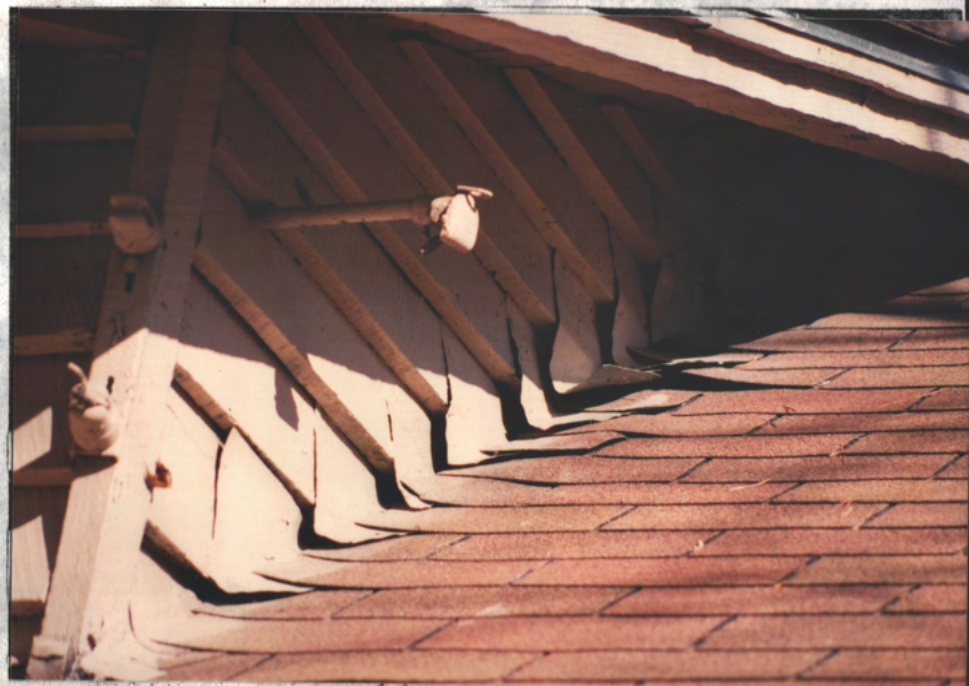
Cabin 10 (Cabin 7 = same.)

These two not in 1936 map.
Probably late '30's or
late '40's (?)

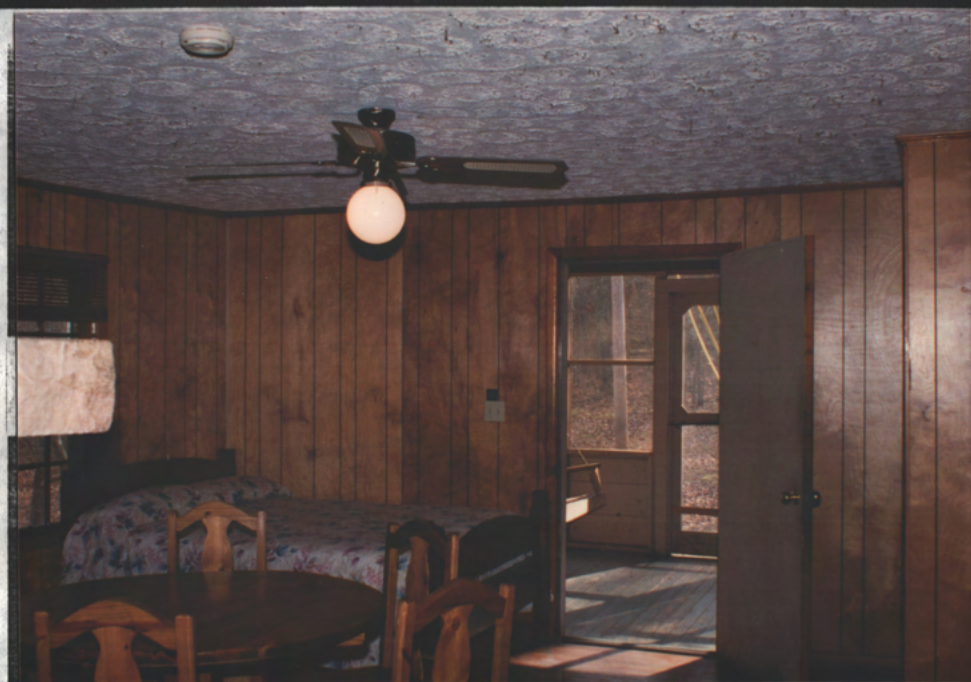
L.R.

fans
probably
1960-70
(?)

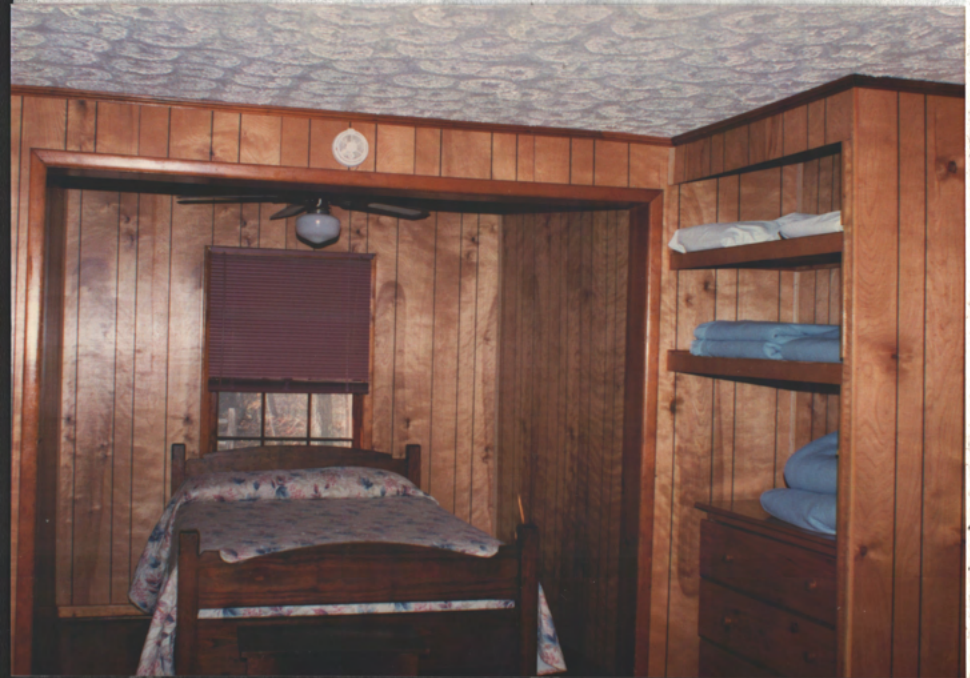
B.R.

app. b.t.
ceil.
probably
c.1960-70
phy. panels
probably
c.1960-70

The interior wall faces of perhaps half the rooms were covered with cheap pre-finished plywood paneling in perhaps c.1960-70. This is to be removed unless unexpected problems are found behind them. The type "D" frame cabins (7 and 10) probably have planked interior walls (to be confirmed).

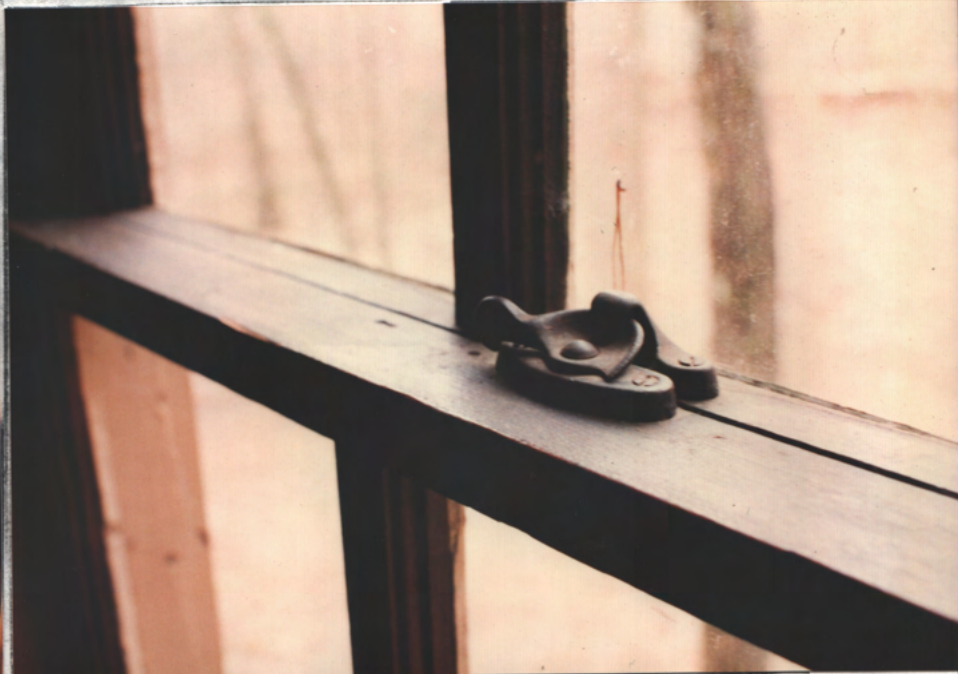
Cabin 2

The sashes and their hardware, except in Cabin 1, appear commensurate with the 1930's. The narrow 4/4 sashes have a thick center vertical muntin like a Victorian sash, but they are apparently 1930's sashes.

Narrow 4/4 sash w/ thick vert. center muntin
(Vic. style, but appears 1930's-?)
Moulded sash lock

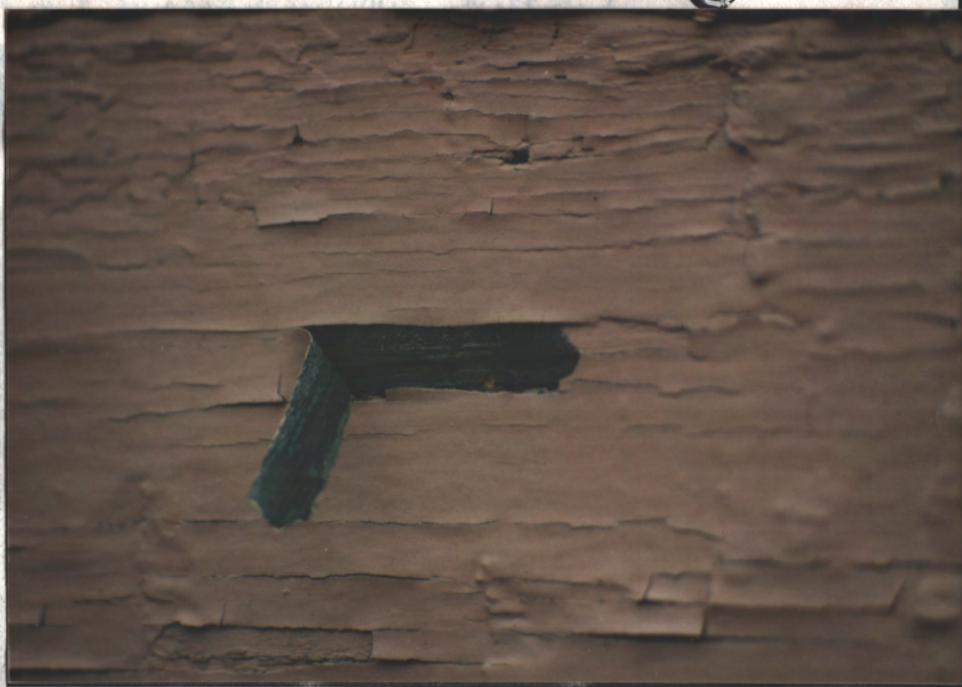
Cabin 2
(typical)

The original exterior finish on the logs and other exterior wood was a dark green penetrating stain, which probably contains creosote because the later paint layers do not and have not adhered to it. We know of no cure for this. We will brush off the loose paint (a light beige color) and repaint the original dark green, which is not only appropriate but will look less spotty when it again peels (the second finish layer of paint, was also dark green). See photographs on Page 14.

Bottom layer is dk. gr. 57W11 (not paint) -
may have creosote in it, causing peeling of all later layers

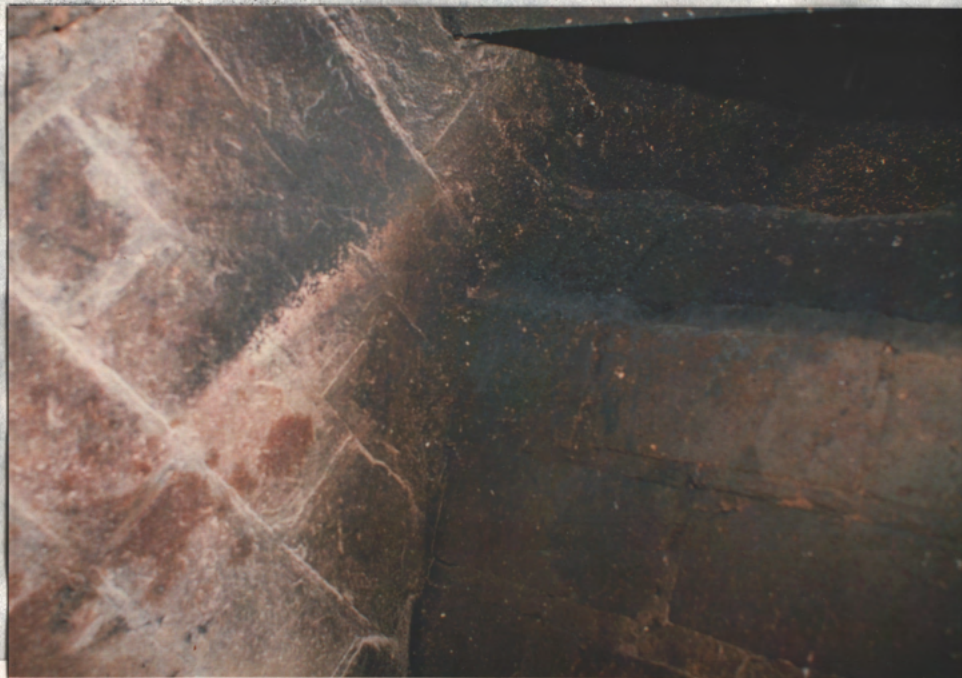
fireplace. Virtually no smoke shelf (F.P.'s smoke)
