JONES & HERRIN

Re: 1859 Greensboro Presbyterian Church
Project No. 96026

1859 FIRST PRESBYTERIAN CHURCH, GREENSBORO, AL. PHOTOS FEB. 1996 James H. Merrin Arch. - Annie P. James FAIA

First Presbyterian Church
Greensboro, N.C.
photos Mar. 1996 Haire P. Jones FAH
for spine & tower restor.
(blown off in c. 1960 & built as above)

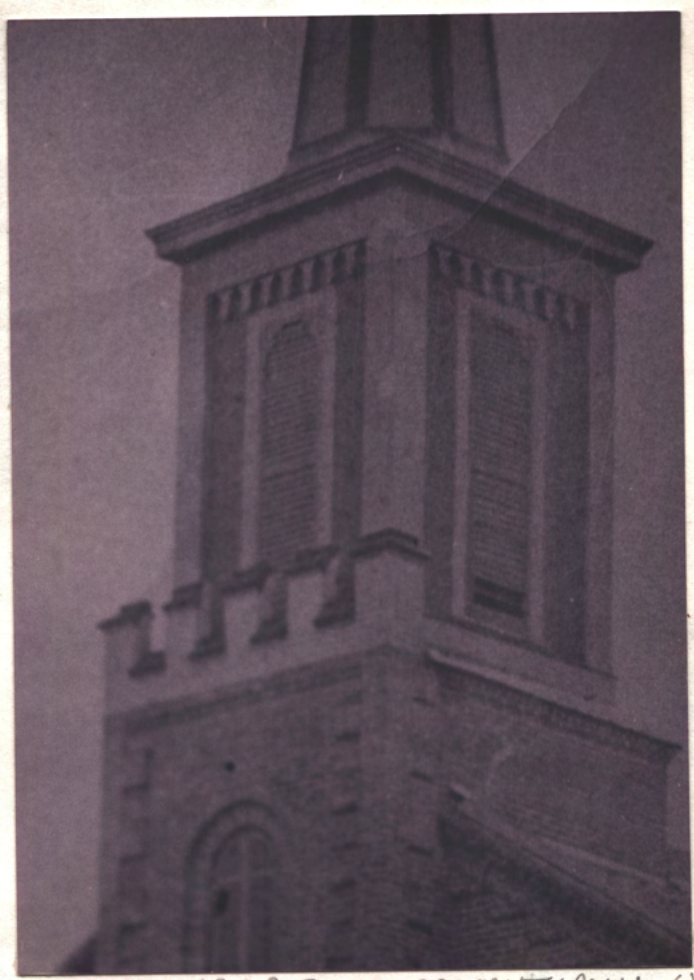
1859 Pict. No. 614. GREENSBORO

HIST. PHOTO SHOWING ORIGINAL SPIRE + BELFRY (later lost)

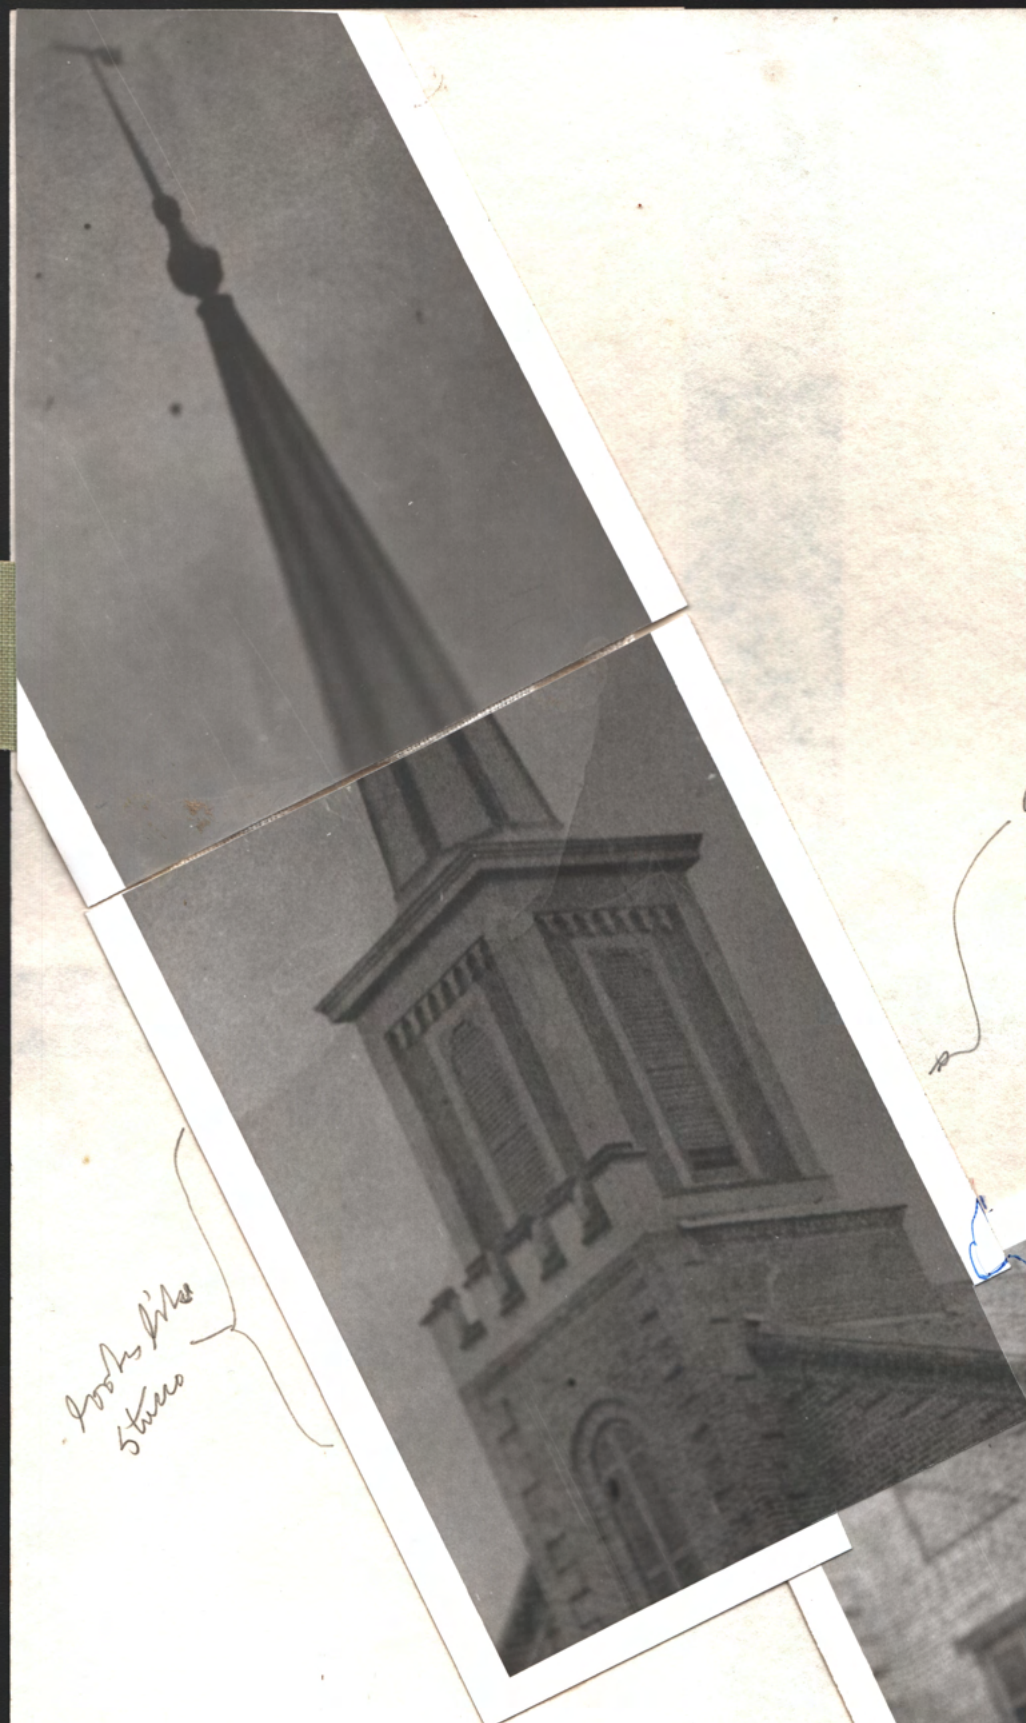
Probs like
Stucco

Corbelations not on sides because
would block roof drainage &
add too much wt. to timber
beam supports at sides

note half-round
gutter

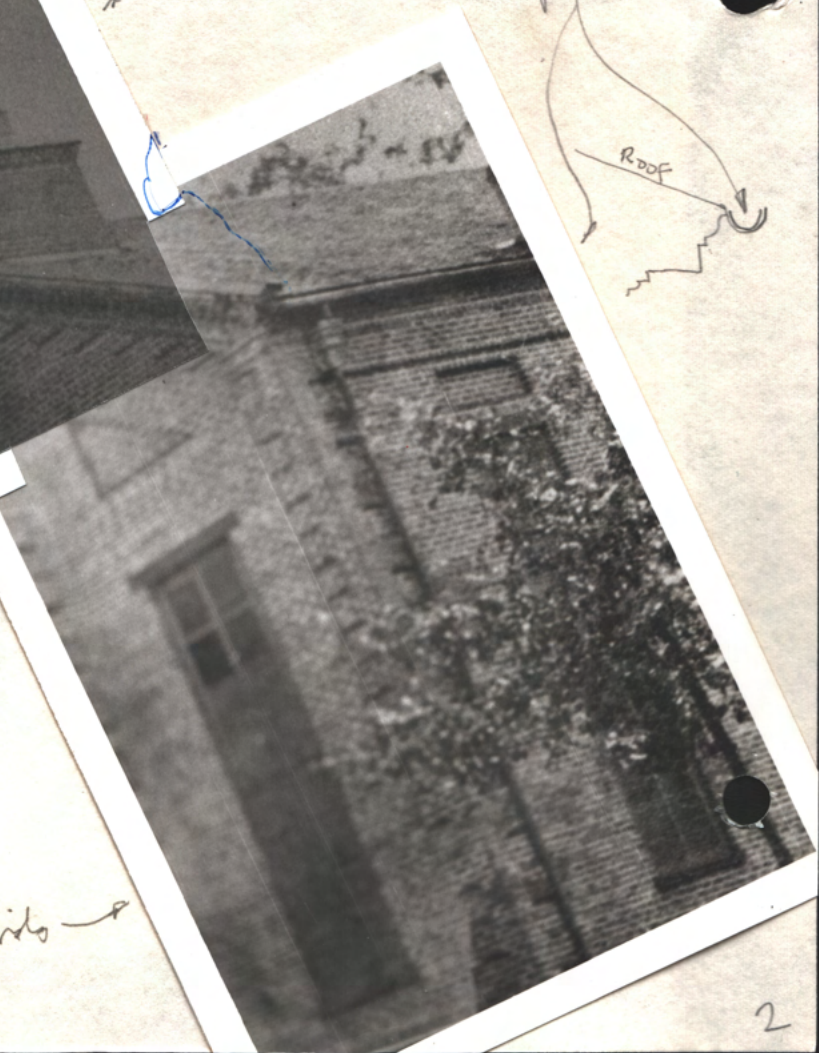
Hist. photo
original copy.

± "Mission Style Gothic"
remodeling of perhaps 1920's
Not original

note stone flue
(now gone)

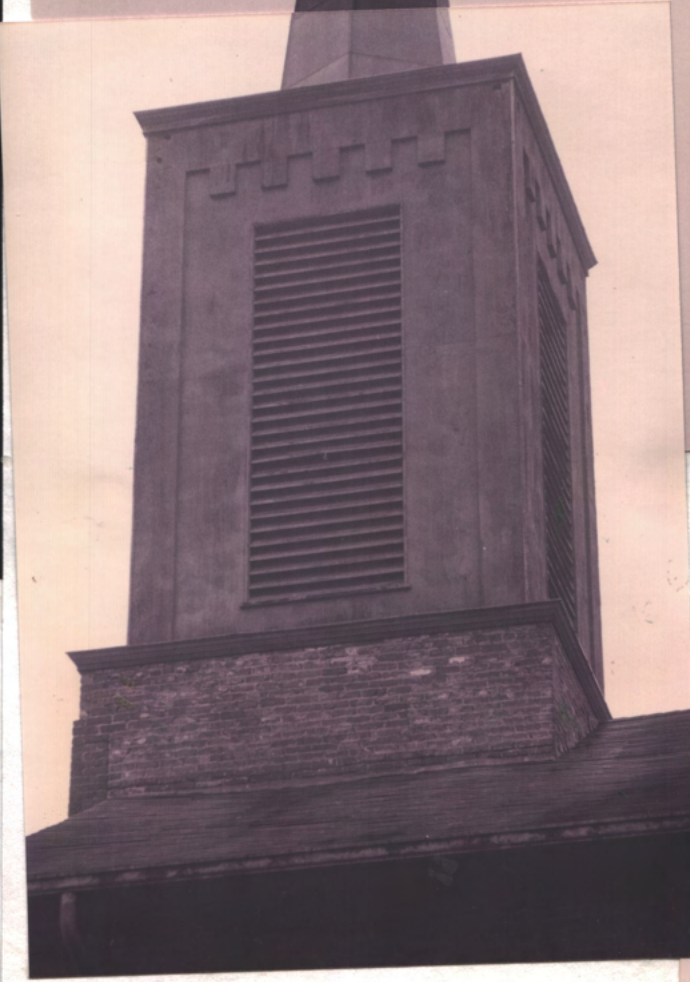
modern gutters
(orig. gutters cut off)

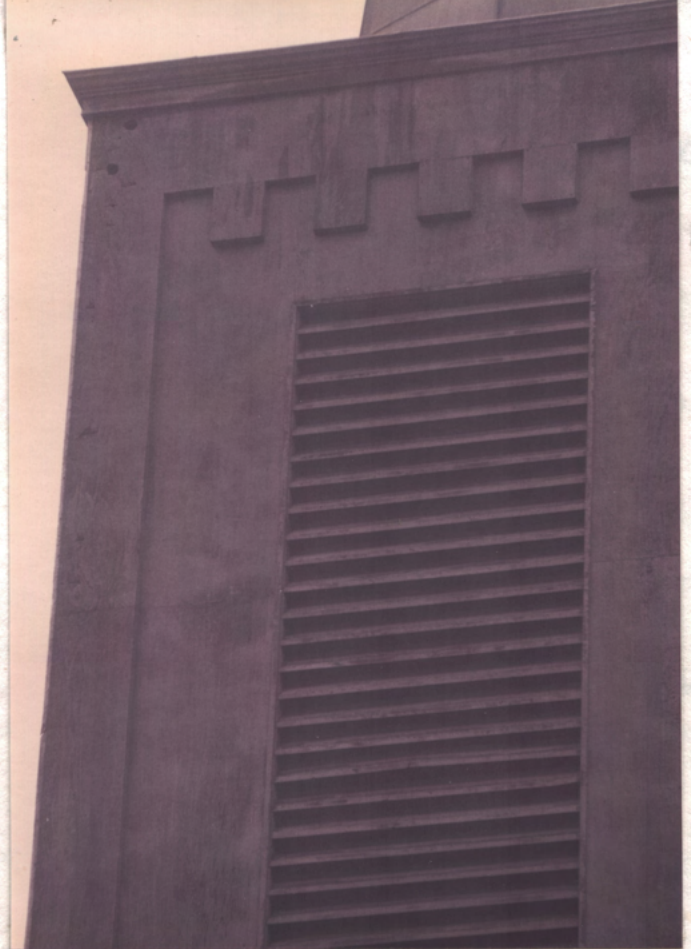
c. 1960 plywood

c. 1960
P. Kewitt
(storm)

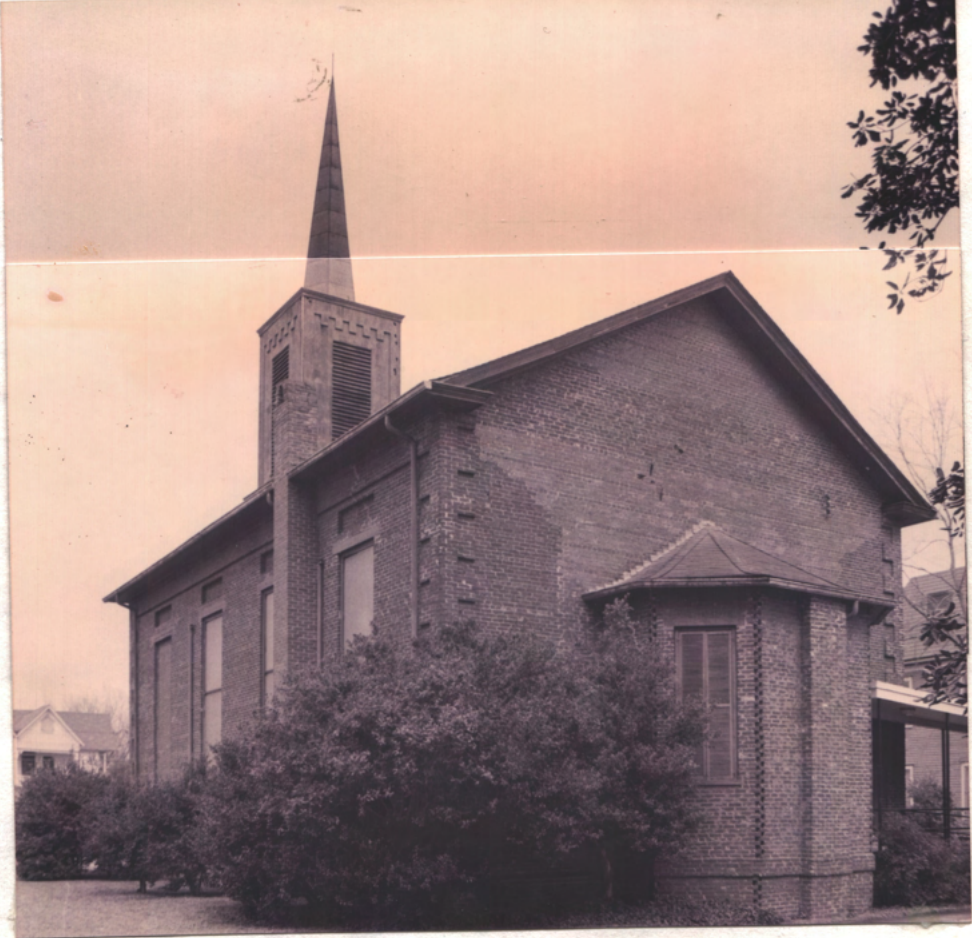
→ reveal bricks =
Storm damage of
fire apse window (?)

→ Apse added at
turn of century

modern gutters (original cornice mould cut off)

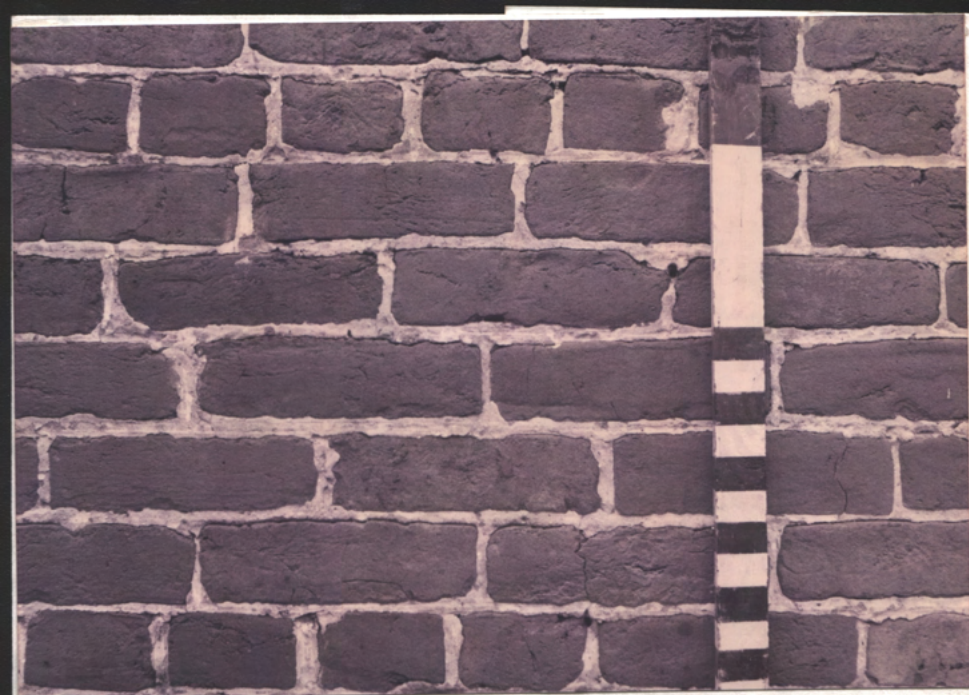
Unrepointed brick at
west wall

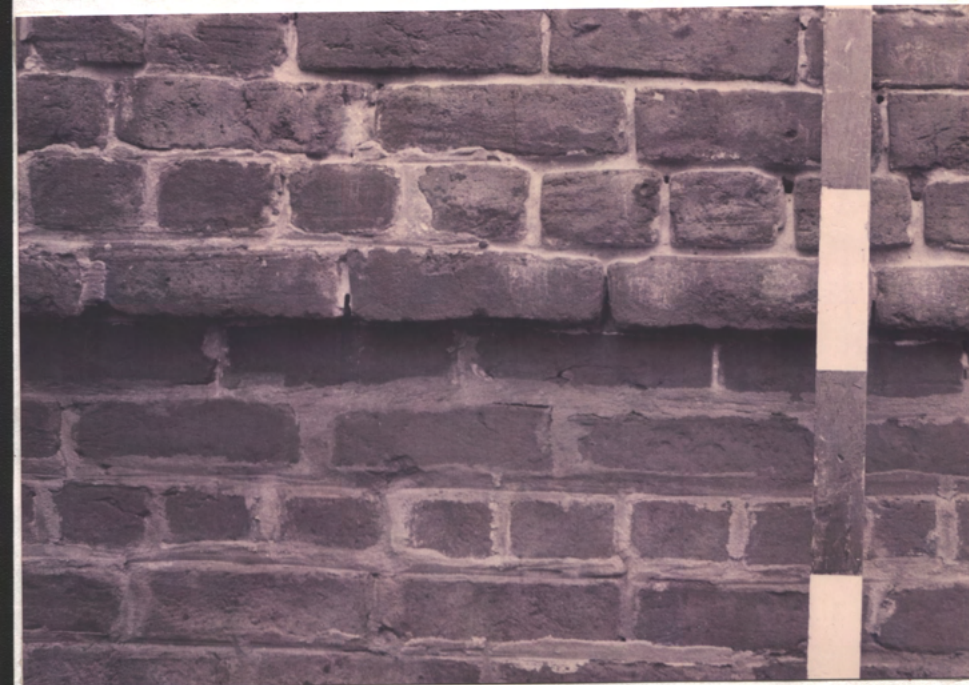
↓ Sloppy repointing at
west wall

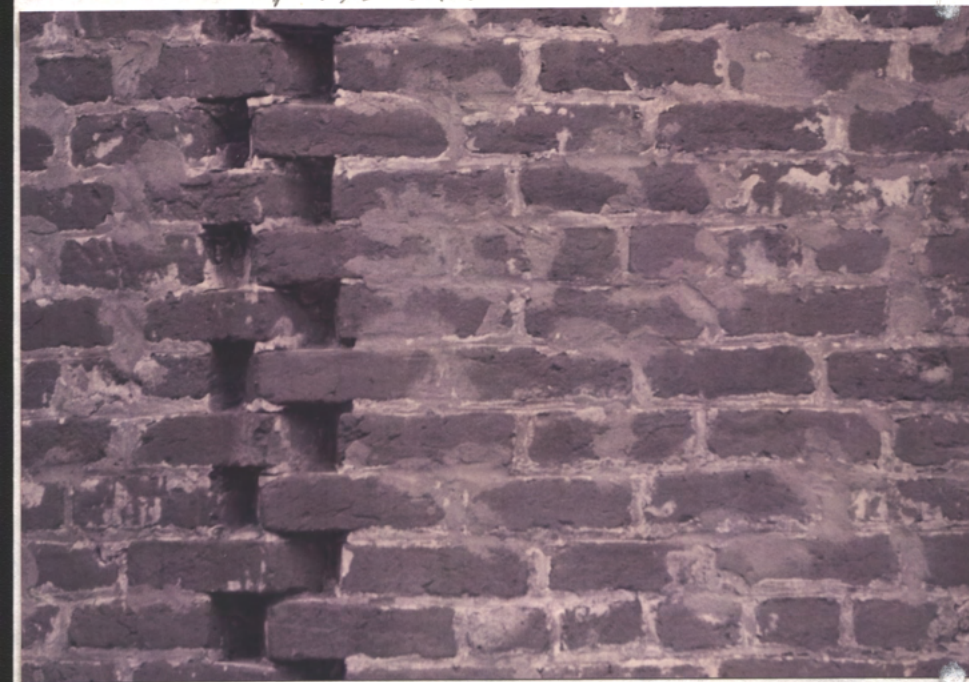
→ S. Apse, sloppy brick repointing

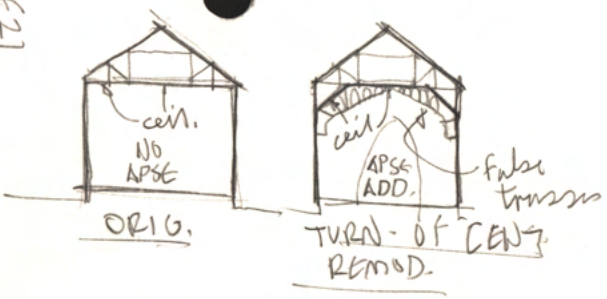
false trusses were
turn - of - 20th cent.

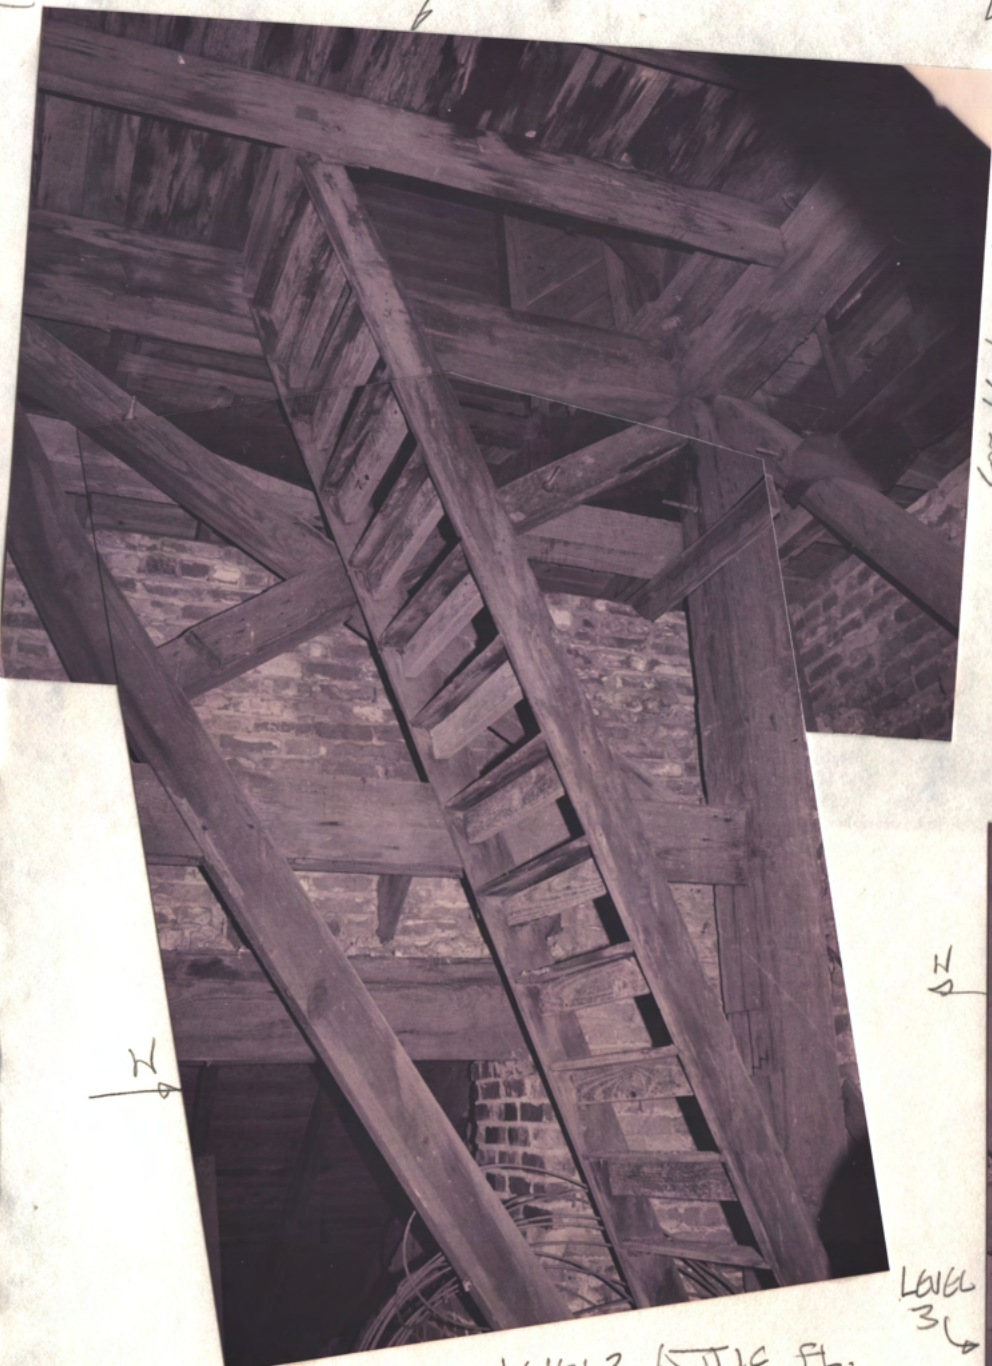
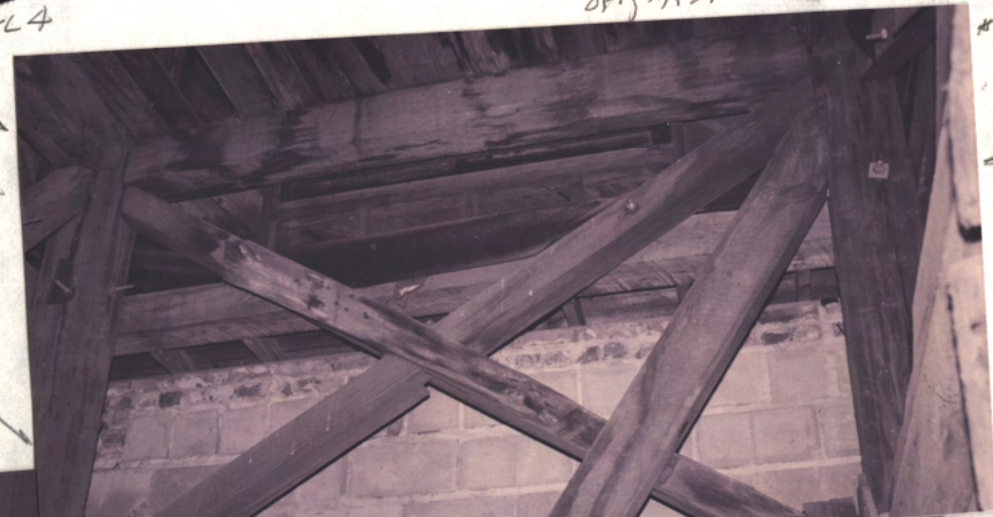
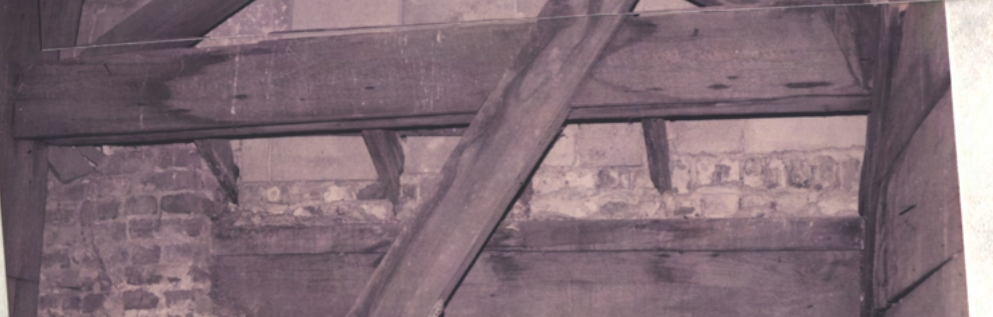
LEVEL 3, STEEL FL.
(IN TOWER)

modern (c. 1960) gals, bolts
to reinf.
orig. frame

Core. block wall from
storm in mid 20th cent

Timber frame is heavy, has extra
mortises, reused but original to this bldg.

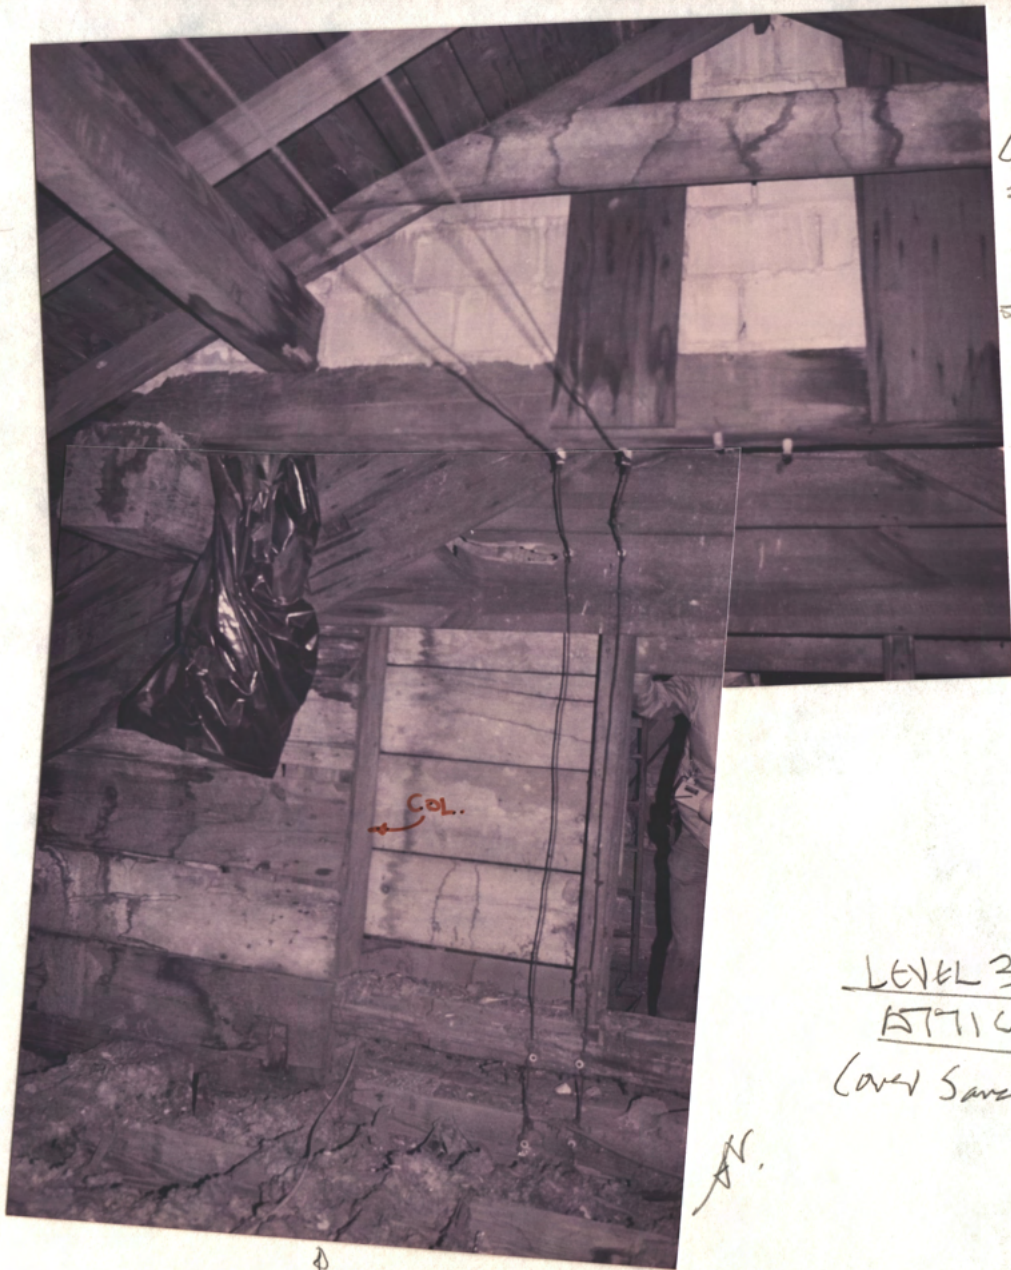
LEVEL 3,
157116
(over Sanct.)

Core. Wk.
= c. 1960
Storm
repairs

↑ beams cut, down to
balk. below, of main fl.
See rt. photo

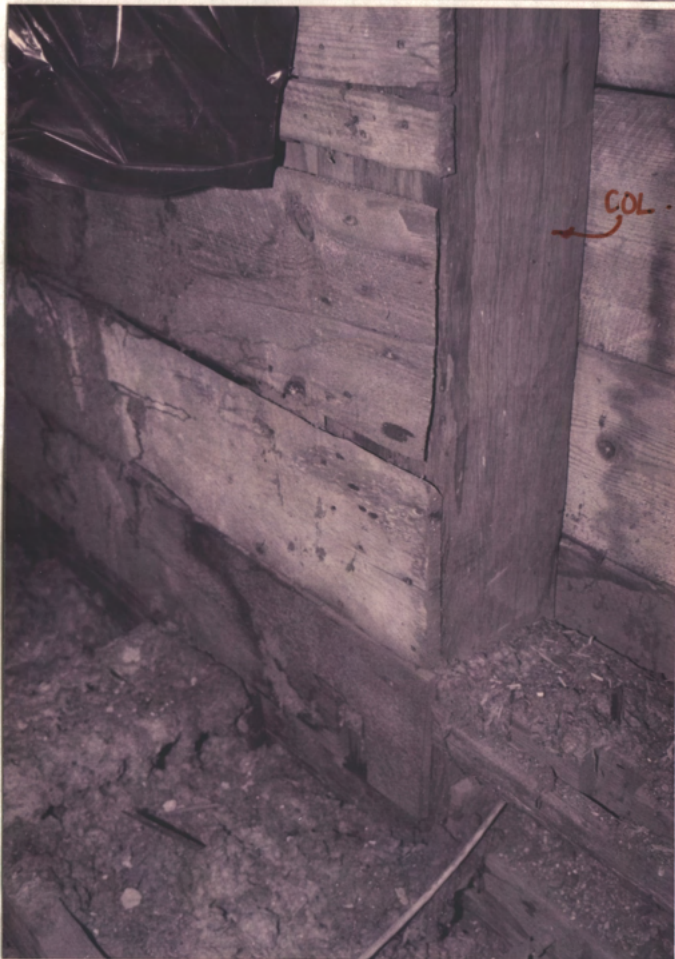
note
decay.
wall painting
from orig.
Sanct.
configuration

← beams
orig. col.
from tower
above, down
to balk. of
main fl.
below

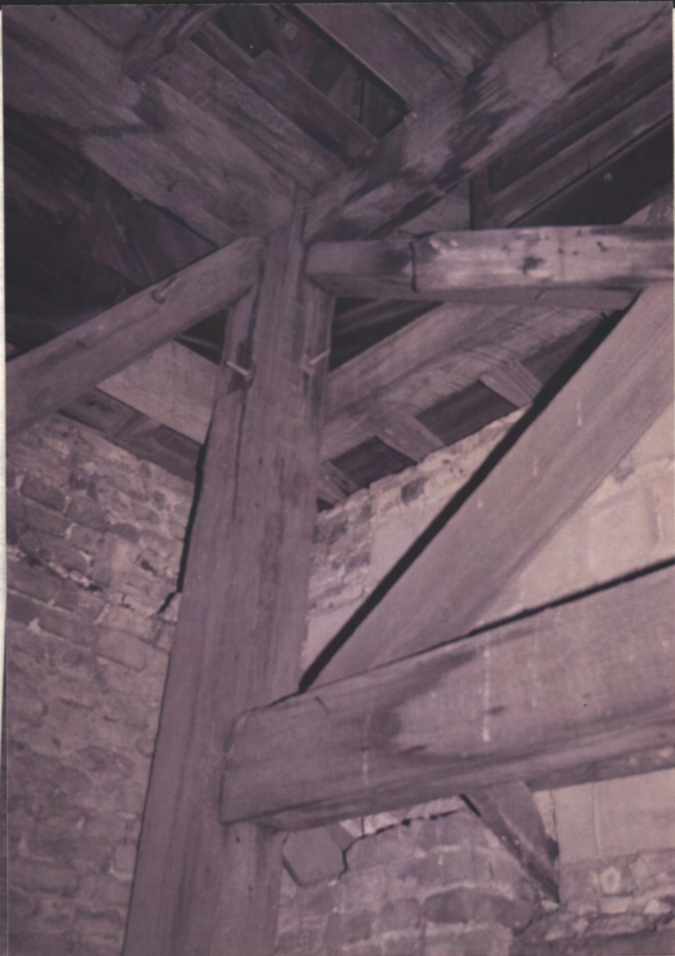
LEVEL 3 ATTIC
(in tower)

note down. wall paintings,
(covered by early 20th c.
ceil. change)

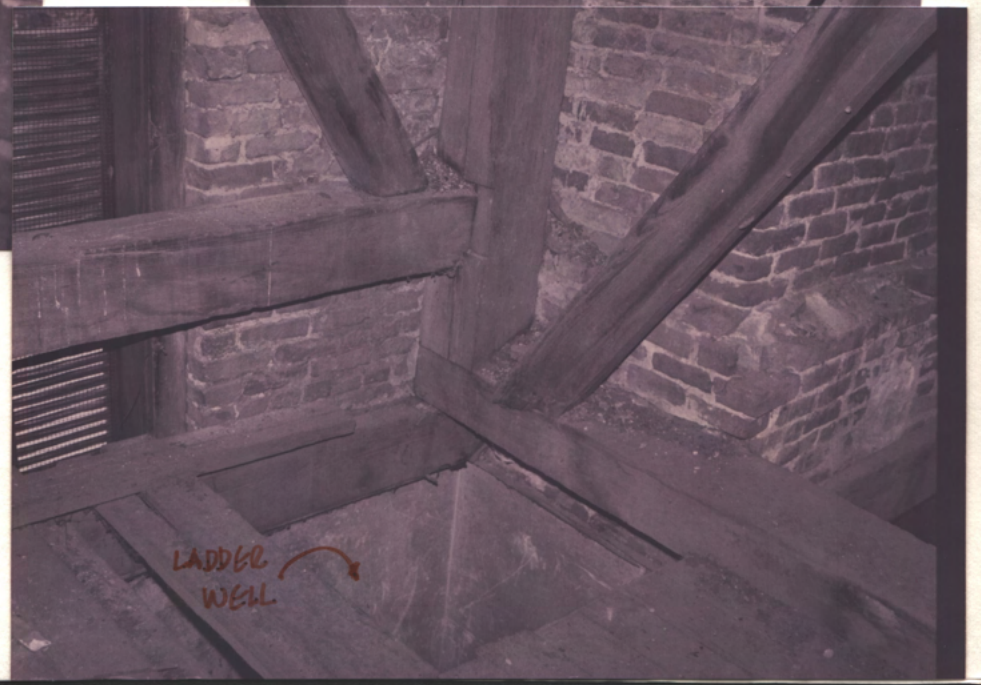
LADDER
WELL

c. 1960
SPIRE
ABOVE
LEVEL 5

(cables and tie-downs
for spire (2 cables))

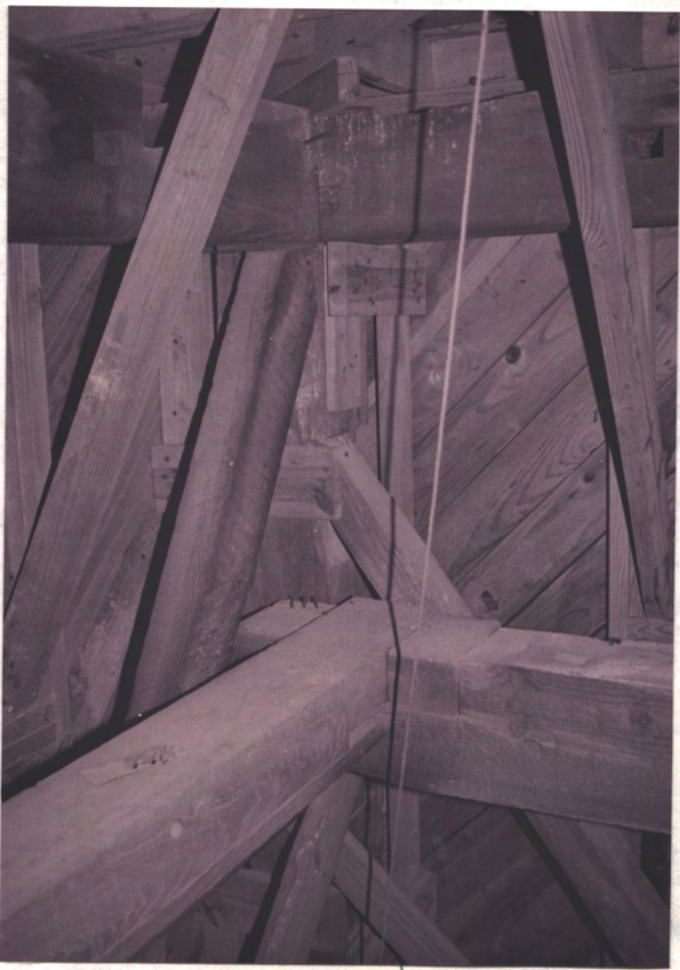
LEVEL
 43/4

note
 extra
 mortise

c. 1960
 sheath
