Re-1987 Overview of Restor. needs

May 5, 1987

Cathedral Church of the Advent  
Building Committee  
20th Street  
Birmingham, Alabama

Cathedral Church of the Advent  
(Episcopal)  
20th St. & 6th Ave  
Birmingham, AL  
built 1893  
photos Jones & Herrin,  
Architects, Huntsville  
Harvie P. Jones, FAIA  
May 1987

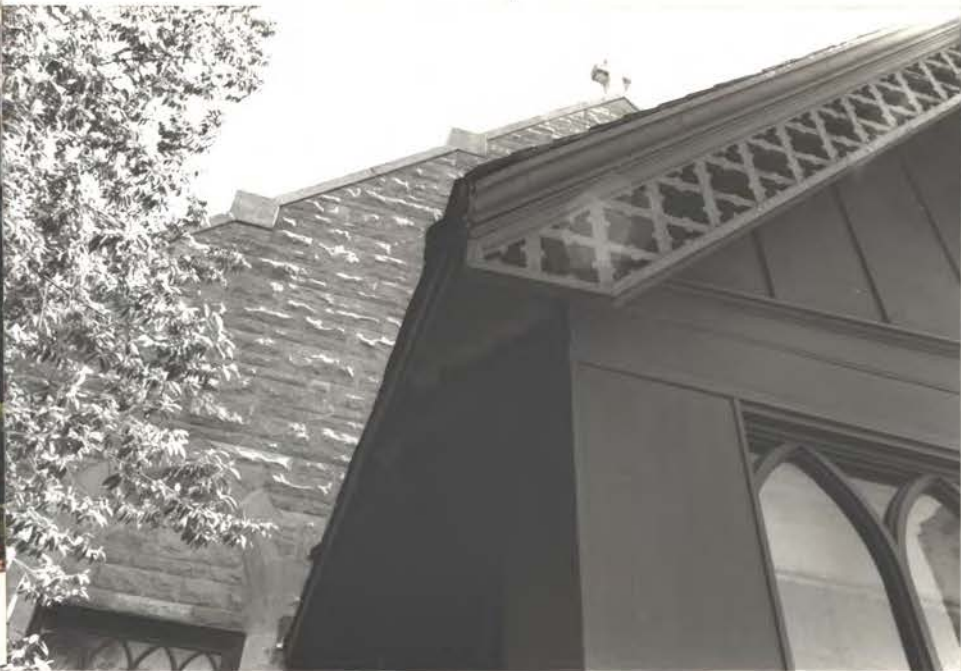
no metal eave-flashing.  
Water goes into eave-ward  
↓

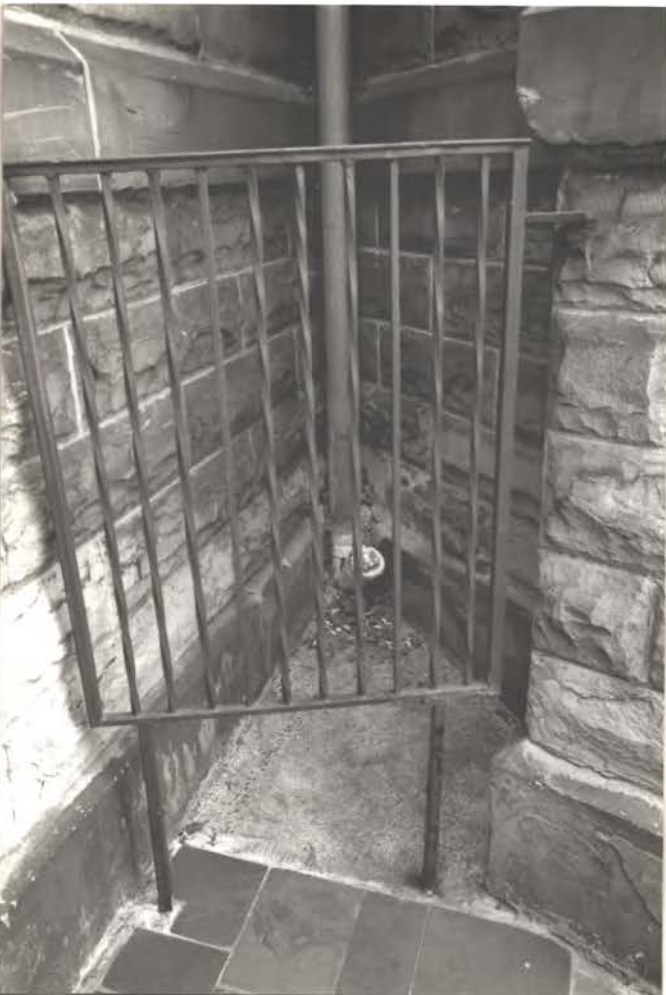
Drain at S.E. corner  
of N.E. "Chapel" (organ chamber)  
No stoppage-relief opening

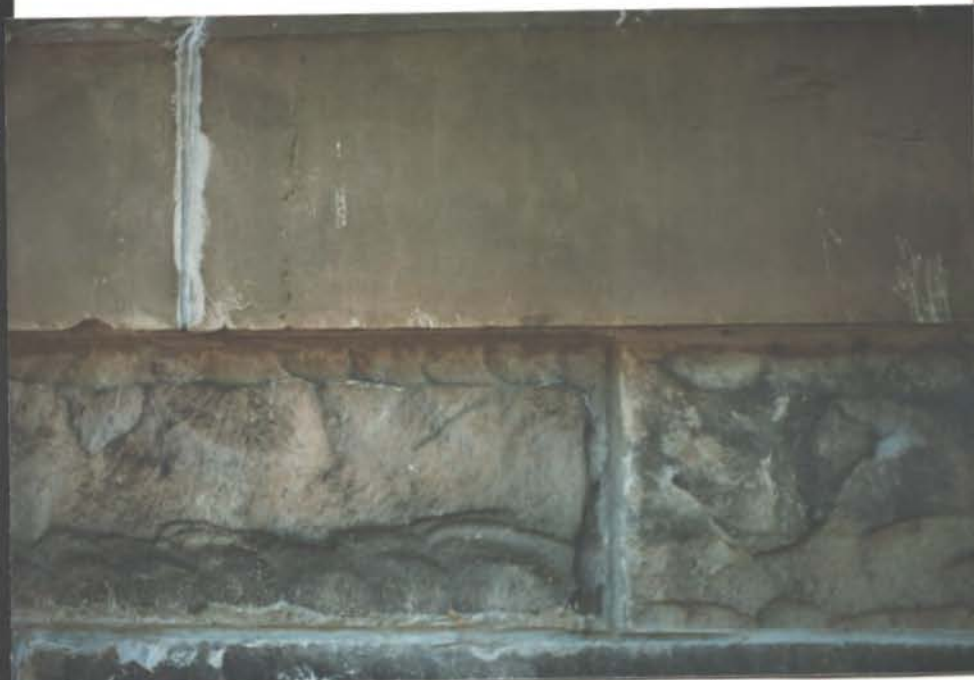
4. Many mortar joints appear to have been re-pointed with gray portland-cement based mortar. Portland cement is much harder and more impervious to moisture than sandstone. This can trap moisture in the stone above the cement, causing stone freeze-spalling. The cement will not "give" in temperature expansion of the wall, as will lime-based mortar, sometimes causing stone cracking and spalling. It would be desirable to remove any portland-cement mortar and tuck-point with a more resilient mortar that is primarily lime-based, which is likely to have been the original mortar composition. (Reference: Photo 6-1, 6-2, 7-1, 8-1, 9-3, 9-4, 10-1, 10-3, 11-2)

apparent portland cem. re-pointing 1  $\frac{1}{2}$  N

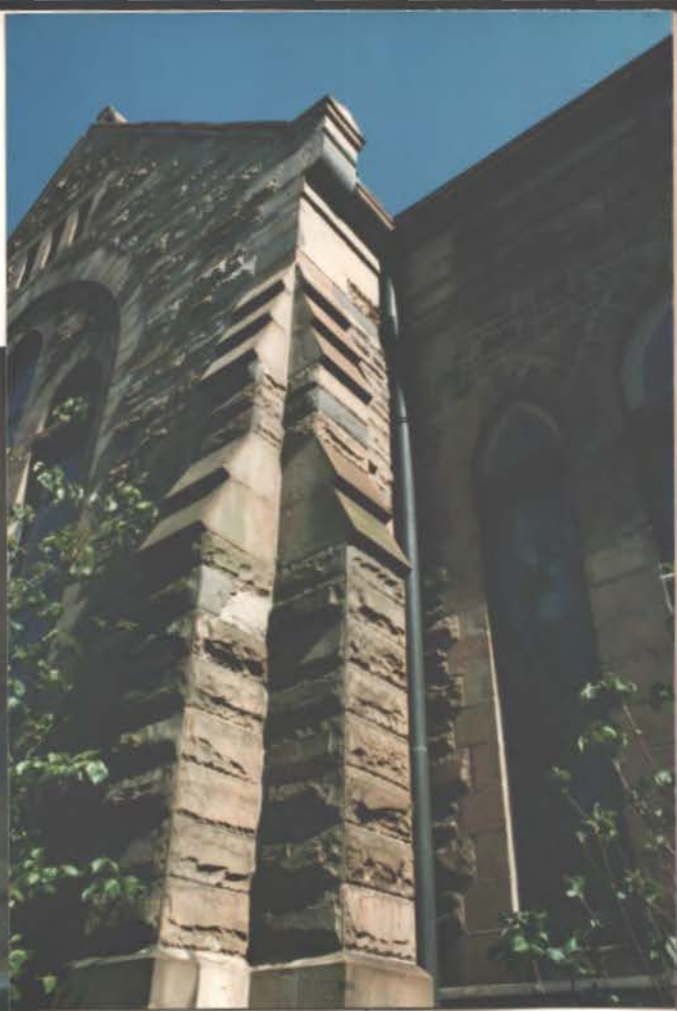
6. Water-stains on the walls below the gutters at several places on the sanctuary indicate either gutter leaks or overflows, or stopped-up leaders. Some open gutter joints could be observed. Gutter and leader sizes should be checked for adequacy per accepted "Architectural Graphic Standards" sizing chart. Joints should be checked and properly repaired without the use of "roofing cement". All leaders should have a "stoppage relief spout". Water stains on walls at roof valleys may indicate that the valley water rushes over the gutter lip. (Reference: Photo 6-2)

2 N → overflow spill from valley

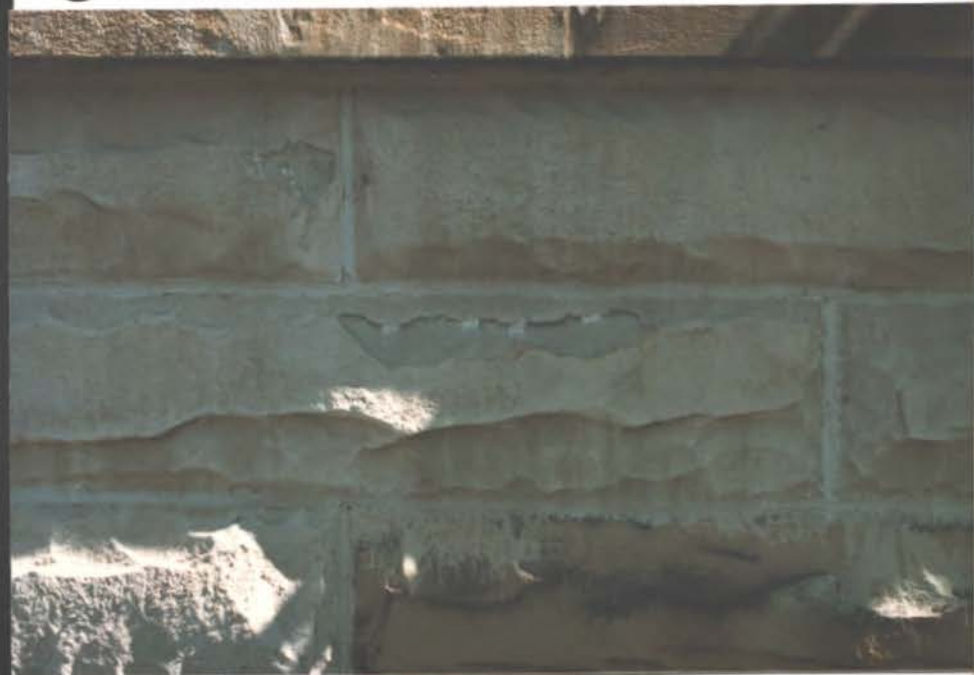
2. Many stones at various heights and locations show freeze-spalling due to moisture getting between the stone stratum planes, which appear to be laid in the vertical plane instead of the horizontal plane contrary to the advice of the architect Vitruvius in his books of 2,000 years ago. (Reference: Photo 6-3, 8-2, 9-3, 10-1, 10-3, 11-2)

3 Spalled & coated sandstone  $\frac{1}{2}$  N

Ribbed & soiled protective glass in steel sash

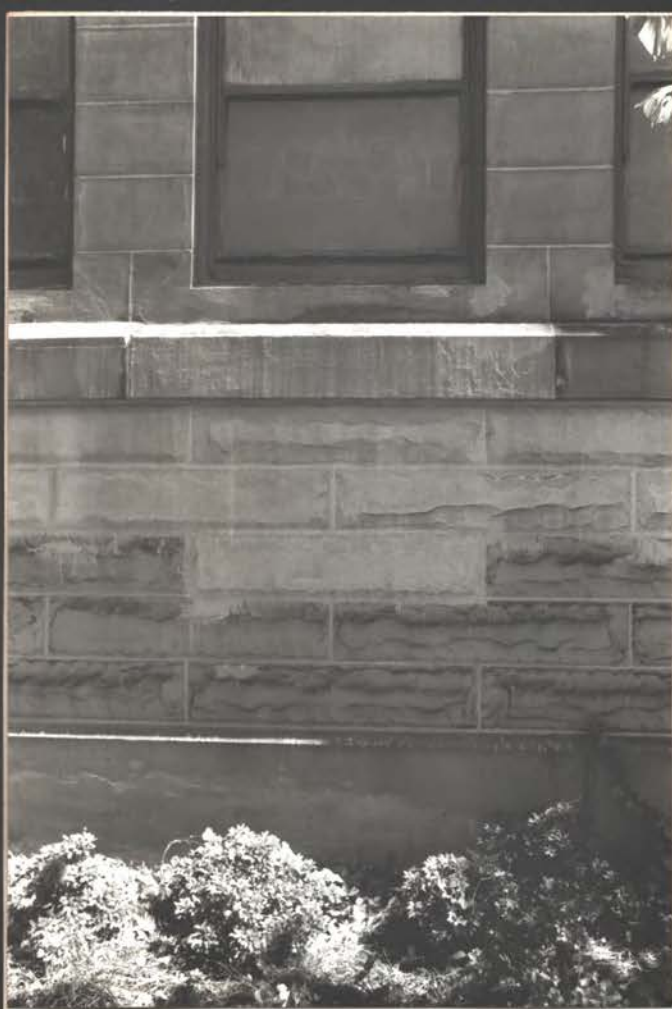
3. Several spalled stone faces have been covered with a thin colored patching material, perhaps "Thoroseal" compound. This film has released in places, allowing water to be trapped behind it in the stone and accelerating the stone deterioration. (Reference: Photo 7-1, 7-3, 8-2, 9-1, 9-3)

← white patches

A  
Re-coated stone  
B

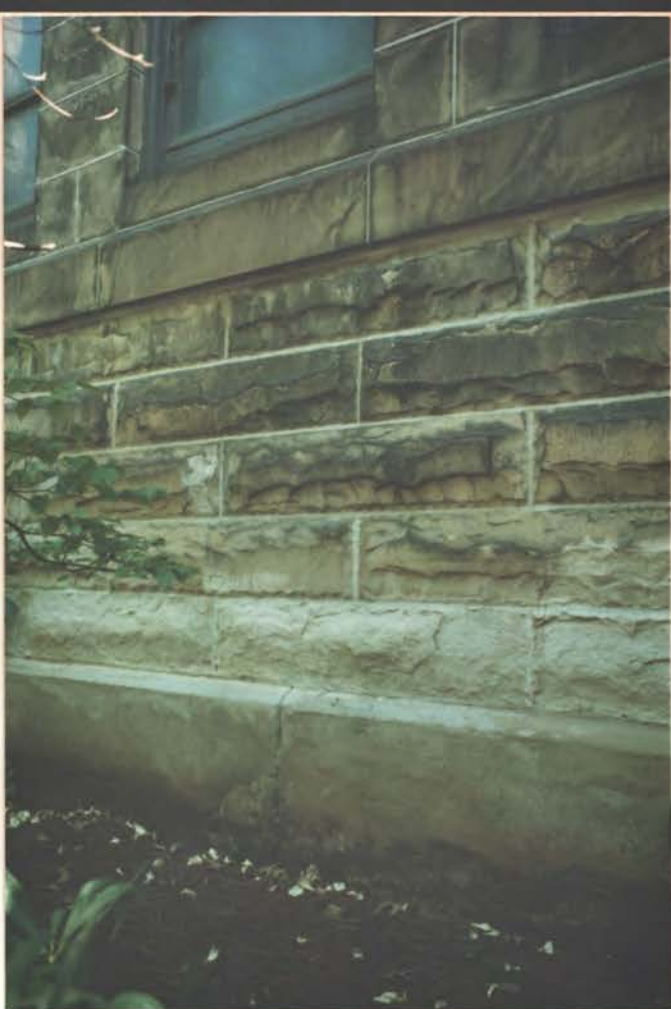
1. "Rising damp" (ground-moisture wicking up into the porous sandstone) is causing deterioration of the sandstone to about 2 feet above the ground in numerous locations. This deterioration may be partly due to freeze-spalling and partly due to the constant wetting and drying of the stone. In some cases the ground is low by the walls, trapping rain water runoff at the foundations. This problem should be partially corrected by altering the ground slopes and composition to drain the water quickly away from the foundation. At more expense, horizontal lead flashings can be inserted in the stone bed-joints near the ground level. Some stones may need replacement or other appropriate repair. (Reference: Photo 7-2, 9-4, 10-1, 10-3, 11-2)

↑  
Rising damp  
deterioration  
↓  
Re-coated (stucco?)  
↓

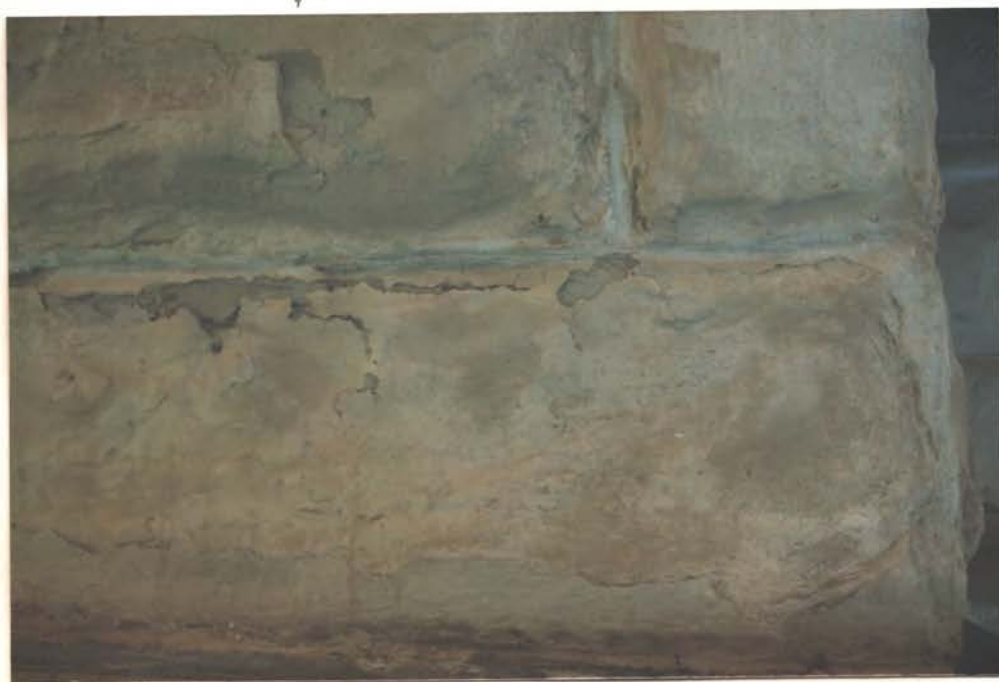
Loose film coating ("Thoroseal?")  
- traps water inside stone

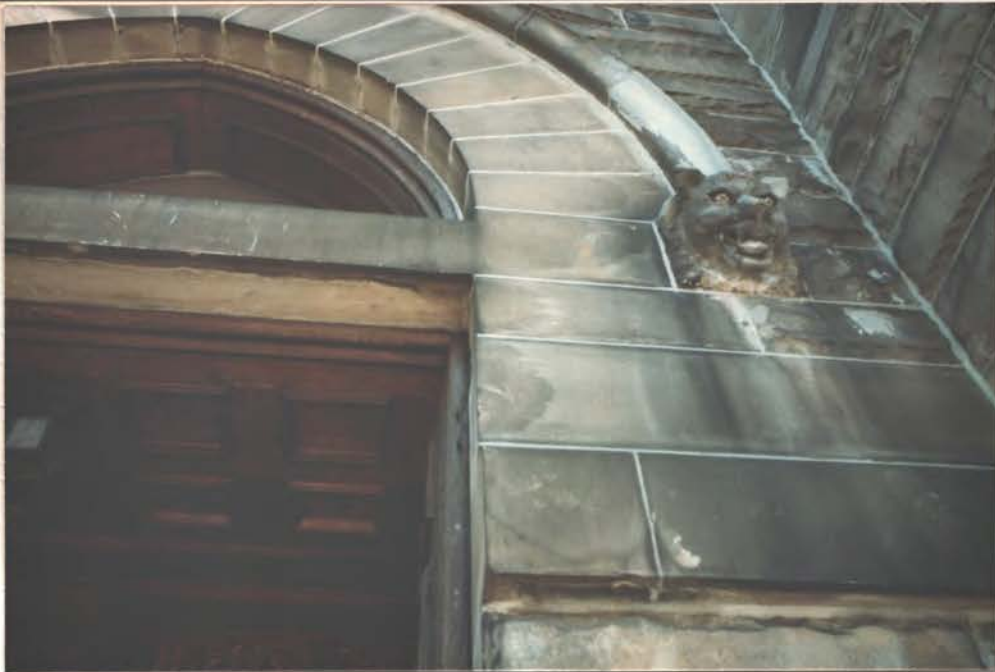
5. Numerous broken-off decorative and trim-stone parts appear to have been patched with a portland-cement mixture. See item 4 above for the problems this can cause. (Reference: Photo 8-1, 8-2, 9-3, 11-2)

1. The Bell Tower north entry woodwork and finish is heavily weathered and patched due to its exposure to rain and sun, whereas the more protected front entry woodwork and finish presently appears to be in good condition. The north entry rotted and patched bottom edges at the paneled oak jambs should be repaired, except the wood jambs should be kept clear of the masonry floor by about 3/8 inch, and the bottom edges of the wood should be sealed. This is to avoid capillary action which draws moisture off the masonry floor up into the wood, causing rot. The open bottom joint should not be caulked, for this would re-connect the floor water with the wood grain. (Reference: Photo 8-1, 8-2)

→ White  
 → cem.  
 → patches

2. The present weathered varnish can be stripped and replaced but will typically not last for more than a year or two in exposed locations such as this. Coatings which cannot be easily "stripped" should not be used (such as hard urethane). They will have to be removed every few years and the wood profile and moldings would likely be damaged each time in the process of scraping, etc. A "polyurethane varnish" may last somewhat longer than "spar varnish" (still not more than a few years) and is said to be easily stripped. This question needs additional study. (Reference Photo 8-1, 8-2)

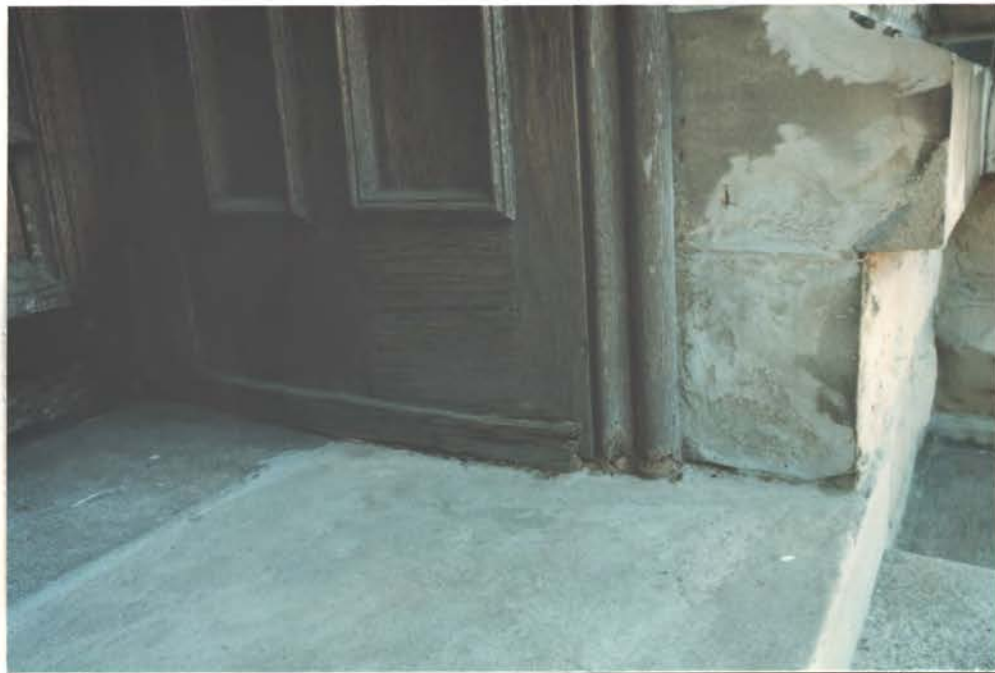
Belltower  
 North  
 Entry  
 (photo 1, 2, 3)

→ white  
 → patches  
 → at stone

→ Rotted  
 → bottoms of oak  
 → + patches

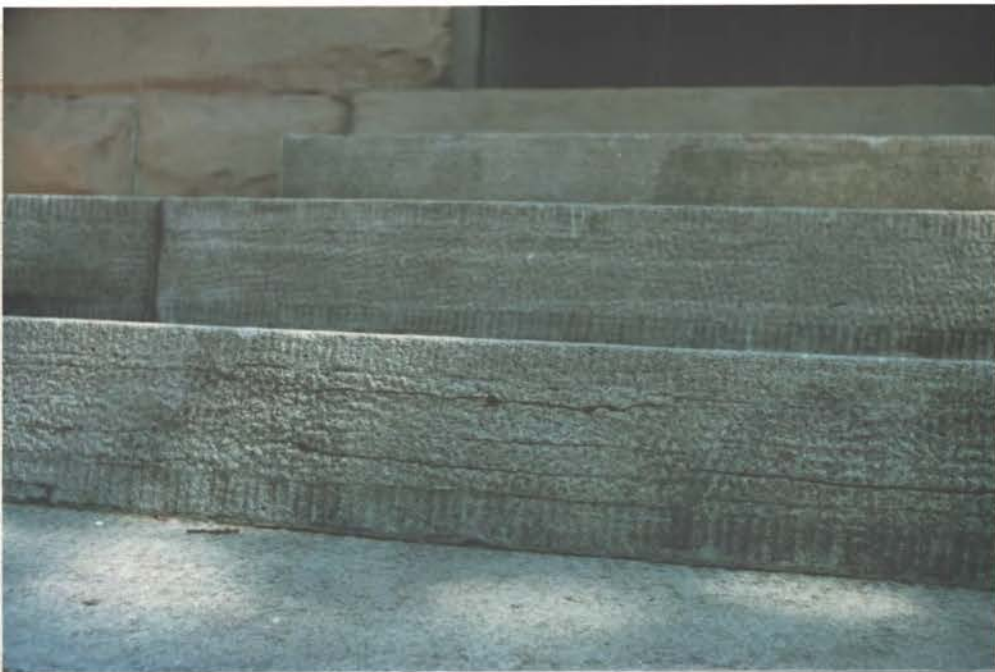
7. Some of the limestone steps, whose stratum planes are properly horizontal, are beginning to separate along the stratum planes. It may be quite a few years before these need replacement, however. (Reference: Photo 8-3)

→ limestone  
 → strata  
 → lines  
 → separating

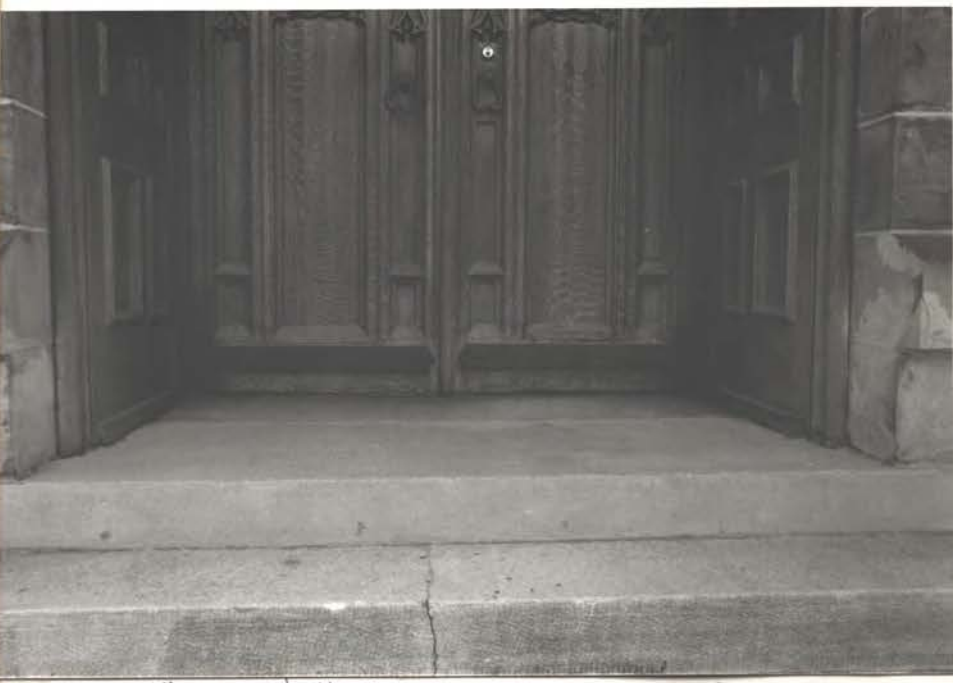
6. Some replacement stones at the Sanctuary entry arch piers are of a greenish-yellow color which does not match as well as desirable with the original stone (gray, weathered to a yellow-tan). (Reference: Photo 9-1)

→ Main (west) entry  
Coating on stone deteriorated 1

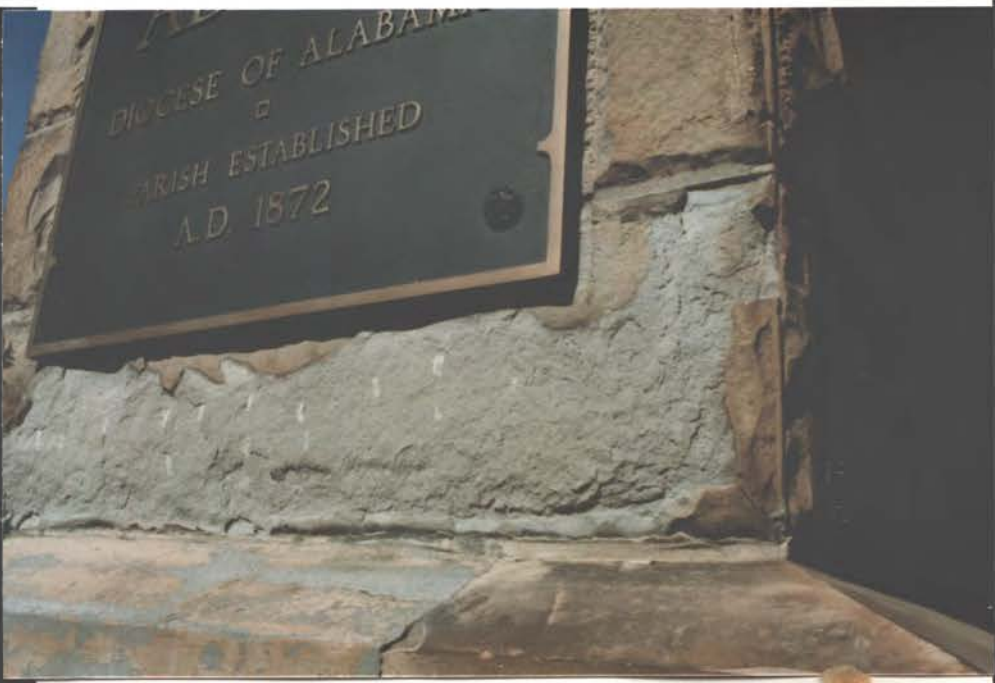
↖ Cement "rebuilding"  
of stone parts  
+ spalls  
3 — West front

↑ Rising damp  
spalls

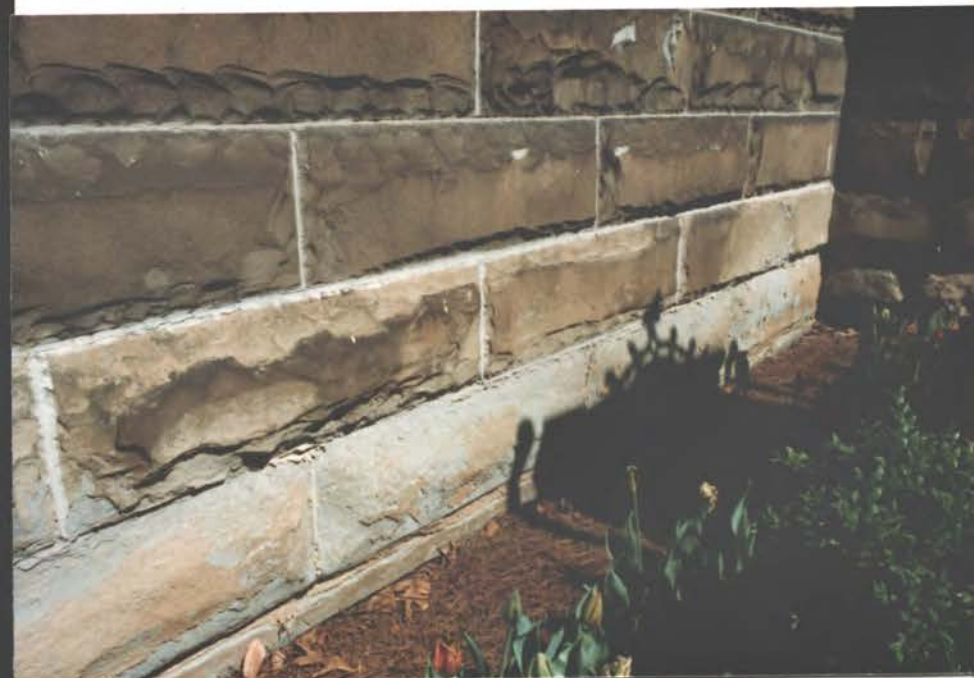
Not ↑ West front, S. part. Low grade traps water against stone.  
 ↓ Spalls & rising damp deterioration

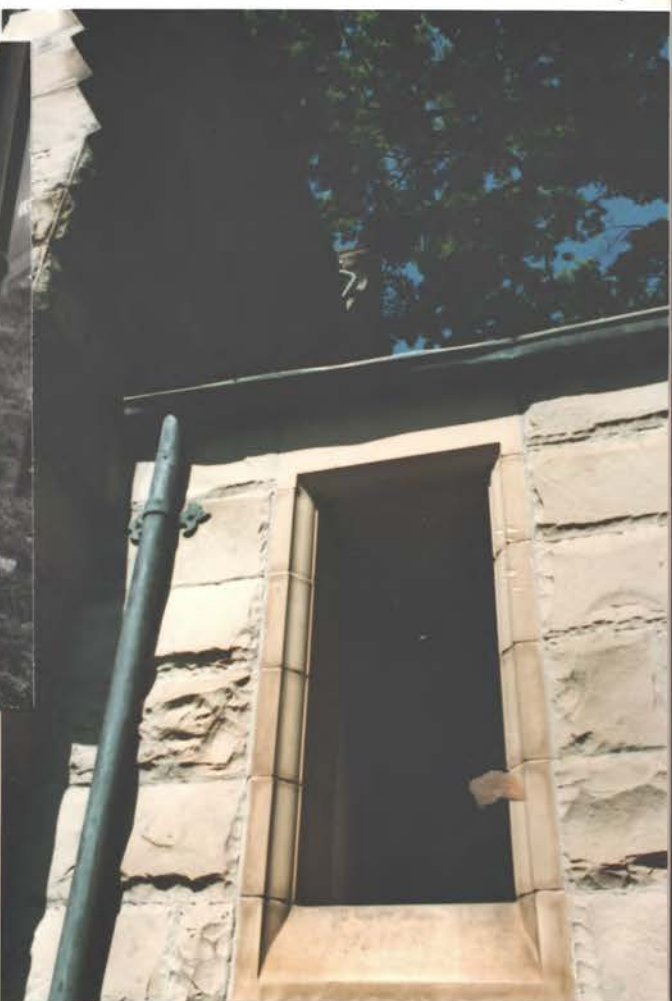
SW. Steps - bent copper gutter Not 4 10

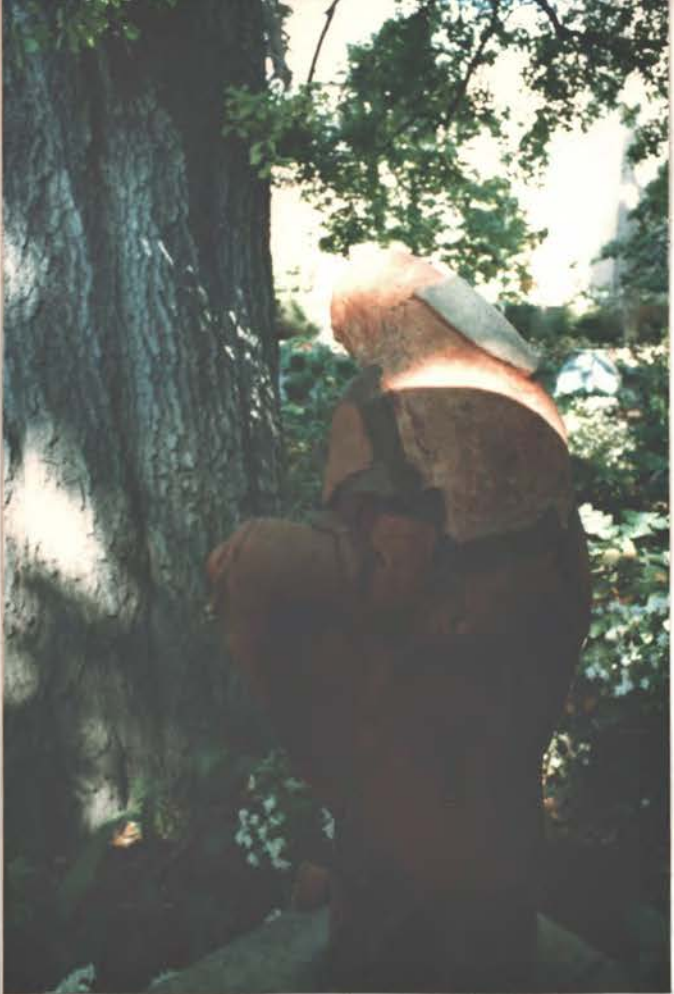
C. The terra-cotta sculpture in the Memorial Garden is suffering severe freeze-spalling and must be put under a roofed pavilion or moved inside to save it. It currently needs the attention of an art conservator for proper repairs. (Reference: Photo 11-1)

1 Garden Sculpture  
(terra-cotta)  
weather-spalls

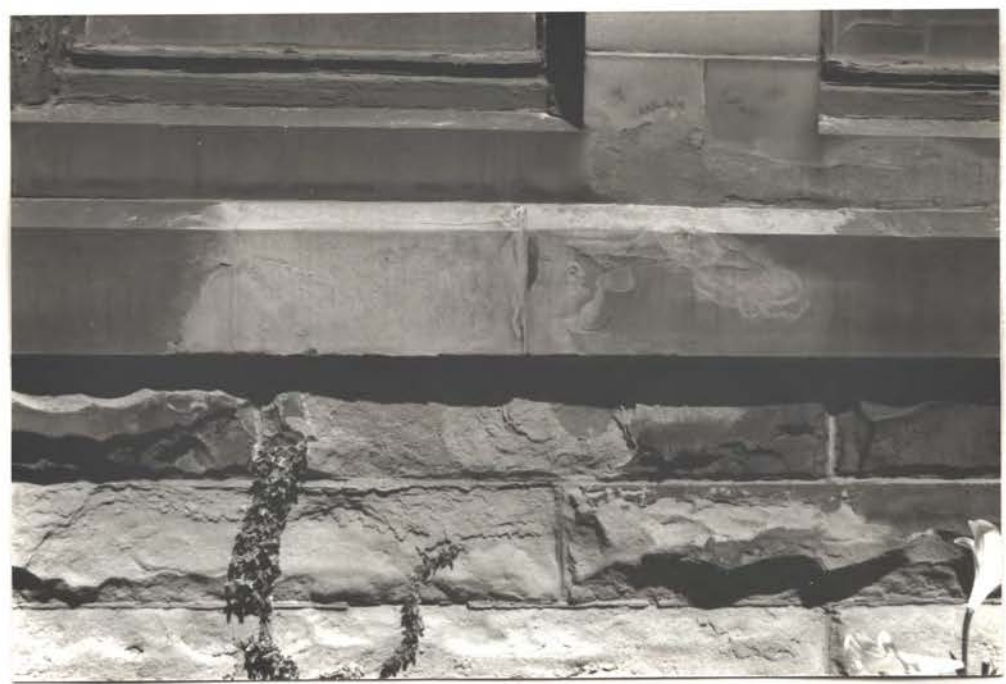
Spalled & patched stone  
South wall of Sanct.  
Portland cement re-point

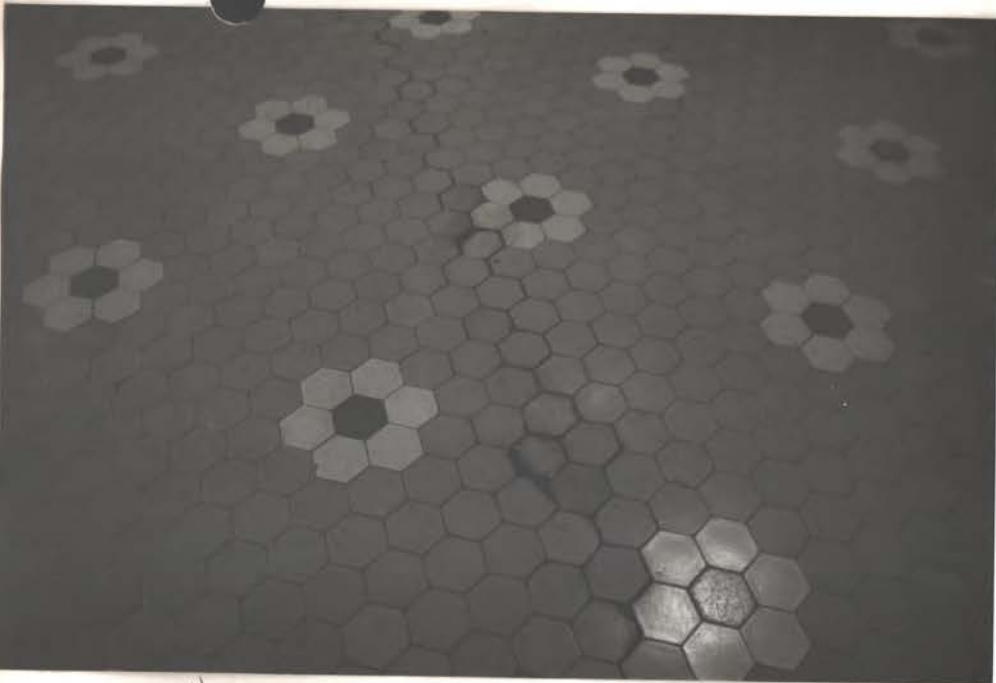
5. The wood sub-flooring under the area in front of the chancel has moved enough to open a line of joints in the small hexagonal ceramic floor tiles. Some tiles have settled and some have been previously replaced in a slightly off-shade tile. If the wood flooring is secure, this does not appear to be a significant defect. (Reference: Photo 15-1)

Cer. tile fl. at Nave  
(some patches)

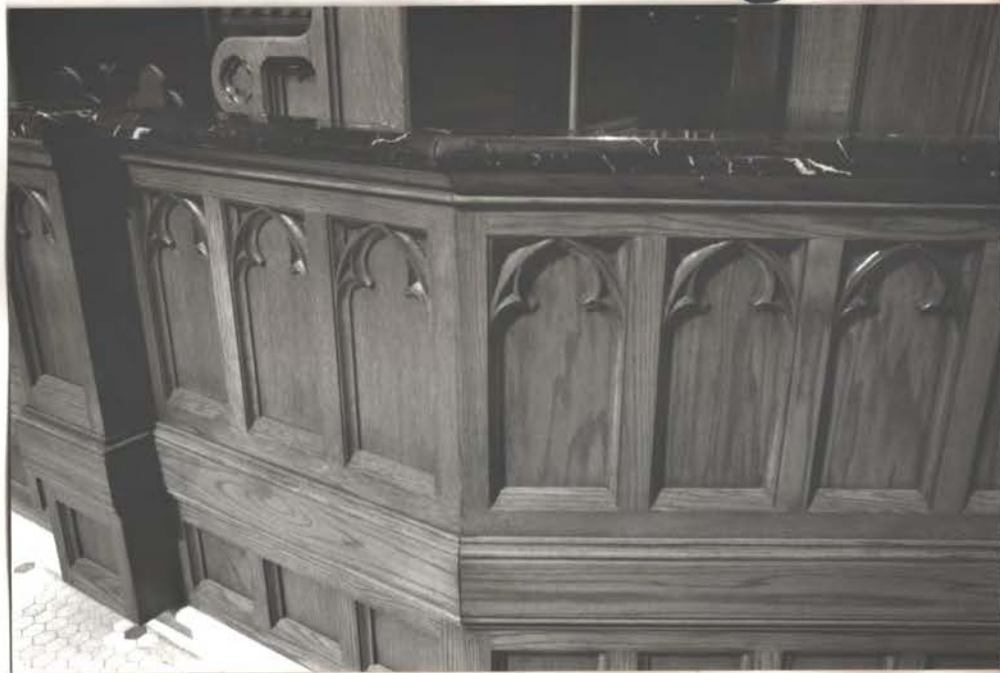
6. Messrs. Martin J. Romaniwicz and Ernie Martin pointed out that modifications to the oak paneling at the Chancel area had used rotary-out (flat grain) oak plywood panels instead of the original rift-sawn solid oak wide boards. They also mentioned there were several different shades and sheens of stain and varnish in this area due to various modifications. The Committee would have to decide where on the priority list this item should be placed. (Reference: Photo 15-2)

⌘original  
rift-sawn  
dense oak panels

⌘ later rotary-cut  
oak ply. panels

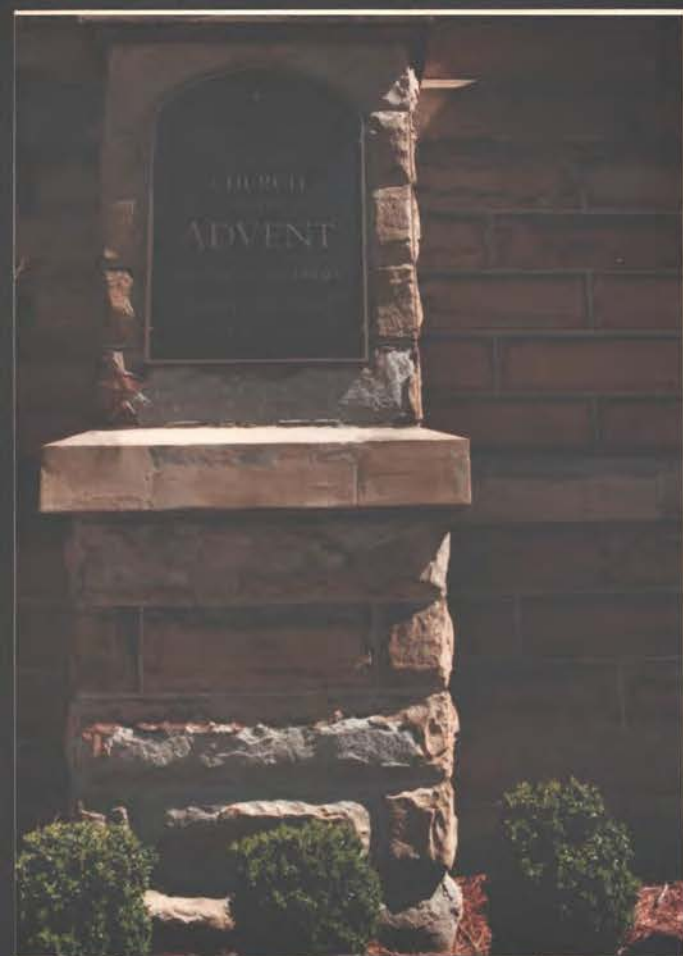
Bell tower N.W. Corner 1 N+  
Rising damp deterioration

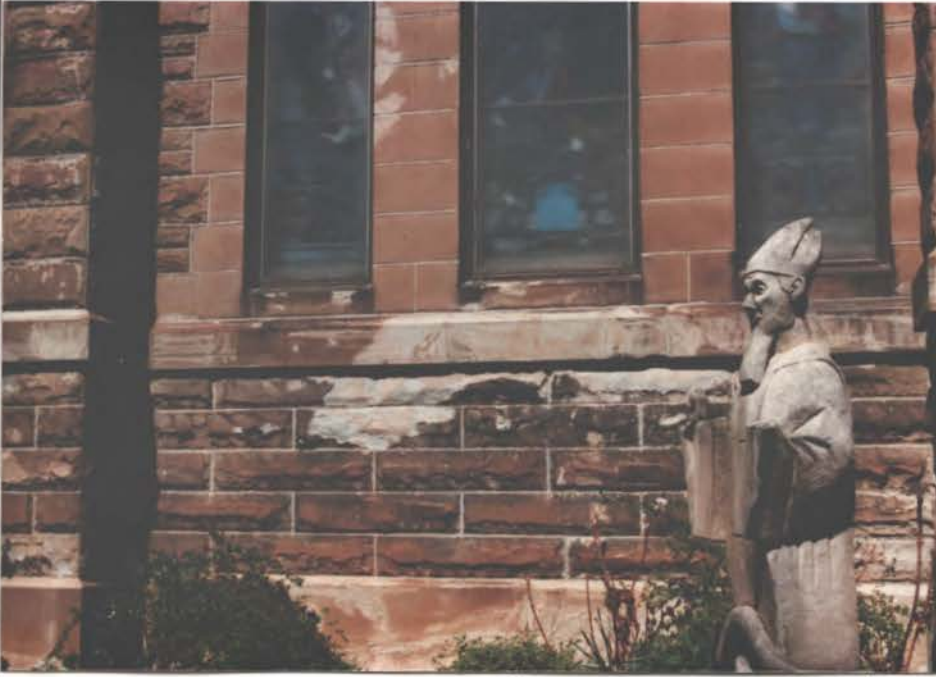
1  
Stone spalls & patches,  
Rising damp deterring.

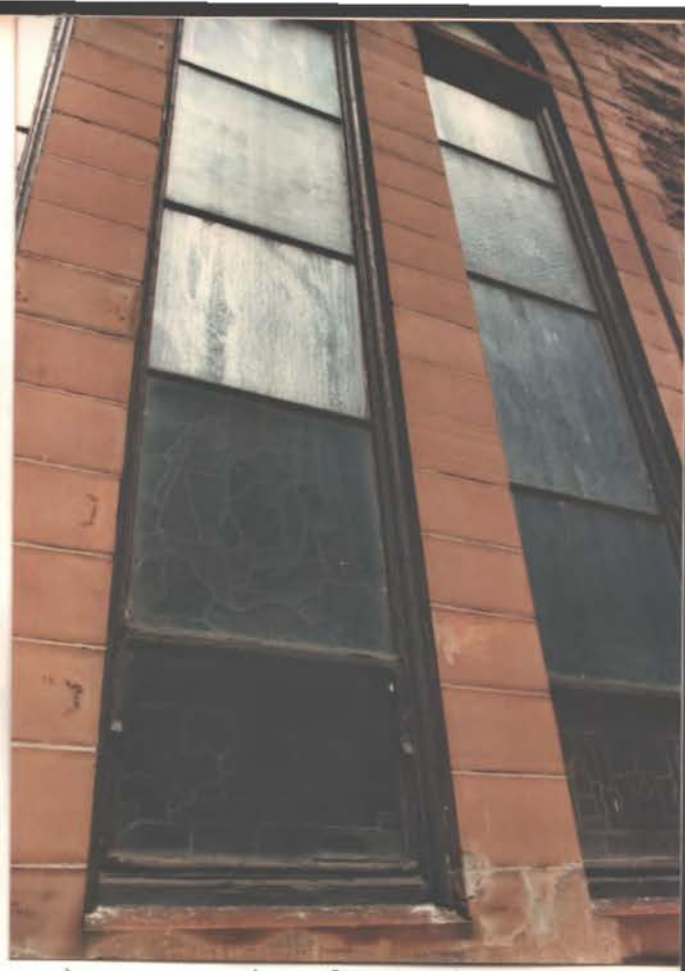
S. Wall at Garden  
Ribbed protective glass  
(in steel sash set in  
orig. wood frames)

2  
Patches

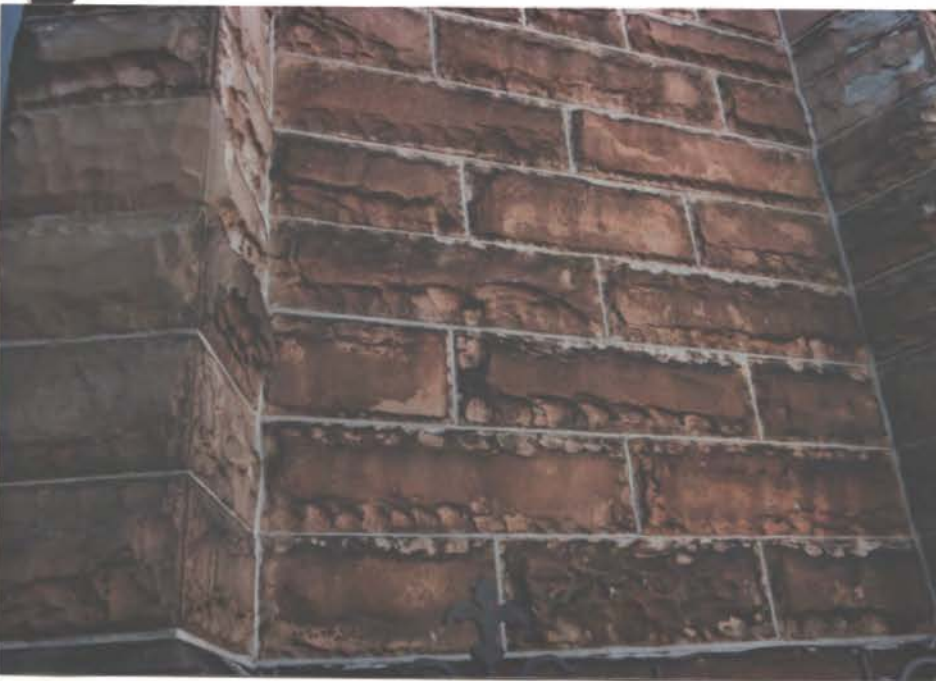
3  
Portland cement re-pointing

coating &  
patches

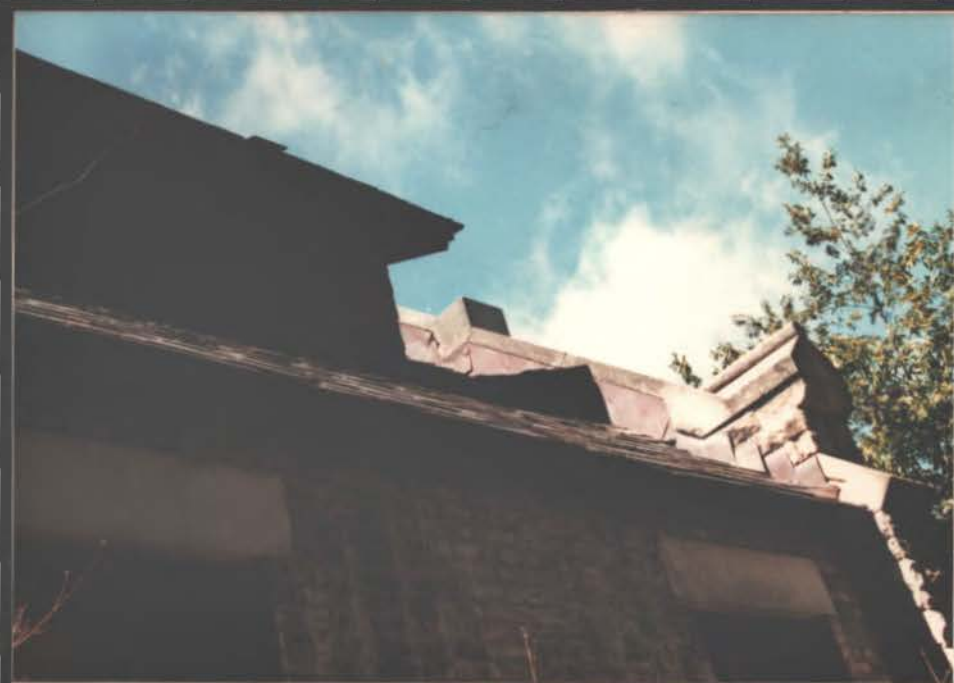
12. The badly stained brick walls due to item A-8 in the walkway east of Clingman Commons would desirably be repaired and repainted after installation of the needed gutters and leaders. (Reference: Photo 20-1)

1  
→ N  
East Wall of Clingman Commons  
(no gutter: runoff soiling + damage)
