Karsner - Kennedy Hse
 Florence
 1828

Kayama - Kennedy House, 1829

Re: 1825 Karsner House, Florence, AL / A87060

Re: Karsner House, Project No. 87060

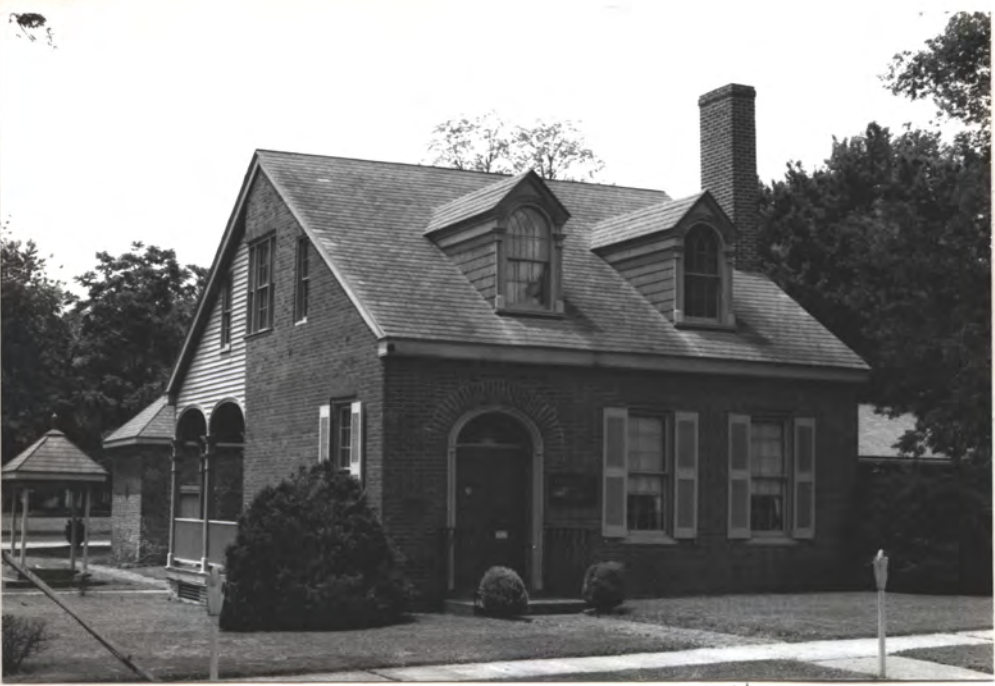
Asbestos shingle replacement
 1988 by J & H - HJ
 Acoustic color research
 on ext. performed by J & H
 & Frank Walsh, color researcher
 in 1987-88 (off-white, not blue)

← design of dormers
 is conjectural (too fancy)
 - by Doug Fuller

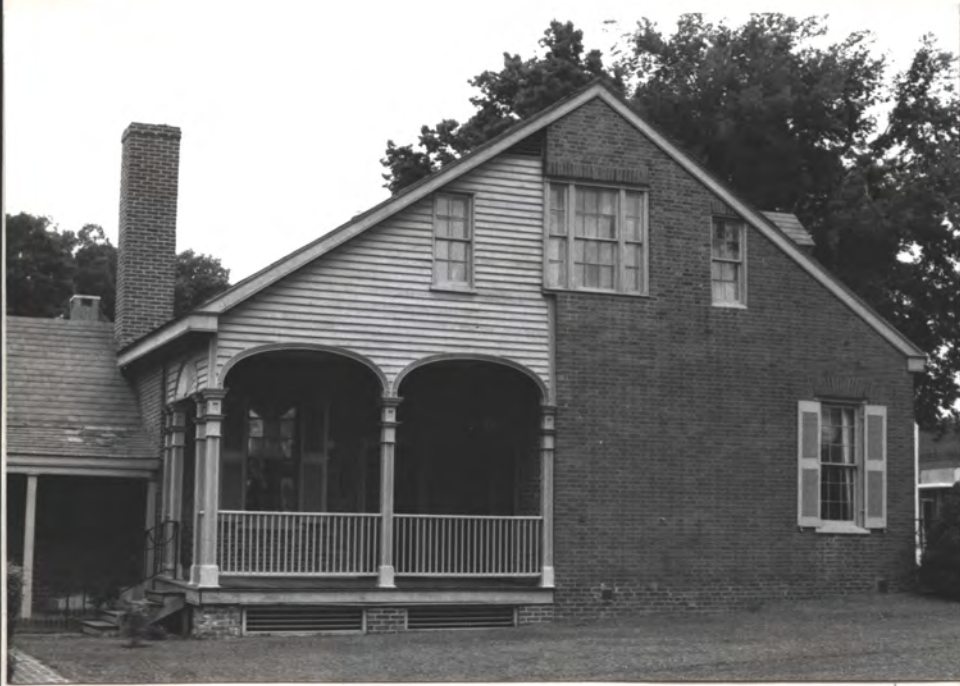
↳ too fancy - Doug Fuller design

All this is conjectural. →
 No basis
 "Too fancy" in my opinion

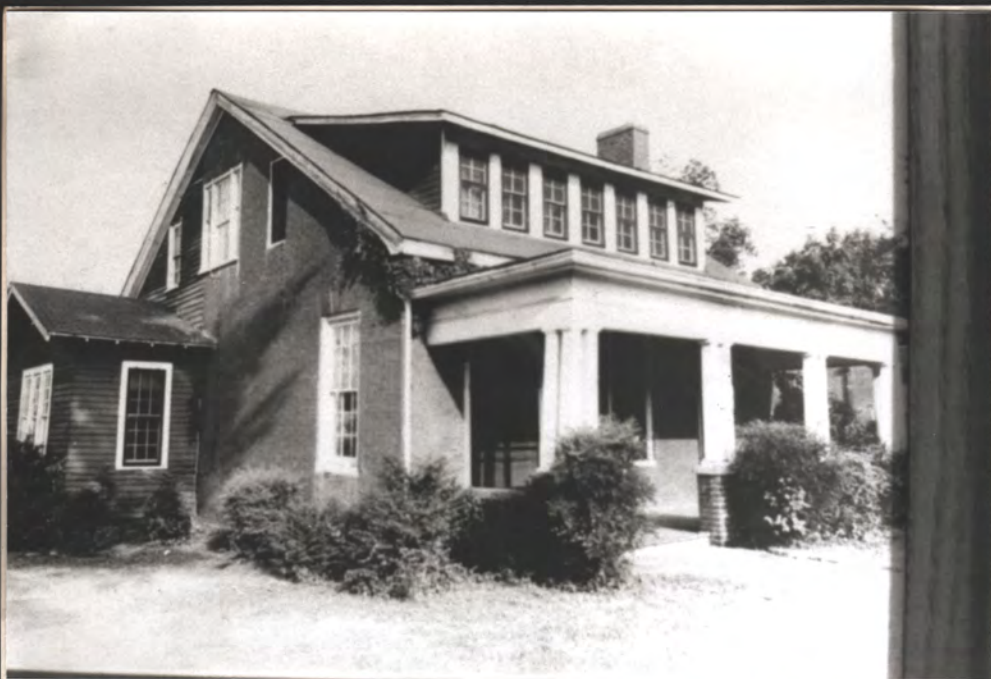
Before restor. in 1970's by Doug Fuller, Arch., Decatur/Hantsell
 "bungalow" remodel, 1920's
 note that the 1825 brick wall is bulged by this time

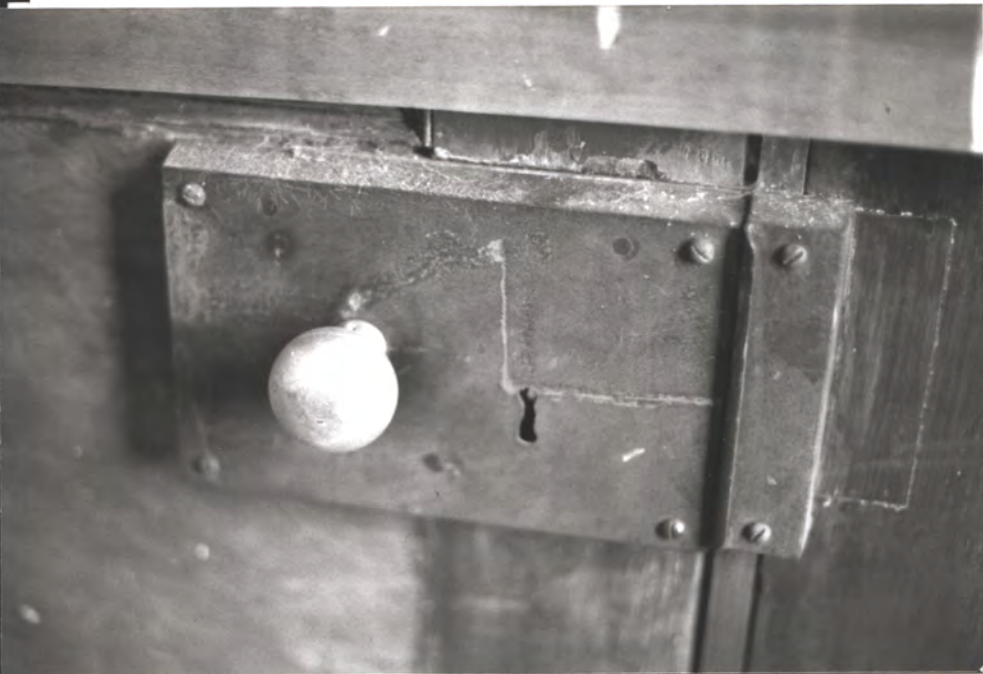
Entry Rimlock N ←

Graining = 1970's, not good N ←

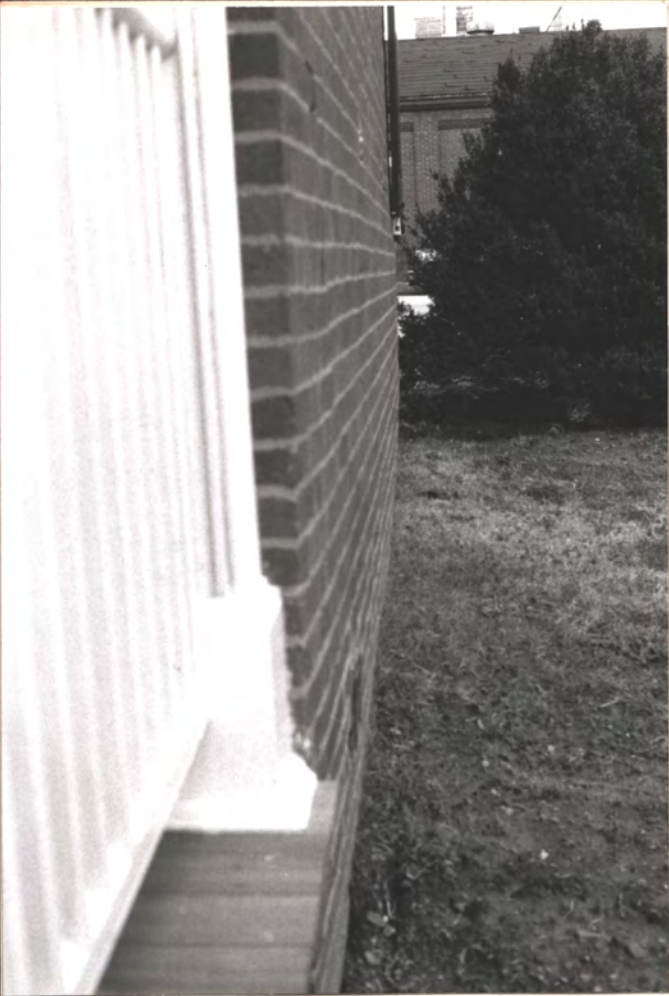
±3"±4" belly in S. wall ±4" above FL.

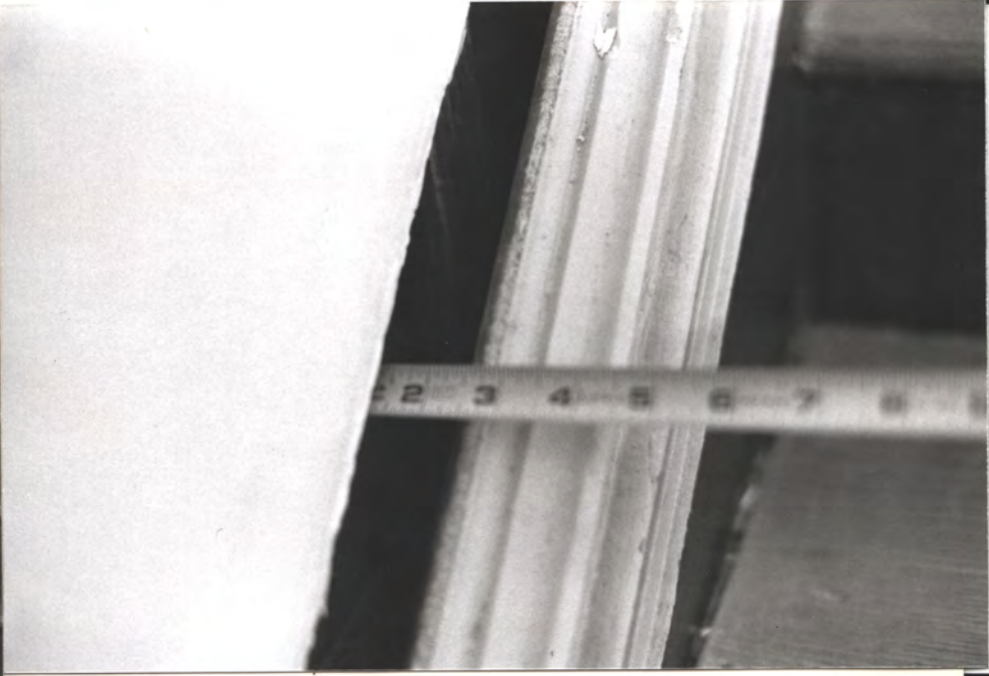
1 1/2" ± GAP DUE TO WALL
MOVING (BELLING) SOUTH
STAIR BASE

I feel the sensible thing is to not attempt to straighten the wall, since the bulge is not obvious to the ordinary observer. Where the inner wall has pulled away from the stair trim I would scribe a neat, flat 1x filler strip and insert it to fill the crack. Verify adequate bearing at the floor joists at both floors.

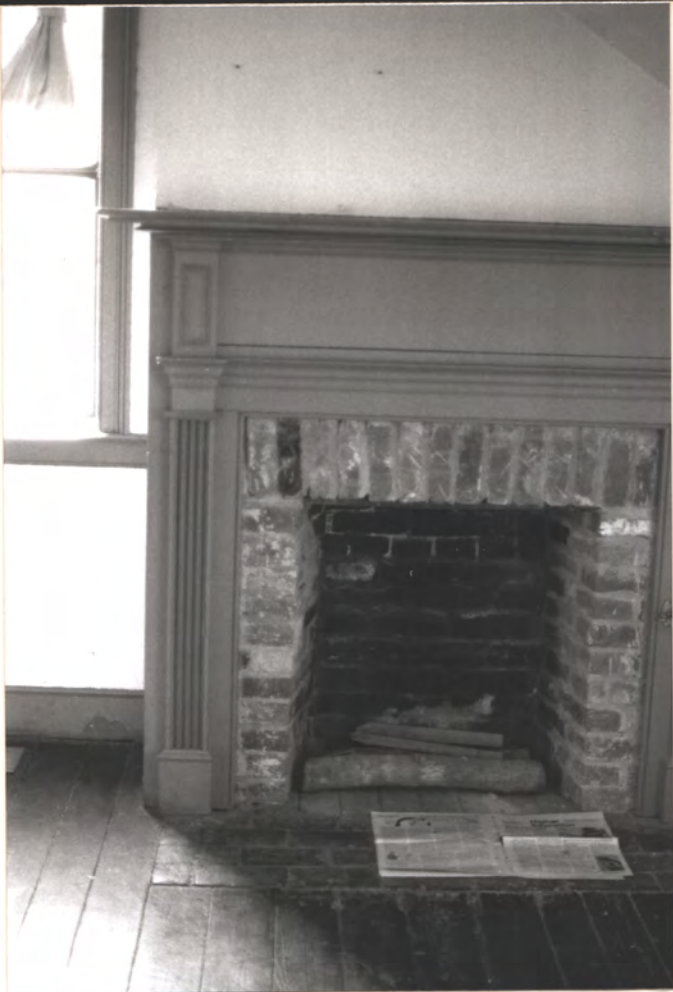
AN 2nd fl. front room mantel.
 "Surround" should be plastered.
 Handls pattern not correct

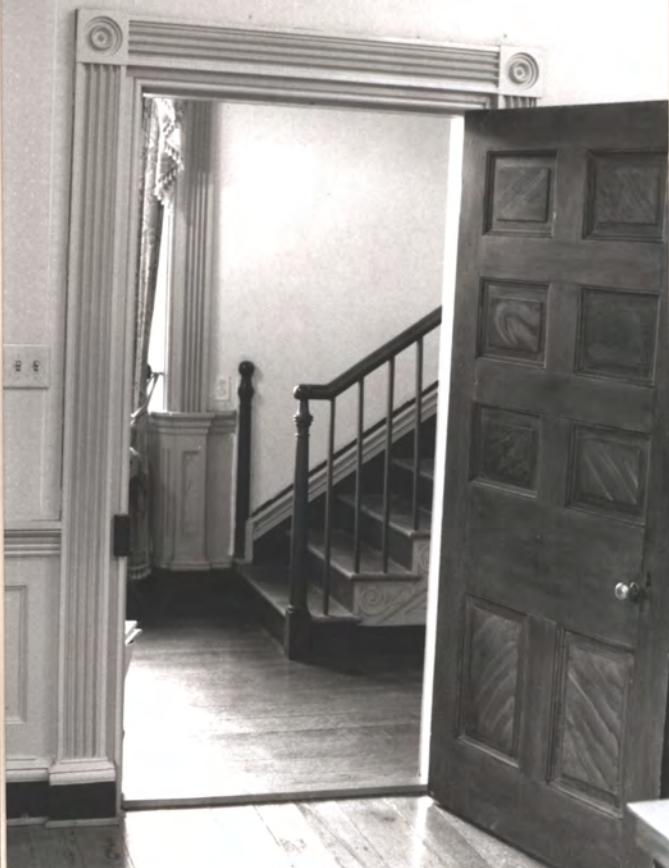
↑ 1970's poor graining

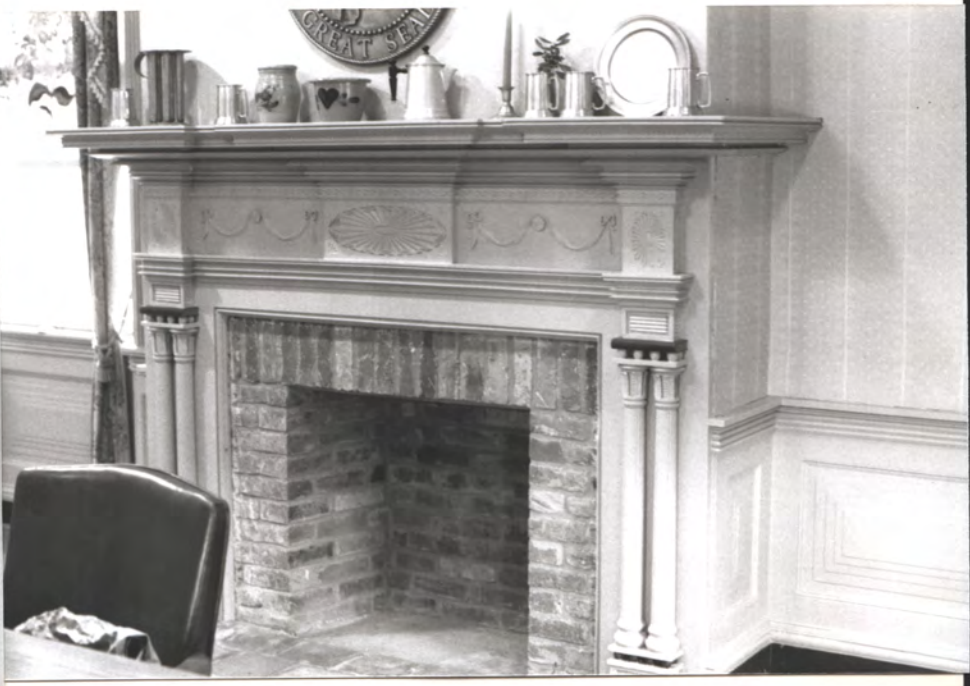
Parlor Mantel
 (very nice)
 "Surround" should be plastered.
 Herring pattern not correct
 Should be →

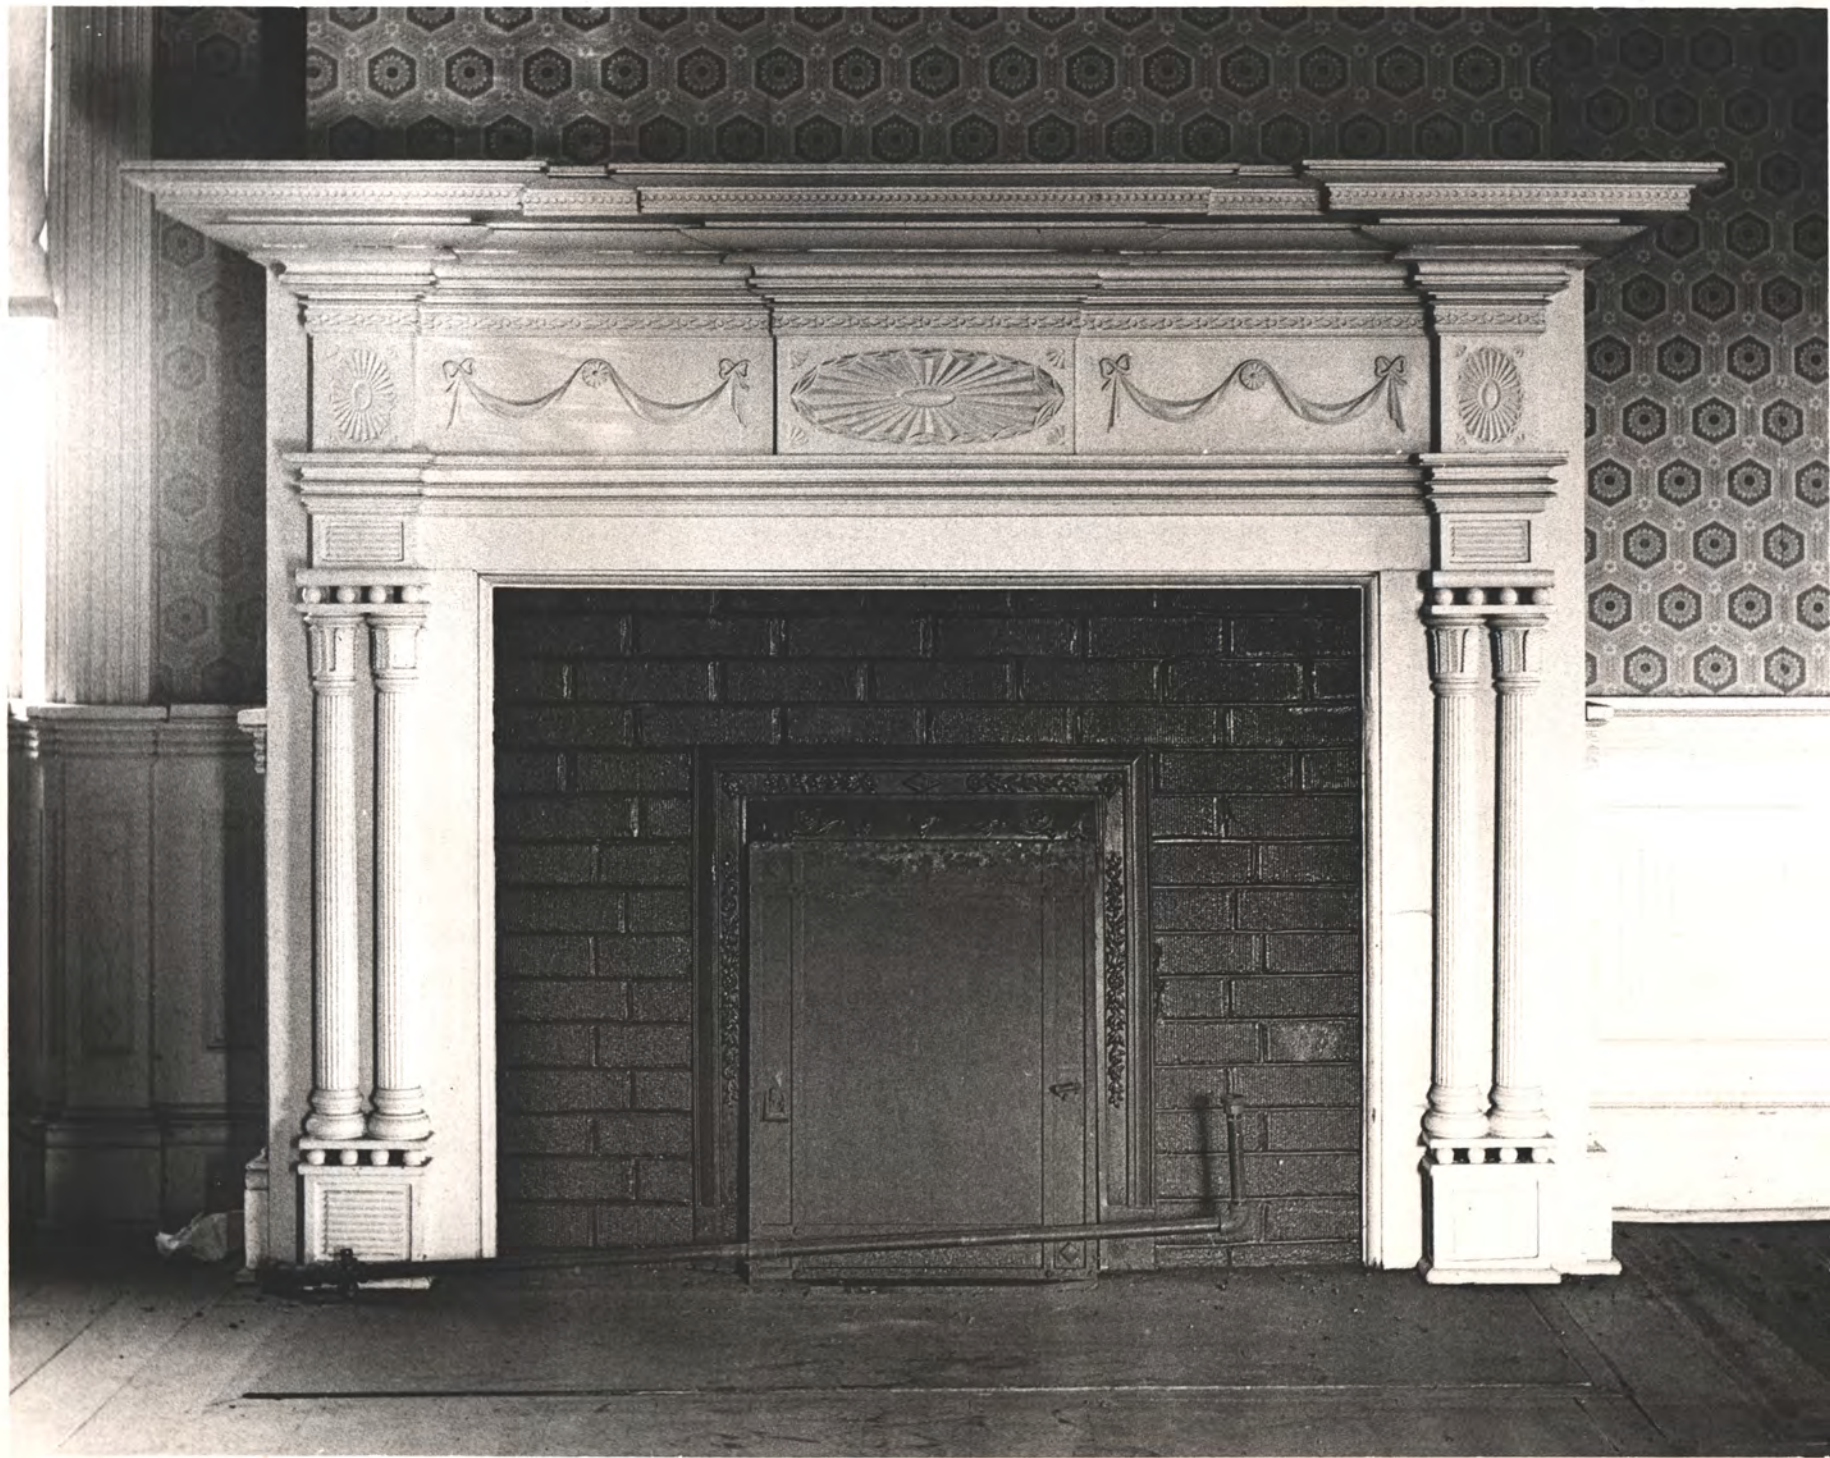
Spaced bricks = later, probably 20th c. Would have been plaster, originally

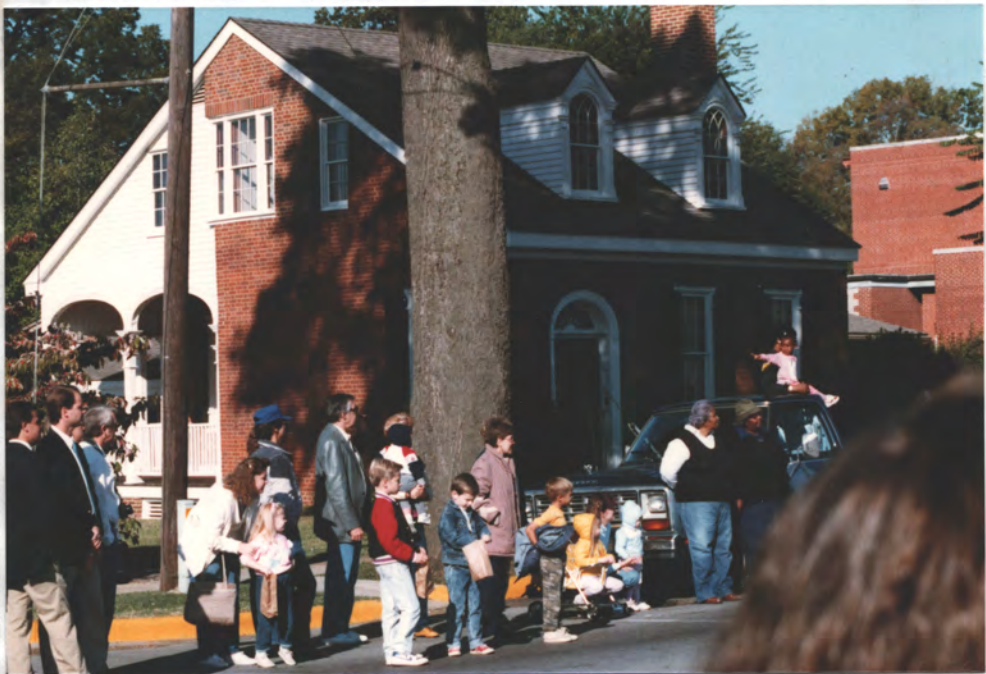
← 1970's
Cam. - asbestos
shingles replaced w/
"GAF Timberline"
compo shingles, seen here.

← original paint color
restored (pale gray-white)
per Frank Walsh analysis,
+ HJ samplings + microscope.

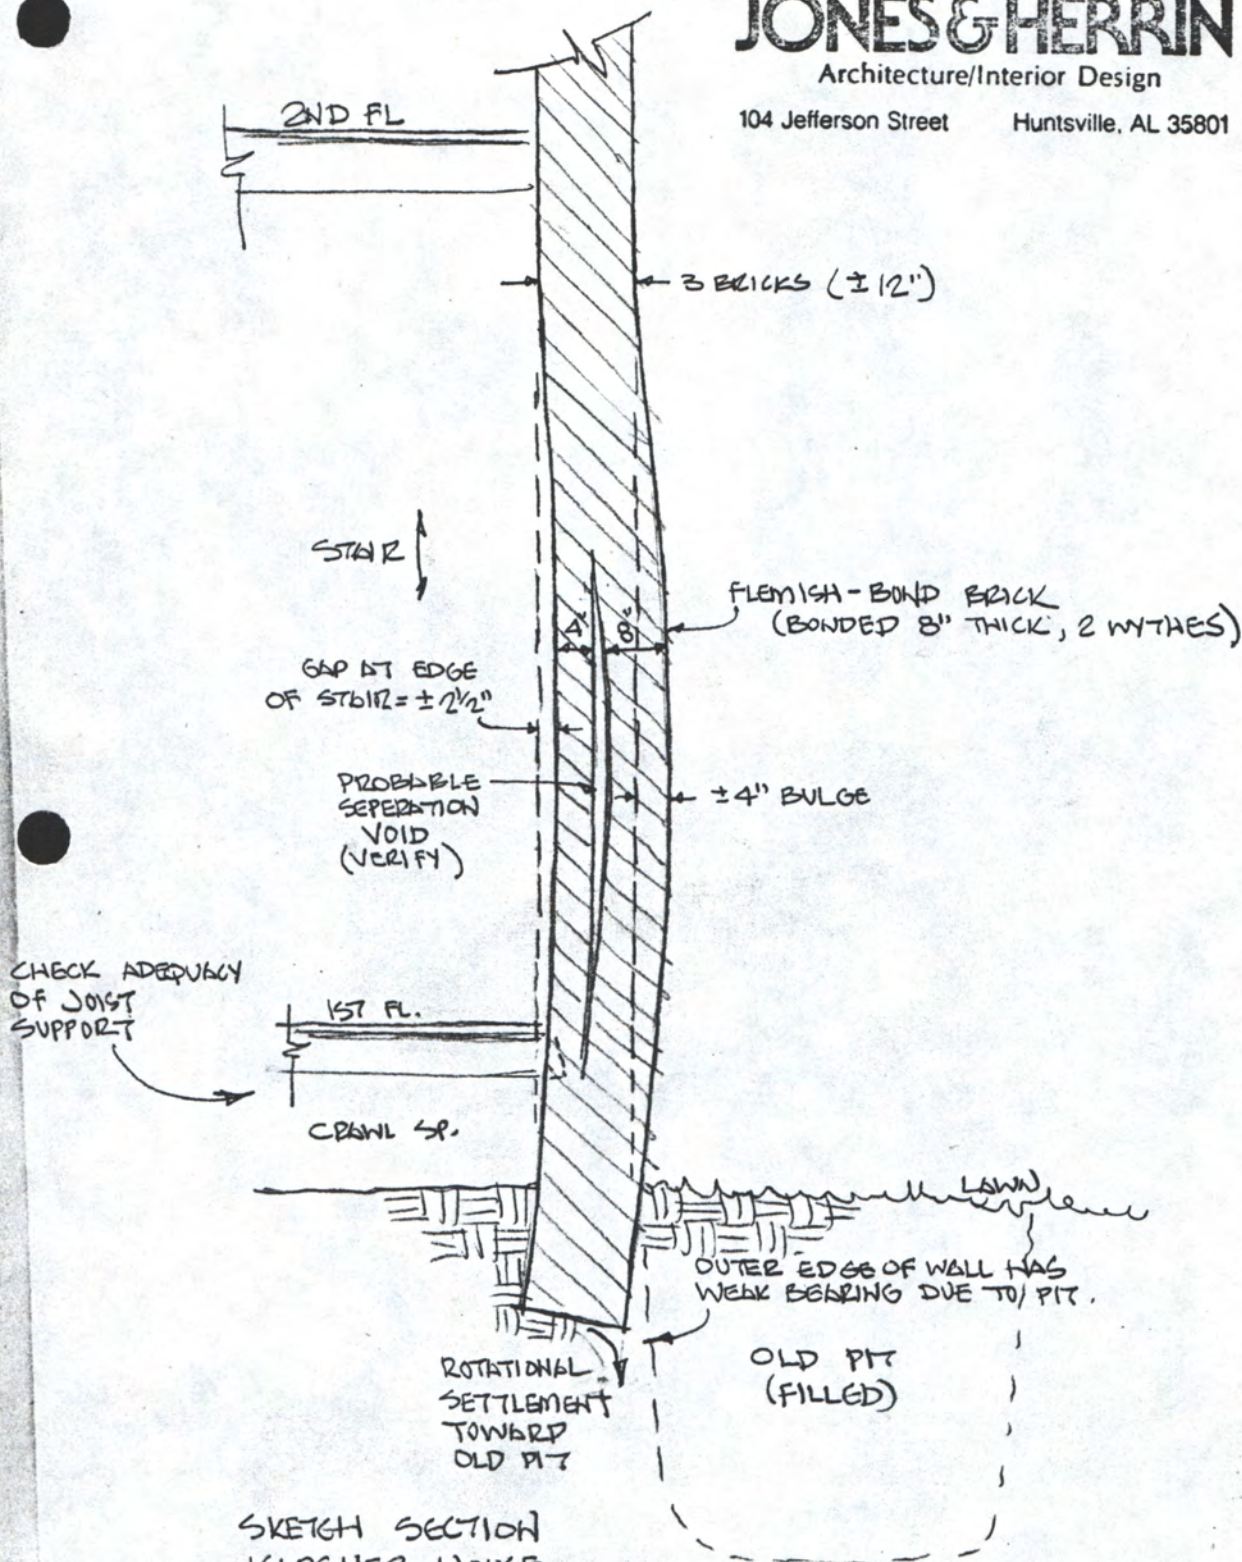
SKETCH SECTION
KORSNER HOUSE

Attached is a sketch of what appears to be happening to the Karsner House south wall, based on the evidence so far. Further investigation may add to or change this supposition.

3. Determine if the outer 8 inches (which is bonded together by the Flemish-bond headers) has separated from the inner 4 inches. The amount of horizontal deformation indicates that this has probably happened (4 inches deformation on the outside, 2.5 inches on the inside), leaving a void inside the wall of up to 1.5 inches wide and leaving only a 4 inch thick inside bearing wall. If this separation has occurred, the void must be filled with a grout which has these characteristics:

SOUTH WALL DEFORMATION - APPARENT CAUSE & EFFECT (VERIFY)
NO SCALE JAN. 14, 1989 HP Jones

1. Test the soil to determine the extent and condition of soil that may need strengthening.
2. Stabilize the soil as needed, either by injecting cement under pressure, or by sectional insertion of a spread footing or reinforced concrete, whichever is cheaper and safer. If the latter method is used the wall would have to be well-braced during construction and might still involve more risk of collapse or settlement-cracking during the work. To be safe, the wall should also be braced during soil injection grouting and wall-void grouting.

- A. A grout that is more resilient than the old soft bricks, so that temperature expansion will not crack the bricks.
 - B. High adhesion, to re-bond the separated wythes of bricks.

C. Natural cement without plastic additives (which will not last).

Cements containing Portland cement cannot be used, for this material is hard and brittle, much harder than the old bricks, and would thus break up the old bricks in temperature movements.

Attached is information on a type of cement developed for this purpose, which we have recently used in stabilizing the separating layers of bricks on the tower of the 1859 Church of the Nativity in Huntsville. This "Jahn M40 Injection Mortar" was injected under pressure into the voids after pressure-washing to remove deteriorated sandy mortar. Core drillings after the work was completed showed good penetration of voids as small as 1/16 inch, and good adhesive strength. Your contractor can purchase and install the material, I understand. If your contractor proposes a different grout, ask him to submit technical data and references for our review. It is most important that no plastic binders be used.

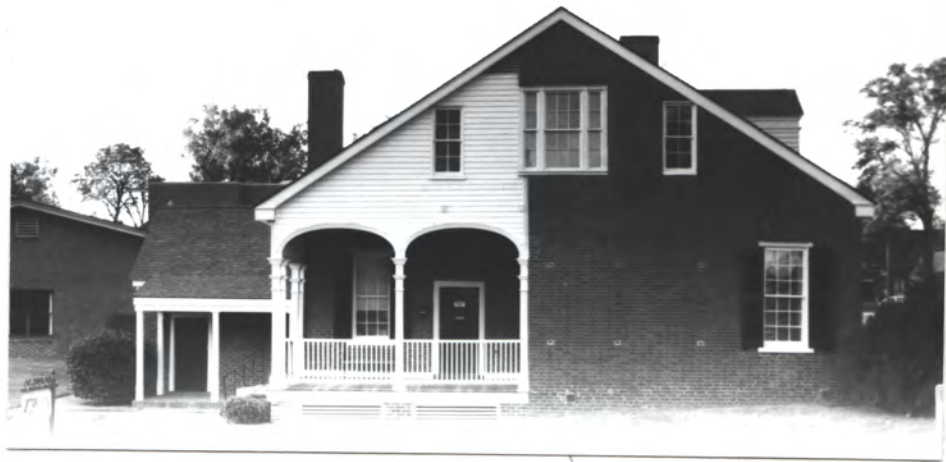
S. Wall (settled & bulged out) PH

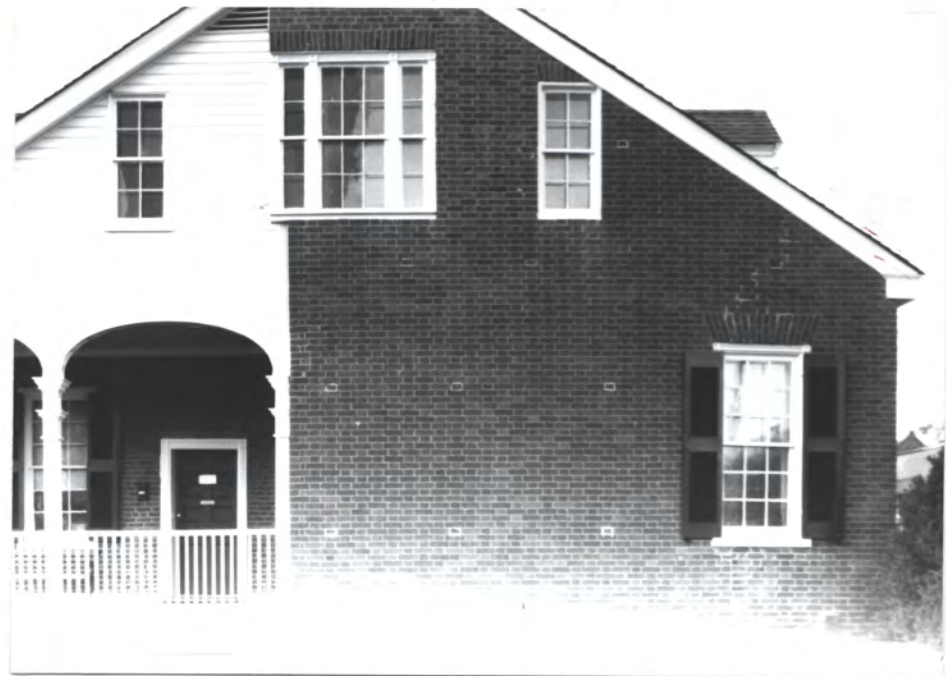
← entirely speculative in c.1976 PH

bulged out ± 2" at old trash pit by wall

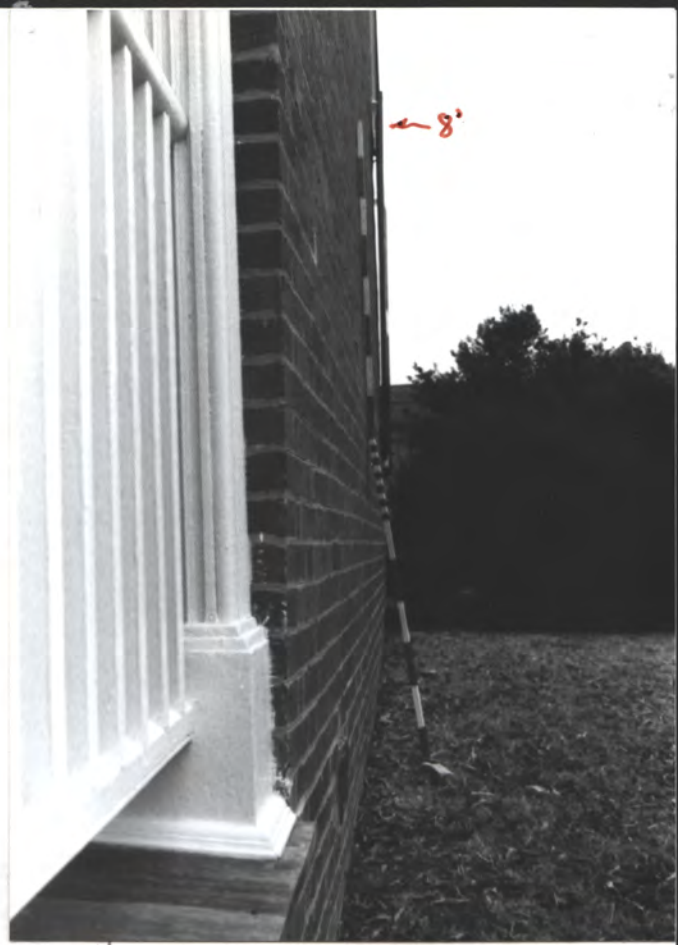
Note bulge ± 2"
at ± 4' ht.

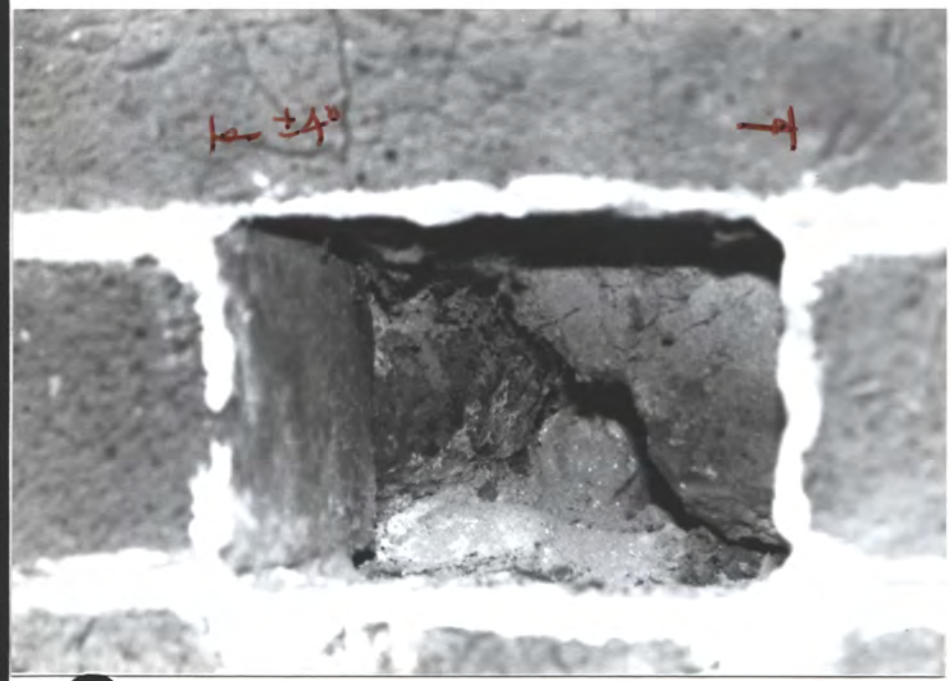
close up of removed brick,
shows wall has not delaminated
at bulge

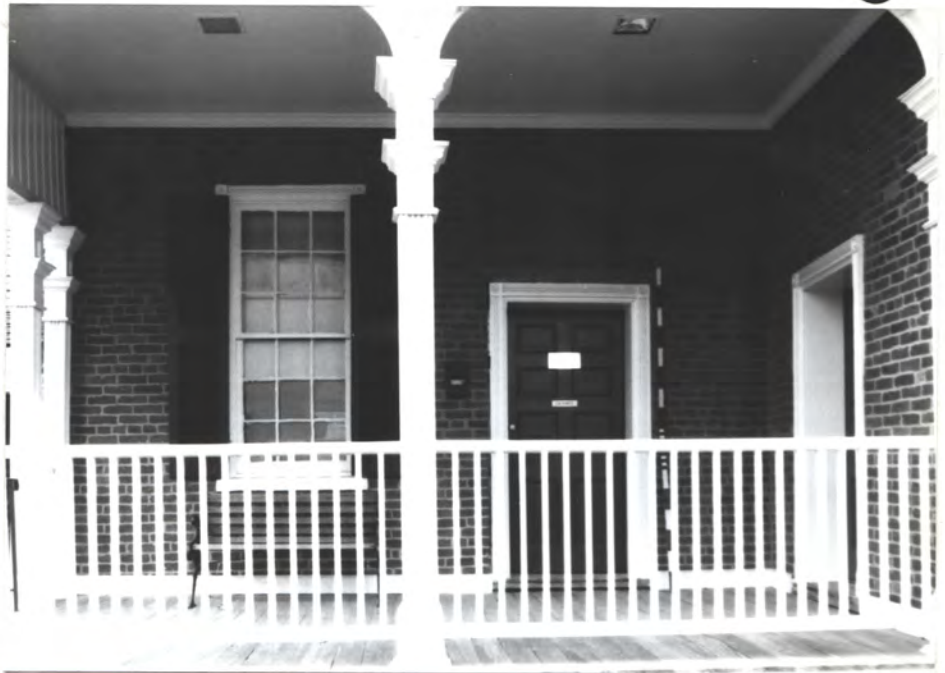
exposed blocking shows
 brick at back porch was
 originally plastered, probably
 marbled & perrilled like stone
 (as it was at the 1818 Belle Court in
 Tusculum)

Also stucco remnants remain here, on
 the blocking.

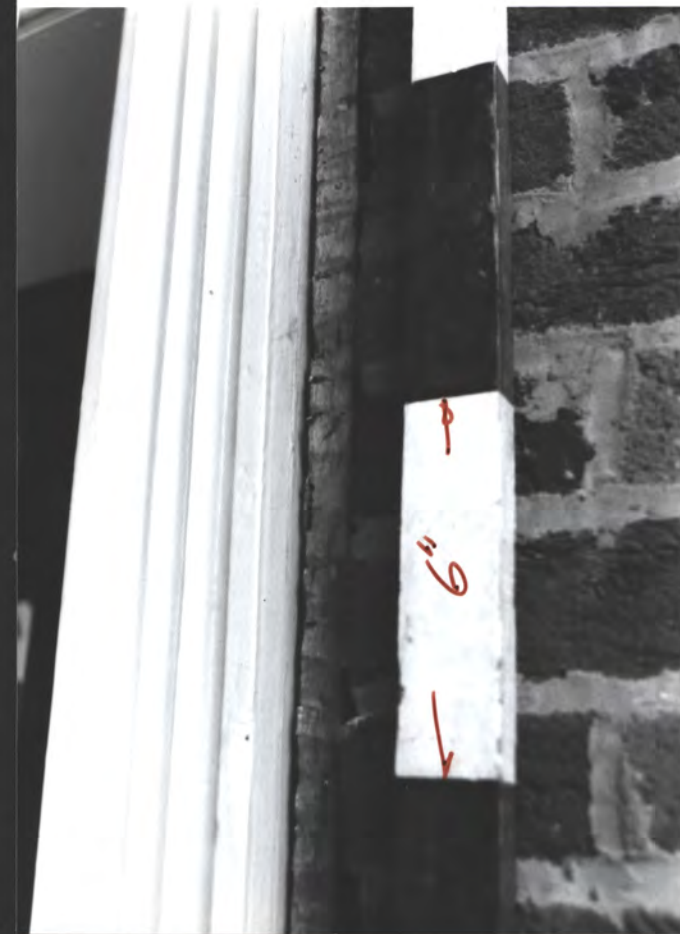
brick was sandblasted in 1970's,
 + Poor repointing (wide, shaggy joints)

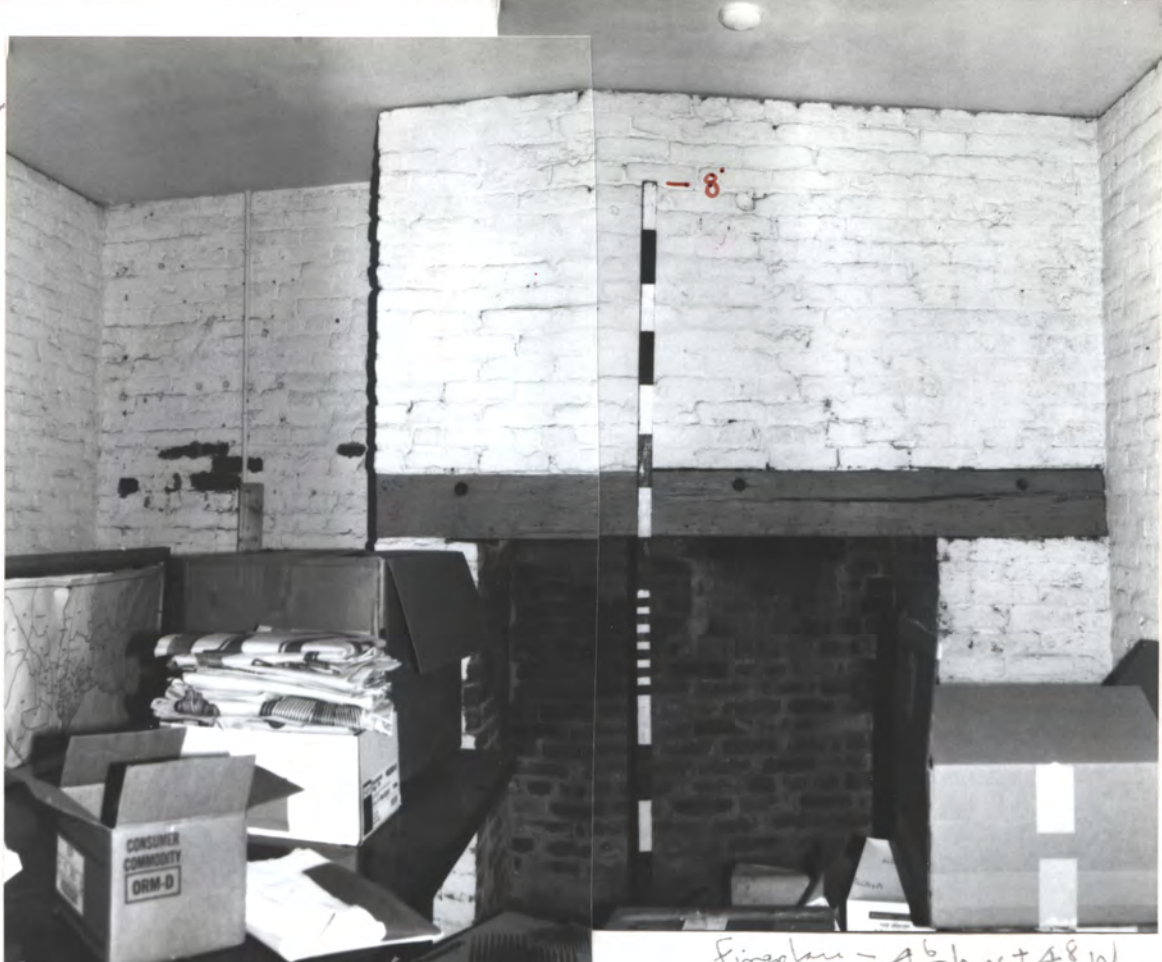
wood
lintel w/
drilled holes
for
(1) pipe?
(2) shelf-holes?

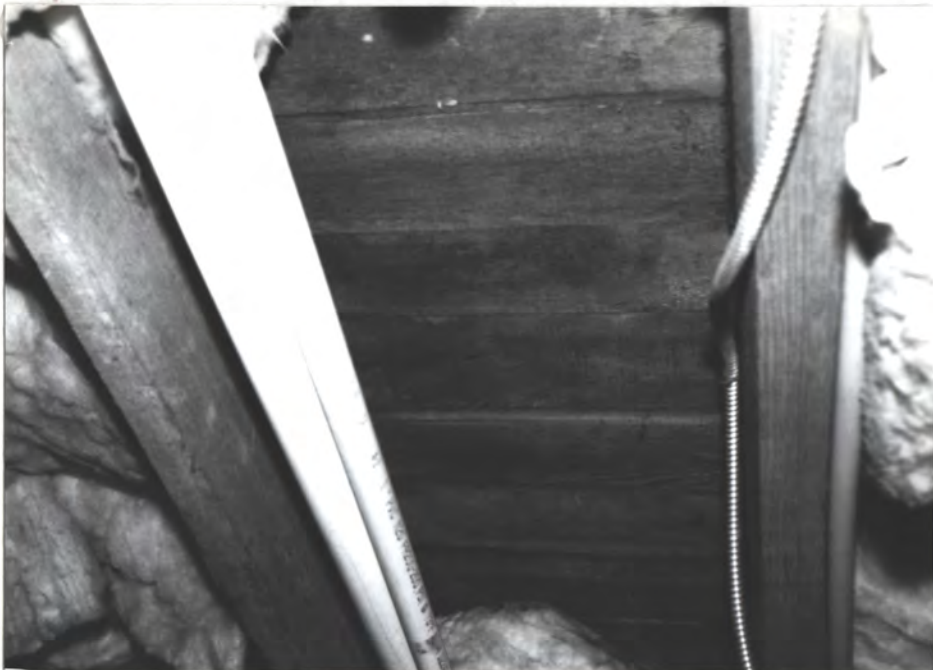
Note
Sash saw
marks on
bottom of
fl. joists
(typical of
1800-1860)

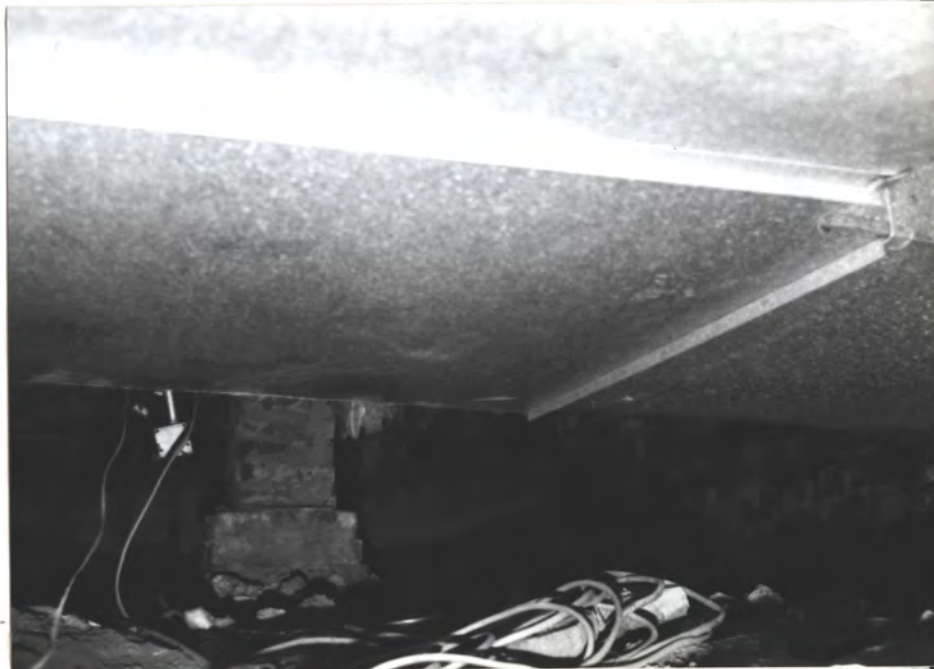
Wall bulged
to south
2'-2 1/2" at
old trans pit
by frame

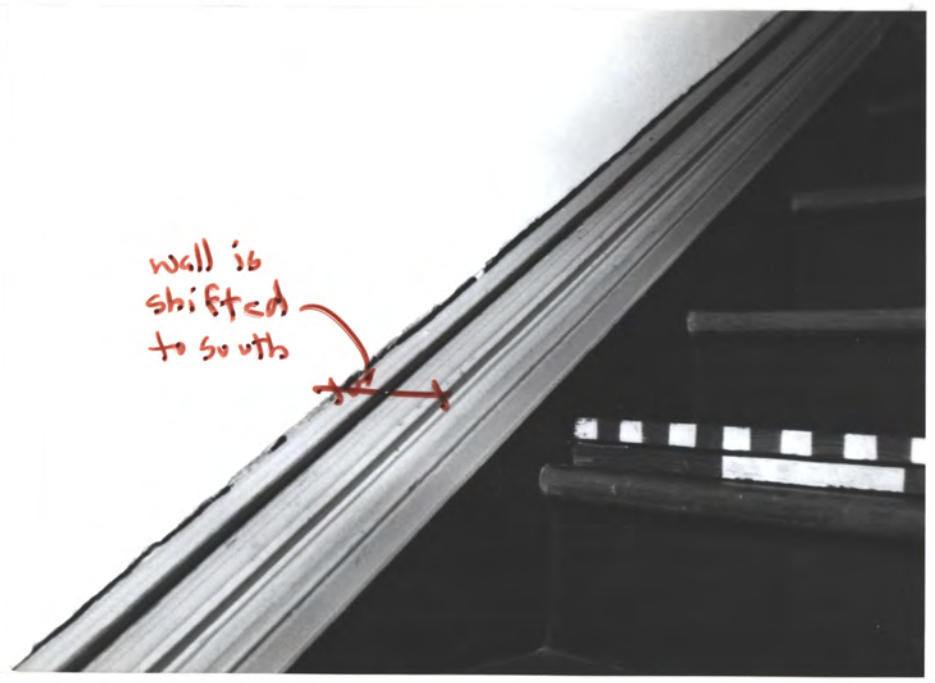
wall is shifted to south

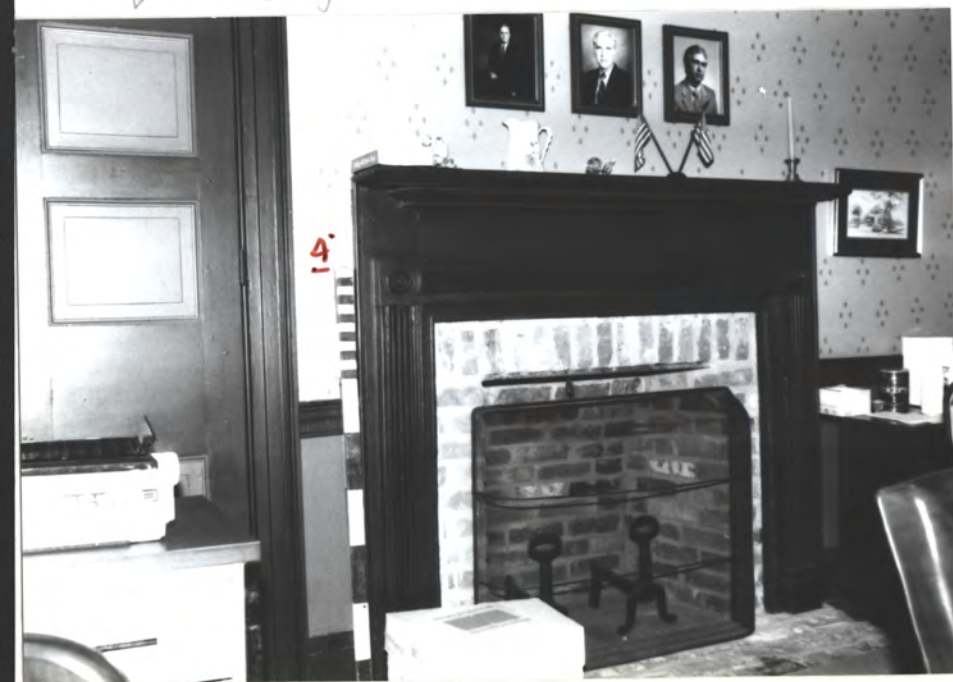
FL. 1 DW. RM. (w. y. porch)

F.p. surround
should be
plastered.
Hearth =
incorrect
pattern &
should not
have wide
marker ribs
(should be
butted tight
w/ no marker)
