**ARCHITECTURAL COLLECTION
OF
HARVIE P. JONES, F.A.I.A.**

BOOK 49

**1940 Rosenbaum Hse.
Florence,
AL**

Milly Wright **FRANK LLOYD WRIGHT ROSENBAUM HOUSE FOUNDATION PROJECT**

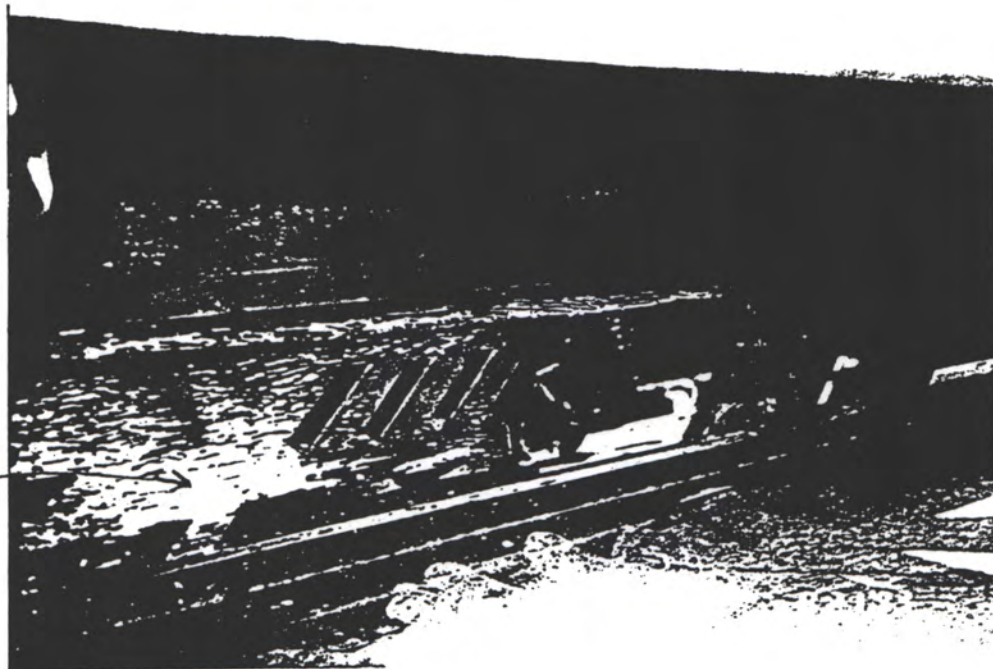
FIG. 8

wood
decay
at
clerestory

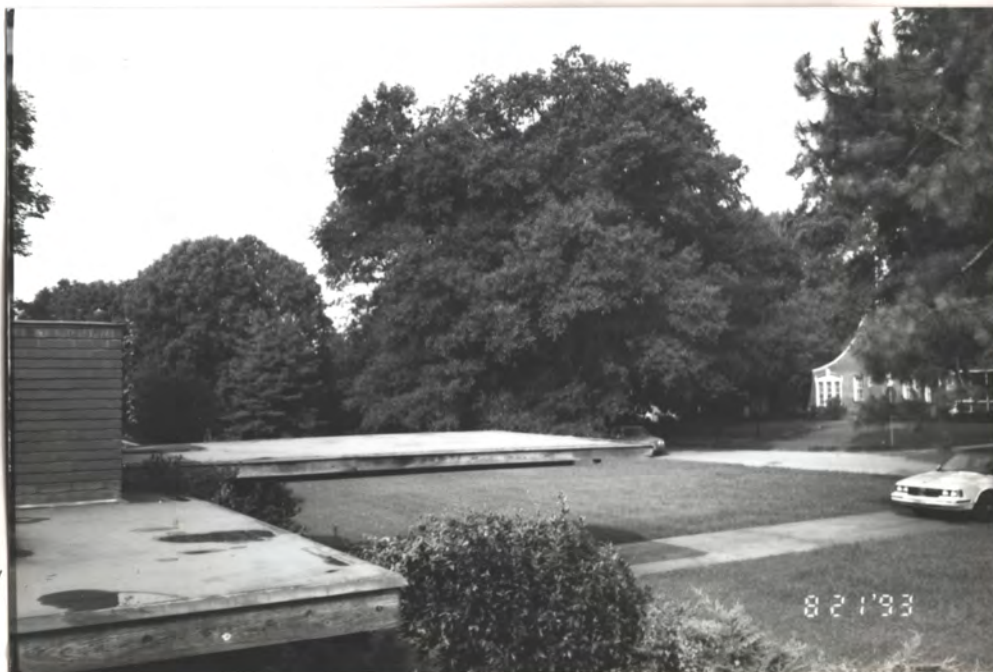
↖ Cross. to Guest Bm
polyethylene roof patch - needs
removal & proper repair

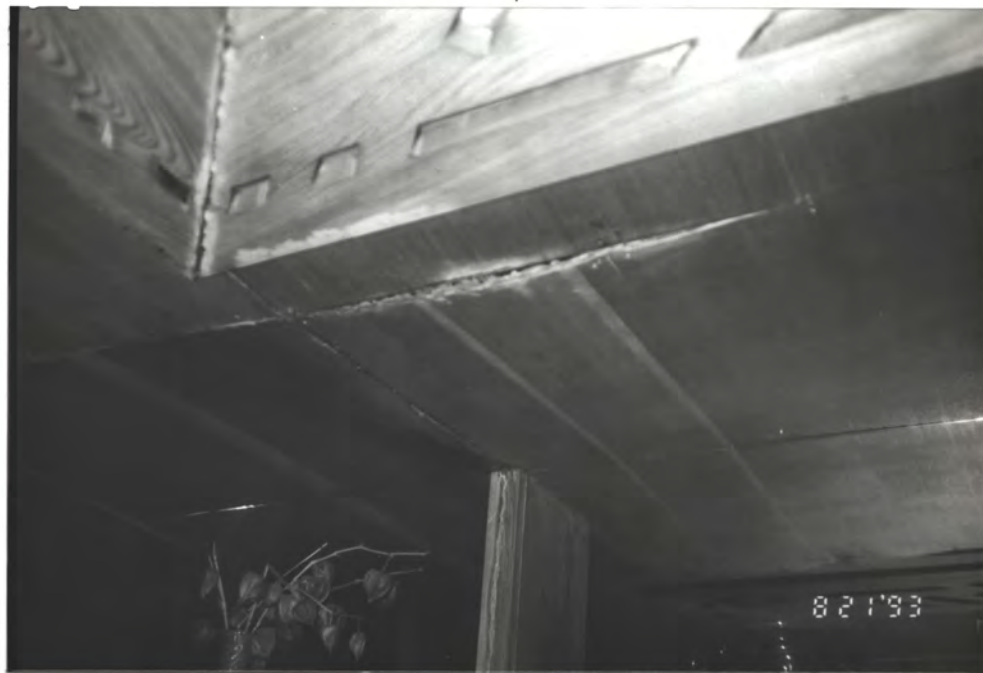
FIG. 1

The roof framing appears to be sagging over the breakfast area (1948 addition). Water is ponding on the roof (Fig. 1) and there is evidence of water damage to the plywood ceiling in this area (Fig. 2). This problem was addressed in the 1968 repairs but evidently the solution has not been adequate.

water damage

Ceiling damage

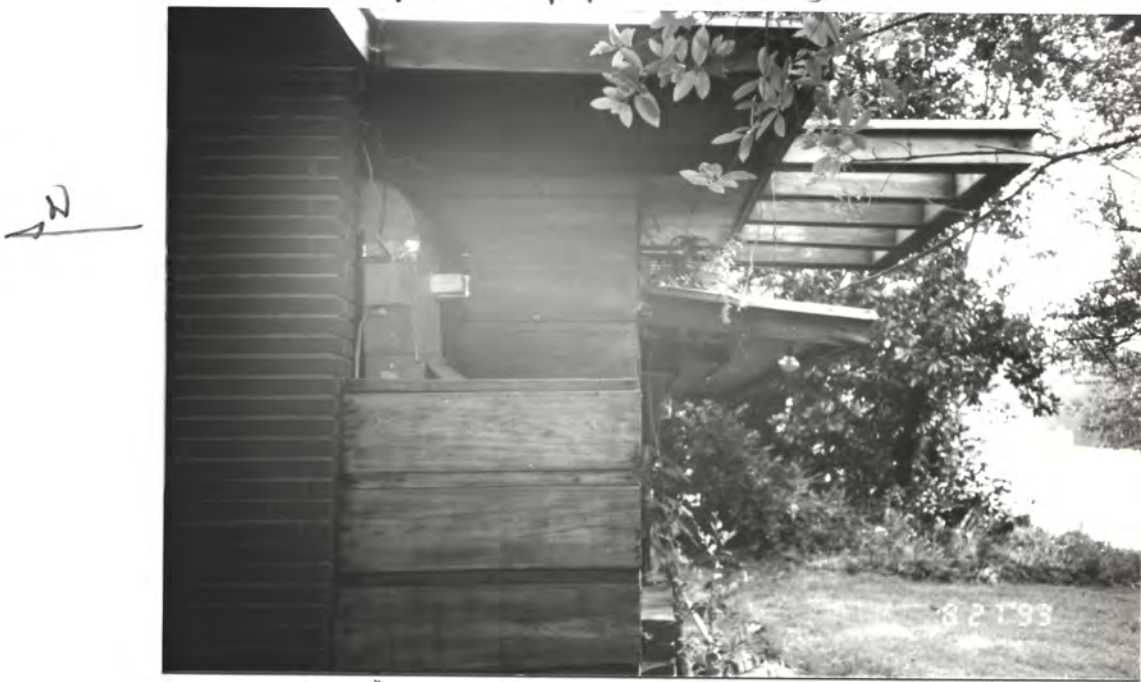
FIG. 5

The cantilevered eaves are sagging at various locations around the house (Fig. 4, 5, & 6). The fascia board that was added in the 1968 renovation has become separated and warped at numerous locations (Fig. 7). It was originally attached with glue. The fascia at the east wall of the '48 addition at the courtyard is decayed badly and covered with plastic at this time.

A.C. unit on balcony

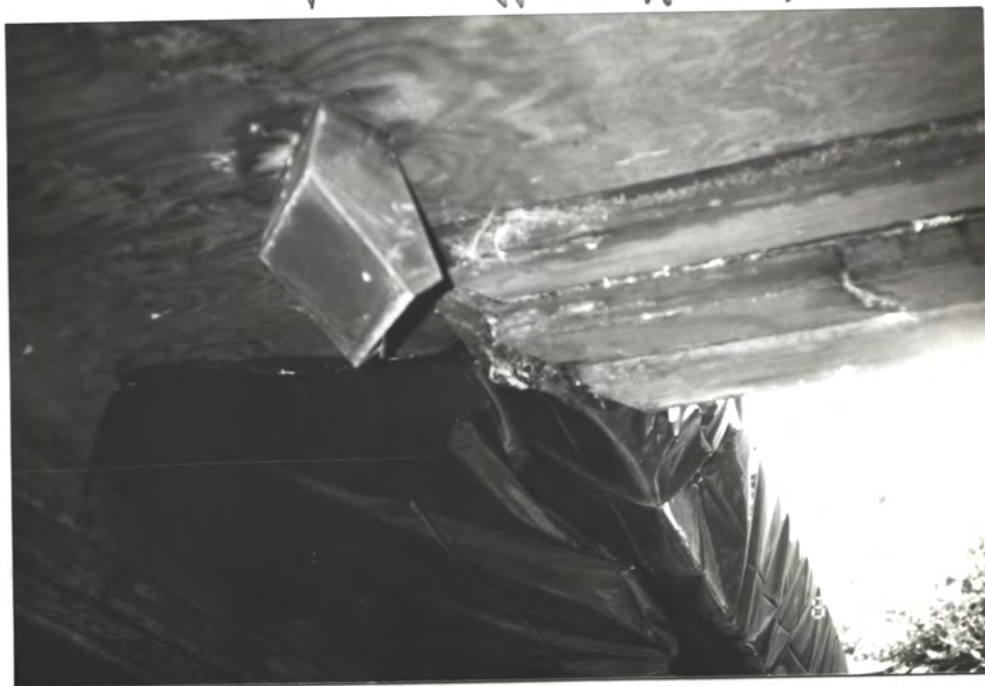
FIG. 7

↳ c. 1967 copper scupper (top.)

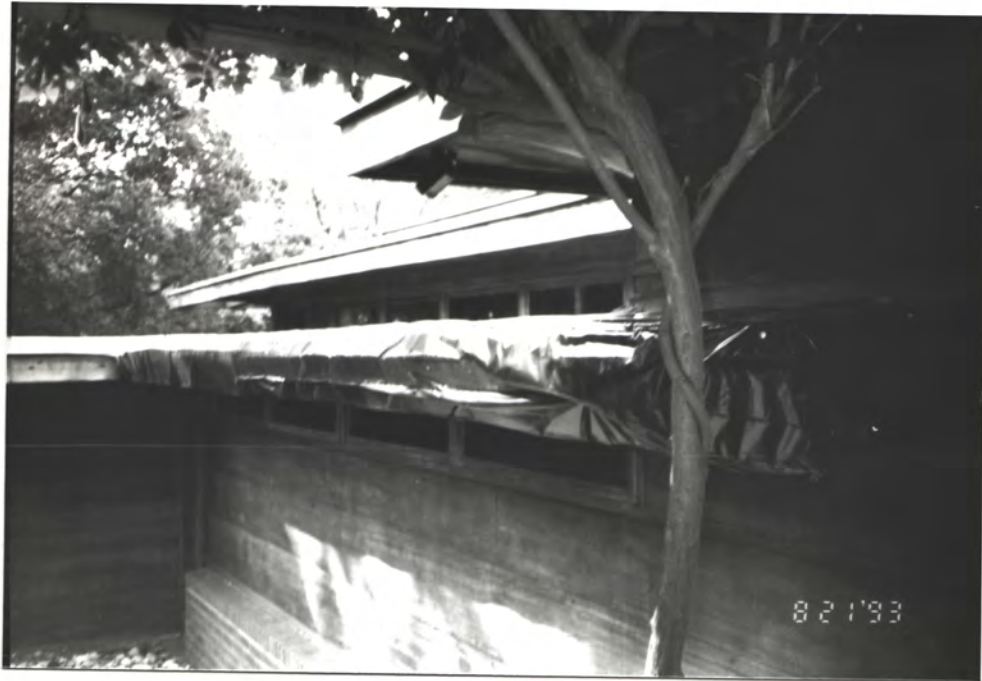
FIG. 7A

↳ polyethylene wrapped
over leaking roof edge
(promotes rot)
Weight removal.

← plastic wrap on edge

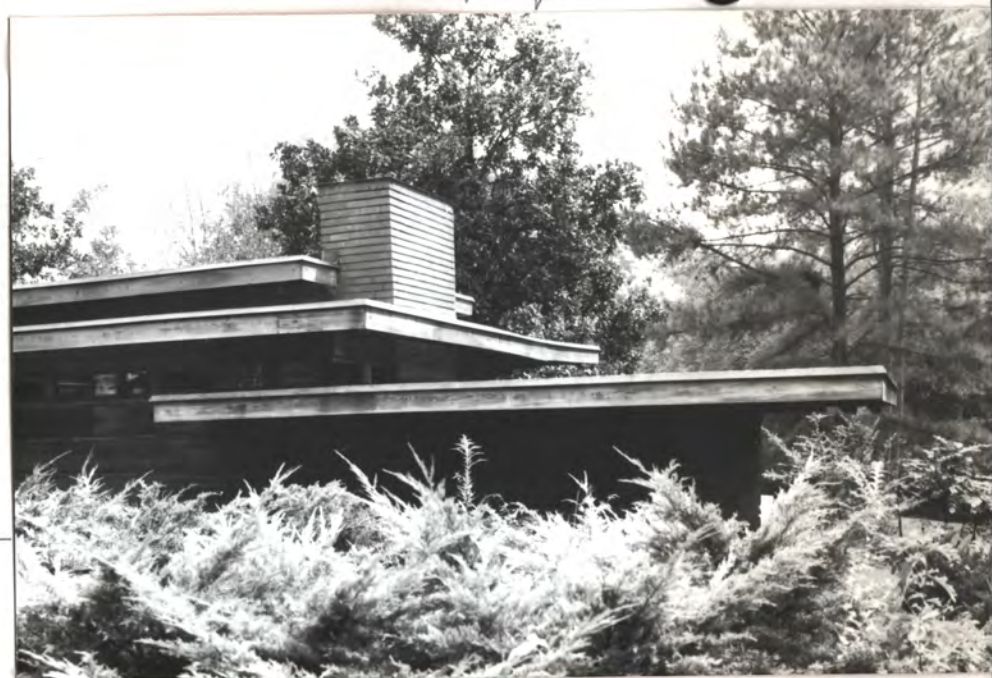
note roof defect →

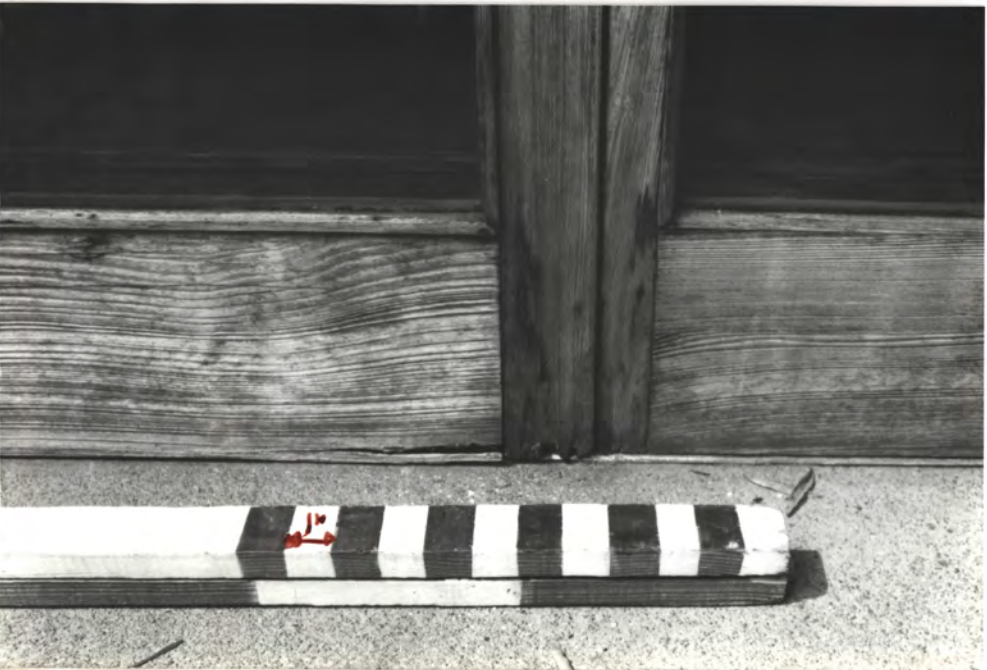
L. R. - S. W. M French Windows (typical)
brass piano hinges

↑ nail-patches at top

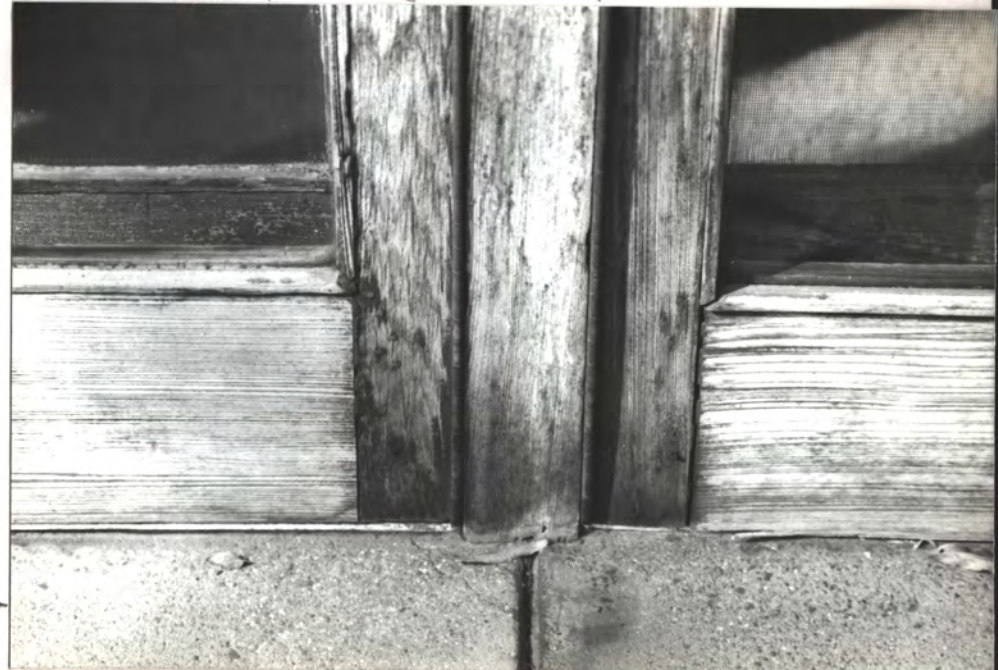
↑ rot, drags

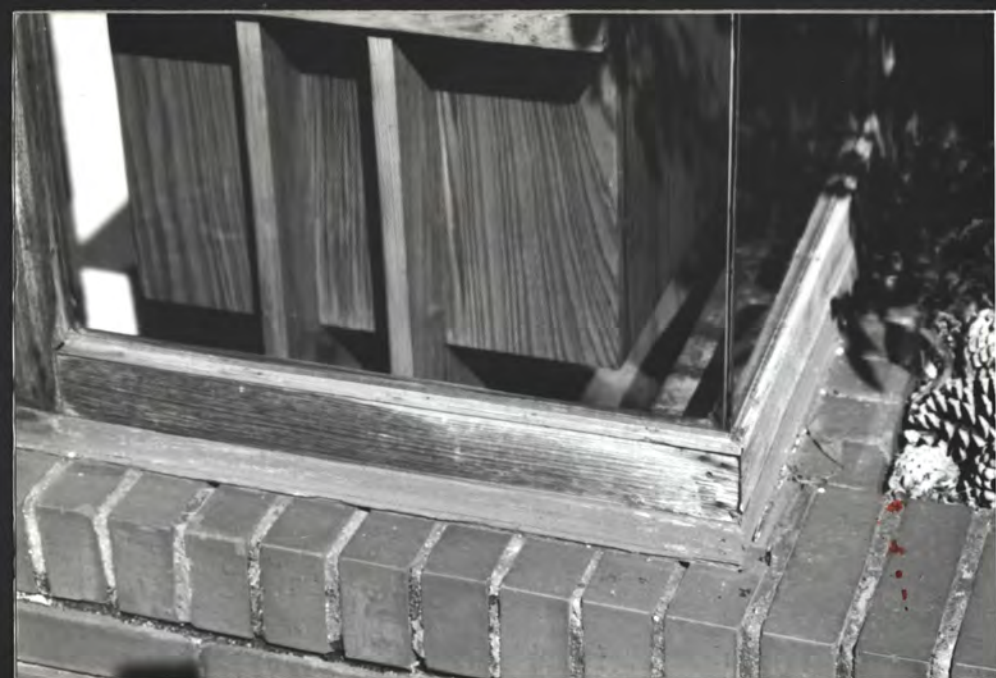
↑ rot, nail-patch ↑ rot

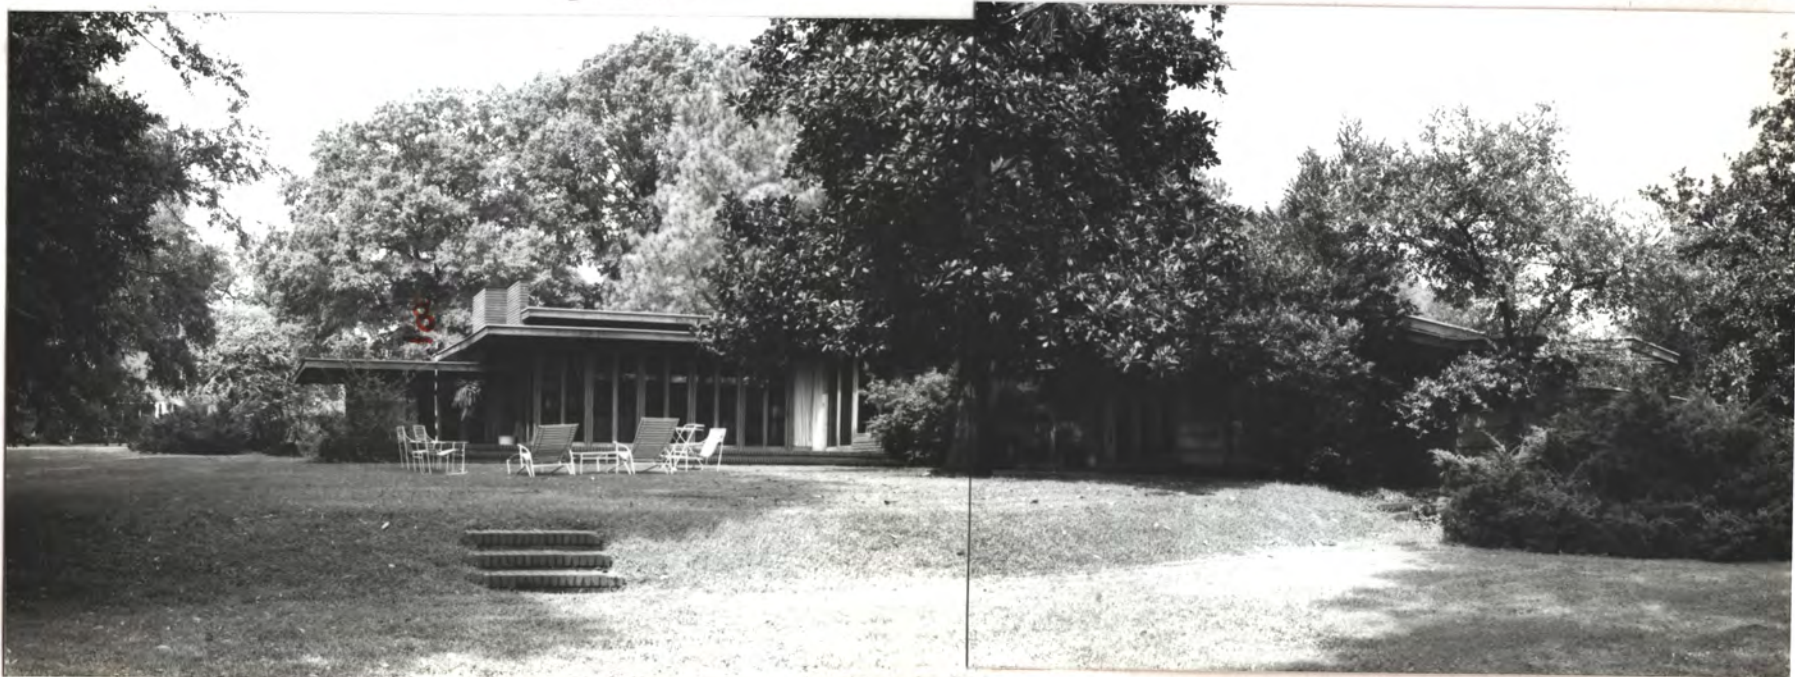
rot ↗ ↑ S.W. Corner at
Din. Rm

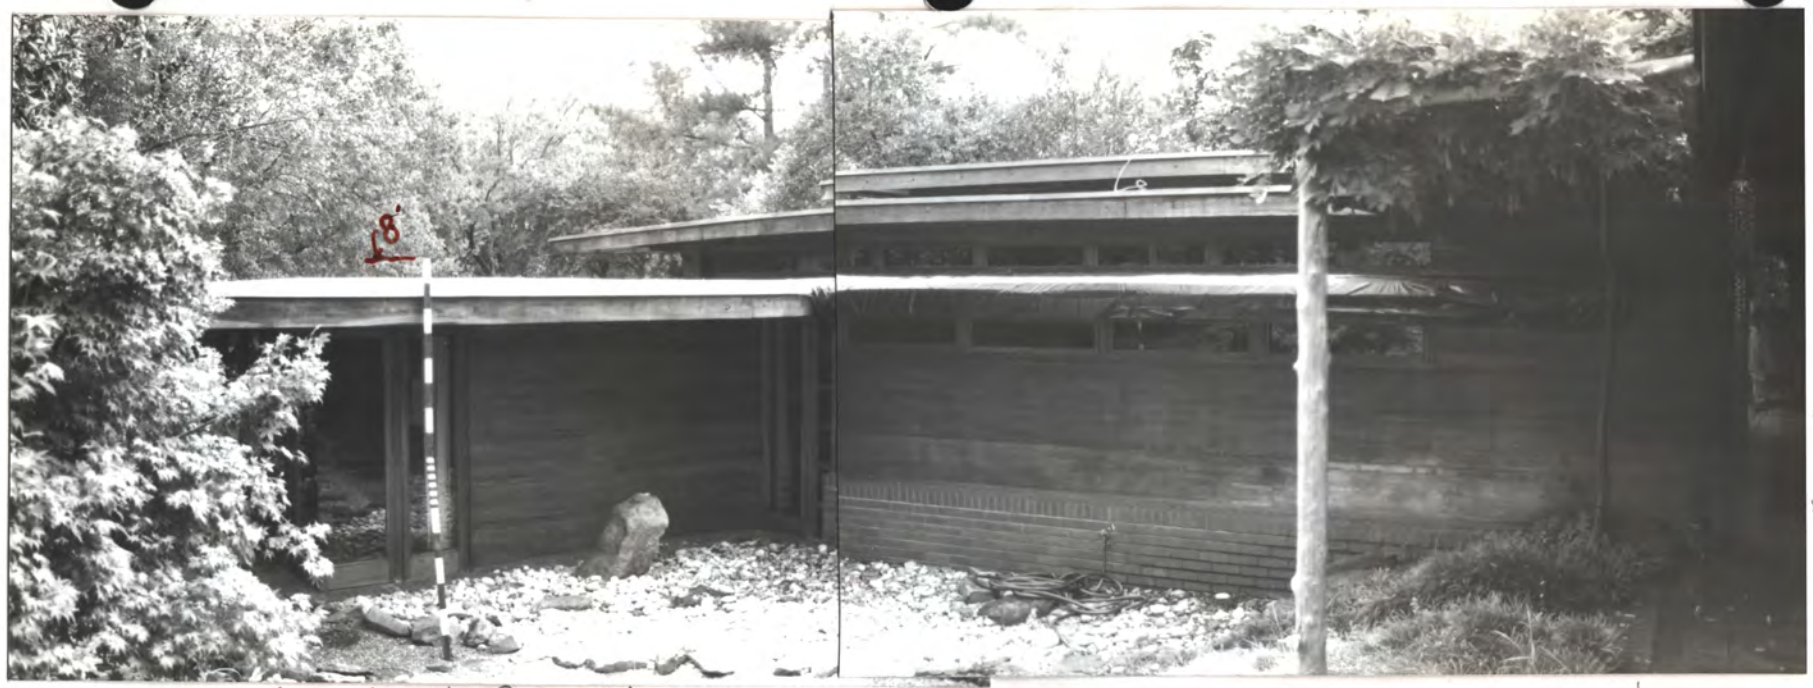
S.W. Gate at courtyard
← opened gate, w/ fence jamb
end (rotten) attached.
gate is very heavy.
Jamb too light for wtd

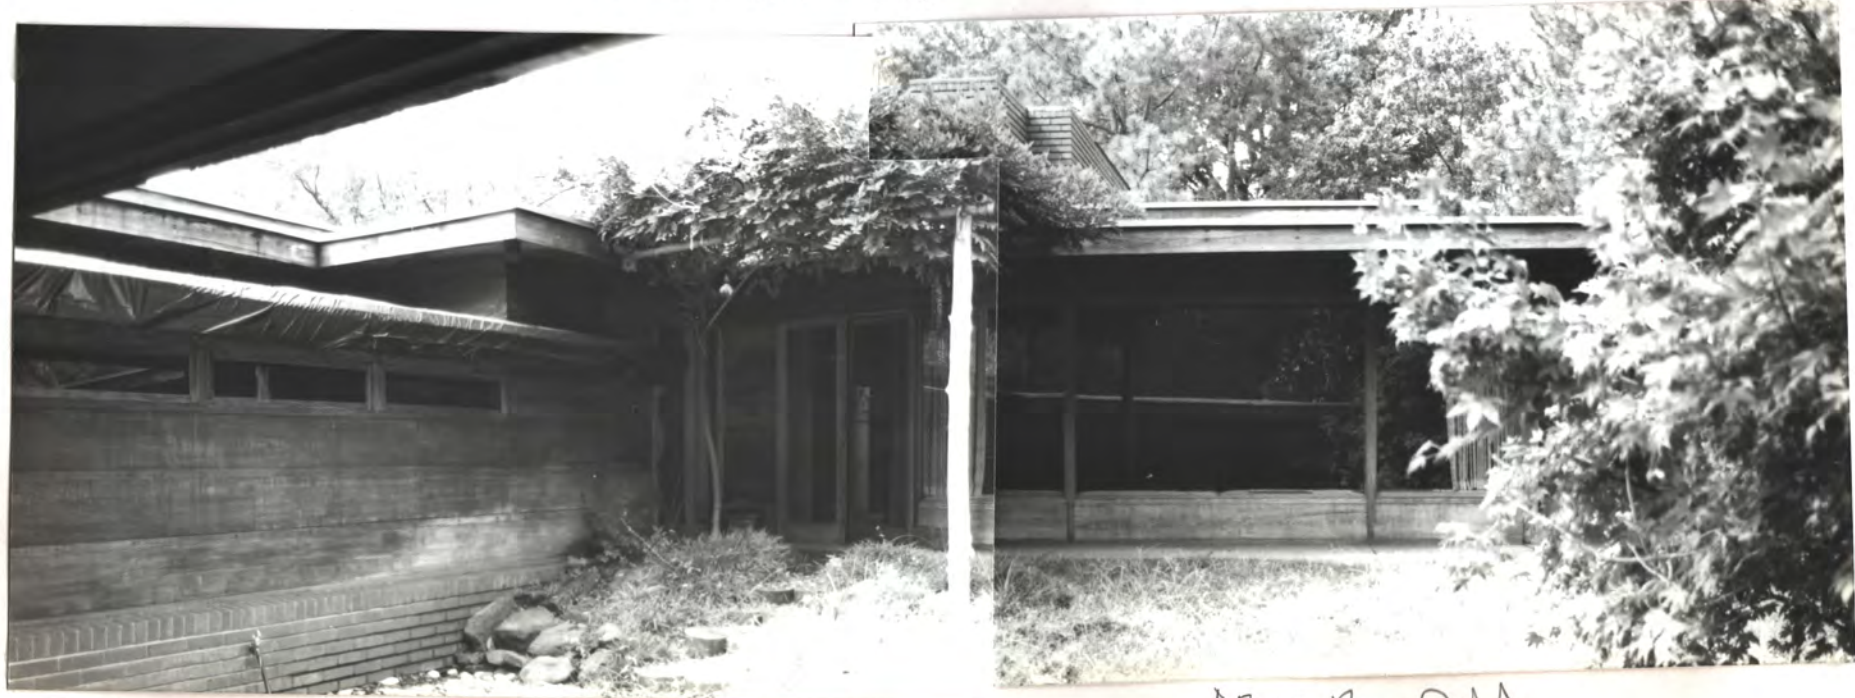
S.E. Guest Rm A.M.
 door to E. Corridor add.
 eave rotted & deflected, wrapped in plastic (urged removal)

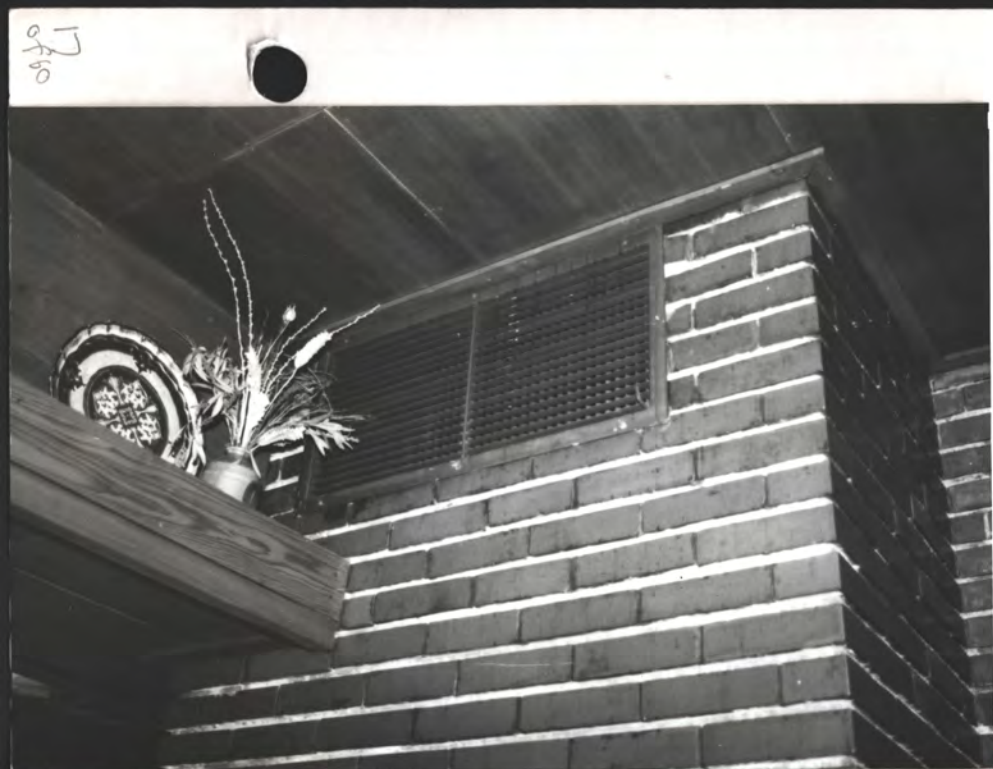
- D. White chemical-salt deposits ("efflorescence") on the interior faces of the bricks just inside the entry and on the main chimney indicate moisture on the bricks. The mortar source should be stopped and the efflorescence removed, if possible, without affecting the color and texture of the bricks. Mrs. Rosenbaum says the bricks were coated with polyurethane some years ago, which increased the difficulty of the job. The polyurethane should also be removed, if possible.

white is
efflorescence
behind later
polyurethane
sealer on
brick
(mistake)

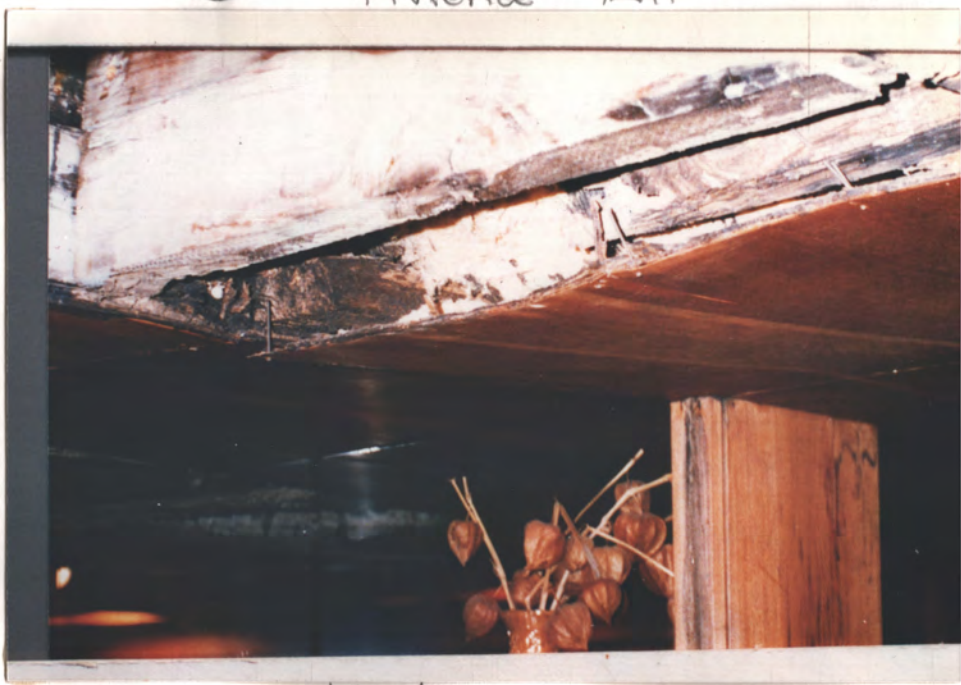
NE Wing, Bkfst roof rot

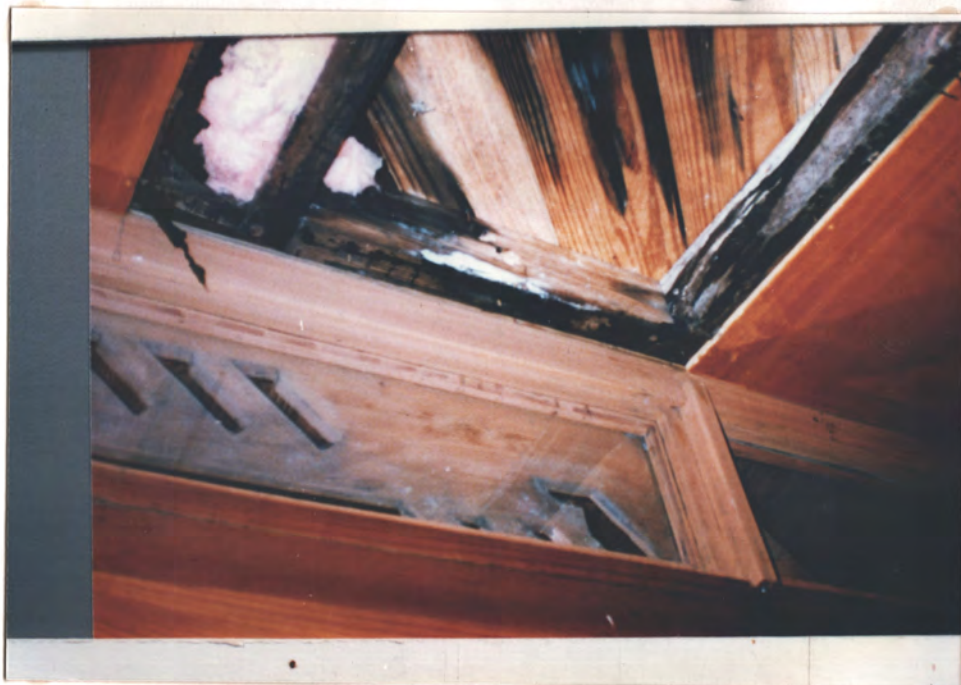
E. Hall, rot & termites

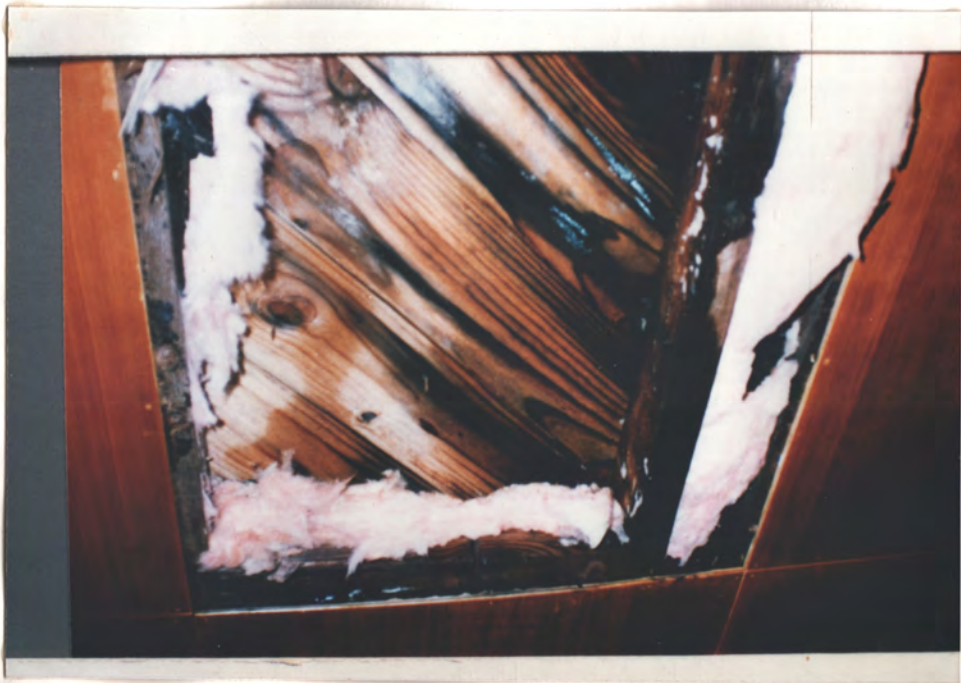
E. Hall, rot & termites

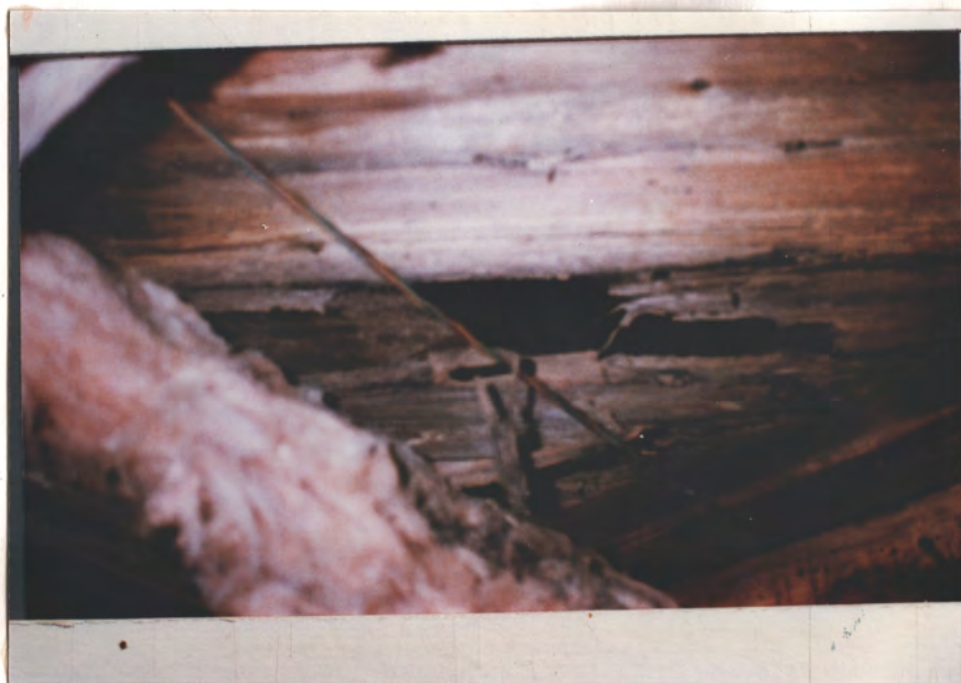
Bkfst — roof rot

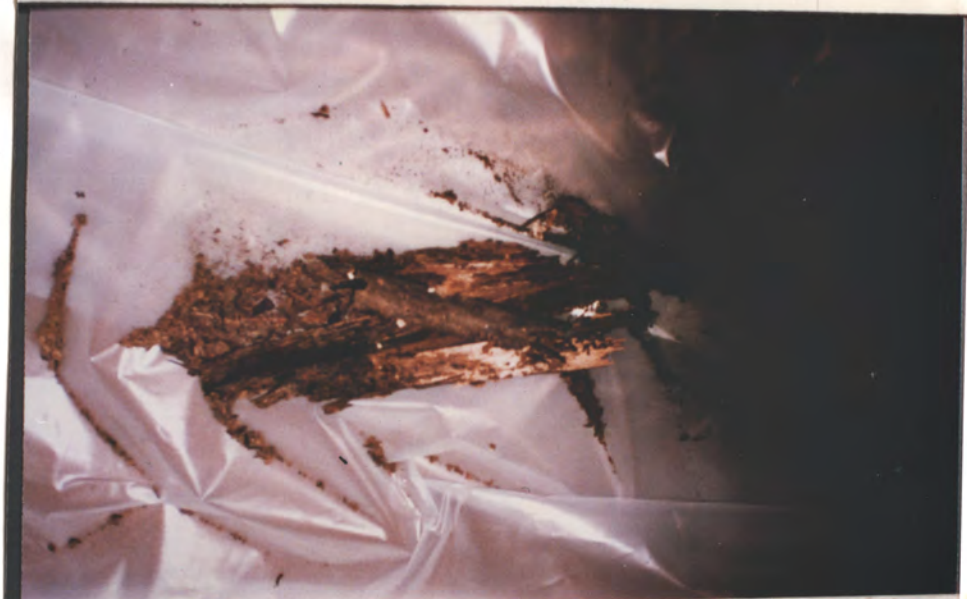
fall out of ceil. at bkfst

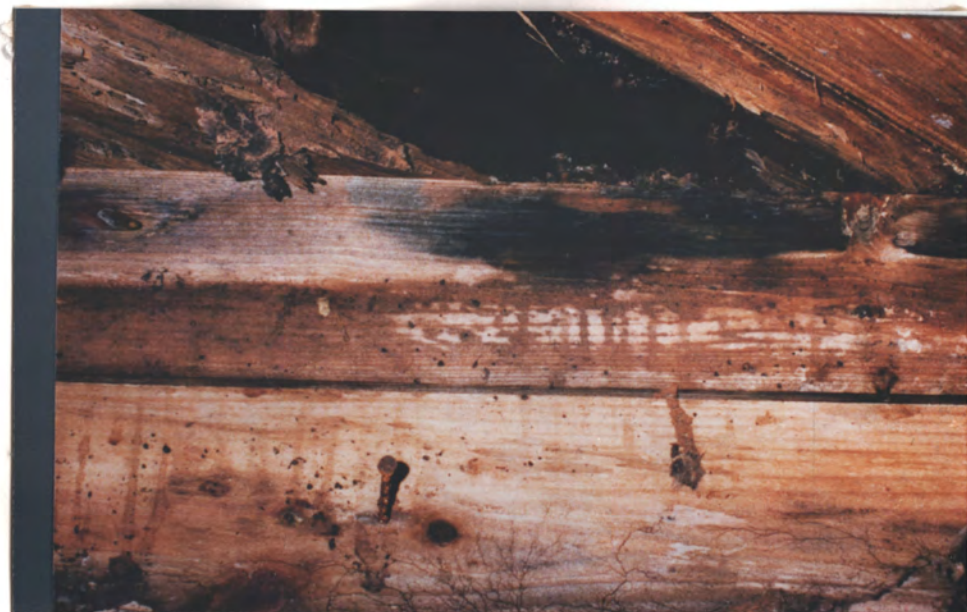
Rkfst, root rot

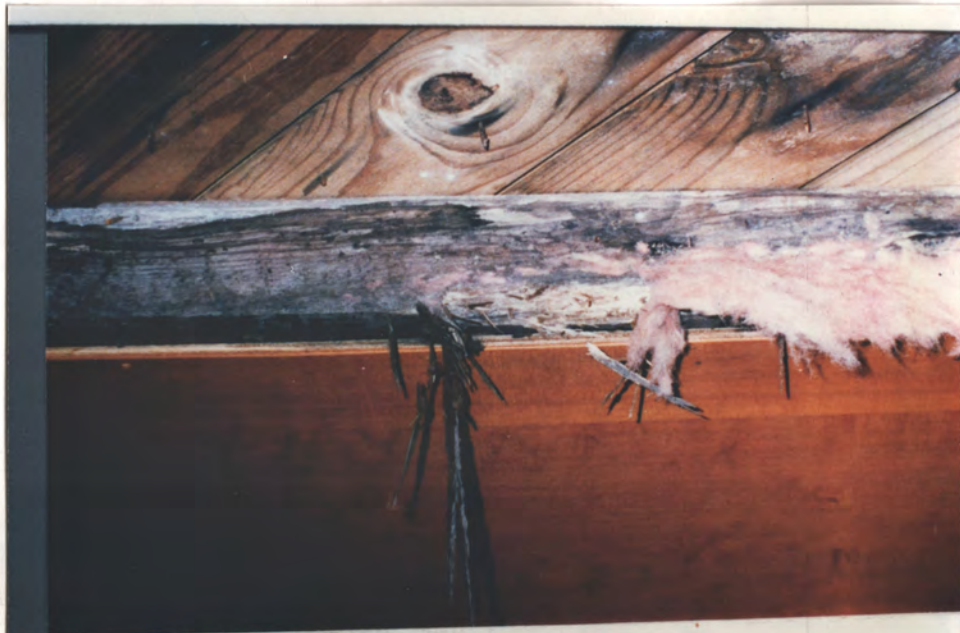
N. BR roof rot

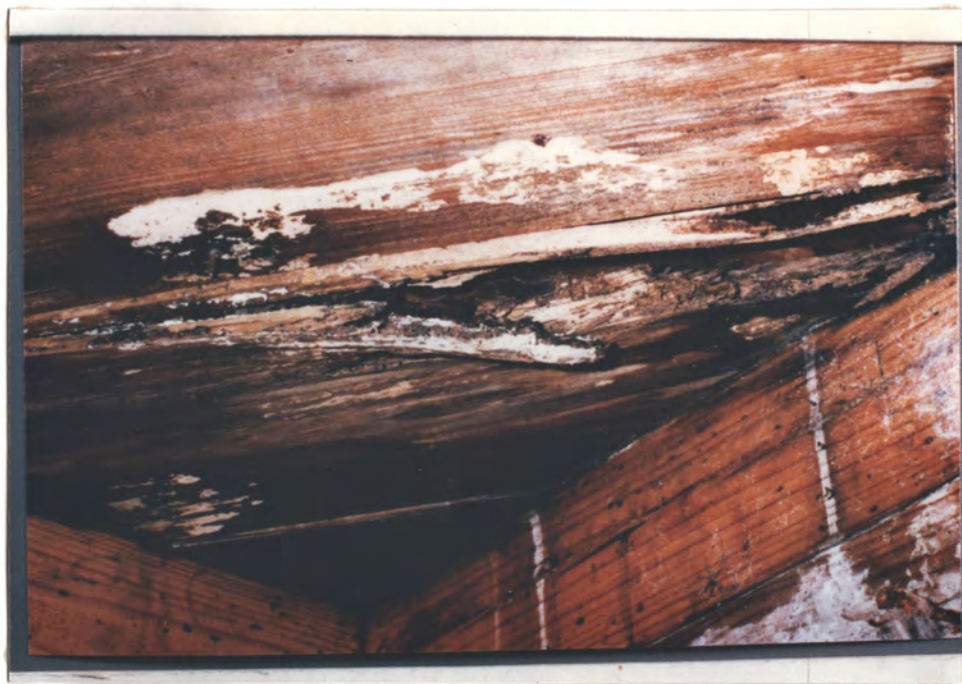
Bkfst - roof decks rot

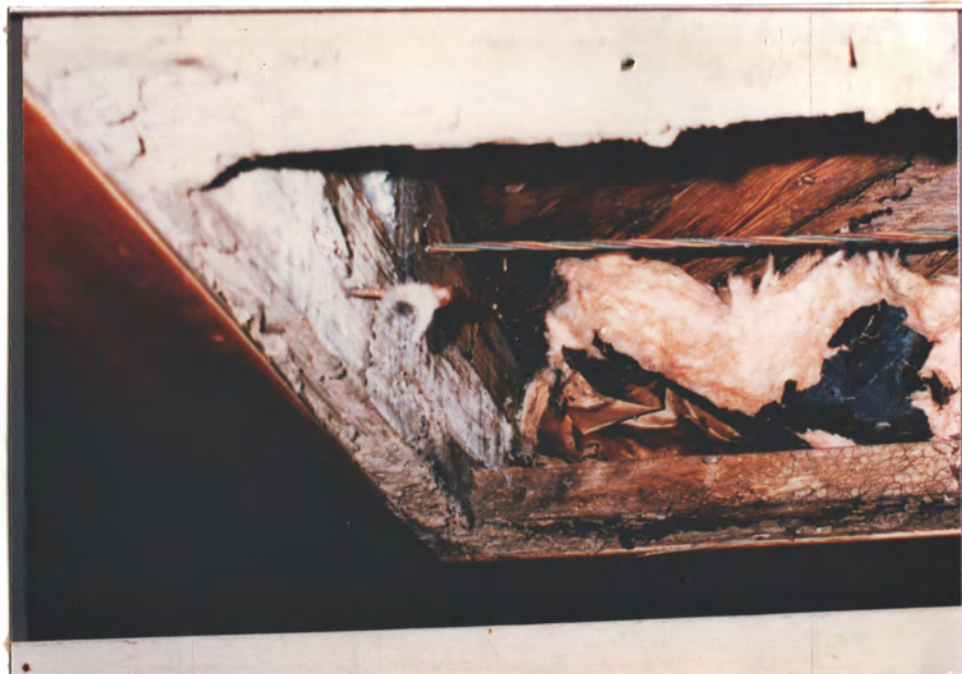
E. Hall, terminals of rot

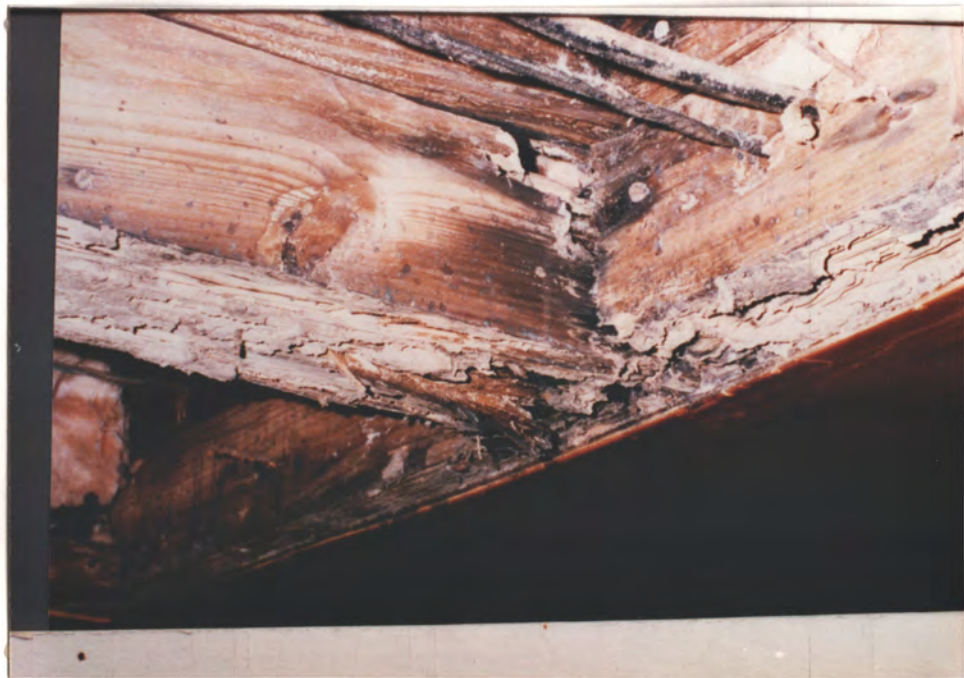
E. Hall, terminals of rot
