Storm Damage - 1860 Huntsville Depot in June 1989
 H & Jones photos - Jones & Herrin, Architects, AIA.

1860 Huntsville Depot
Storm Damage
June 1989
photos W. Jones
1 of 7

1860 Memphis & Charleston R.R. Passenger Depot & Eastern Div. N.C.
Photos Nov 9 '97 HJ

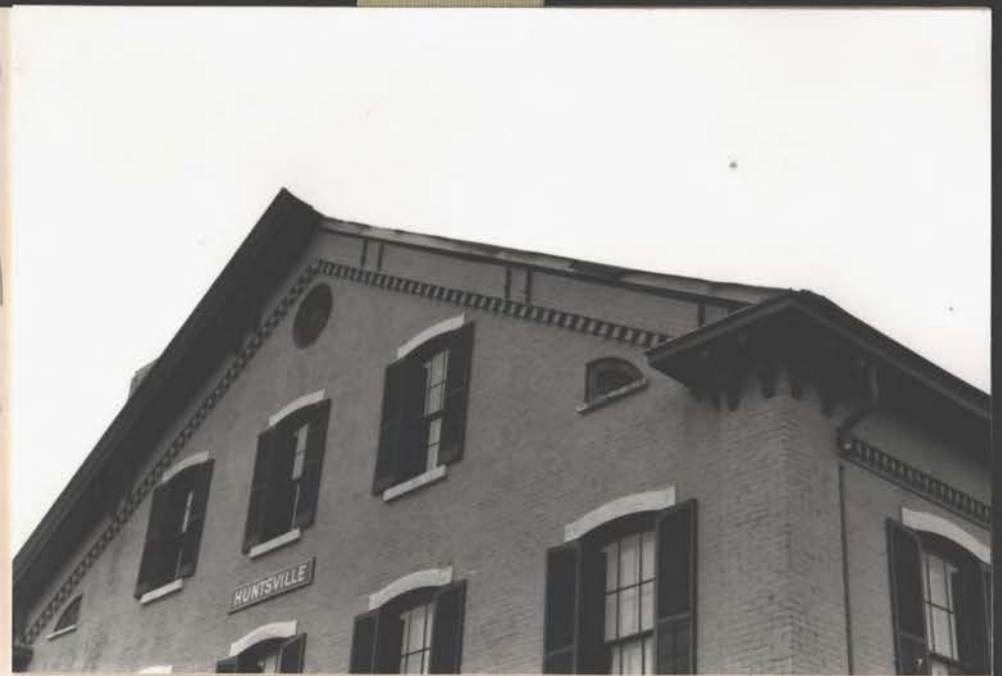
N ← S.W. CORNER
 ROOF PITCHED, WEST CORNICE HALF-BLOWN OFF

N ← CORNICE BLOWN OFF
 CORNICE
 BACKED
 BY WIND
 S.W.
 CORNER

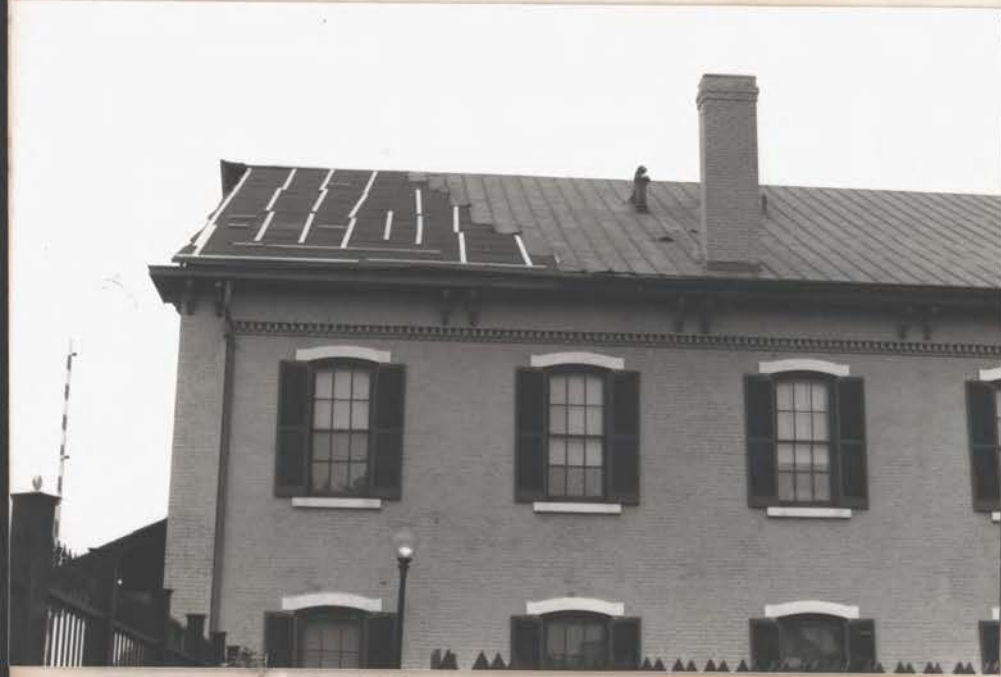
N ← ROOF PITCH
 SOUTH WALL
 ROOF DENTED

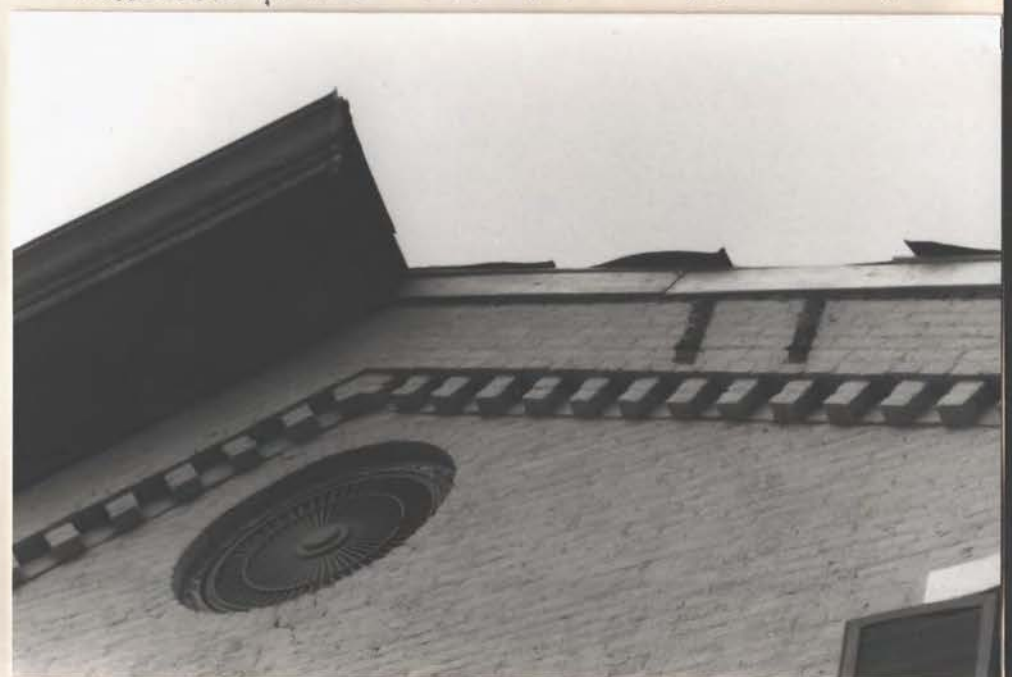
N ← WEST CORNICE
 BLOWN OFF

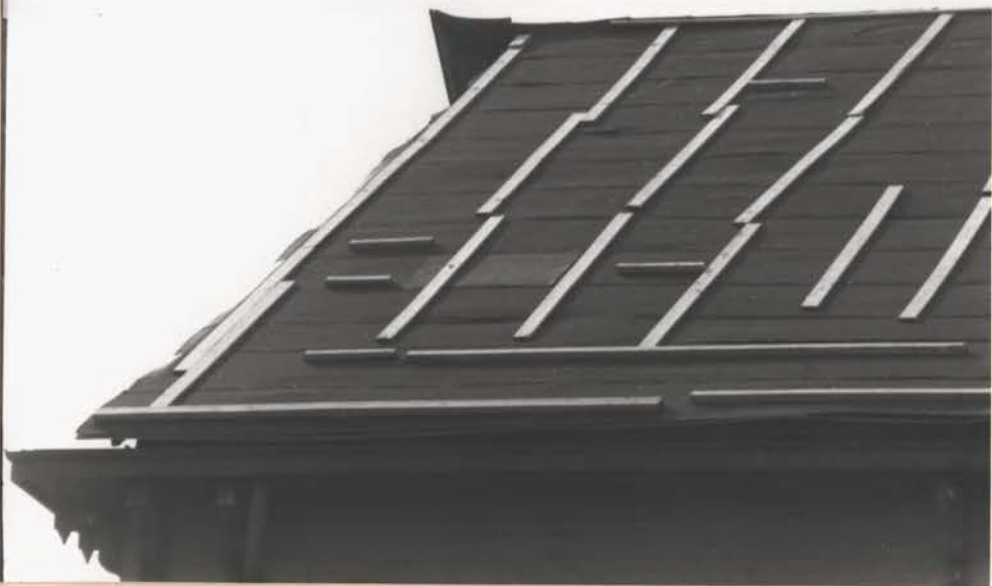
↑ S.W. CORNER

TEMPORARY ROOF PITCH

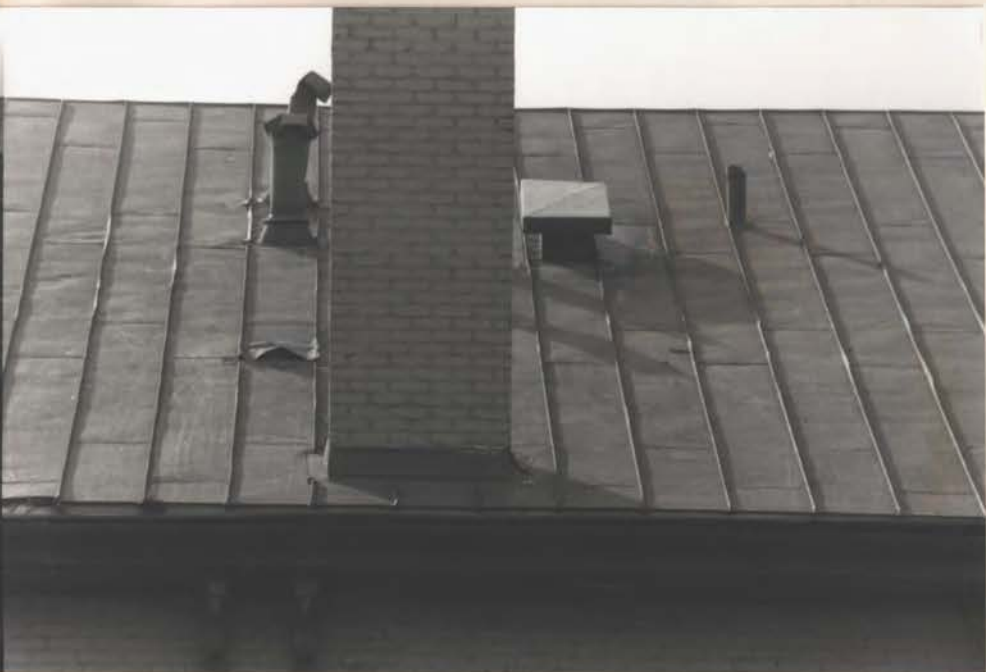
↑ S. CENTRAL CHIM.
(REBUILT W/ VERT. STL. REINF.
+ CONC. CORE IN 1976)

↪ ALL ROOFING
BENT

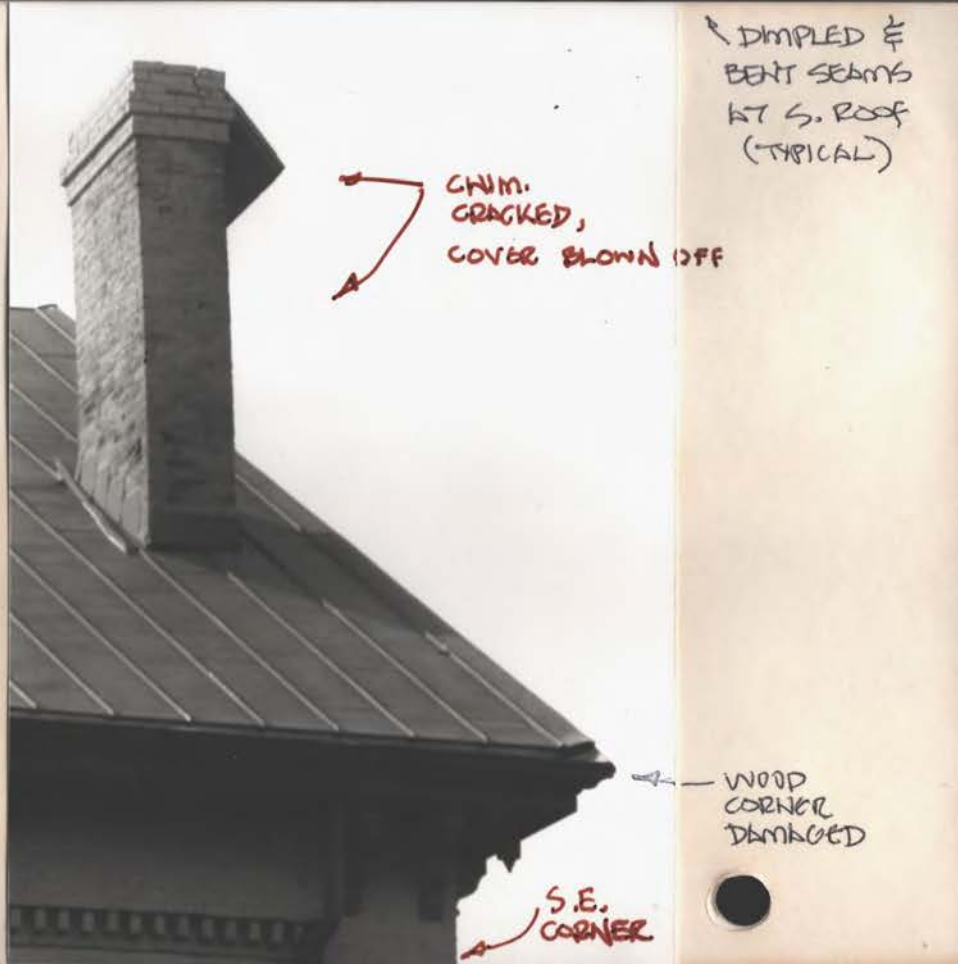
↪ S.E.
CORNER

↪ DIMPLED &
BENT SEAMS
AT S. ROOF
(TYPICAL)

↪ CHIM.
CRACKED,
COVER BLOWN OFF

↪ WOOD
CORNER
DAMAGED

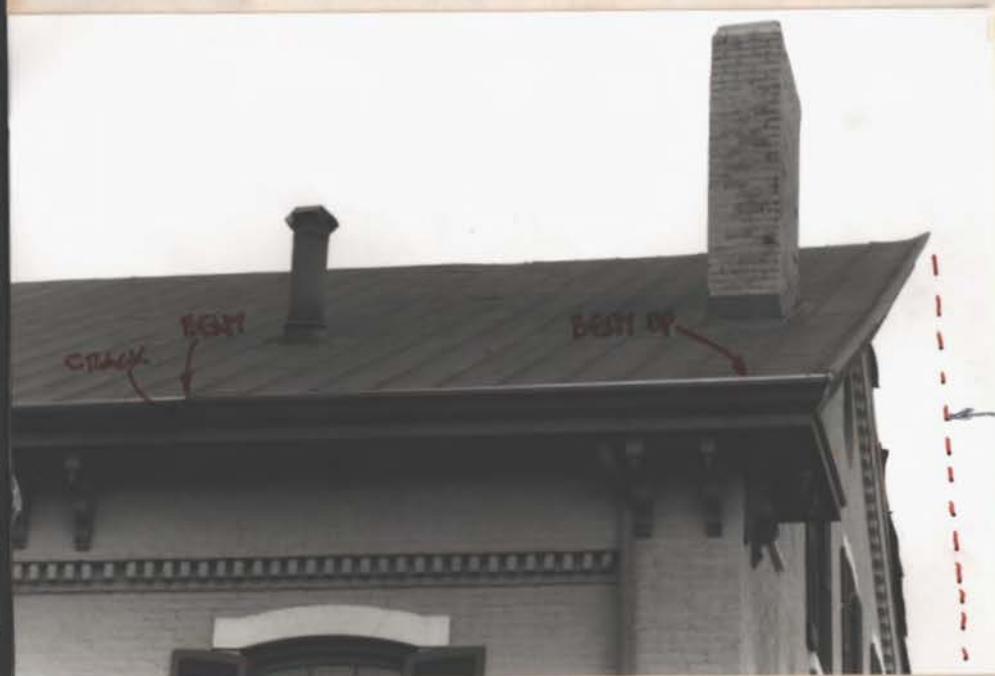
N ↗ N.W. CORNER ↘

CORNICHE
BLOWN
OFF

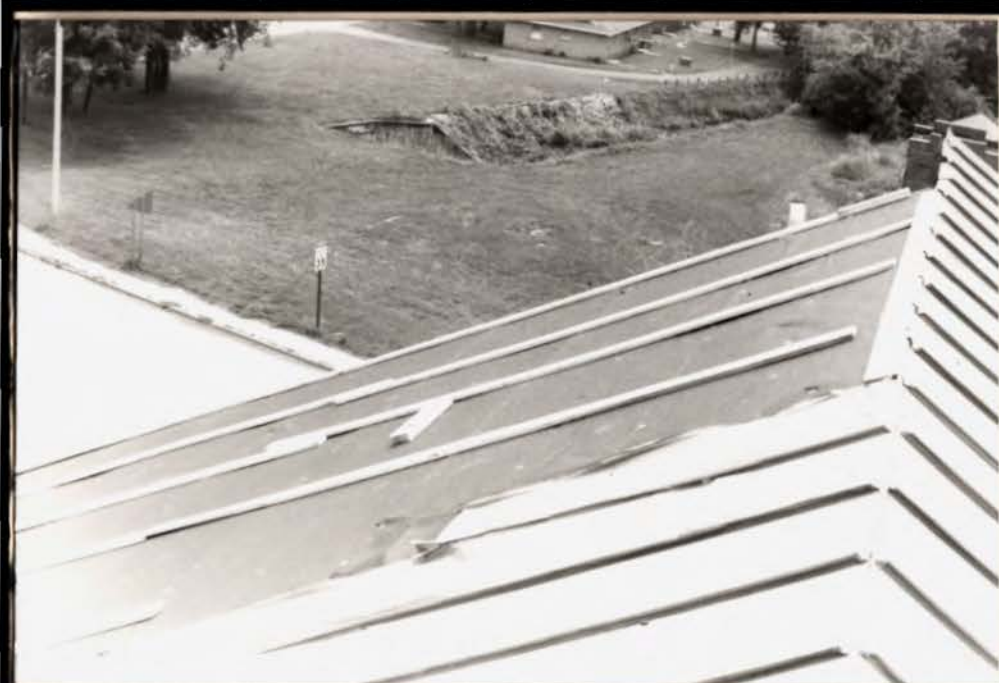
TEMPORARY ROOF PITCH

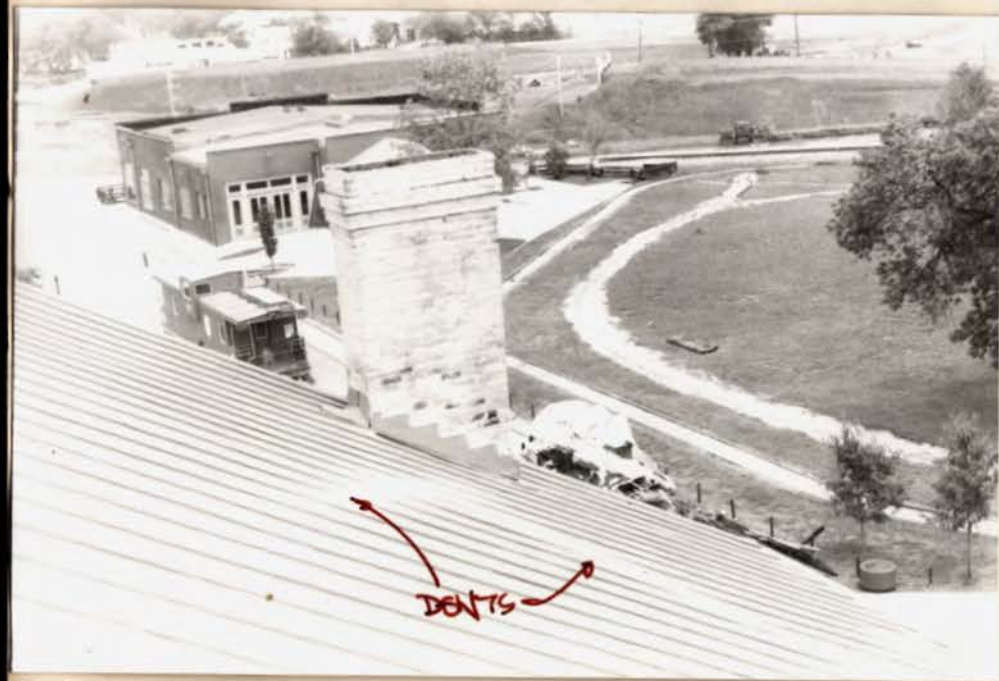
DENTS

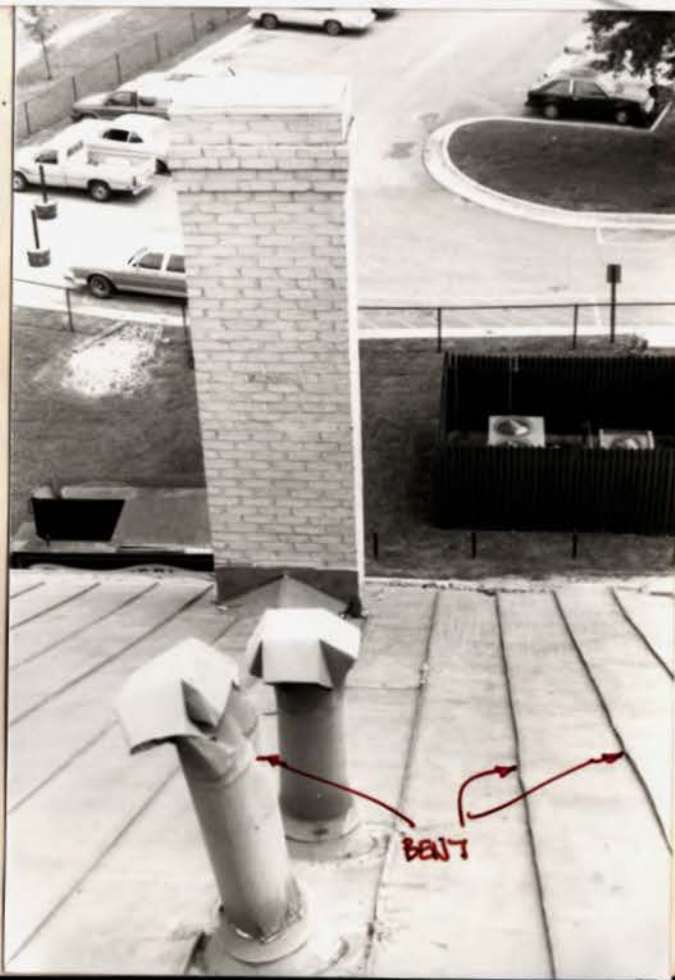
S. CENT. CHURCH
REBUILT + REINF.
IN 1977

BENT UP

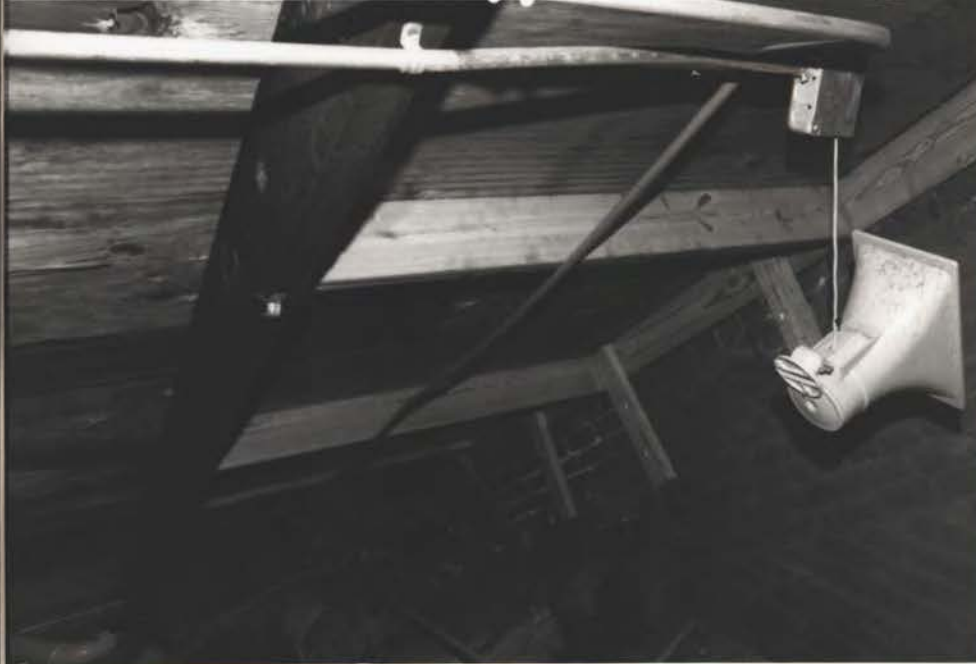
← conduit hanging loose

← 2x4's & ply. = temporary roof patch. Rafter is missing

← siren is loose

← bricks = west gable

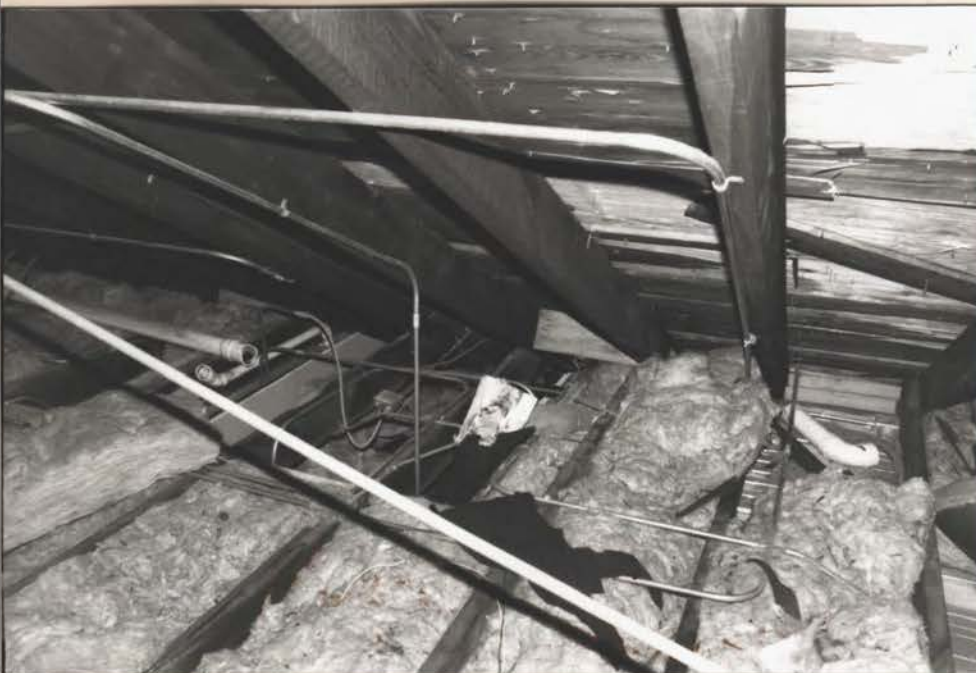
← ply. = roof patch (storms)

← insul. out of place

ASTIC AT
WEST END
(above 3rd fl. rms.)

two pipes broken (vents)

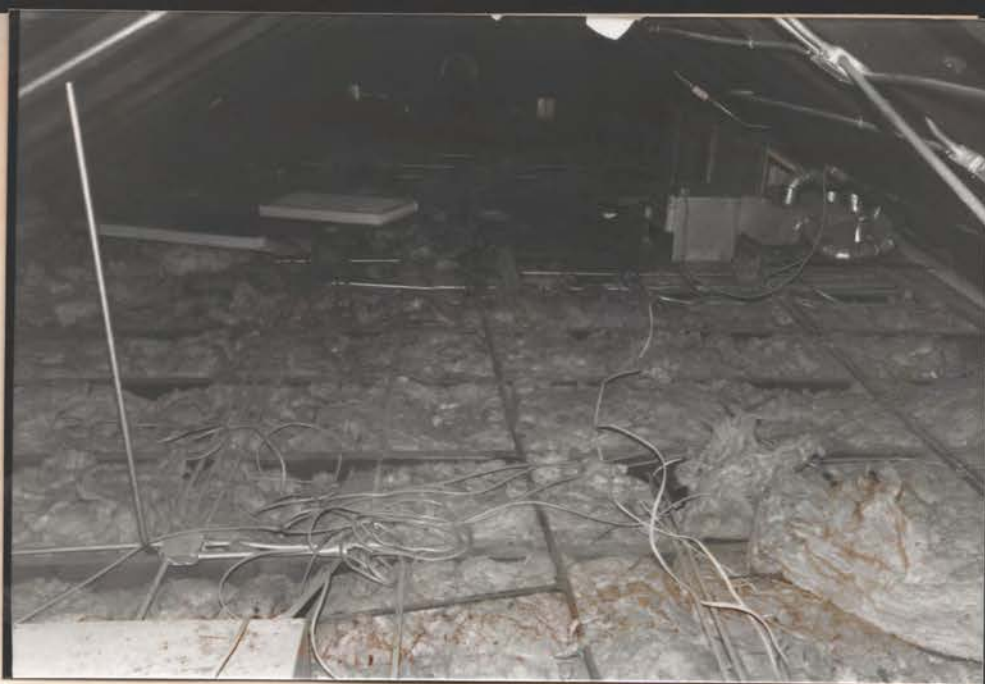
ATTIC

later fan plugged in
w/ the extra cord
(not code)

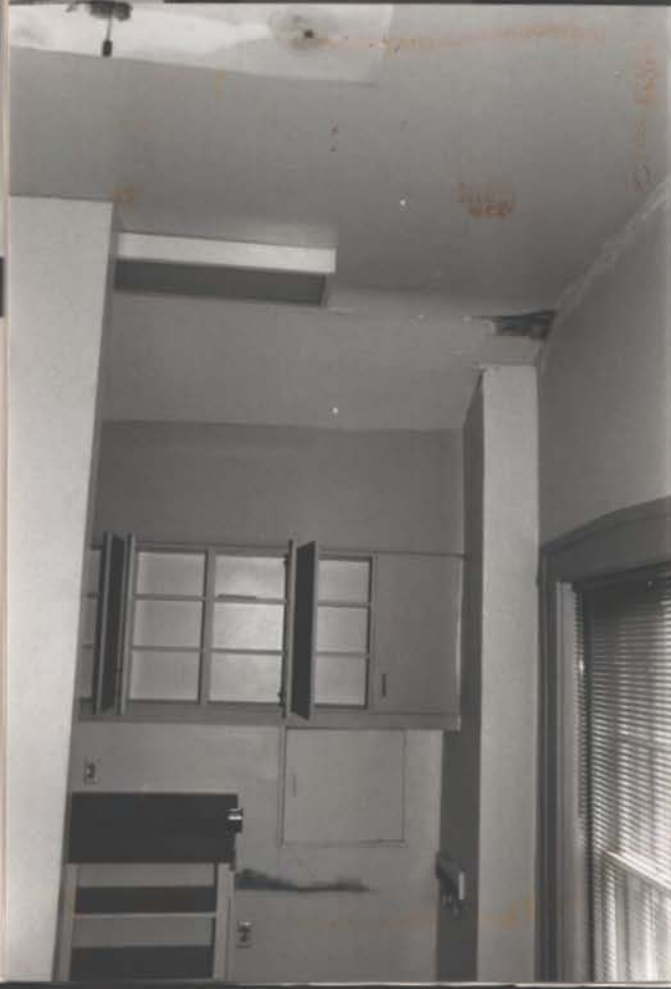
cracks + moist: damage

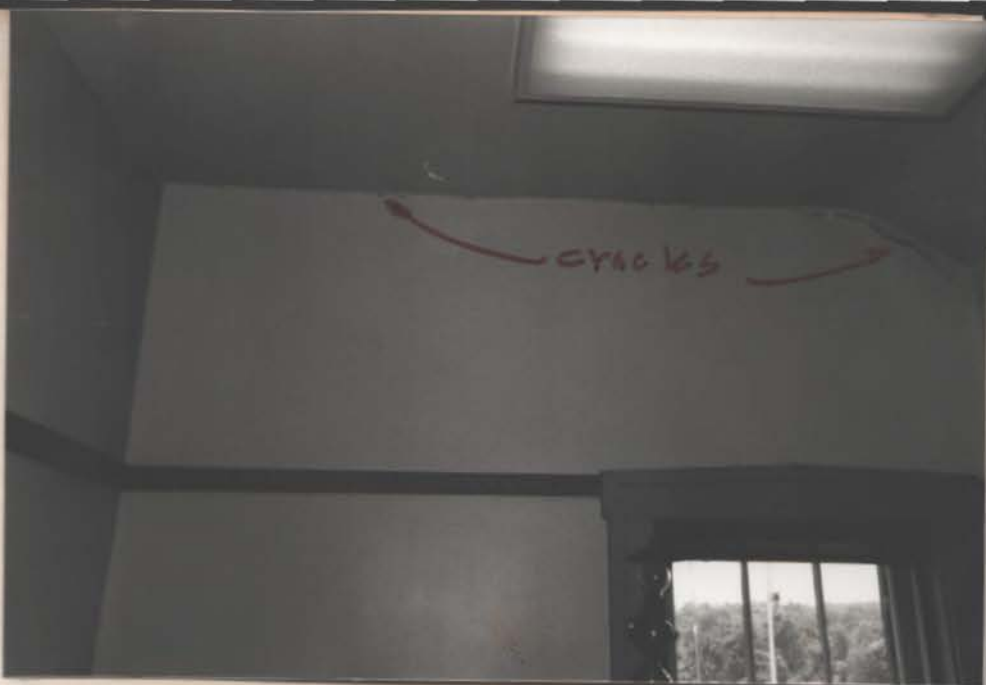
N. W. Office, 3rd fl.
Cracks & possible
moist. damage at
west & north walls

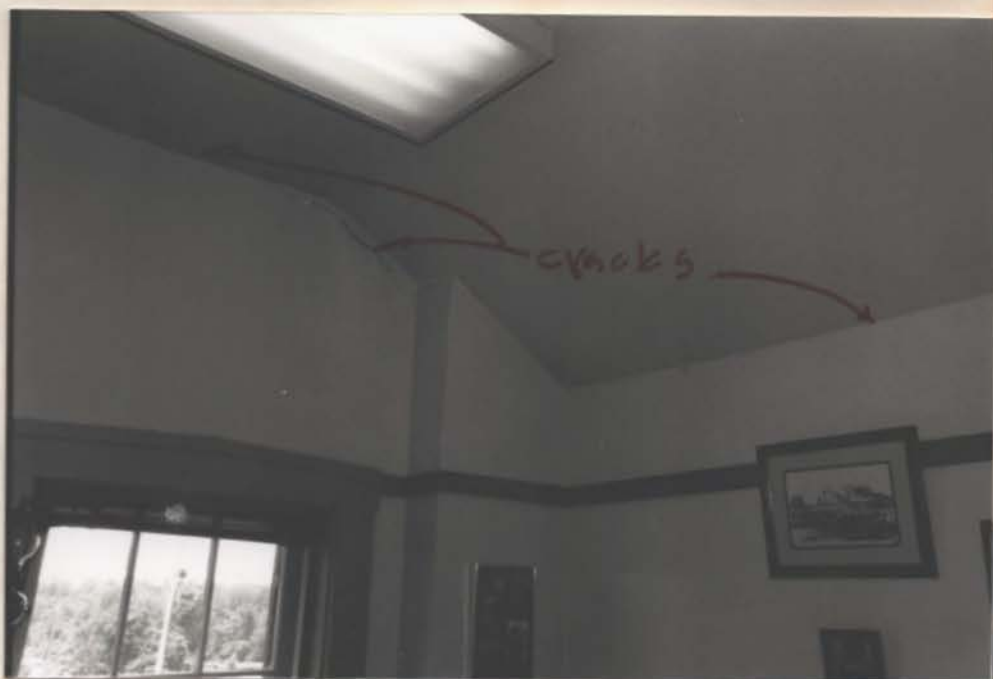
cracks

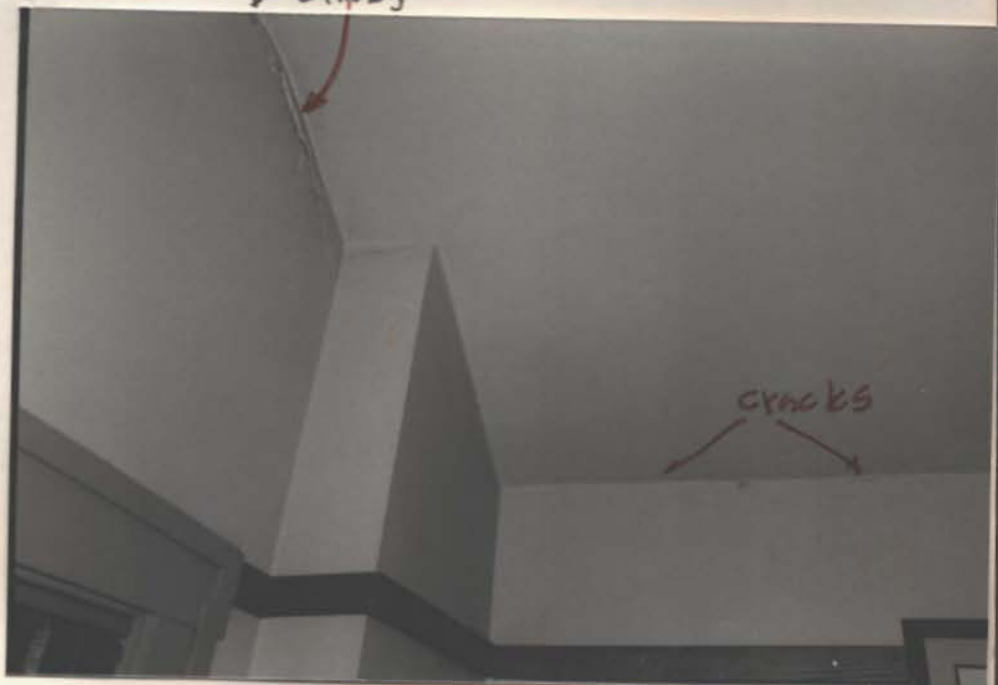
cracks

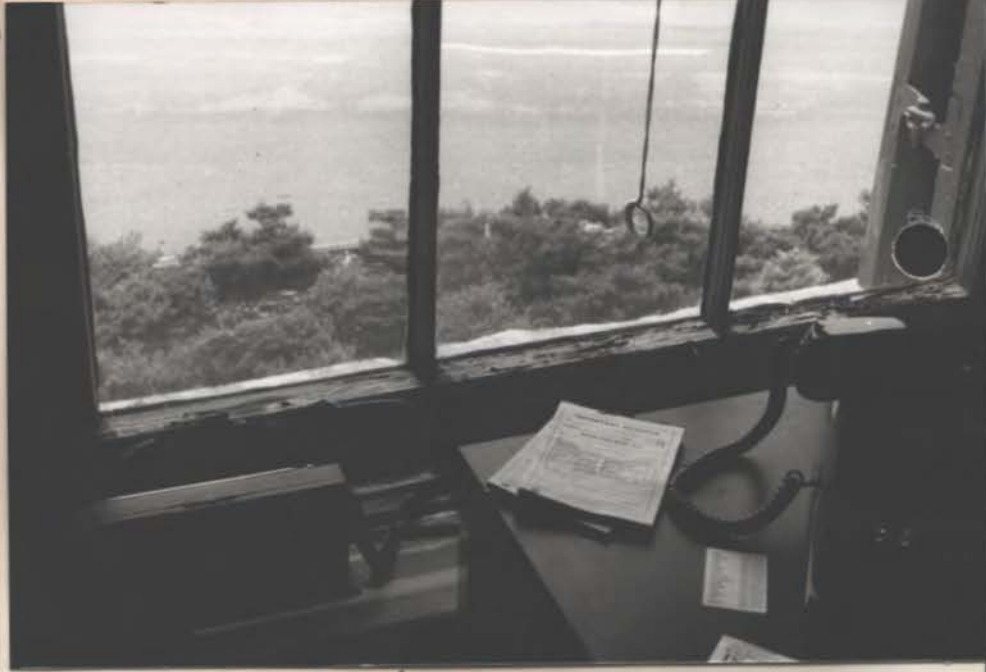
2ND FL. S.W. OFFICE ← Moist. damage to sash

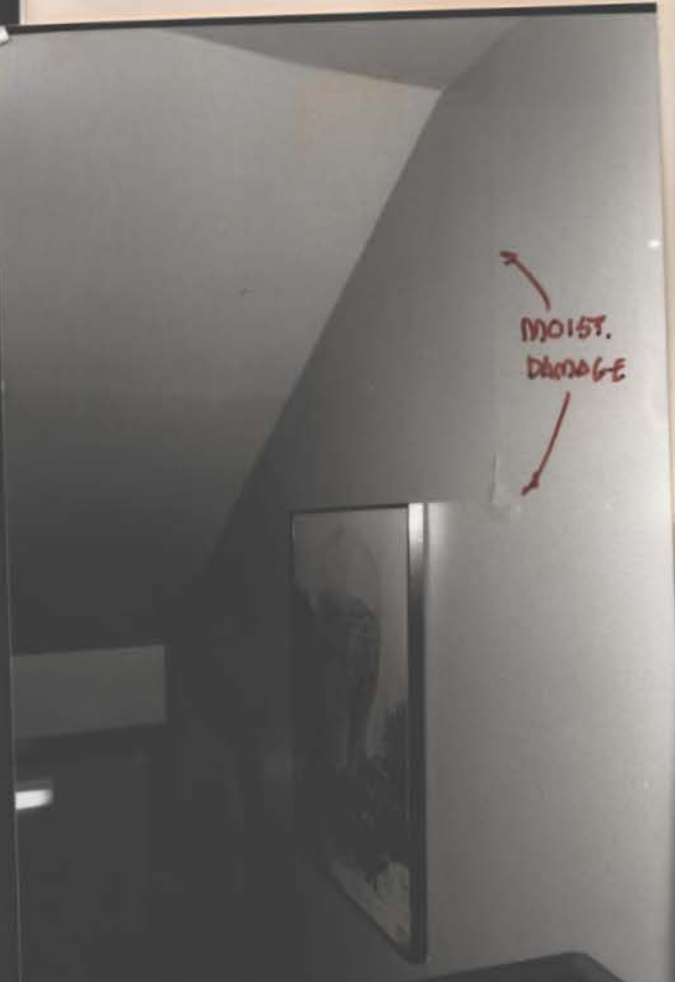
MOIST. DAMAGE

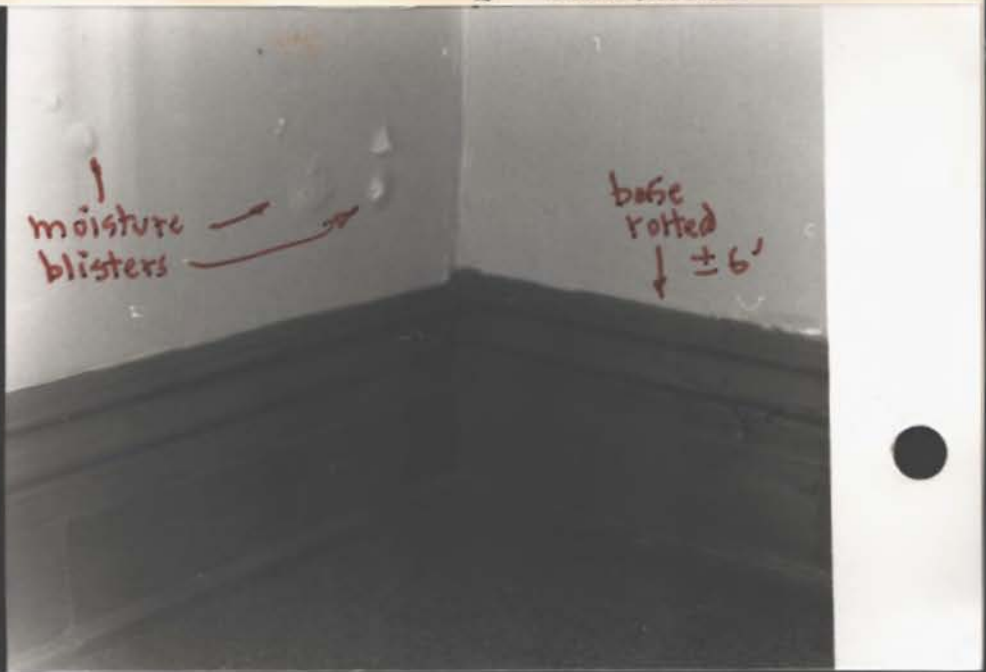
moisture blisters

base rotted
↓ ± 6'

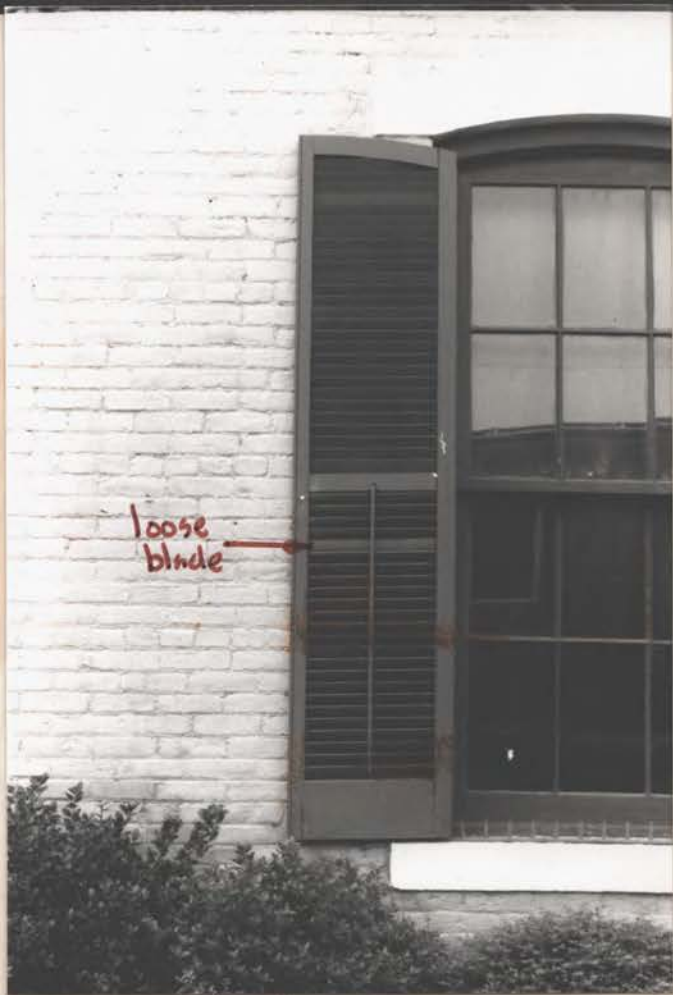
loose blnde

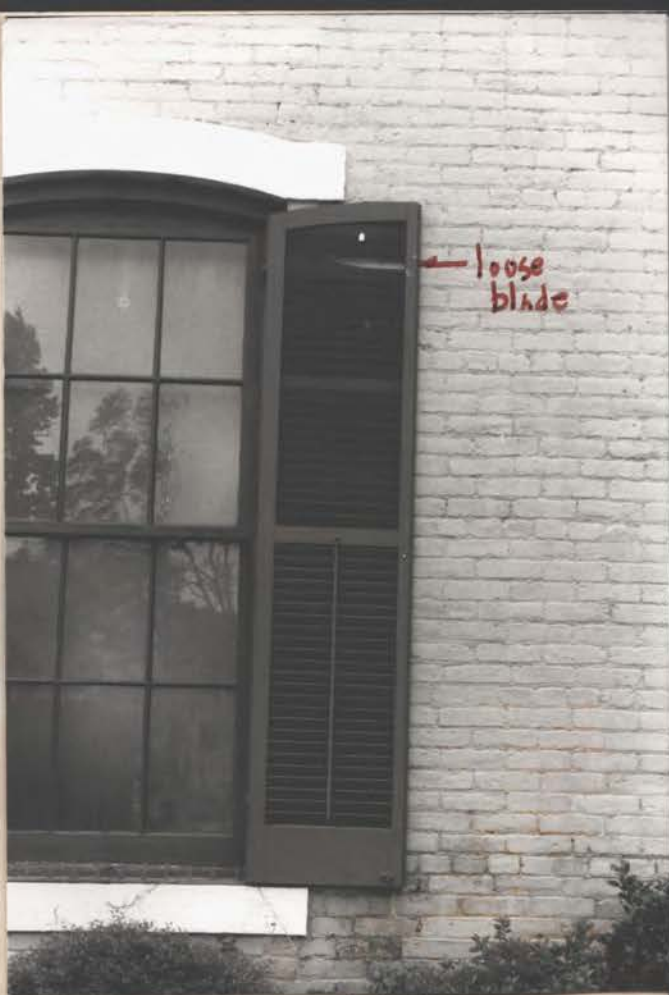
loose blnde

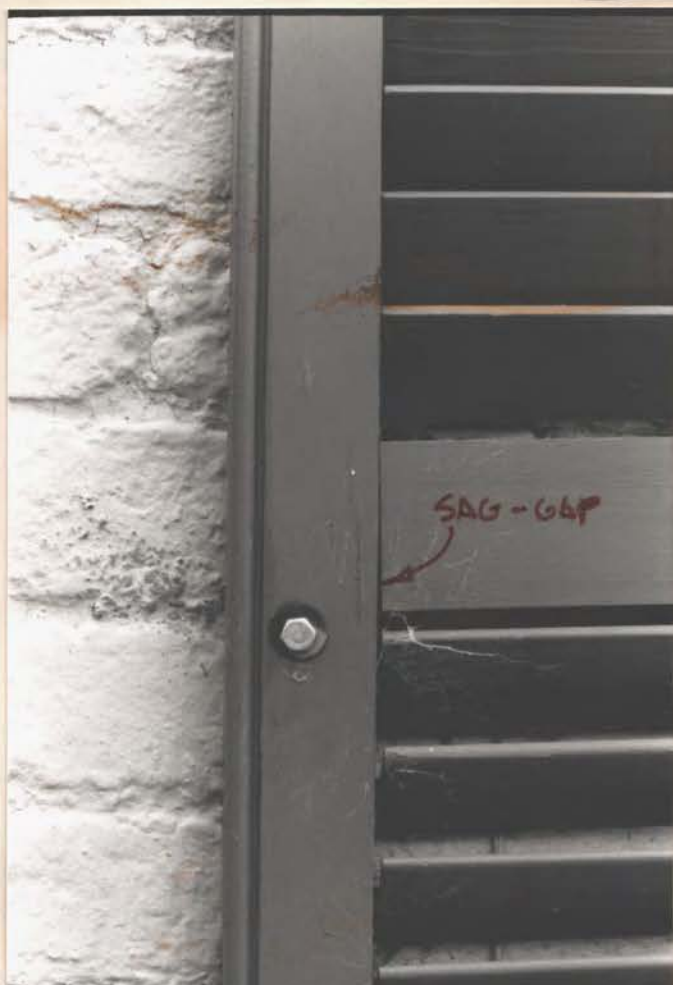
SAG - GAP

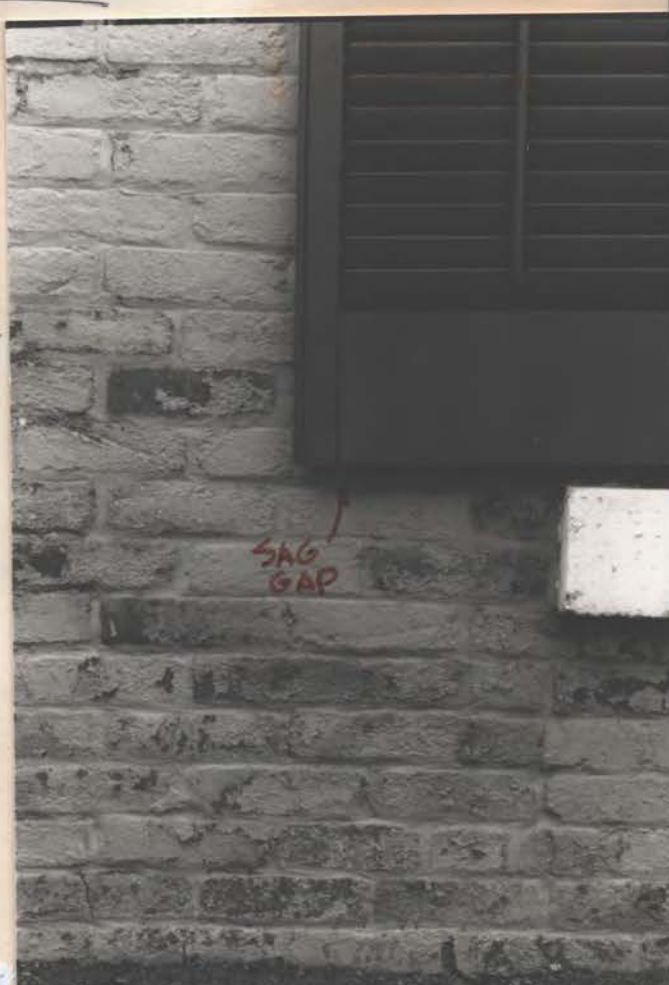
SAG GAP

"RISING DAMP" peeled paint

PEELED PLASTER

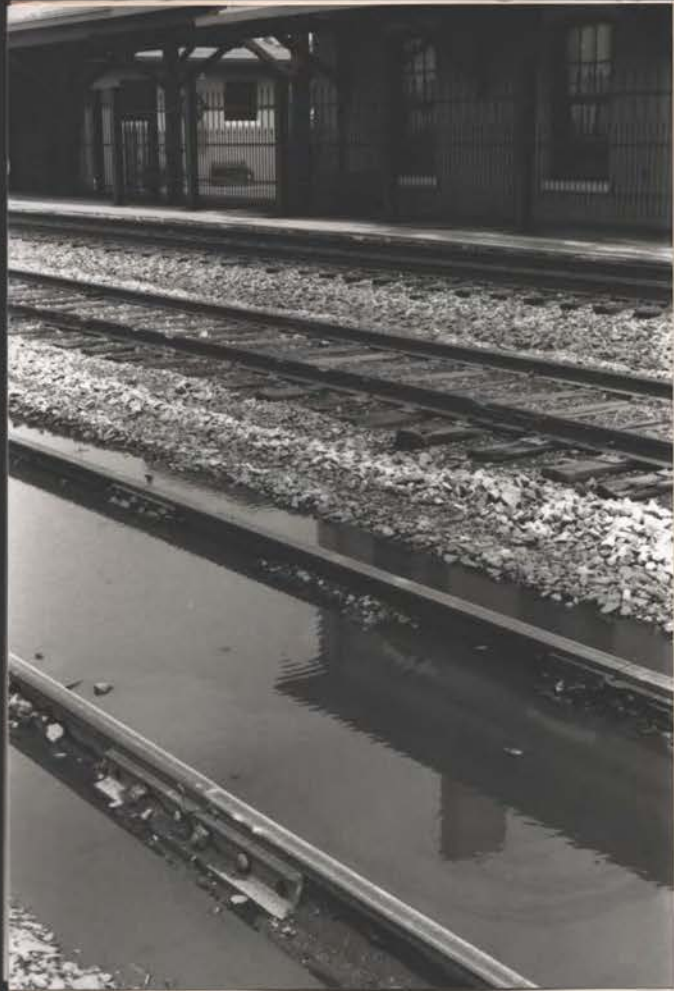
trapped water north of
 bldg., aggravates
 "rising damp"

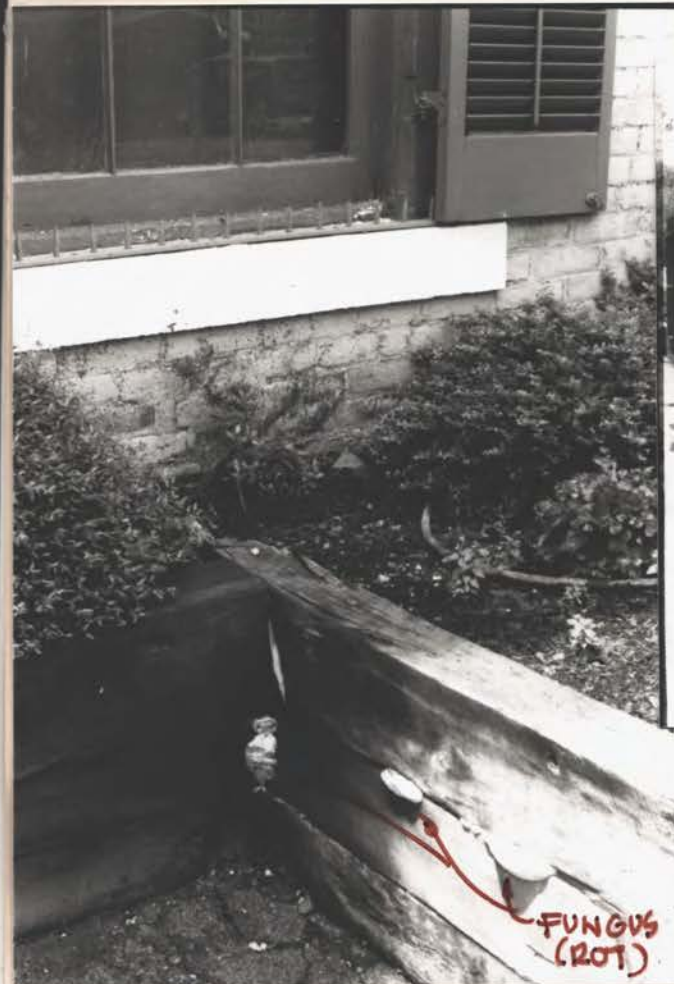
FUNGUS
 (ROT)

rotted baseboard & blistered
 plaster inside at S.W. rm.

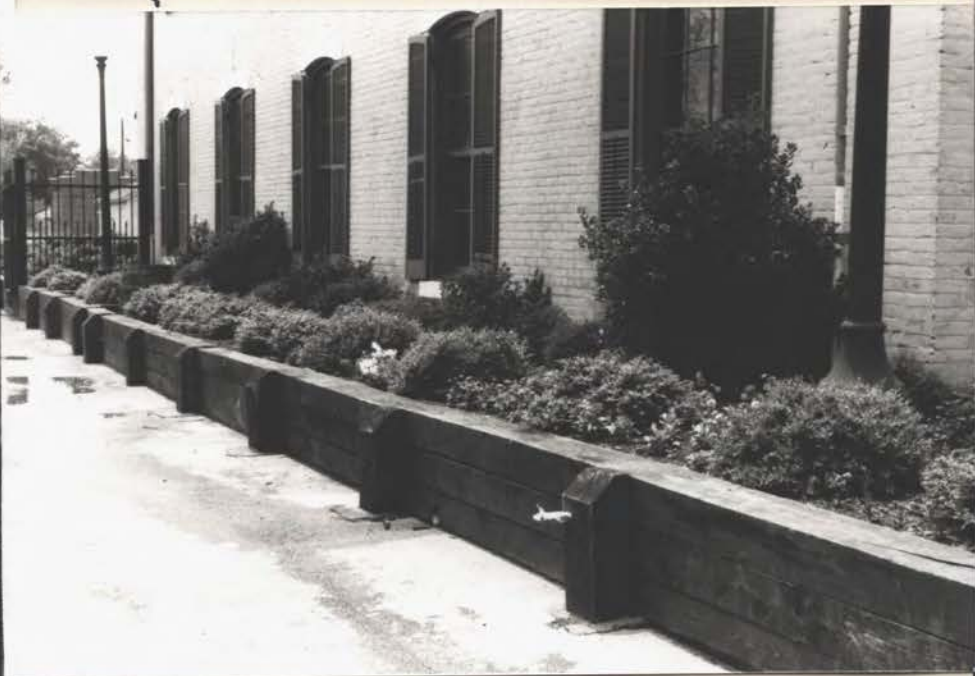
S. WALL
 (modern raised planter)
 aggravates rising damp
