JONES & HERRIN

June 28, 1994

ALTO BUILDING HUNTSVILLE DEPOT HUNTSVILLE, AL DECEMBER, 1980 PROJECT # 80.031 (AMERICAN LEGION BLDG.)

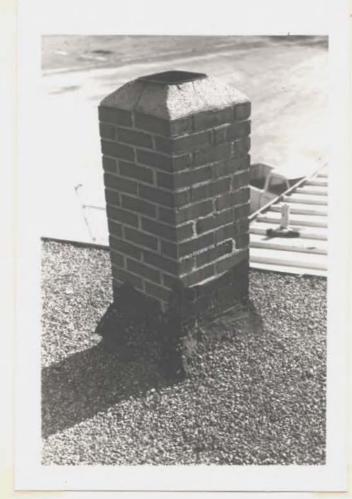
Brick flue from kitchen @ South well.

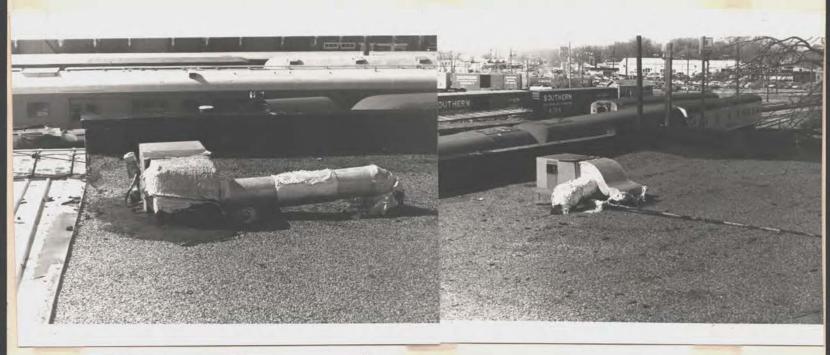
HVAC units on roof.

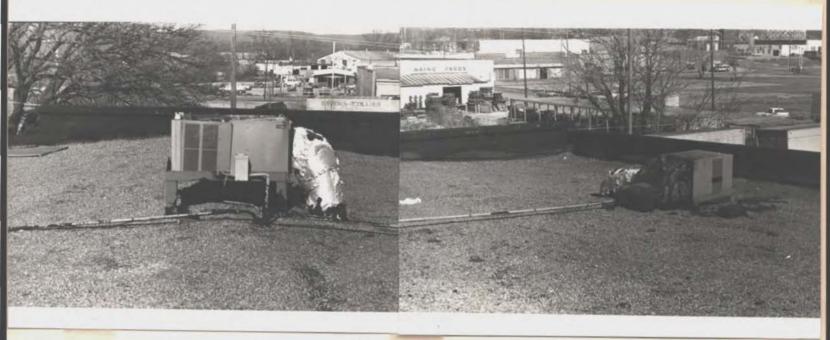
HVAC units on roof.

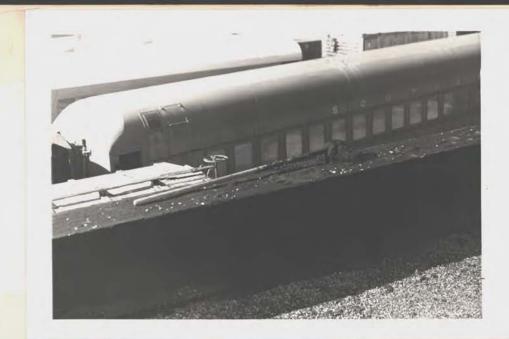
Pitch on conc. coping.
North Well ->

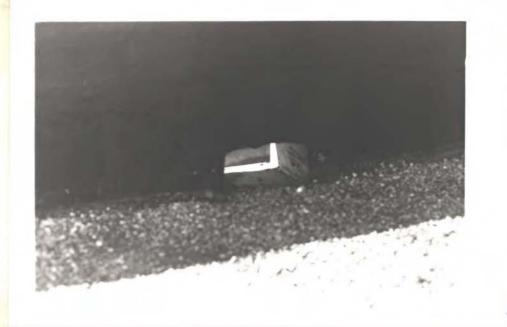
Roof drains & flashing details. North well.

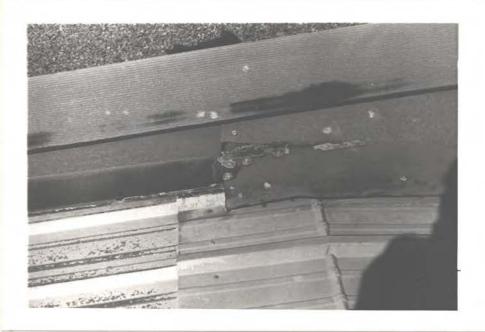
Flashing detail @ connection of built-up root of metal root.

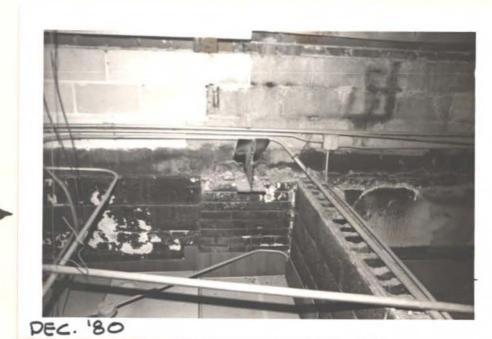
ATOP WOOD FRAMED ROOMS LOOKING NORTH AT REMAINING PORTION OF CUT-OUT STEEL TRUSS.

NOTE: SIGNS OF EARLIER
BURNING AND NEW
MASONRY ADDED.
