## BLEVINS - MASTIN HOUSE

FRAME STRUCTURE, FEDERAL STYLE CIRCA 1827  
LOCATED ON NORTH MEMORIAL PARKWAY AND  
OWNED BY THE CHURCH OF CHRIST WHEN  
TAKEN OVER BY THE CHURCH, THIS HOUSE WAS  
USED AS A CHURCH, WITH THE WALLS IN THE  
ENTRANCE HALL REMOVED WHEN IT WAS  
CONVERTED BACK TO A HOUSE TO SERVE AS  
THE PASTOR'S HOME, THE WALLS WERE PUT  
BACK UP, AND THE ORIGINAL DOORS AND DOOR  
MOLDINGS (WHICH WERE FOUND IN THE BASEMENT)  
WERE REPLACED. THE ADDITION THAT RUNS THE  
LENGTH OF THE BACK OF THE BUILDING WAS  
ONCE A SCREENED-IN PORCH, BUT WAS CLOSED  
IN TO SERVE AS A FAMILY ROOM. THE HOUSE  
IS CONSTRUCTED OF CEDAR, AND THE ORIGINAL  
CLAPBOARDS ARE NOW COVERED WITH PLASTIC  
SIDING.

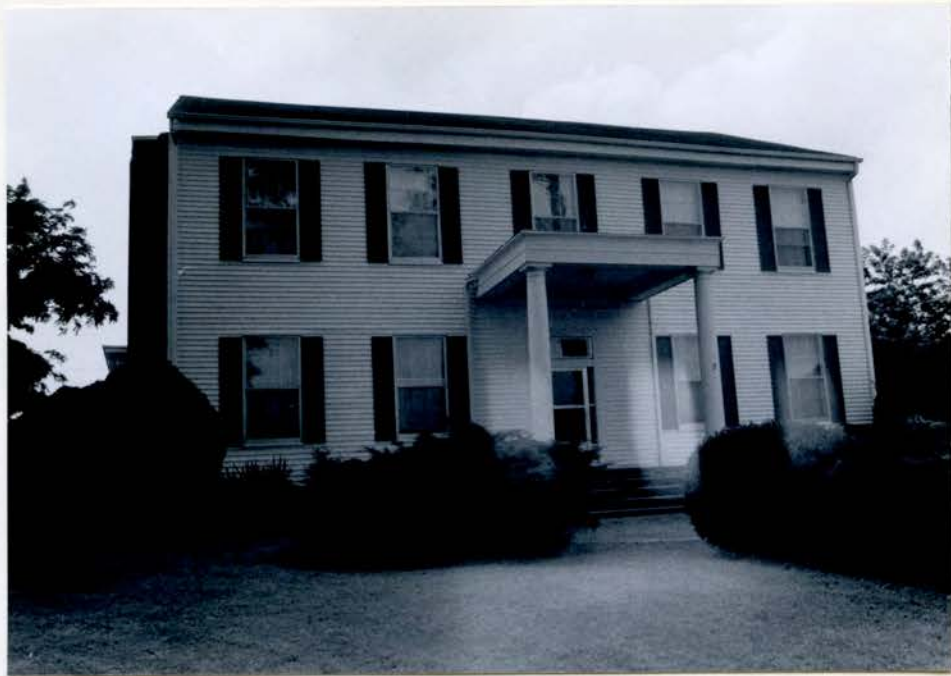
FRONT OR EAST FACADE - PORCH IS NOT  
ORIGINAL

ALUMINUM FRAME  
WINDOWS

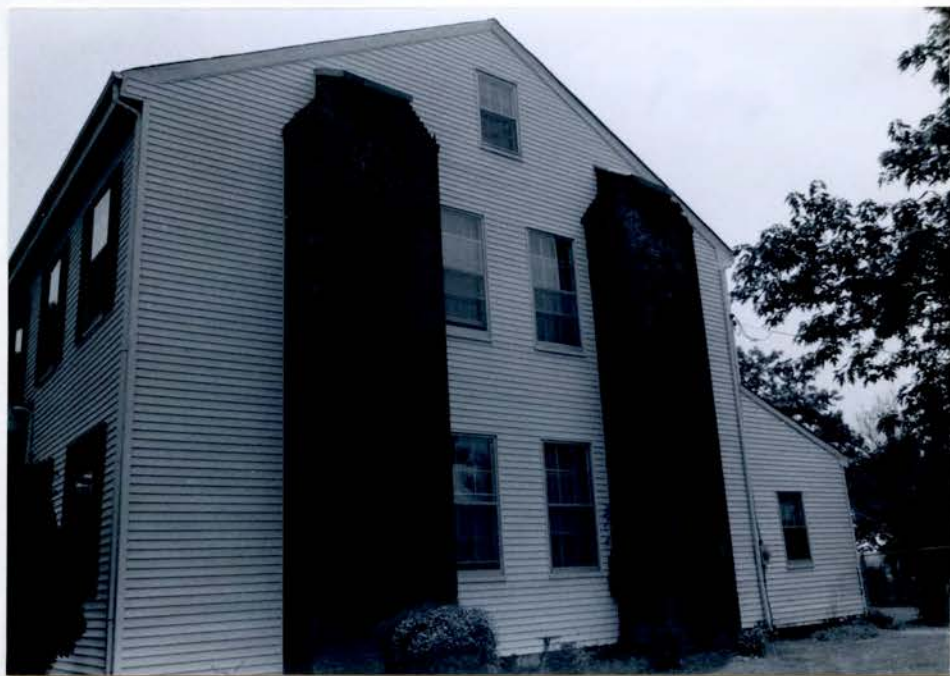
NORTH FACADE

CHIMNEYS  
HAVE DETERIORATED

SIDING IS  
PLASTIC, NOT  
ALUMINUM AND  
WAS INSTALLED  
CA 1950s

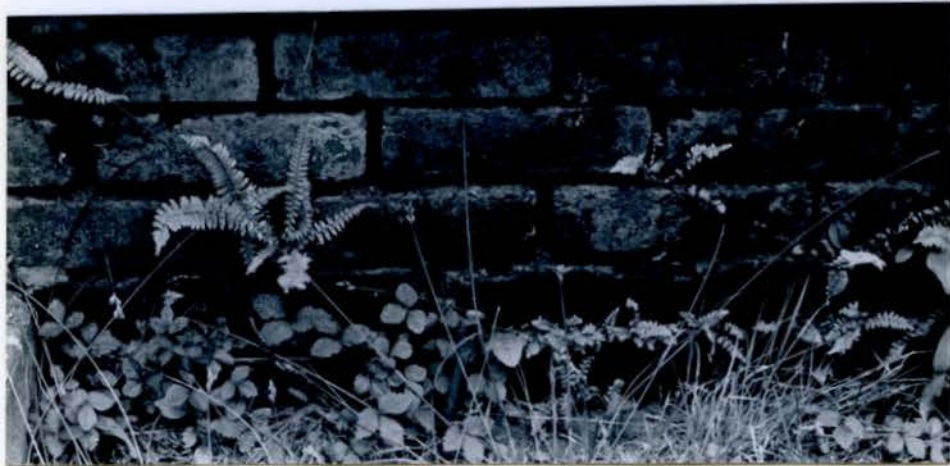
↑ BRICK FOUNDATION WITH OVERHANG OF  
↓ PLASTIC SIDING

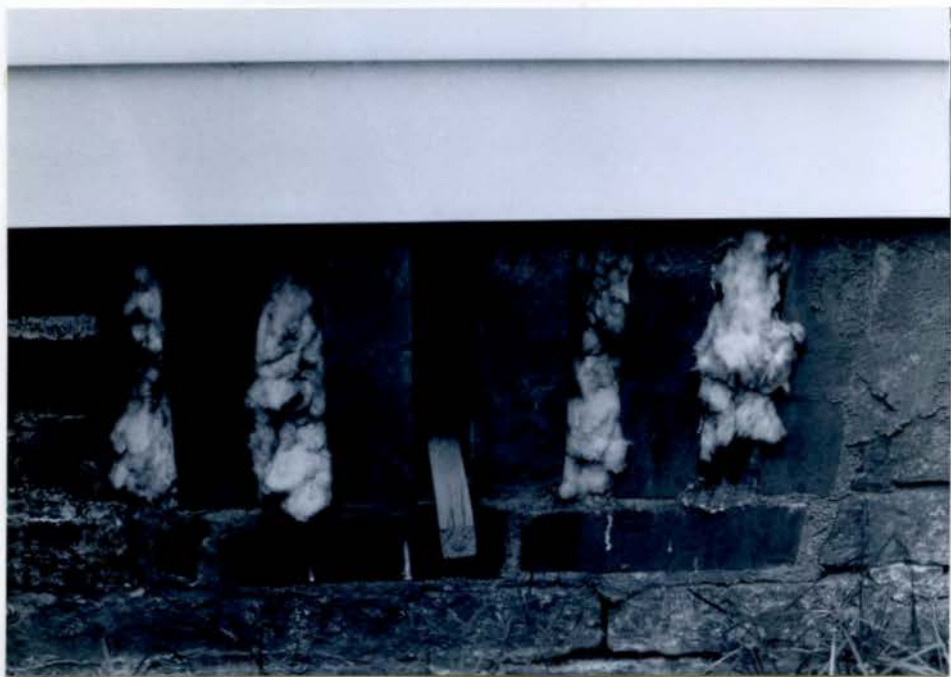
DETAIL OF VENTS IN FOUNDATION - NOT ORIGINAL

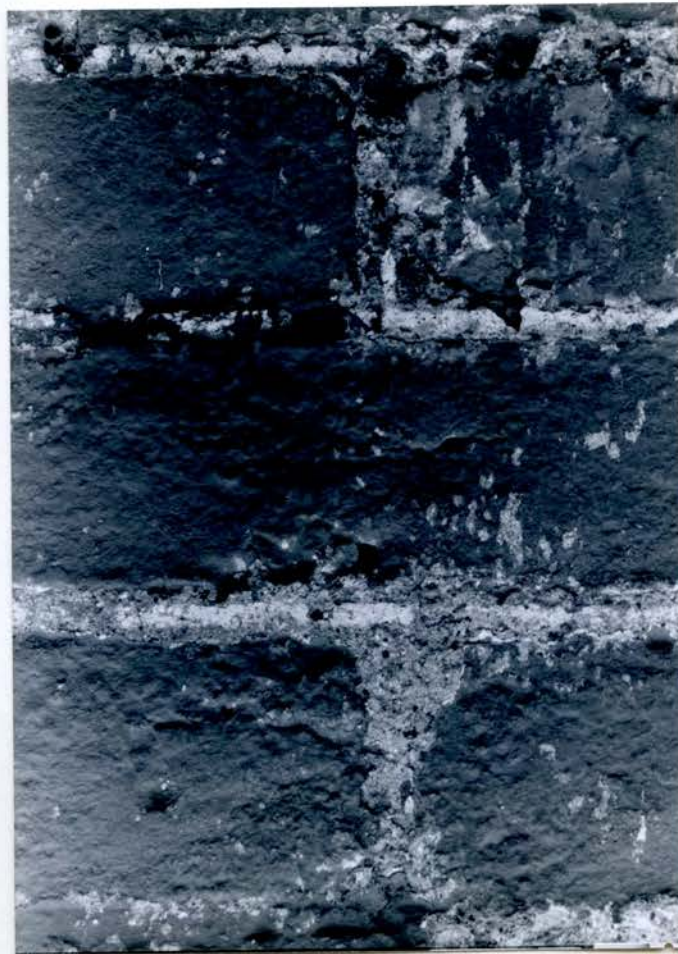
CLOSEUP OF CHIMNEY  
BRICKWORK SHOWING  
PENCILLING

← BRICKS SHOW  
RED, WHITE, AND  
GREY-BLUE PAINT  
LAYERS

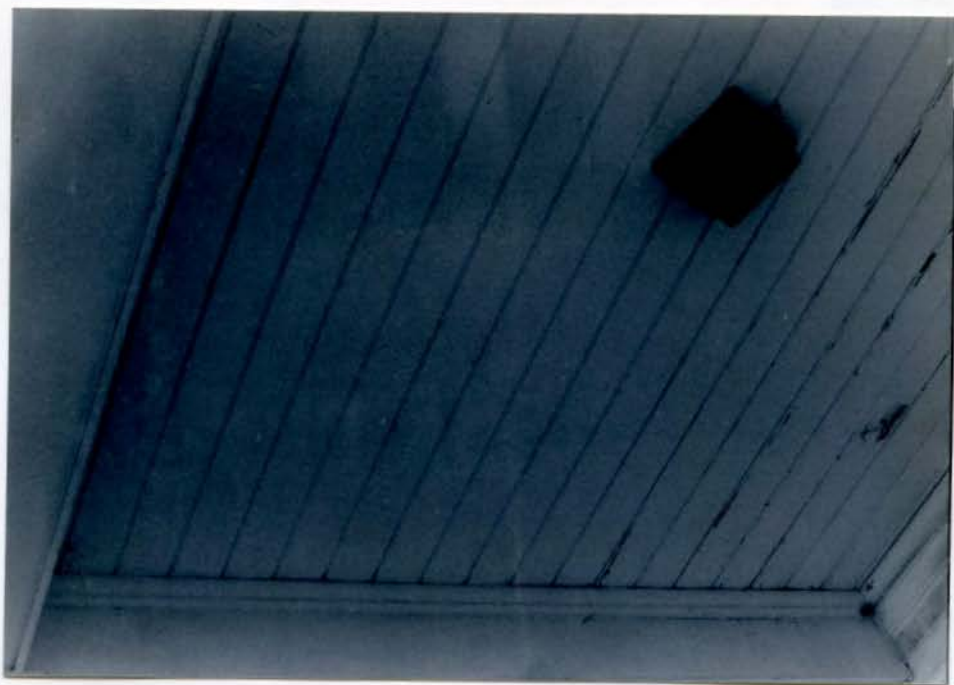
DETAIL OF CEILING OF FRONT PORCH  
(NOT ORIGINAL TO HOUSE)

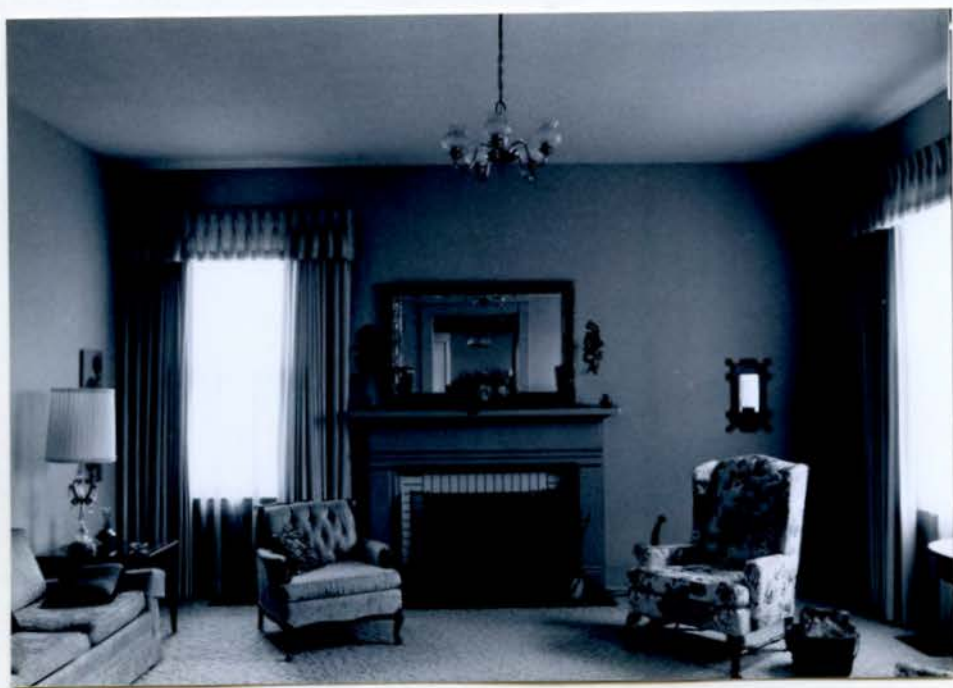
NOT KNOWN IF  
MANTLE IS ORIGINAL.  
FIREPLACE HAS BEEN  
REBRICKED WITH NEW  
HEARTH

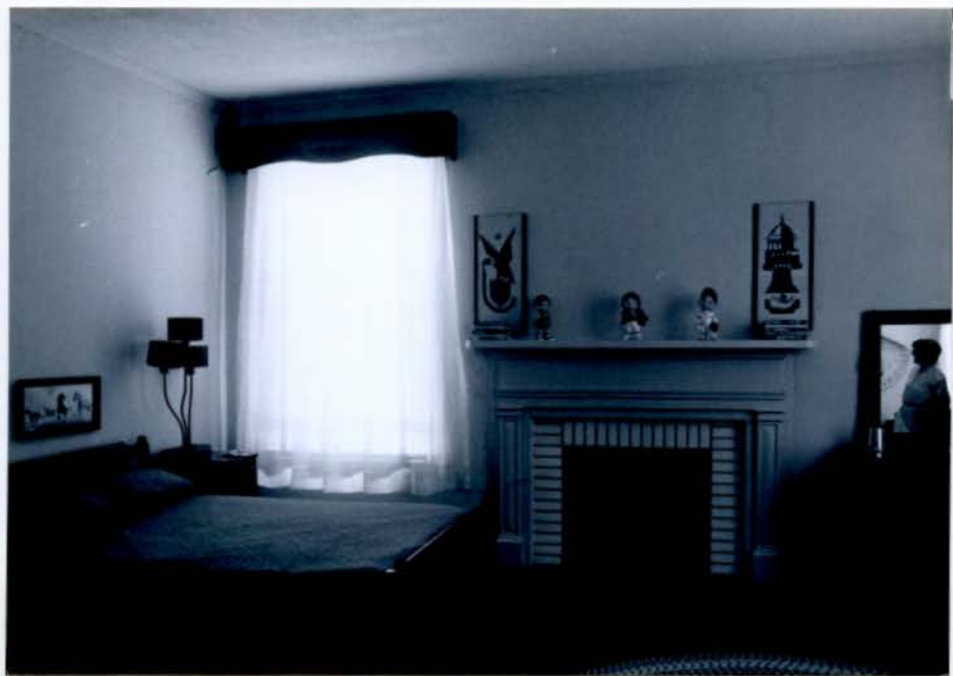
BEDROOM 3 - VIEW OF NORTH WALL

INTERIOR OF  
FIREPLACE HAS BEEN  
REBRICKED  
NOT KNOWN IF MANTL  
IS ORIGINAL BUT  
THOUGHT TO BE

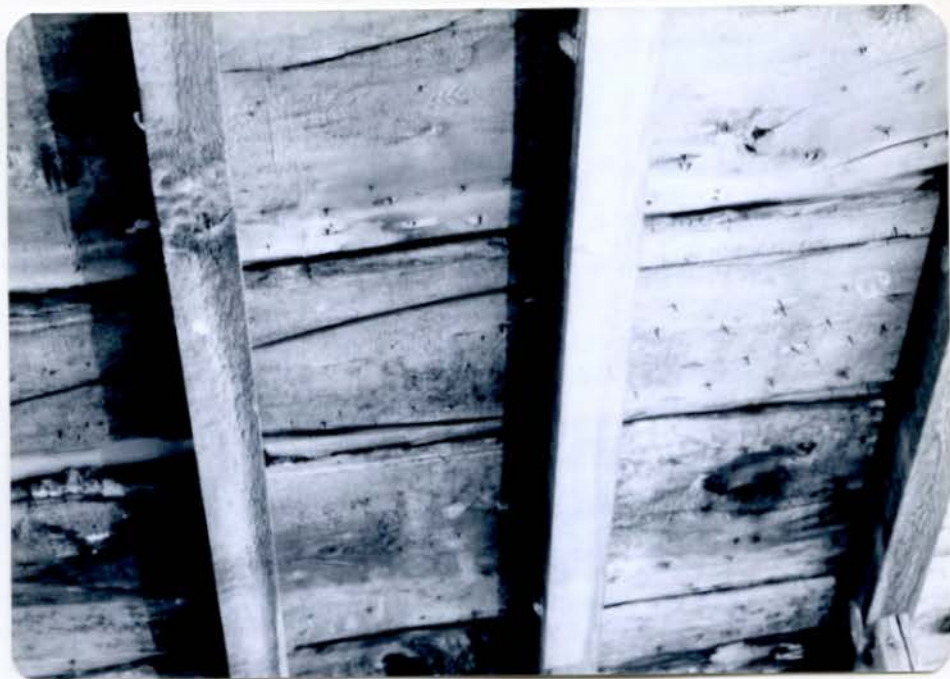
ATTIC - RAFTERS AND ROOF SHEATHING - ALL OF  
CEDAR AND WITH ORIGINAL CUT ROOFING NAILS  
PROTRUDING
