403 Franklin St. - Huntsville, AL
c 1891 photos (1980 copies) when house was new, apparently

403
FRANKLIN ST
1891

ca. 1820 Bradley Hse
405 Franklin St.

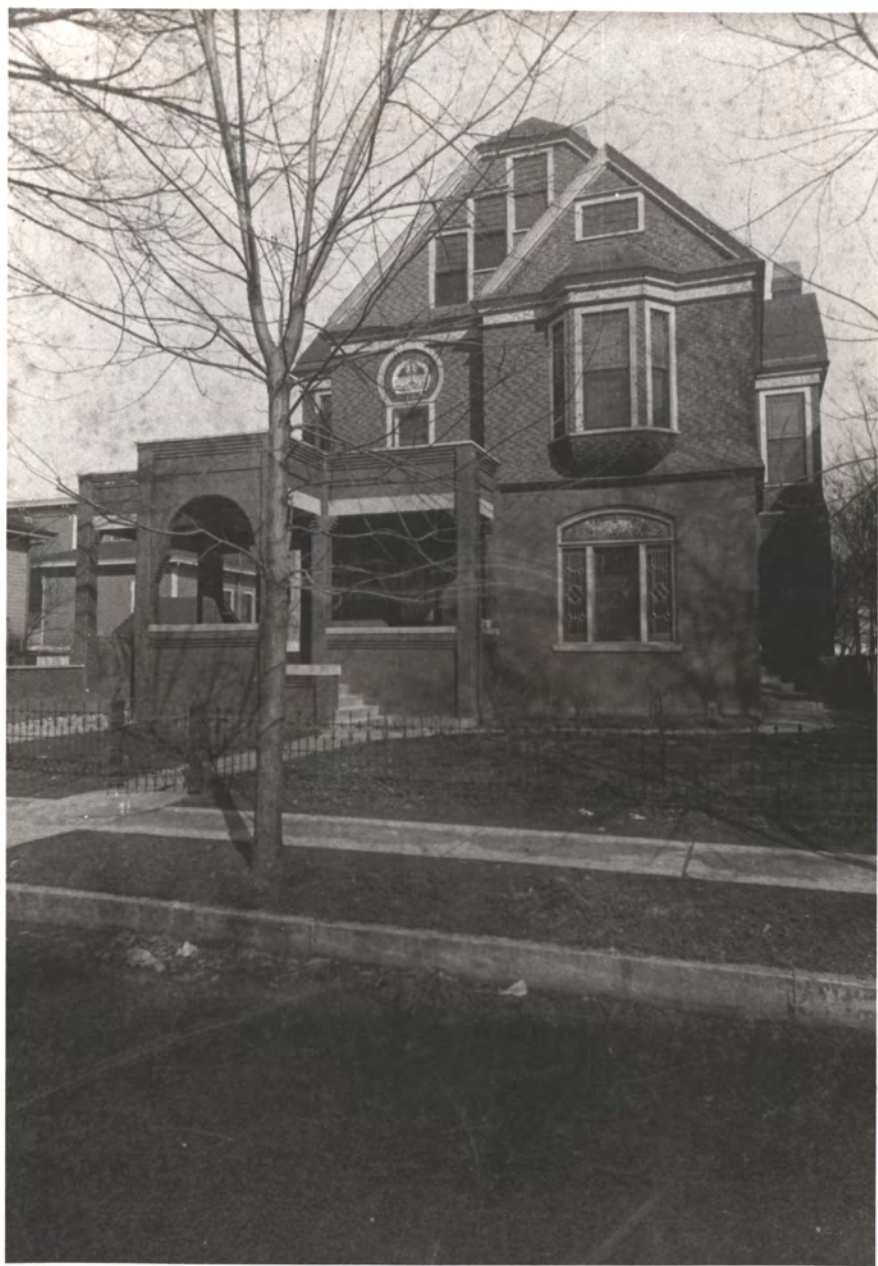
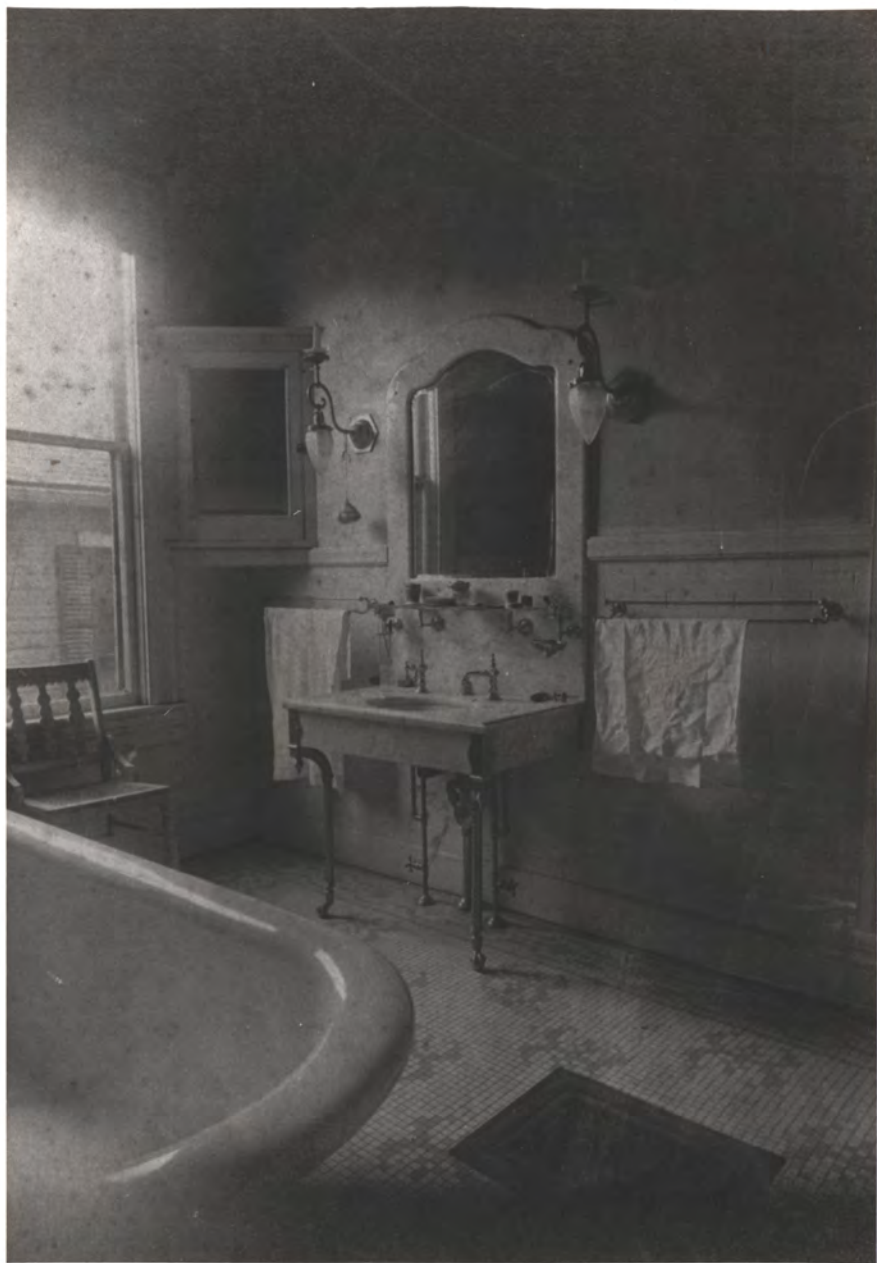
f N. Porte-Cochere gone by c. 1990. Removed w/o permission of Hist Commission

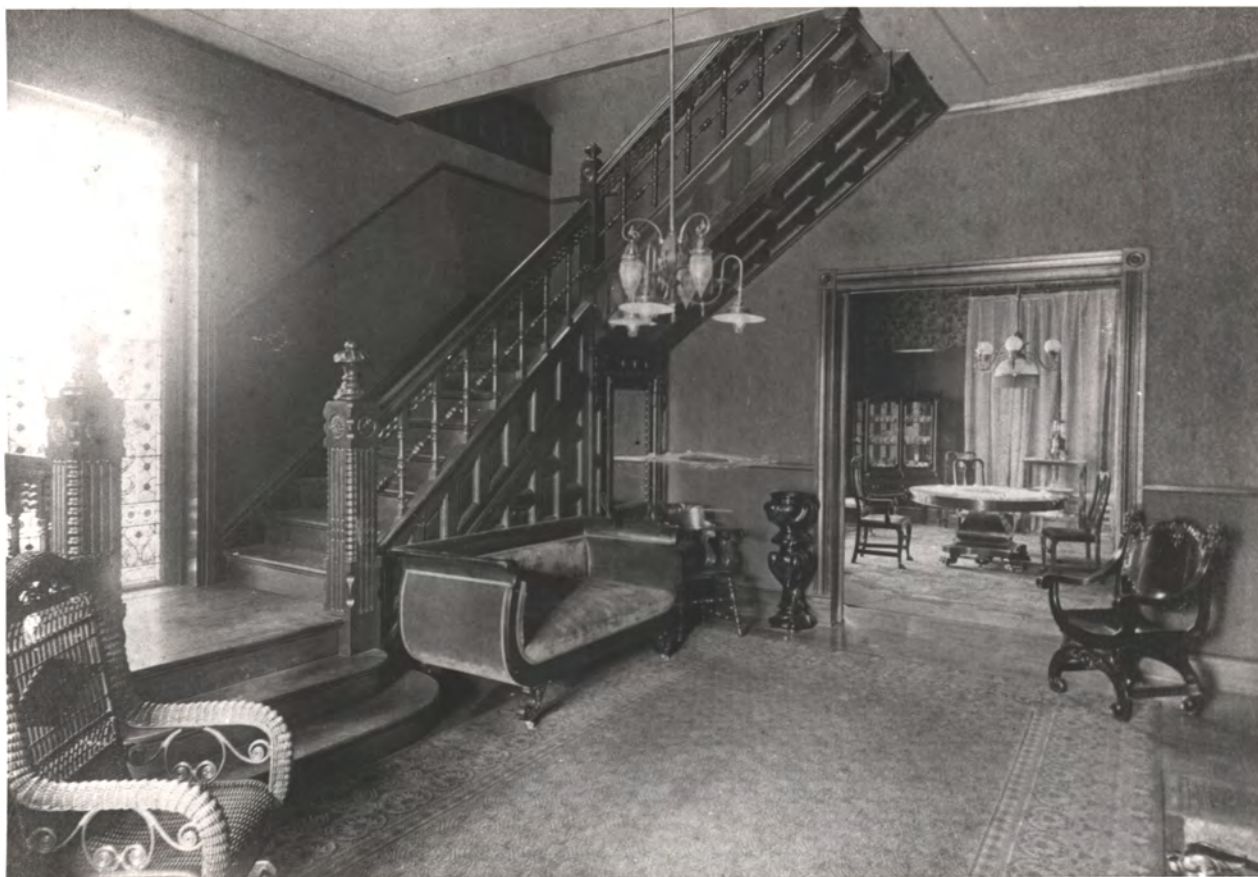
Entry bottom landing had been modified prior to c.1990. Landing eliminated & stair runs straight down to fl. Poor modif.

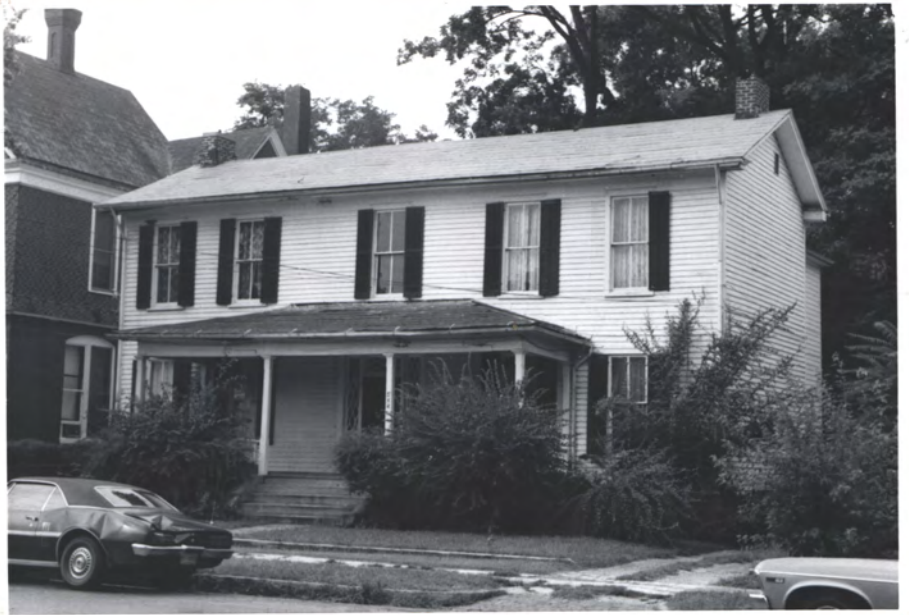
Remodeled to this form
& shifted south about 20'
prior to 1894 Sanborn map.

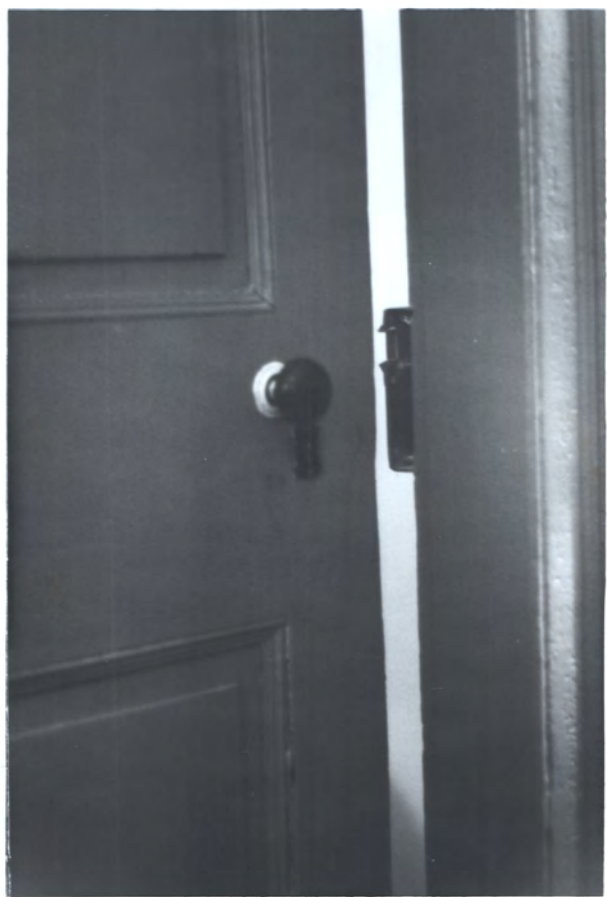
Fad. door & lock in rear wing 1st fl. room

exposed
terms
+ pegs →

← kenhole
cover

cast iron
hinge →
