c. 1870's (?) Hse on
104 Steele St.

photos 8 Feb 1991 H. Jones, FAIA
To be renov. by Chandler, Contr.
(no arch)

STEELE ST.
C. 1870'S

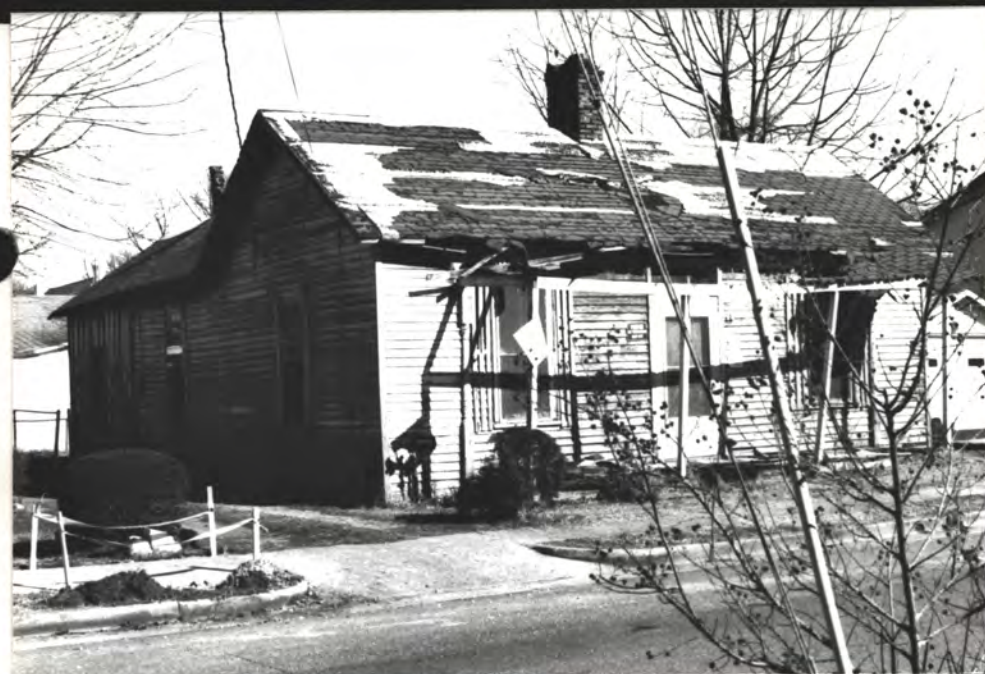
West front

Porch remnants
look mid-20th. c.
makeshift. No
evidence seen that
there originally
was a porch.

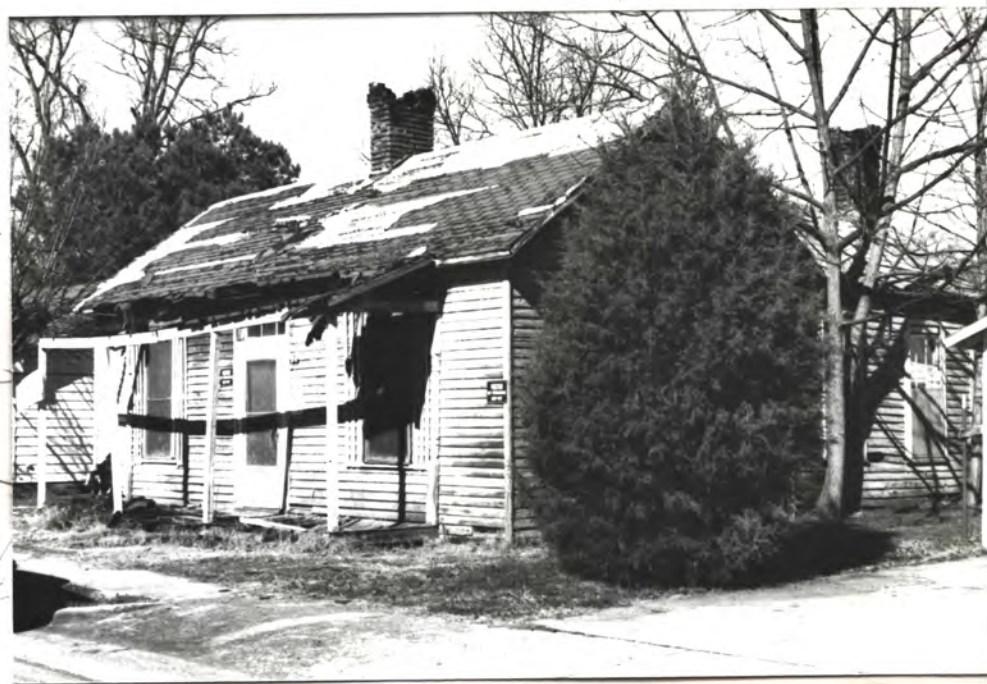
West
front +
S. side

gabled part is vic. addn.
Shed = 20th. c.

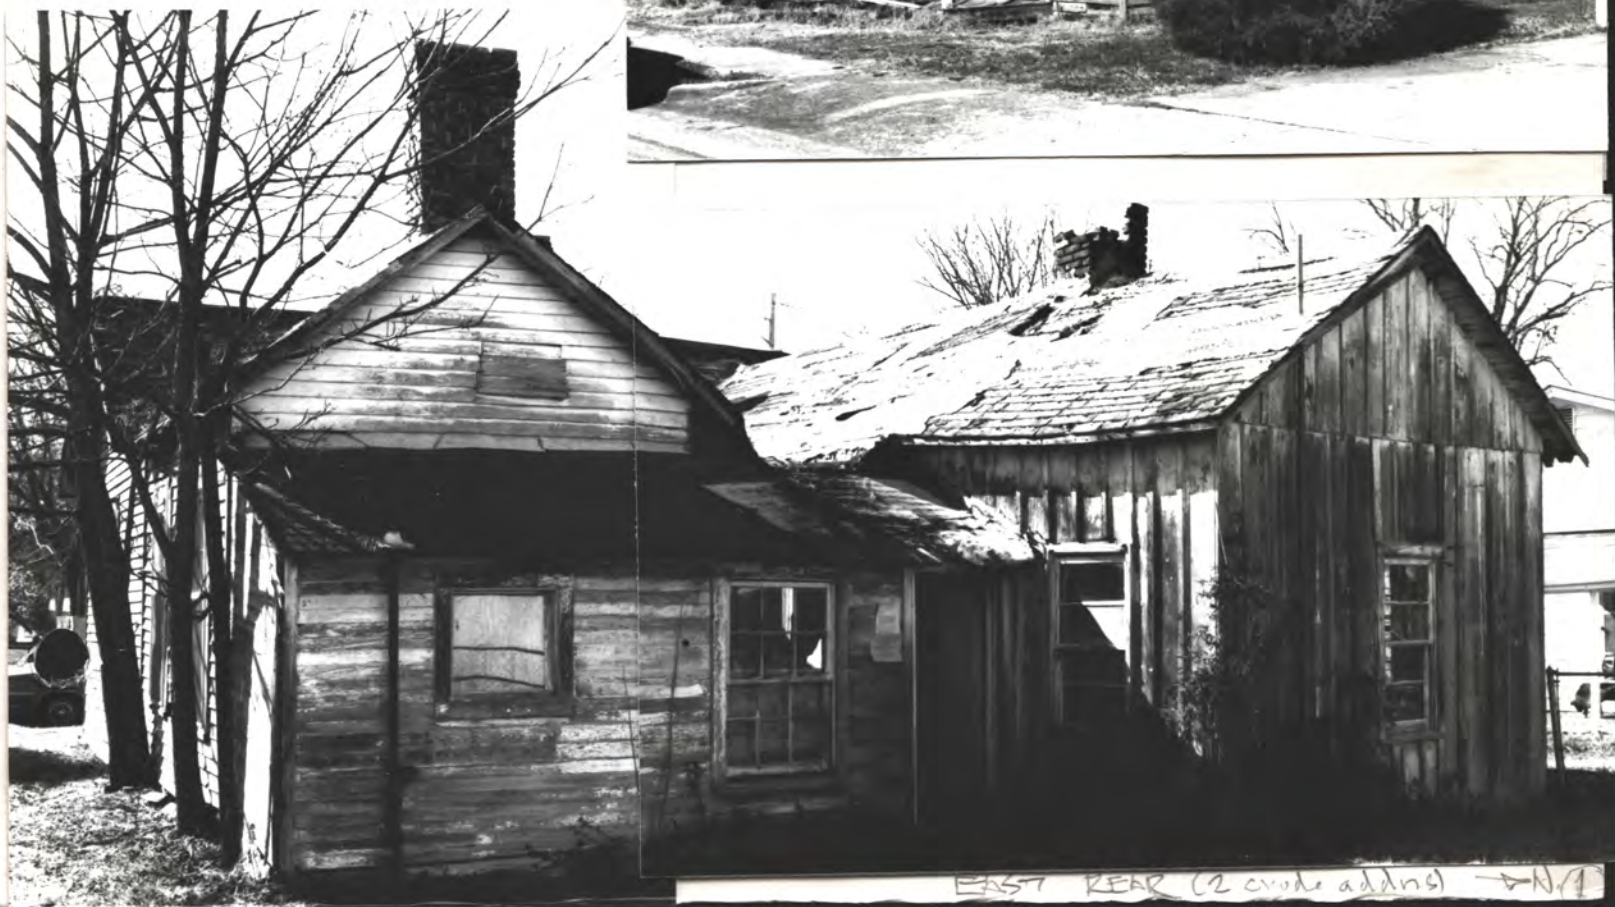
EAST REAR (2 crude addns)

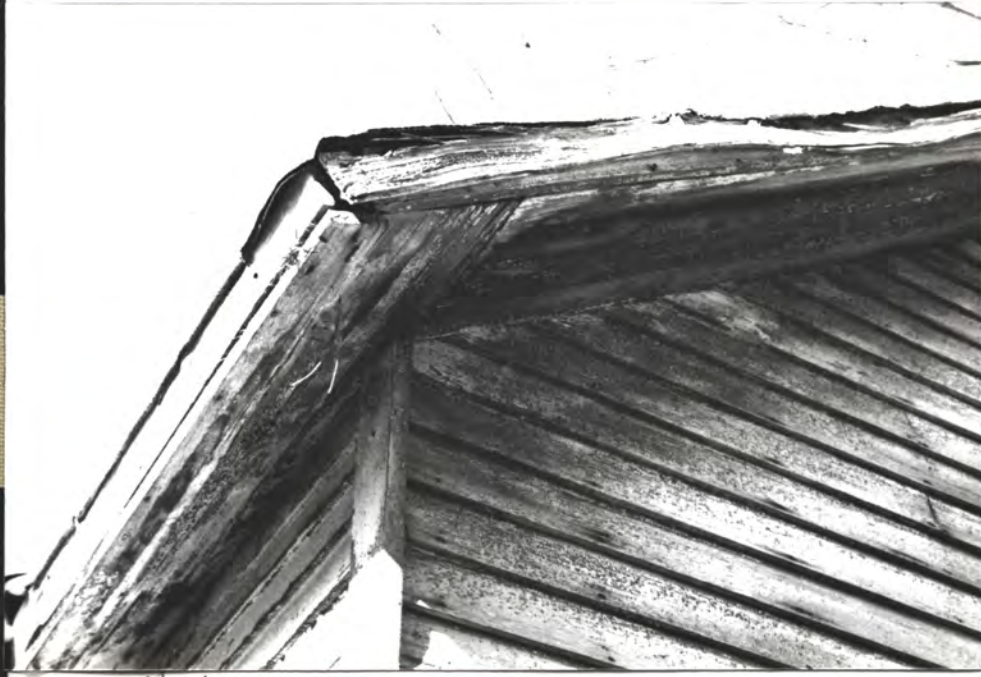
front S.W. corner.
Typical Vic. roof
detail (note pattern
of soffit boards)

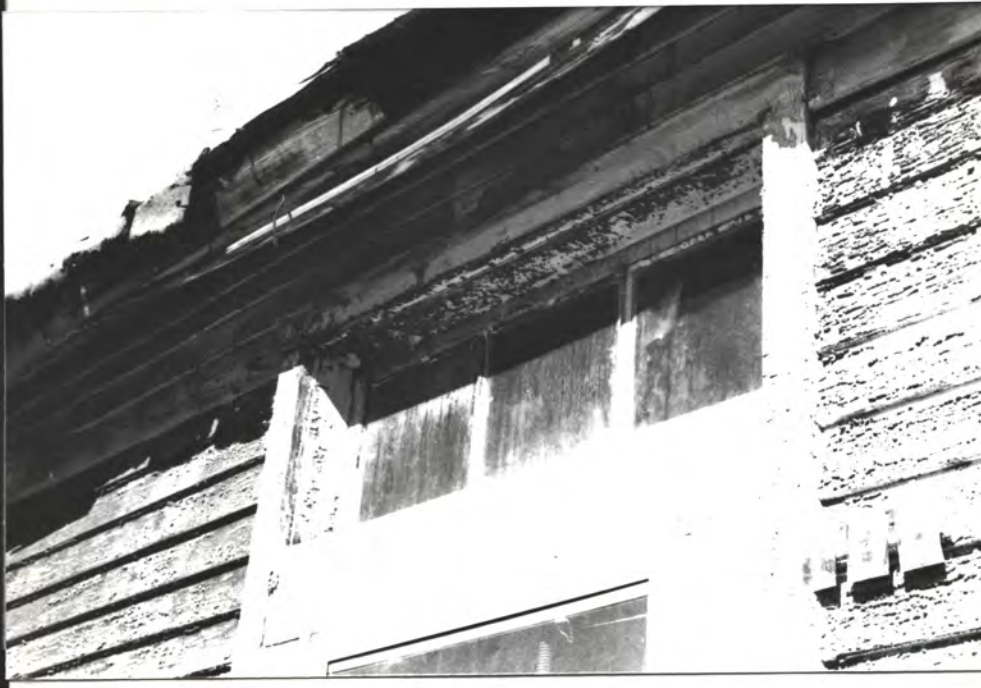
front (west) entry.
No apparent evidence that
there ever was an
original front porch

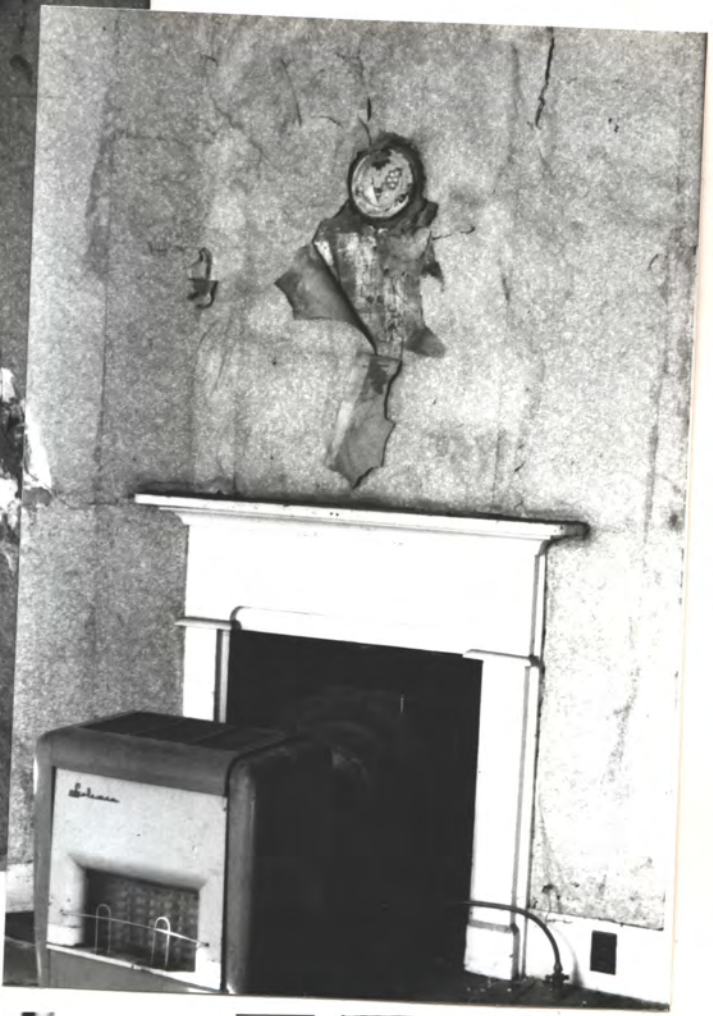
← later stove thimble

orig mantel (for coal fires - small, shallow f.p.)

look at S.E. address rm. (late Vic.)

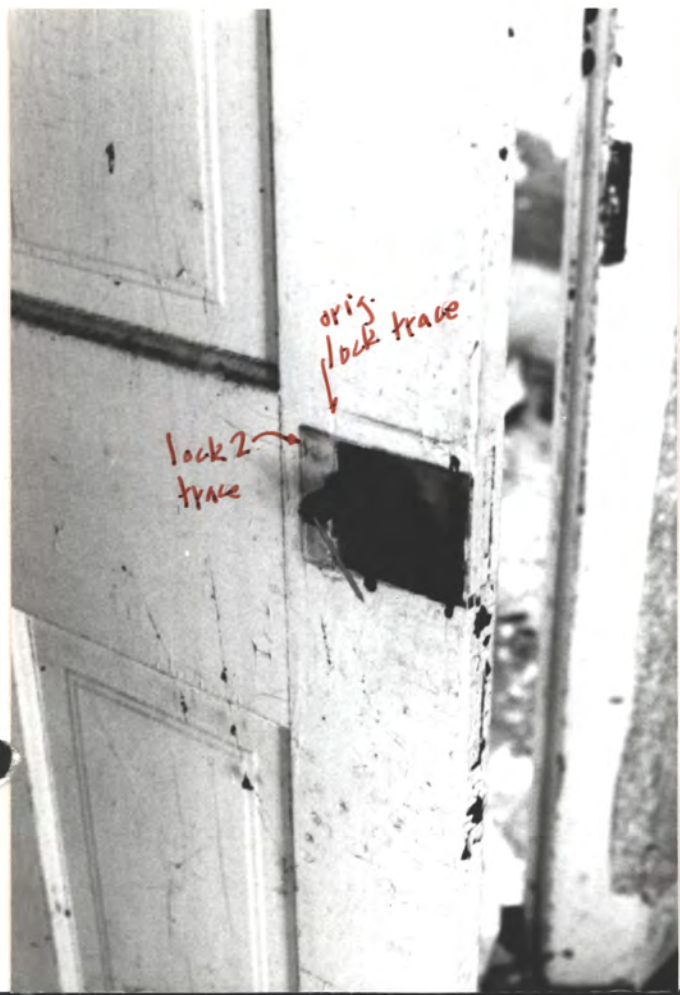
lock 2 trace

orig. lock trace

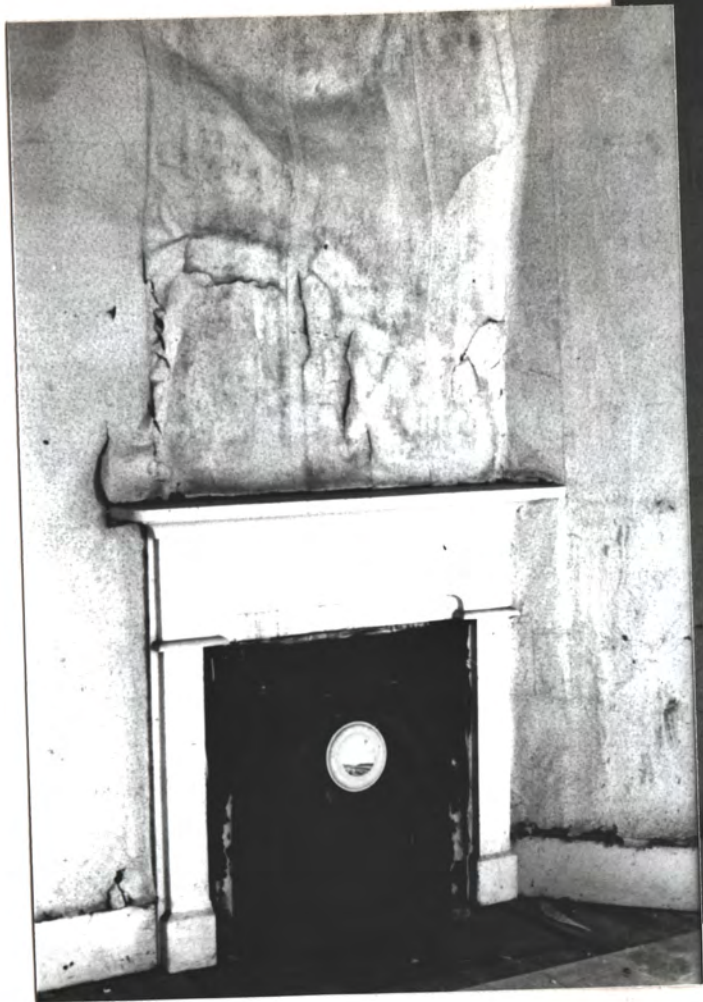
orig. mantel (small f.p.
to burn coal)

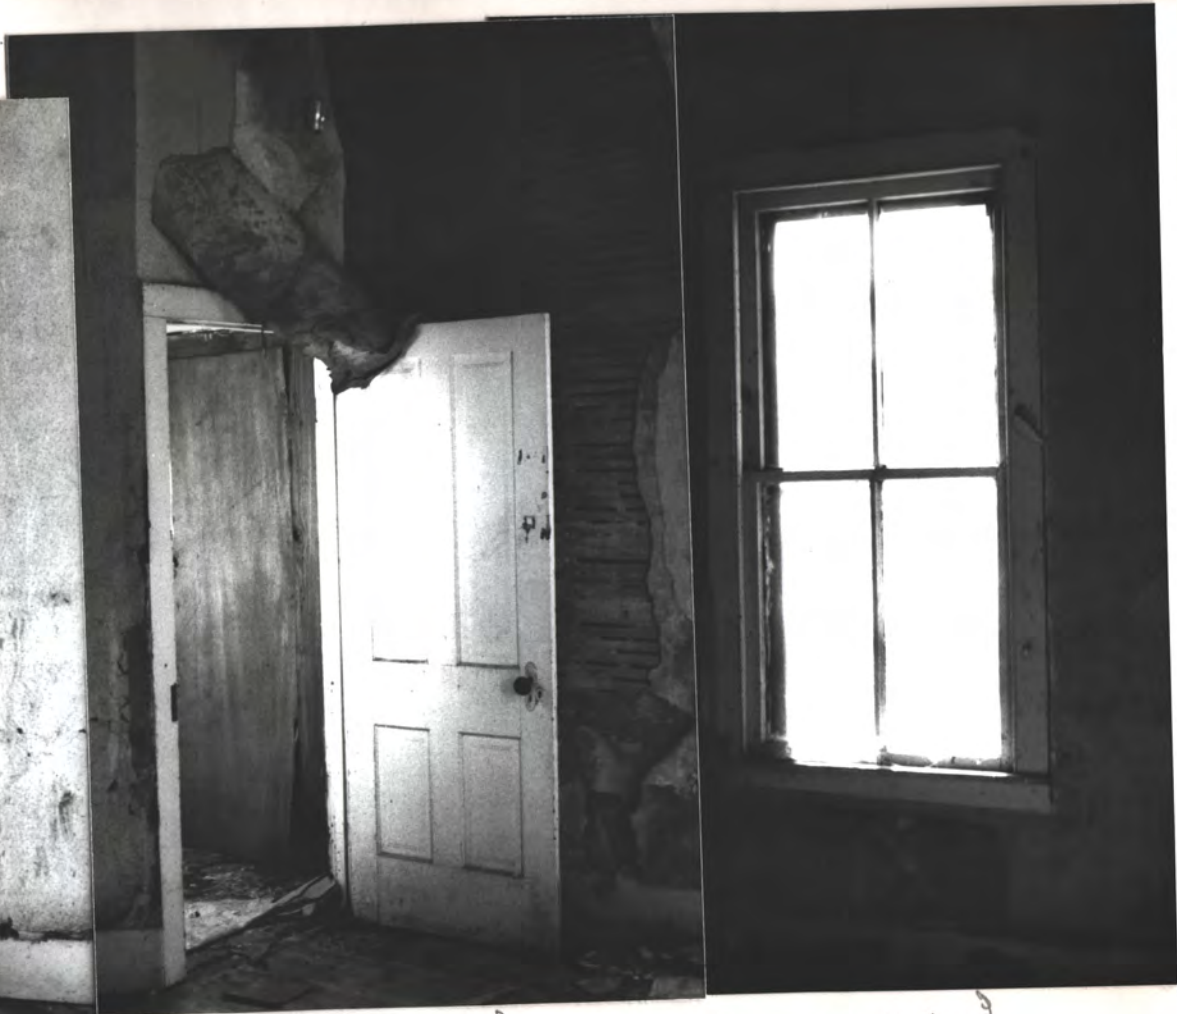
N.W. Rm
HAN

orig. door

orig. sash.

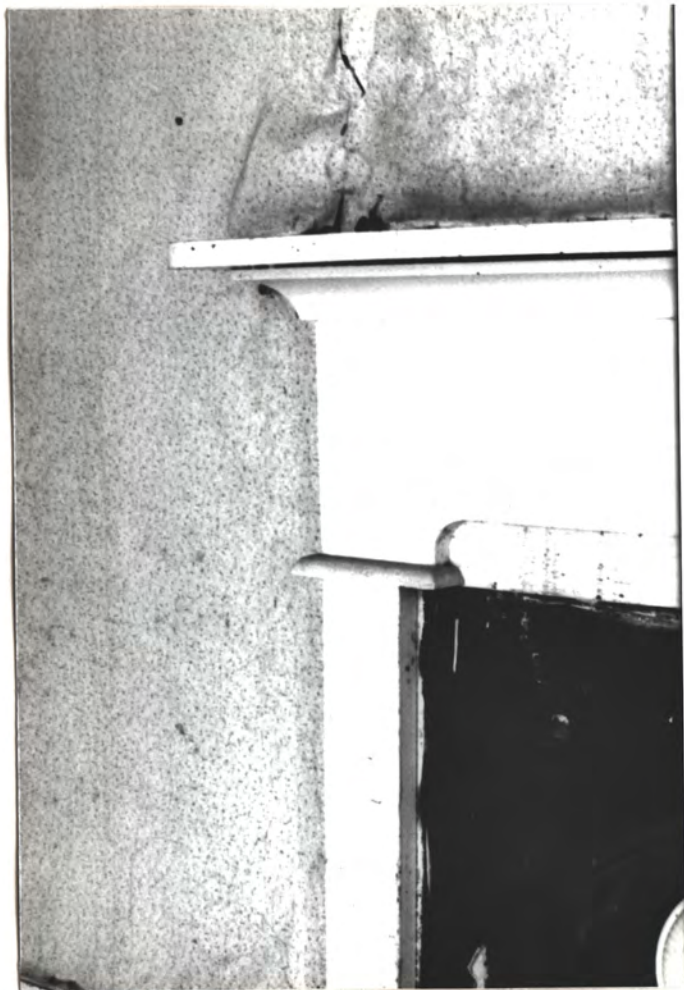
N.W. Pm. orig. mantel

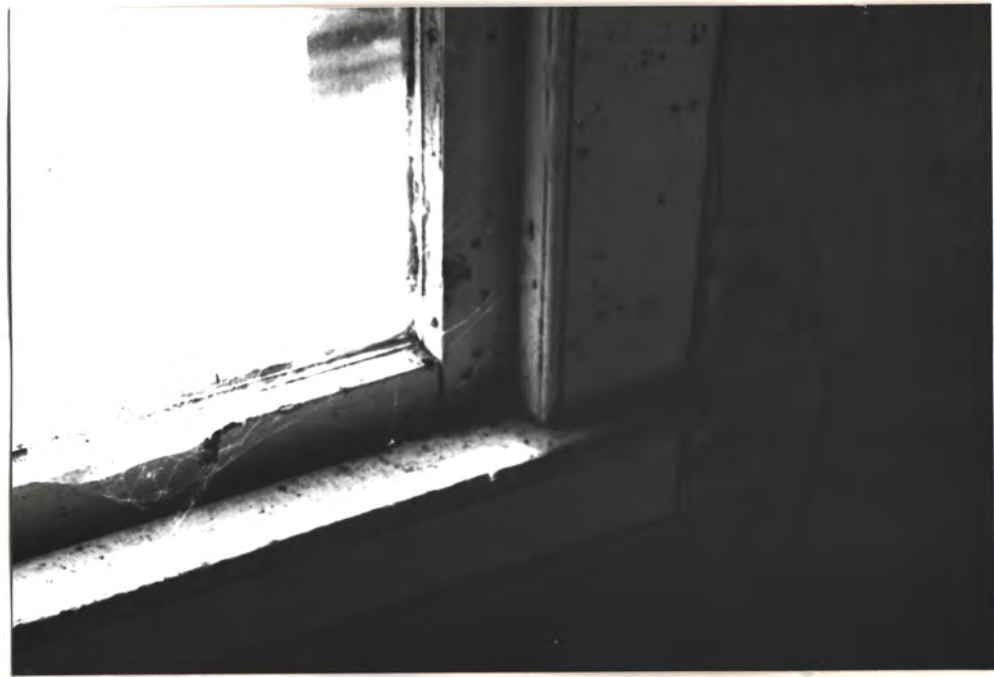
N.W. Pm - orig. sash & frame

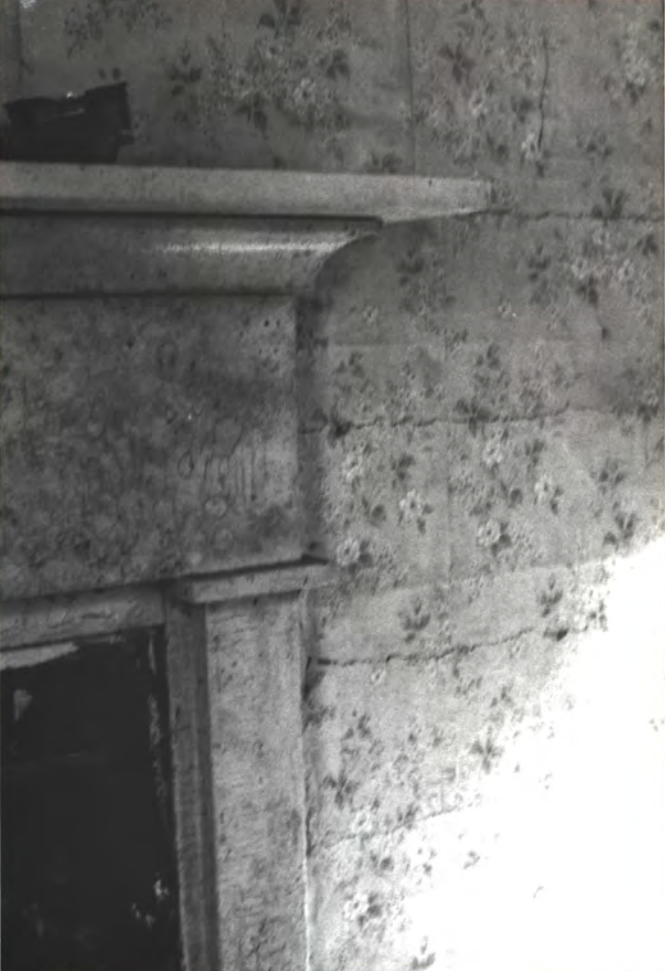
Mantel at N.E. Rm. = orig.

Walls = plaster on
 some wood lath
 Ceils = boards (all rms)

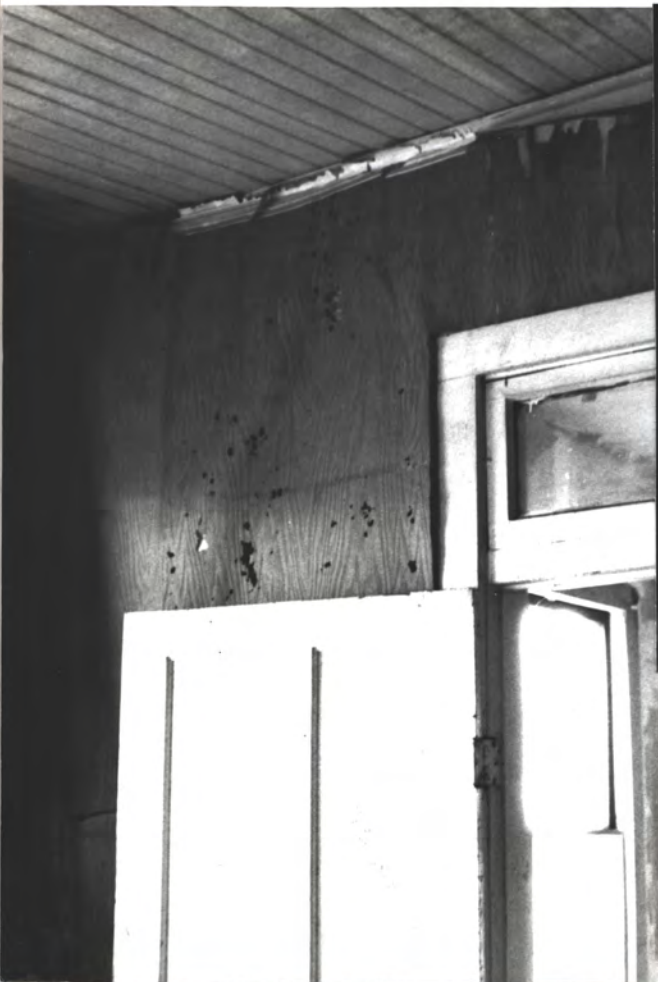
South door to "courtyard"
 at N.E. Rm

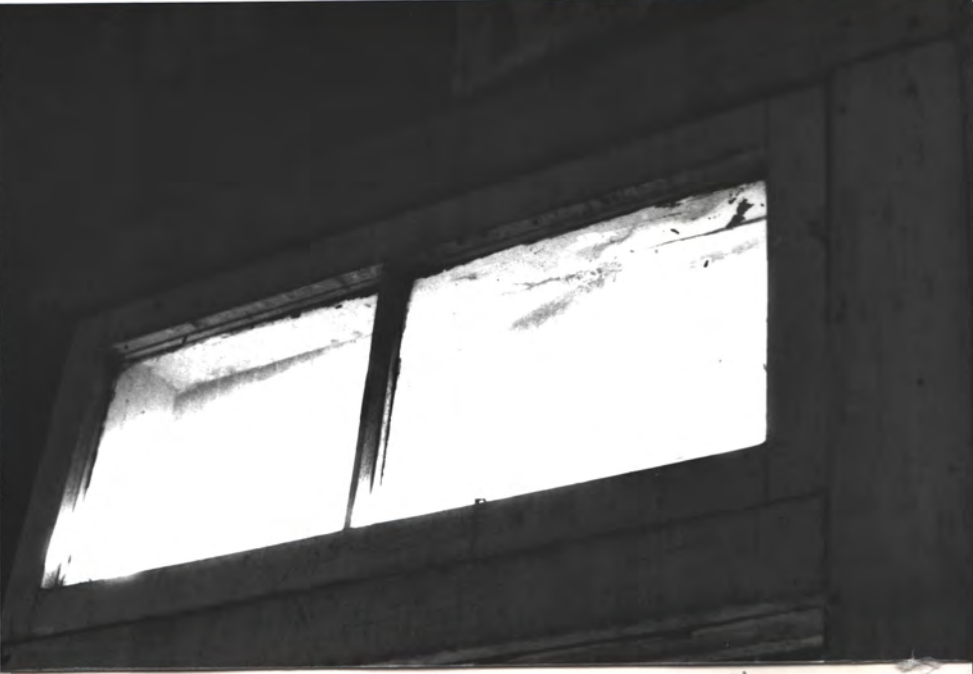
← Door from S.E. Rm
 to S.W. Rm. beyond
