Re: Church of the Nativity Administration Office
Project No. 95075

Re: Circa 1870 Building at 208 Eustis Avenue
(Church of the Nativity Administration Building)
Project No. 95075

NATIVITY ADMINISTRATION BUILDING
PROJECT NO. 95078

CHURCH OF THE NATIVITY ADMIN. BLDG.

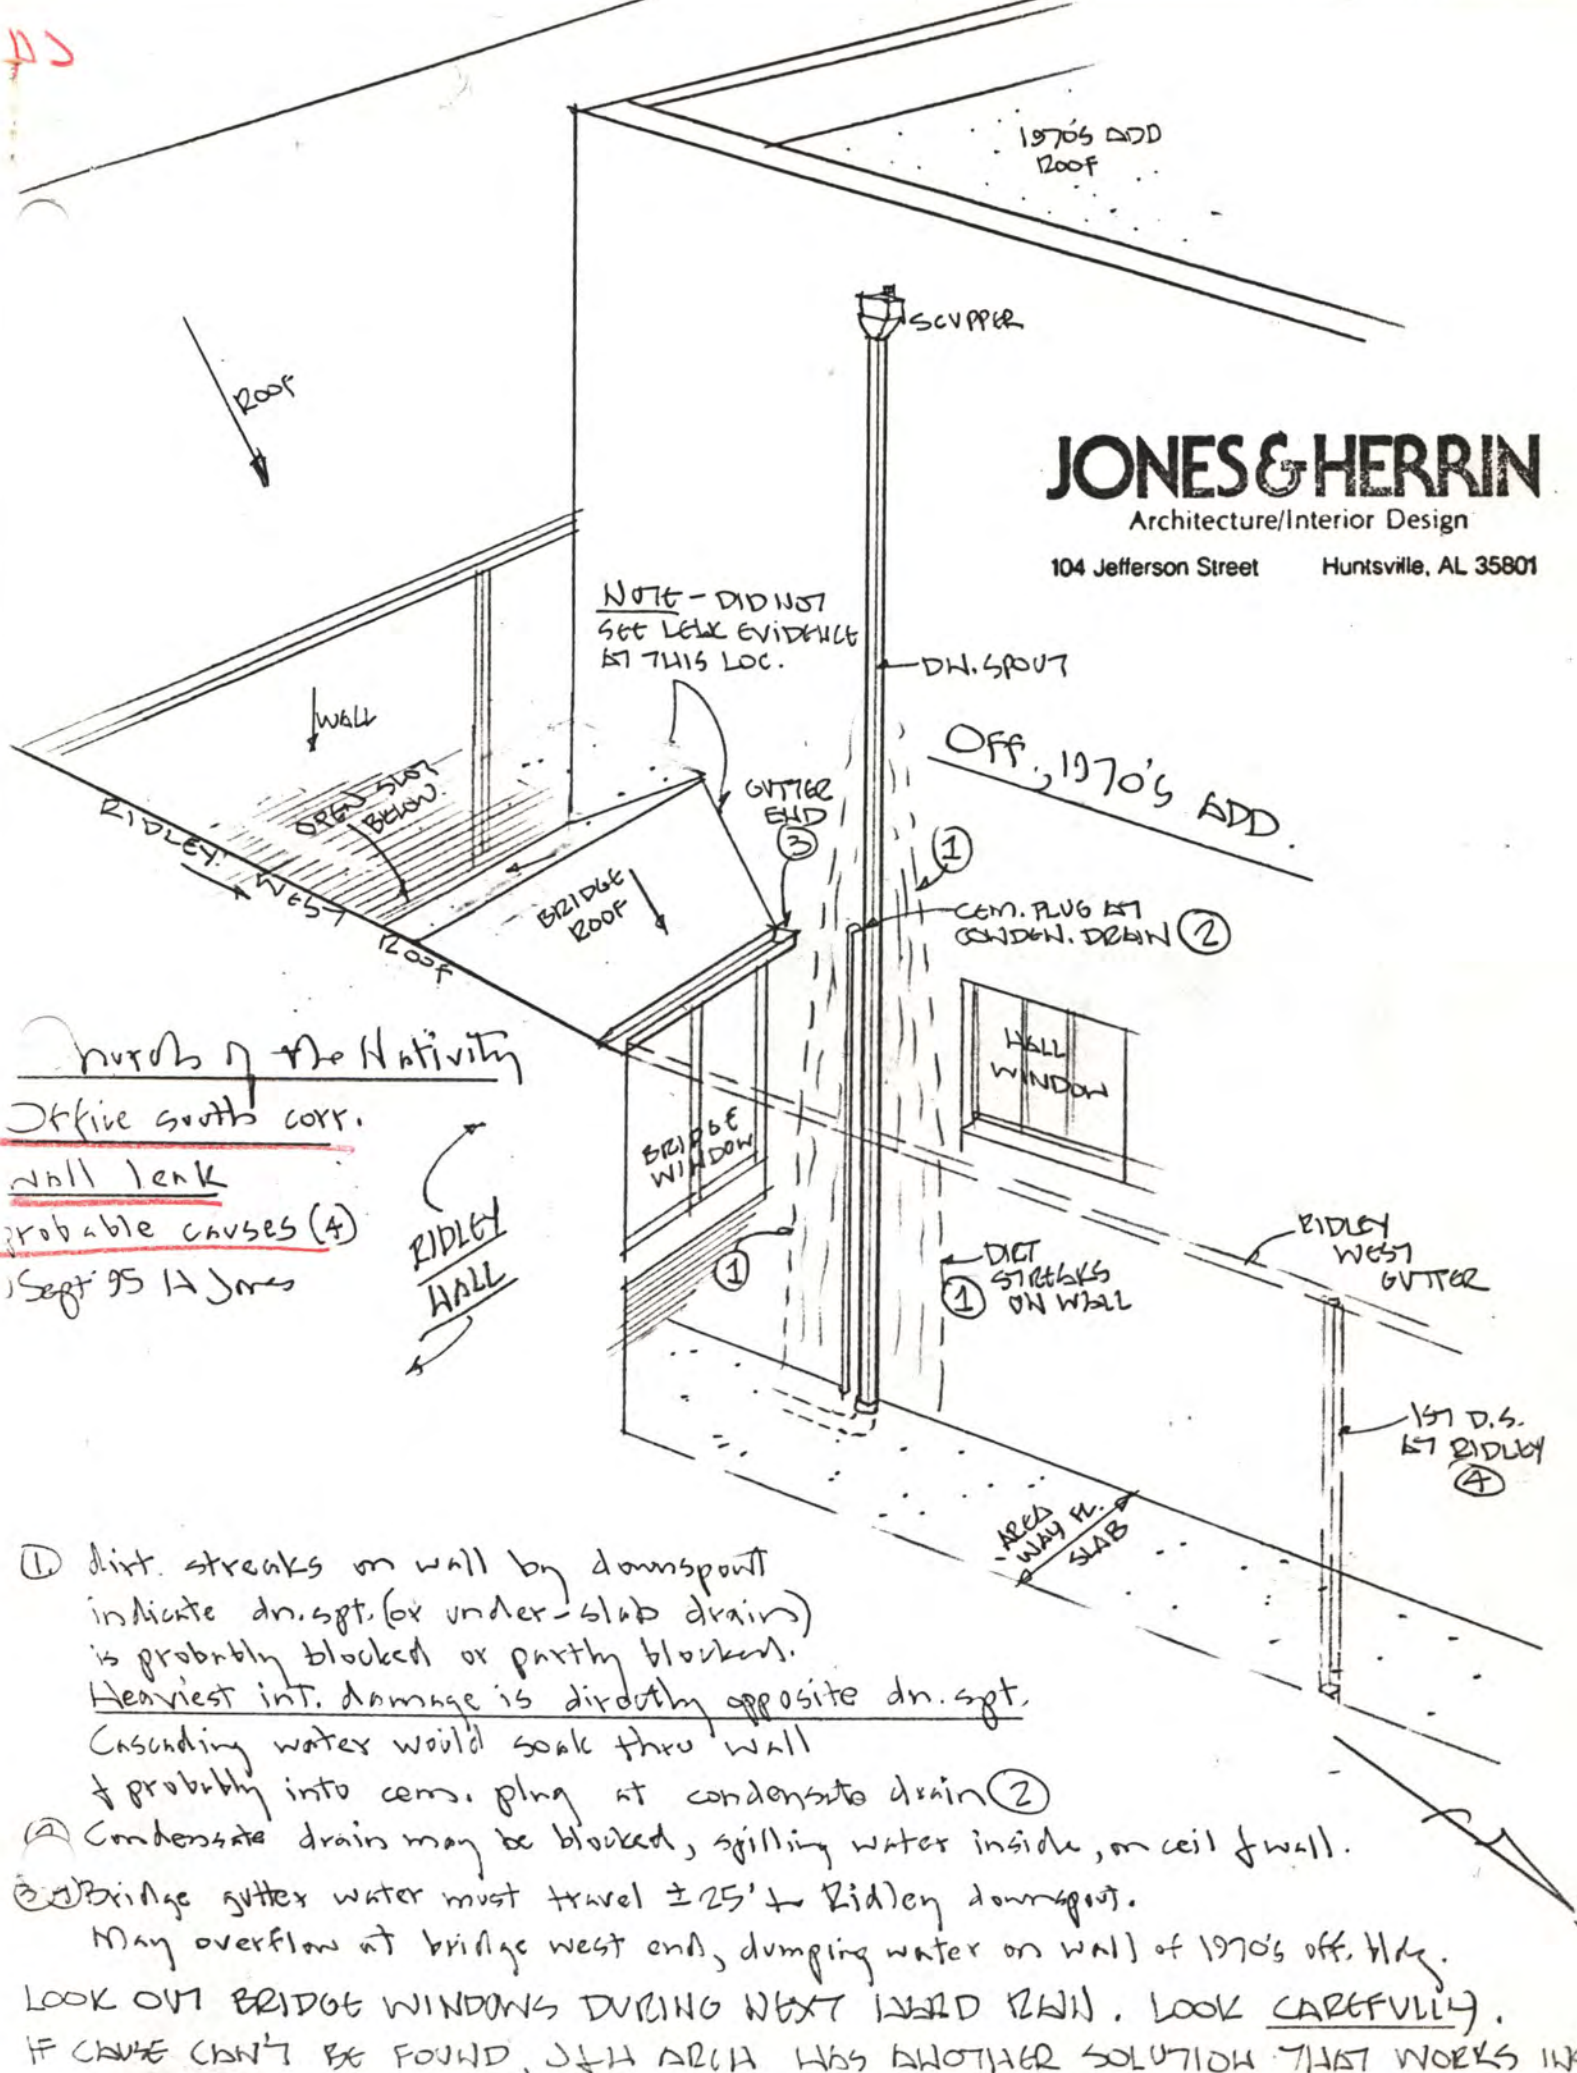
murder of the Nativity
 Office south corr.
wall leak
probable causes (4)
 Sept 95 H Jones

NOTE - DID NOT SEE LEAK EVIDENCE AT THIS LOC.

- ① dirt streaks on wall by downspout indicate dn.spt. (or under-slab drain) is probably blocked or partly blocked. Heaviest int. damage is directly opposite dn.spt. Cascading water would soak thru wall & probably into cems. plug at condensate drain ②
 - ② Condensate drain may be blocked, spilling water inside, on ceil & wall.
 - ③ Bridge gutter water must travel ± 25' to Ridley downspout. May overflow at bridge west end, dumping water on wall of 1970's off. Hdg.
- LOOK OUT BRIDGE WINDOWS DURING NEXT WIND BLOW. LOOK CAREFULLY.
 IF CAUSE CAN'T BE FOUND, J&H ARCH HAS ANOTHER SOLUTION THAT WORKS INSIDE

Charles — here are the 4 probable causes of the long-term leak at the office window to Ridgely. I've asked Janet McWhorter to look carefully during the next hard rains. It could be a combination of 2 or 3 of the 4 items.

If all else fails, there is another solution we have used successfully (over)

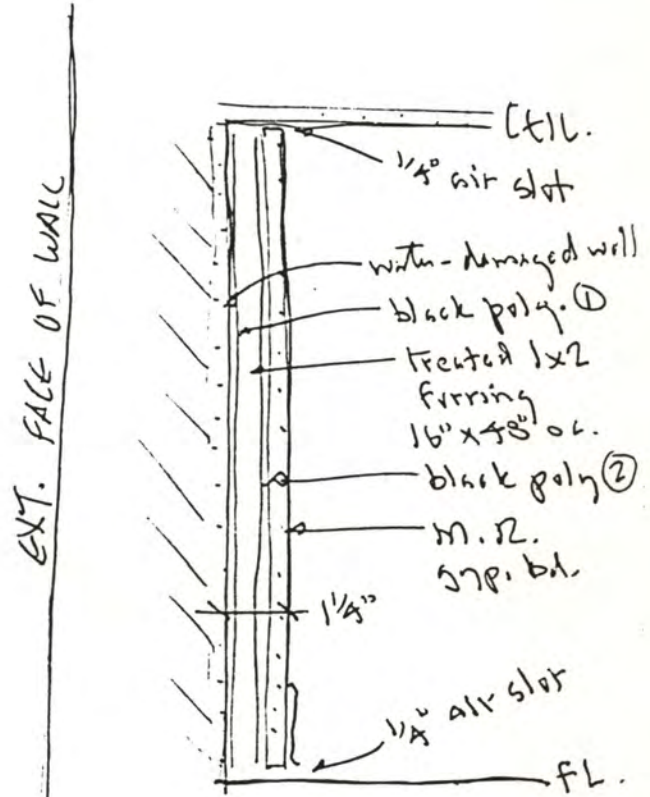
Section —
treatment for water-damaged wall to prevent future damage due to small seepage thru wall.

Used several times by J&H work.

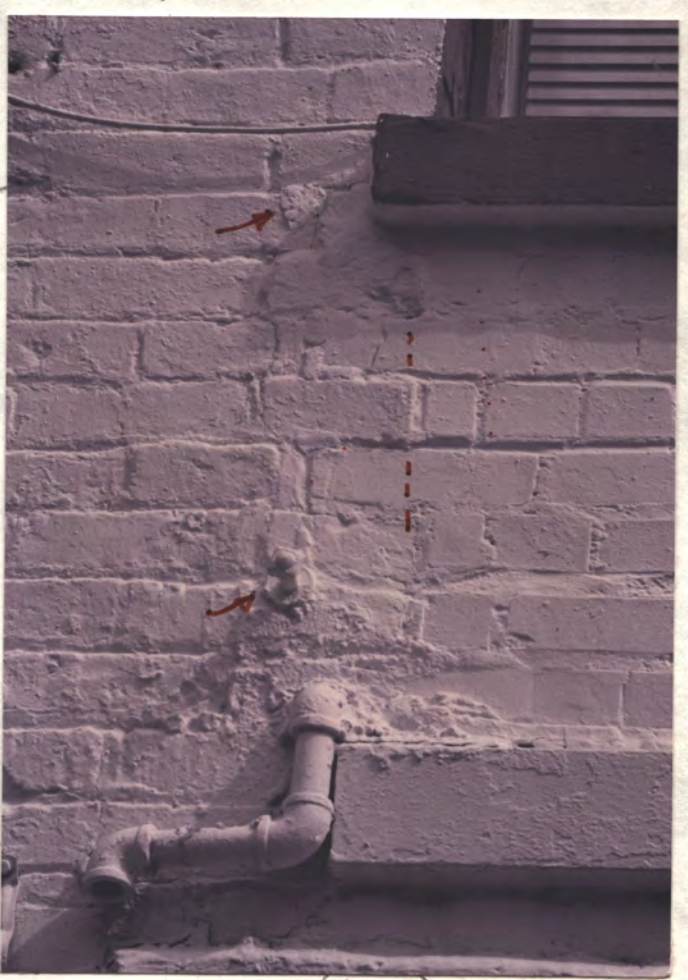
→ orig. balcony rail met. anchor or filled hole
: Top Pt. (West) South sim
: original jumbo track

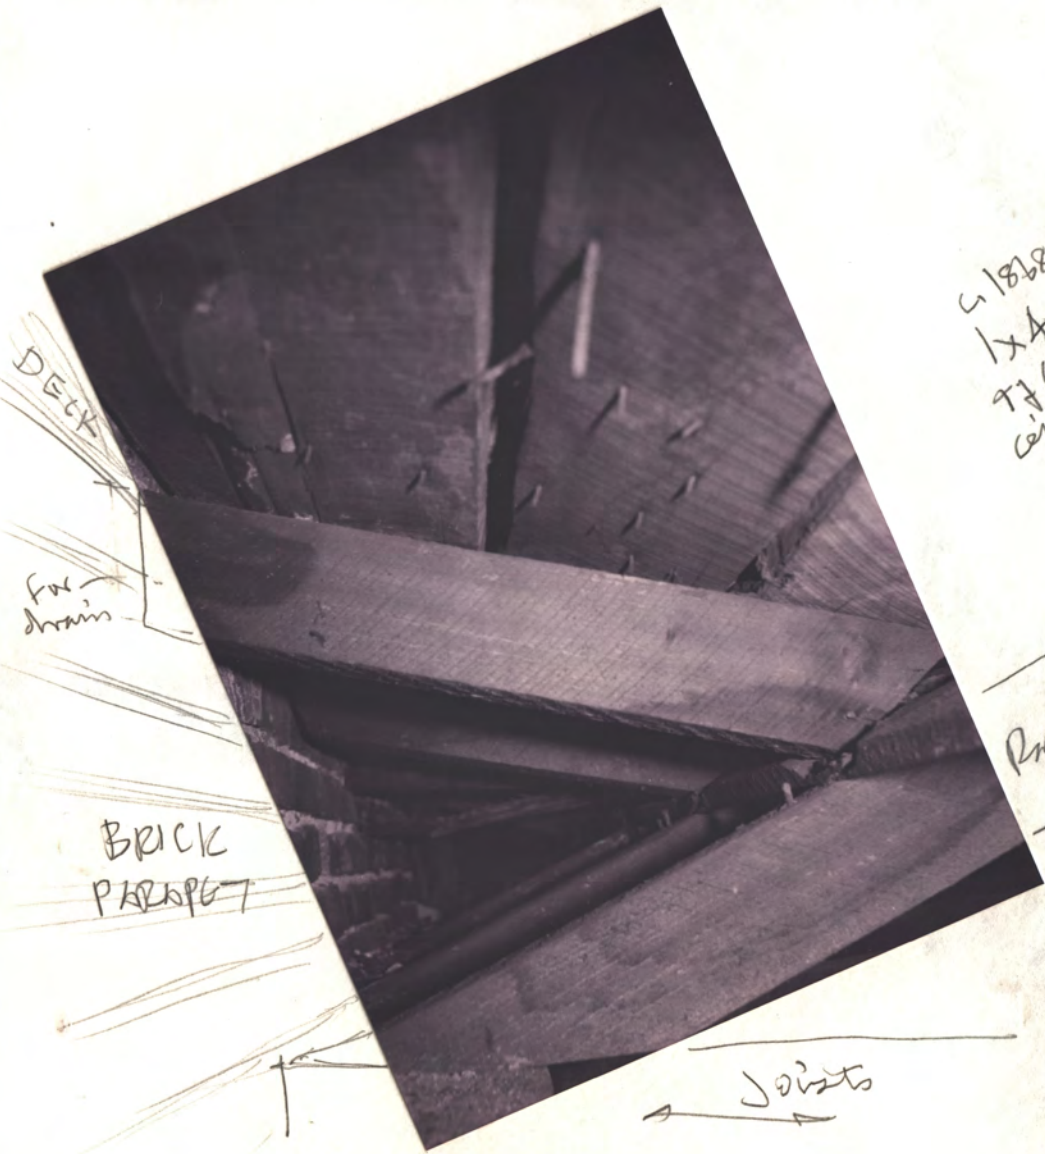
c. 1868
 1x4
 2x6
 ceiling joist

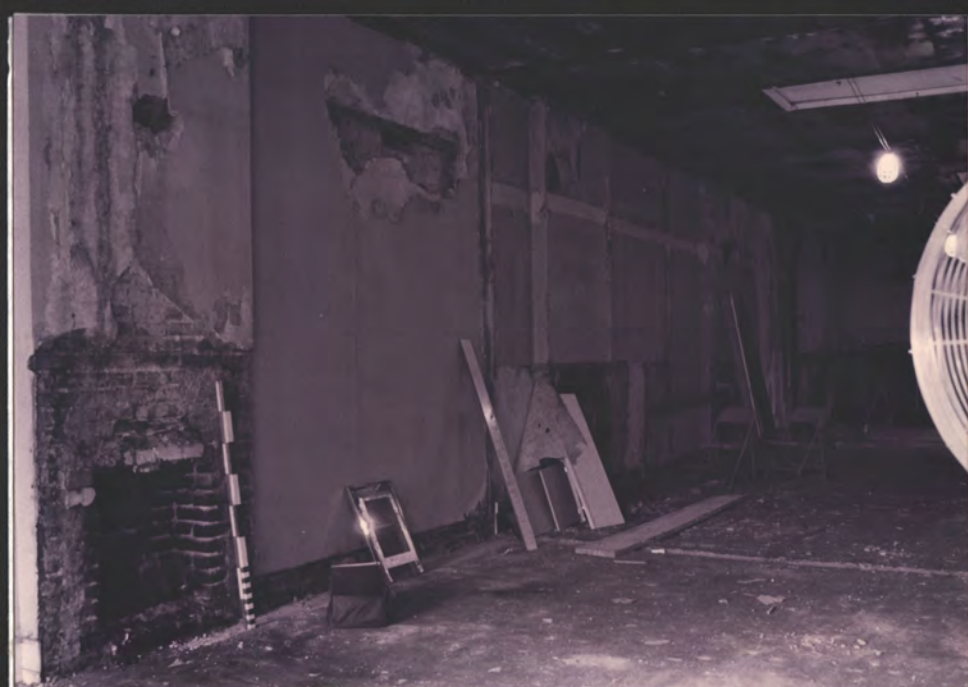
original
c.1870
wood-burn
fireplaces
(3 ea.)

Not mantel
trace →

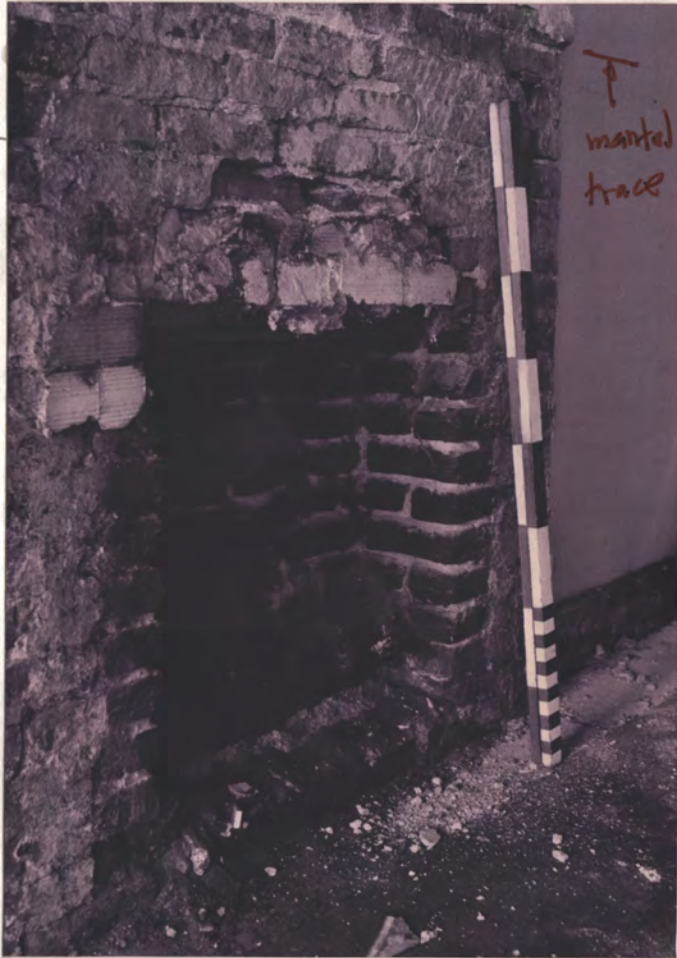
North
fireplace
(wood-burn)

↑
mantel
trace

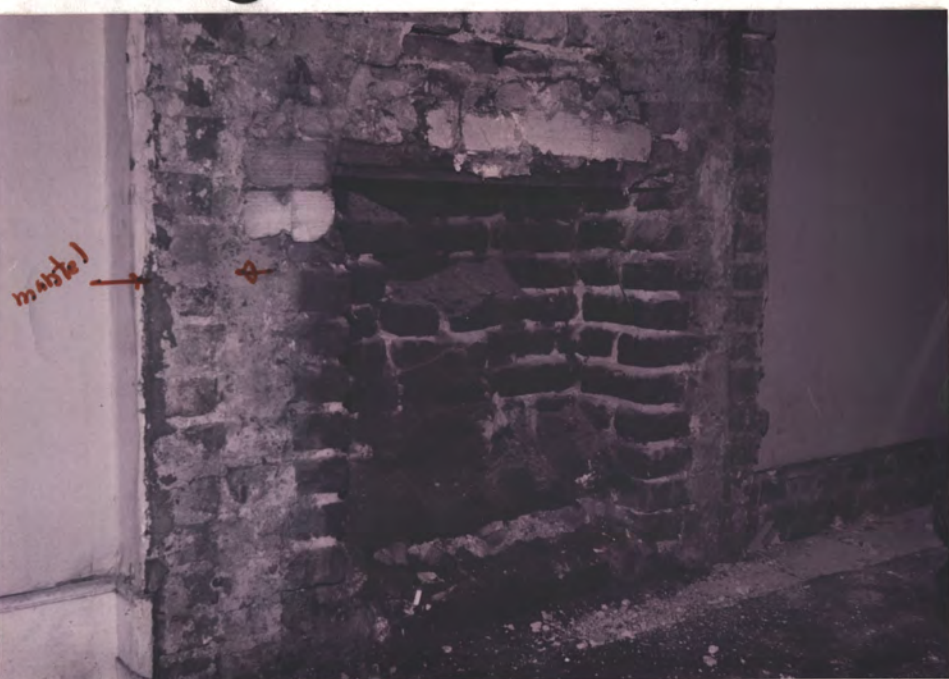
all
mantel
removed
by or before
1950 removal

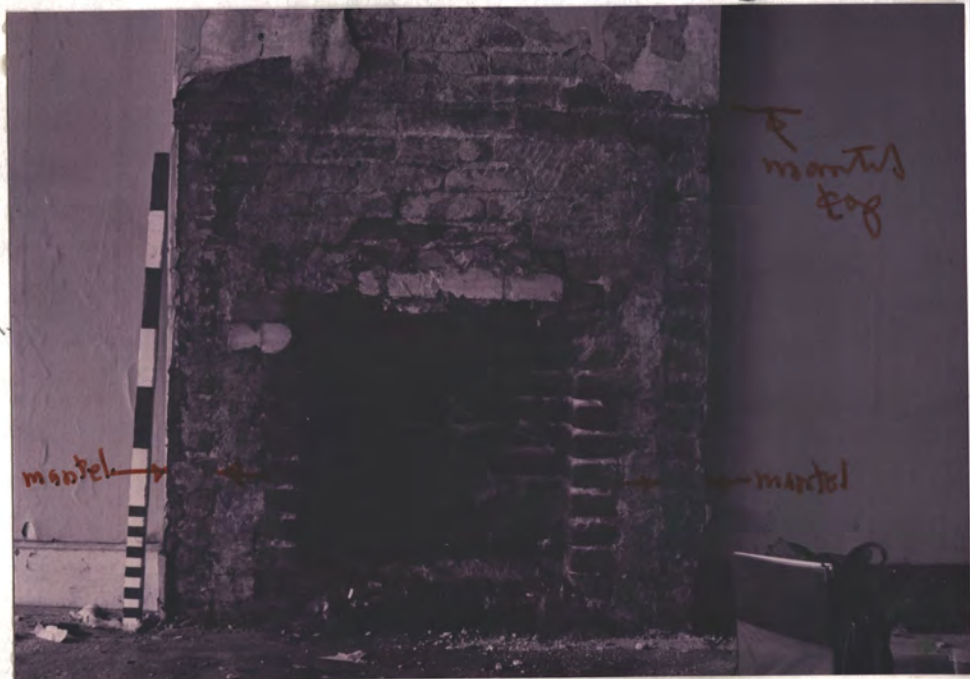
NORTH c.1870 fireplace, for burning wood (all wood, no modif. for coal)

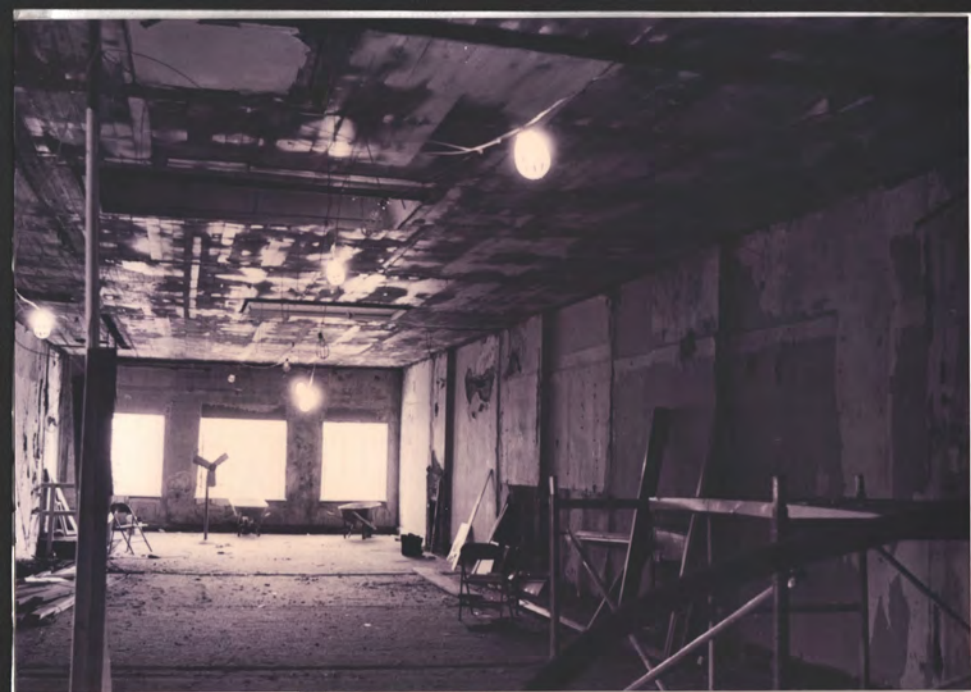
orig.
plank
ceil.
T & G 3/4"
x ± 4"-5"

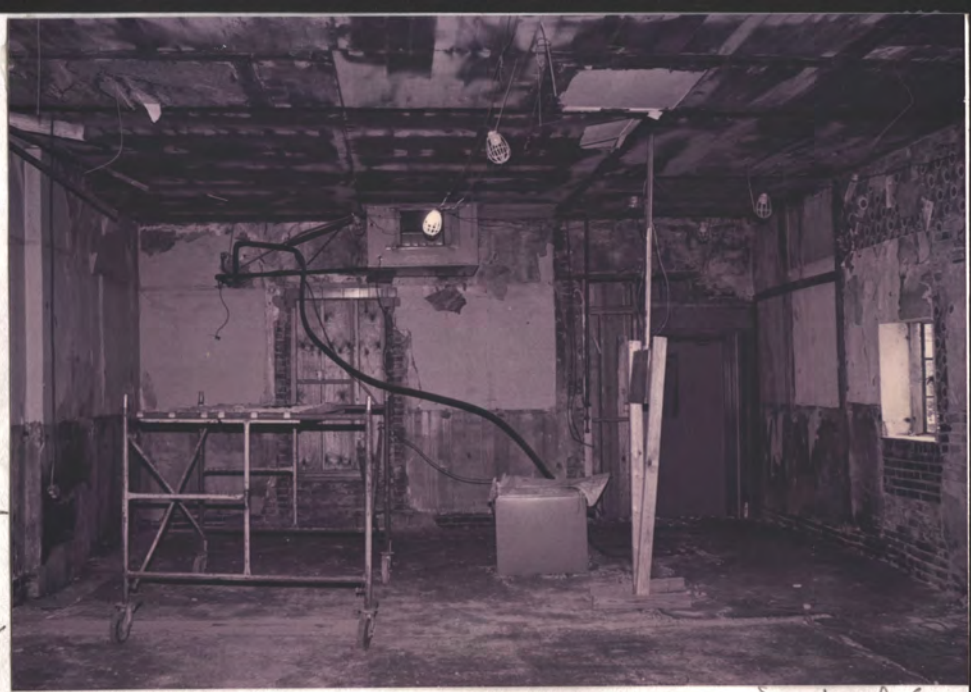
← s. 1670 window open & modified in 1950 & 1975

widened fire door to add. in c. 1975

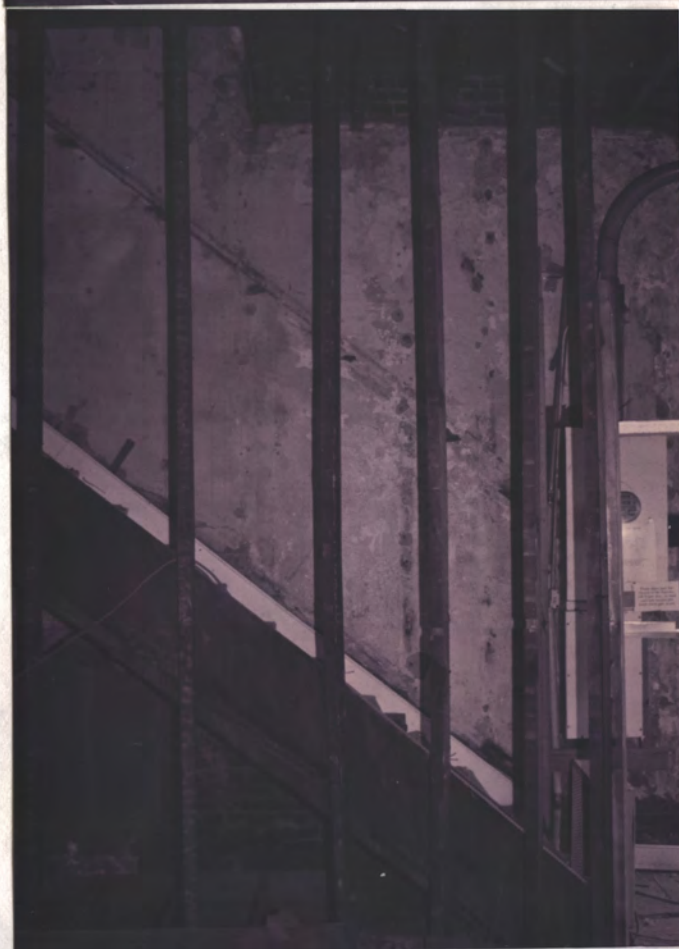
Orig. stain
at NW
corner
removed in
this remod.
(conf. rem. to
be hard)

note lots
of plaster
ceil. traces
(orig. ceil)

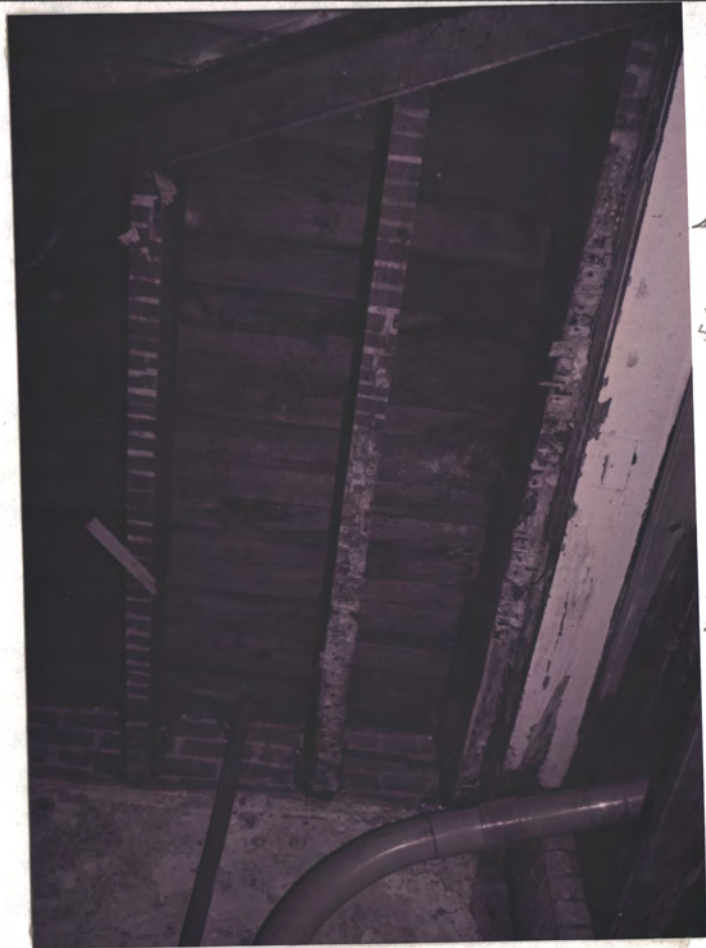
← WP,
Beam
over
shop front

shop front
opening

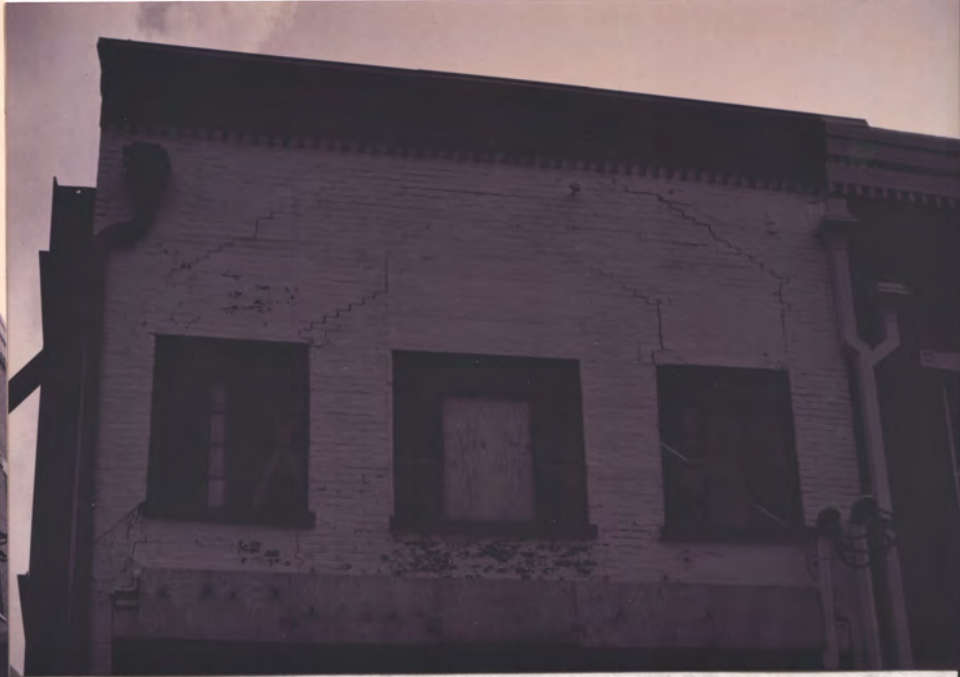
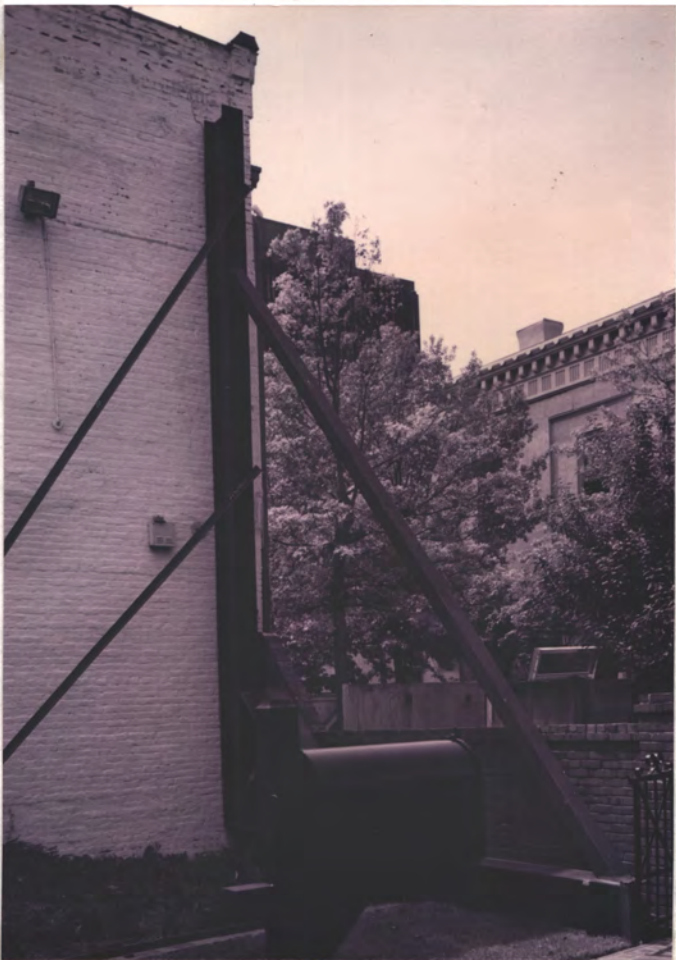
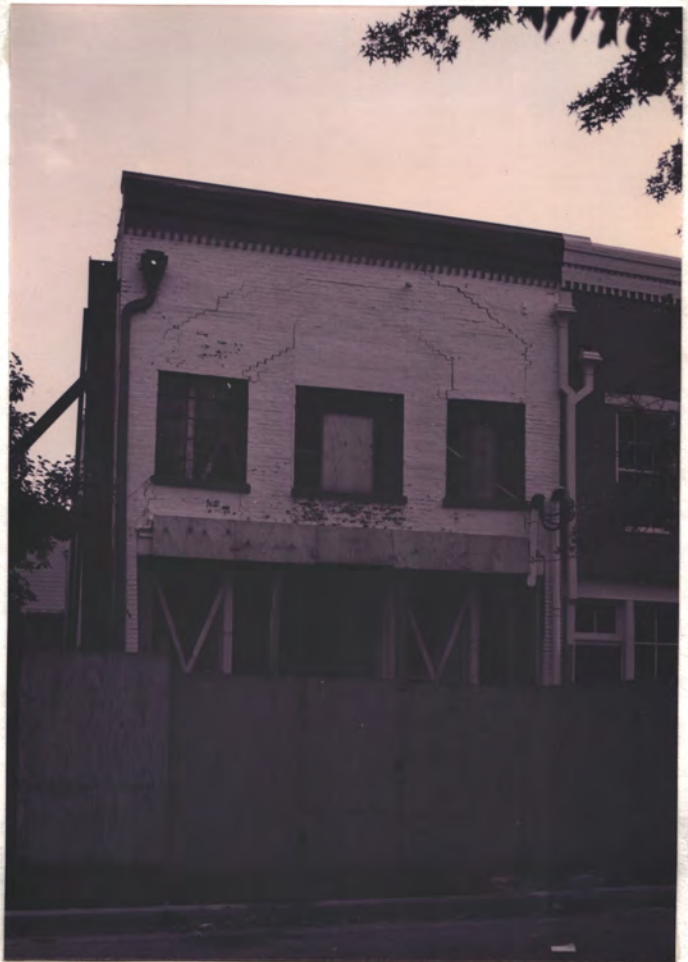
Wall not resupported securely before
1950's cols were removed. Dropped $\pm 3''$ & cracked

± 30 Aug bracing

Note cracks & $\pm 3''$ sag in wall

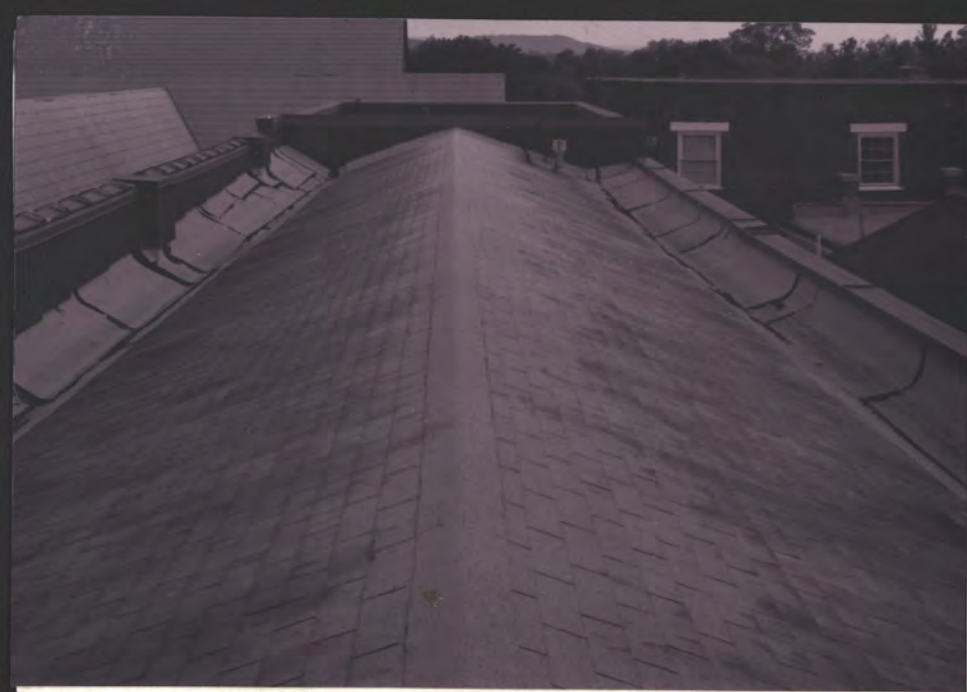
1984
"Tamko"
Modif.
Bitumen
"Mans
N
4

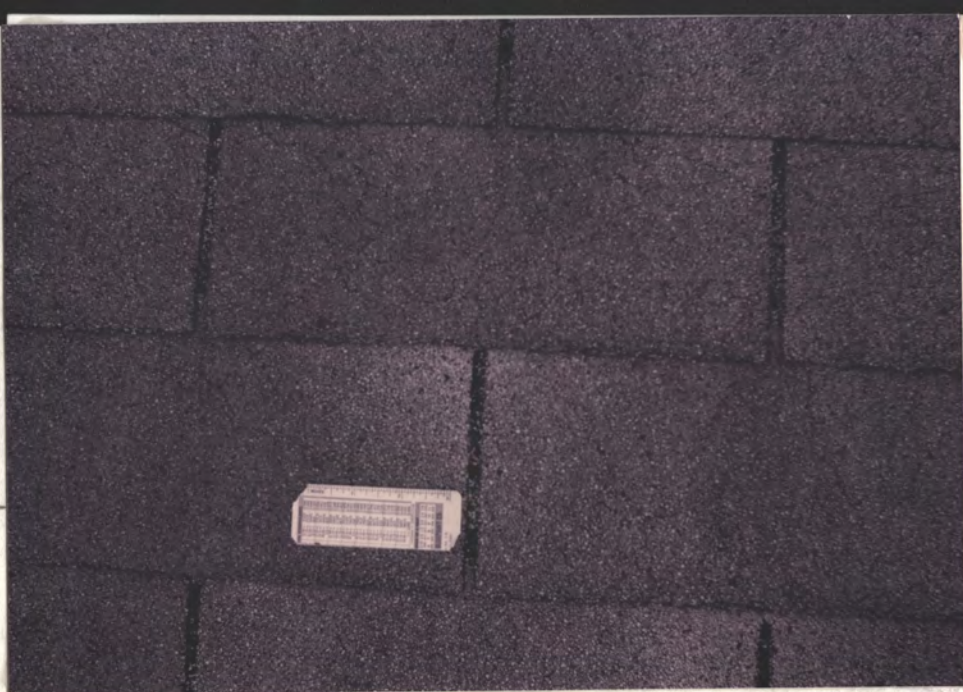
1. Shingles (standard weight composition) and valleys (roll roofing) are streaking, losing aggregate, have popped joints at valleys and should be replaced. This roof is +/- 14 years old and is at the end of its normal life.

↓ N
Std.
12-14 yr. life
shingles, 11 yrs old

1984 shingles = streaked & beginning to decay

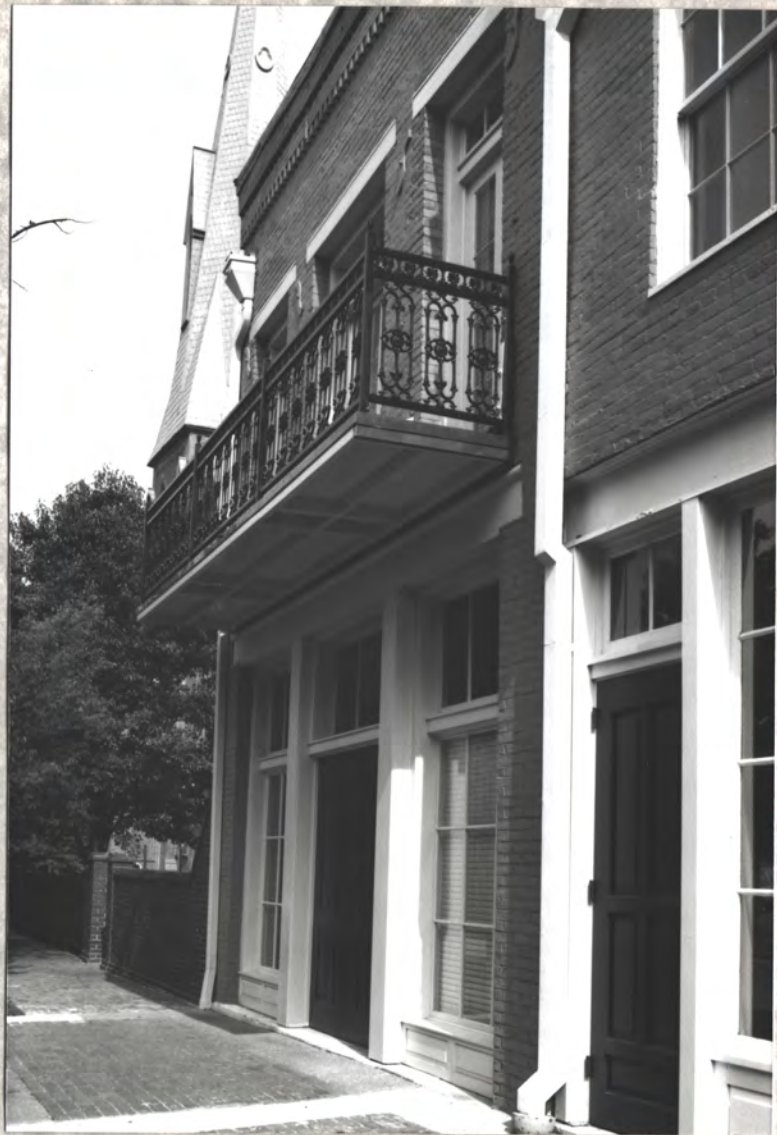
Reopened orig. windows
bricked up in 1871 ±

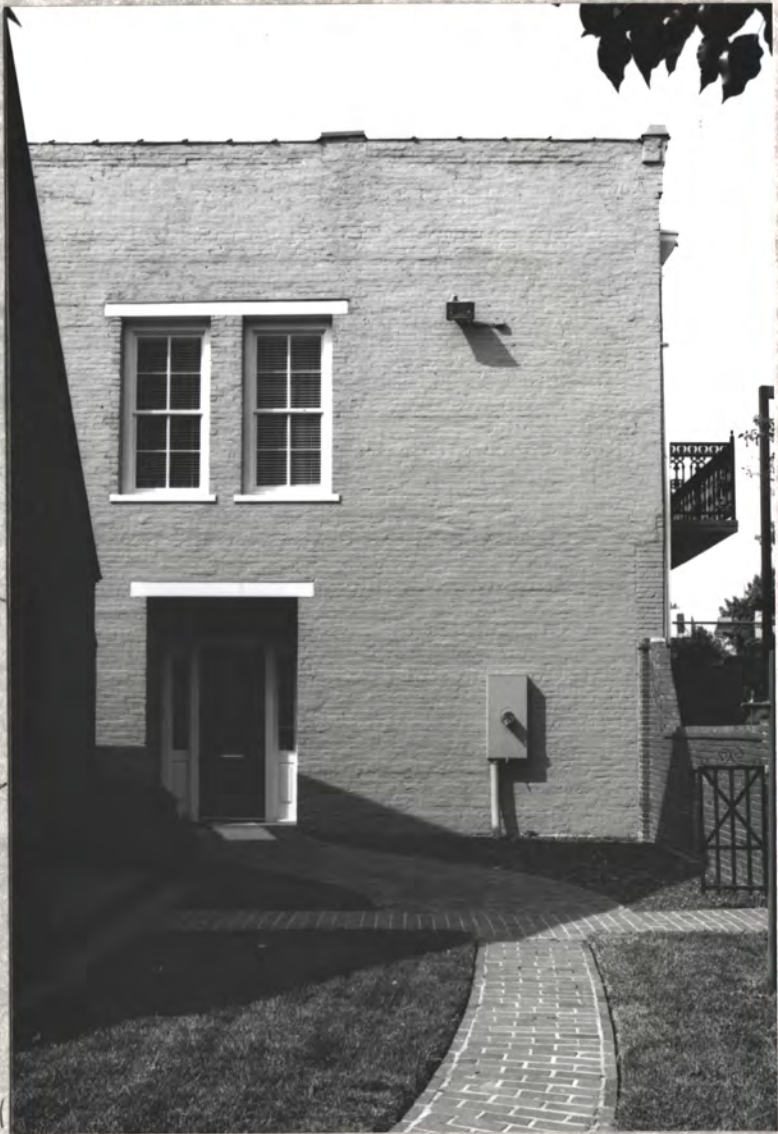
fl. 1 opens. are
1997, not orig

new open. fl. 2
new lobby entry at fl. 1

Church is responsible for exposed
elect meter. AD had it in a
shallow clus. by entry. The Ch.
Outsmarted themselves

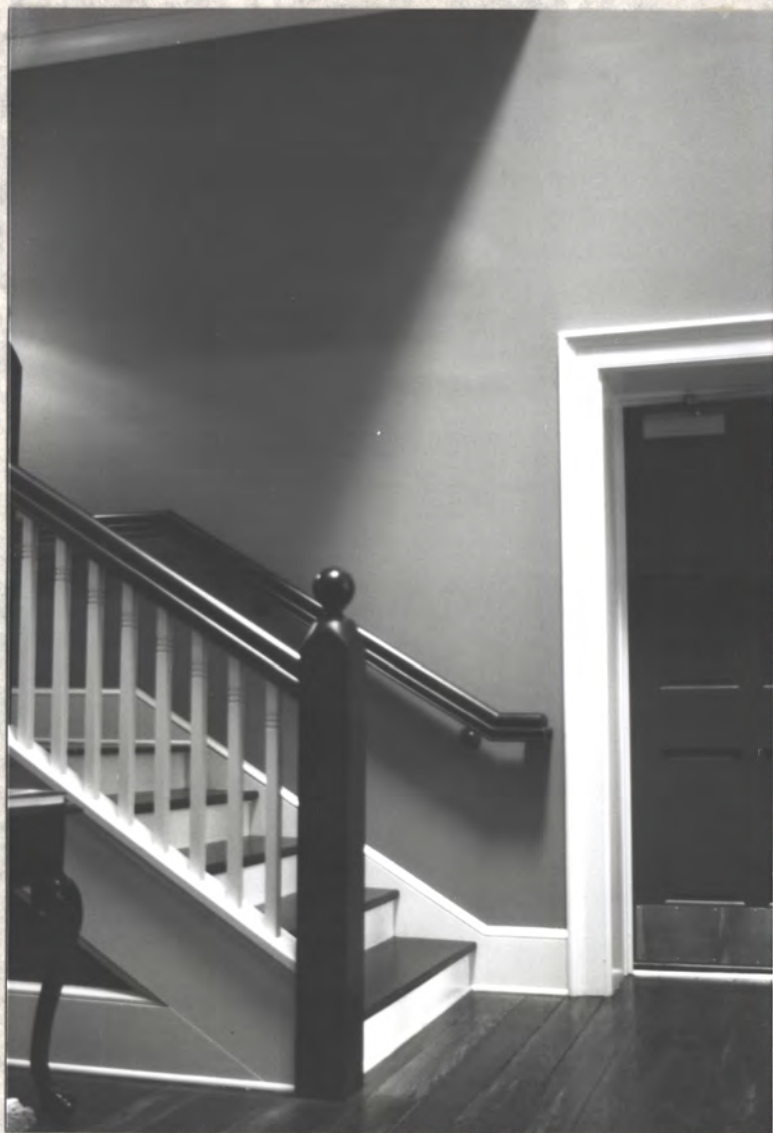
Lobby.
 Fl. = orig.,
 heart pine
 Stair & trim
 doors based on
 1870 exa bl'gs.
 in HV Lib.

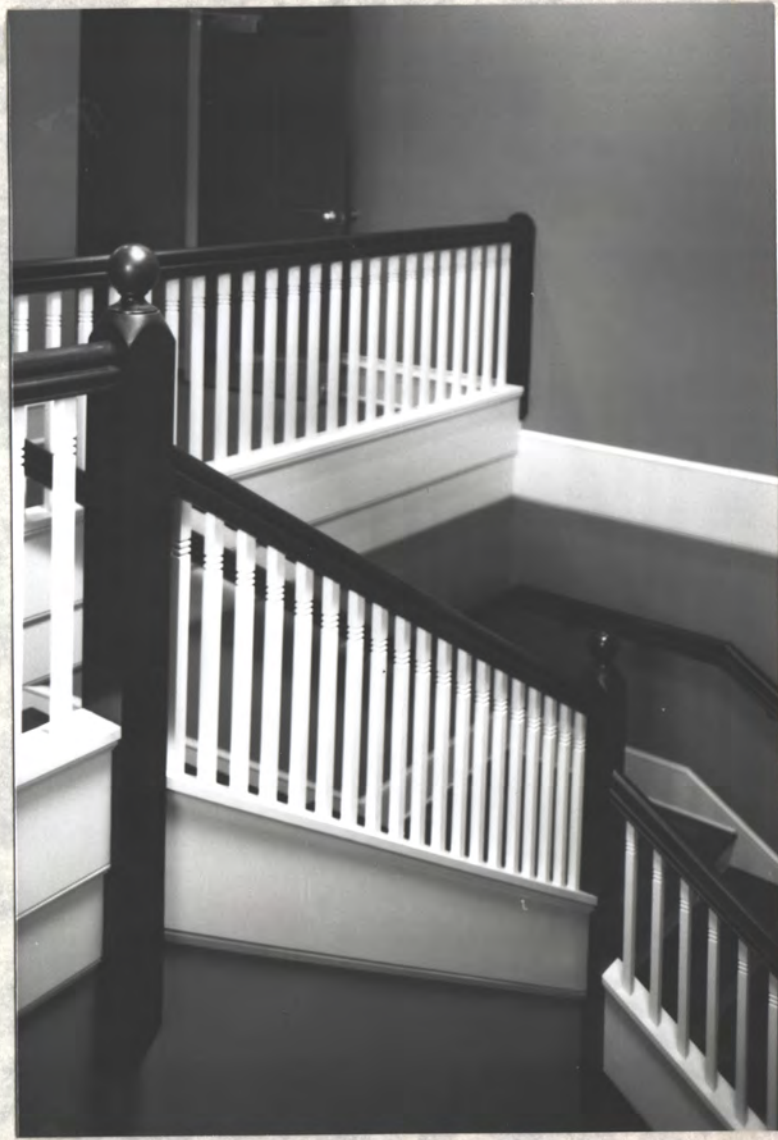
Orig. Fireplace repaired, at fl. 2 E. wall
at top of stairs.
Mantel is from c. 1881 Bernstein Hse, 110 Steele St.
(had been given to Hv. Hist. Fndn. when by builder)

new Stair at fl. 2, HJ design
per c. 1870 example
