**ARCHITECTURAL COLLECTION
OF
HARVIE P. JONES, F.A.I.A.**

BOOK 42

1840's - 50's
Solomon DeBow
Log Hse, Madison Co., Al.

Photos April 1993
Harrie P. Jones, FAIA
Huntsville

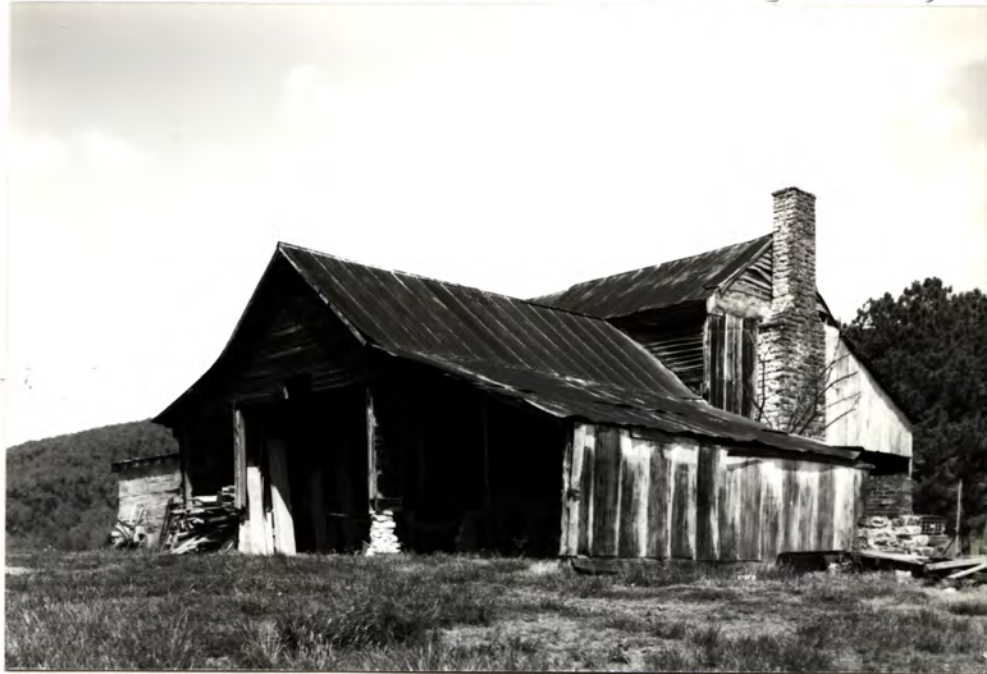
ALL SHEDS = MODERN (used as a barn) LOOK N.W. (front)

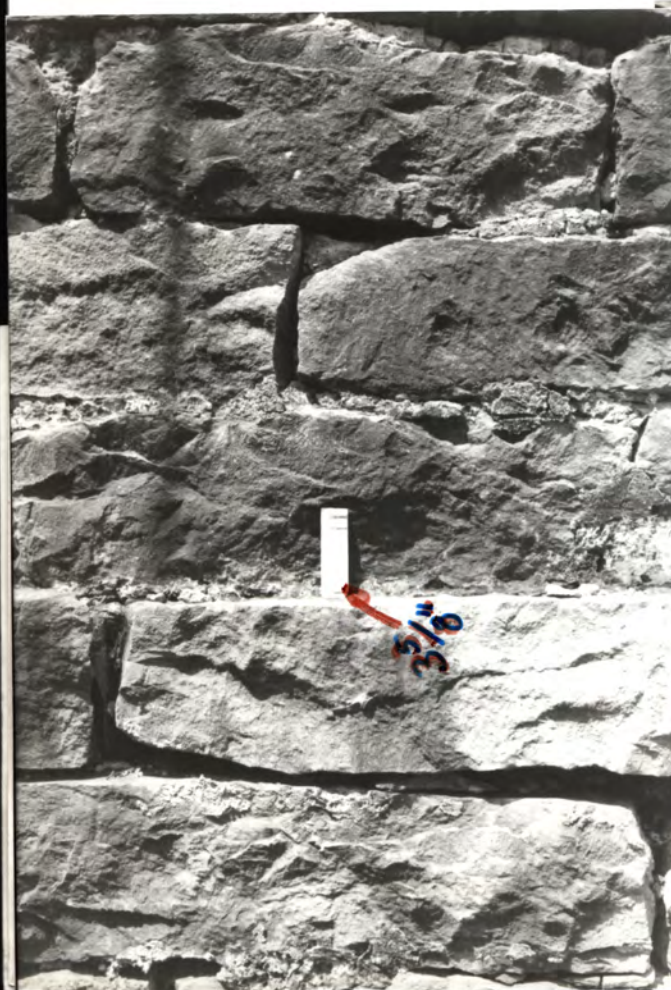
ledge at $\pm 3'$ off ground
S. CHIM.

S. CHIM. (LIMESTONE)
 Typical of
 19th. c. chimney
 shoulders
 (slopes vary
 $\pm 45^\circ - 70^\circ$)

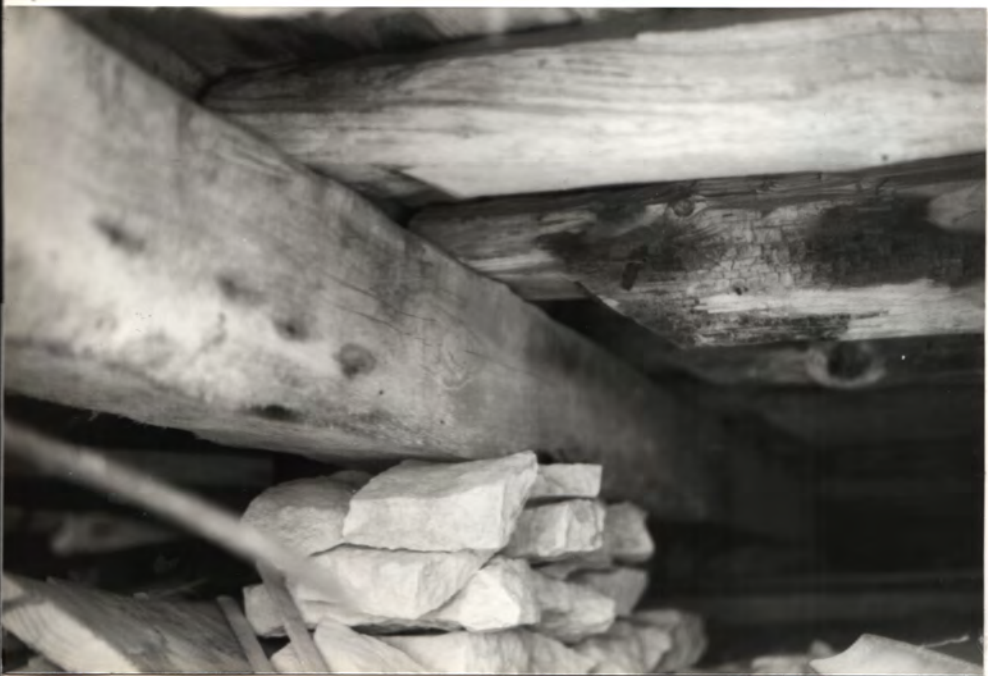
probably original
limestone "pier";
no mortar.

± 5/4 x 6" single-floor, pine,
tongued & grooved (see p. 11)

"punchon" joists (logs)

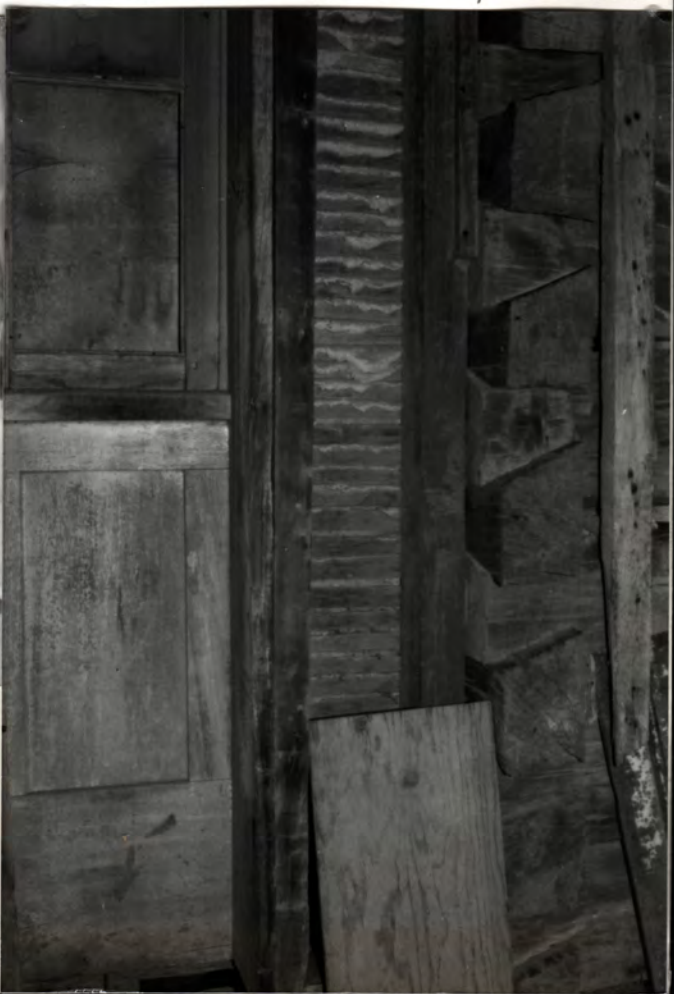
→ N ↑
nailers for
clapboards
(may be later, of
c. 1850's - ? -)

NO LOGS
(ALSO NO LOGS
AT FL 2.)

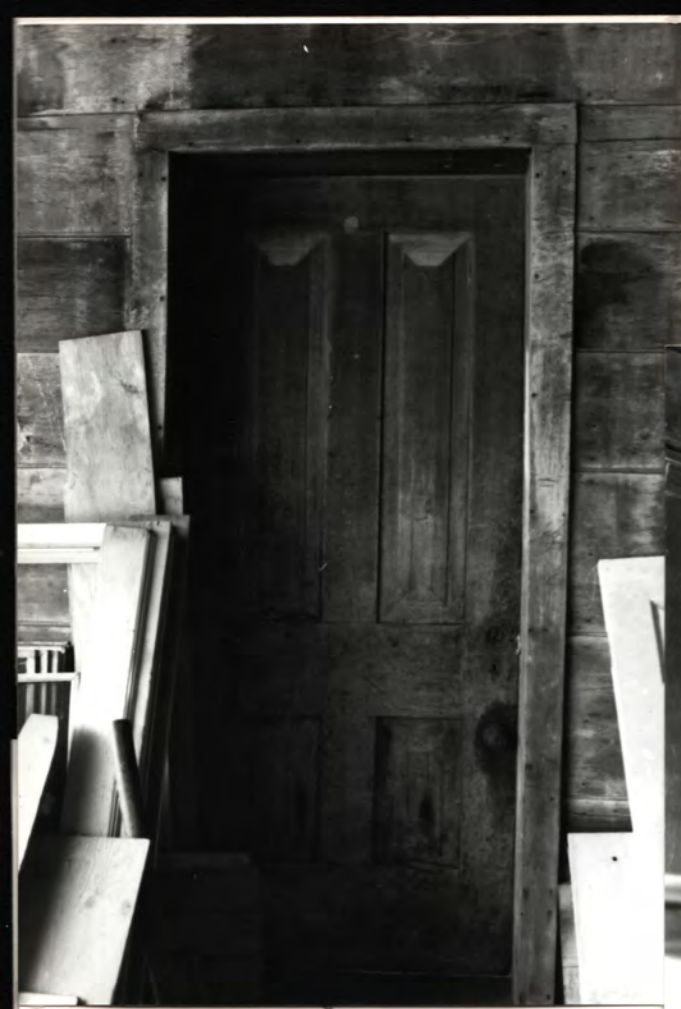
← heavy panel details at door
+ 4-panl door indicates
1840's-50's date (Gk. Rev.)

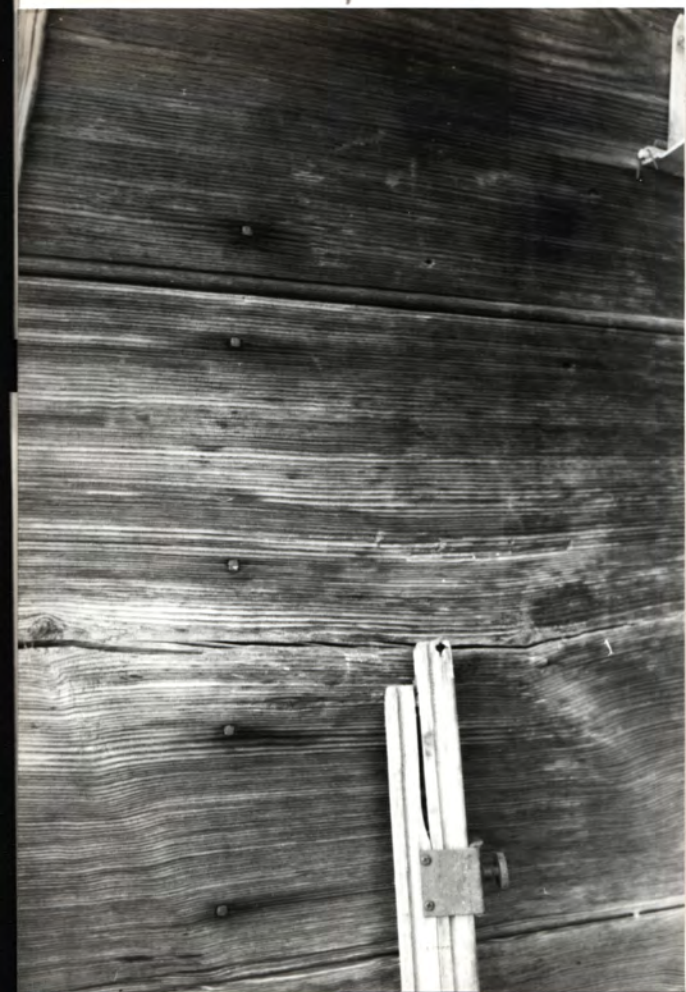
REAR
WEST
WALL
wide
banded
joint
T & S
siding
indicates
this was
covered
by a
porch

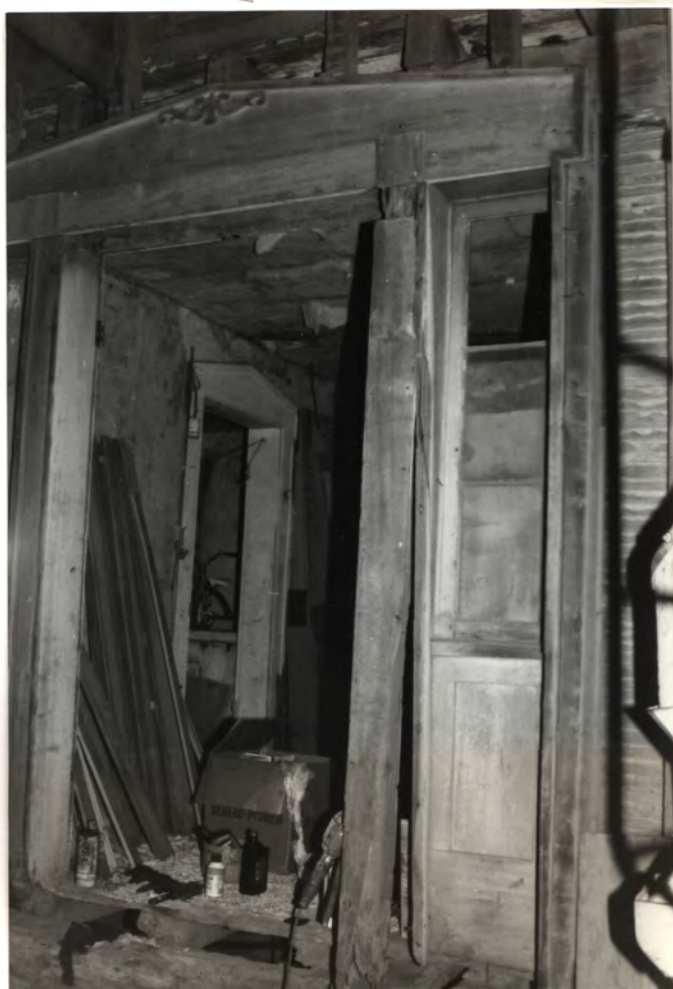
EAST FRONT ENTRY (DOOR + SIDE WTS)
Scroll at frame peak may be vic. or may be orig.

NOTE - unweathered log faces indicate the house was clapboarded either originally or shortly after completion

Scroll at frame top may be Vic.
but could be original to this
Greek Revival frame (?) Remove & verify.

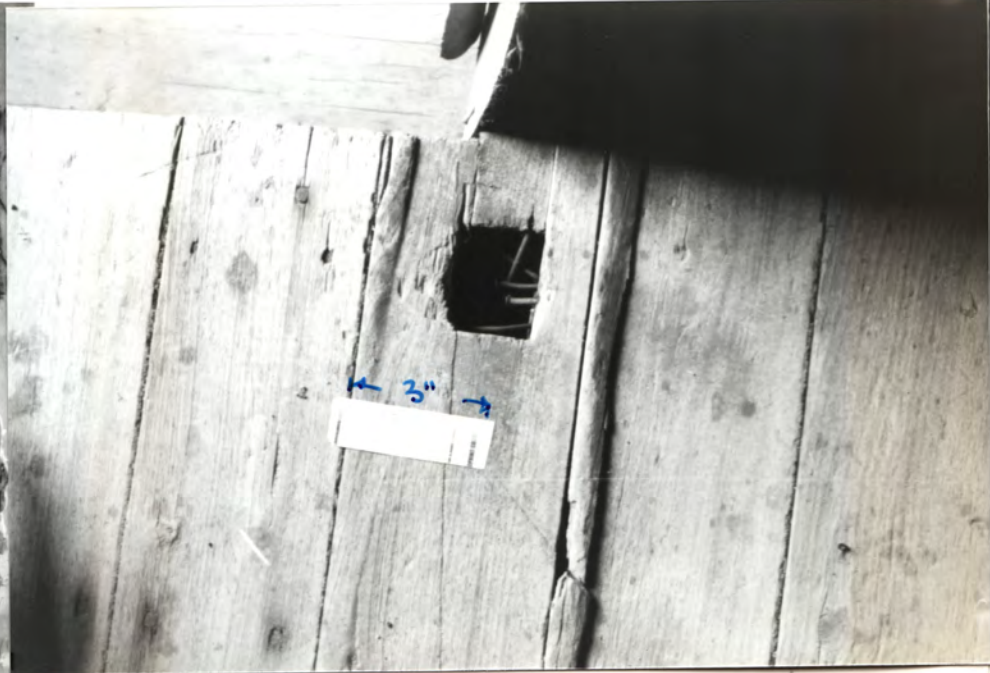
↑ 1 5/4 x 6 pine fl. (orig.)
 ↑ 3 3/8" plastic ruler
 ↑ mortise for original newel at fl. 2
 FL. 2 HALL, SWIRWELL S. EDGE

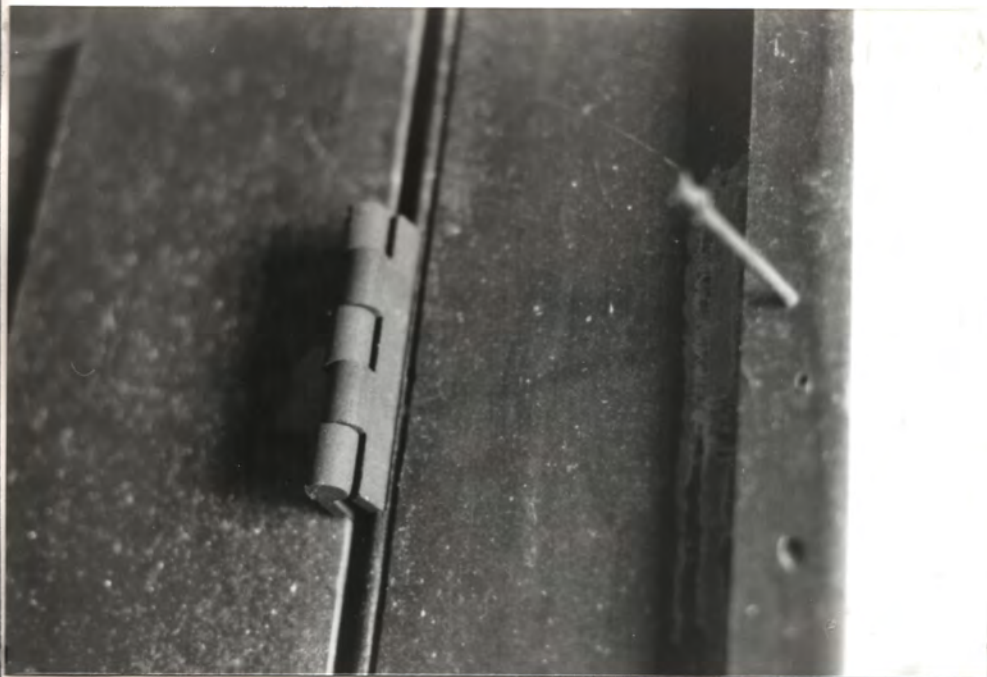
N.R.M., W. DOOR TO PORCH
(INT. SIDE) = ORIGINAL

traces of 2 previous
locks, 1840-50 proportions

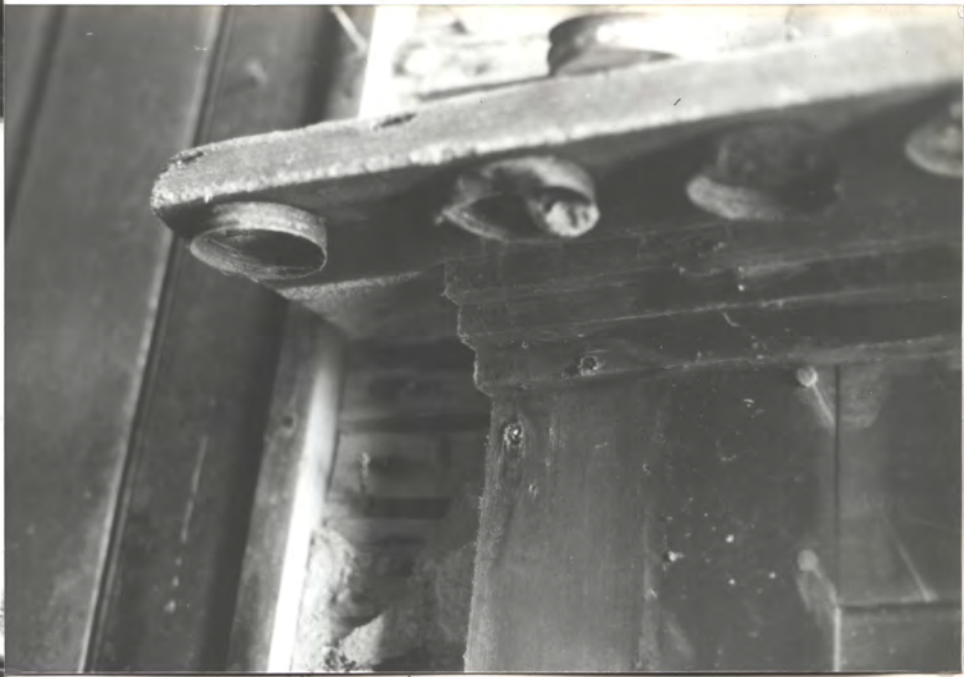
W. DOOR
 beaded base =
 typical 1800-1850's

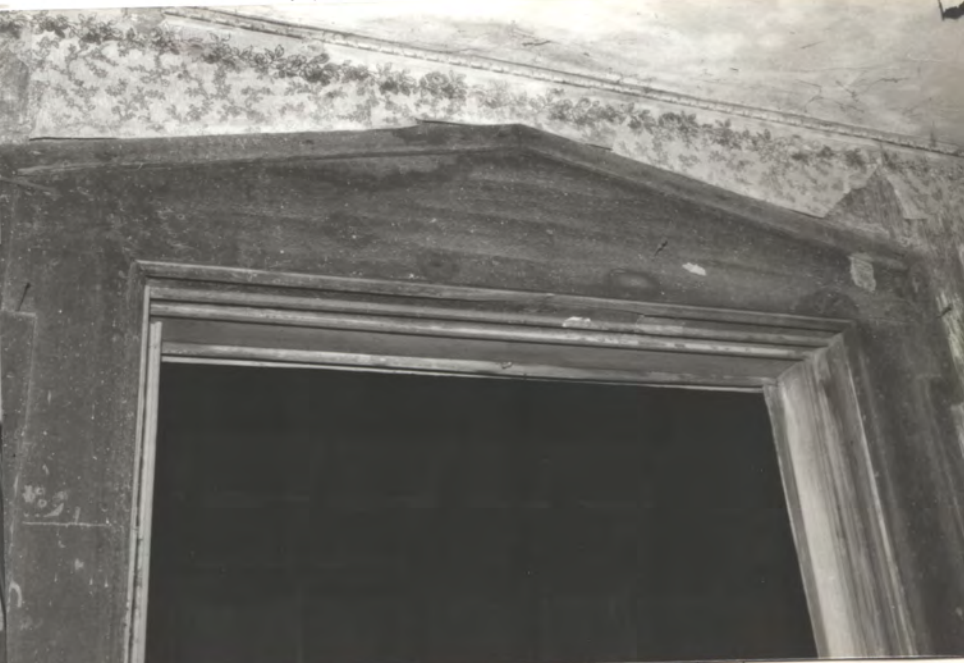
EAST WINDOW, FL. 1 N. Rm. - 34 x 63 ±
 "GREAT EAST" FRAME.
 No orig. sashes found. A shed attic had
 several LATE VIC. 2/2 sashes for Fl. 2 sizes.

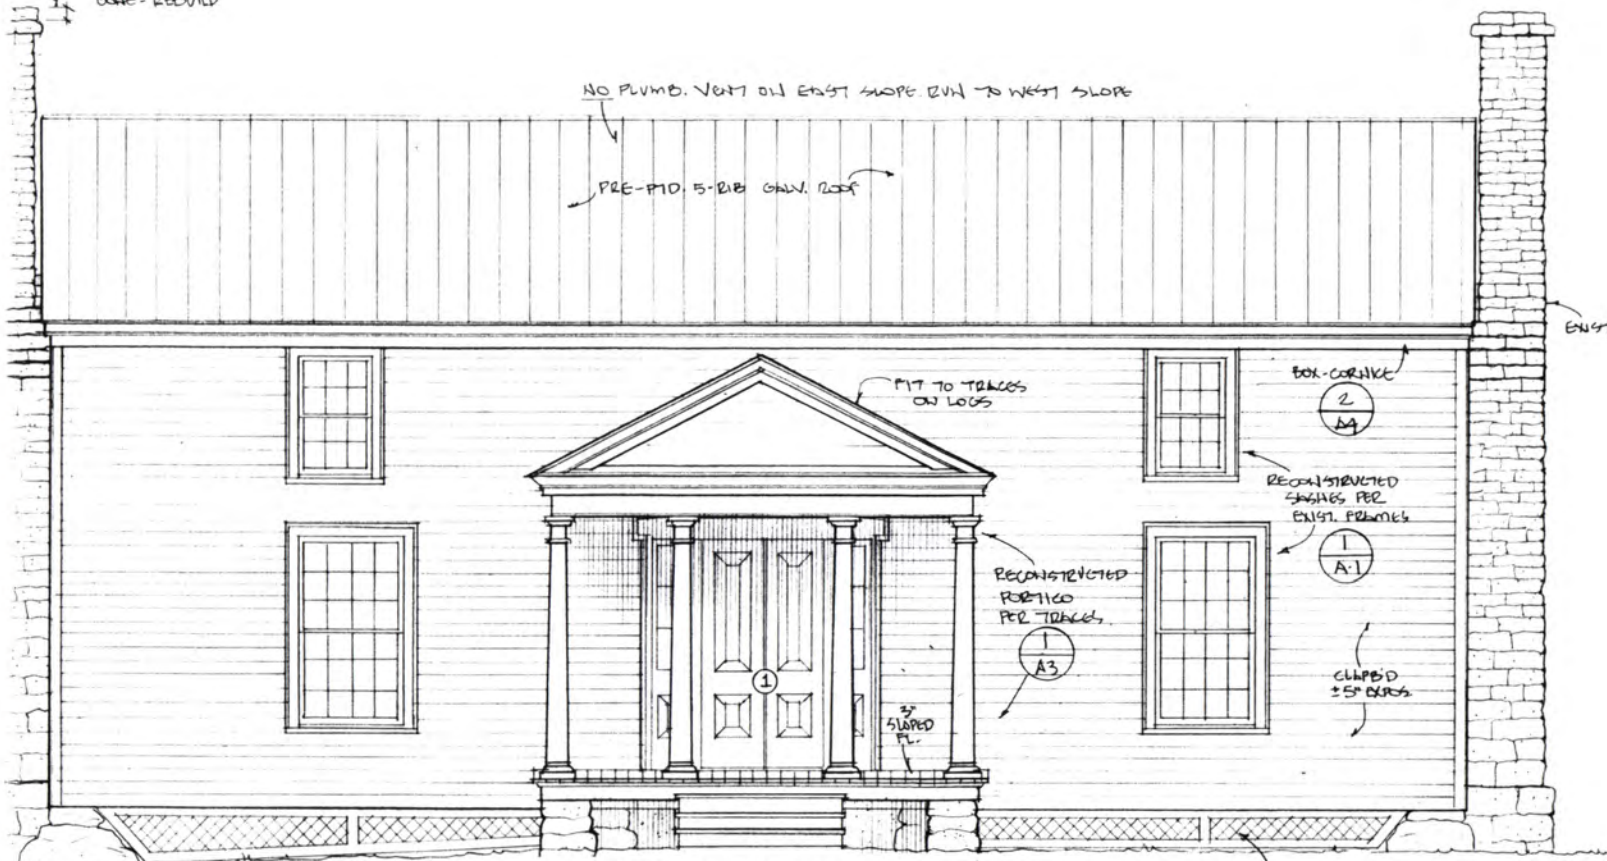
EAST FRONT ELEVATION

exist. windows are not symmetrically placed,
A/c like this

MORTISES IN SILL FOR C. 1860 PORCH
NOTE!

ALL SASHES GONG EXCEPT ENTRY SIDINGS. SEE 12:1 SASH SCHED.

RECONSTRUCTED
SASHES PER
EXIST. FRAMES
1
A1

RECONSTRUCTED
PORTICO
PER TRACES
1
A3
