ca. 1930 (verify) GLOVER HOTEL, Guntersville, AL.
Owner: George Kappler - photos April 1984 Harvie P. Jones, FAIA

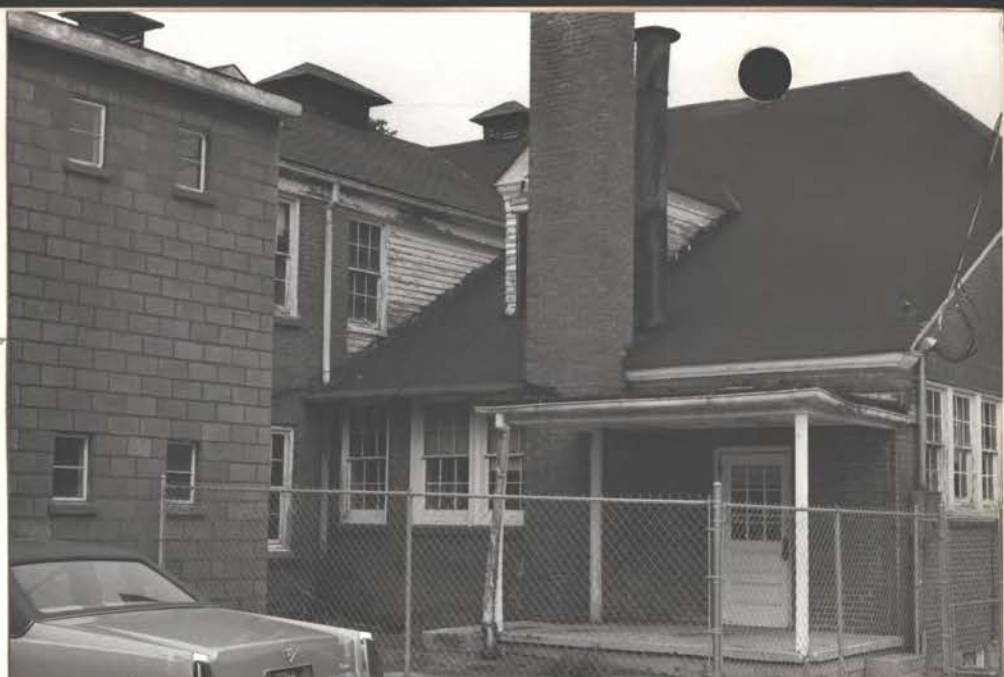
→ N
Bad drainage by
KIT. west wall
+ water damage to
wall inside, at corner
(see pg. 11 photo)

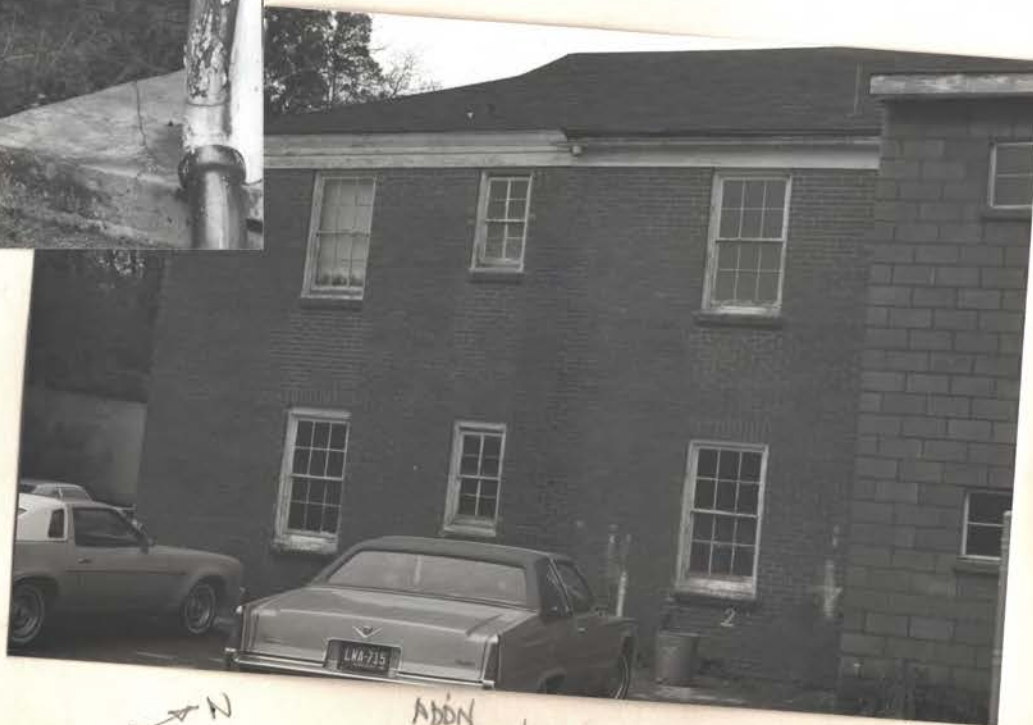
added
baths, c. 1950?
KIT →

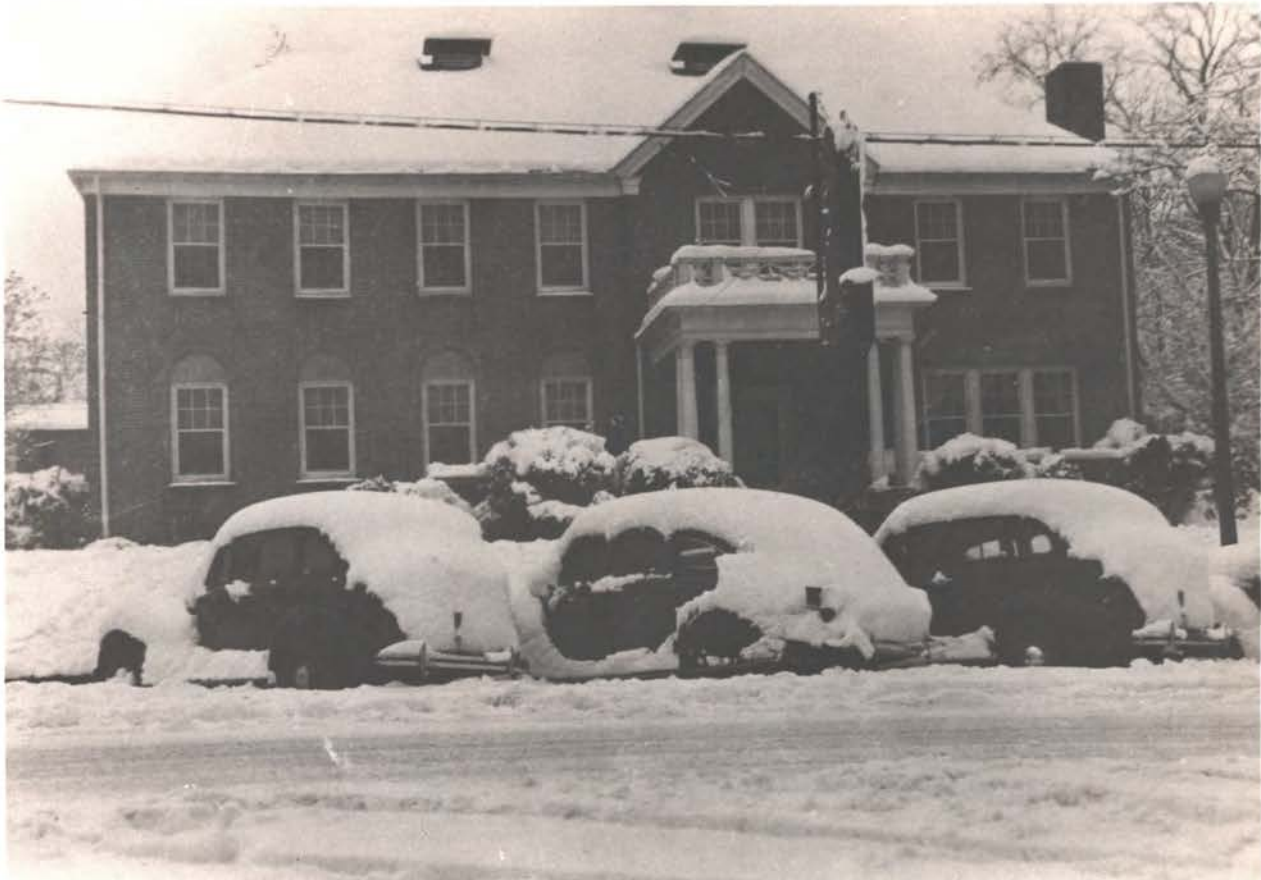
←
NOTE
ORIG.
RAIL
NOW
GONE

CA. 1930'S PHOTO, BASED ON CAR'S.
GLOVER HOTEL (1924) GUNTERSVILLE, AL. COPY = 1984

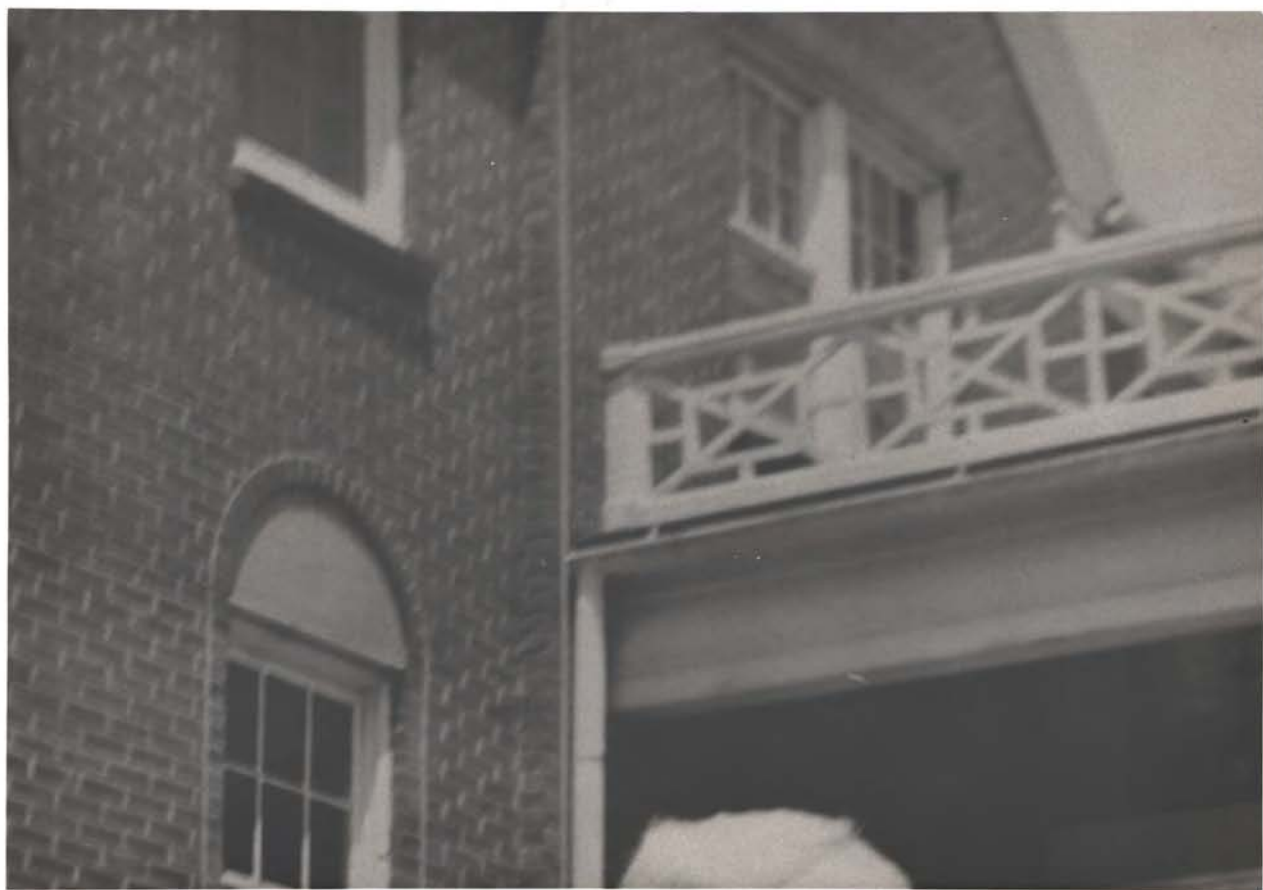
←
NOTE
ORIG.
RAIL
NOW
GONE

↑
1/2 END
GUTTER
+ RAIL
ON SPOT

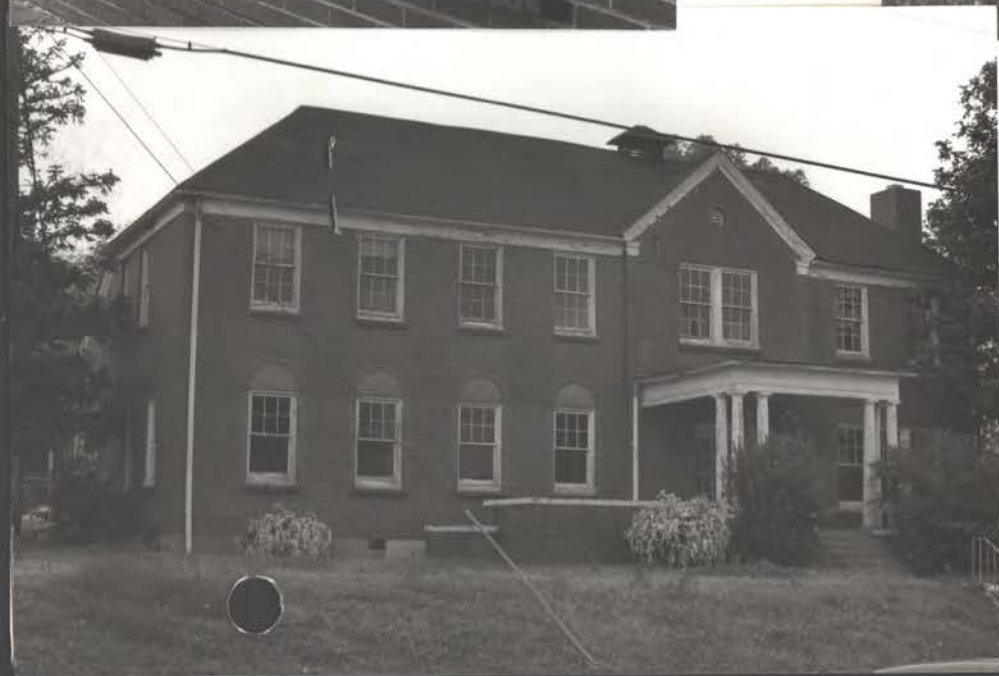
EAST
FRONT

← RAIL
GONE

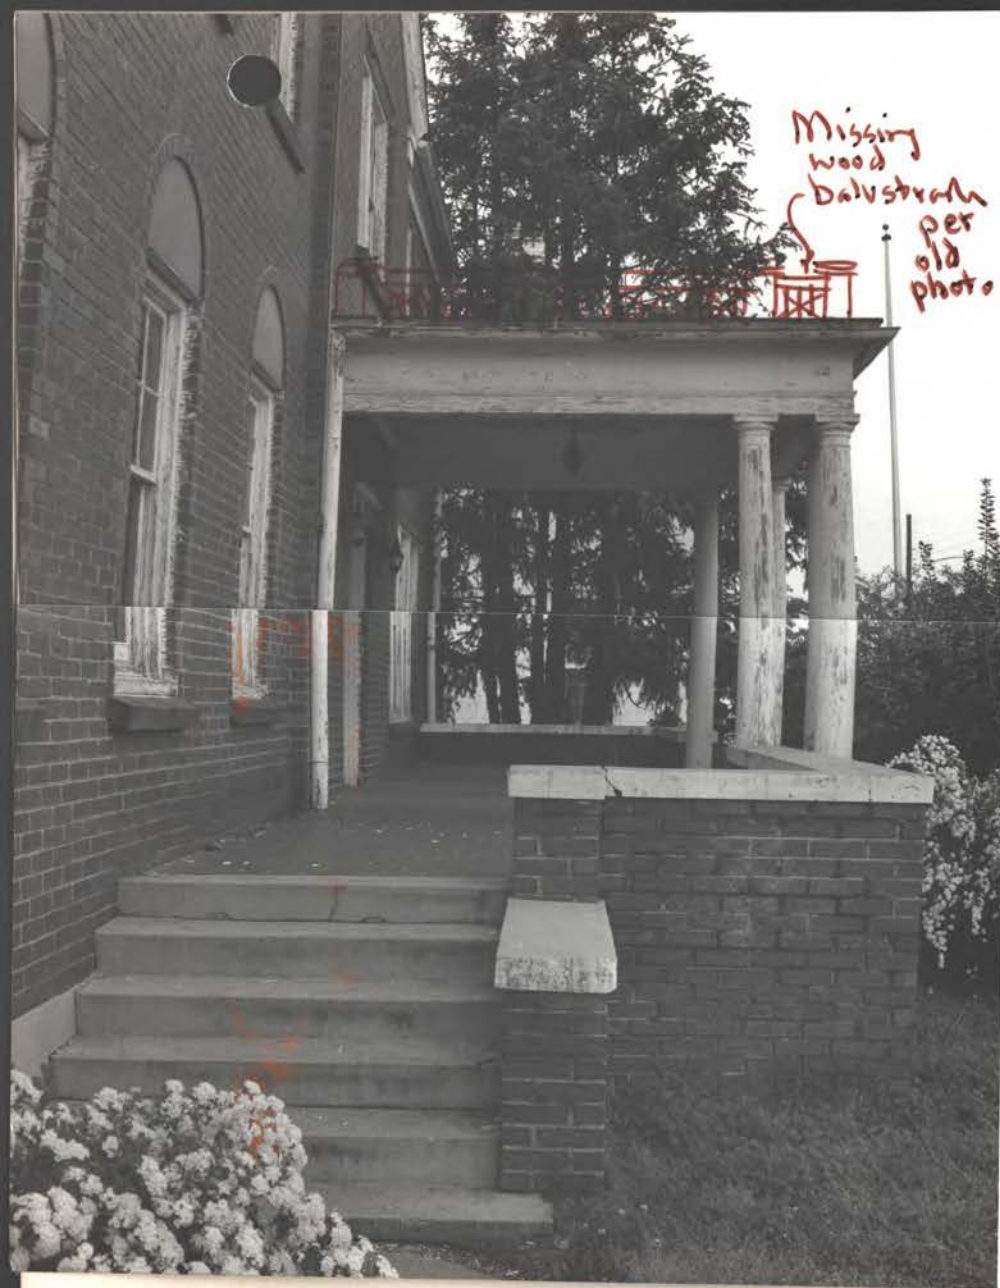
Missing
wood
balustrade
per
old photo.

rusty
Flat
seams
metal
roof

← was a
balustrade
on top
w/ 3
corner
posts
(see
map)

Red
Quarry
tile

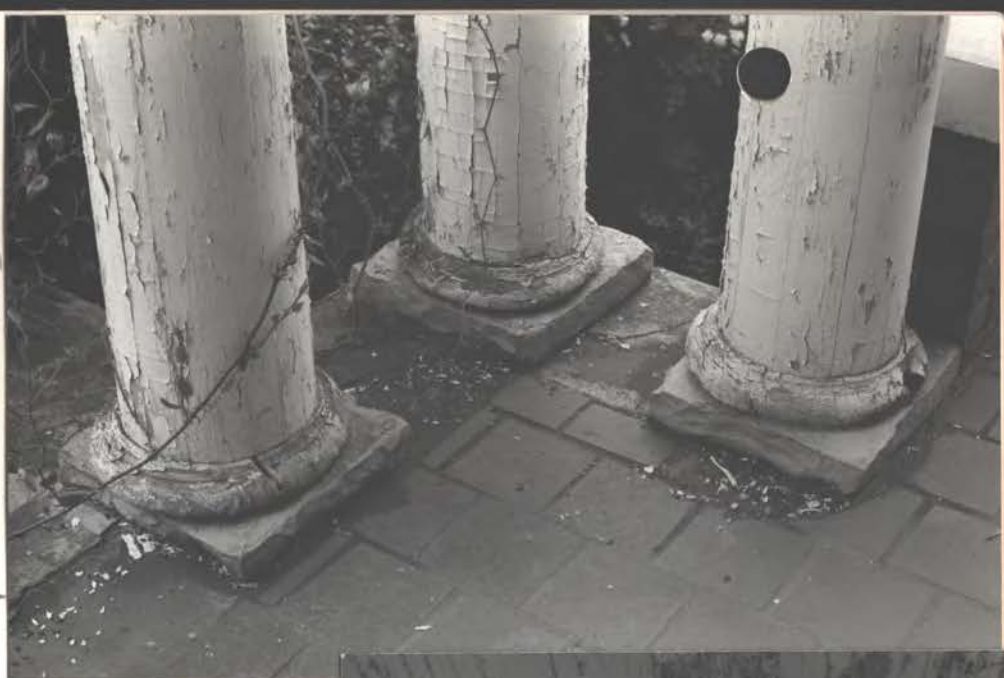
PORTICO

(rough sandstone
plinths,
rotted col. bases)

added? →
looks "carpenter
designed"
afterthought

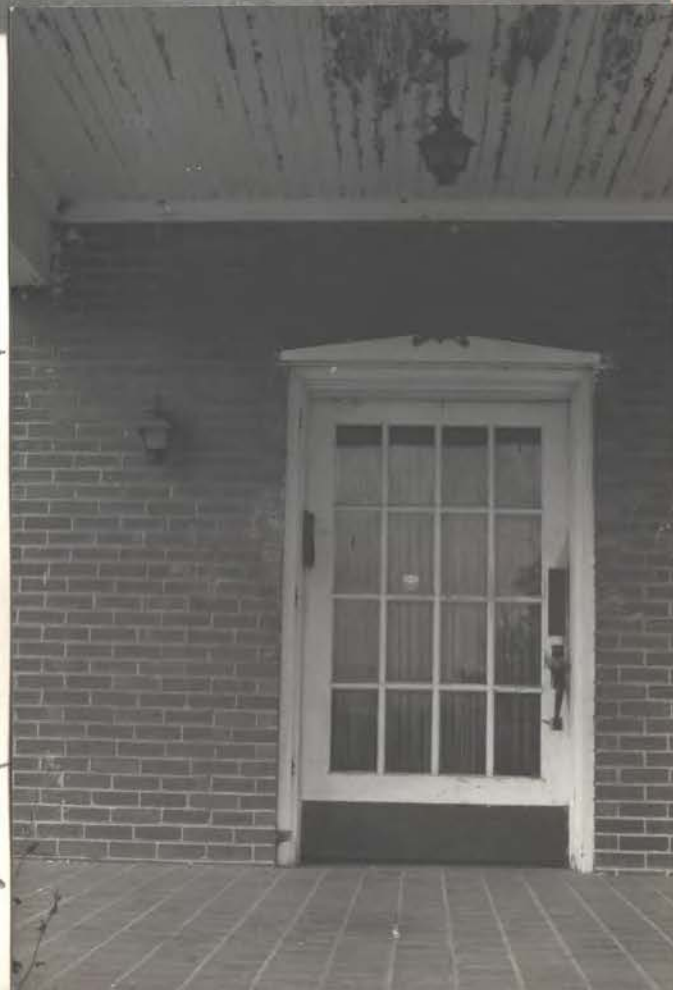
AN ENTRY

Red brick,
white trim

red quarry tile
(post drainage - settled)

Note - porch may had a low
balustrade of wood. See
old photo in file

(Jan '86 P.S. - NOT rebuilt per old photo)
PS JULY '86 - REBUILT PER PHOTO

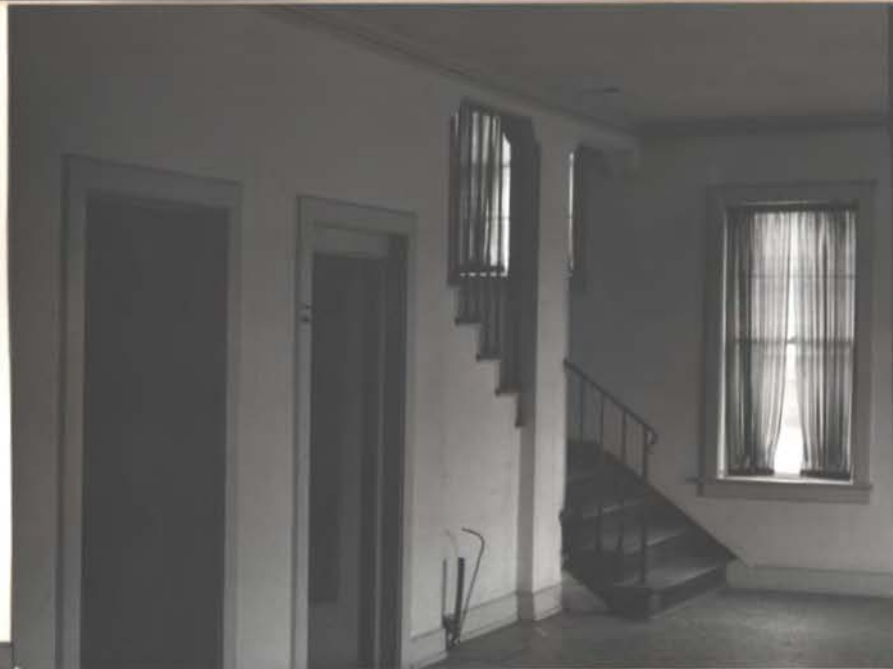
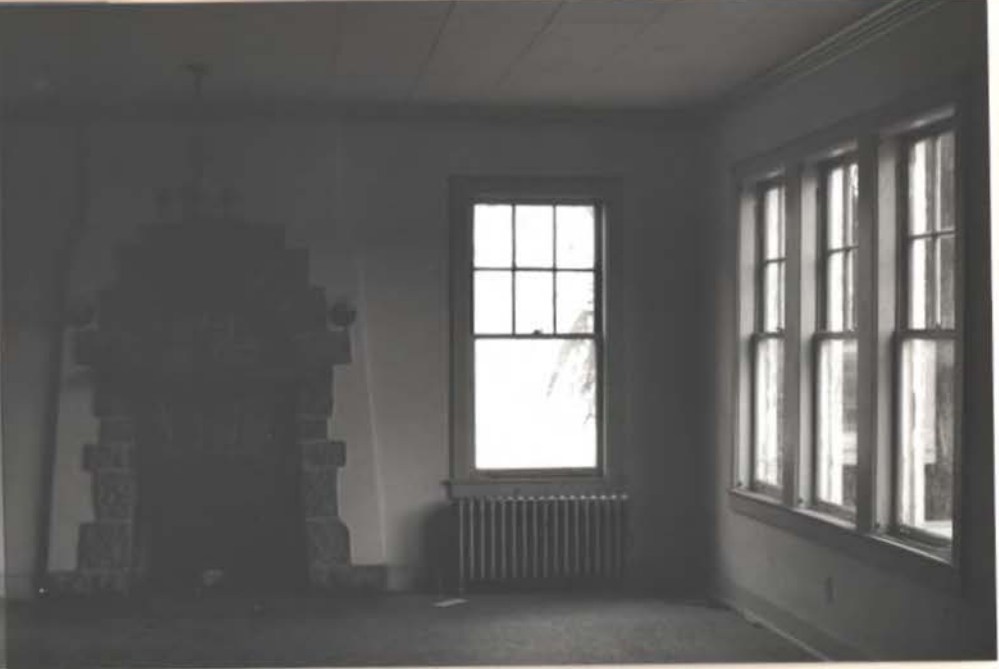
Lobby "bungalow" style fireplace, sandstone

P.S. - all Mission style elements (fireplace, stair, tile fl. etc. removed by owner in 1985-6 remodel. not by JH (interior) - by Mrs. Kappeler

Above off lobby (for hotel desk)

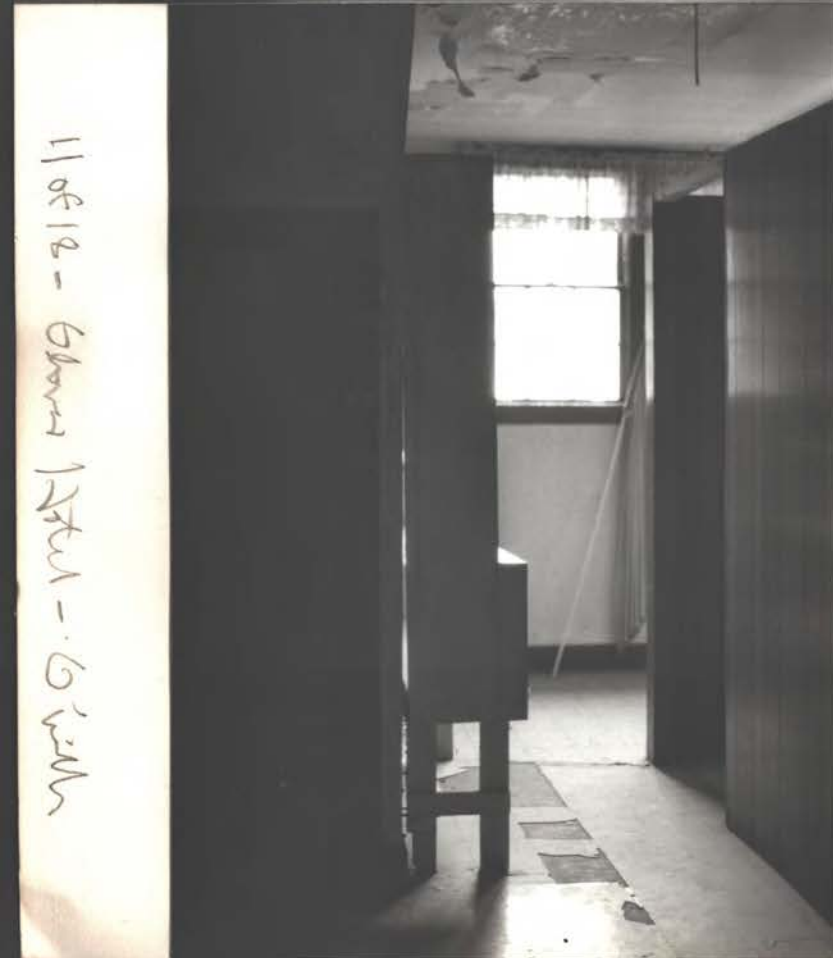
Kit., west of
restaurant

water damage
in Kit. near
"inside" corner
of S. wall
