1850's Bledsoe - Kelly Hse (1993 owner = Charles Kelly) Al. 21, 1.5 miles N. of Snylaccuga, Al

Re: Kelly 1840's House Restoration
"Mountain Springs", H.A.B.S. Al. 428
Sylacauga, Alabama
Project No. 93027

Field Notes H Jones
 Mar. 1993 "Kelly Hse"
 c. 1840-50's "Htn. Spring" Hse

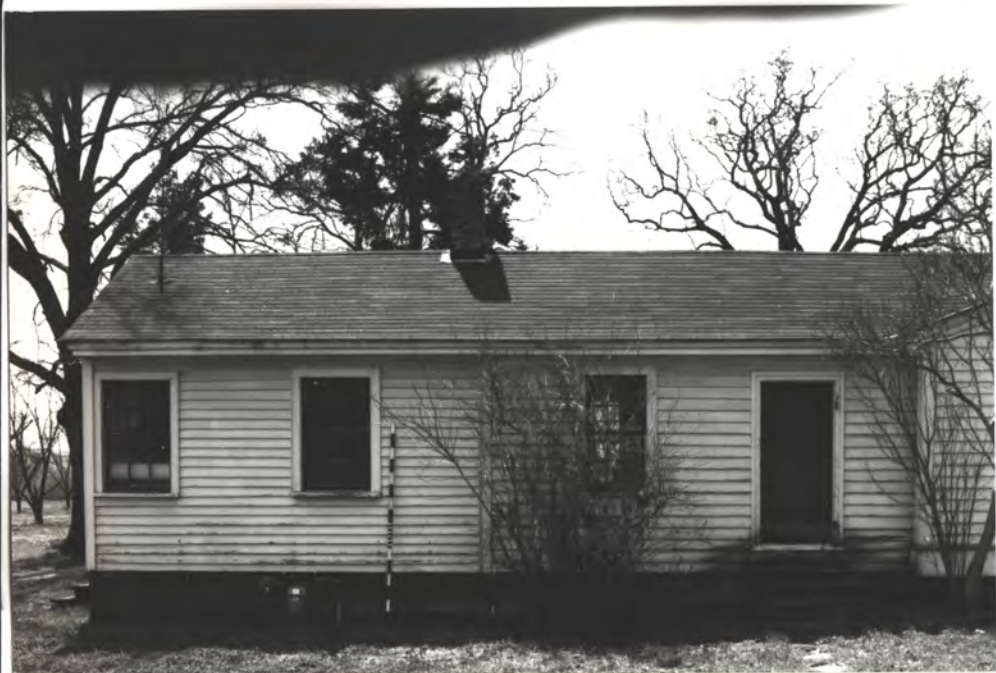
NORTH
WALL

note typical 19th c
mortar joint profile

note white
paint
"penciling" on
jts., typical of
19th c.

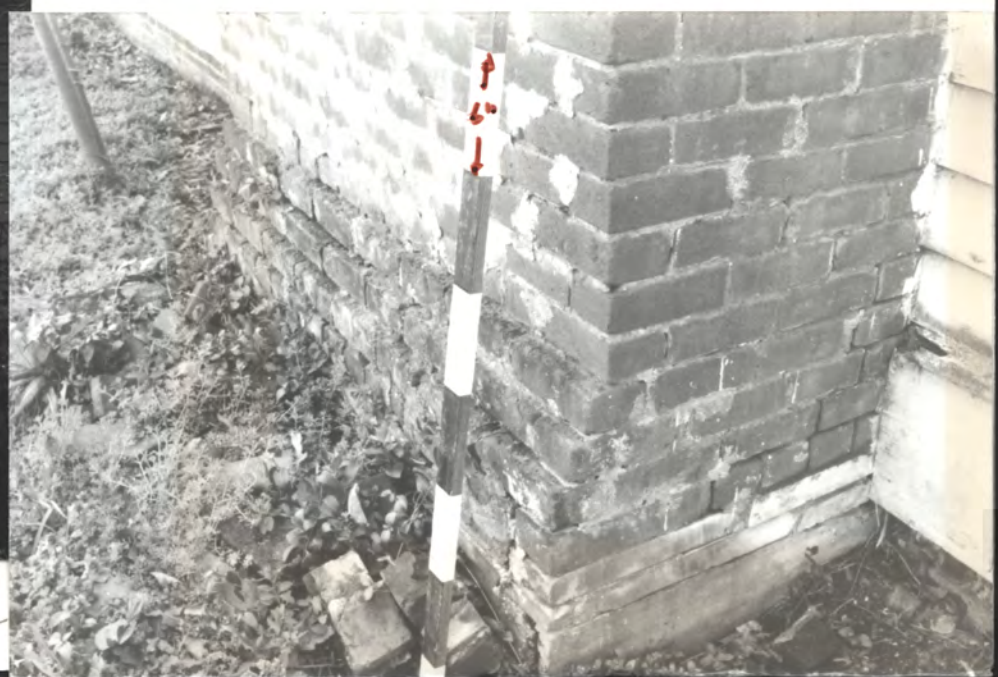
NORTH
CHIM.

bottom 10" =
white Syracuse
marble

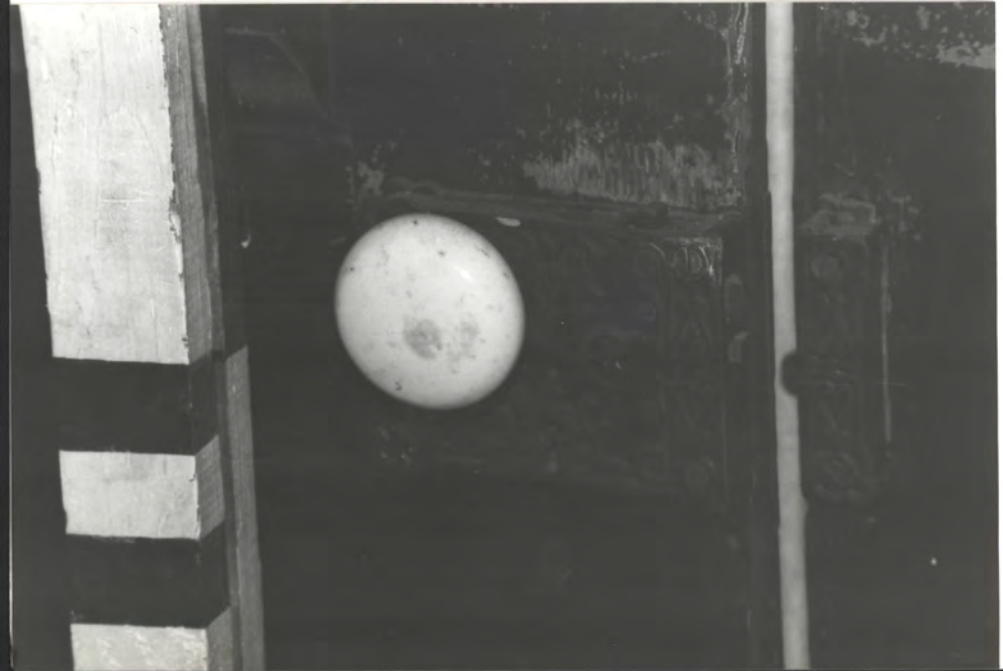
Handbolt at rear (east) entry
(See photo at rt.)

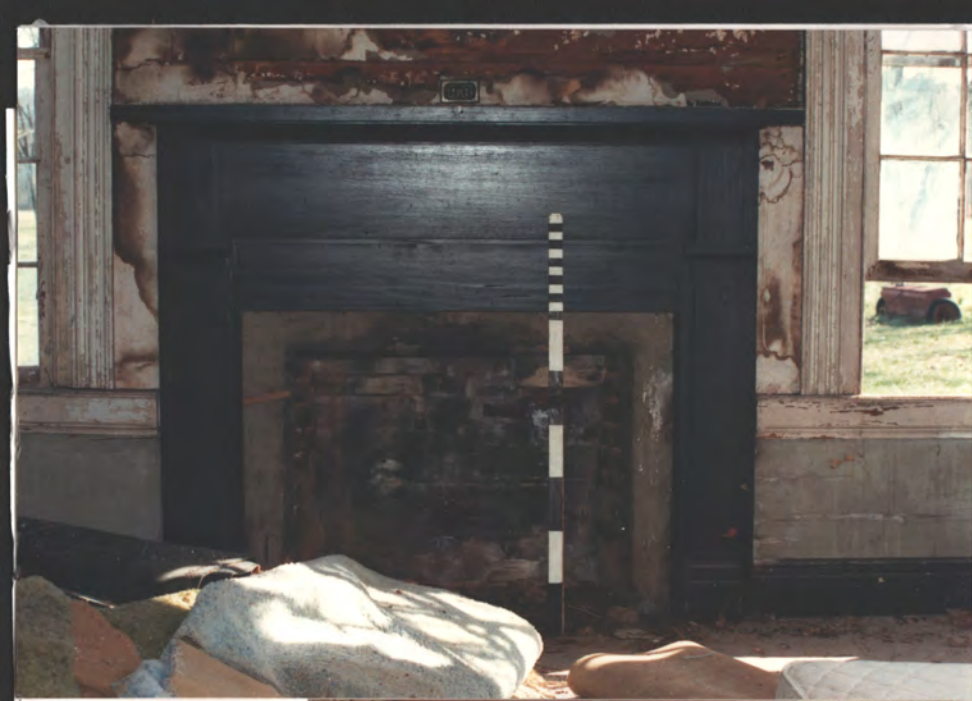
←
→
Vulpin.
Sash Sums
bds. on
walls
indicate
wallpaper
was originally
used over
the bds

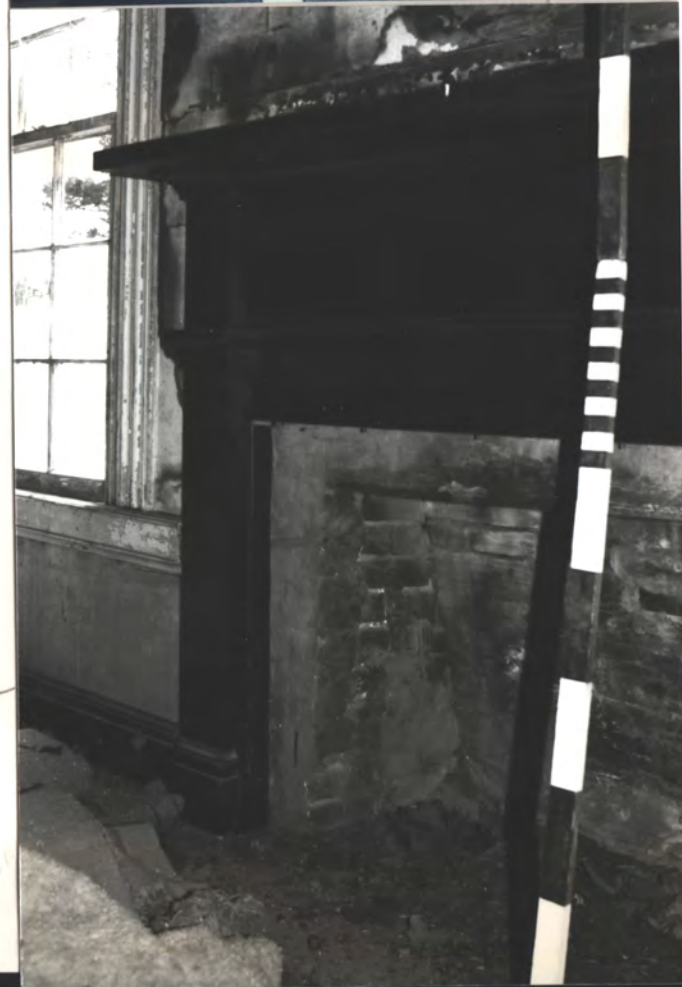
↓
Plaster surround =
stl. 1800-1860

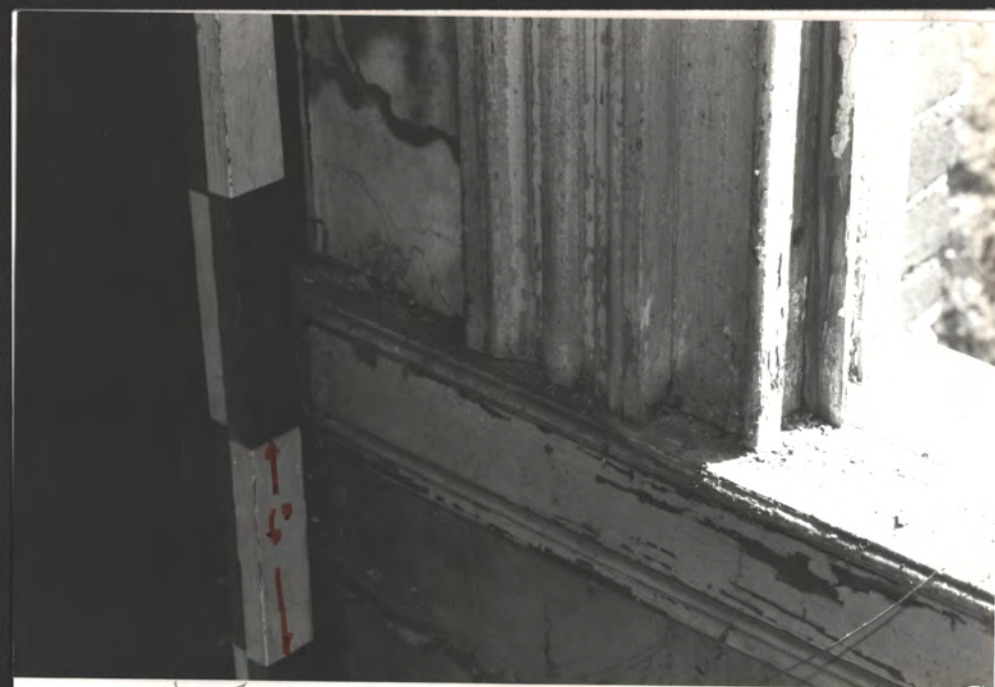
S.W. RM, S. WALL

walls = wallpaper over
w/fin. Sash & inner planks
(orig. cord)

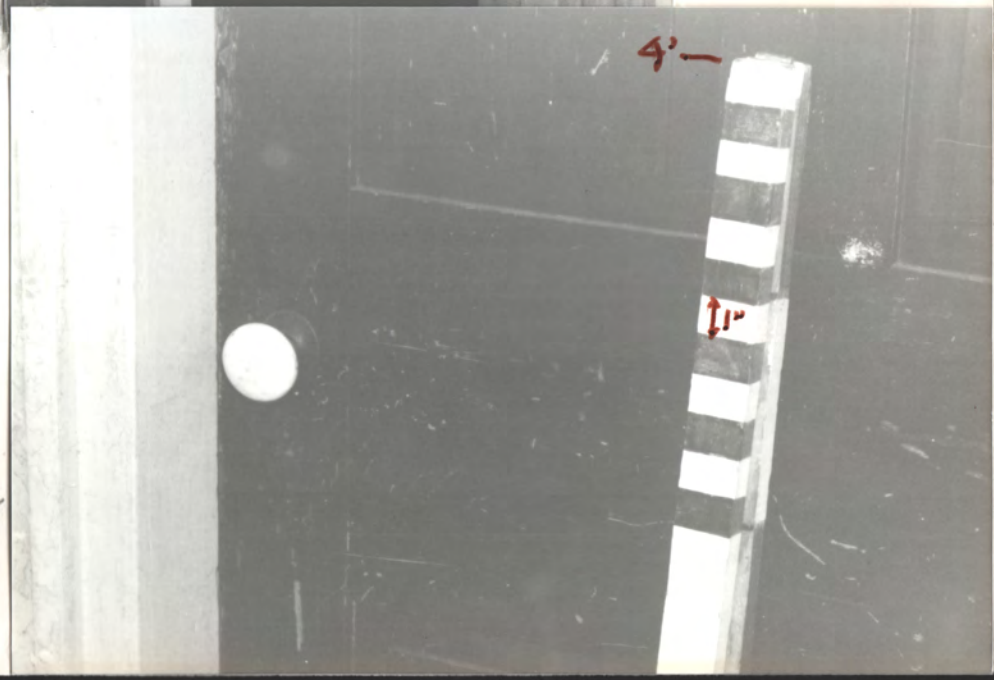
prob. the
original
grain
on N. side
of S. door
at NW corner

← orig.
CT
hinge

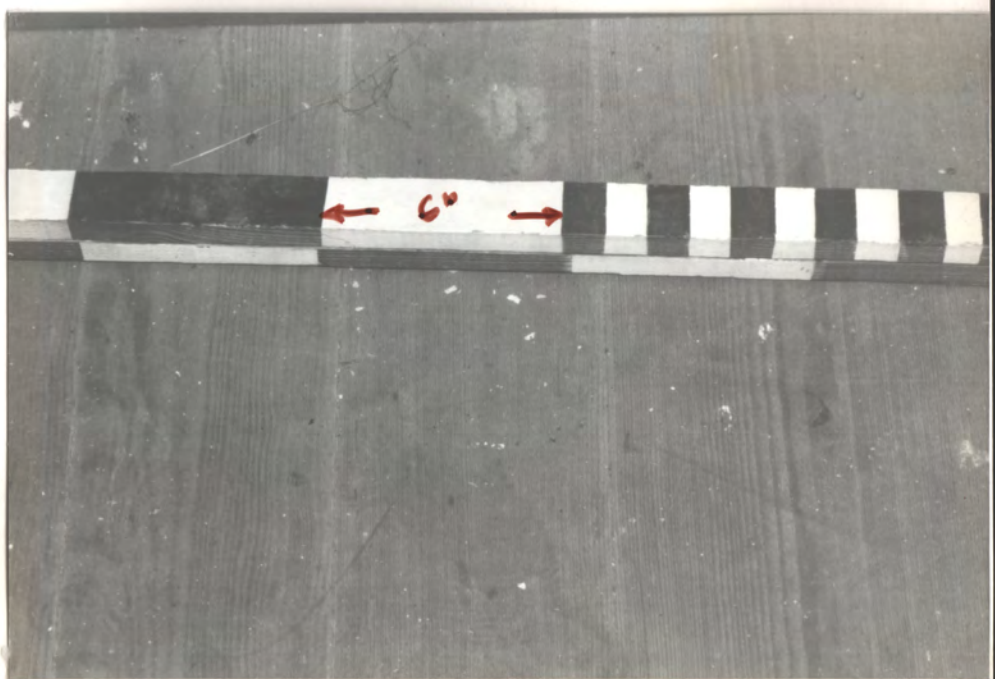
Medium Blue
= ORIG. color
←

Orig. paint colors of NW Rm trim (W. Sash W. Sash frame)
