JONES & HERRIN

August 4, 1997

Re: 1829 Gorgas House Museum, The University of Alabama

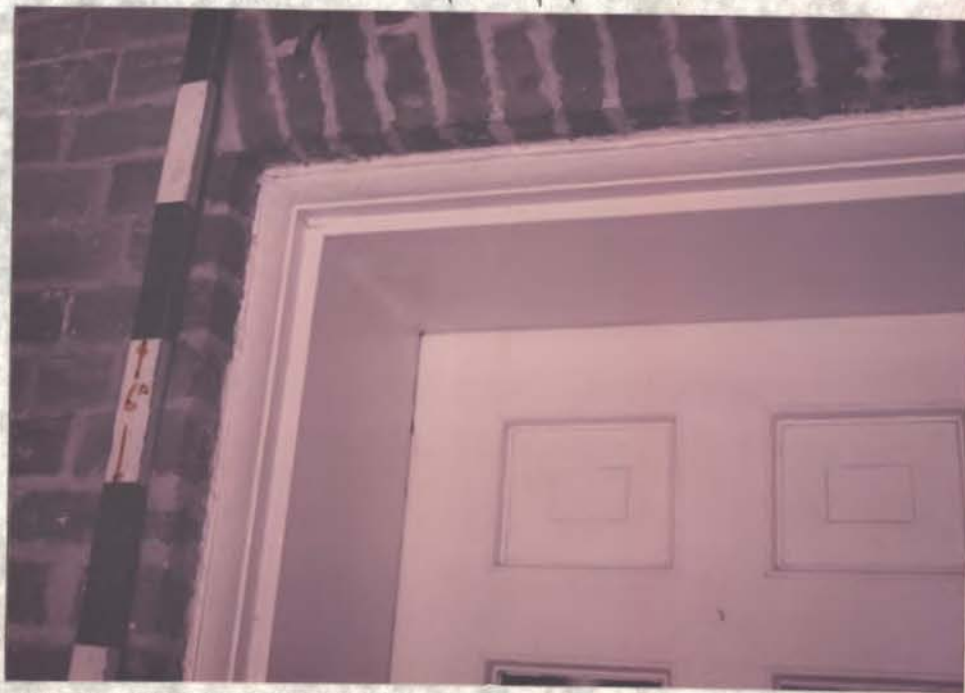
HEAVY REPOINTED BRICK
(Sandblasted, portland cem., wide sloppy jts)

Repointing in areas has been done, using hard modern Portland cement mortar, sloppily applied. At best this may be only partially reversed. Hard modern mortar subjects the soft 1829 bricks to temperature-stress cracking and spalling, and water entrapment and consequent freeze-thaw spalling. Hydrated-lime and sand mortar should be used, tooled like the unweathered neat 1829 joints.

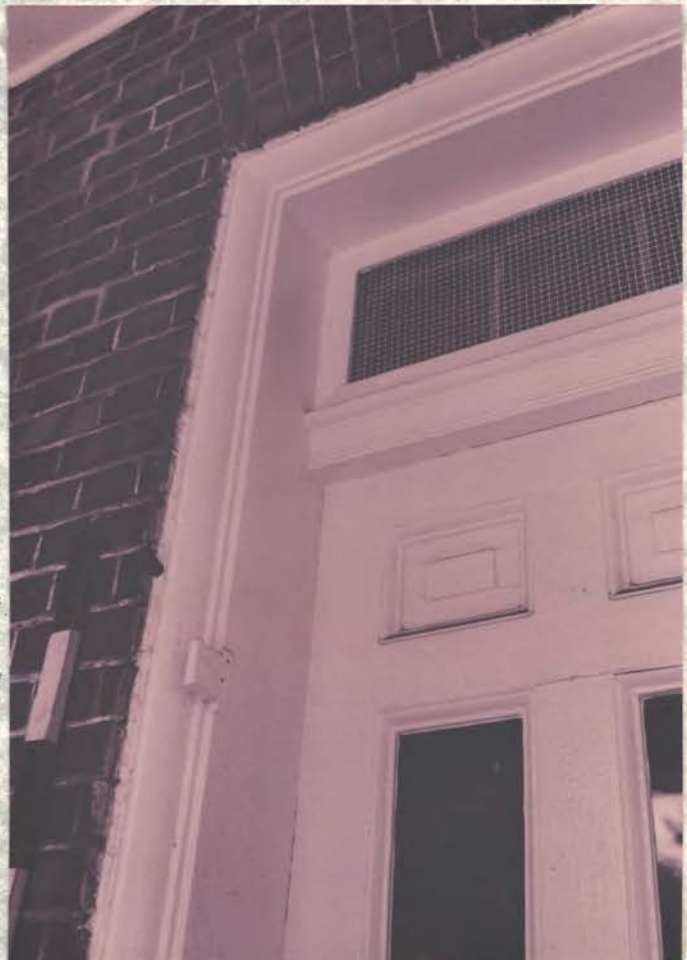
UPPER ENTRY AT PORTICO

MOD.
HEAVY
GALV.
MESH
OVER
TRUSSOM
LEAD
PROTECT?

GLASS
PANELS
= LATER.
ORIGINALLY
WOOD
PANELS,
NO GL.
EXCEPT
BY
TRUSSOM

MOD. BIRD
PROTECTION SLOPED CAP

8. Bird control at portico column caps and upper entry transom:
Can be done less obtrusively.
9. 1953 brick pavers at lower entry and at one re-laid hearth:
Grid pattern is incorrect. Should be half-bond as evidenced by several intact 1829 hearths inside, and other nineteenth century Alabama examples.

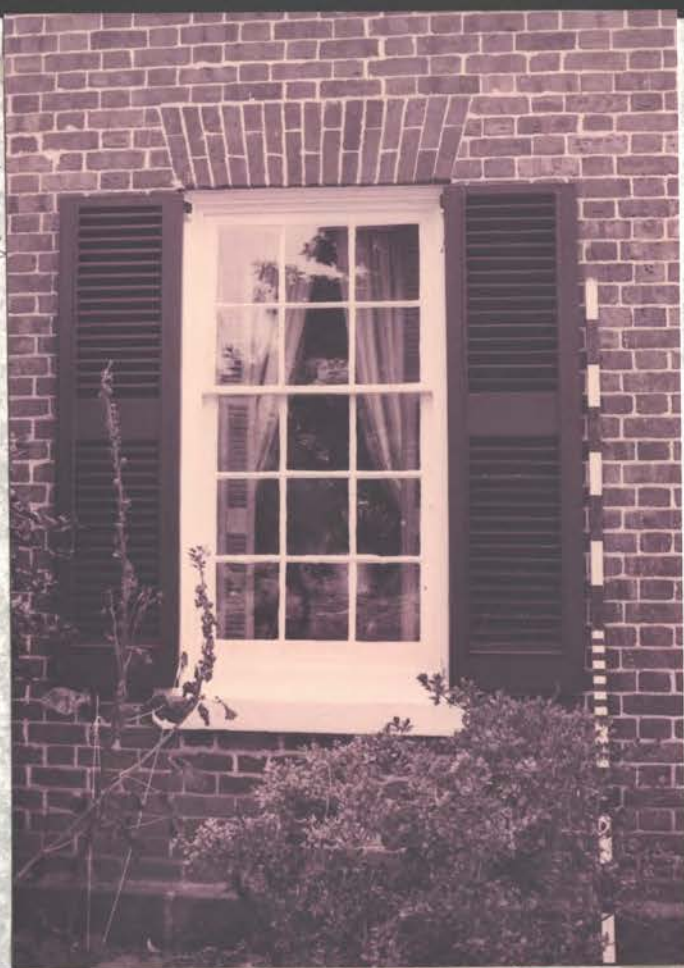
ORIG. JS5,
 BADLY SANDBLASTED,
 SLOPPILY REPOINTED,
 HARD PORTLAND CEM.
 (c. 1996 work
 per Blkg. Supt.)

ORIG. JS5. (LINE SAND MORTAR)
 NEAT & SMALL (3/8")

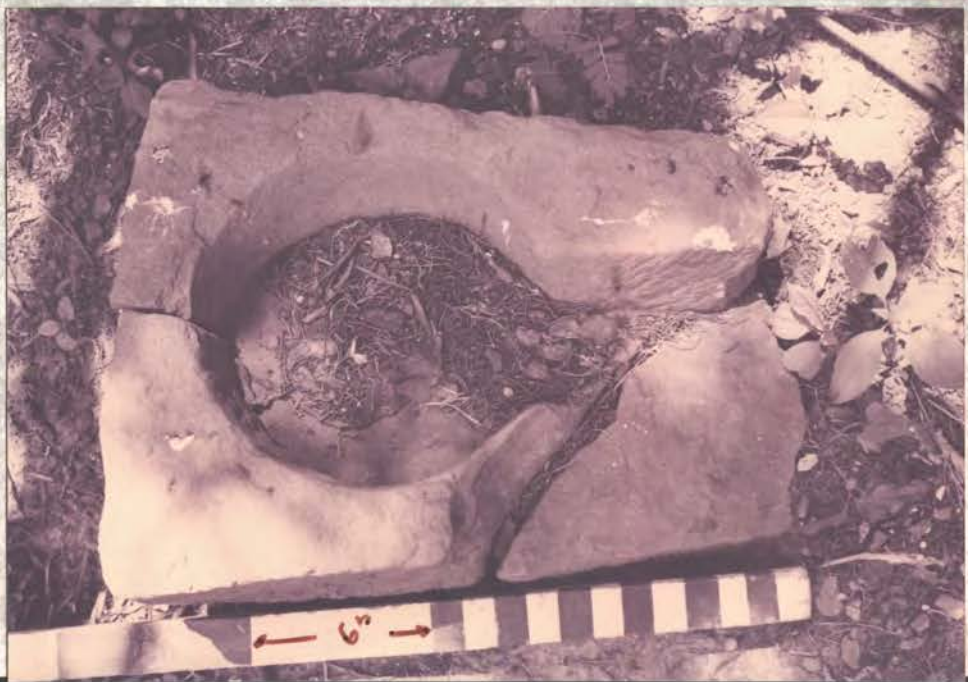
Discarded 2/3 of orig. Sandstone
splash block, now in N.W. yard corner

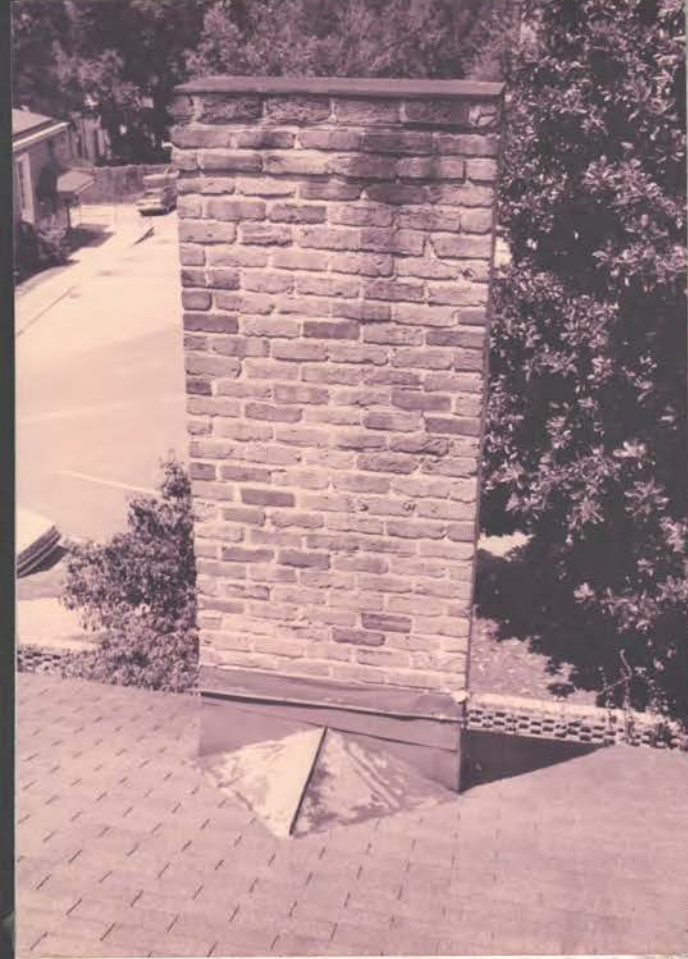
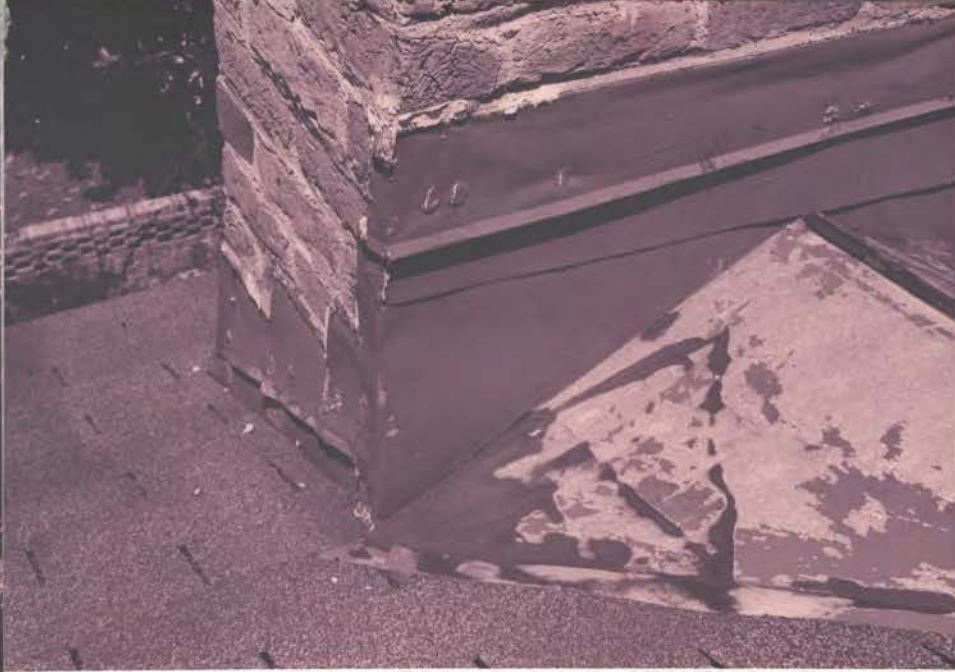
N.W. CHIM. (rebuilt w/ salvaged salmon bricks
thru a portland cem. mortar)

N ← N.W. CHIM.
rusty metal cap

N ← rusty galv. flash
ALL CHIMNEYS LEAK
DOWN INTO ATT.

4. Catering Kitchen:
Improvements as needed. Consult with caterers. Meet Health Department specifications.
5. Roof and flashing: (1982):
Chimney leaks, better choice of shingles and flashings. Two north chimneys are rebuilt in porous "salmon" bricks and Portland cement mortar. 1982 shingles are near the end of their life. Galvanized flashings are rusty.

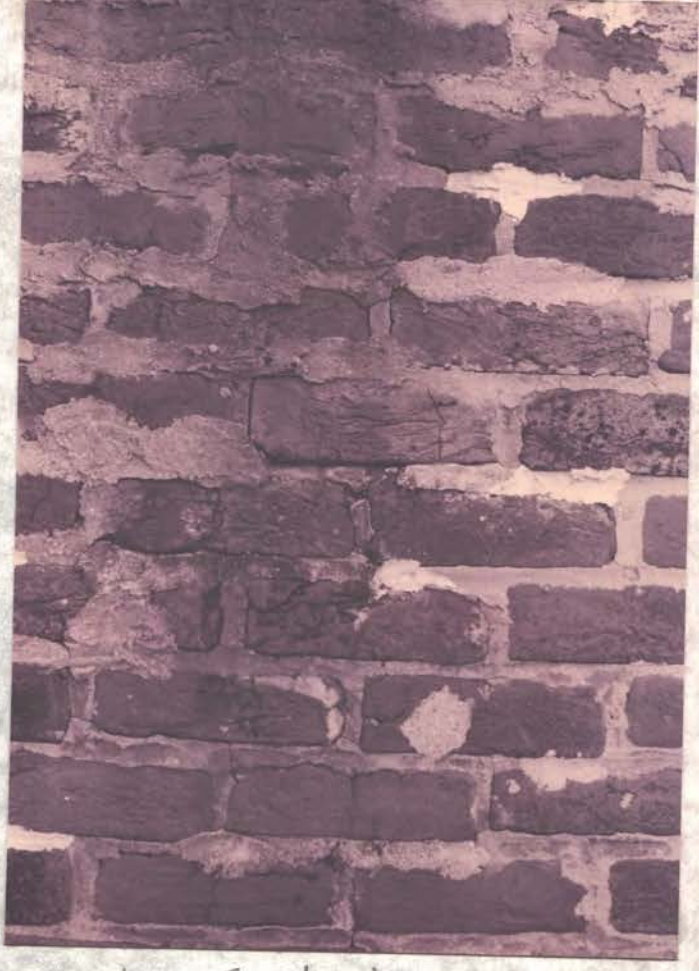
S.W. CHIM.

portland com mortar, cracks

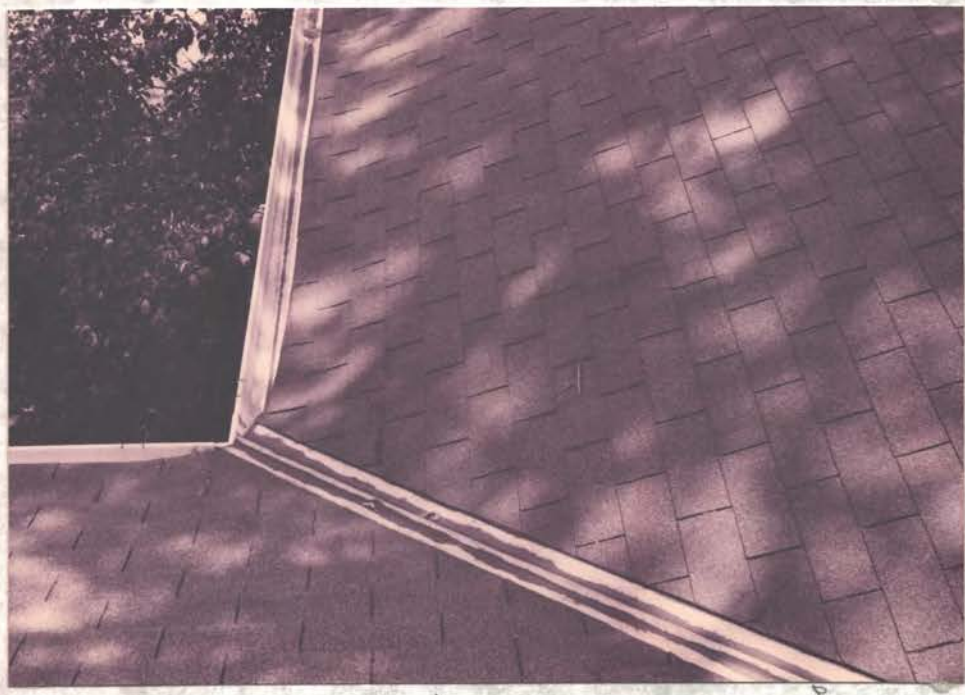
c. 1984 std. wt. (14 g. r. ±) compos. shingles
rusty galv. met.

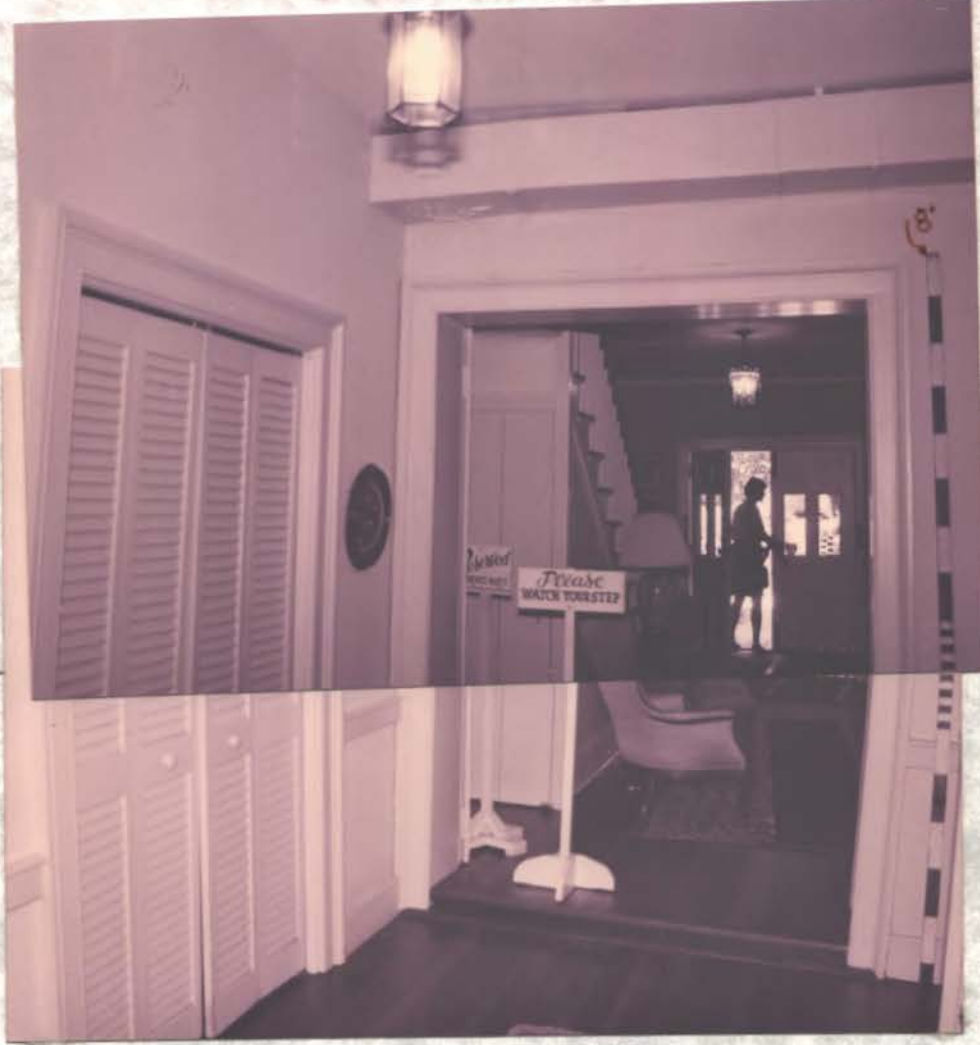
c.1970's duct

c.1970's closet for HVAC unit

1. Mechanical system (c.1961, exposed pipes and ducts):
Better hiding, adequately sized. Eliminate exposed ducts and radiator pipes.
2. Plumbing: (c. 1964):
Get rest room out of ground floor southwest bedroom, perhaps put in northwest service area. Address handicapped-access question.

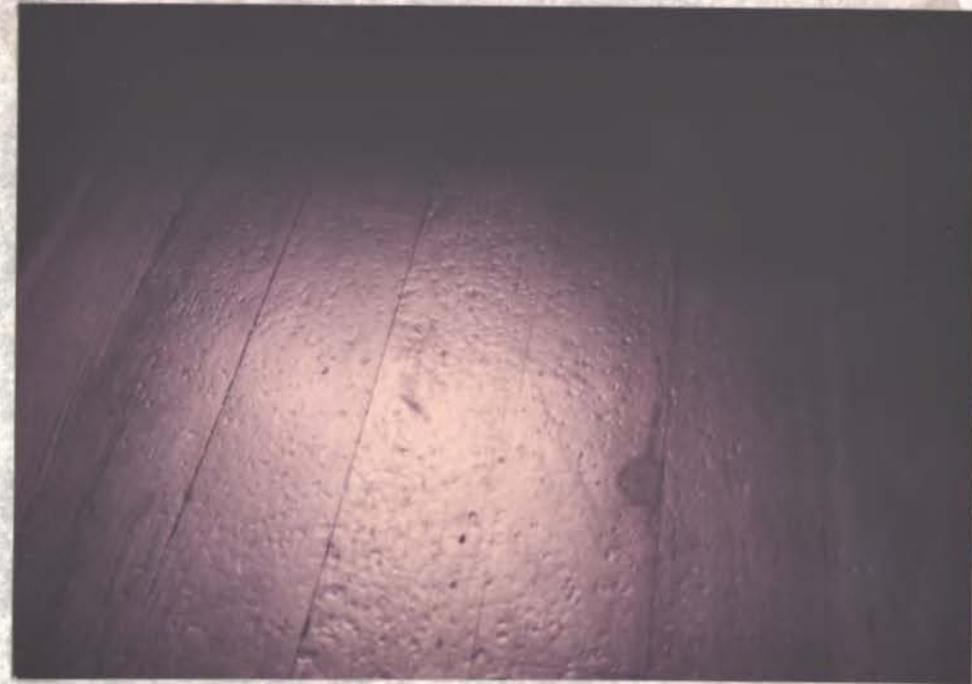
FL. & N.E. DIN. RM.

spike-heel dents (fl. was sanded in 1980's per the mus. mgr.) PN

marked with heel dents. Stiletto heels seem to come into fashion about every twenty years, so they are sure to recur. Consider allowing only heels of a reasonable diameter, perhaps 3/4".

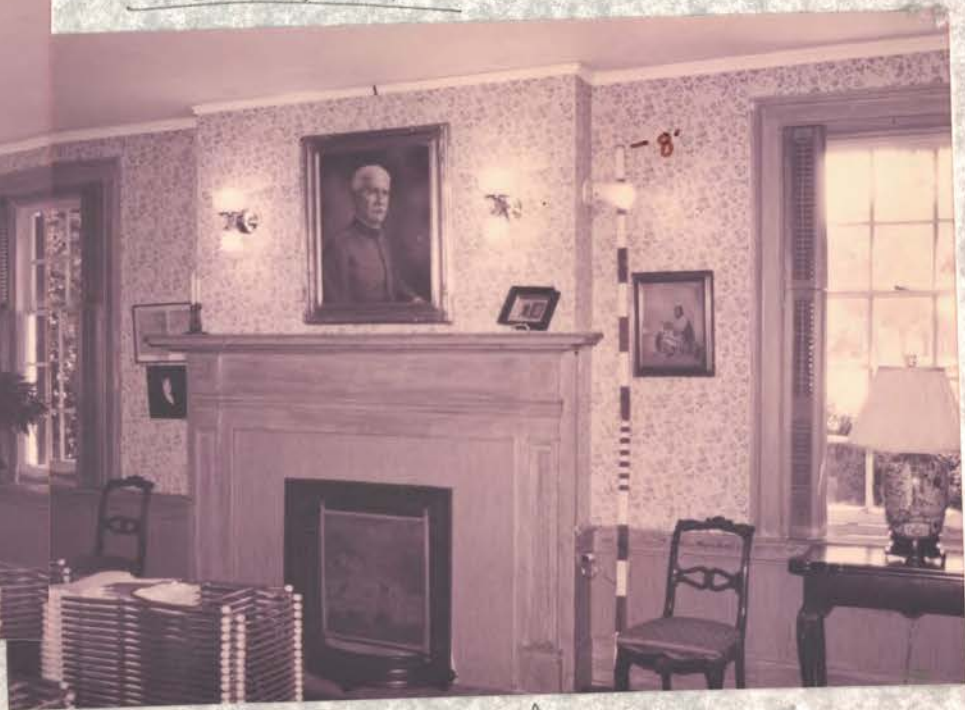
FL. 1
SE. RM.

c. 1970's "pickled" fin. on wd.

1970's
Ando fin.

1970's
hearth

This mantel has a circa 1953 stripped-and-pickled finish, popular in the mid twentieth century but not in the nineteenth century. Prior to the Civil War, mantels were painted, typically glossy black and sometimes marbled black.. Doors were usually grained, and sometimes trim was grained as well. Evidences of these early nineteenth century finishes were observed at several paint-nicks in the Gorgas House. Depending on the chosen period of restoration, modern finishes should be removed.
