**ARCHITECTURAL COLLECTION
OF
HARVIE P. JONES, F.A.I.A.**

**1859 Miller
Tuscaloosa,
Neville Res.**

1857 Miller Hse ("ALACK PLACE")

photos of renovation progress, Oct 1996 H P Jones FRK Huntsville
Restor. Consultant

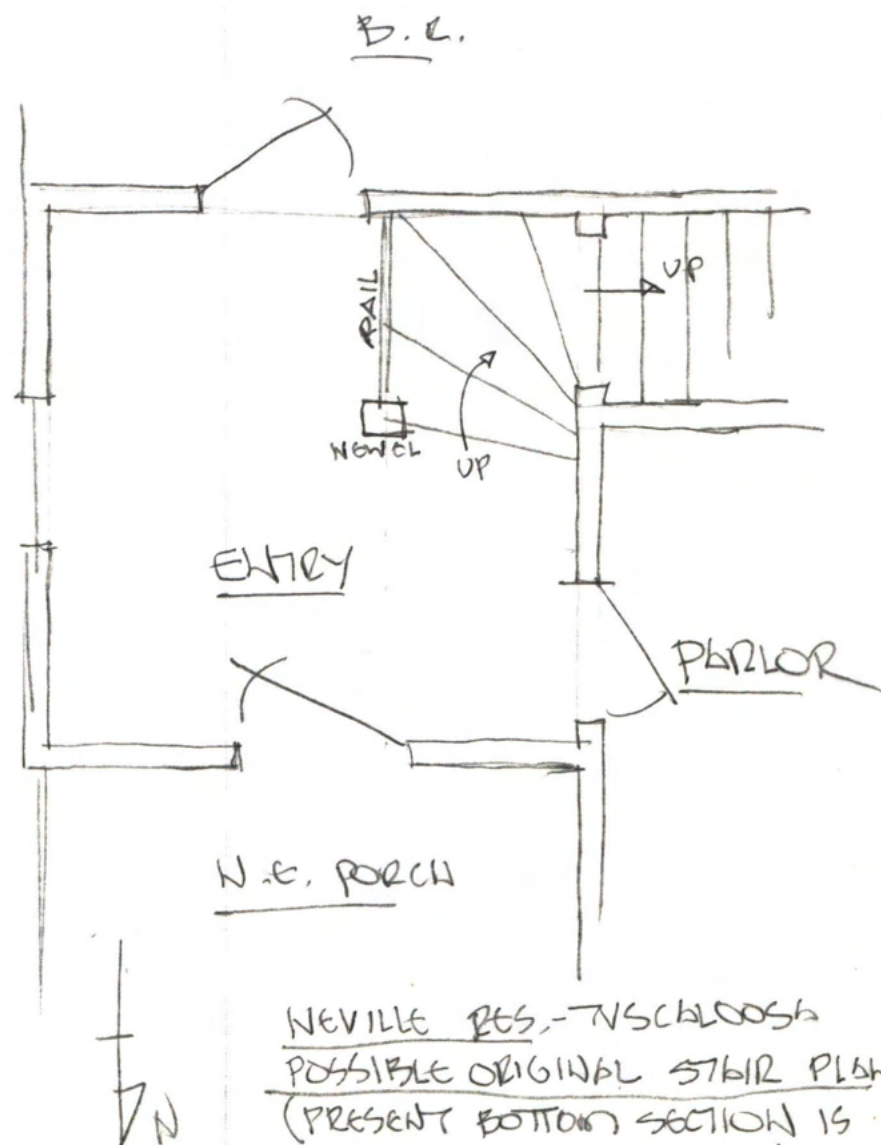
NEVILLE RES. - TNSCHLOOSH
 POSSIBLE ORIGINAL STAIR PLAN
 (PRESENT BOTTOM SECTION IS
 LATER CRUDE MAKE-SHIFT)

Since we know the bottom section of the stair is a crude c.1920's revision, look for clues on the floor, baseboard and walls of the possible original configuration. Look for a floor-peg that would have been the original newel anchor, and plaster patches and base-patches. I will sketch on the

plan some ways I think it might have been. If you want to restore this we will need to find an appropriate heavy 1857-style newel. We can make the balusters and rail if need be.

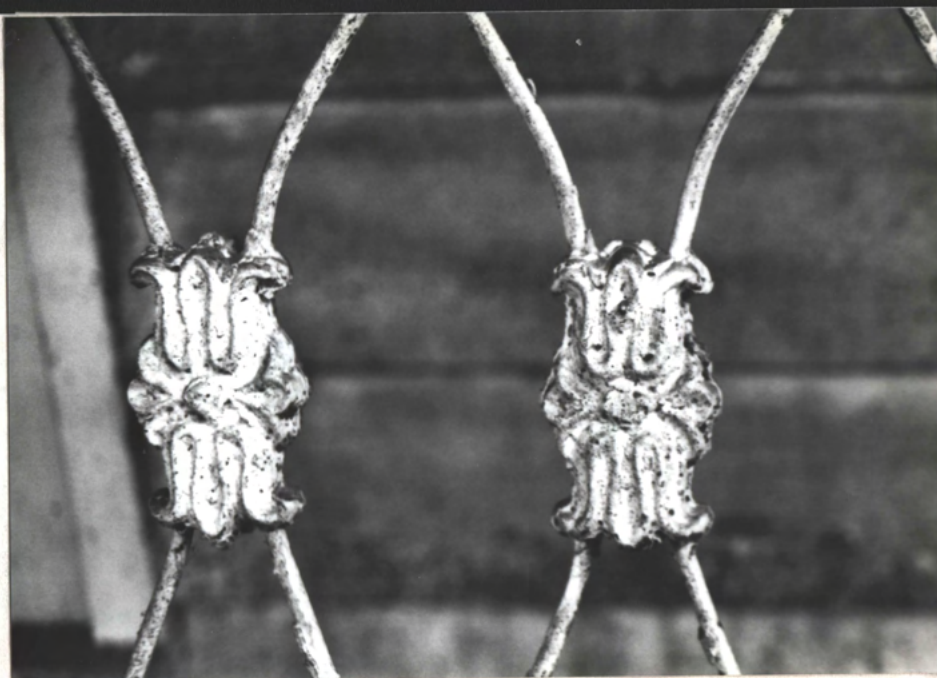
N.E.
Porch

loose
rail
from
this porch
not safe

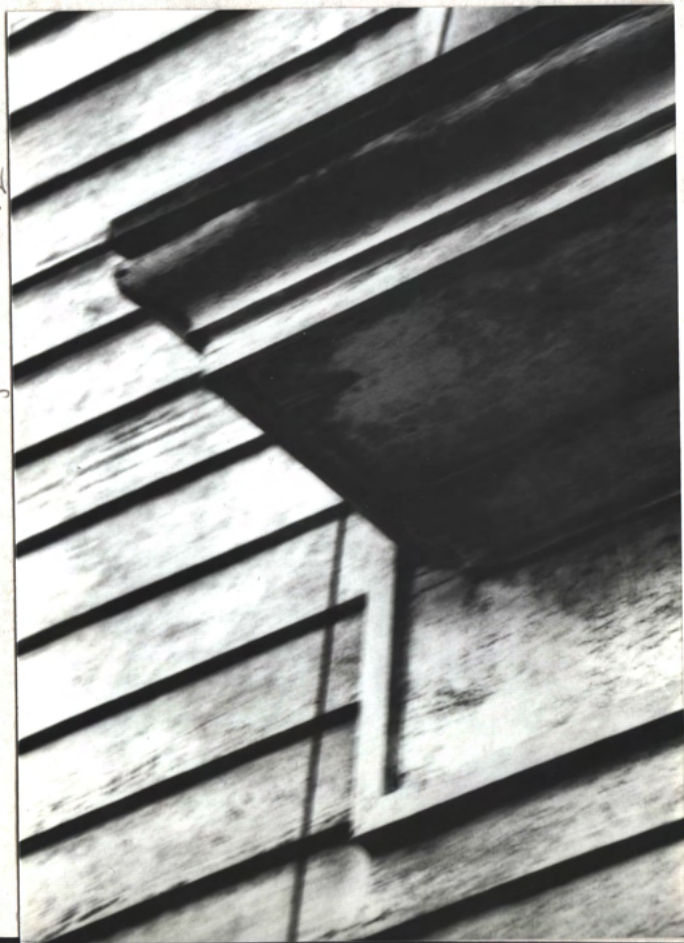
Cornice at
 S.E. corner
 of N.E. porch

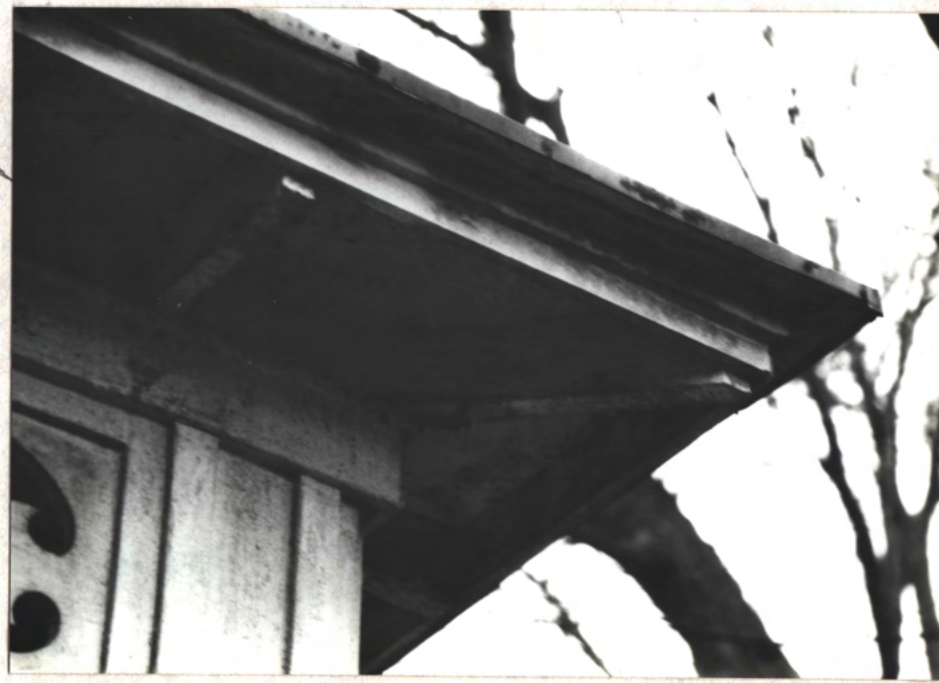
Cornice at N.E. corner of N.E. porch

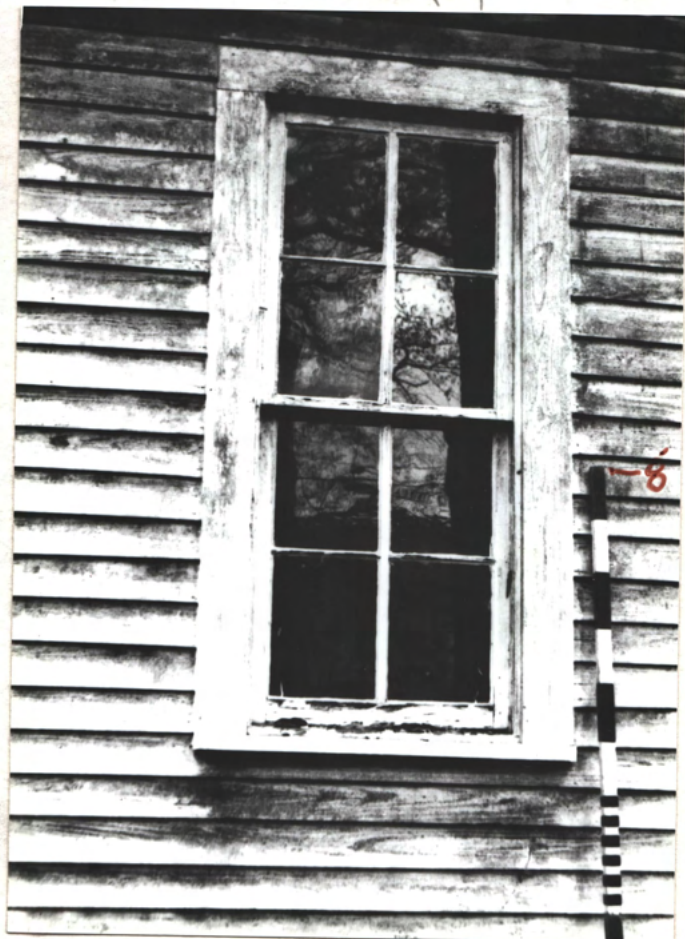
At E. wall of later S.E. Shed Rm
sup. 9 photo

core block mfm brick pier

→ Was a porch, later enclosed
Note porch floor edge

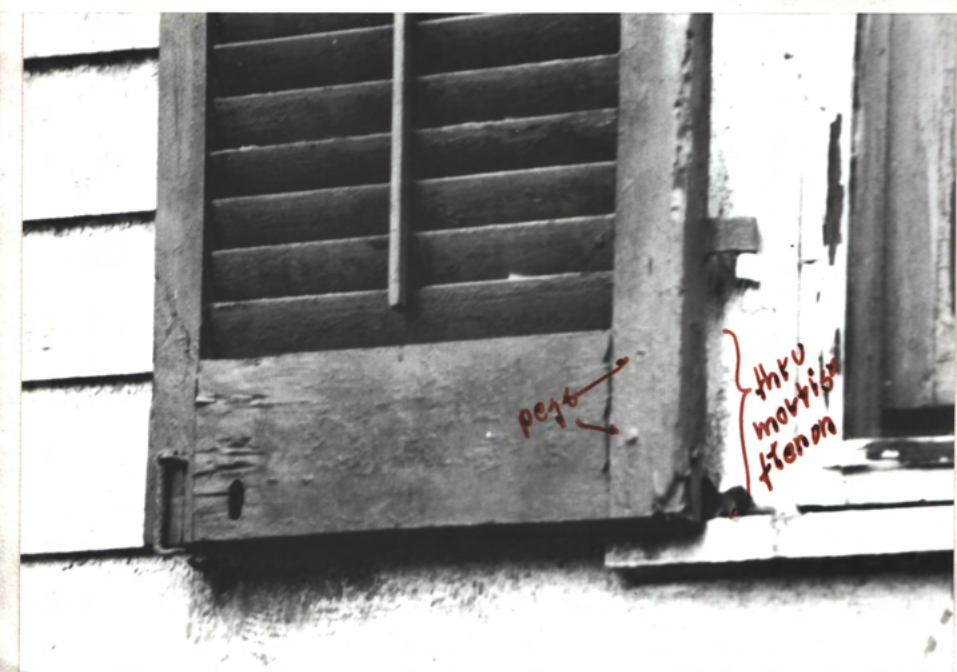
Blind-hook
 (at west wall)
 Typical blind
 (this at East stair hall rm.
 - see p. 11)

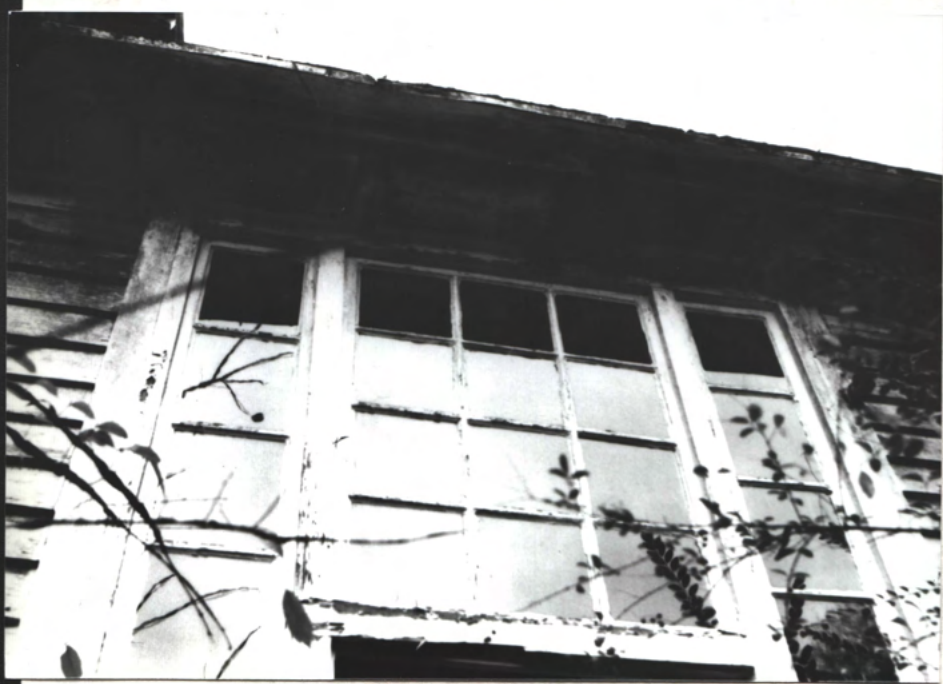
Later enclosure of
original side porch

porch fl.
edge
(fl. slopes
inside)

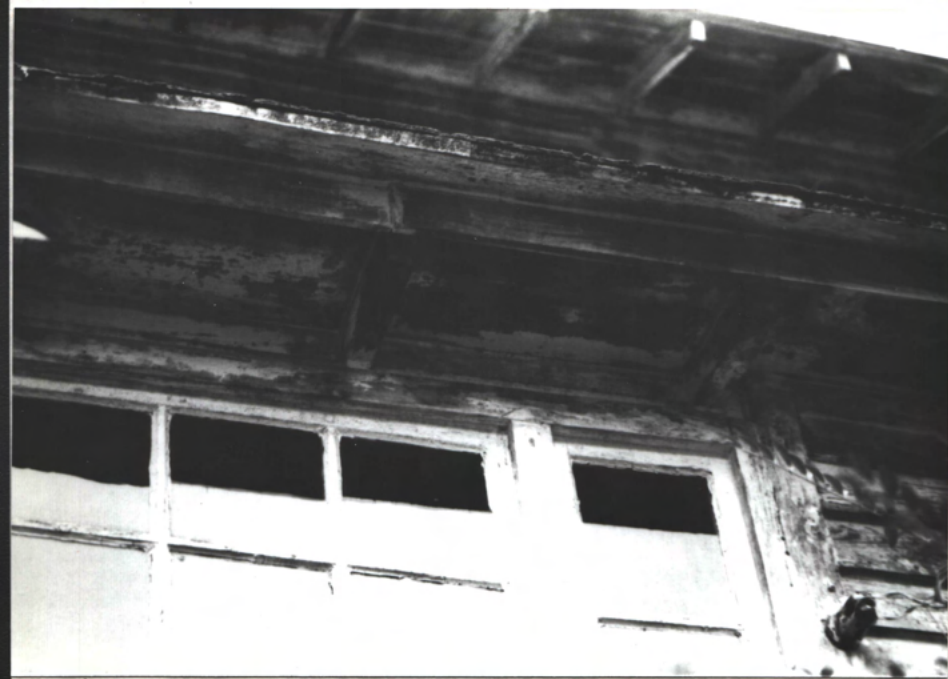
Upper part of open. it now-enclosed
south-west "porch"

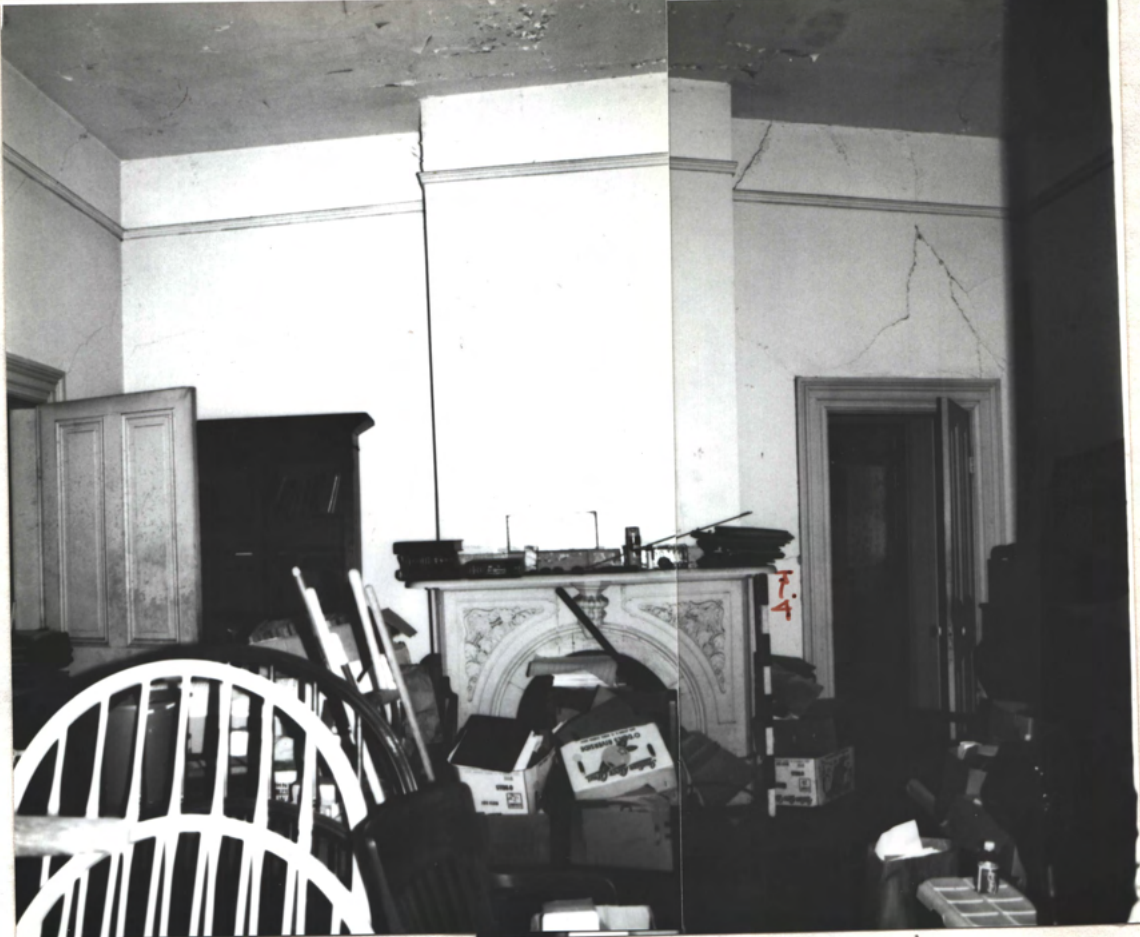
FIG. 1 - N. East. Parlor

WOOD!
(not
marble)
mantel
carved in
imitation
of Italian
marble

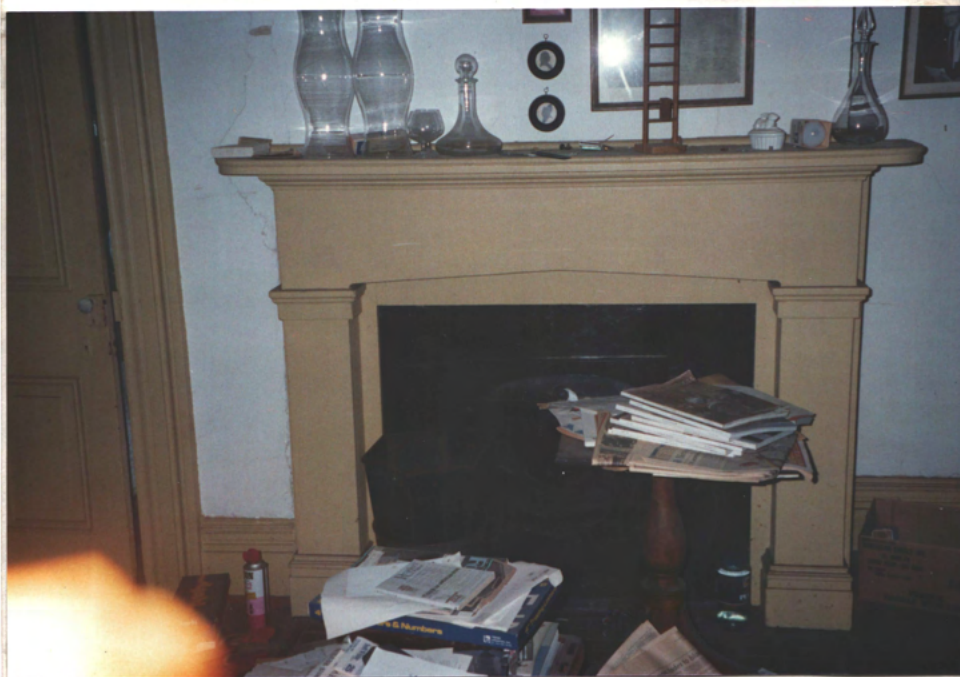
Fl. 1 W. Cent. Room
 (S. of Parlor)
 Mantel was black
