c. 1890's (per arch. evidence)
CUMBERLAND PRESBY. CHURCH
MANCHESTER, TN

to be city Arts Center
photos Aug, 1992 HP Jones, FA/B

1890's
MANCHESTER
C.P. CHURCH

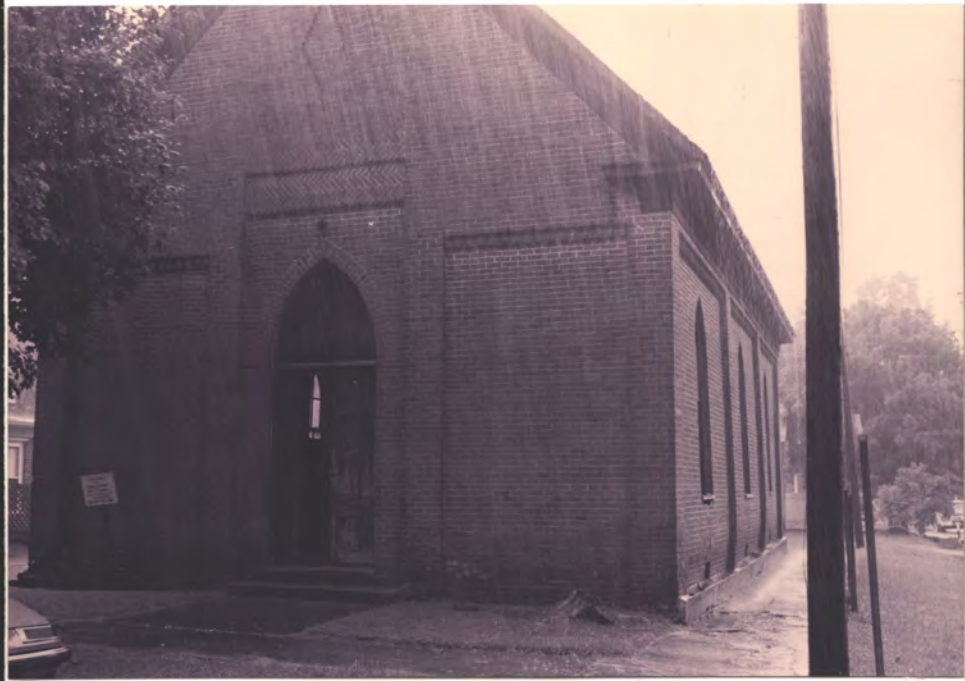
Walls bowed out 2"-3" at ± 3' above grade due to footing rotation due to wet, softer, weak soil at ext. of wall
Note gap at jamb

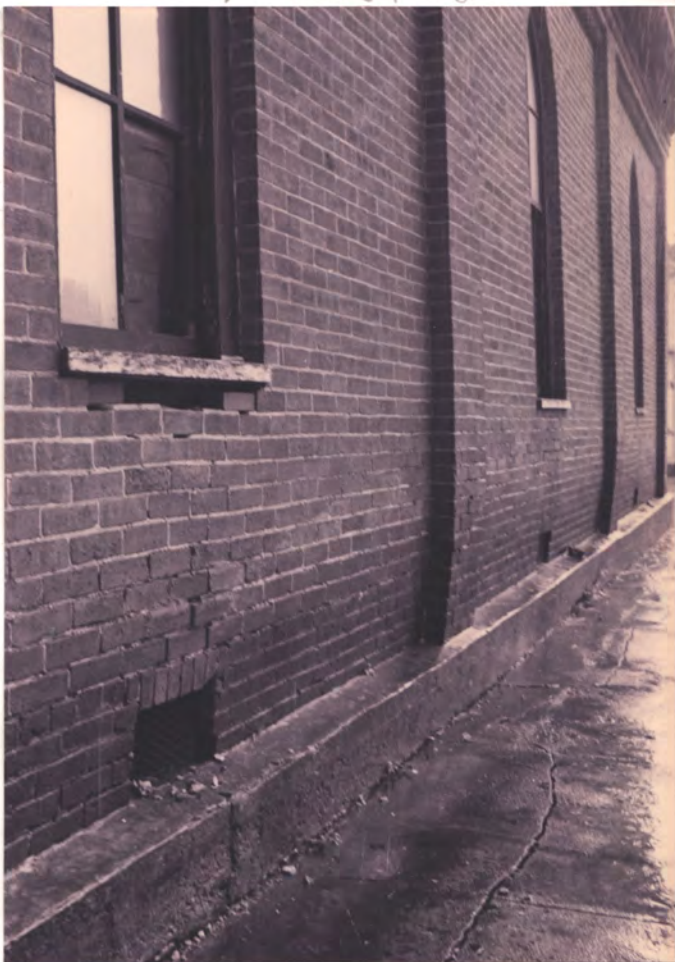
Walk cracked due to rotation of wall HIGH ST. SIDE

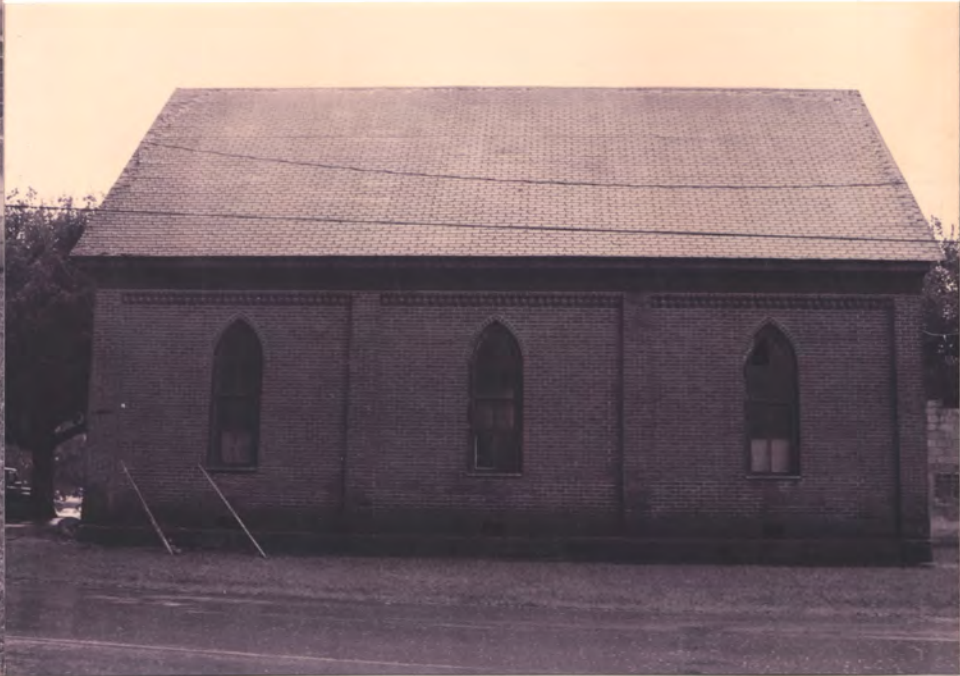
HIGH ST. SIDE

↓
 bowed out + vert. crack
 at center

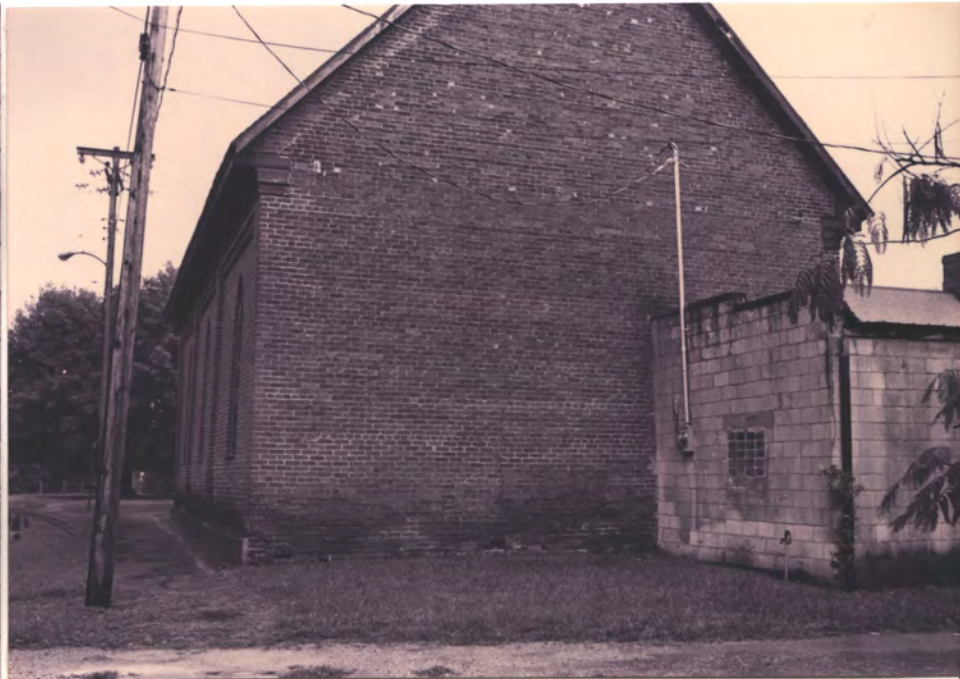
↑
 vert. crack
 (see rt.)

↓ bowed out 2"-3" at ±3'h.

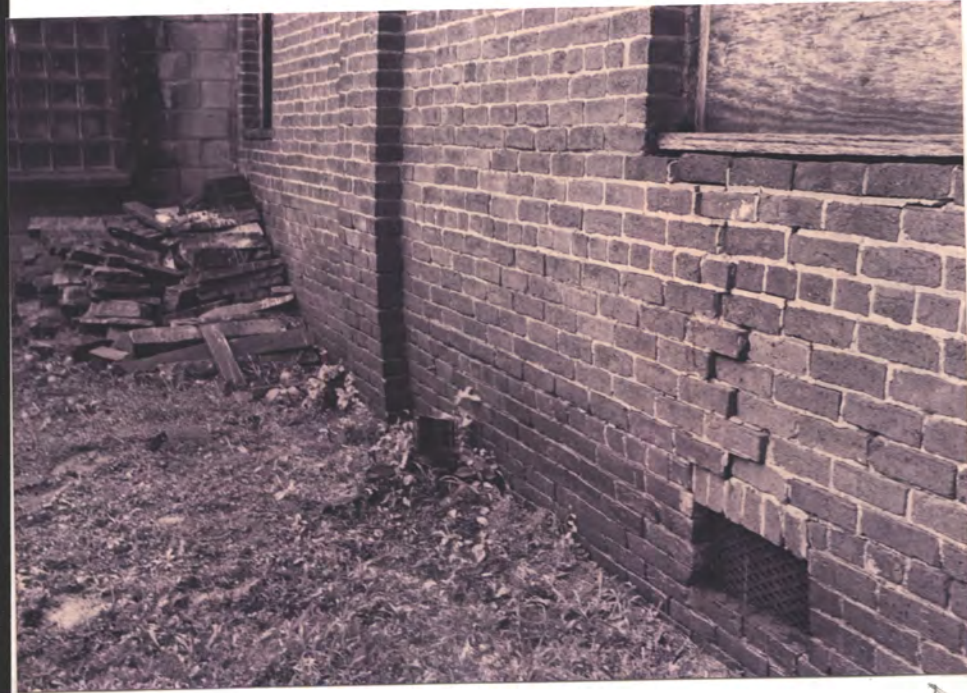
LEFT SIDE
(opp. High St.)

↓ bowed out ±2"-3", ±3'H,

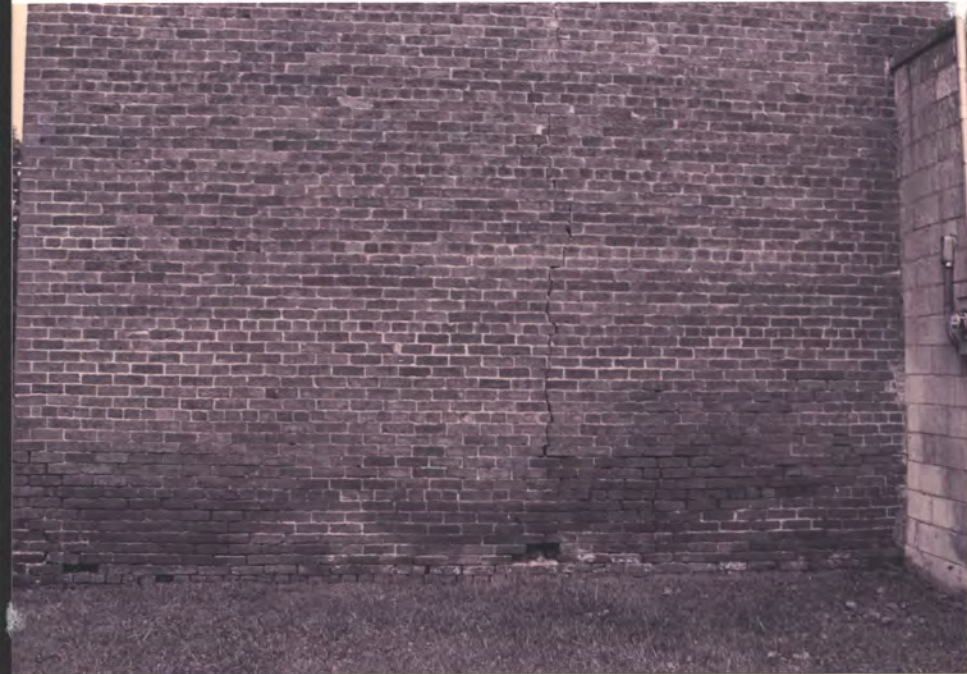
Back

↑
vert. crack due to
bowing - out of wall

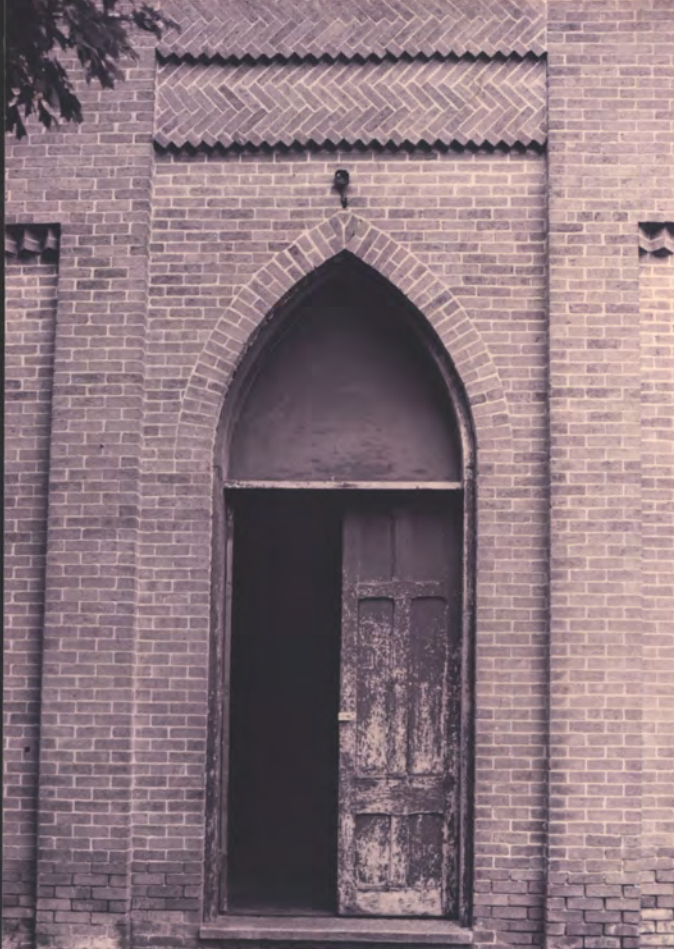
bowed out perhaps 1st-2nd over door

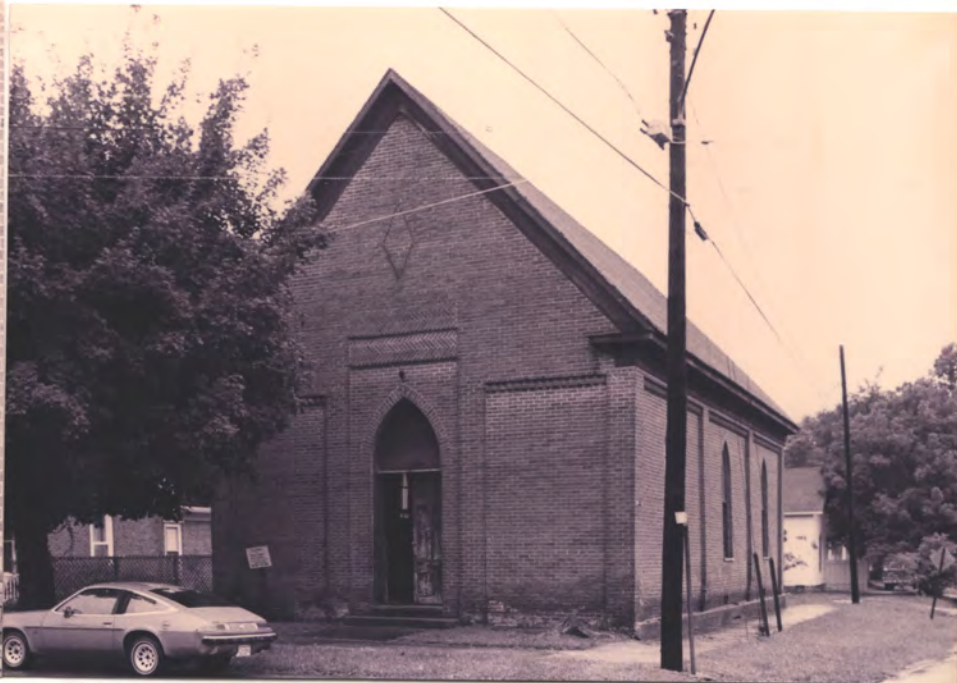
deteriorated, mortar / FRONT (Church St.) High St. due to rising damp = typical of most hist. Wlp = easy to repair

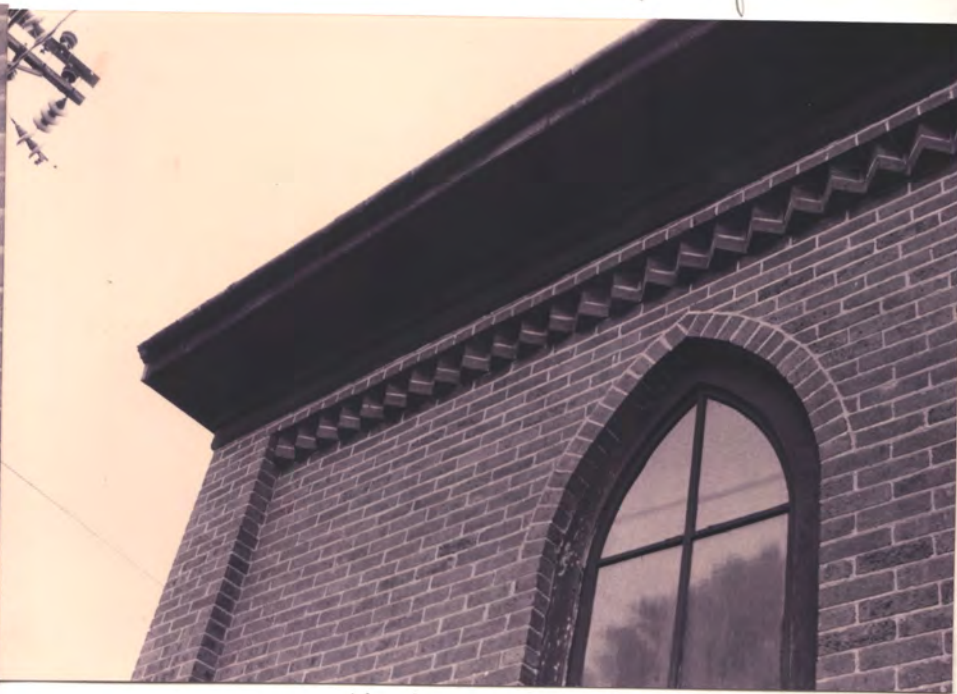
High St. wall top bowed out 2nd-3rd

bowed out 1"-2" ±
above entry arch

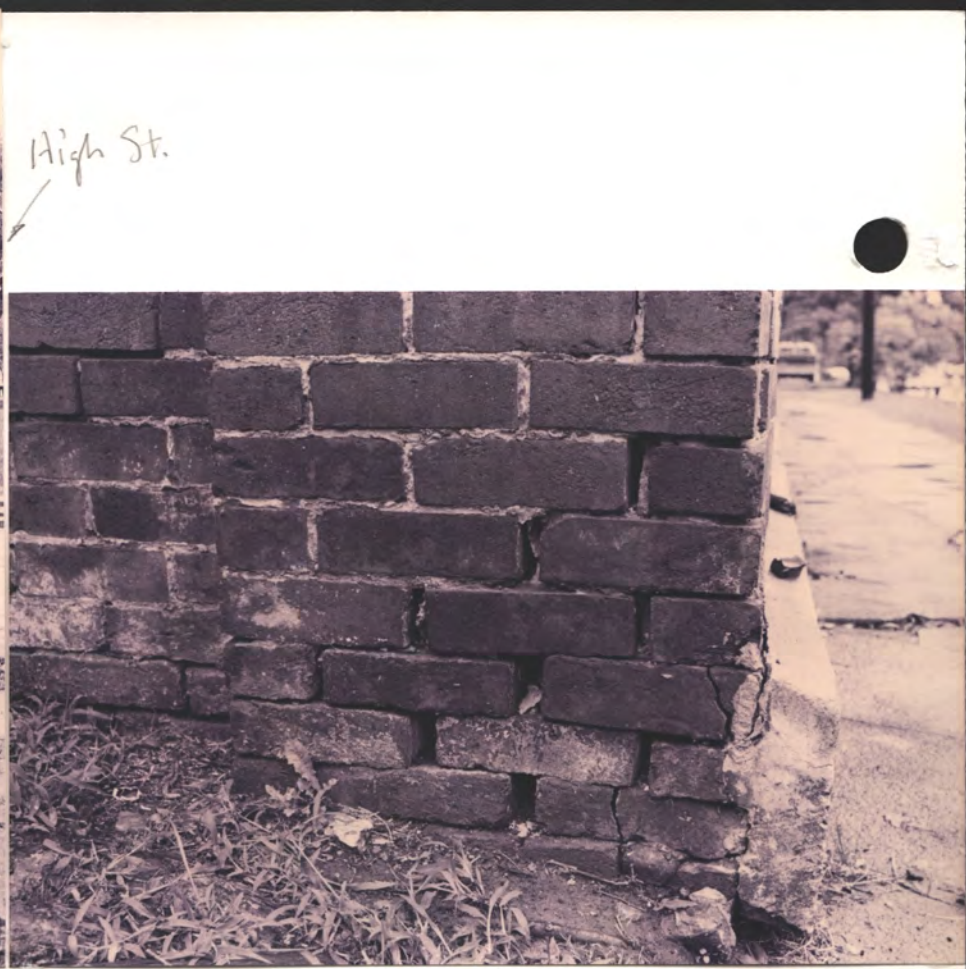
Rt. Corner at St. intersection
(combined rising damp + footing rotation)

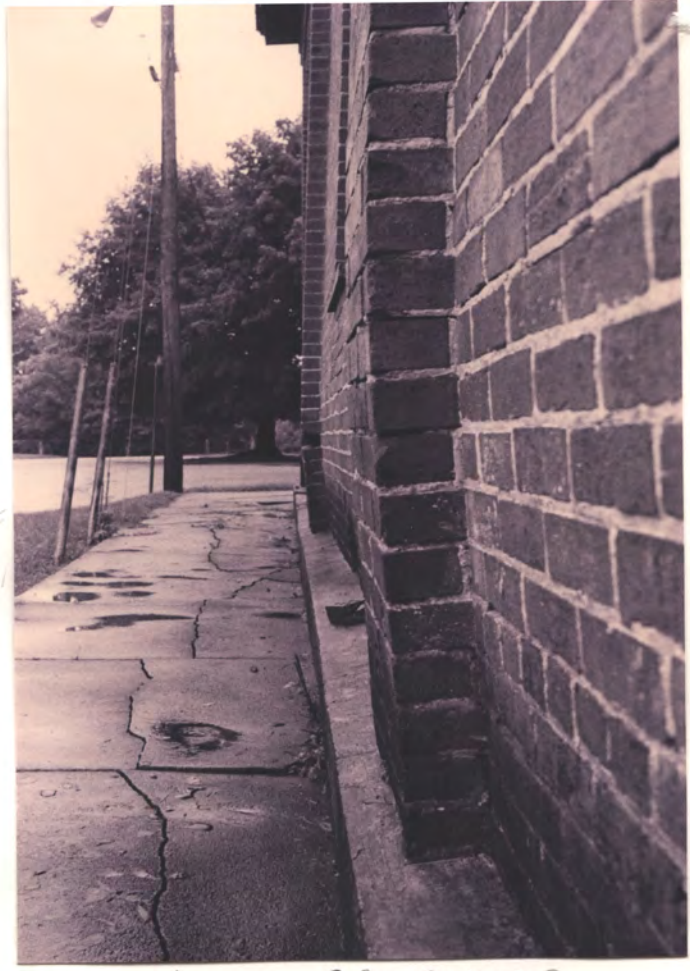
2ND PILASTER
walk bowed due to foot. rotation

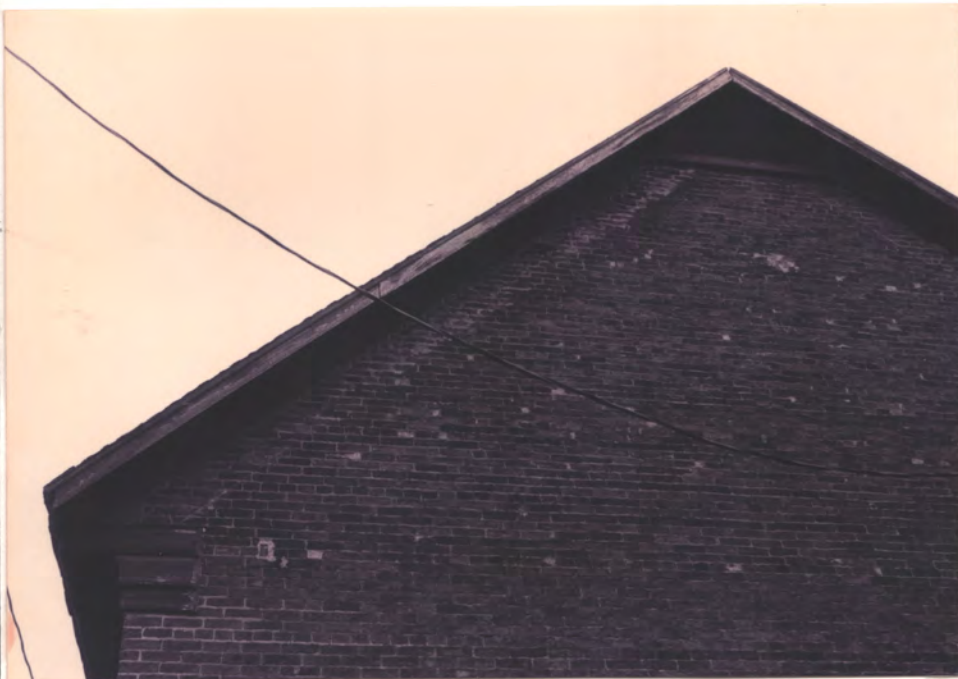
Note trace of removed wood
cornice of frieze that
must have been like
the one remaining on front

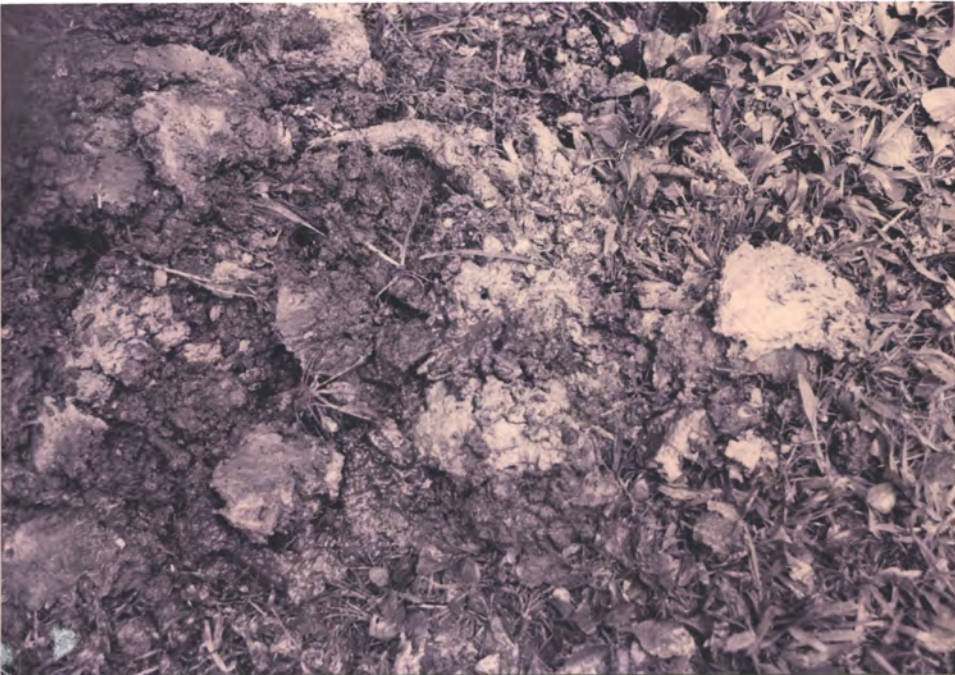
lt. soil = lt. tan clay, looks bad.
 dark soil = top soil
 Need a profess. soil test & analysis, +

digging for footing & soil
 Left side
 (opp. High St.)
 determine footing size, depth & condition

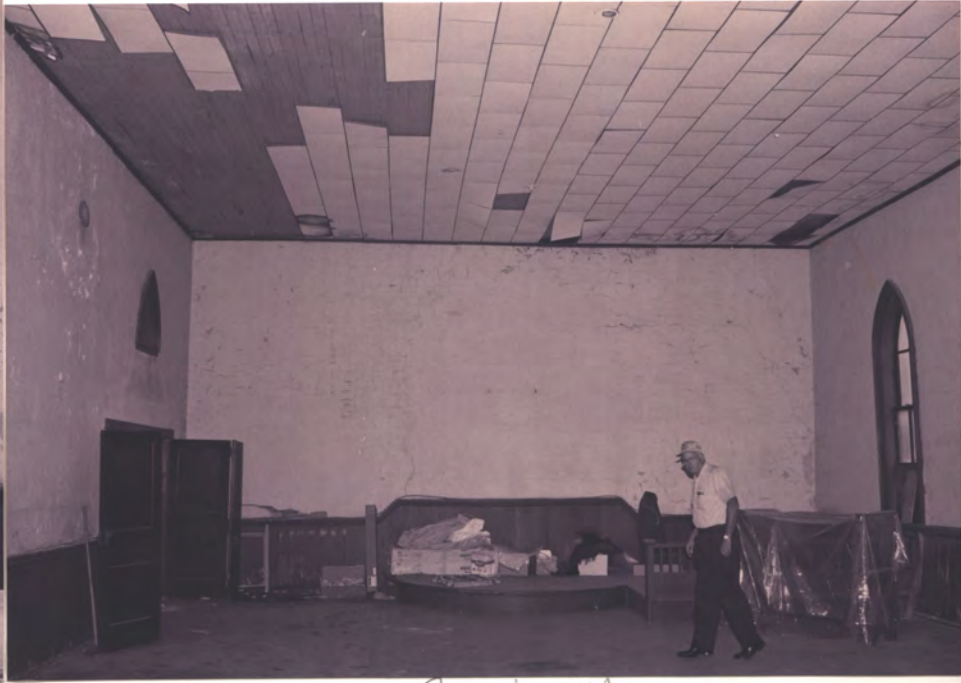
left front corner,
Note diagonal settlement/bow crack

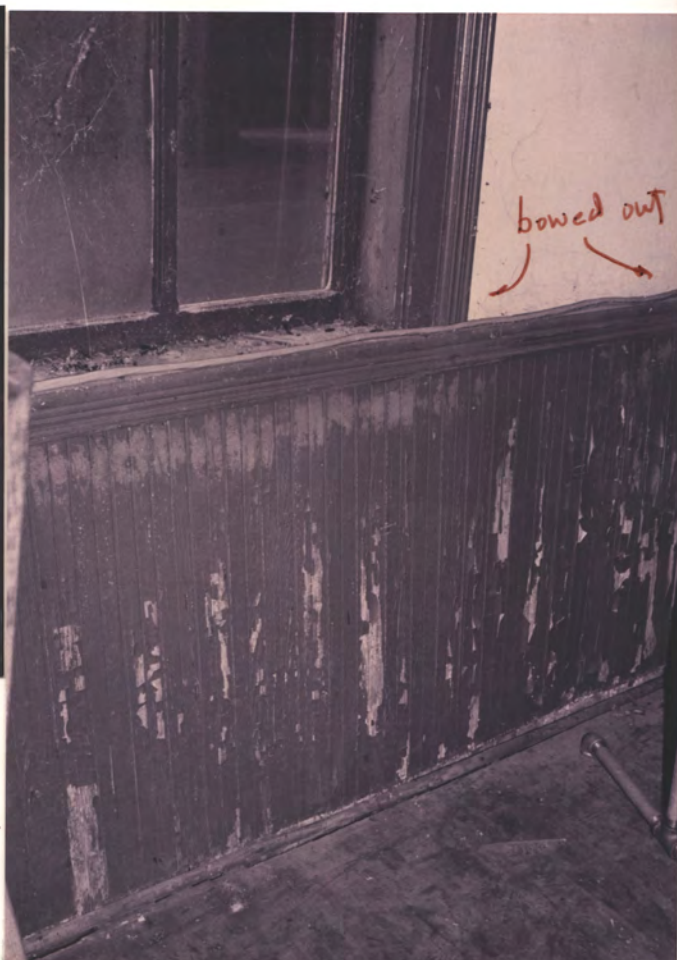
shifted +
bowed
right →
slab
(High St.)

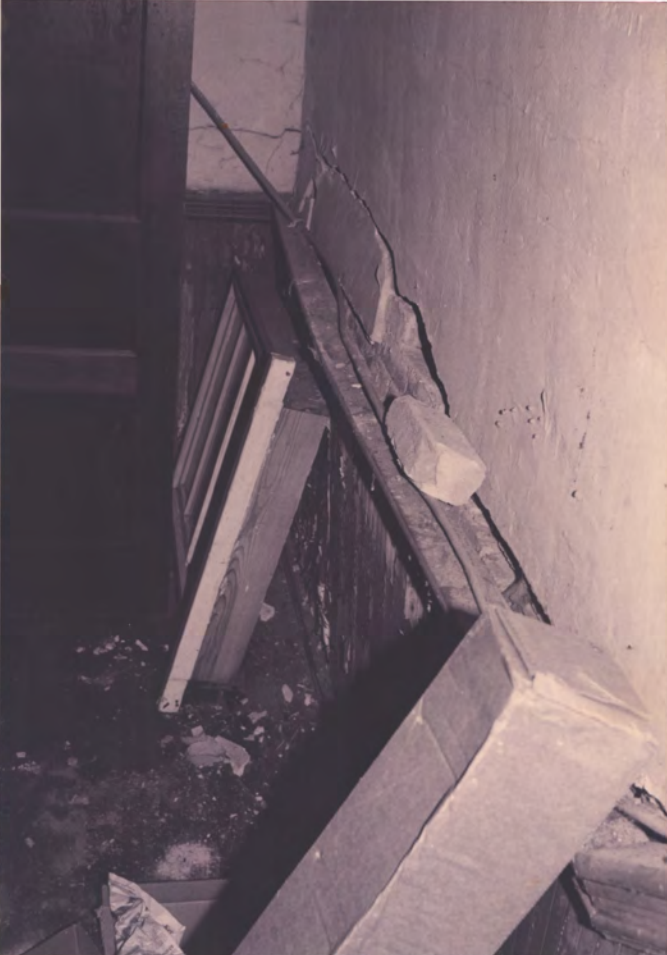
CHANNEL REAR WALL
bowed out $\pm 2"$

Left side
wainscot
bowed out
 $\pm 1"$
settled $\pm 1/2"$

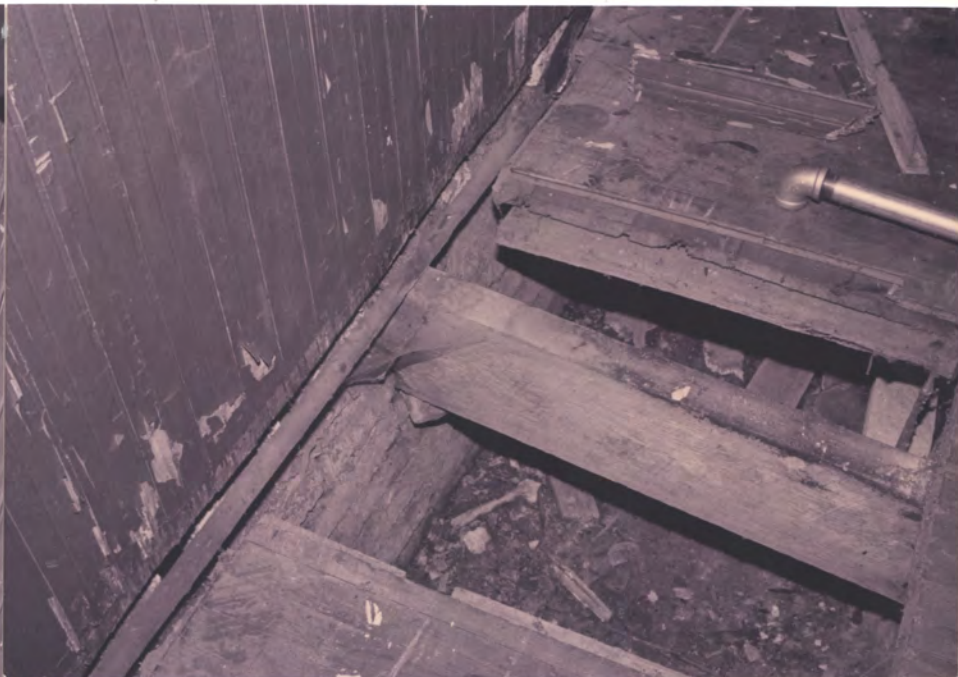
settled $1''-2''$, +
shifted out $1''-2''$
Joists out of mass. pockets
+ some detent.

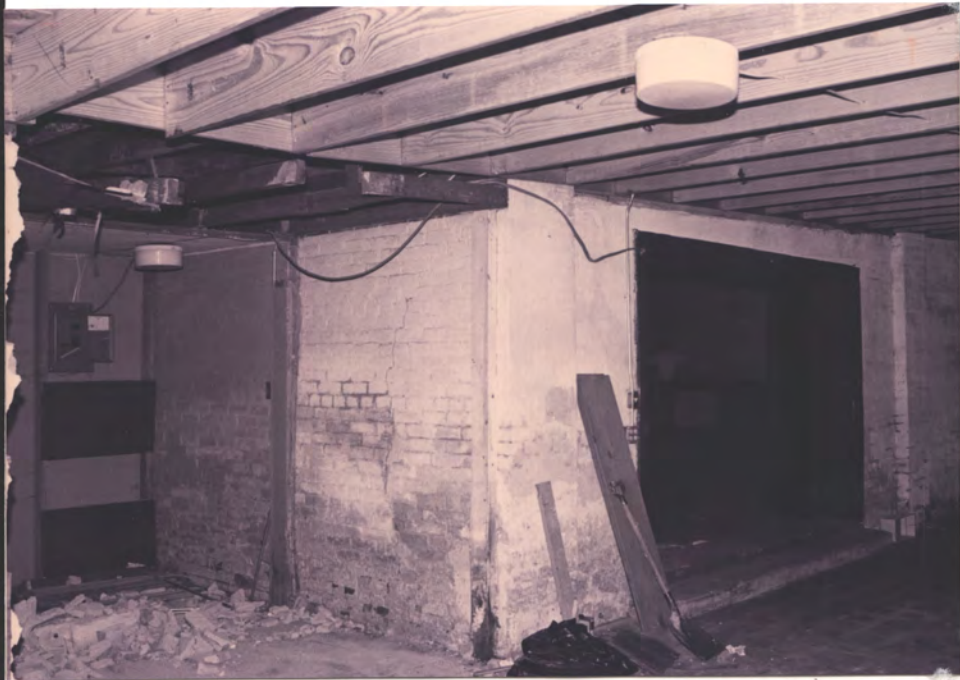
Rem wall of church
= bowed-out
