**FIRST PRESBYTERIAN CHURCH  
EUFAULA, ALABAMA**

**Preliminary Observations Report, June 18, 1997**

**Harvie P. Jones, F.A.I.A., Architect**

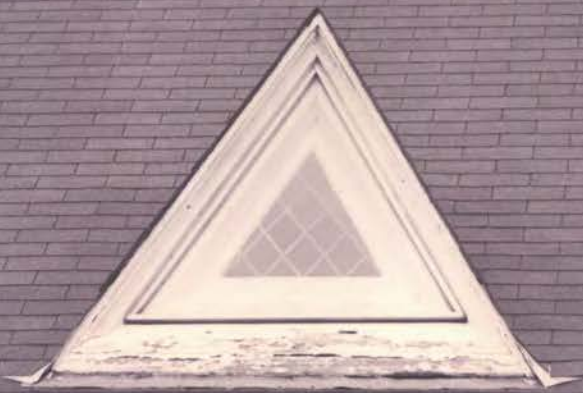
DORMER (N. SIDE)  
(PEELED PAINT,  
GRAY OXIDATION FILM ON WOOD)

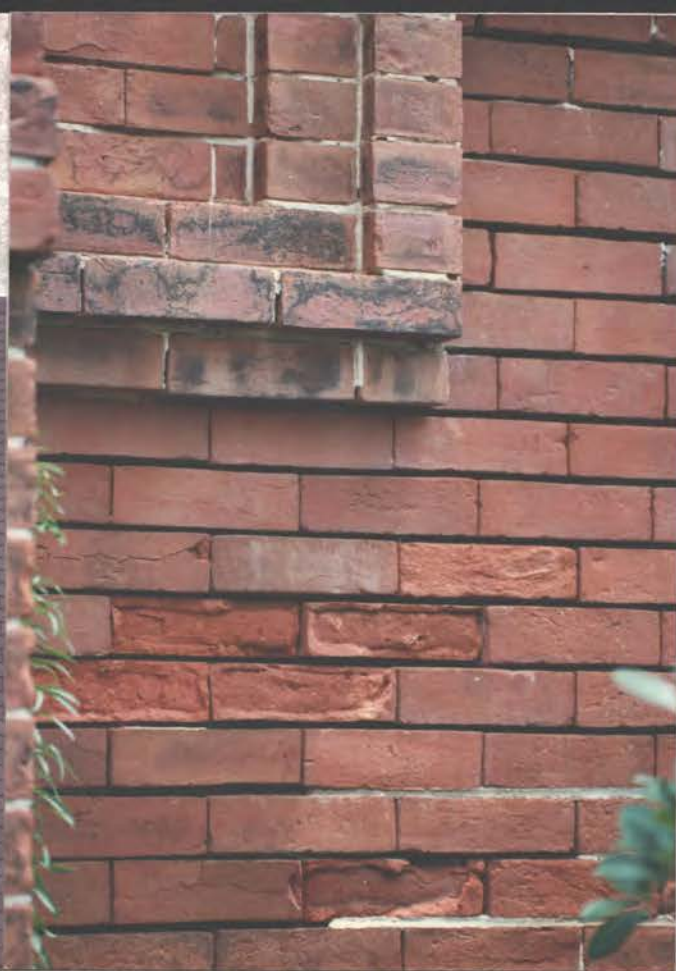
S. SIDE AT TOWER  
ERODED BRICK FACES  
+ ERODED MORTAR JOINTS

J. A few exterior brick faces are deeply eroded and must be either reversed or replaced with 1869 face bricks borrowed from inconspicuous locations, with best-available matching or blending bricks put back in the "borrow" areas.

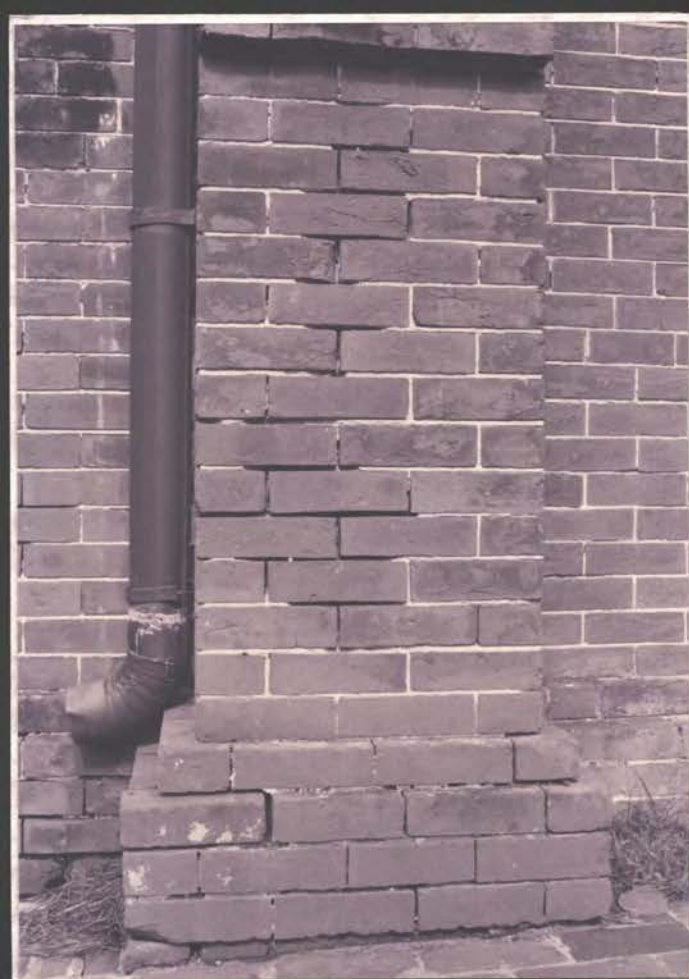
DOWNSPOUT DISCHARGES  
DIRECTLY ON BRICK, JTS. ERODED  
(N. OF N.W. ENTRY)

E. Several down spouts dump water about a foot up on the sides of the brick buttresses and have caused severe erosion of the mortar and the brick faces. The water should discharge directly onto grade on a flush brick splash block sloped away from the building (detail to follow).

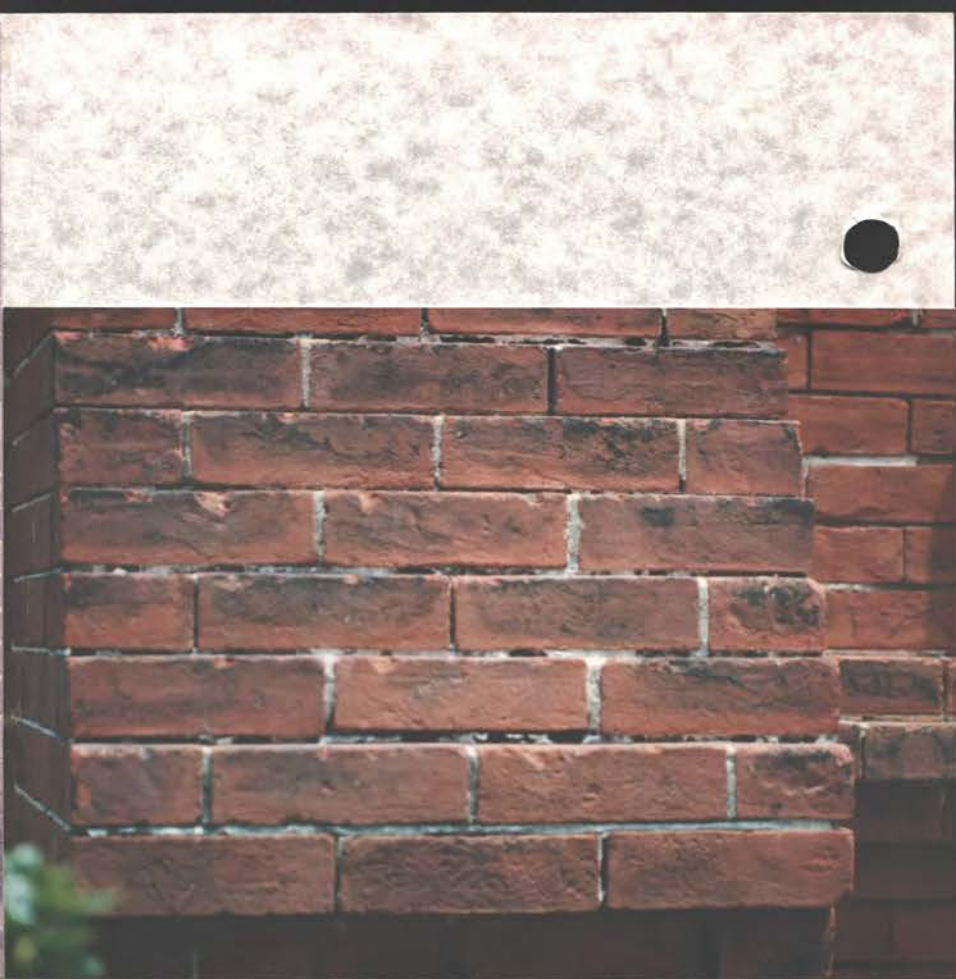
ERODED JTS. EDI TOWER

I. This same process has deteriorated the mortar joints at the exterior walls at the grade-line in particular, and some areas of the upper exterior walls also need repointing. Do not repoint sound joints, only those where the mortar is powdered and eroded-out to about ¼ inch or more in depth. (Don't fix it if it ain't broke.) Find a mason who likes old buildings and who understands how the 1869 masons mixed their mortar and tooled the joints. Look at the unweathered joints by the N.W. entry for this unusual original profile. If the mason can match this profile, using white hydrated-lime mortar and unscreened creek-sand (like the original) so much the better. If not, a neat smooth nearly-flush joint that approximates the original appearance may have to do. Require samples, cleaned and dry. Keep the new mortar off the old brick faces, for cleaning the old faces in areas to be repointed (only) will give a blotchy appearance to the walls.

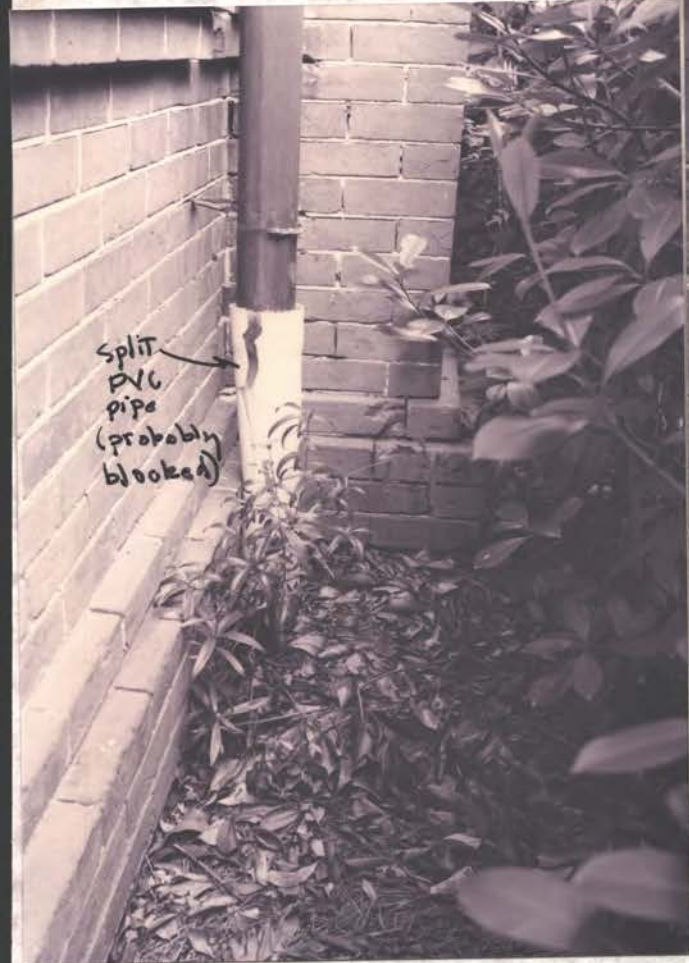
Split  
PVC  
pipe  
(probably  
blocked)

It also appears that the two south wall down spouts, underground drains, or both, may be blocked. The underground drains should be abandoned since they are typically found to be blocked and causing damage by subsequently blocking the down spouts. At a minimum there should be relief suppers near the bottom of each down spout so blockage in the underground drain will not in turn block the down spout and spill water down the wall.

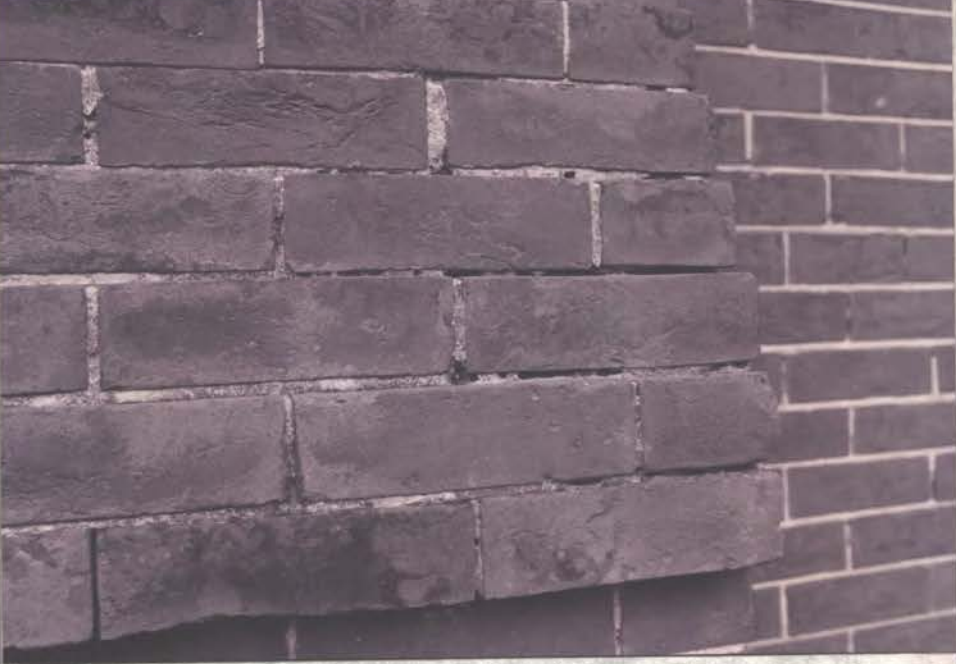
ERODED JTS.

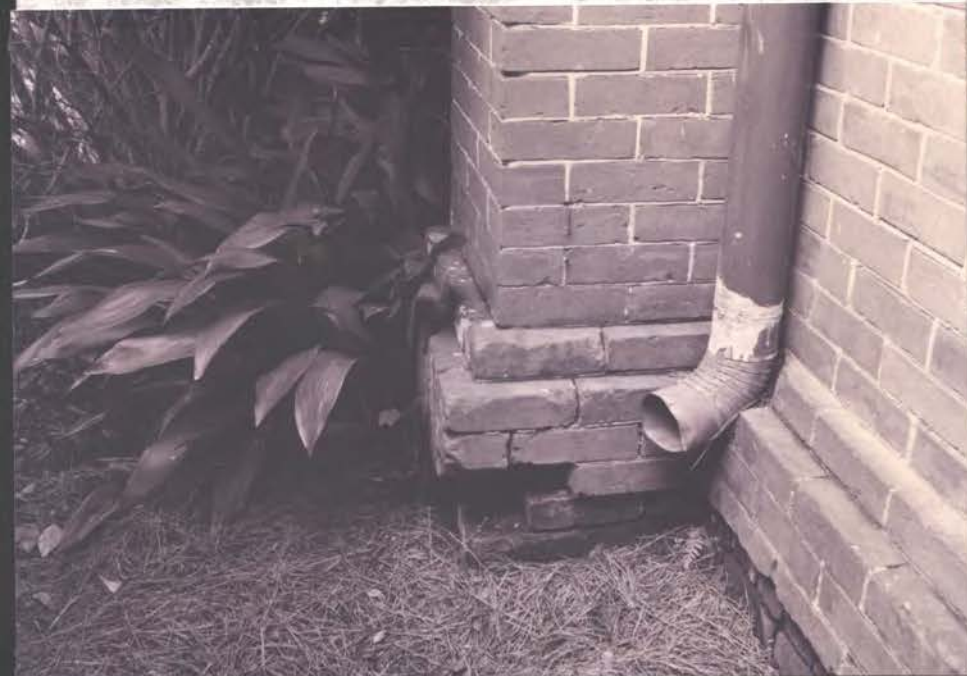
← D.S. DISCHARGE HAS ERODED JTS.  
(SHOULD DISCHARGE AT SOIL LINE)

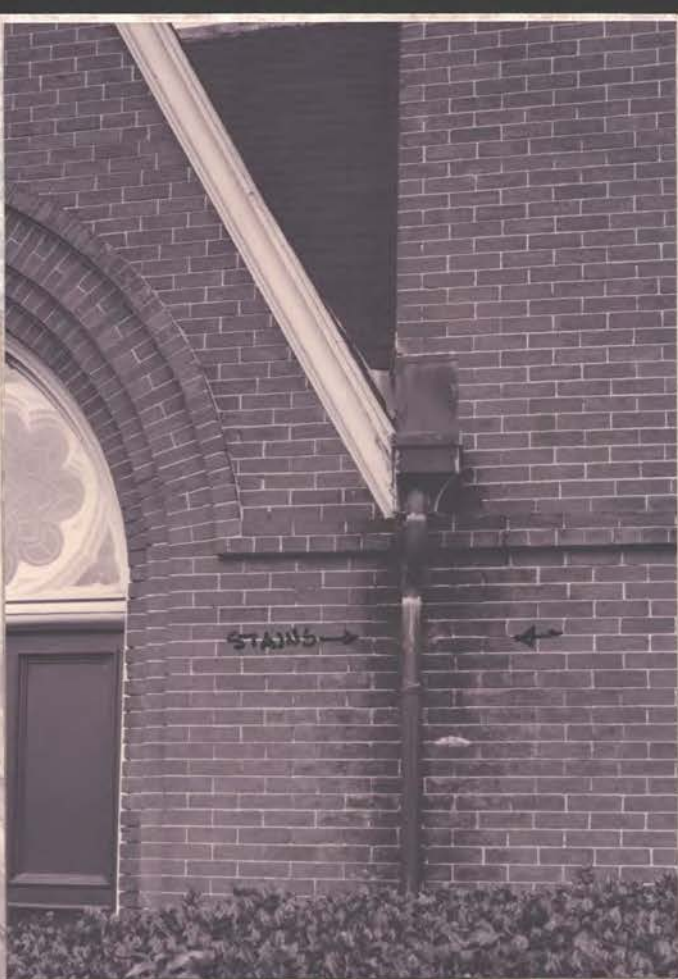
← STAINS INDICATE BLOCKED D.S. & WATER FLOW DOWN WALL (S. OF N.W. ENTRY)  
←

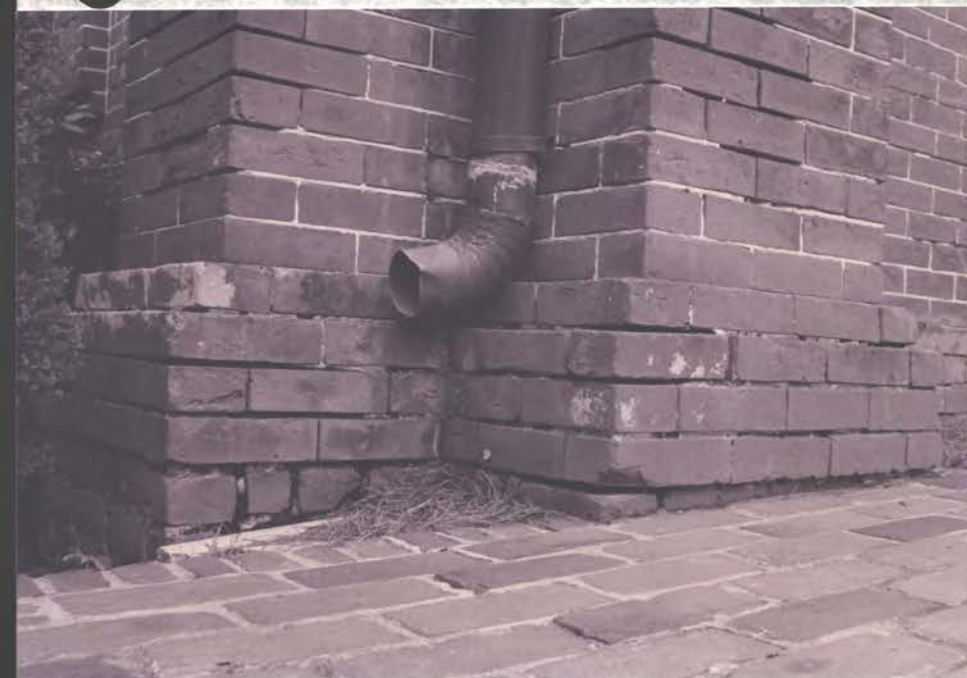
← DOWNSPOUT DISCHARGE 10" UP ON BRICK HAS ERODED JTS. - N. OF N.W. ENTRY  
(SHOULD DISCHARGE AT WALK LEVEL)

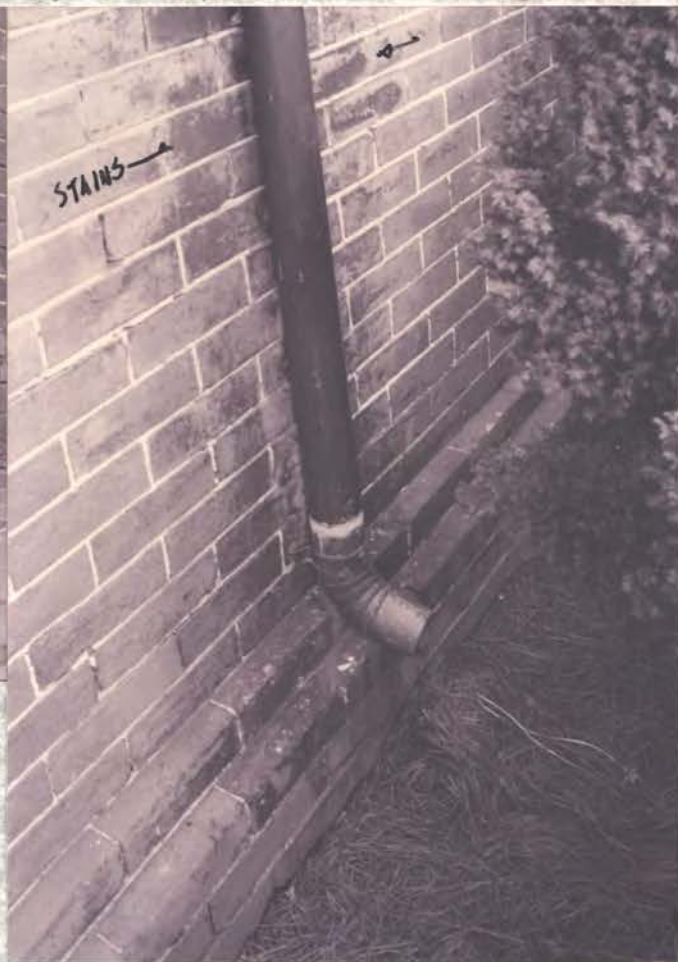
← STAINS  
← NO WASHING OF STAIN INDICATES BLOCKED D.S.

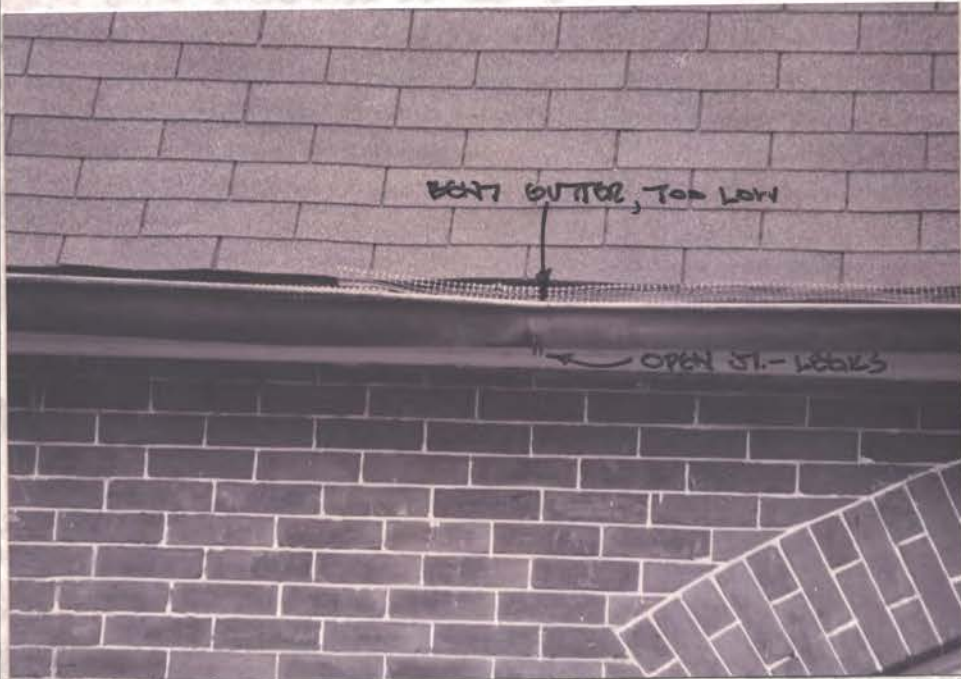
N. WALL

SEE PHOTO P. 10  
FOR WATER DAMAGE  
ON INT. PLASTER  
AT THIS LOC.

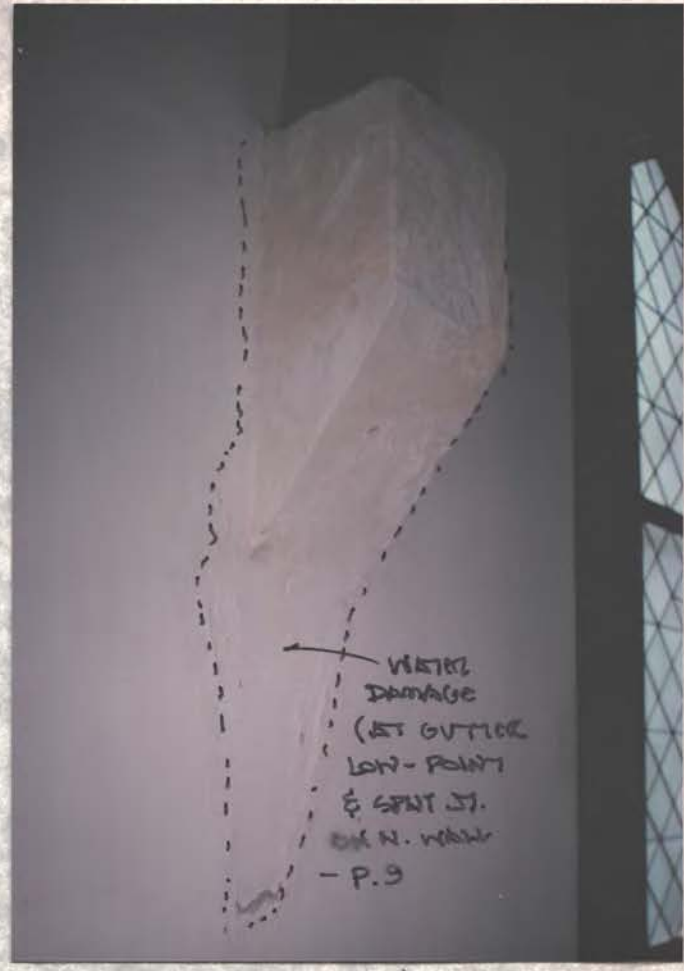
WATER DAMAGE  
(AT GUTTER  
LOW-POINT  
& SPILL ST.  
ON N. WALL  
- P. 9

DAMAGED GUTTER IS AT THIS LOC.

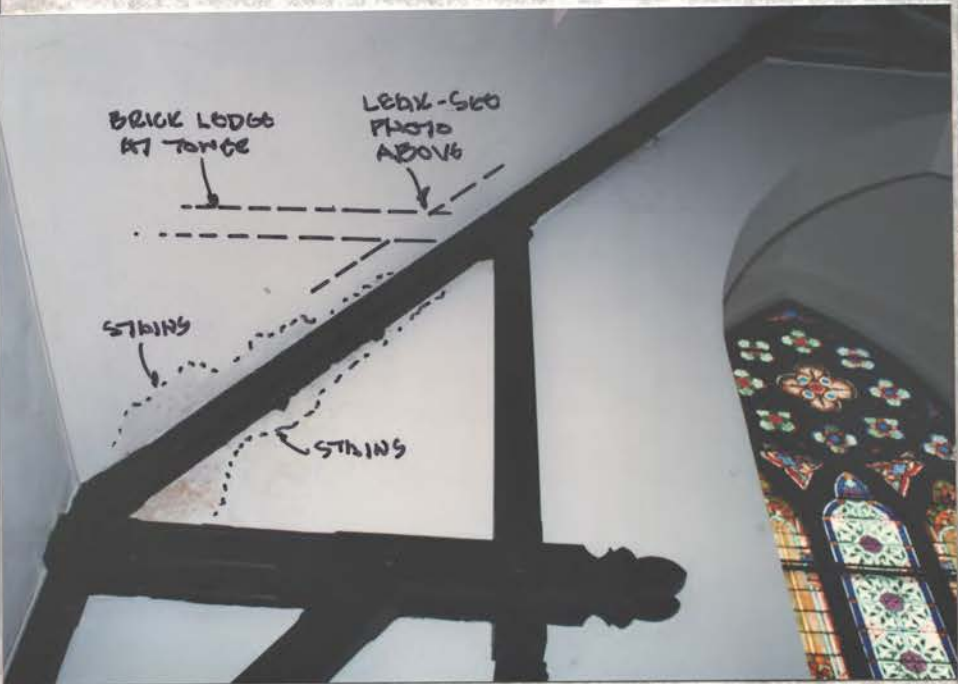
S.W. CORNER AT TOWER

BRICK LODGE AT TOWER

LEAK-SEE PHOTO ABOVE

STAINS

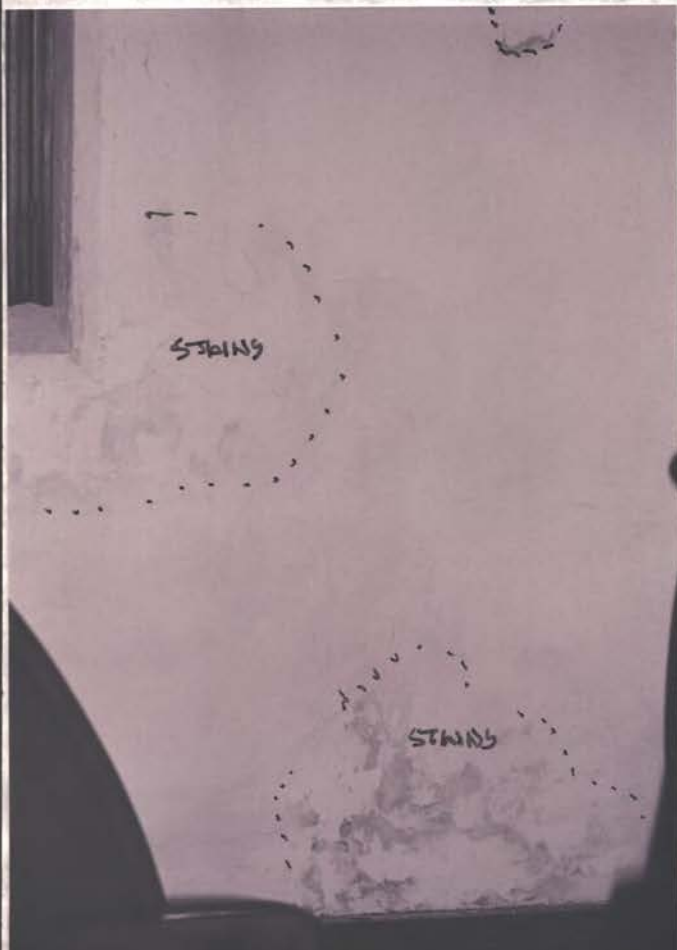
N. WALL AT DAMAGED GUTTER

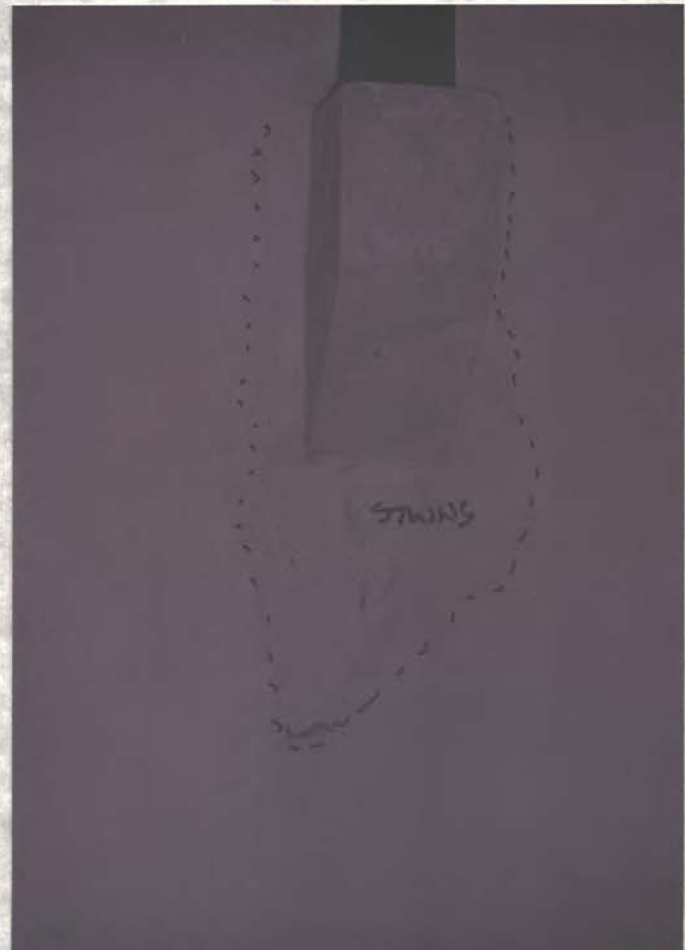
N. WALL AT DAMAGED GUTTER
