Preliminary Observation Notes

1872 Vicksburg & Brunswick Railroad Depot

Adaptive-Use Renovation for First Methodist Church Building

April 10, 1997

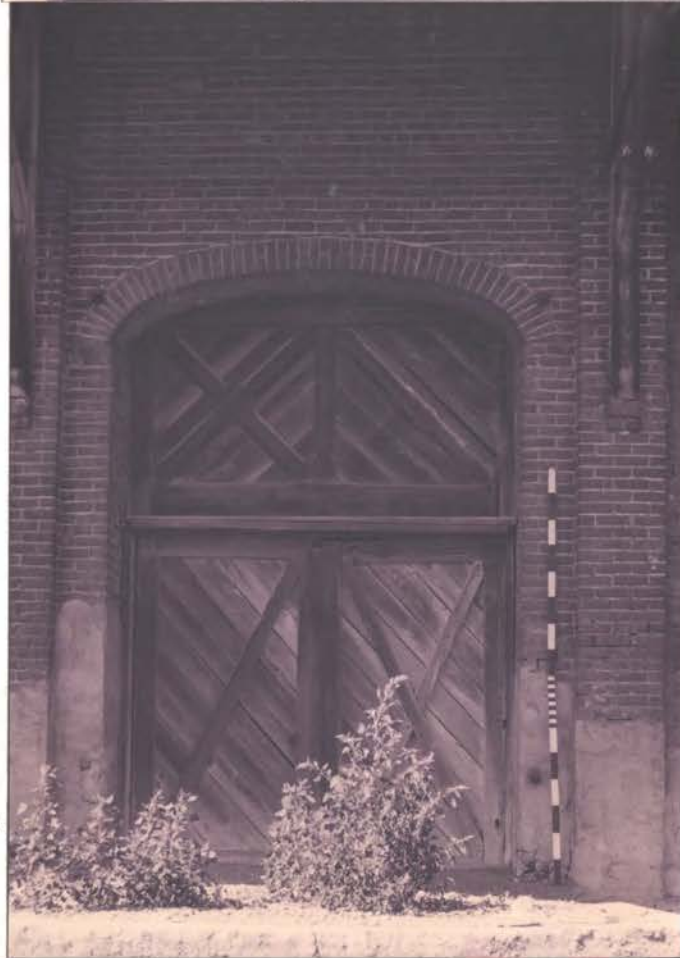
Counter-weighted
"sash" doors
slide up. See
int. photo

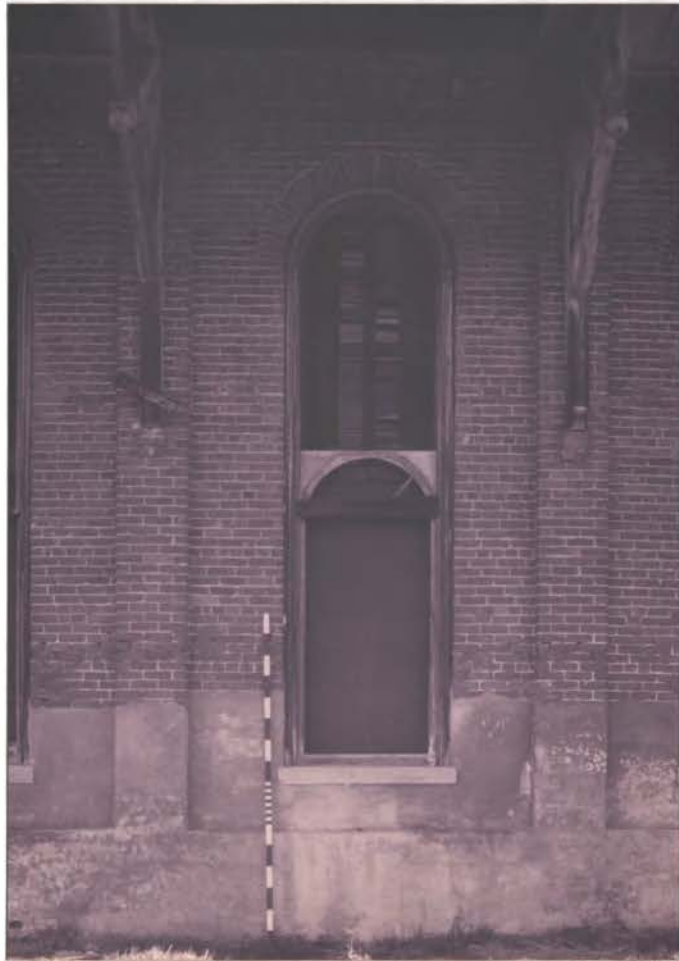
The brick walls contain a considerable percentage of soft underbaked salmon-color bricks, which were typically used as filler rather than as face bricks, as has been done here. Salmon bricks are almost like adobe, very soft and subject to powdering in repeated wet-dry cycles. Capillary rising of ground moisture creates this wet-dry cycling, as seen in the Depot. In the past, rough cement parging has been troweled onto the lower interior and exterior faces of the brick up to about 6 to 8 feet above the soil line to try to patch the brick surfaces. This has greatly disfigured the walls. The best procedure would be as follows:

↓
sloppy patching of
cement is modern.
"Rising damp" ↑
soft bricks

1. Improve the soil drainage to lead the roof and ground water quickly away from the building.
2. Remove the parging and deteriorated brick outer wythe from the walls in 4-foot wide isolated sections and replace the spoiled bricks with a "Bickerstaff Woodmould" brick in a closely matching color, size, mortar color and joint profile. Doug Purcell has our instruction sheet on how to do this. A good mason is needed. As long as 4-foot-wide by 1-brick-deep isolated sections are removed there should be no structural problems in the process. Twelve-inch thick wythes would remain in place, and each truss bears on a 20 x 20 inch pilaster, more than adequate.

5. "Rising damp" can be stopped at grade by a fluid-injection process by the "Pro-So-Co" company in Atlanta. We used this process successfully on the 1819 Weeden House Museum in Huntsville in about 1980 and on a c.1820 home in Courtland.

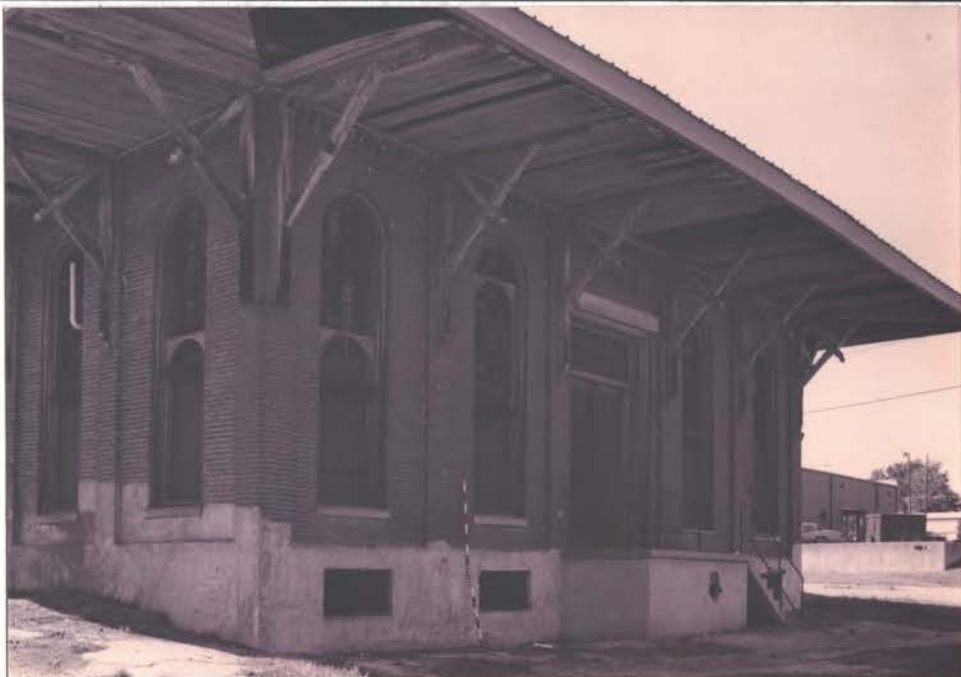
20th cent. iron roof with
corr. block entry stoop

soft common brick ← → "pressed brick" ST. FRONT (EAST END)
on St. front only, 1/4" - 1/8" fs.

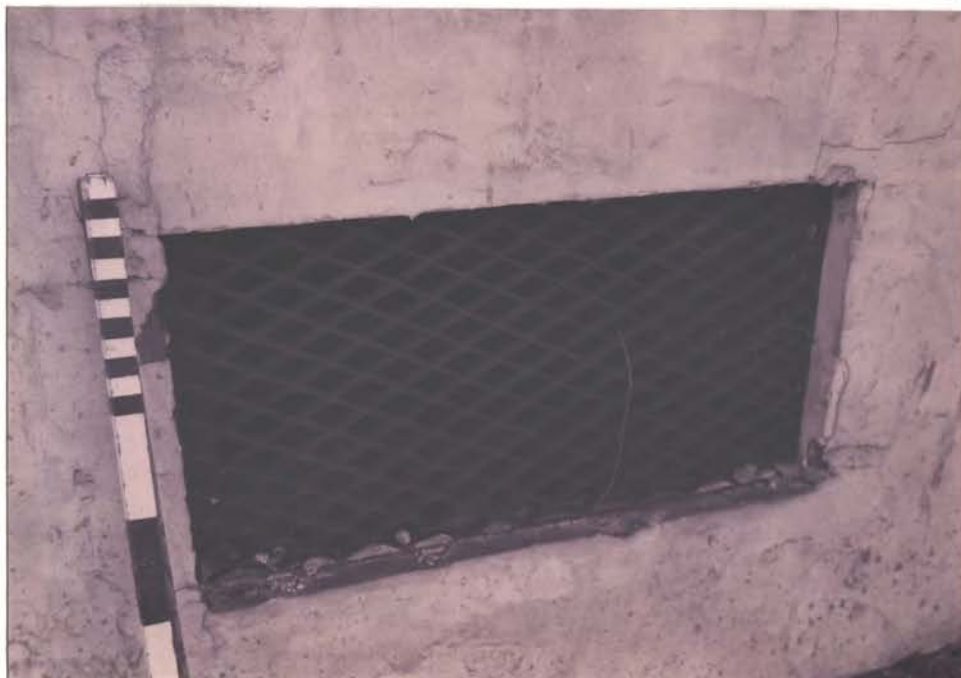
cast iron gravel-space vent
+ Modern portland-cem. pargeing
over soft bricks

3. If the budget prohibits the above, simply paint the parging in a flat latex masonry paint that blends with the overall coloration of the masonry and this will help somewhat.

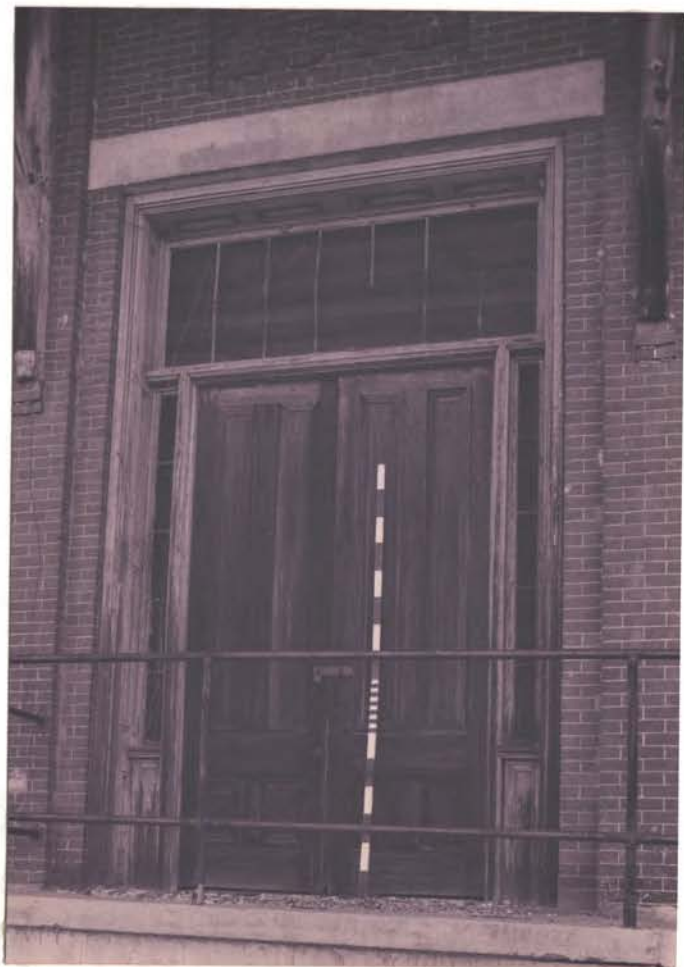
modern stoop, original entry →

A more appropriate entry stair to the attractive east front entry should be provided, and the use of this entry encouraged. Are there historic photographs of this entry?

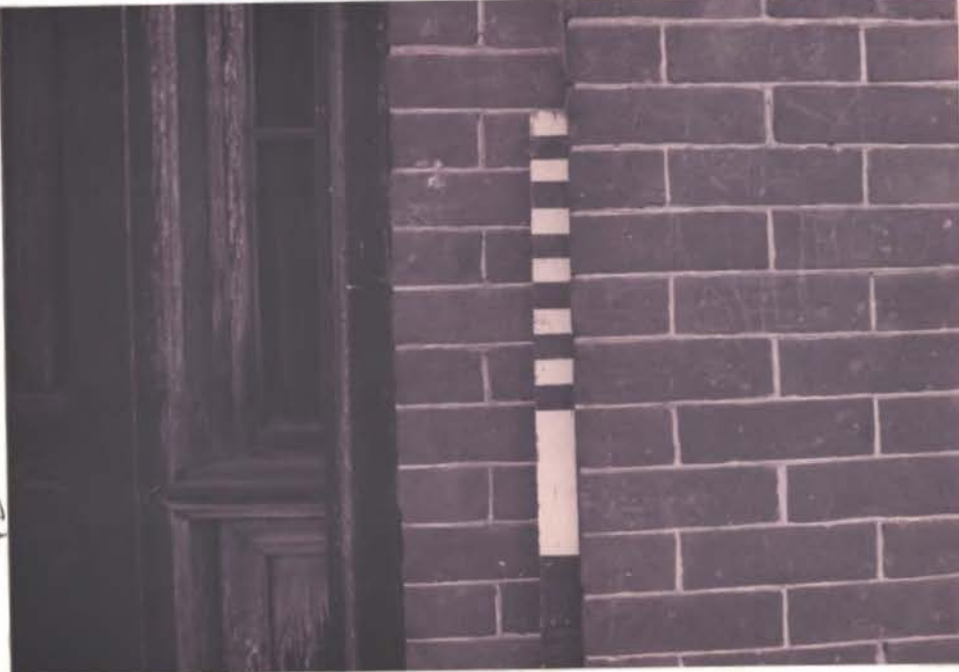
EB 51 ST. - FRONT ENTRY

"pressed bricks" on
St. front only.
J_s = 1/4" - 1/8"

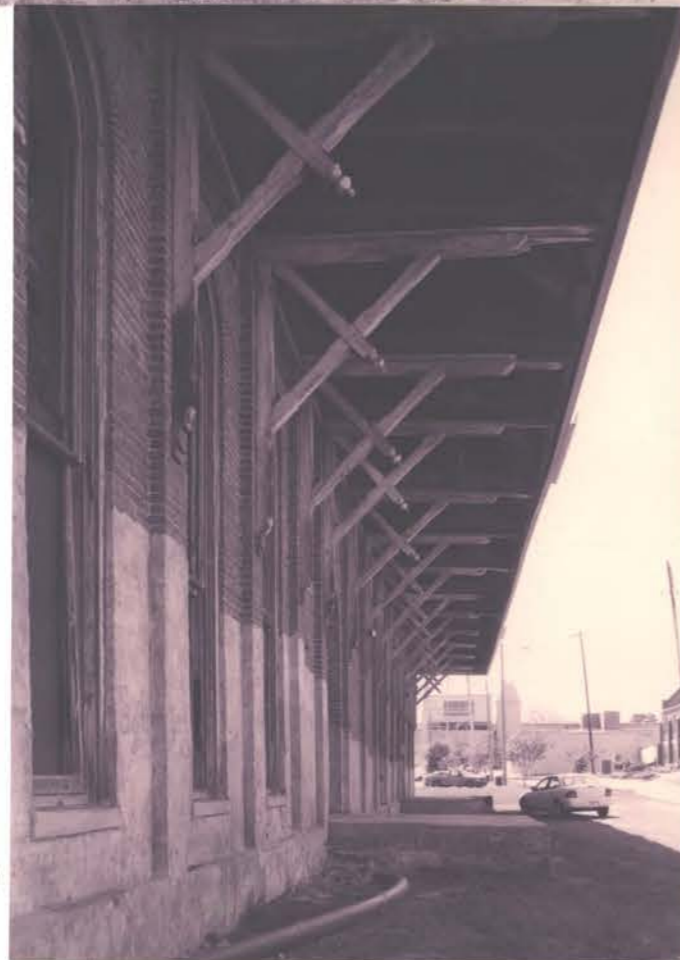
modern
concrete
plat.

All lx
soffit
bds.
gone
this side.
See p. 1

The plank soffits under the roof eaves are mostly gone and must be replaced to match, with screened vent-strips installed inconspicuously.

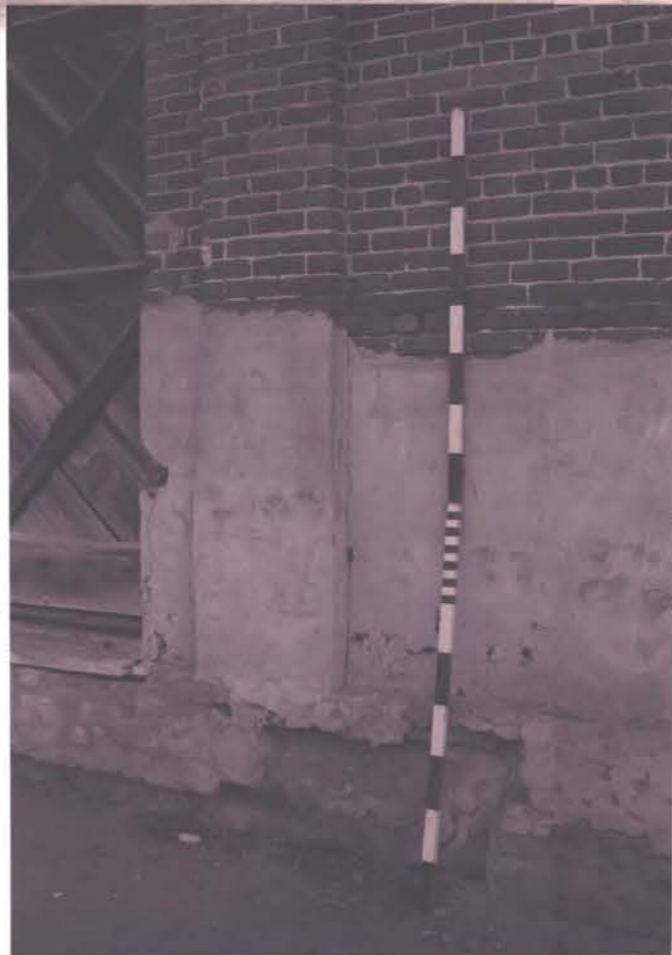
NORTH SIDE
(plat. gone)

Shabby modern
portland cement
parge, due to
"rising damp" &
soft underbaked
bricks

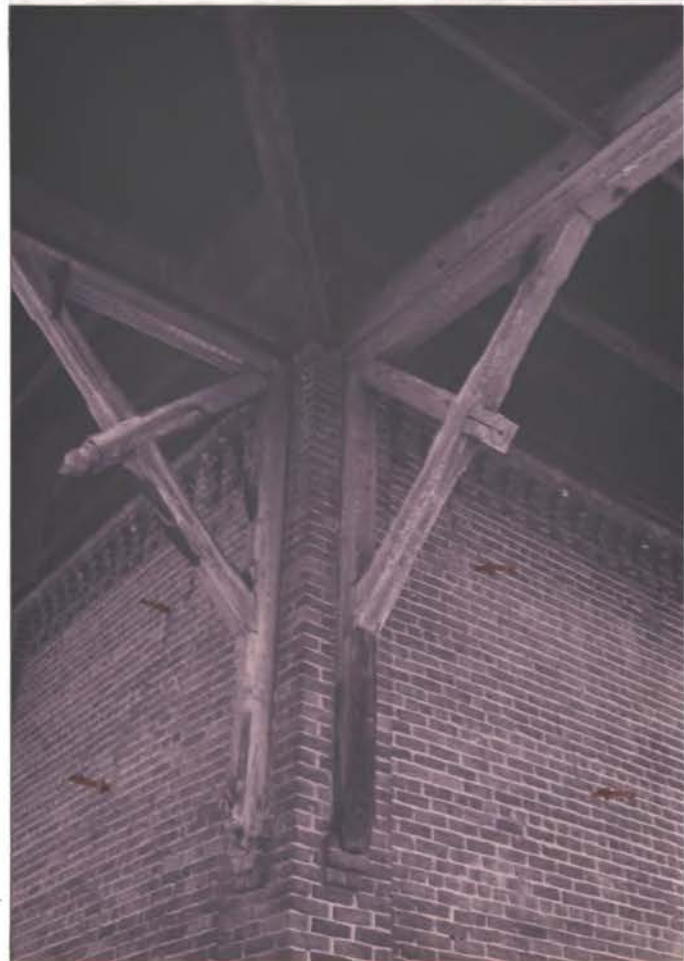
↑
N.W.
CORNER

The Committee asked about the two diagonal cracks in the brick wall at the N.W. corner. Their direction indicates that the soil within about 10 feet of the N.. W. corner was slightly compressed by the building's weight more so than the other soil. Very likely this compression took place shortly after the building was completed and has ceased. The cracks can be neatly grouted with brick-colored lime mortar and monitored for a year or so. If the cracks recur, the soil may be of the type called "Plastic" that swells and shrinks according to ground-moisture content. If so, we have stabilized such soil by injecting cement into the soil under controlled conditions. We have used this on three early 19th century buildings with success.

arrows = diagonal settlement cracks
(don't appear serious)
See HJ rept.

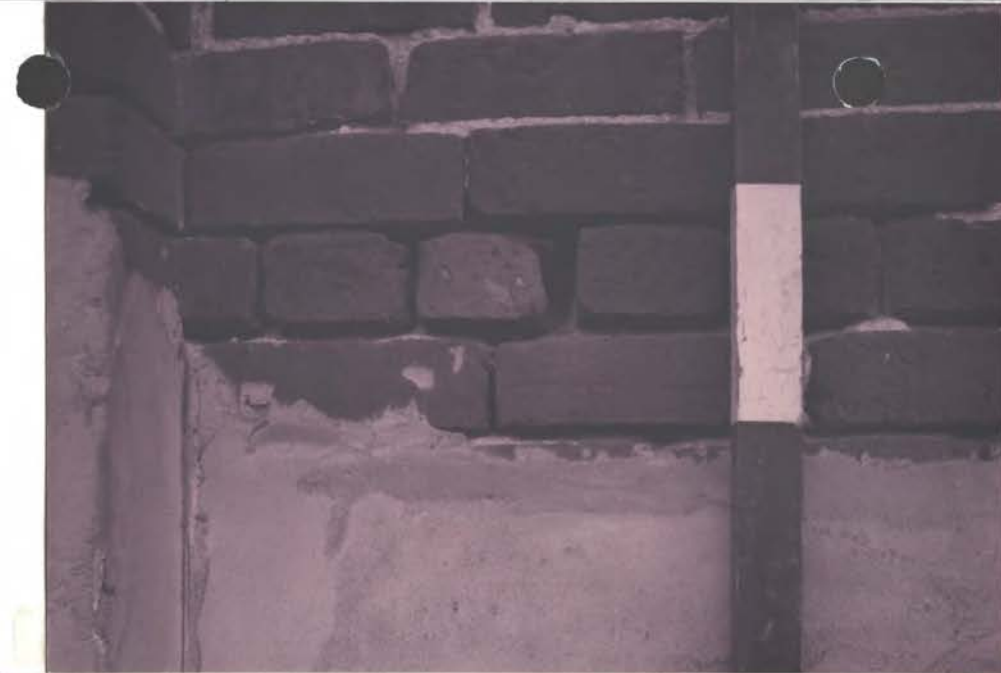
Soft underbaked
bricks & deterior.
lime-mortar jts.
at N. wall near
E. end (typical)
+ mod. cem. parging

4. Where mortar joints have powdered (interior, exterior, and in the basement) properly repoint the joints with matching-color and joint profile hydrated lime mortar. Doug Purcell has our instruction sheet.

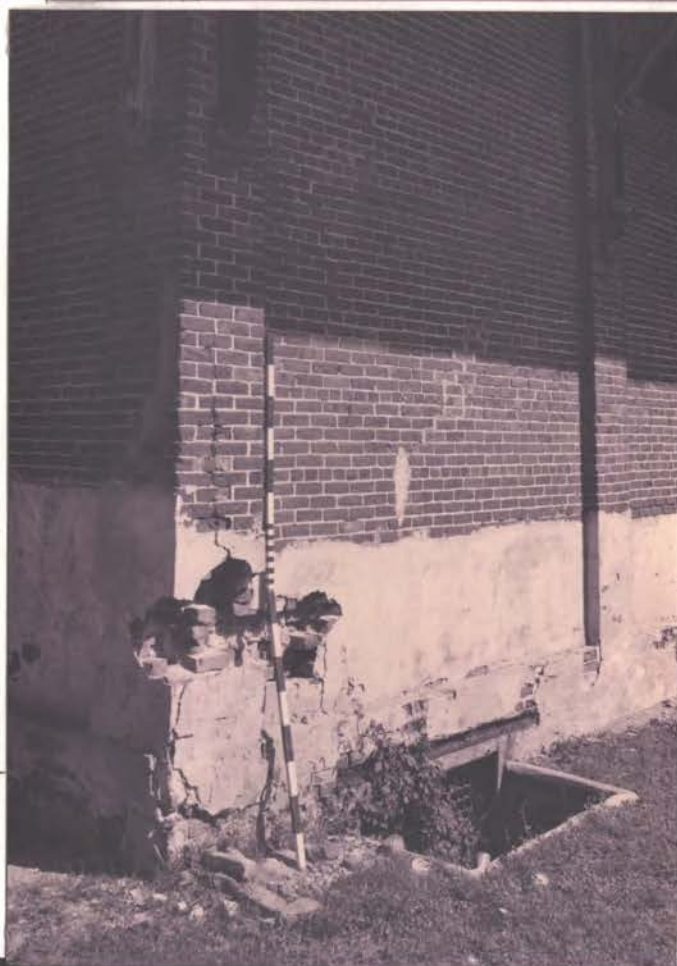
← mod.
parging

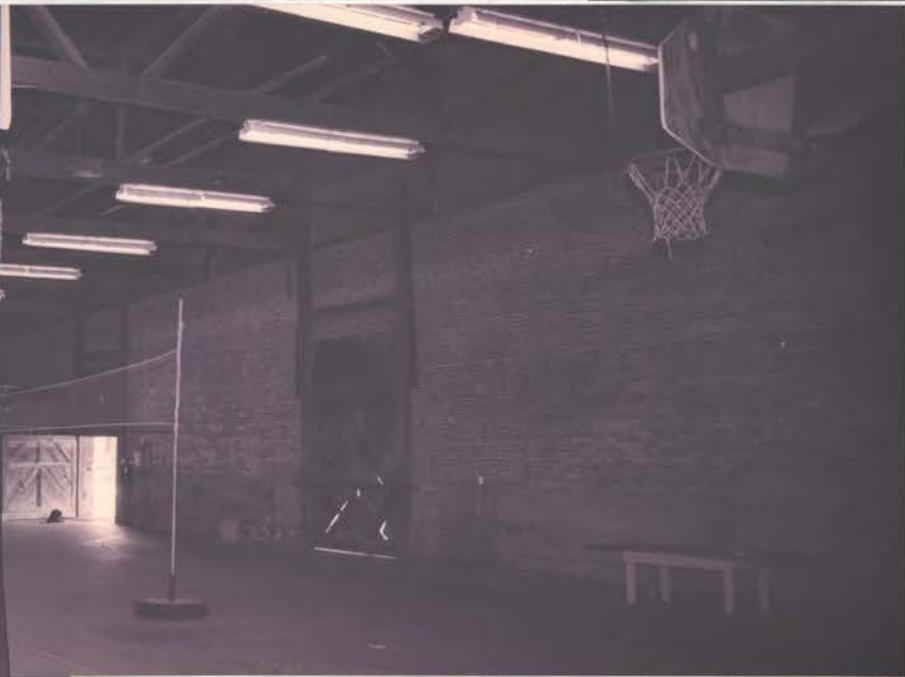
The present modern plywood floor in the recreation space is laid over a non-original 1 x 4 tongue-and groove pine floor which is laid over the original full-1-inch thick x +6 inch wide dense heart pine floor. In an adaptive-use renovation, I believe it would be acceptable to install a modern gym floor over the original floor if desired (review with grant sources). It would not be good to sand down the original floor, in all probability, because of probable deep wear areas near to the tongues and grooves. It would be better preservation to cover the original floor.

Modern: ply. over orig w.A. fl., parking on walls
 floor. lbs., sports equip

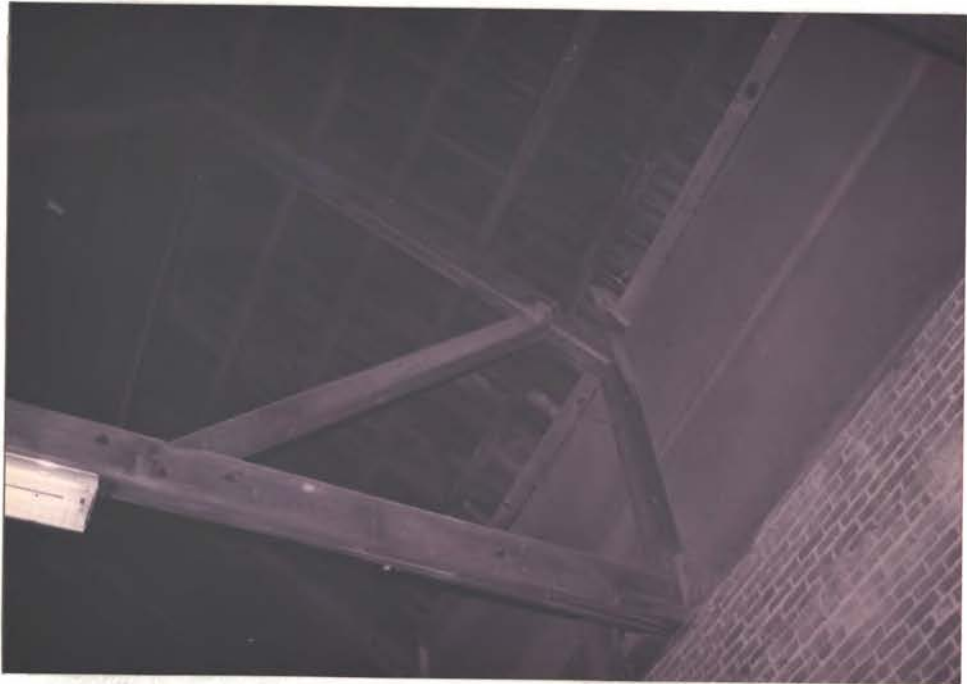
The two trusses that support the diagonal hip-trusses have deflected two or three inches due to the extra load imposed on them. There would be no reason to try to level them. While the trusses are probably alright, a structural engineer should advise on whether to add stiffener plates. All trusses should be examined for wood deterioration, loose connections, solid bearing, etc.

triple 2x12 truss
 bottom chords,
 1" φ iron brgs, etc

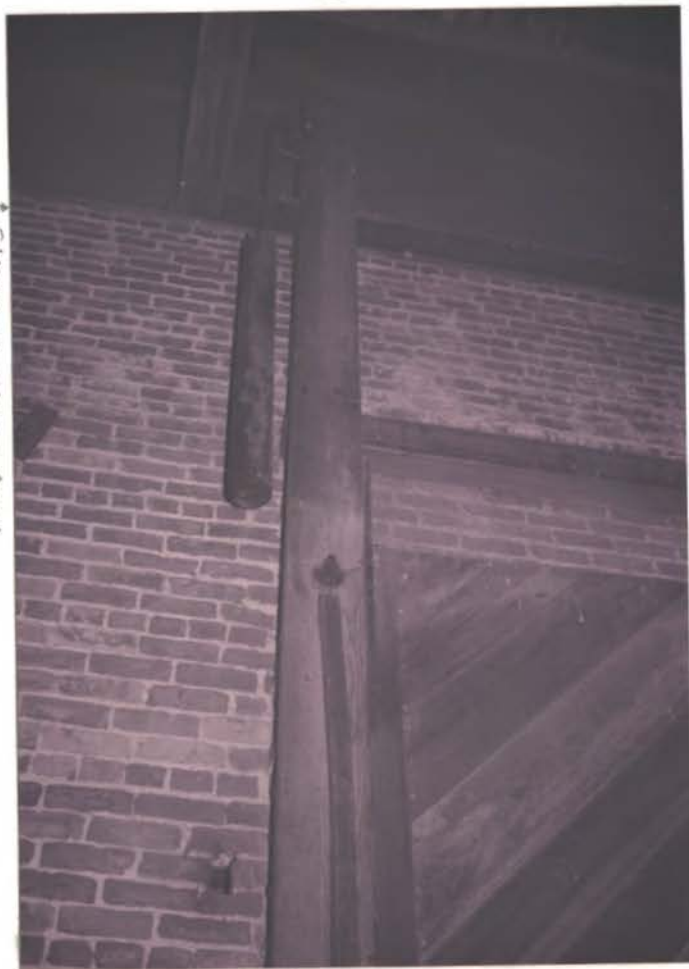
TYPICAL FRZ. DOOR
(N. DOOR, EAST MOST)

IRON COUNTERWEIGHTS

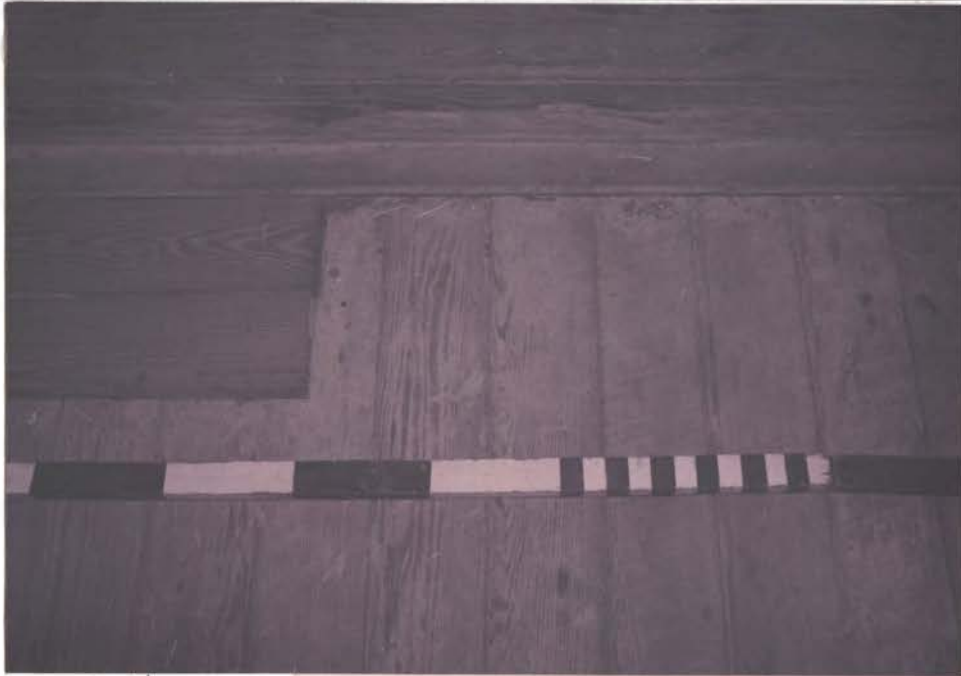
1x6
T&G
2nd
fl.
↓
Full 1"x
± 6"
T&G
ORIG. PL.
(DENSE
HEAVY
PINE)

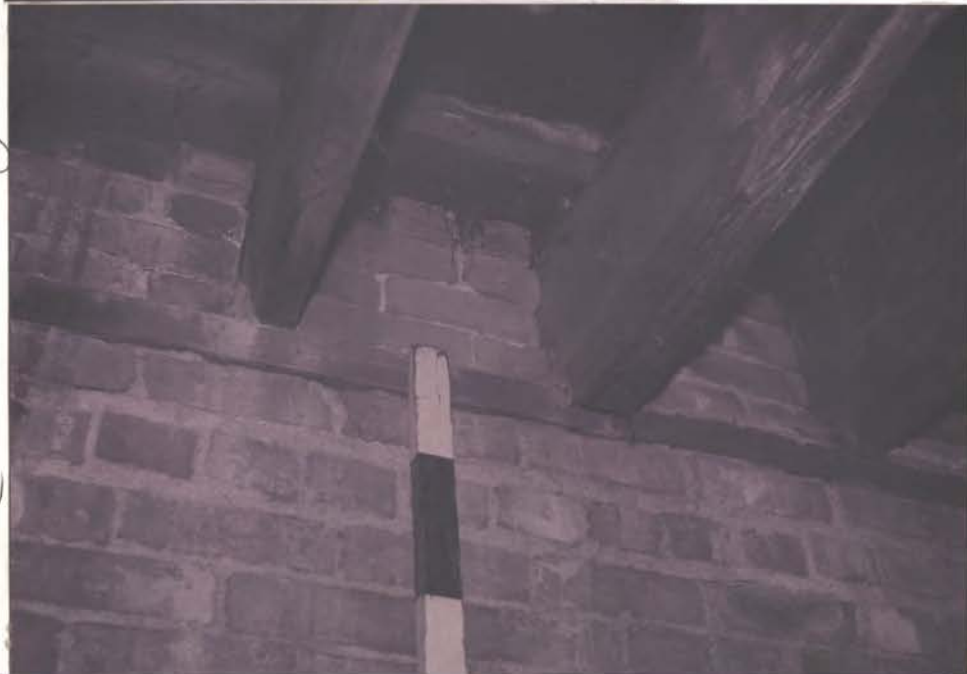
(12)

heavy dusting
from deterior.
brick mortar

negligible wood
deterior.
observable

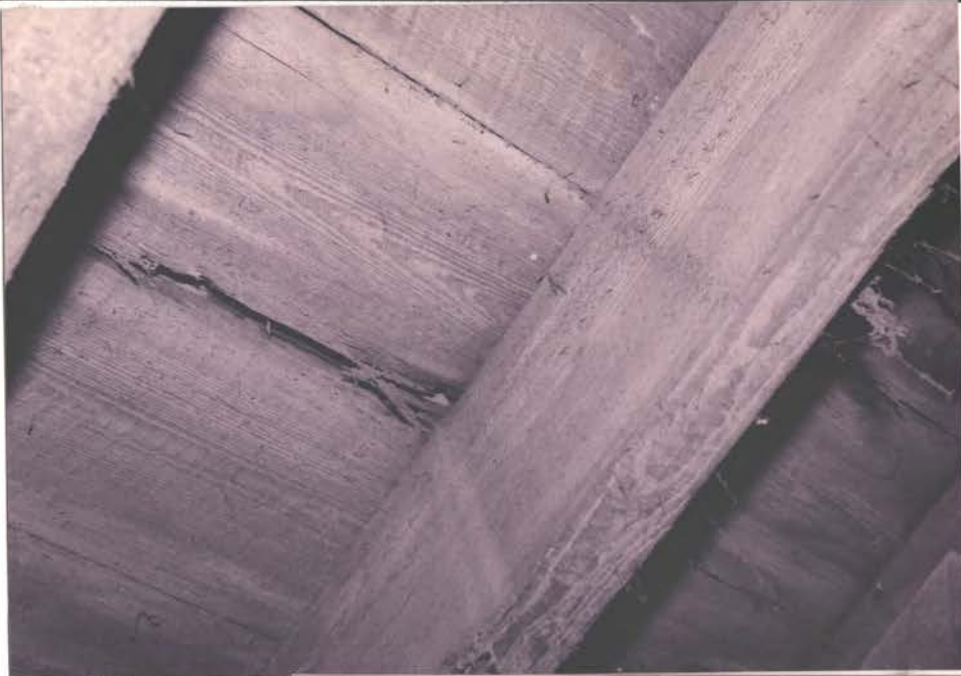
(15)

A miniscule amount of insect and decay damage was observed in the basement joists. Some mechanical damage and resultant propping is present, mainly due to the improper imposition of dead-loads from the bearing walls of the modern west end storage platform above, whose weight was put in mid-span of the floor joists. This platform is to be removed. Any new walls on the main floor should bear onto the basement bearing walls or otherwise be properly supported in the basement.

Joists
 $\pm 3" \times 12"$
 $\times 16"$ oc.
 Fl. (no subfl.)
 $= 1"$ full-thick
 $\times \pm 6"$ or more
 dense pine

modern props
 under
 improperly
 placed modern
 str. plat. at
 west end of
 Ext. rm.

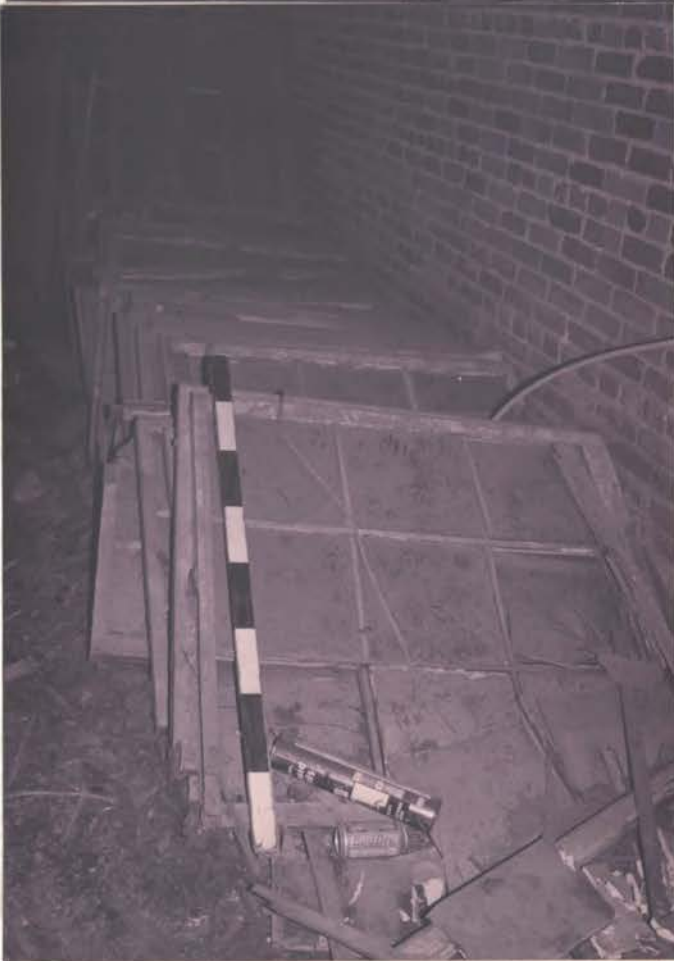
deterior-
 brick &
 mortar at
 S. extremity
 below grade
 + above

Sashes,
 probably from
 this bldg., most
 look o.k. or
 repairable.
