# THE PENTAGON . . .

## BEFORE AND AFTER SEPTEMBER 11, 2001

### Historic Preservation and Force Protection of a National Historic Landmark

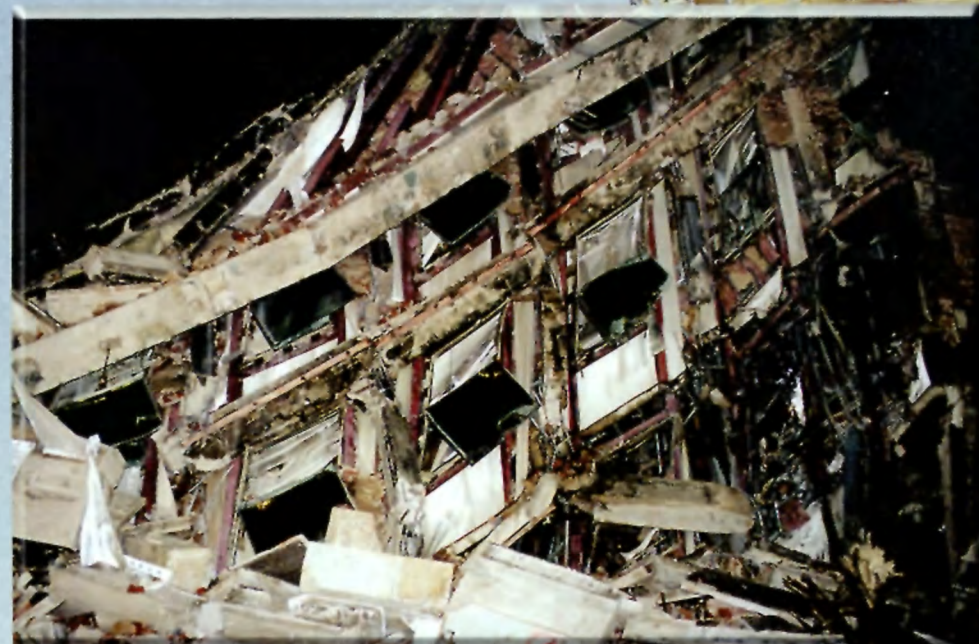
Collapsed portion of Wedge One showing the blast-resistant windows and steel frames still in place. Fire damaged the wooden roof and limestone facade. Replacement limestone will come from the same quarry in Indiana as the original stone.

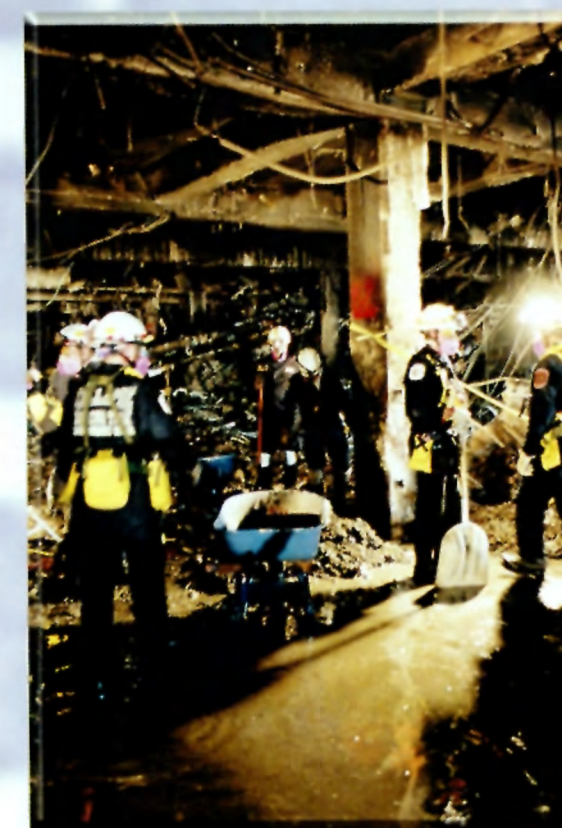
Water and fire damage inside the Impact Zone.

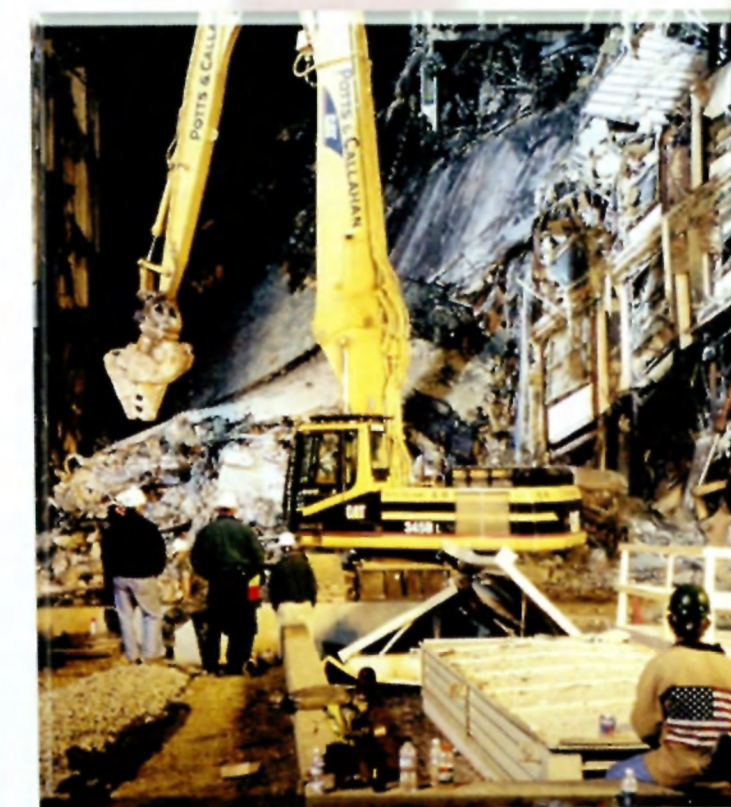
Collapsed section at the Pentagon - it held for up to 30 minutes after the attack because of security designs.

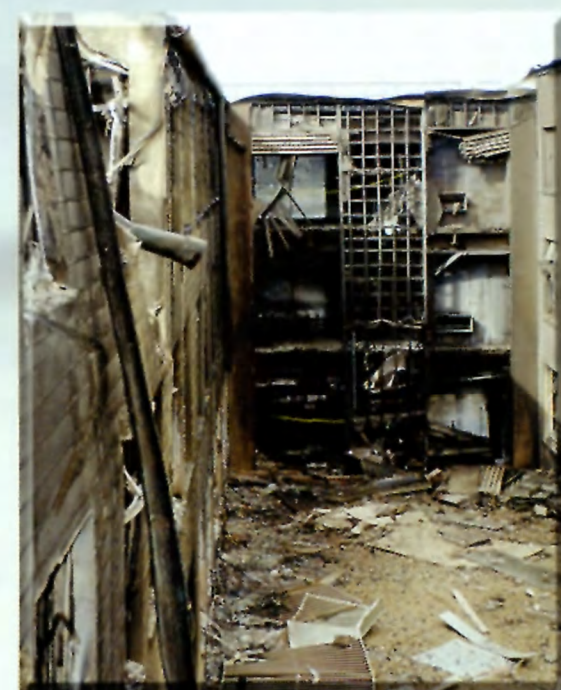
Debris inside the Impact Zone (1st floor; E Ring).

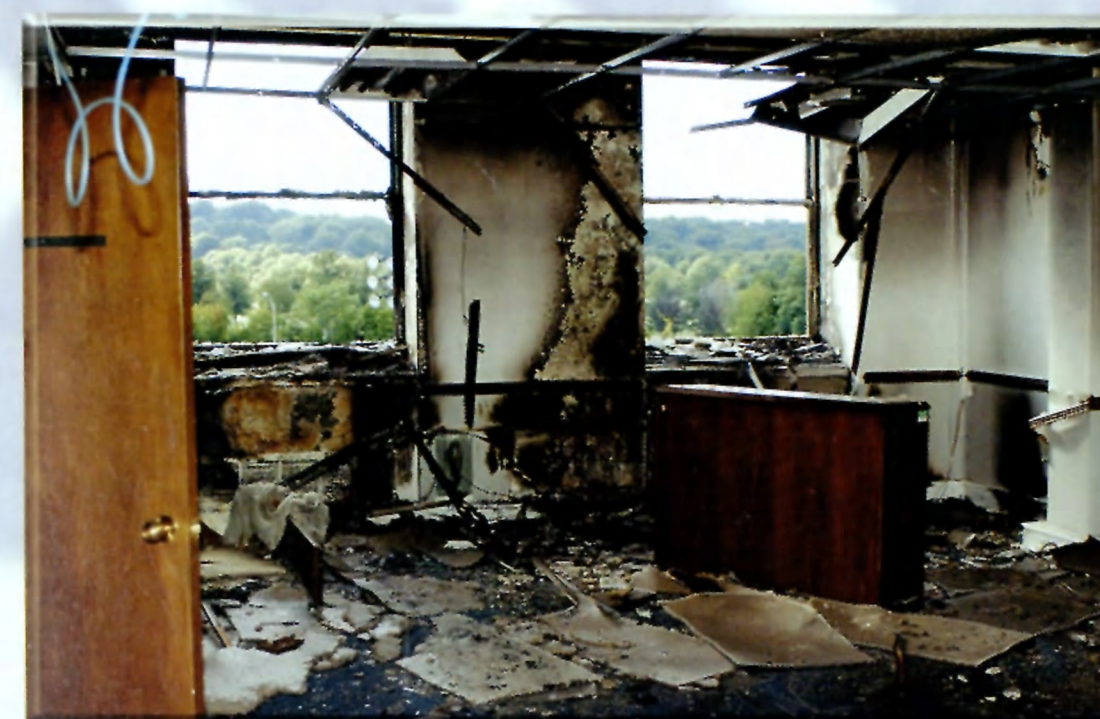
A burned office with original windows blown out. Fire spread easily through unrenovated areas without preventive sprinkler system.

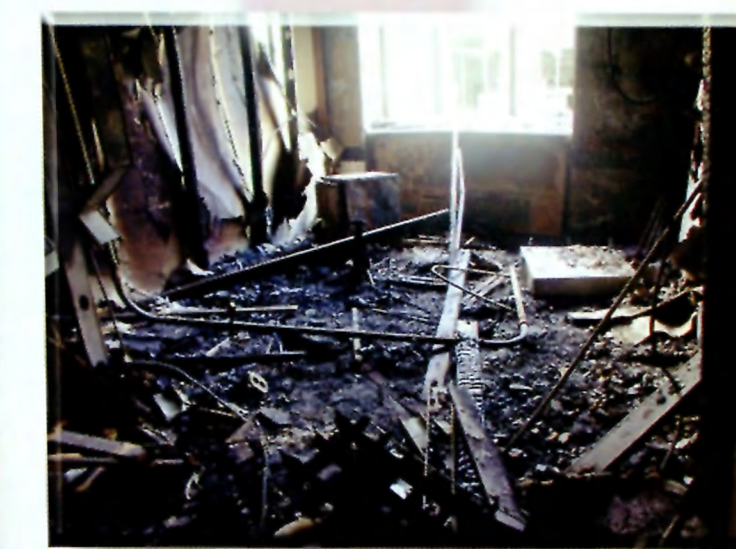
Occupants of these offices, adjacent to the collapsed impact area, survived the attack. Blast-resistant windows, supported by steel frames, remain visibly intact with curtains still in place. Walls remained sound due to Geotech panels that prevented fragmentation.

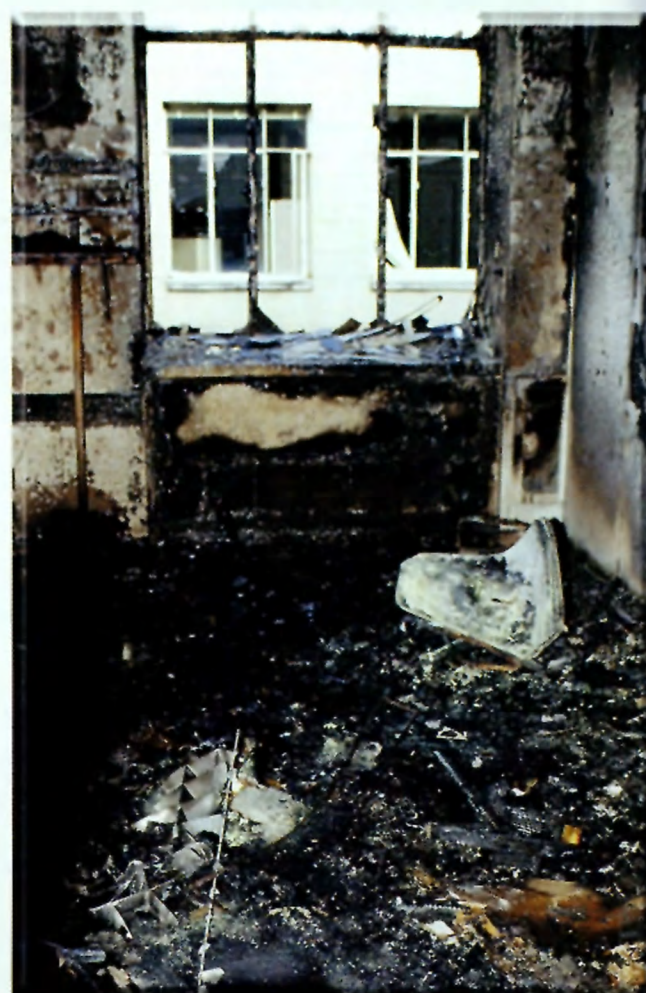
Damage inside an E Ring office without blast-resistant windows and other security designs was far greater.

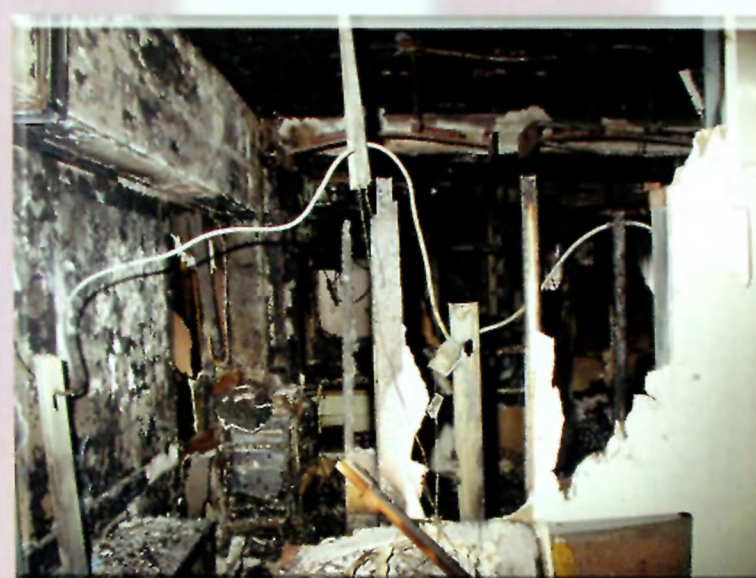
The remains of an office, including copy machine, in the impact area.
