FAILURE INVESTIGATIONS
OF
LARGE LIQUID PROPELLED
ROCKET ENGINE
COMPONENTS

G. J. East

Rocketdyne Division
North American Aviation, Inc.
Canoga Park, California

Western Metal and Tool Conference
Sponsored by the American Society for Metals
Los Angeles, California
March 15, 1967

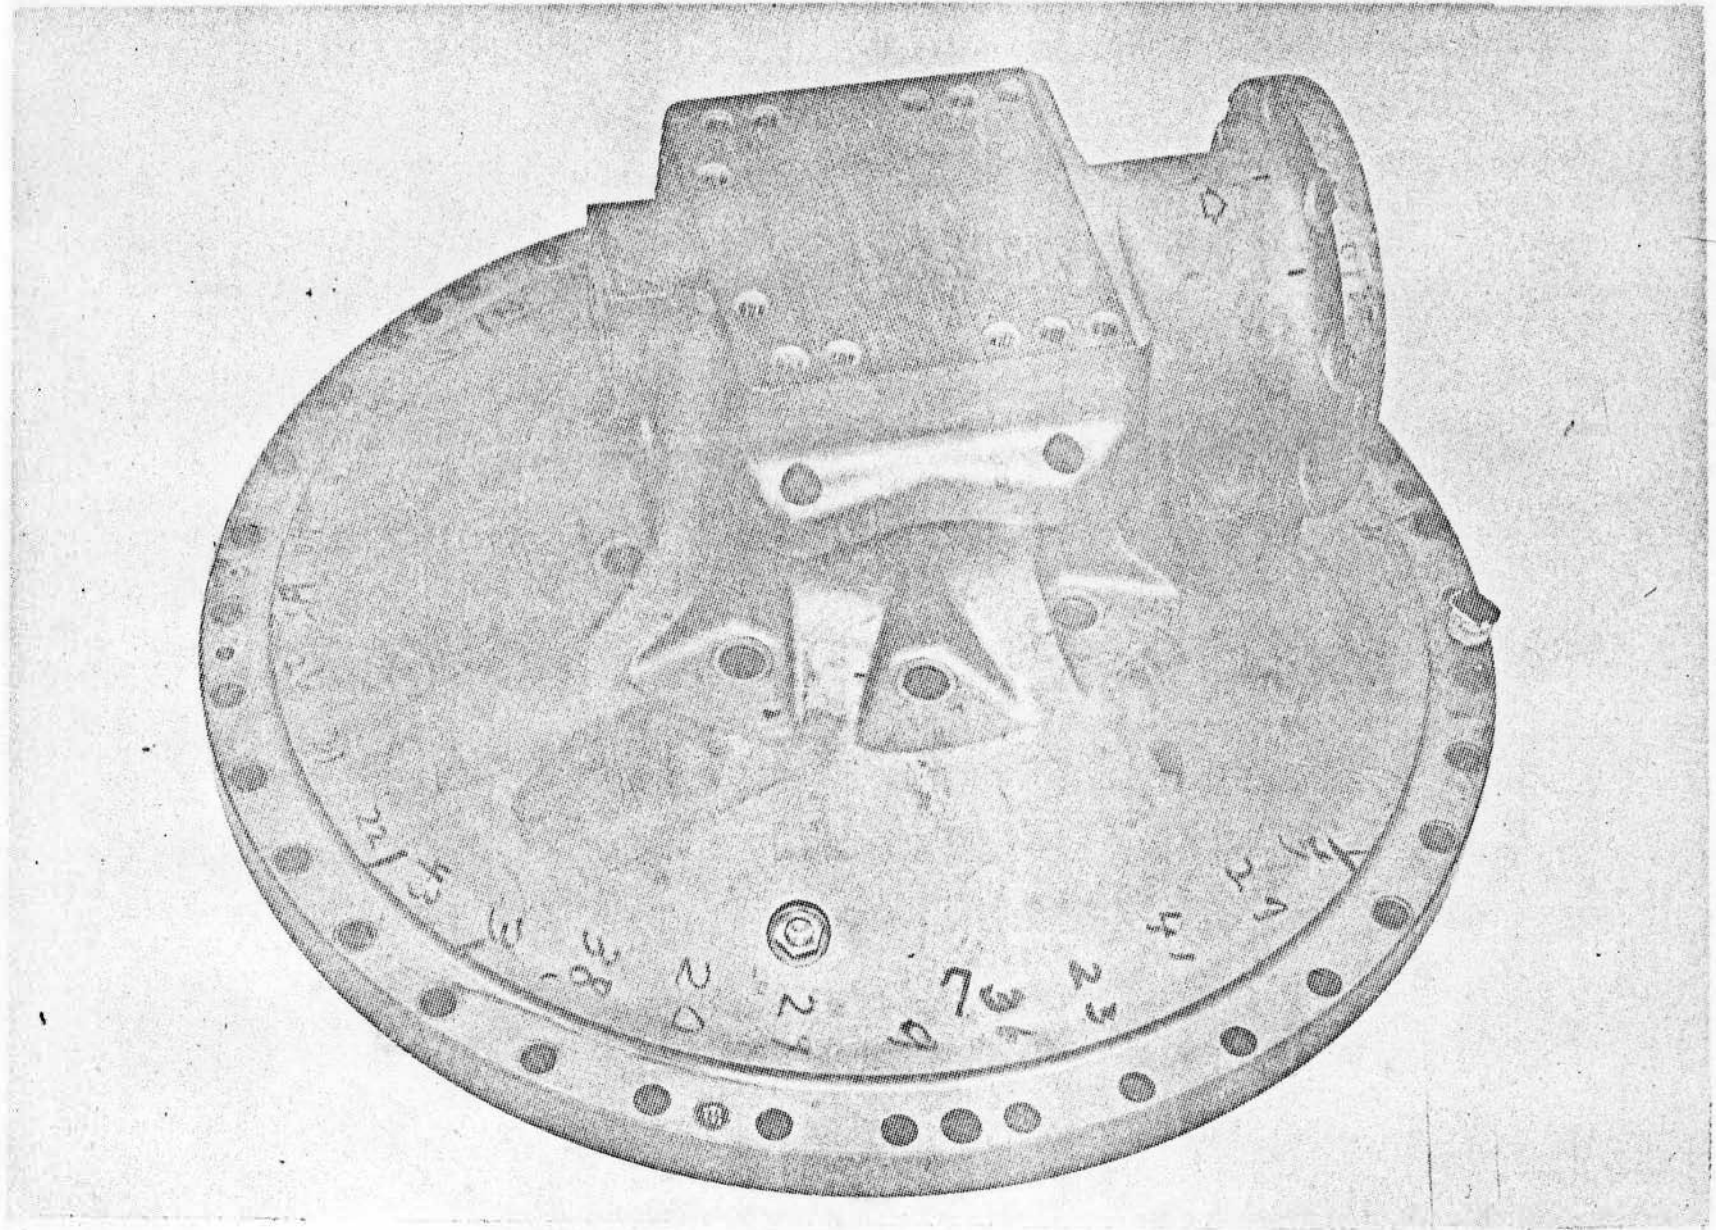
Failure Investigation Results: After removal from the engine, the dome was examined and the crack shown in Figure 1 and Figure 2 was observed. The metallurgical examination revealed the crack was parallel to the grain direction in the inlet area and therefore, the crack was in the weakest orientation and in the direction most susceptible to stress corrosion cracking. A metallographic examination of the crack, Figure 3 and Figure 4, revealed a intergranular "tree root" crack pattern typical of stress corrosion cracking. Stress corrosion test bars were removed from the dome inlet near the original crack and subjected to an alternate immersion test in 3-1/2% salt solution. The bars were stressed at 75% of yield strength and failed in 2 to 11 days.

From the results of the investigation, it was concluded that the failure was due to stress corrosion cracking. The stress being due to a combination of residual stress and additional stress due to installation of the connecting component to the inlet.

FIGURE 1. Crack in Dome Inlet

Solution: Three things were done to prevent the recurrence of the dome cracking problem. The material was changed to 7075 aluminum heat treated to the T73 temper. This is a slightly overaged condition and is virtually free from stress corrosion. The forging process was changed so that the grain direction in the inlet would always be parallel to the inlet centerline. This would preclude the possibility of stress across the short transverse direction. In addition, the dome was shot peened to place the surface in compression to reduce susceptibility to stress corrosion cracking.

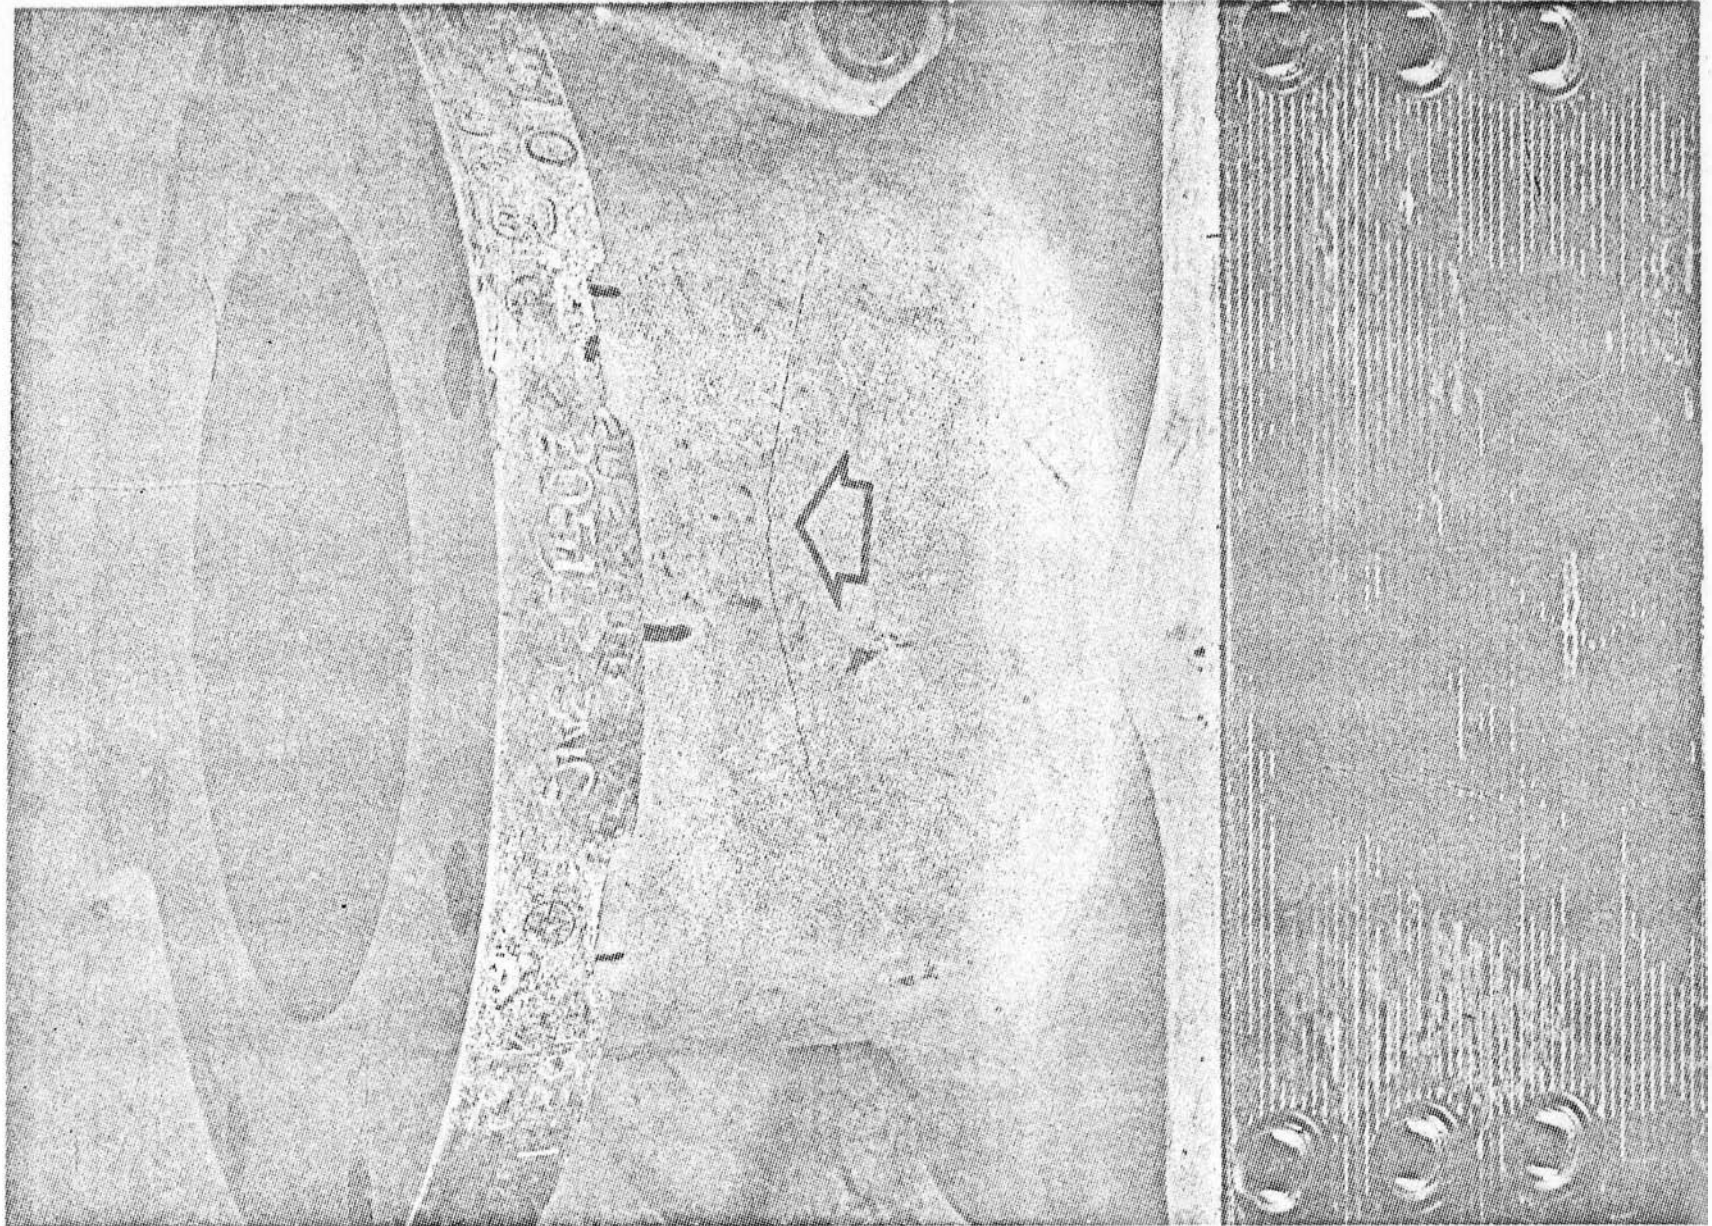
FIGURE 2. Crack in Dome Inlet

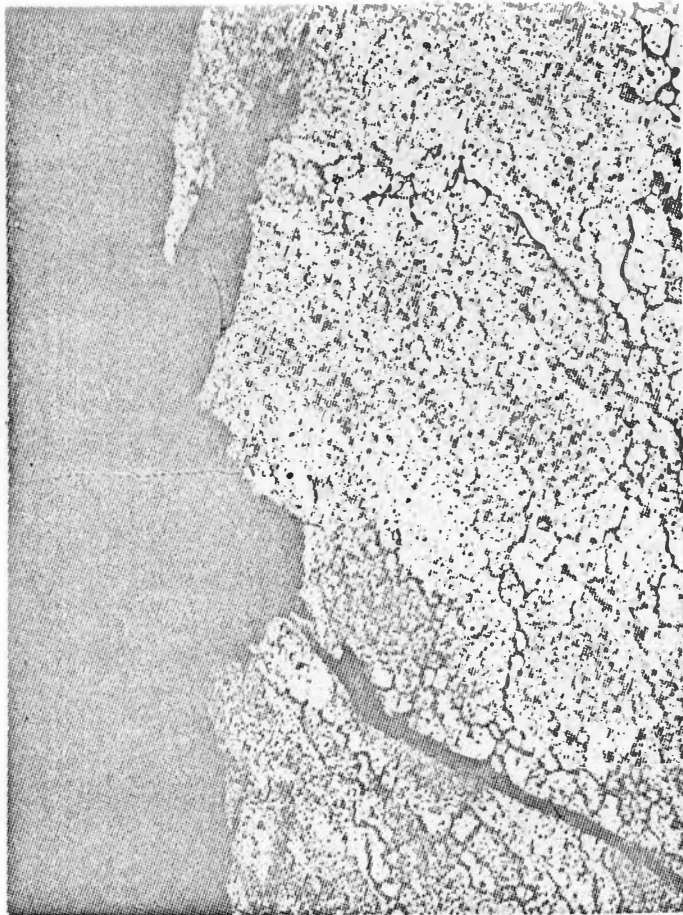
FIGURE 3. OD Start of Crack 500X

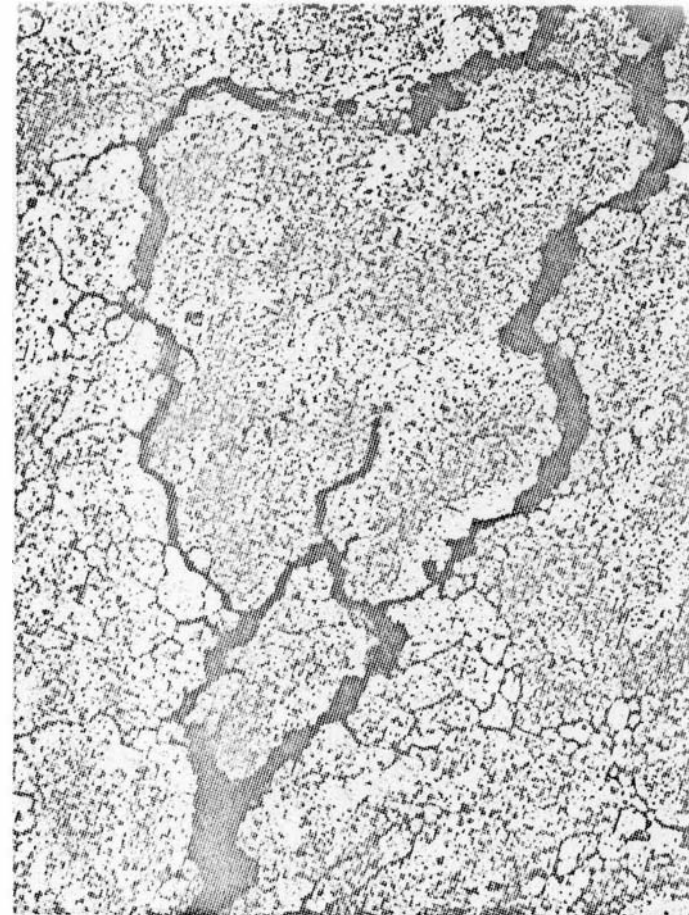
FIGURE 4. End of Crack 500X

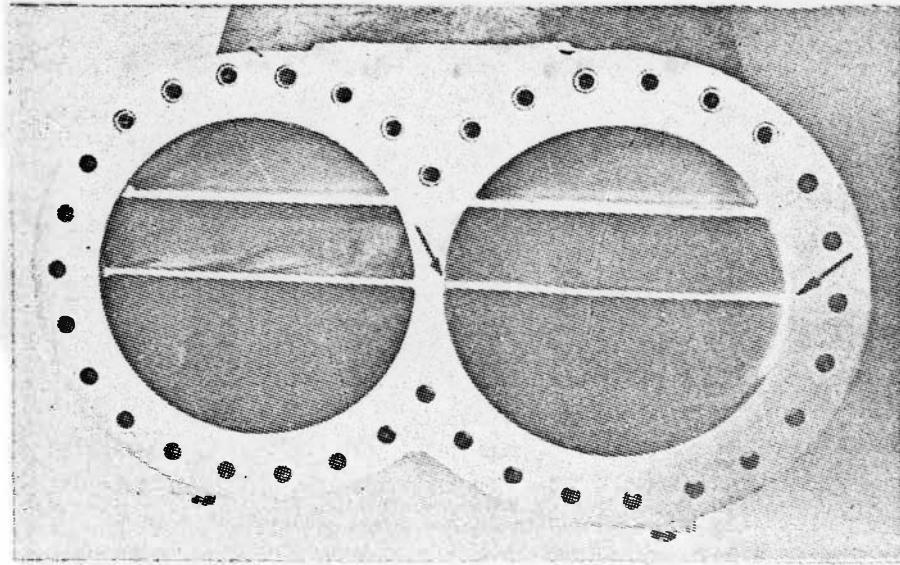
Problem: During a routine inspection of an engine fuel inlet duct, two small cracks were observed in one of the four vanes, Figure 5 and Figure 5A. The elbow is a Tens 50 aluminum casting heat treated to the T60 condition. The failed component was removed from an R & D engine after about 3000 seconds of operation.

Failure Investigation Results: A visual examination of the crack area revealed that the hand finishing of the fillet area was very rough and irregular. A strip from the defective vane was removed and fractured in the cracked areas. Visual and electron fractographs verified the crack was due to cyclic fatigue. Figure 6 shows a photomicrograph of the crack surface. In castings, particularly aluminum castings, the fatigue markings (beach marks) are not nearly as evident as they are in hardened steels or wrought aluminum alloys. However, the electron microscope fractograph, Figure 6, reveals the fatigue striations clearly.

FIGURE 5. The Arrows Indicate the Location of the Fatigue Cracks. Note that the Vane Is Slightly Bulged. 1/4 Scale

Solution: The solution to the fatigue problem was two-fold; first, the quality of the blend radius was improved and secondly, the inside of the elbow assembly was shot peened to have the surface in compression.

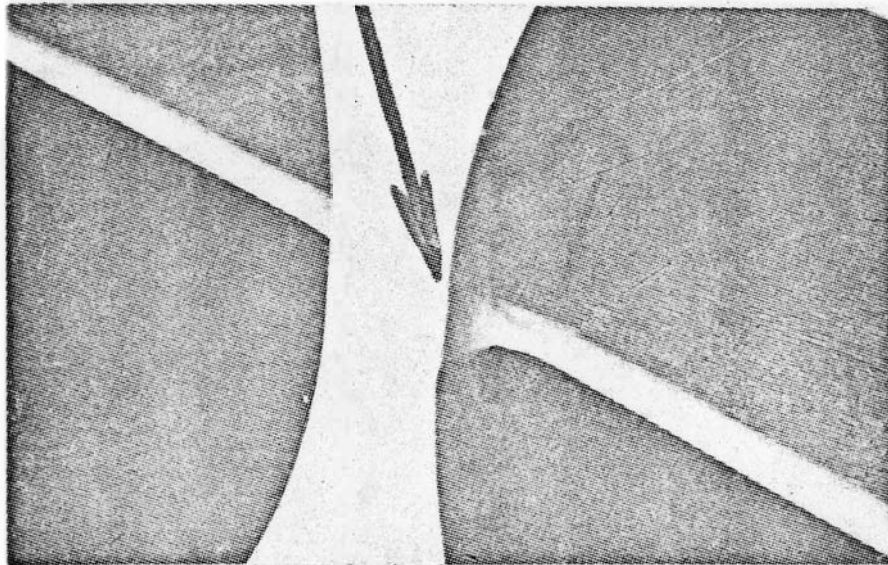
FIGURE 5A. Enlargement of the Photo Above. 1X

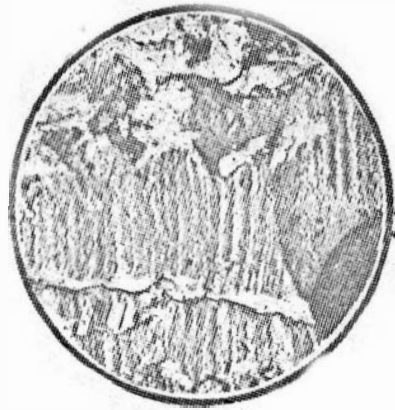
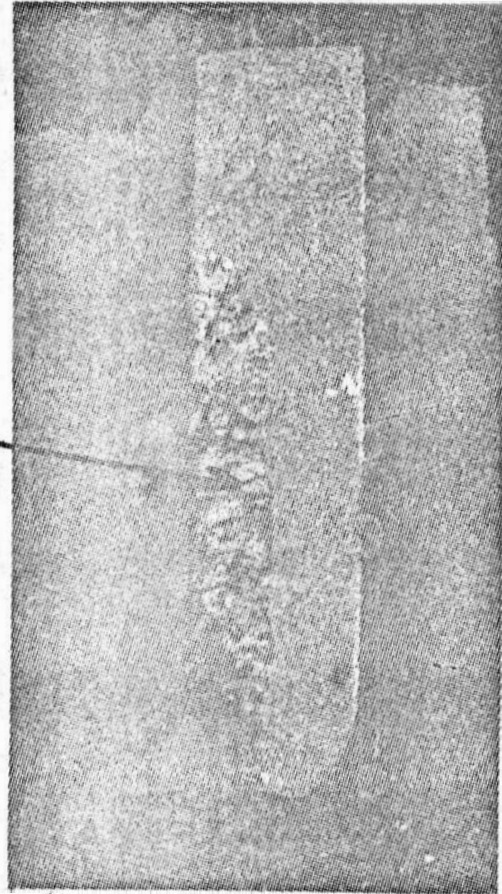
FIGURE 6.

Electron Microscope Fractograph
Showing Fatigue Striations
3000X

Photomacrograph of the Fracture
2X

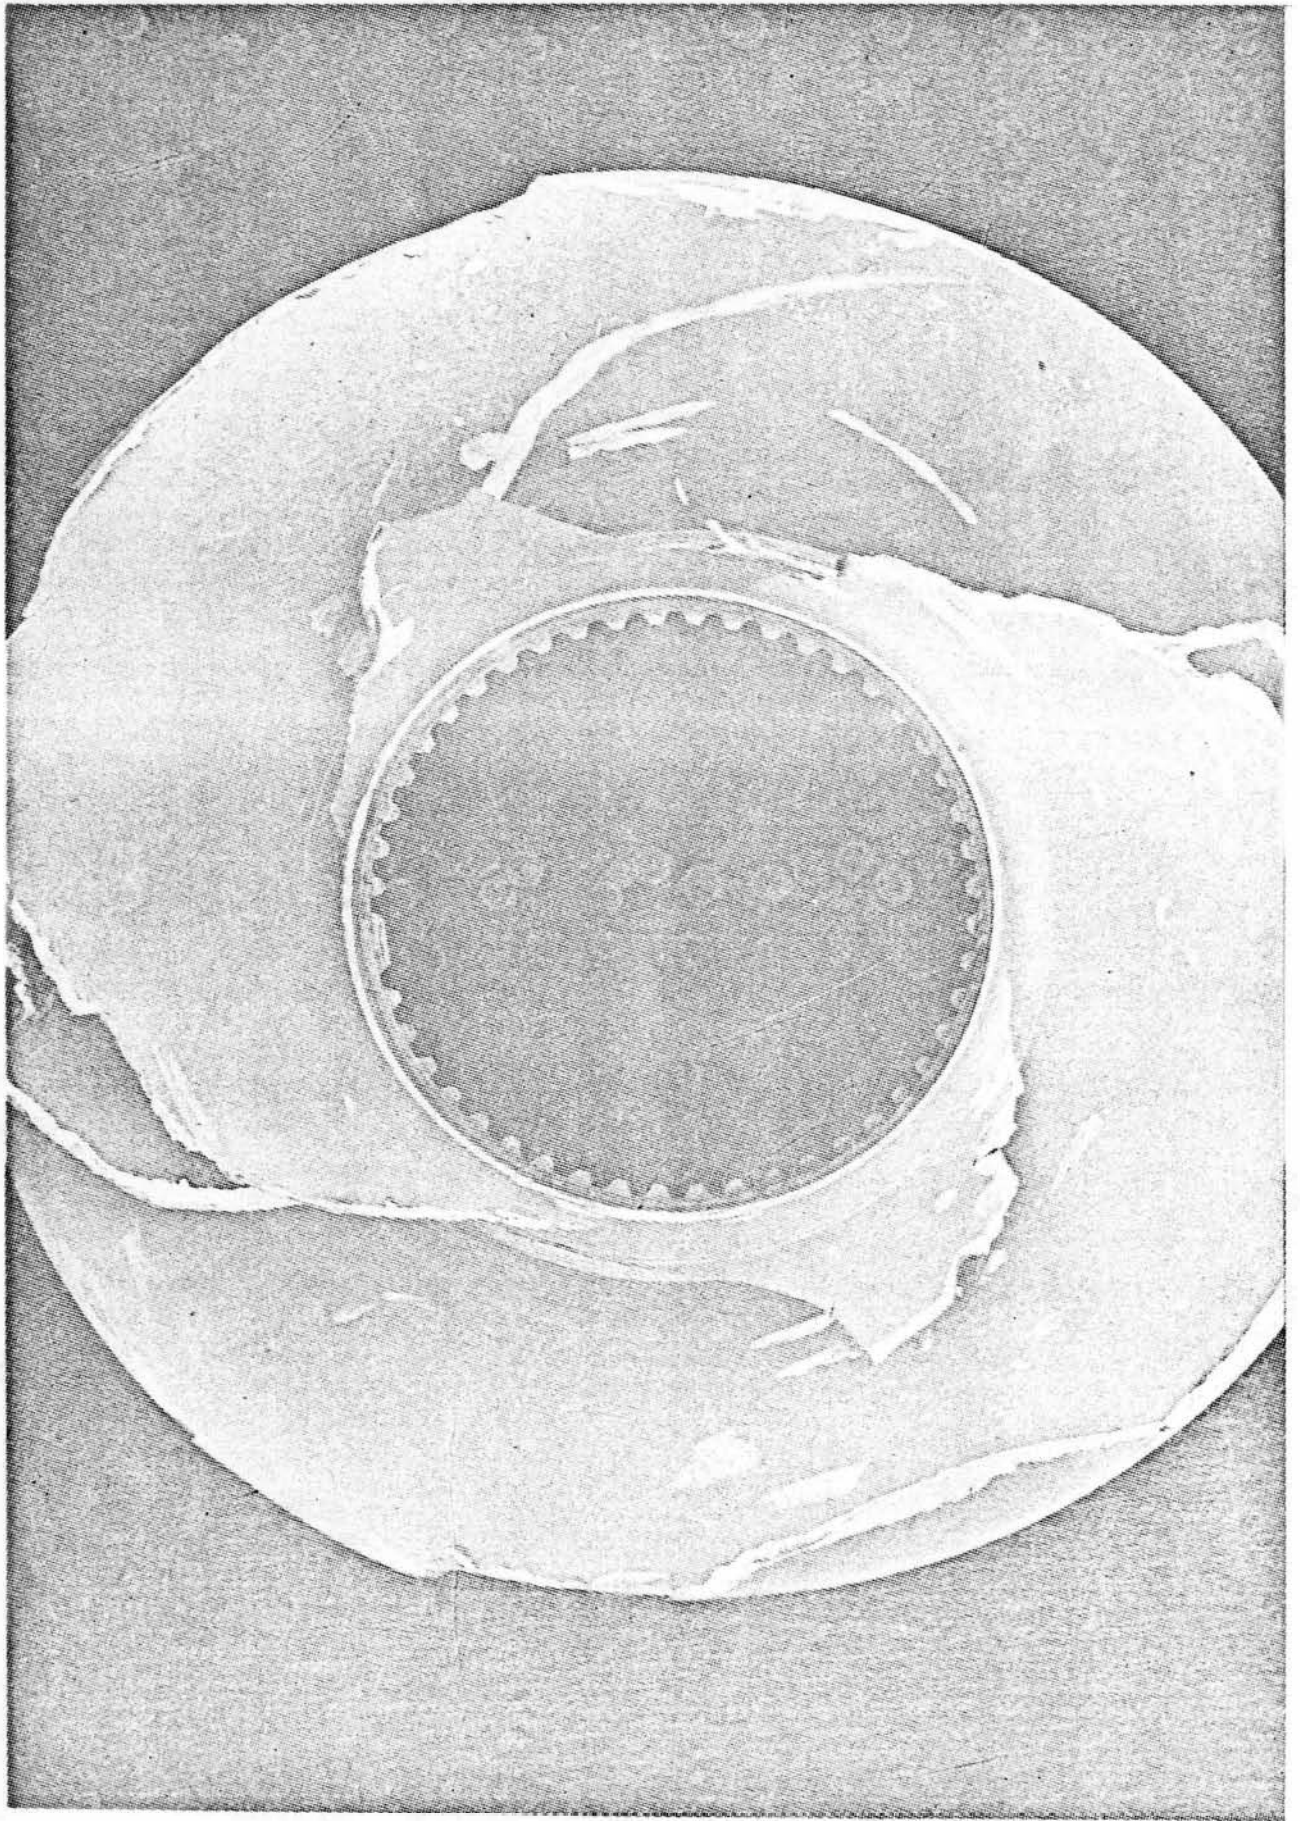
Problem: A failure occurred on an engine fuel turbopump inducer made of 7075 aluminum heat treated to the T73 temper. The inducer failed after approximately 2300 seconds of R & D operation. About one-half of the run time was under off-flow conditions in which various trim configurations were being investigated on the pump impeller. The pumped fluid is RP-1 fuel. Figure 7 is an overall view of the failed inducer.

Failure Investigation Results: The metallurgical investigation revealed that the inducer failed in fatigue due to vibration of the blades. The fatigue cracks which precipitated the failure proceeded across the thickness of the blade on one side according to Figure 8 and on the other side approximately 180° from the first failure. The strength of the material met the requirements of the specification. There was no stress corrosion cracking evident.

FIGURE 7. Overall View of Inducer 1/2X

Solution: The off-flow conditions experienced by this inducer caused the premature failure. These operating conditions created a large pressure change across the inducer which caused excessive cyclic bending of the blades which led to the fatigue fracture. Under normal ^{flow} conditions, failures have not been experienced in this component.

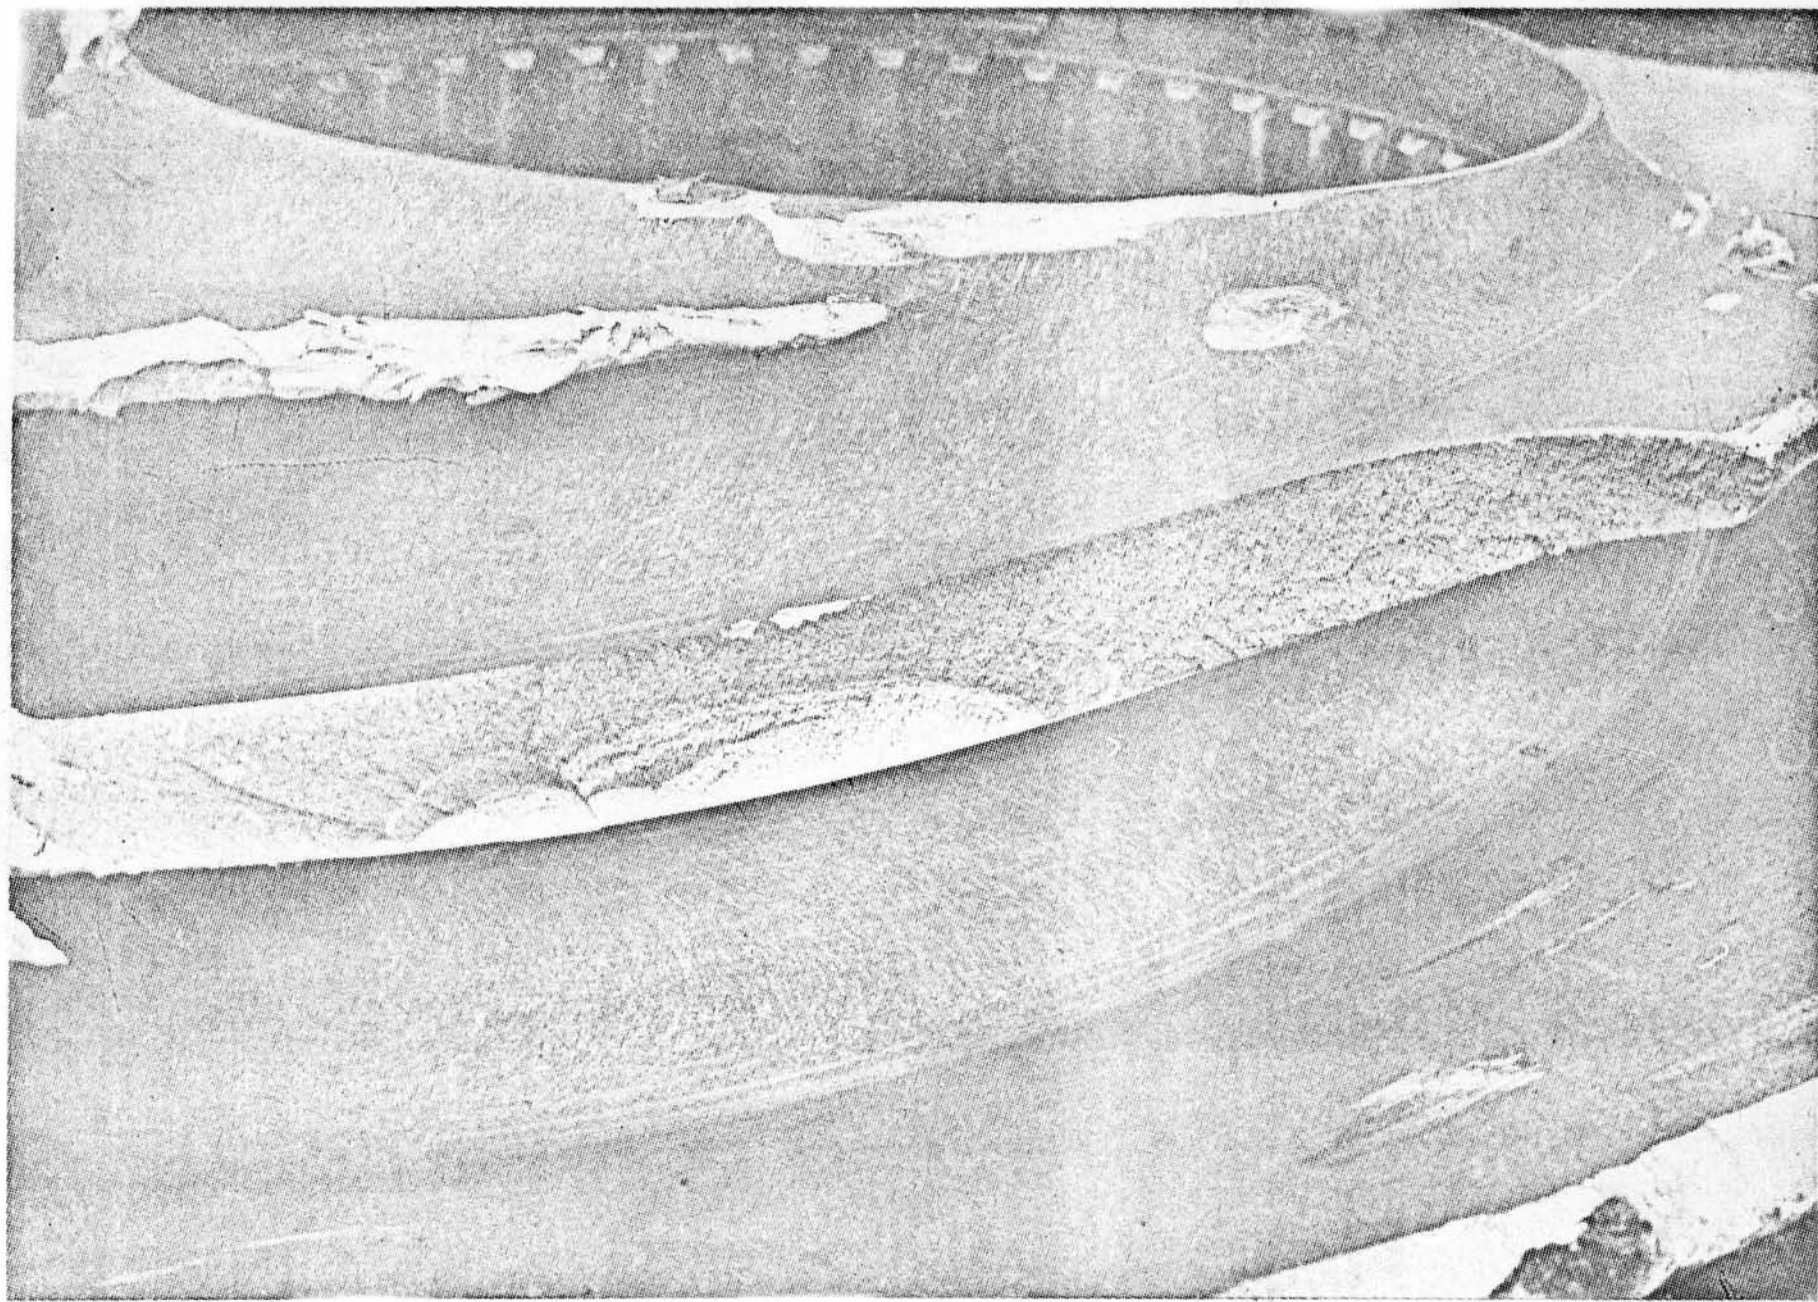
Figure 8 shows the typical fatigue markings (beⁿch marks) which were not nearly so evident in the previous investigation of the casting fatigue failure.

FIGURE 6. Fatigue Beach Marks on Inducer Blade IX

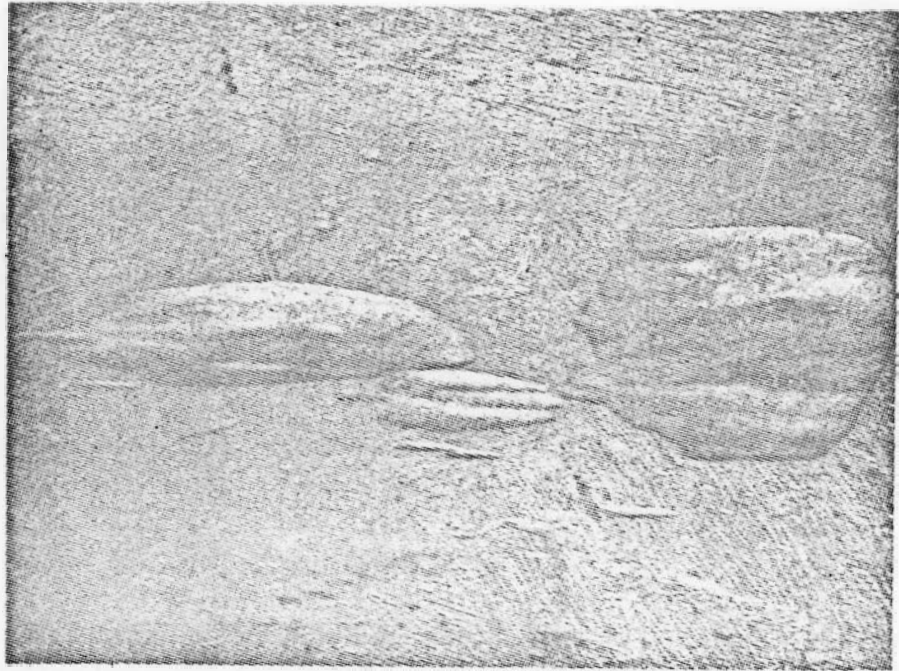
Failure and Investigation Results: Several typically damaged shingles were removed from a nozzle extension assembly and subjected to microscopic and metallographic examination. Figure 9 and Figure 10 illustrate degrees of erosion on the combustion side of the shingles and Figure 11 and Figure 12 show melting and coking on the shingle surfaces. The metallographic examination revealed a carburized surface on the shingles, Figure 13.

FIGURE 9. Typical Erosion on the Combustion Side of the Shingle. Mag: 4X

Solution: Up to the present time, a complete solution to the problem has not been found; however, various protective coatings that will prevent or retard carburization are being tested with some success.

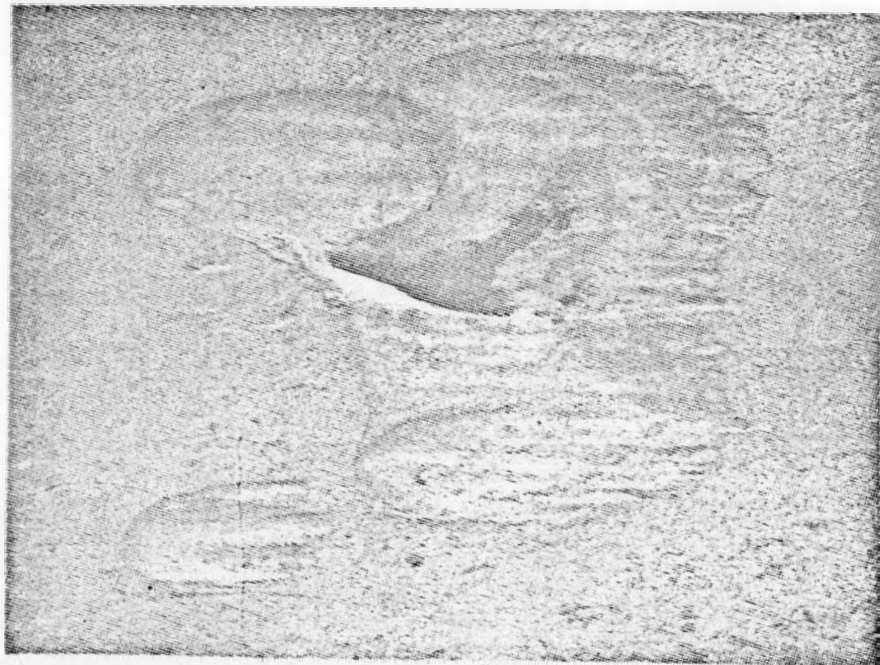
FIGURE 10. A More Advanced Degree of Erosion. Mag: 4X

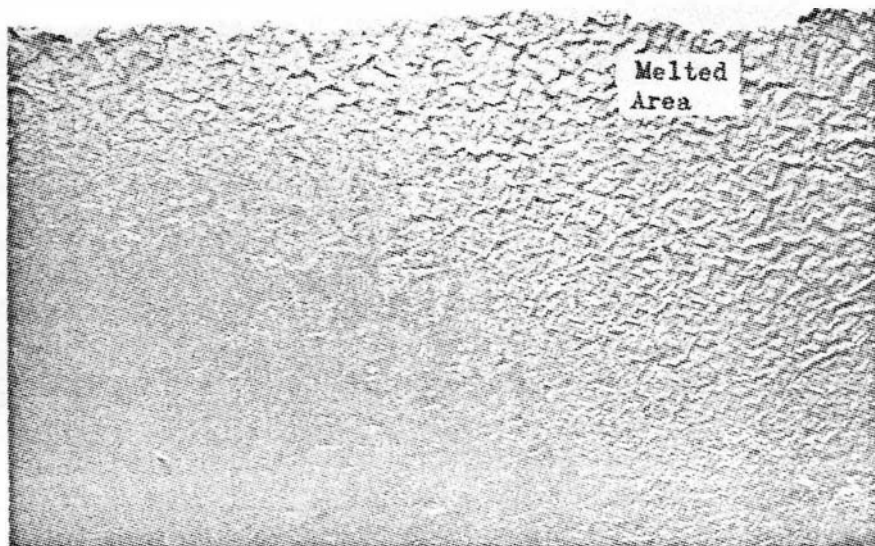
FIGURE 11. Combustion Side of A Shingle. Note the Initial Stages of Surface Melting Prior to Erosion.
Mag: 10X

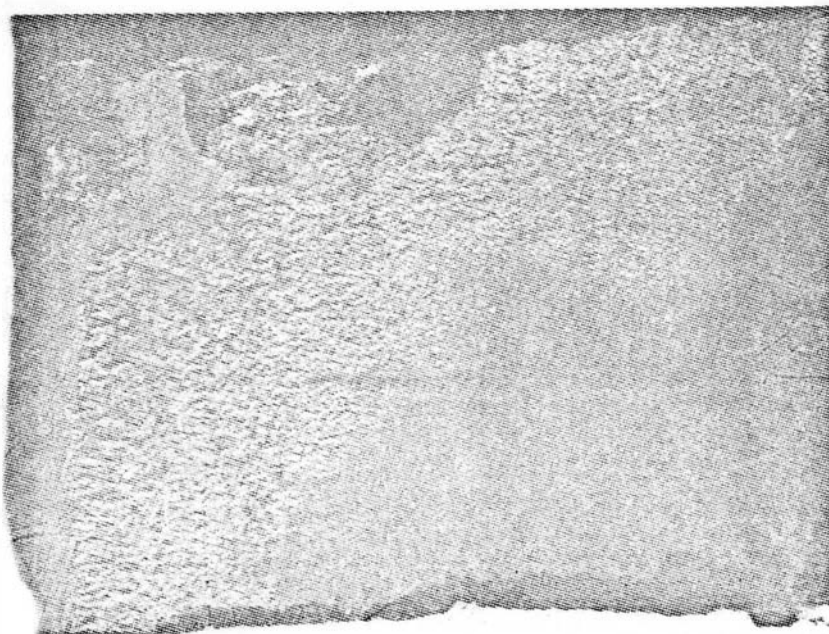
FIGURE 12. Coolant Side of Shingle. Note the Surface Melting and Coking.
Mag: 10X

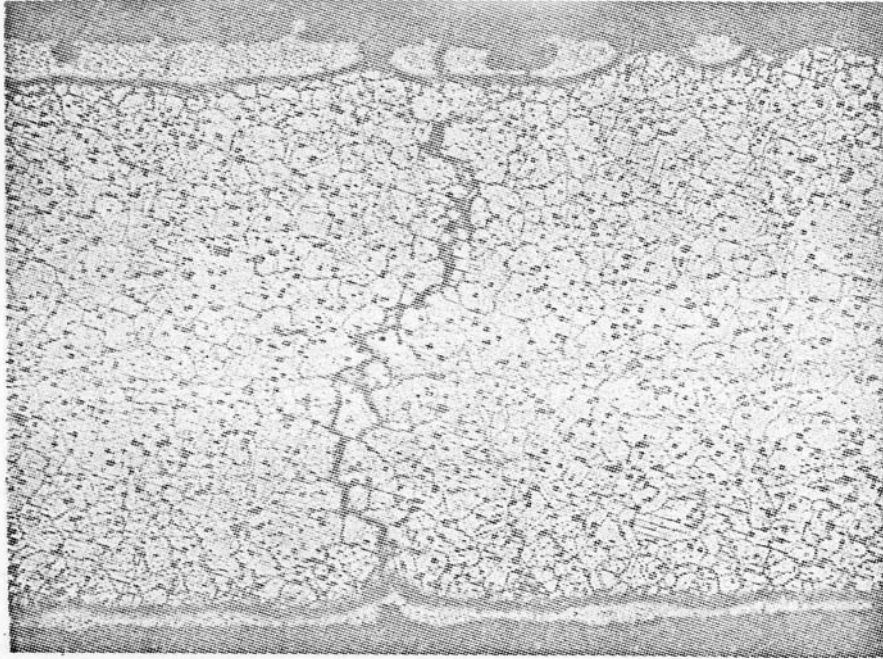
The turbine exhaust gases are fuel rich and carburizing in nature and the temperature is sufficient to cause carburization. The failures were due to the following sequence of events:

2. With time and localized temperature increases, due to carbon build-up and subsequent restricted coolant gas flow, areas of the shingles become carburized.
3. The higher carbon content on the surface of the Hastelloy C sheet lowered the melting temperature of the alloy sufficiently to cause premature surface melting and subsequent erosion. The high carbon skin also resulted in a brittle layer susceptible to cracking on engine starts.

FIGURE 13. Corss-Section through A Cracked Area
Showing Carburized Surfaces.

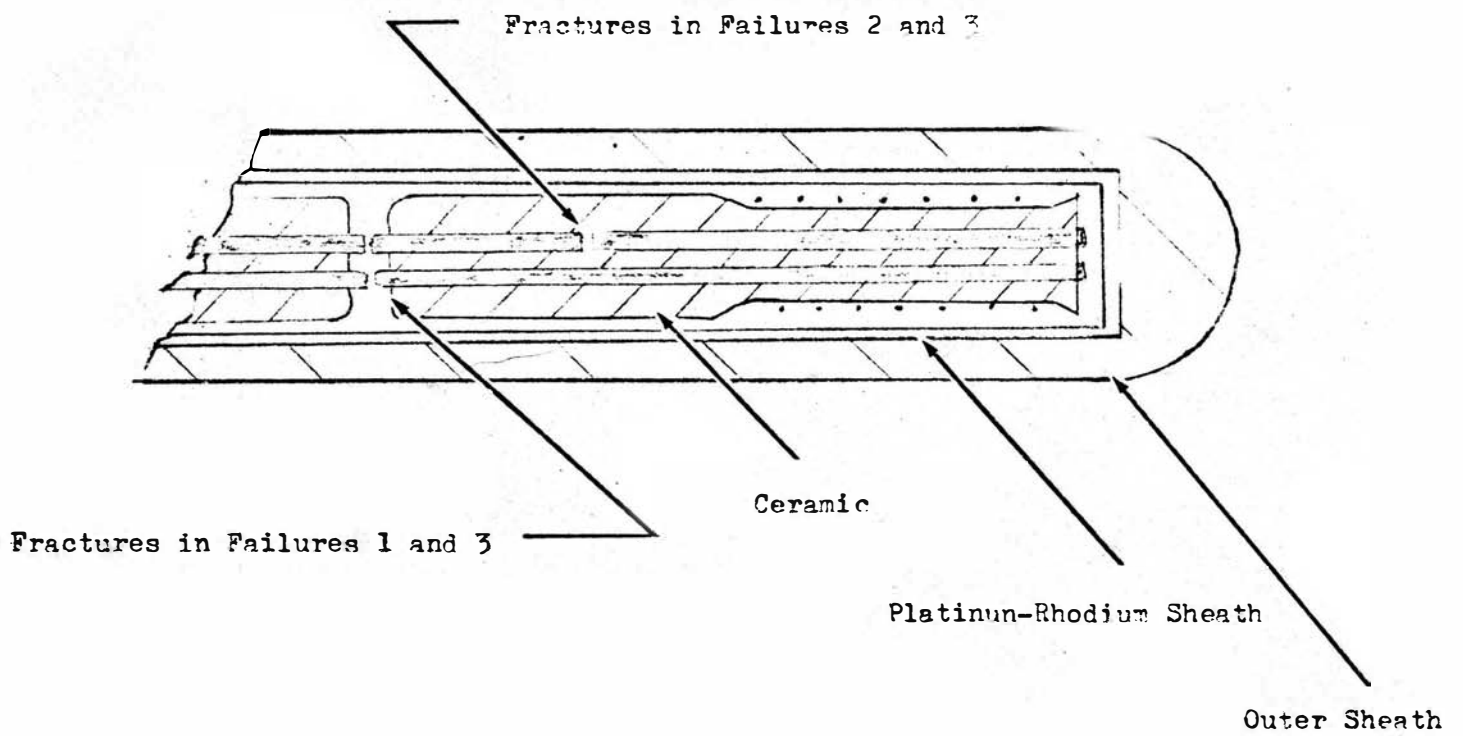
Failure Investigation Results: Figure 14 is a schematic sketch of the transducer showing the location of failures. Figure 15 is a positive enlargement of a x-ray of the transducer showing the failure location so that sections could be cut in the proper location in order not to damage any evidence inside the housing. After disassembly metallographic sections were prepared and examined. Figure 16 shows an intergranular constituent extending completely through the cross section and Figure 17 shows a brittle fracture following the intergranular constituent. A microprobe analysis was conducted on the grain boundary constituent and this revealed the presence of phosphorus. Figure 18 is an electron microprobe readout

FIGURE 14. Schematic Sketch of Transducer Tip End Showing Approximate Platinum Wire Fracture Locations in each Failure as Designated.

Solution: The transducer has been redesigned to make the ceramic core slightly larger for more strength and the use of ceramic cement has been discontinued. These changes have increased the service life of the probes considerably.

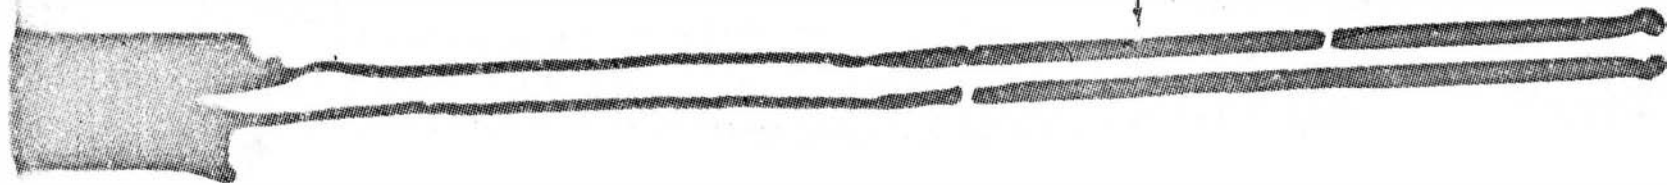
FIGURE 15. X-ray Photograph of Failure Number Three. This Enlarged Photographic Positive Print Reveals that Failure Number Three Experienced Platinum Lead Wire Fracture in Three Locations. The Wire Segment with Two Fractured Ends Was Chosen for Metallographic and Microprobe Analysis.

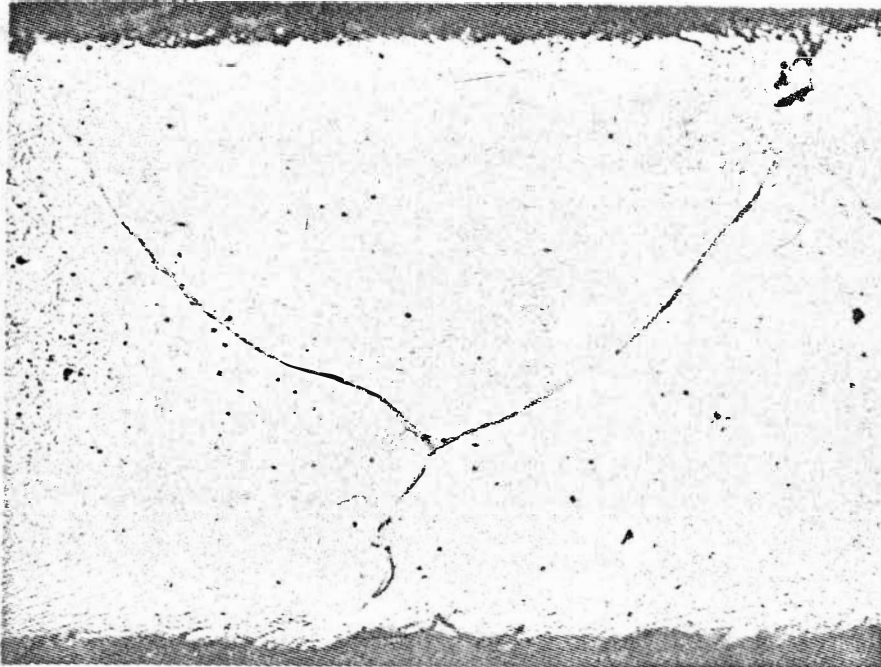
FIGURE 16. Photomicrograph of the Wire Segment Chosen for Investigation from Failure Number Three Showing Presence of a Constituent in the Platinum Grain Boundaries. The Photomicrograph Illustrates How This Intergranular Constituent Extends Completely through Wire Cross-Section.

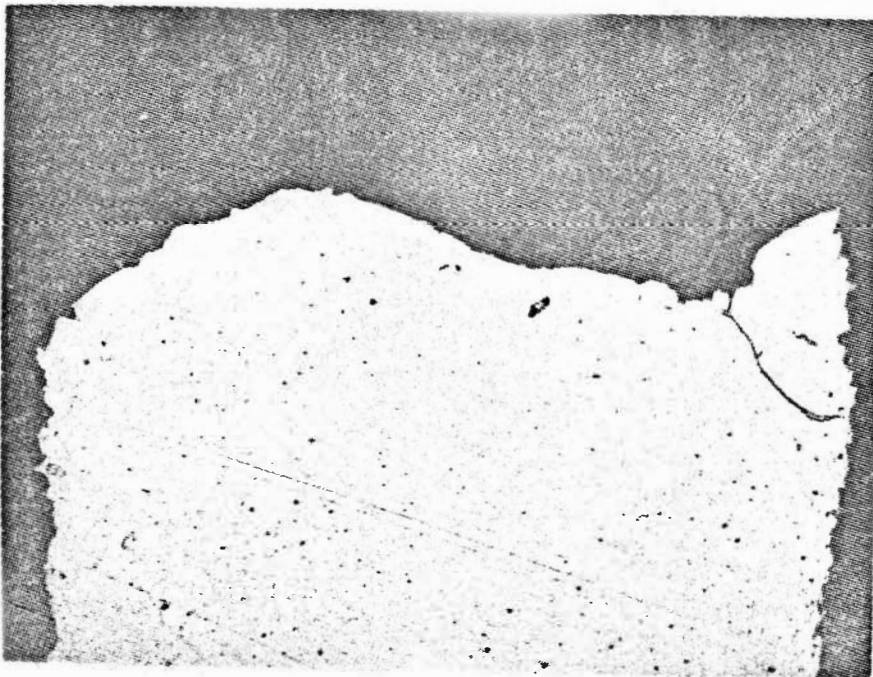
Wire failure mode may be described as grain boundary melting at operating temperature caused by formation of intergranular low melting platinum-phosphorus constituent. The resulting metallurgical structure was incapable of withstanding vibrational loading imposed during engine operation. Fracture took place in the assumed semi-molten grain boundary area without ability for plastic deformation.

FIGURE 17. Photomicrograph of a Fractured End in the Wire Segment from Failure Number Three Showing Presence of an Intergranular Constituent in the Fracture Surface Vicinity. Note Lack of Plastic Deformation at Fracture Surface.

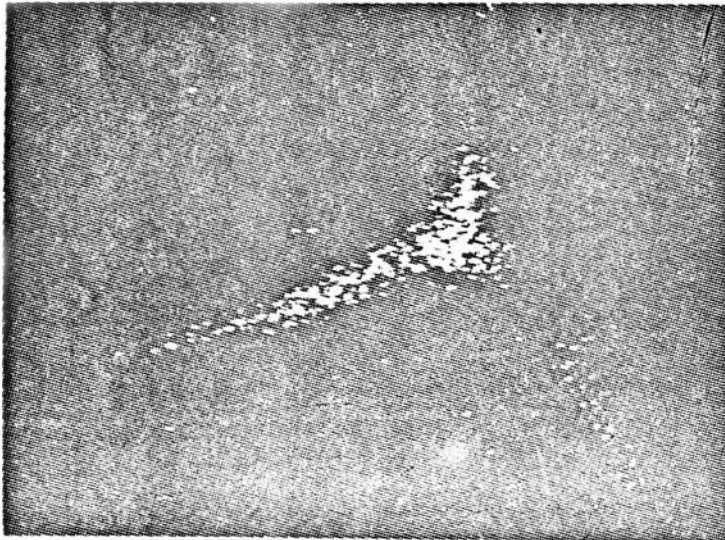
of the grain boundary area in Figure 16. The x-ray detector was set for selective response only to phosphorus. The light dots indicate phosphorus response from the intergranular constituents. Figure 19 is an electron fractograph of a fracture face. Contour line indications of a solidification reaction are seen. The fractograph illustrates that the fractured surface existed as a liquid phase

Further investigation revealed that the phosphorus came from the ceramic cement used in the construction of the probe.

FIGURE 18. Electron Microprobe Readout of Microprobe Analysis Area Illustrated in Figure 16, with X-ray Detector Set for Selective Response Only to Phosphorus. Light Dots Indicate Phosphorus Response from the Intergranular Constituent.

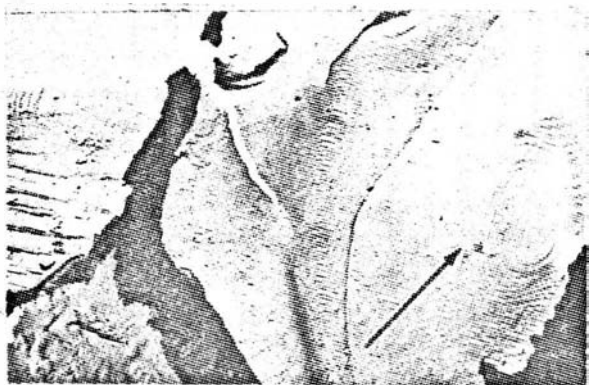
FIGURE 19. Electron Fractograph of Fractured Surface Failure Number Two. Arrows Point to the "Contour Lines" which are Indicative of a Solidification Reaction. The Fractograph Illustrates that the Fractured Surface Existed as a Liquid Phase.

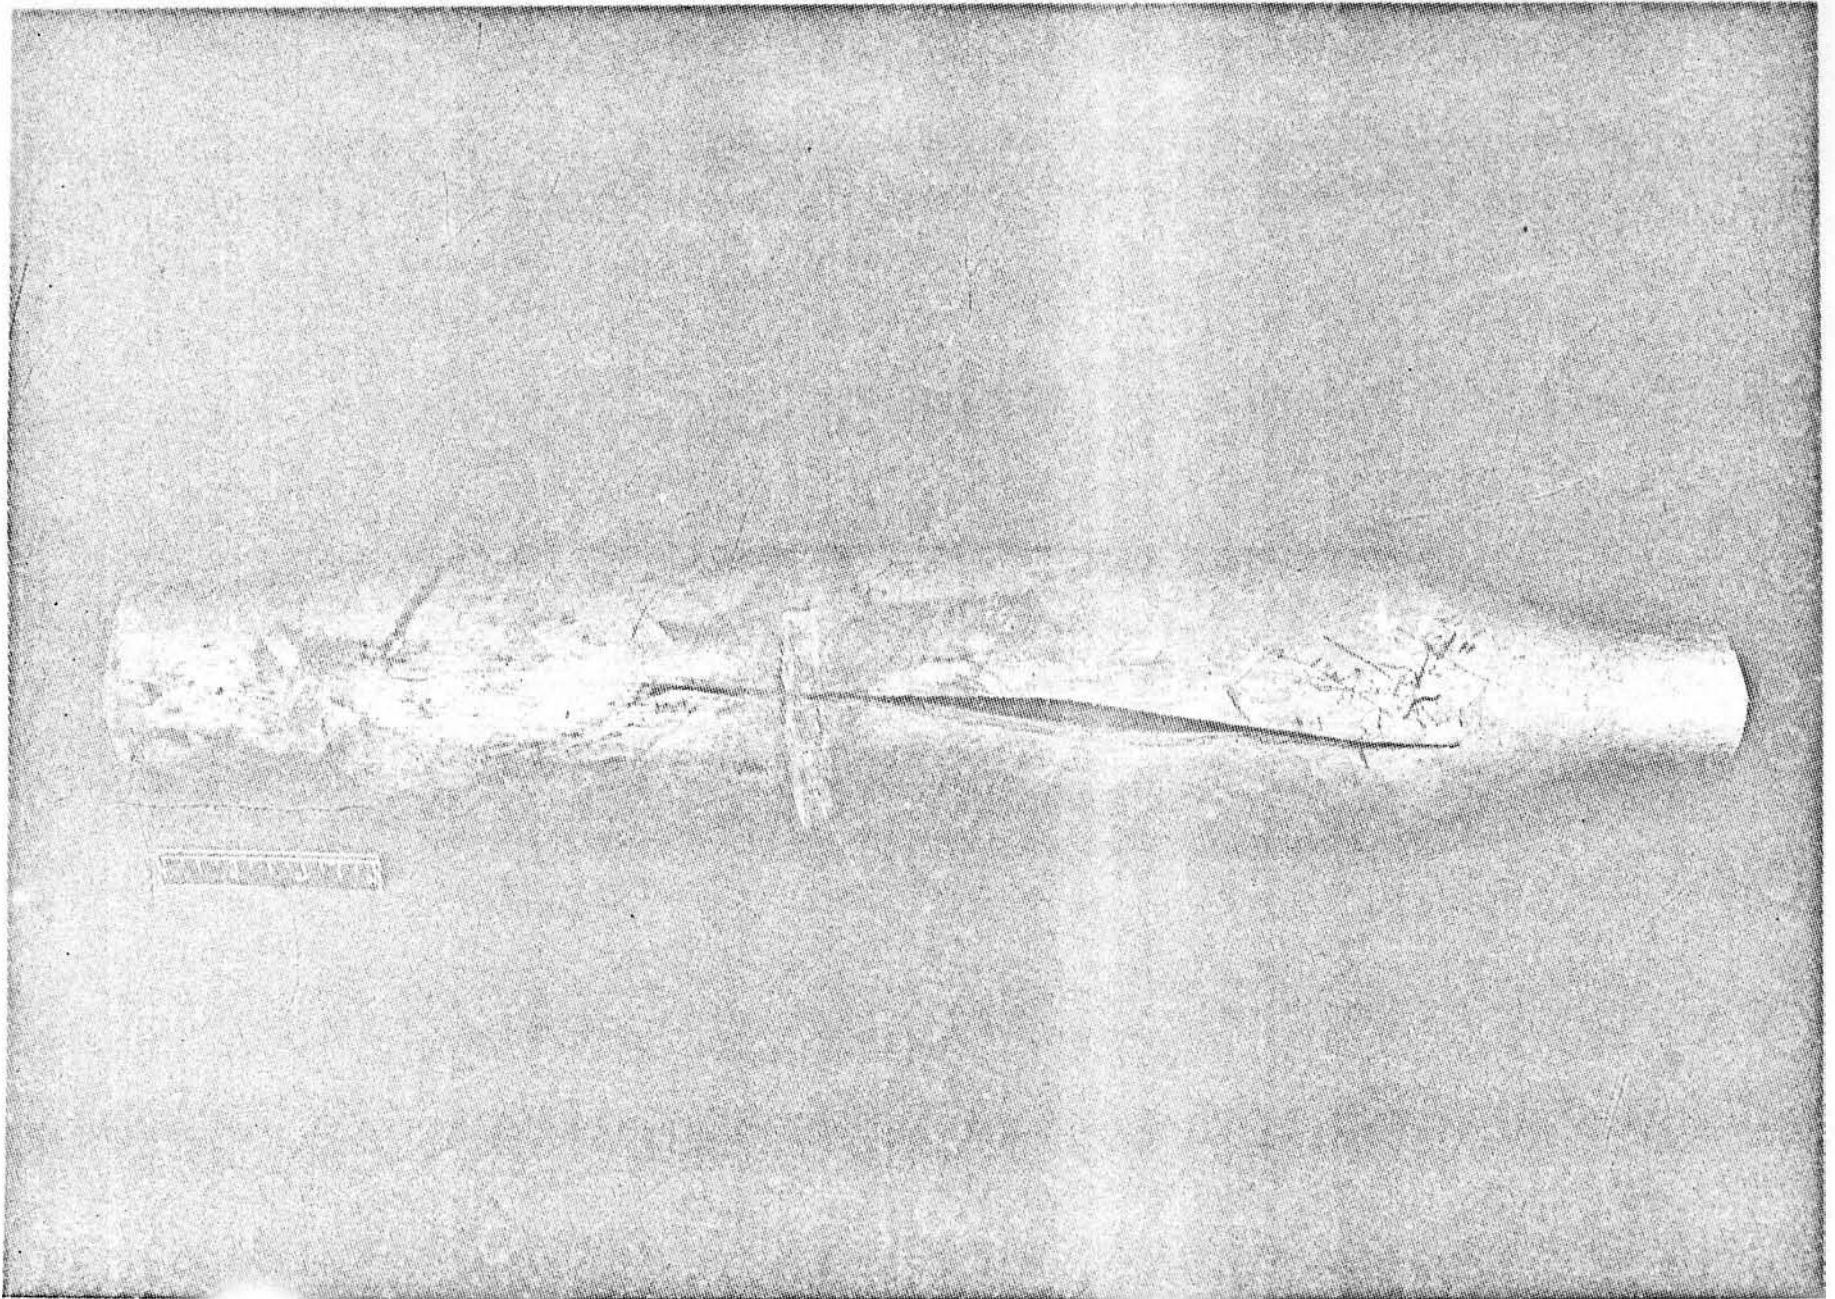
Failure Investigation Results: A metallurgical examination revealed that the material conformed to AMS-6372, 4135 steel tubing and was properly heat treated to 160 - 180,000 psi. The fracture, Figure 20, indicated that the failure was not caused by a defect and was ductile in nature.

From the investigation, it was concluded that the fracture was the result of water freezing inside the strut.

FIGURE 20. Failed Strut

Solution: Provisions for removing entrapped water from struts and eliminating entrance holes were made on all chambers. Since this provision was put into effect there have been no strut cracking problems.
