FAILURE INVESTIGATIONS
OF
LARGE LIQUID PROPELLED
ROCKET ENGINE
COMPONENTS

G. J. East

Rocketdyne Division
North American Aviation, Inc.
Canoga Park, California

Western Metal and Tool Conference
Sponsored by the American Society for Metals
Los Angeles, California
March 15, 1967

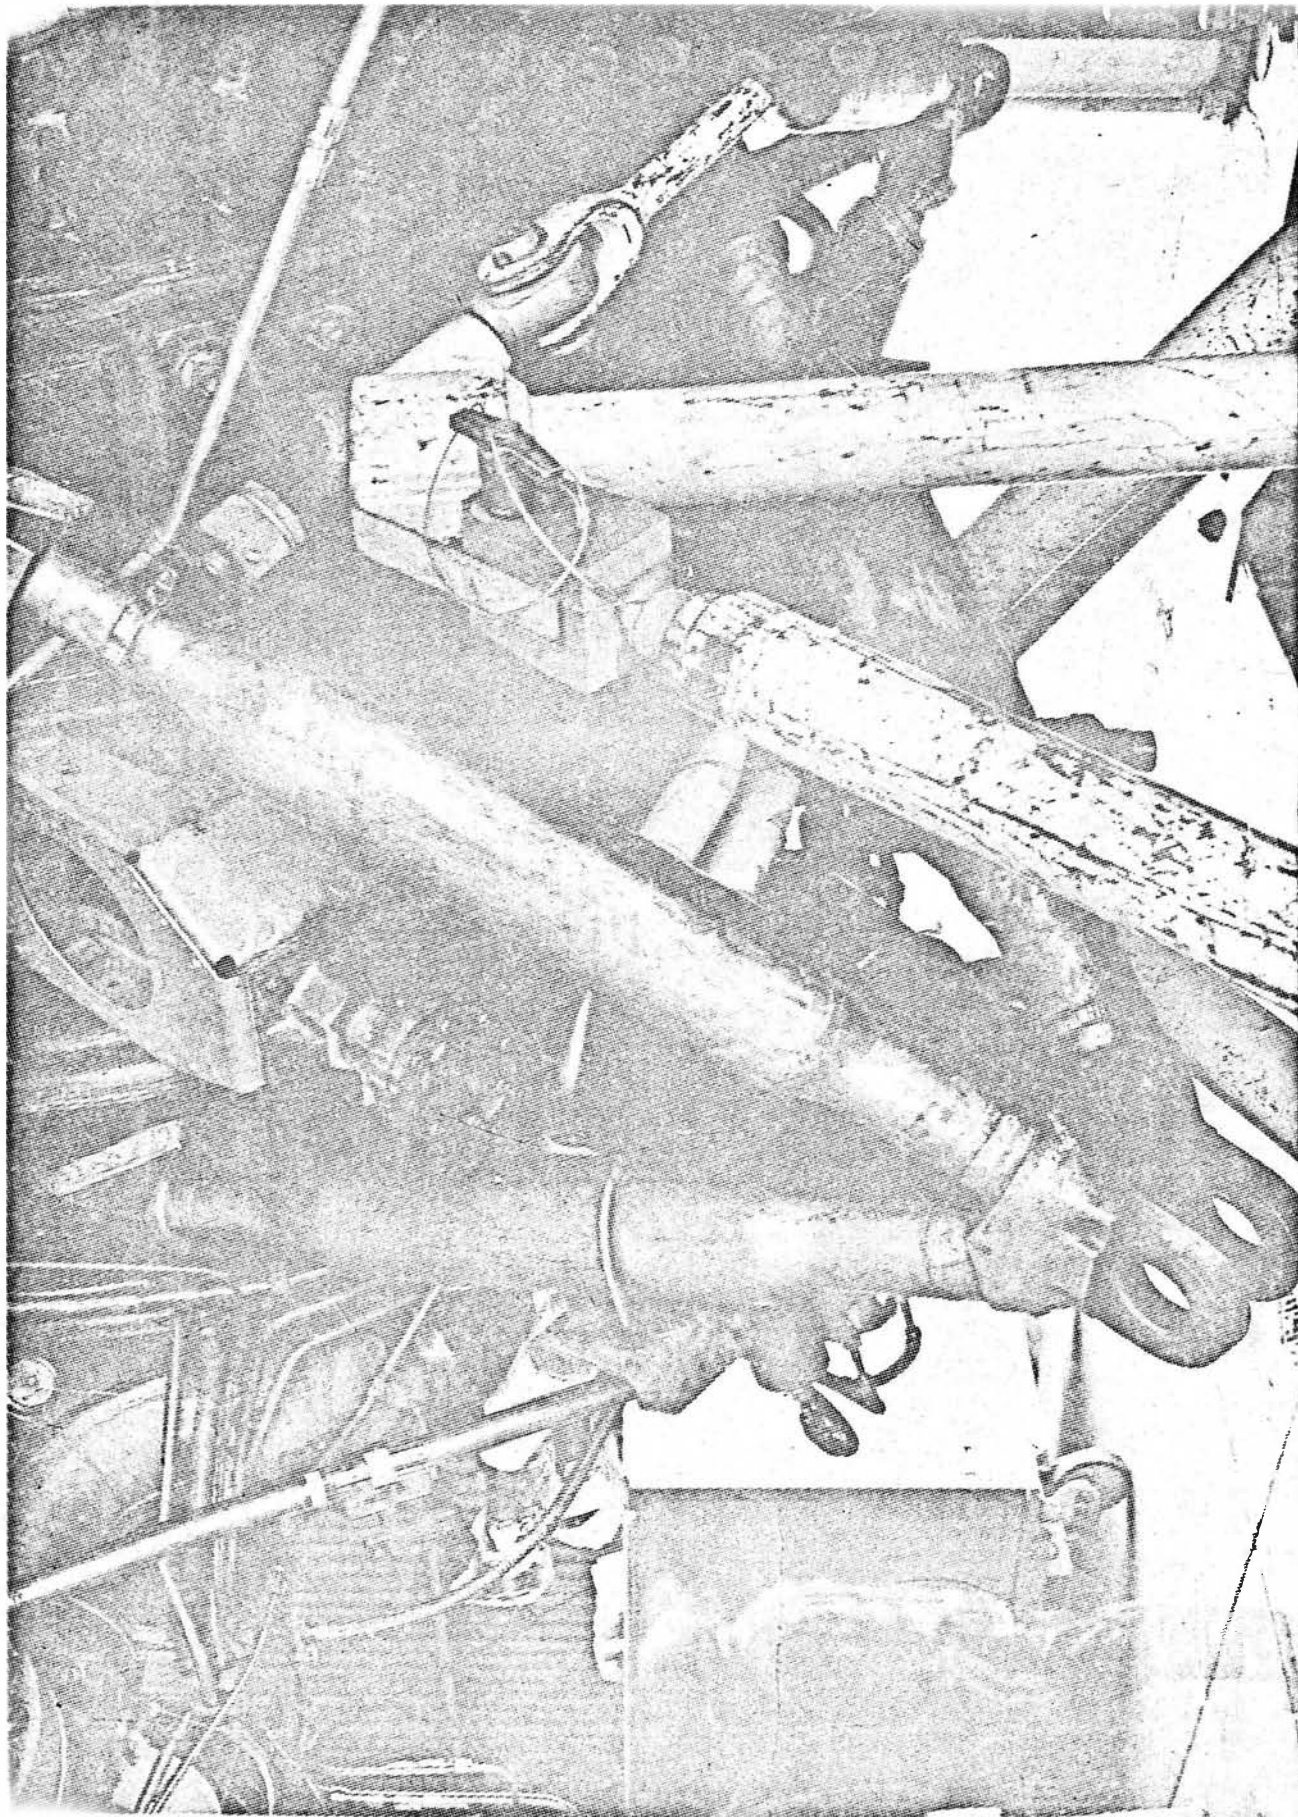
The general appearance of the failed area of the strut indicated that failure had occurred from an internal force. When the strut was removed from the engine, it had been noted as being partially full of water. Further examination of the chamber revealed that water could be introduced through holes in the pad and drain between the jacket and aggregate assembly to the strut in question, Figure 21. An x-ray and ultrasonic examination of a strut adjacent to the failed one showed it to be approximately half full of water.

FIGURE 21. Failed Strut on Engine

Solution: Provisions for removing entrapped water from struts and eliminating entrance holes were made on all chambers. Since this provision was put into effect there have been no strut cracking problems.

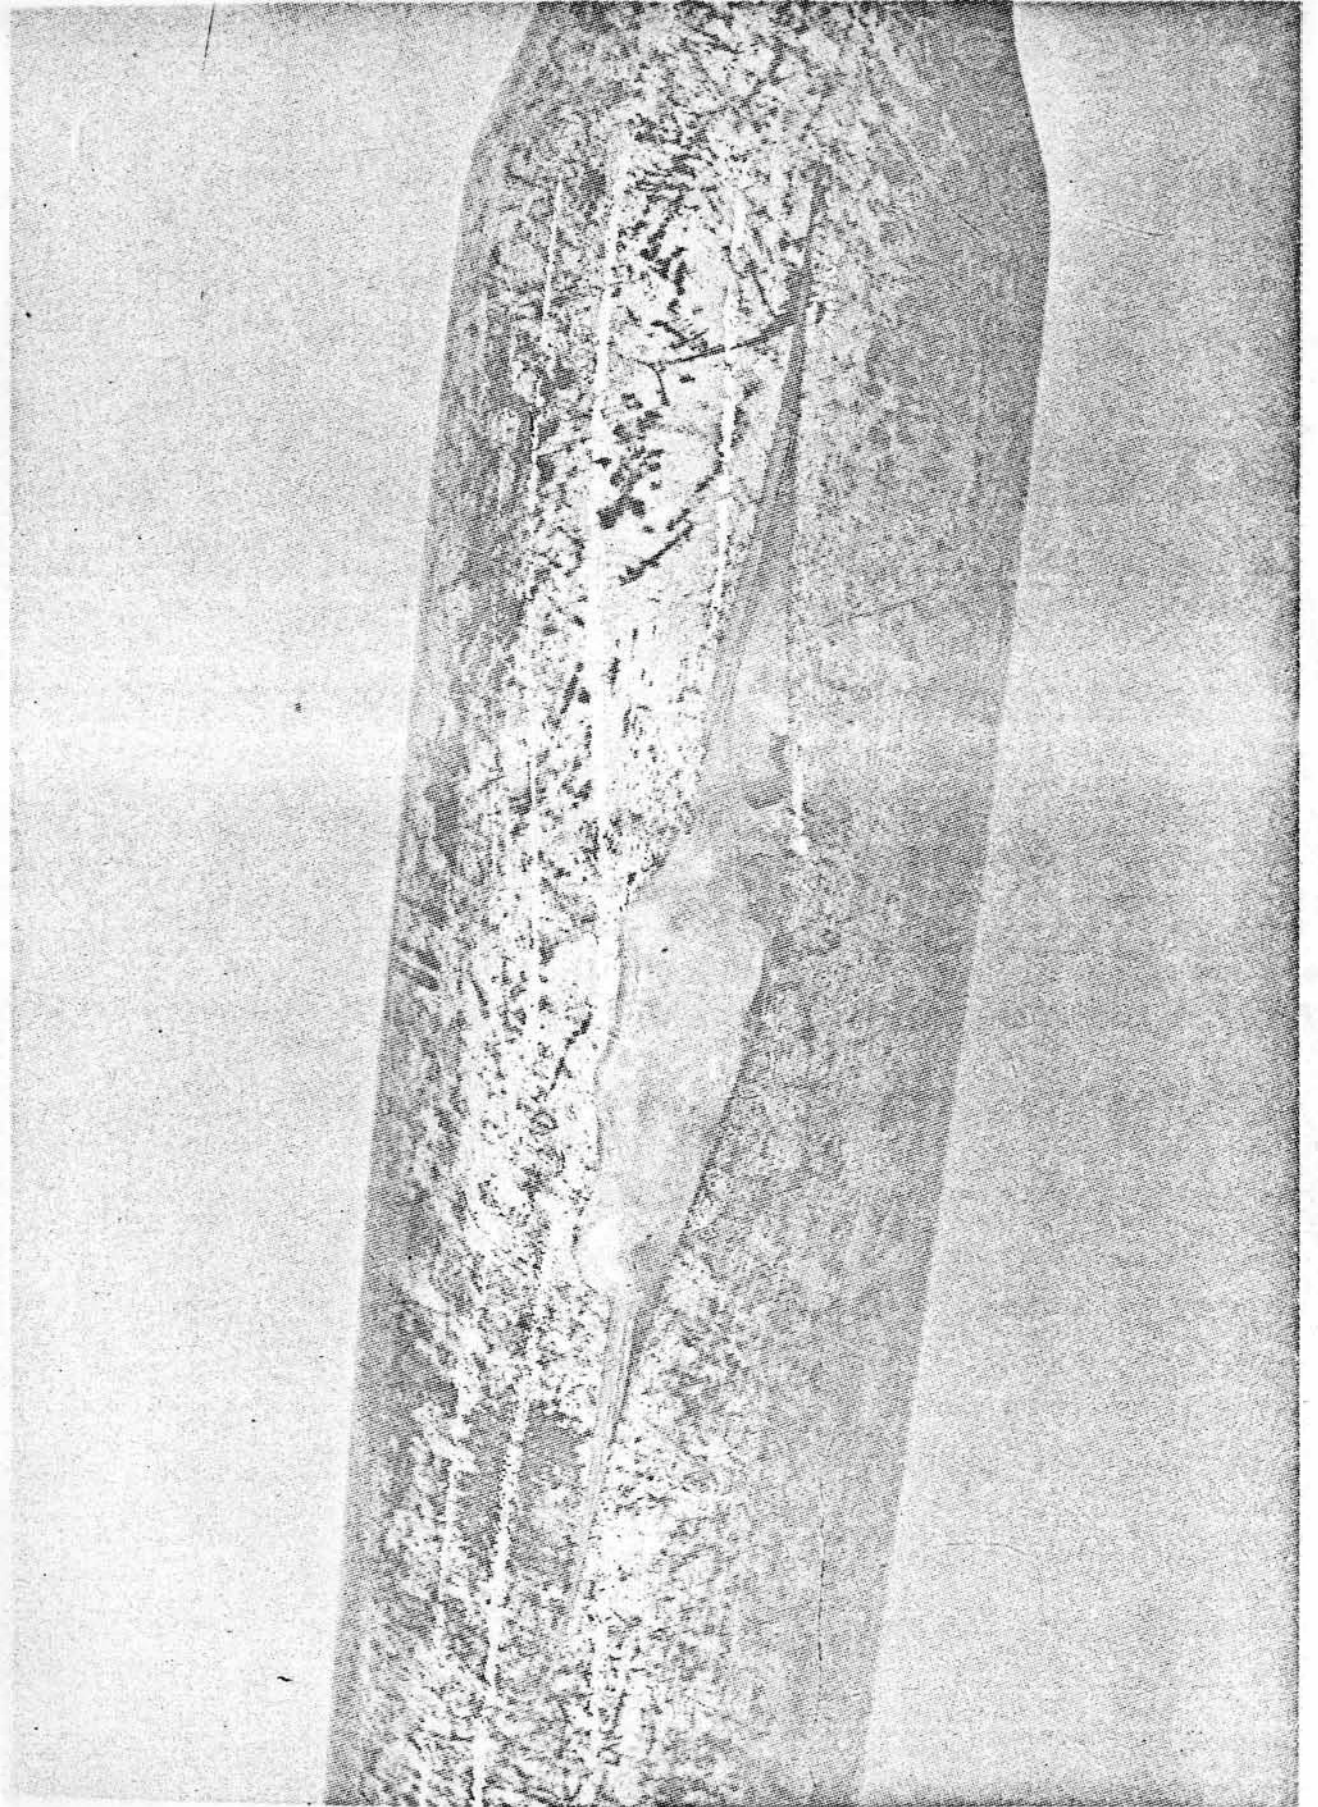
This assembly was filled with water and placed in a 0°F refrigerator overnight. It failed in a manner identical to the subject part, Figure 22.

FIGURE 22. Intentionally Failed Strut.
