CIRCA 1795 GEORGE SPENCER HOUSE
WARREN SQUARE, 22 HABERSHAM STREET
SAVANNAH, GEORGIA

Re: Mills Lane c.1795 Spencer House
Project No. 92013

Re: Stone and Spencer Houses
Project No.(s) 92012 & 92013

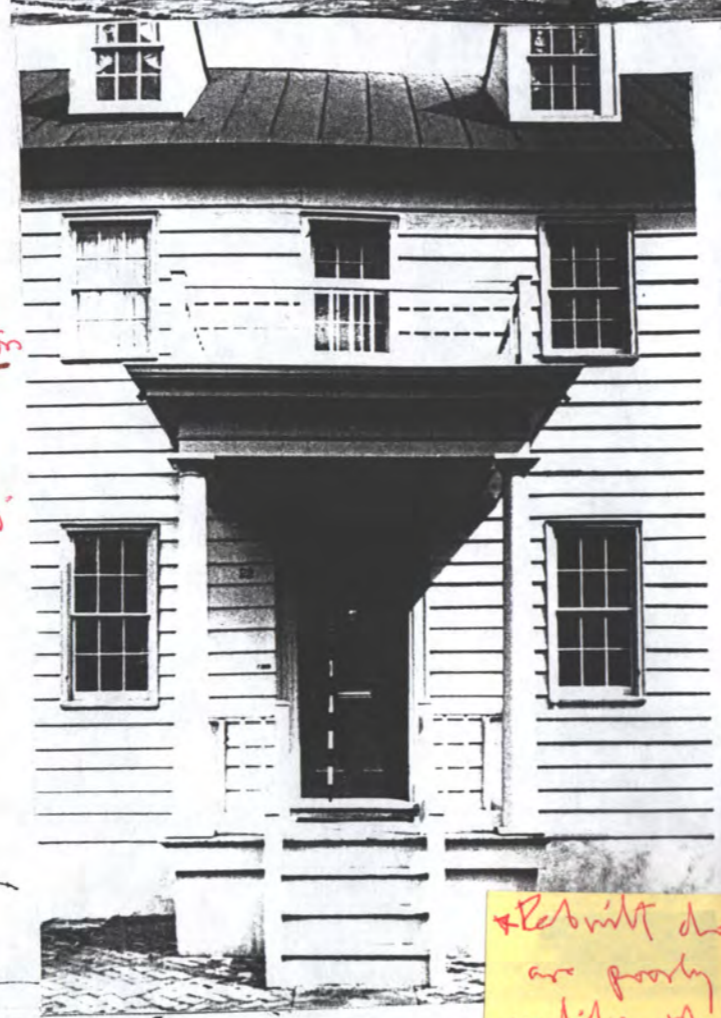
Francis
Derwin
Johnston
photo

6 - shadow indicates
a beak-panel mould
less, under water

7 - width = good proportion, not like now
1 - shadow indicates this
is at least $1/4"$ deep,
looks much better
than present $3/4"$
2 - shadow indicates
sash is set back
2 or more inches
from face = much
better than present $3/8"$
3 - Note blind-hinges.
Do you want to
put blinds back on?

Rebuilt dormer
are poorly proportioned
while those
in the F.B. Johnston
photo. Would be
good to rebuild

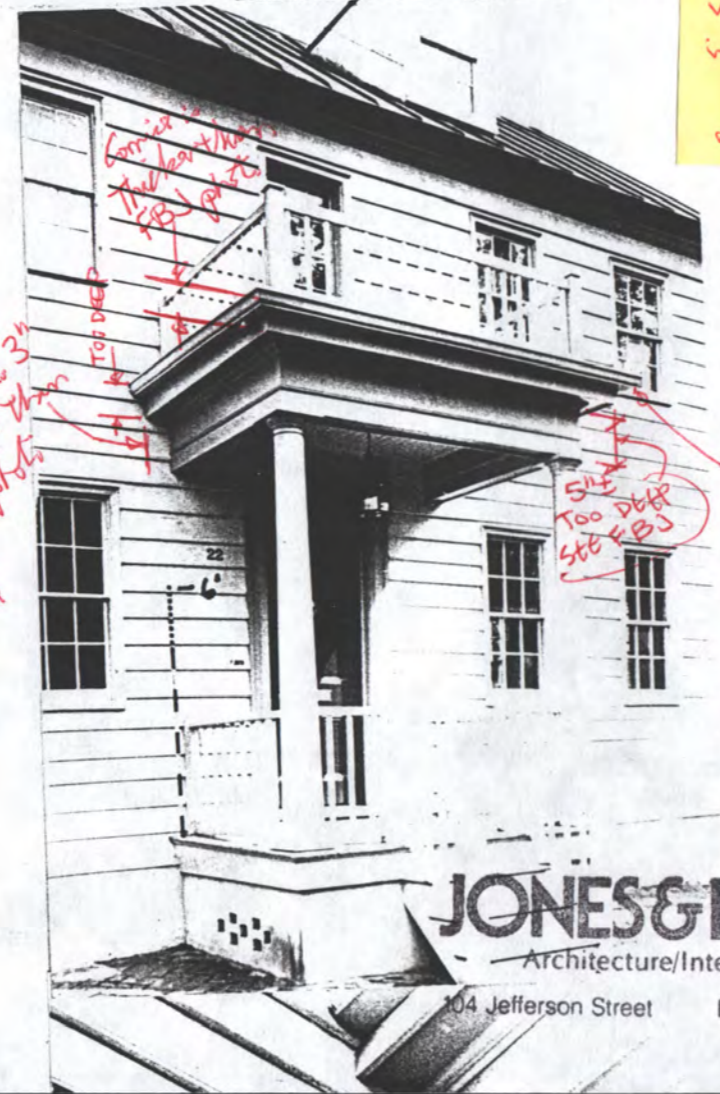
Eave
is
approx 3"
wider than
FBJ photo
= too wide

Correct
the lead
FBJ photo

5 1/2"
Too deep
see FBJ

modern
eye
gutter.
Was a
cornice-mould
See FBJ photo

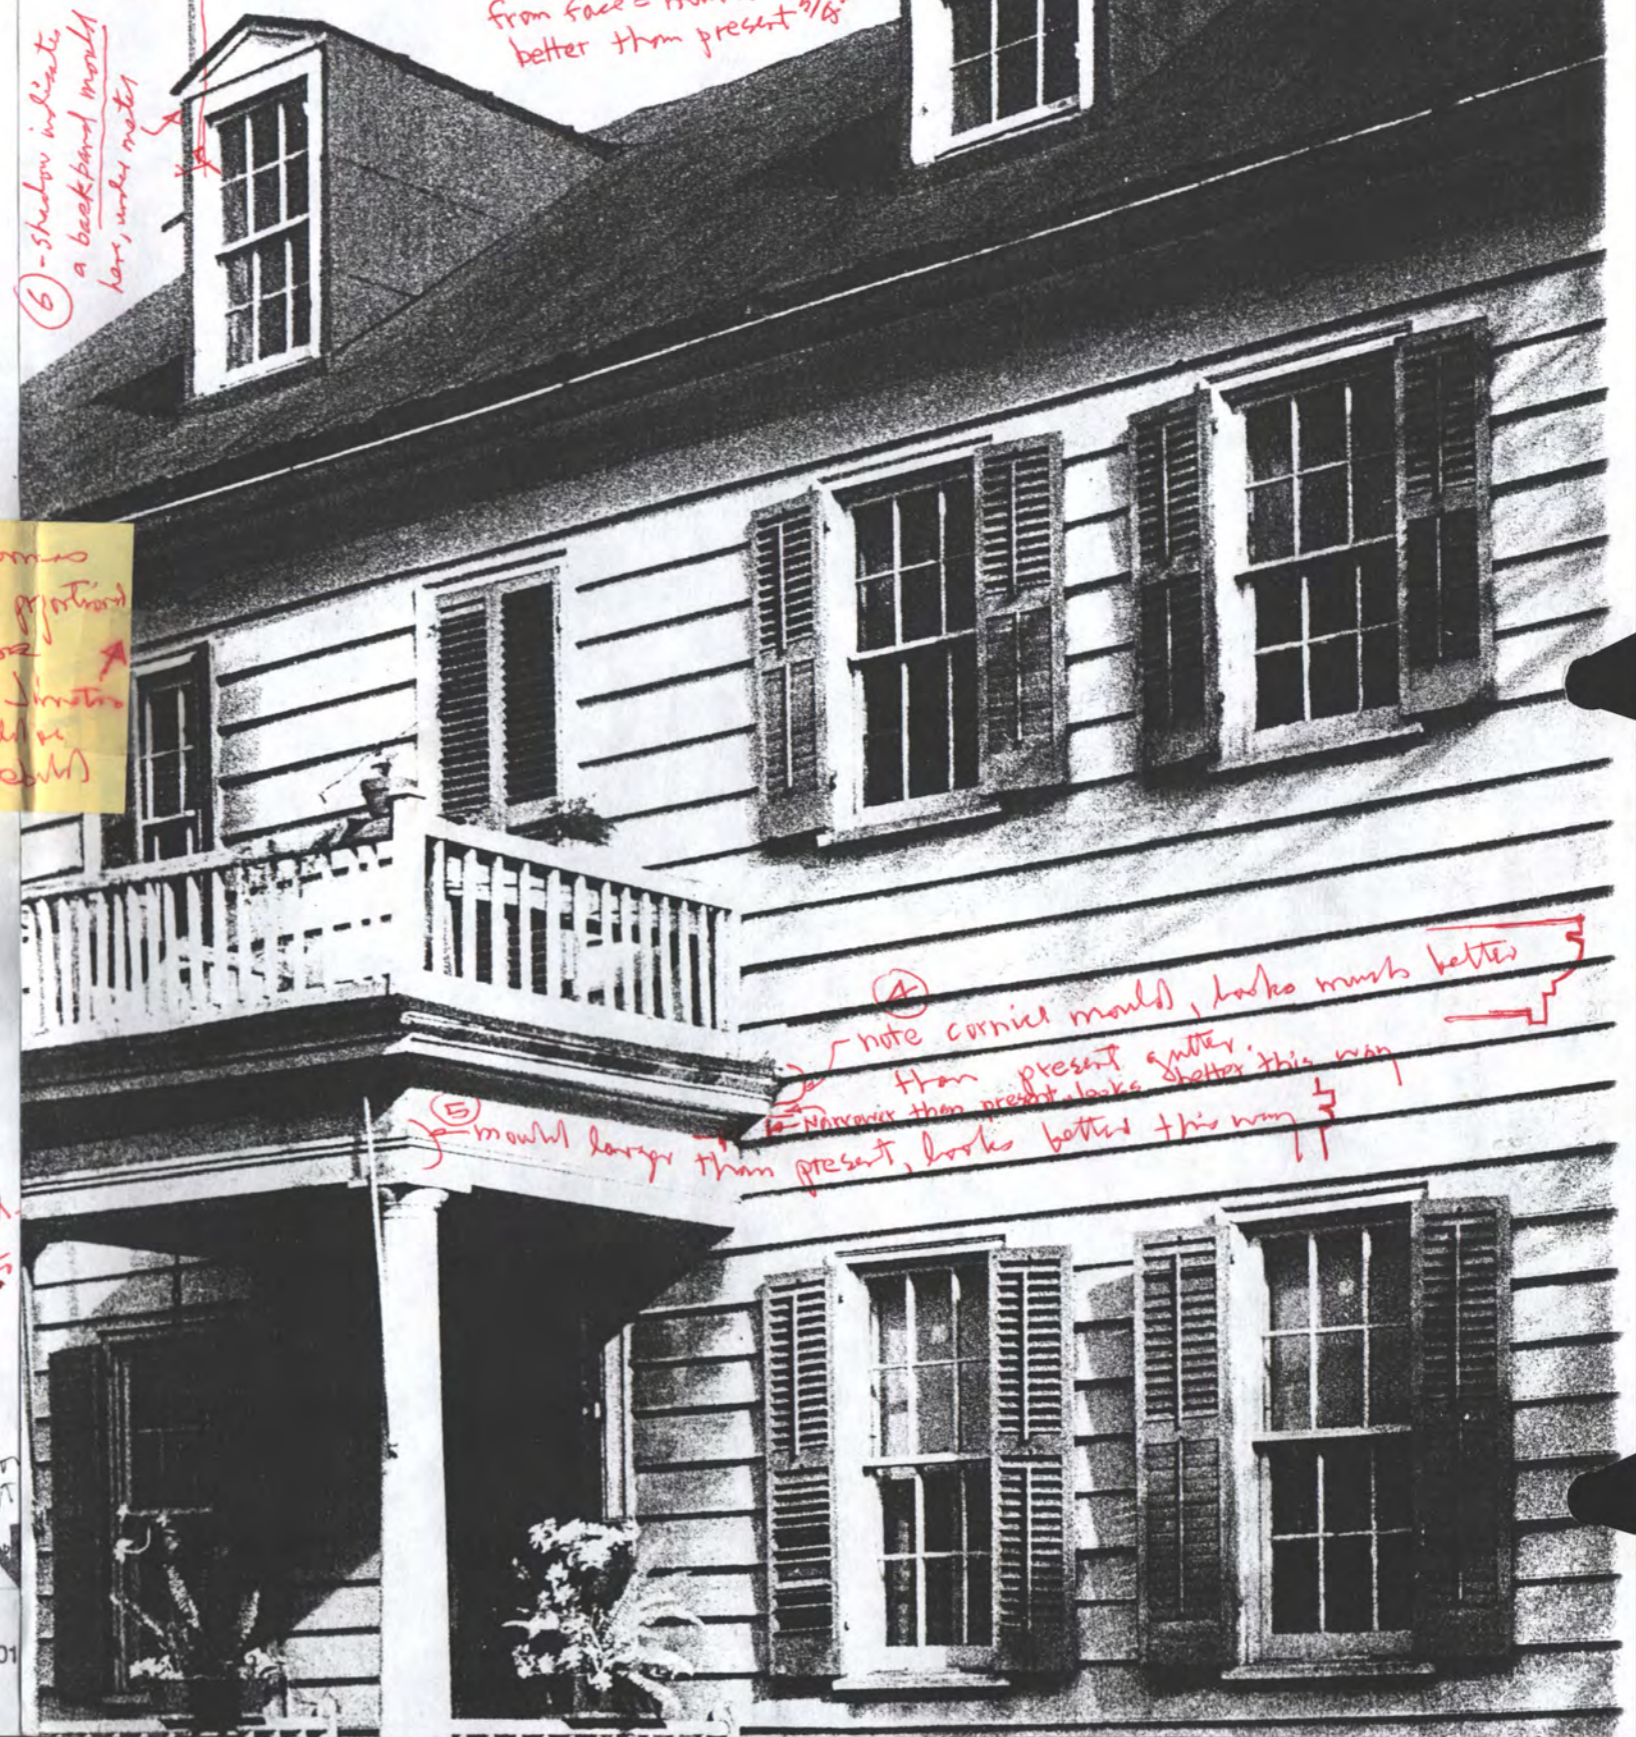
4 - note cornice mould, looks much better
than present gutter.
5 - narrower than present, looks better this way
6 - mould larger than present, looks better this way

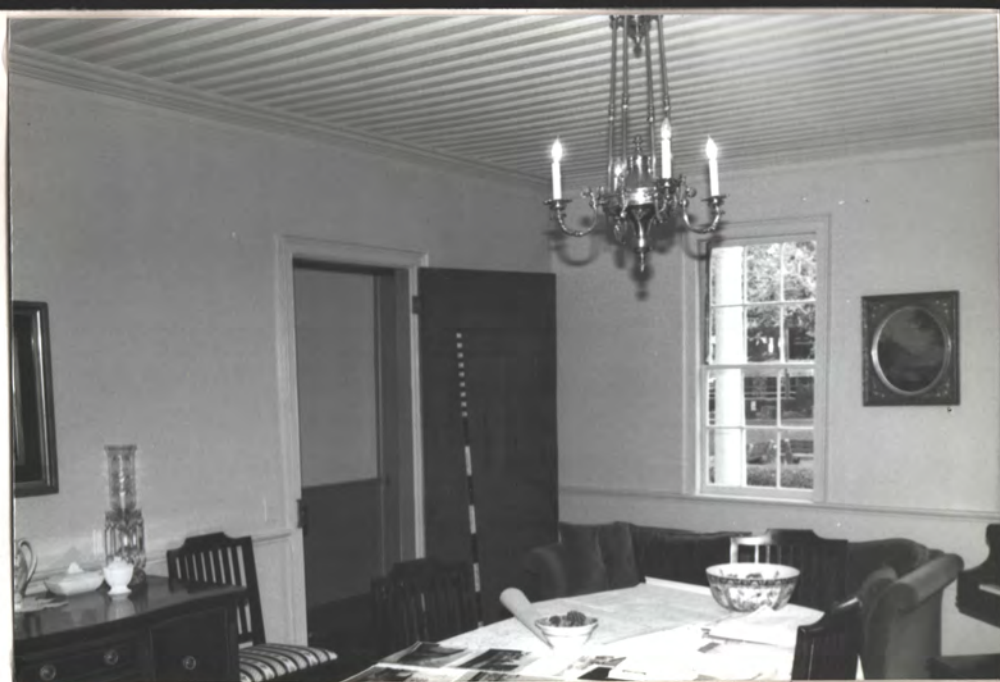
Fl. 1 N.W. Rm. (Bd. ceil is Victorian
 (Smooth, machine-planed exposed face, 2 1/2" w. ± 6 ds.)

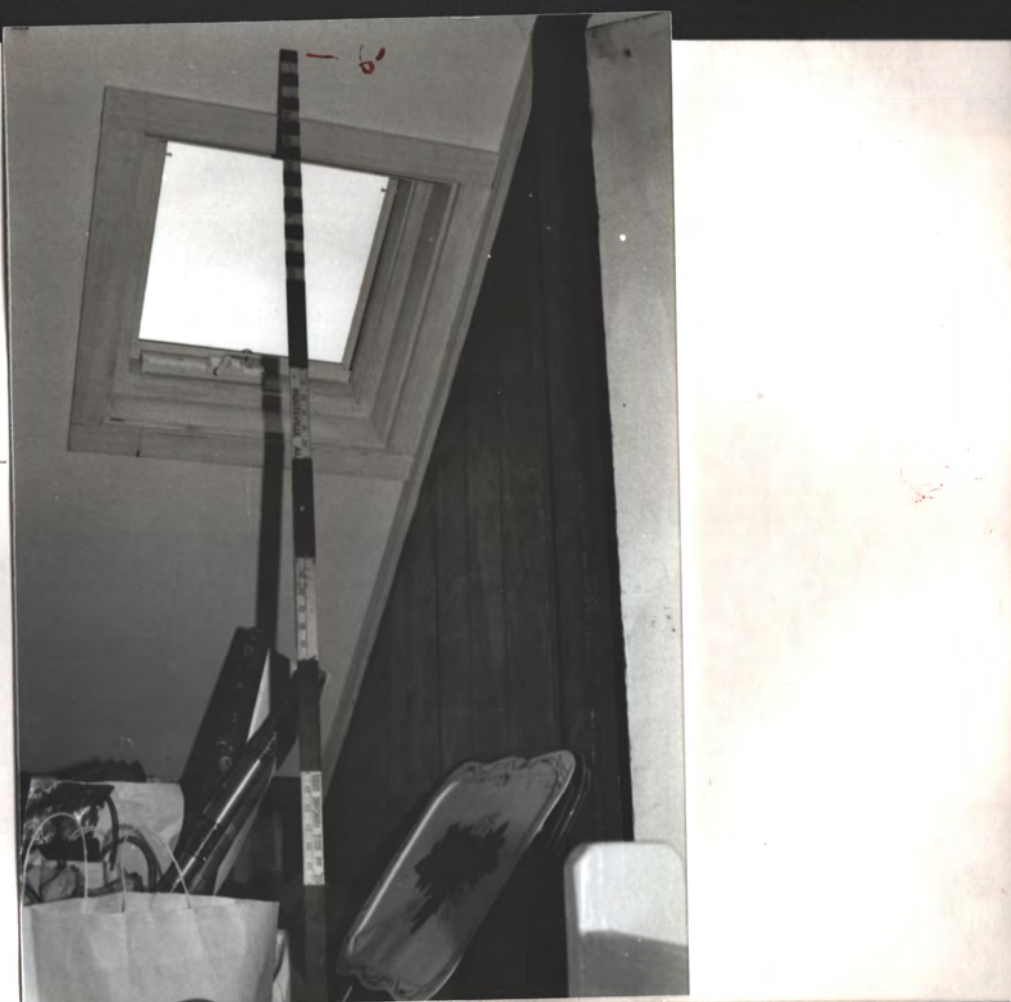
Portico roof
 (1940's sheet rubber)
 from Fl. 2 hall.

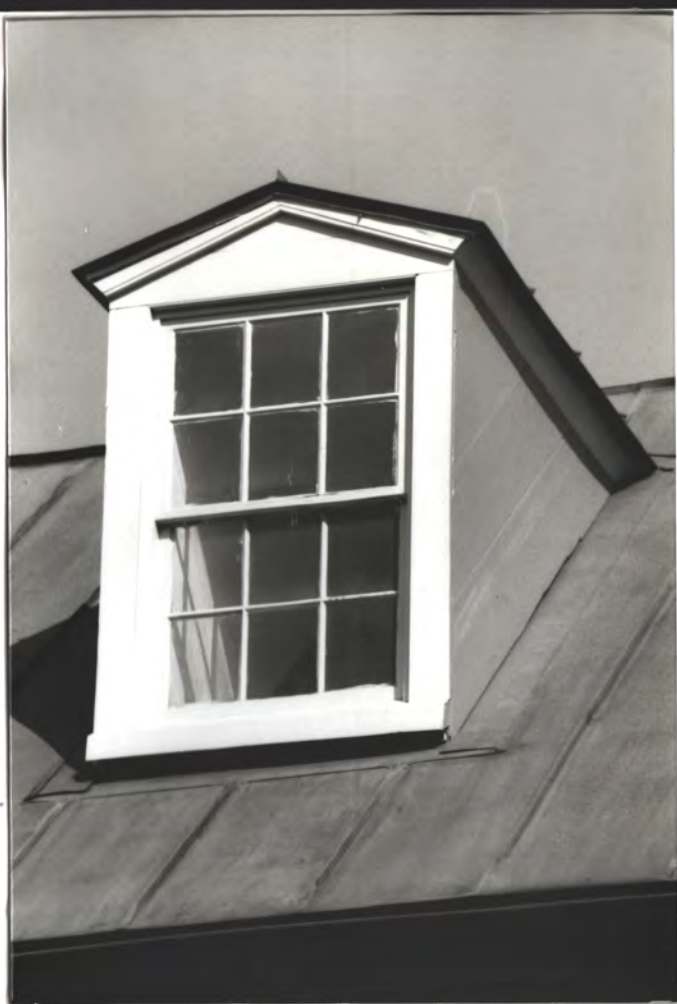
Dormer proportions
corrected from
1991 records
to fit
Francis Benjamin
Johnson early
20thc. photo
(narrower, such
set deeper)

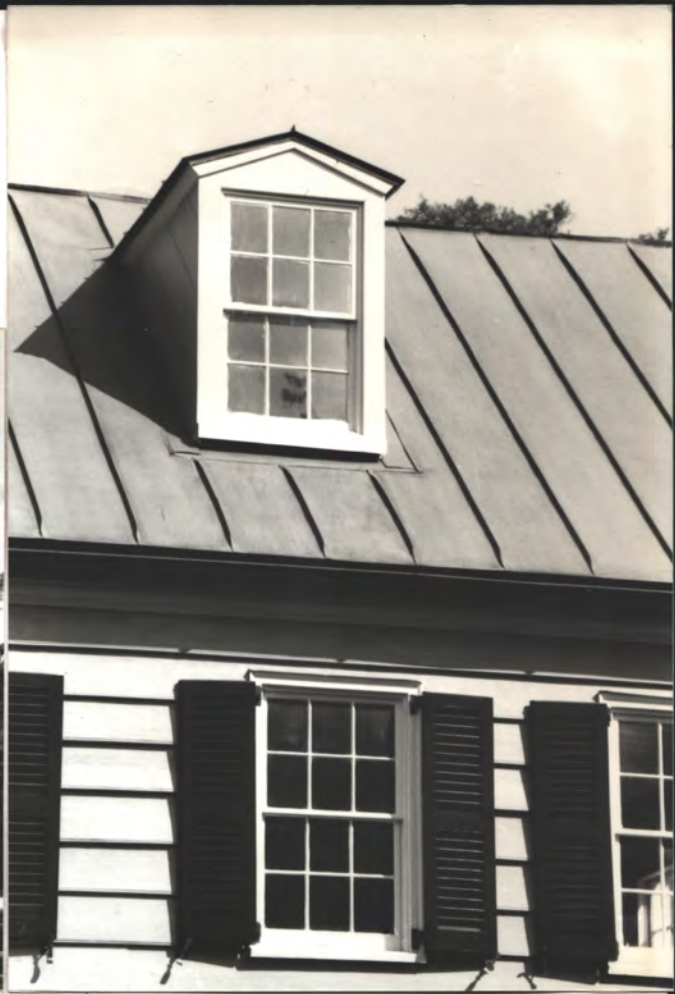
N ← 1980's Dormers & portico were out of proportion,
per the 1920's Frances Benjamin Johnston
photo. Here rebuilt to original proportions.
