# JONES & HERRIN

January 24, 1994

My "after" photos and copies of your circa 1990 "before" photos of your transplanted c.1850's family house from Rehobeth, Alabama came out well, so with the maps and my sketch plans and notes I now have a fairly good history of your historic house. These photos will someday be in the Huntsville Library Heritage Room Architectural Archive.

H →  
"AFTER" photos  
Jan '98 H Jones  
Little Cove Rd.  
S.E. Madison Co.  
Al.

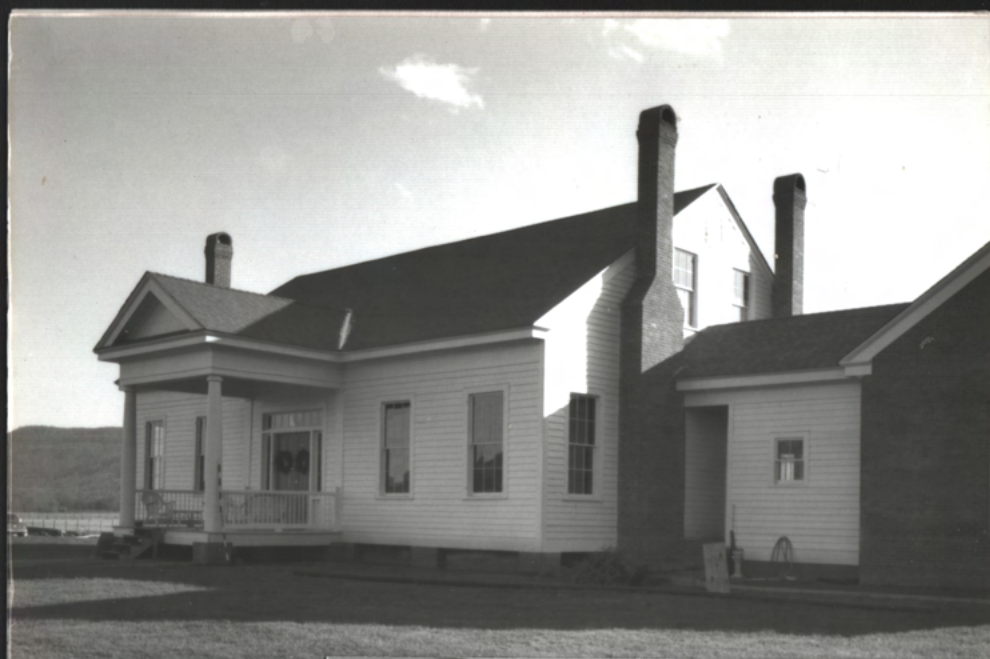
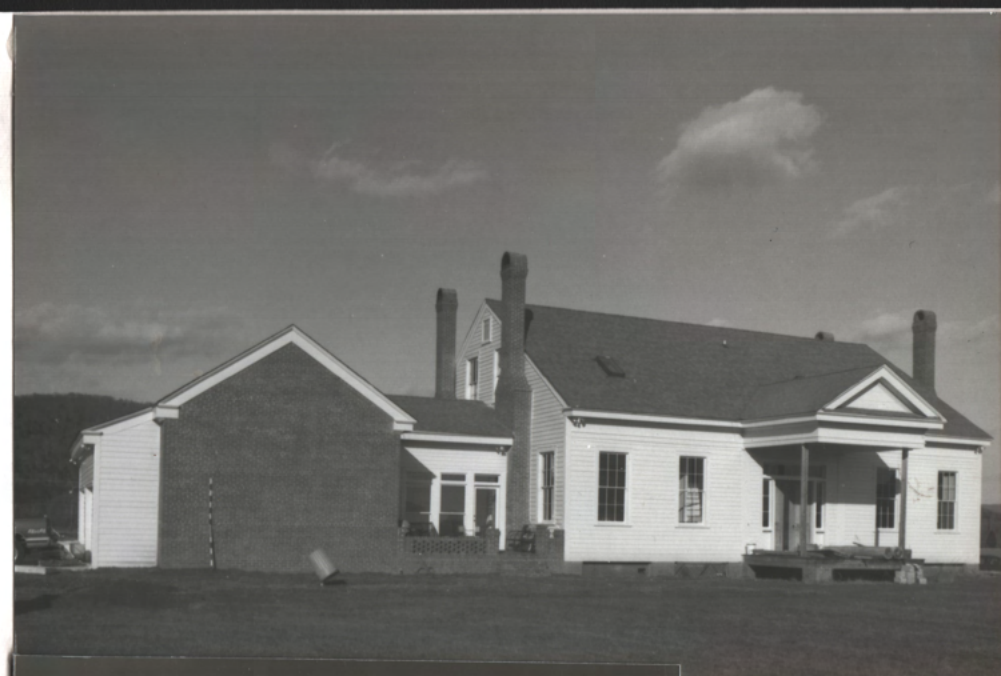
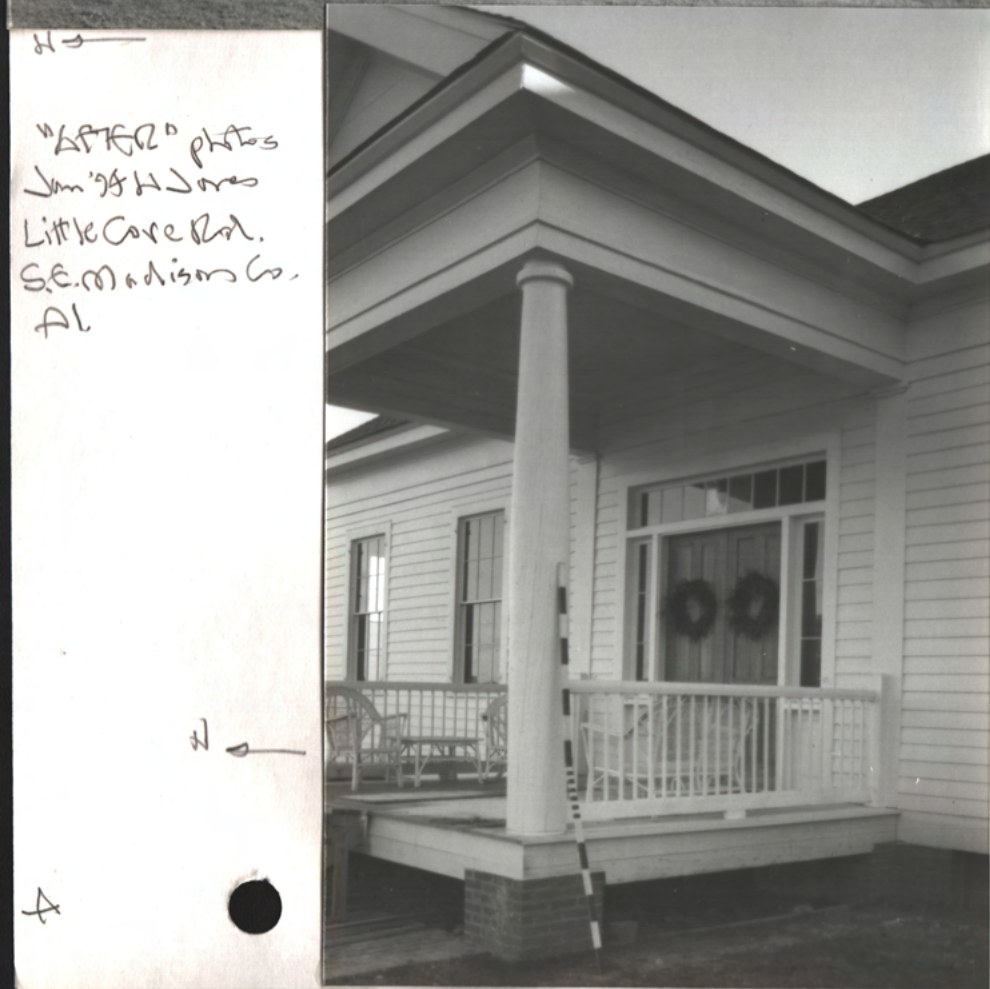
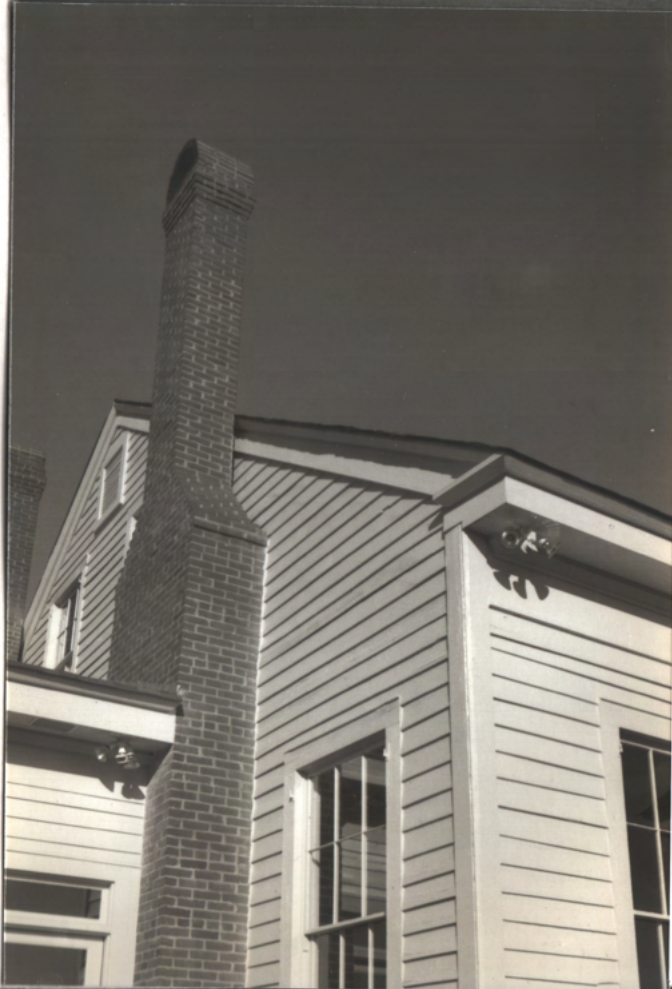
↖  
cols. not on  
net  
(was like  
front)

↖ they missed the  
band on rake  
↖ fascia - seq. 2

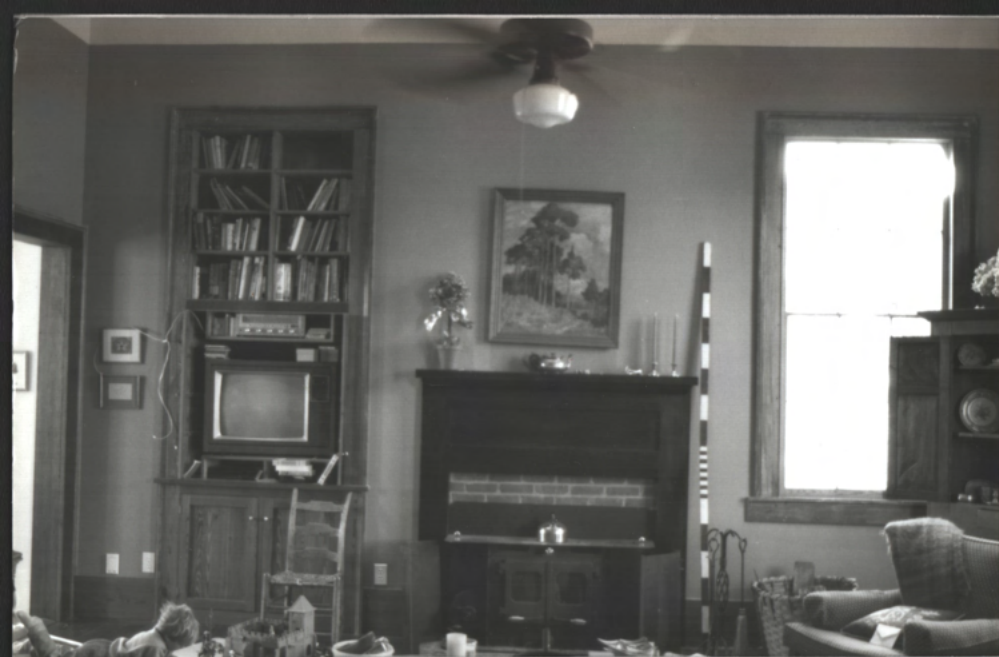
N.W.,  
PALLOR

was originally  
a window

orig.  
mantel  
(black,  
typical  
1800-1860)

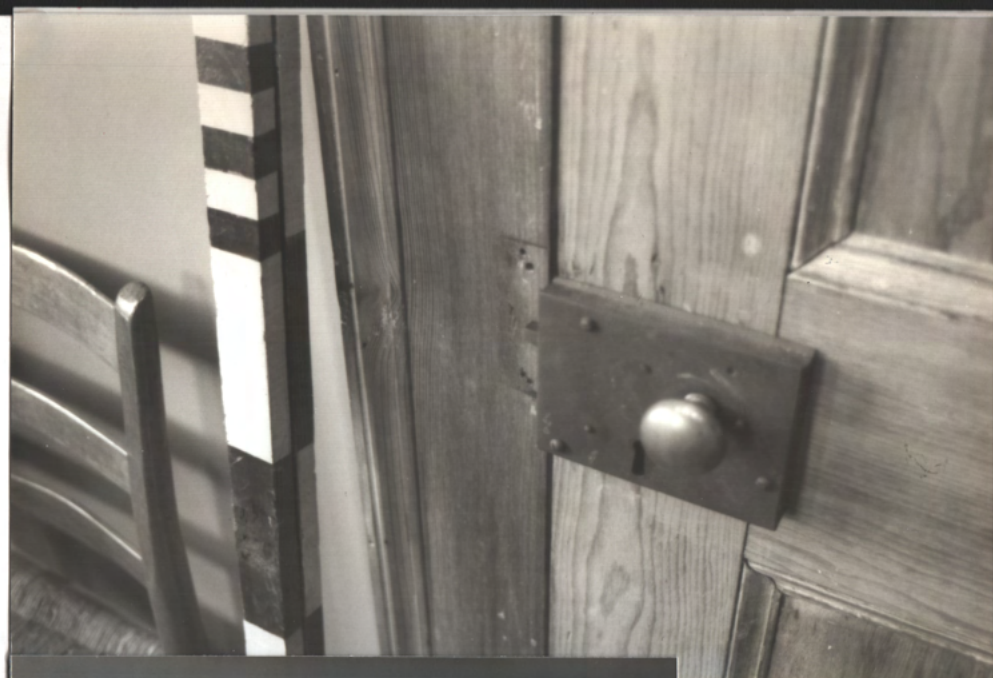
orig. look,  
"Carpenter"  
type.  
Brass trademark  
is cut off

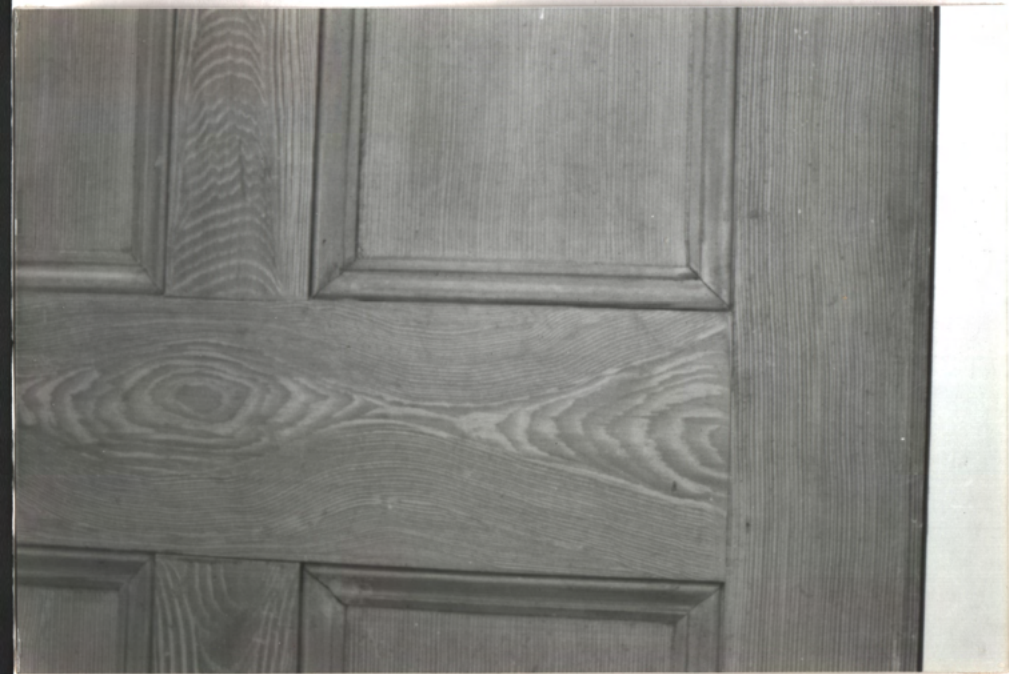
← original paint-graining,  
door moved from kids corridor  
to garage (new W. addn.)

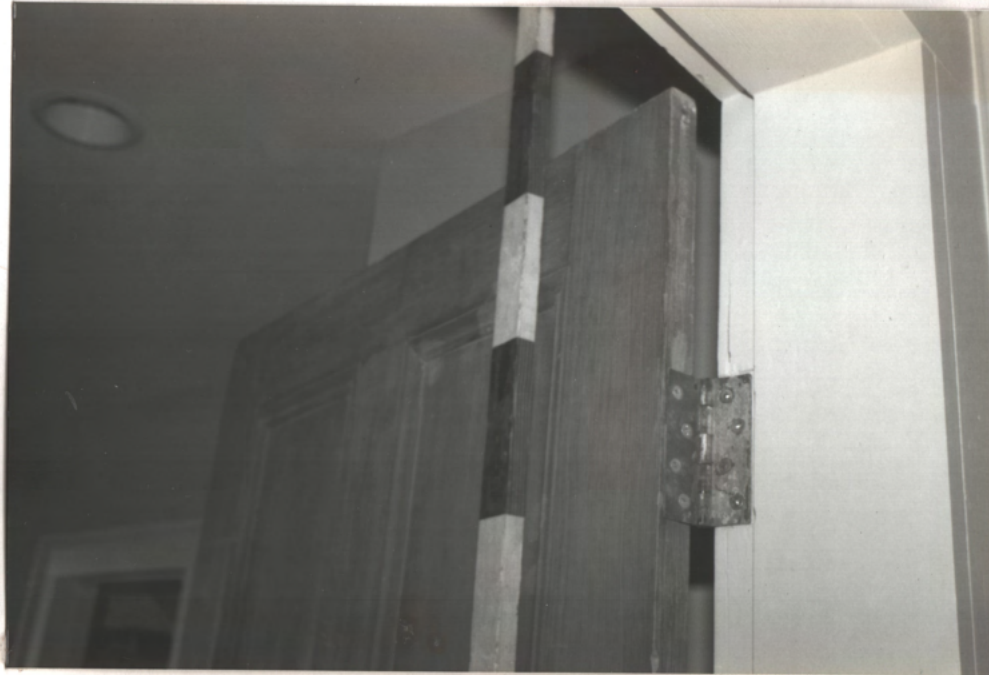
orig. 1-pc. c.f. hinge  
modern Phillip's Hd. screws (wrong)

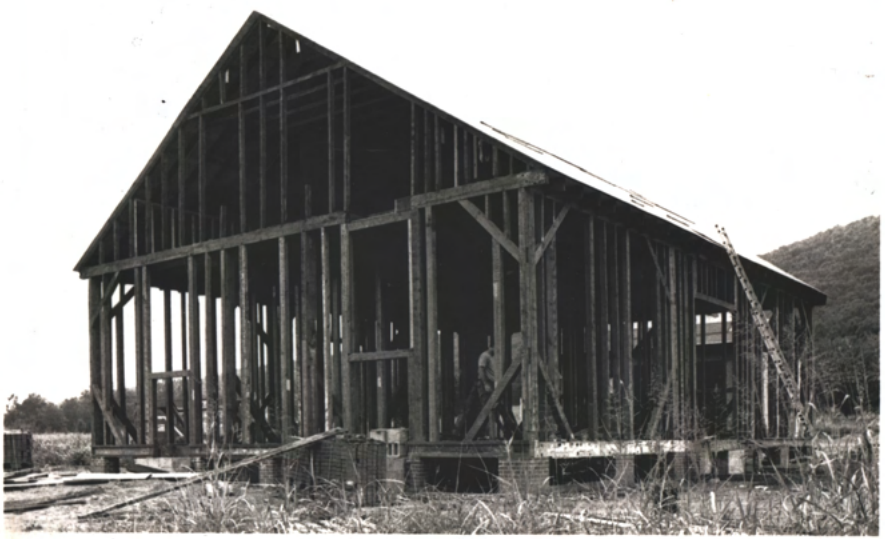
diagonal  
braces at  
top are  
unusual

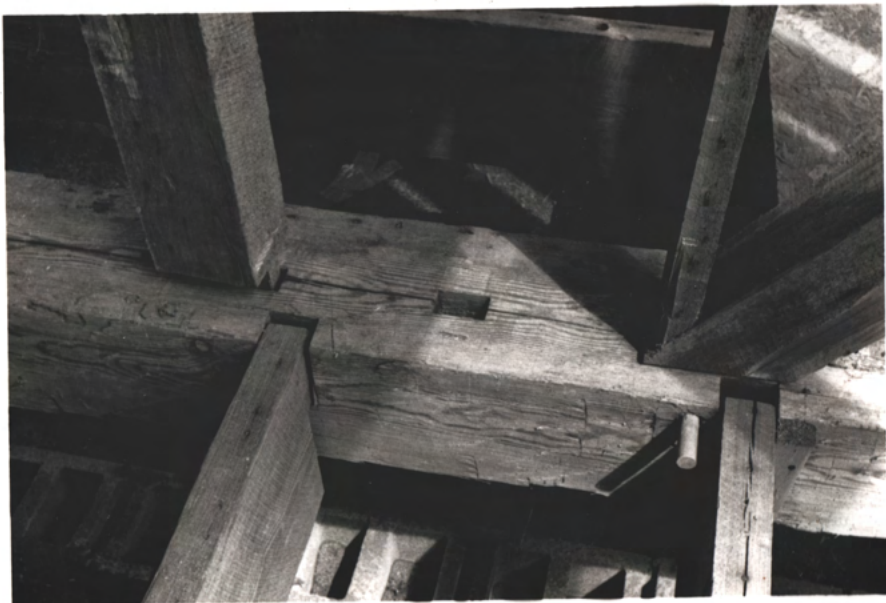
Detail of photo loc. at left

Coats (Lunny Beddingfield) need  
round dowel pins = not good or correct.  
Should be whittled

to grip better

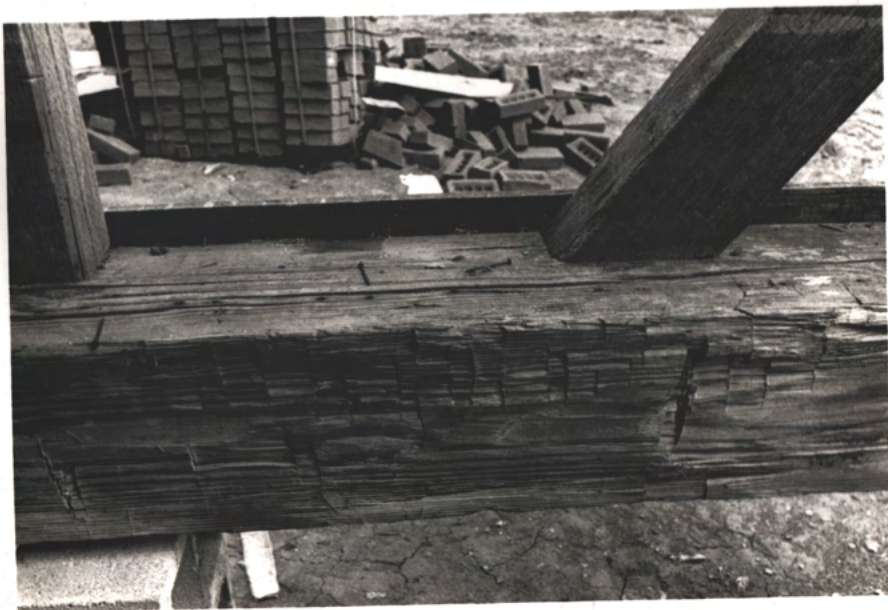
↑ mortar, term  
of pegs =  
typical

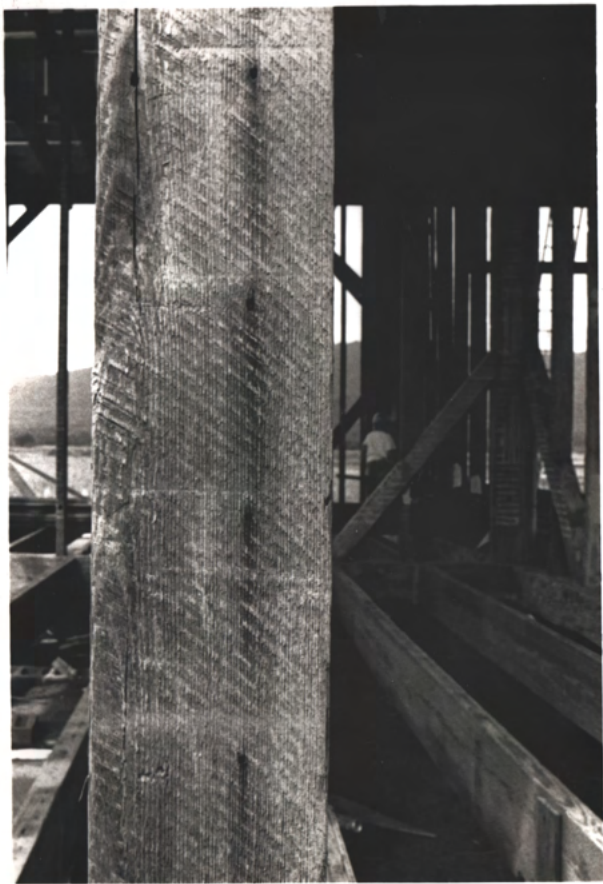
Note plaster  
key marks  
(wood  
laths)

↔  
All Imbr. is  
rotary saw  
indicates  
1850-1860  
most likely  
date

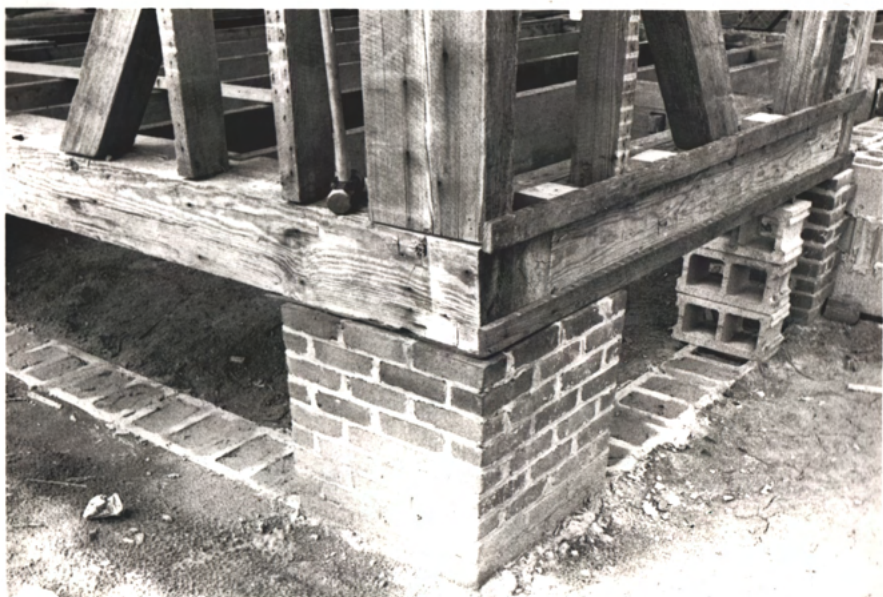
45° brace  
tenon  
(where is  
peg hole?)

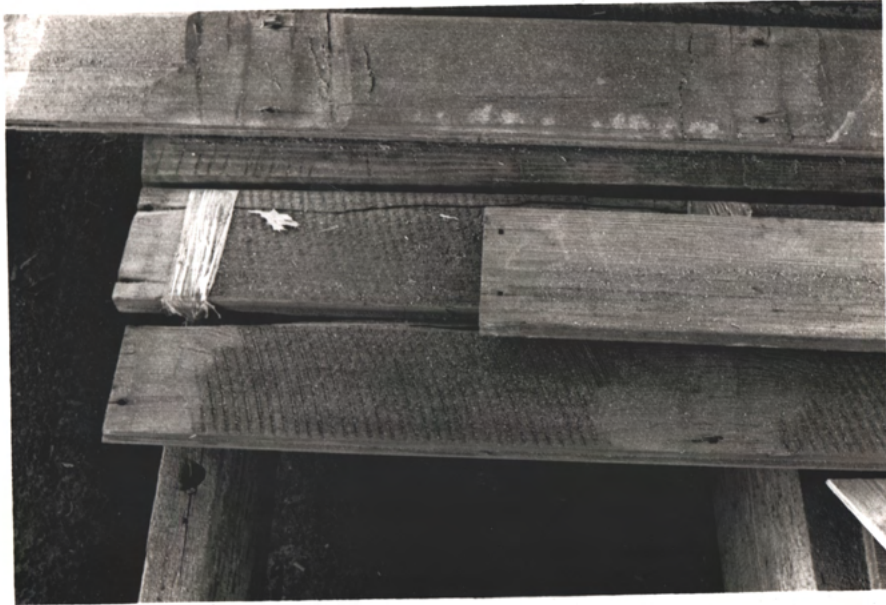
↖ holes in  
fl. joist  
tops are  
to "prize"  
fl. planks  
tight together

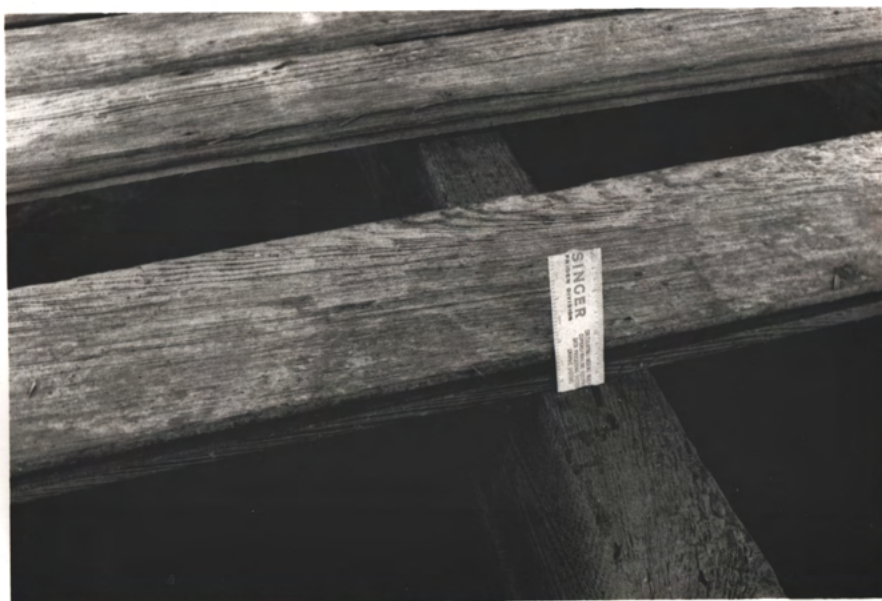
↖ front  
bottoms of floor pl.  
= rotary screws, w/ or w/ hatchet  
cutouts to level the fl. at the  
joists = typical 1800-1860

← fl. = 5/4 heart pine T&G

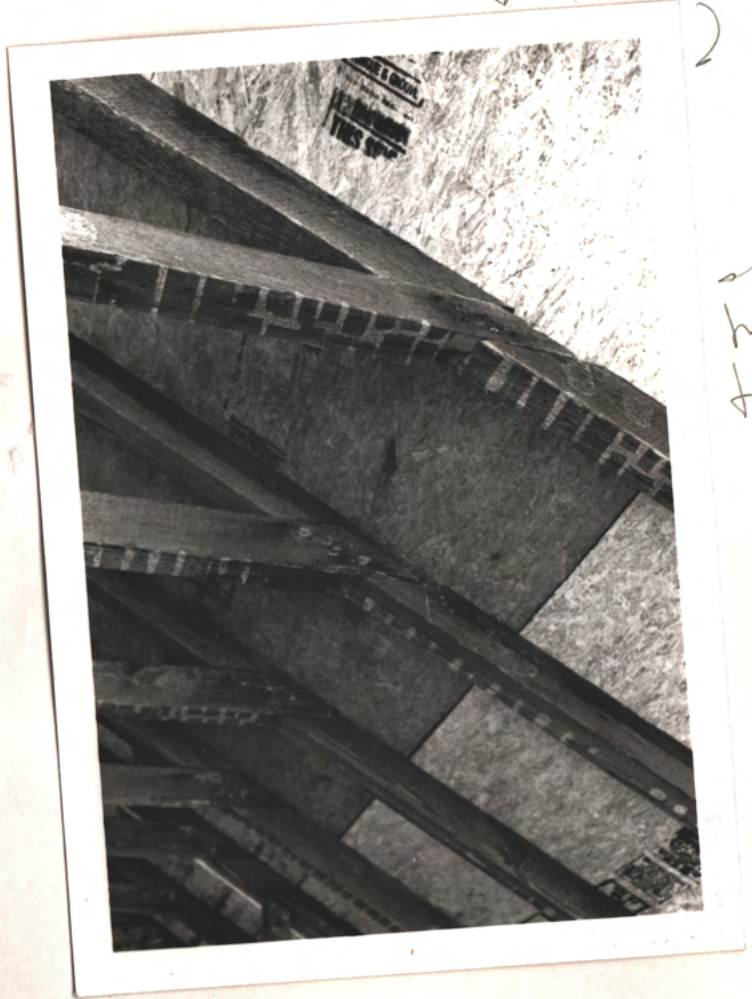
joists =  
half-lapped  
& nailed

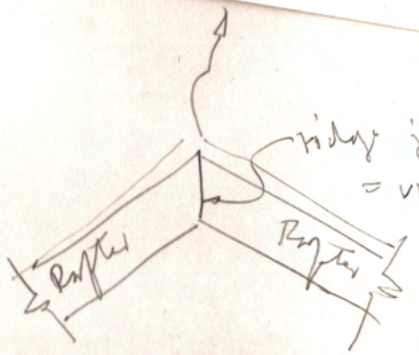
ATTIC

ridge jt. = butted & nailed  
= unusual for pre-Civil War!  
Usually half-lapped  
& pegged

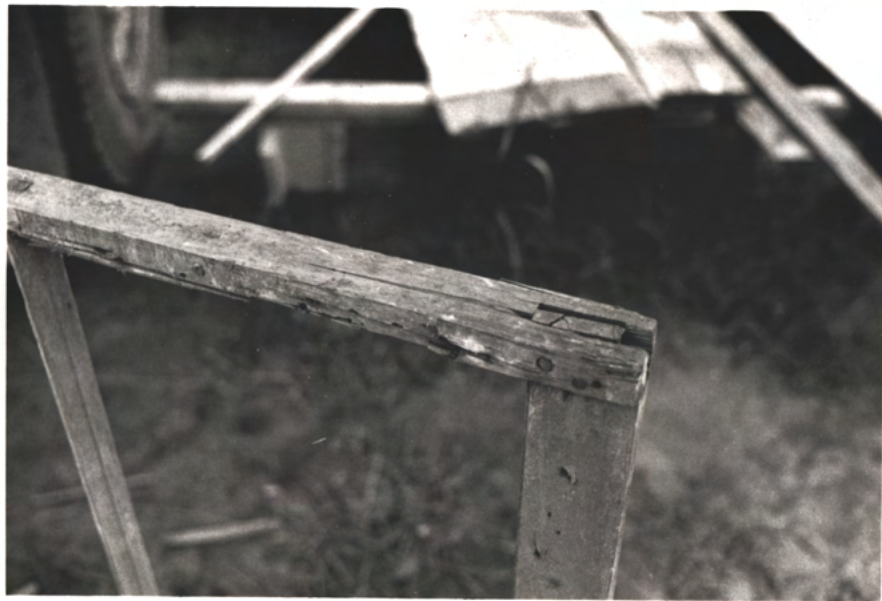
← thru mortised & pegged  
= std. pre - Civil War
