Re: Inscho Residence (Hagan House, Mooresville)
Project No. 95125

Re: Inscho Residence
Project No. 95125

FEDERAL PERIOD + ADDNS.
IRVING-HOBAN-INSCHIO HOUSE
MADRIDVILLE, AL.
1986, 1995
JONES & HEERIN, ARCHITECTS
ANNHURSTVILLE, AL.
ARVIE P. JONES, F.A.I.A.

HAGAN HSE, MARTINSVILLE, VA.
EARLY 1800'S + LATE 1800'S ADD. & INT. REMOD.
+ C. 1960'S N. WING
photos June 1995 by Wally Insko, new owner,
for add'n's & renov. by Jones & Herin, Arch
Huntsville (Harvie P. Jones F.A.I.A.)

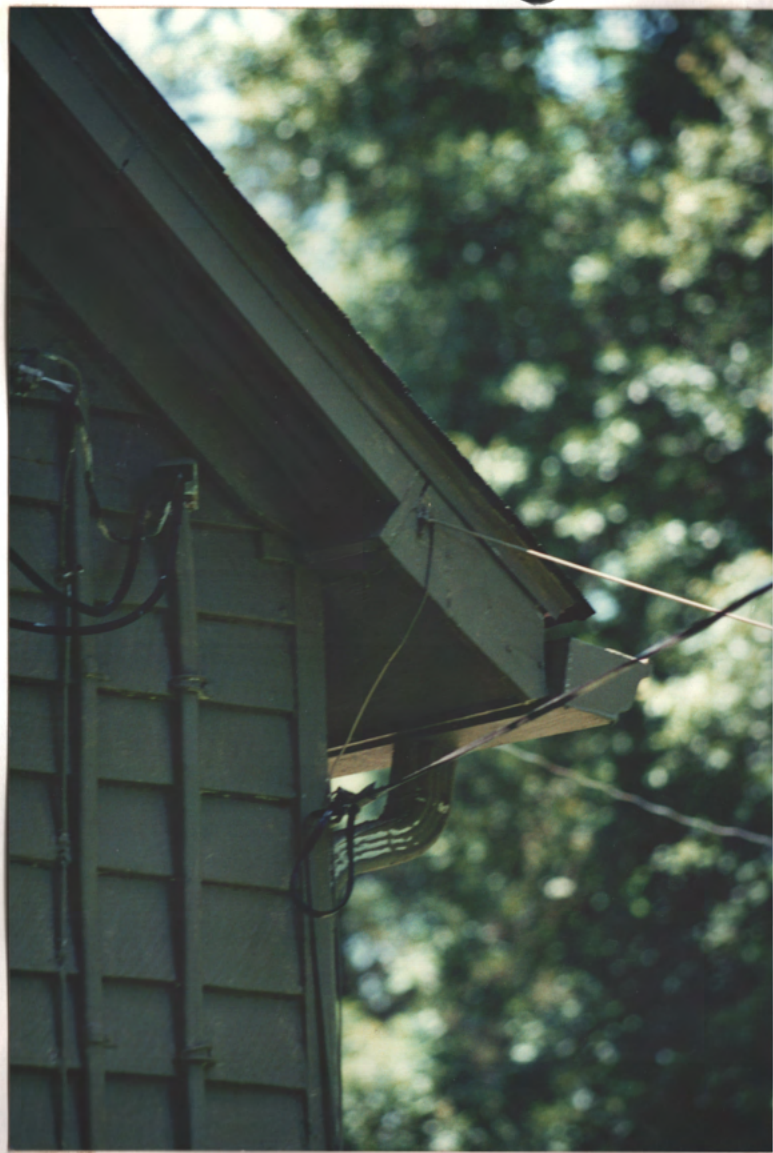
→ N
N.E. Corner of E. Wing (Vic.?)
Note joint in fascia indicating
that the drip-edge was attached later

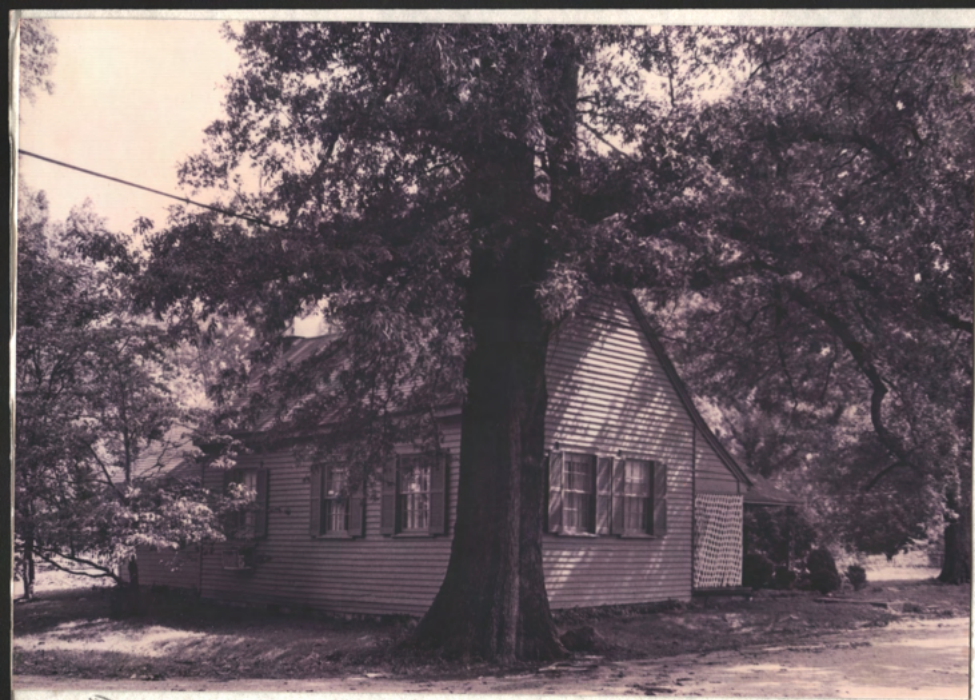
This cent. window was the front door, per an old resident of per several practices in Hall & Parlor plans.

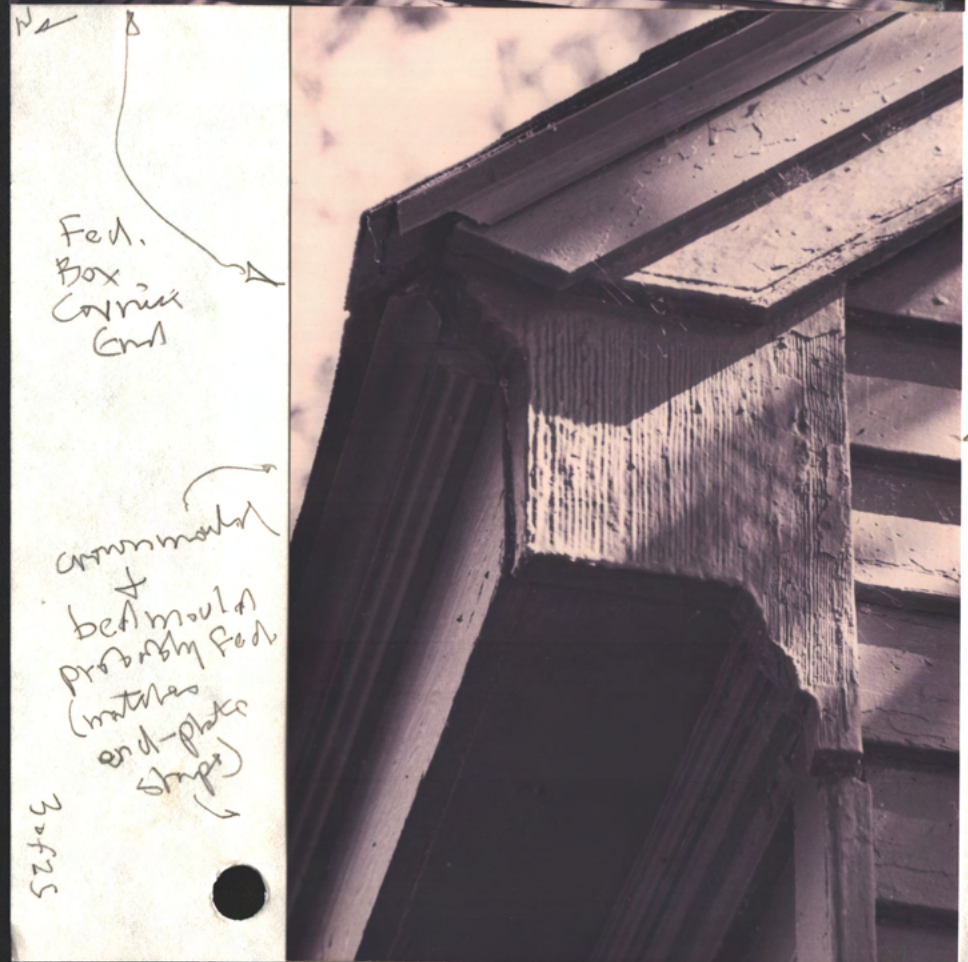
Fed.
Box
Cornice
End

ornamental
&
bead mould
probably Fed.
(mould
end-plate
strip)

← Fed.
Tapered &
beaded
rake -
fascia

← Vic.
Chap.
(rotary
Sawmill
mt. side)

c. 1960 fake blinds
nailed backwards
(to wall)

20th c. shutters

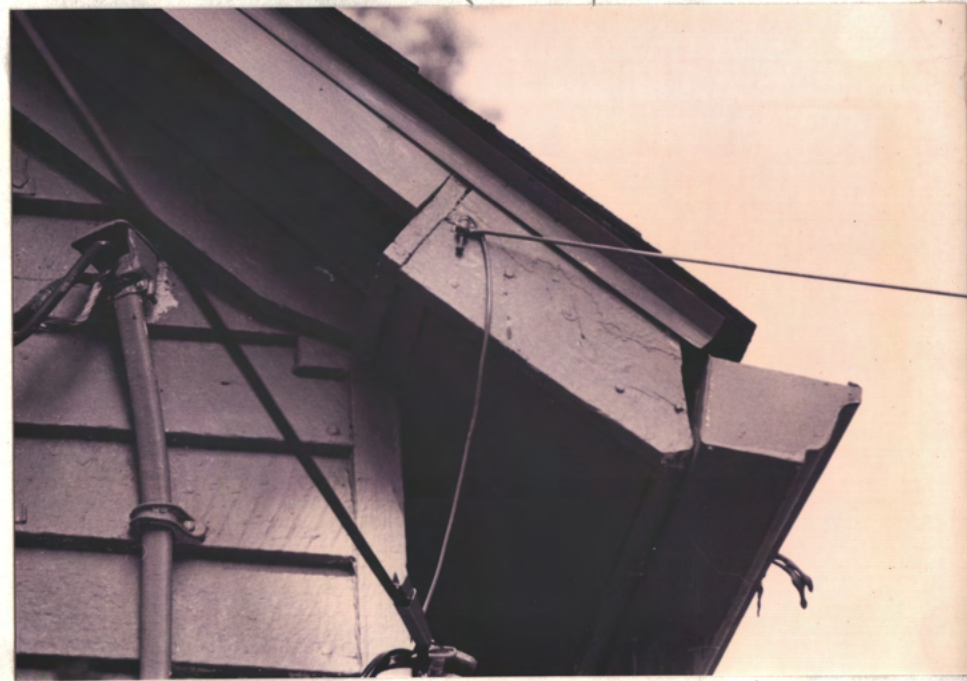
rotary sun marks ↗ & N.E. corner of Vic. E. Wing → N

Note some extensions
probably 20th cent.

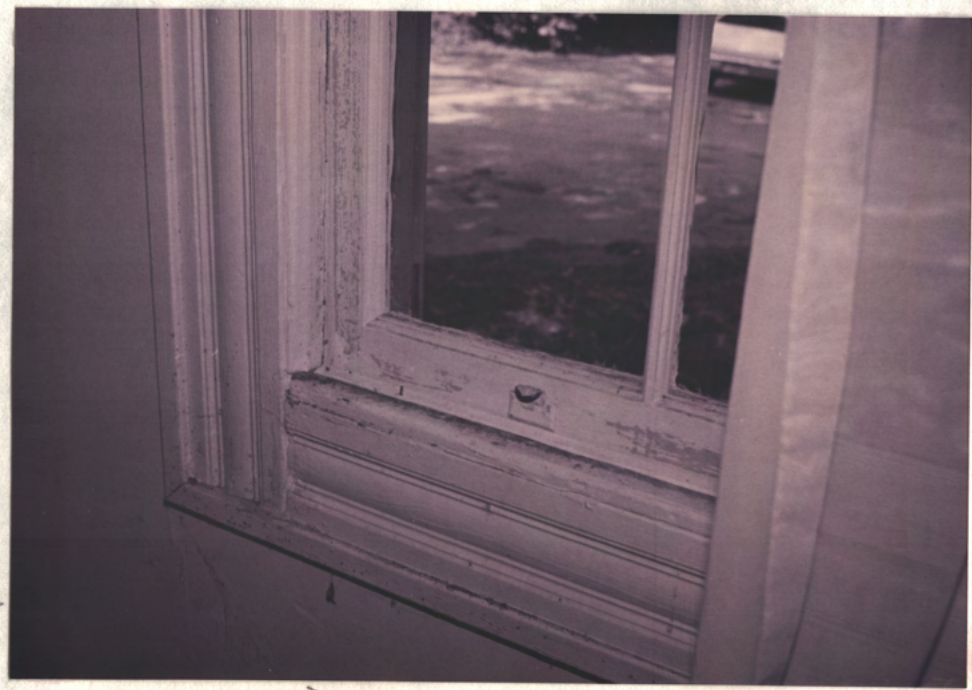
newly
 exposed
 studs at
 12M-Park
 orig. draw
 loc. at
 cent. west
 mod. window
 (at Fl.)

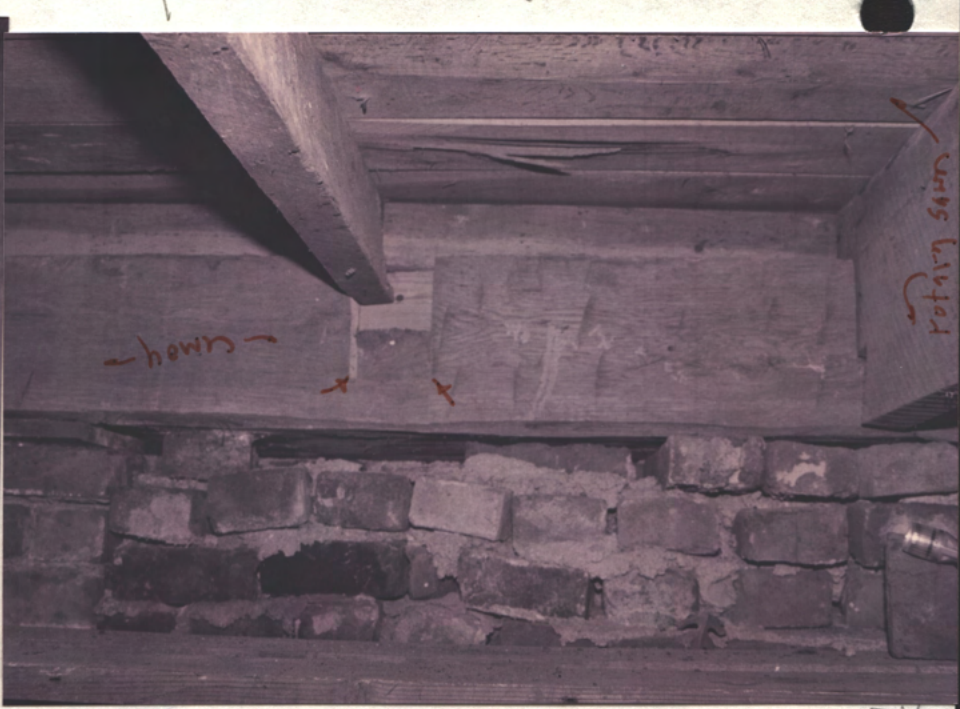
Revised & inverted
Fed. painted stringers

Cellar (dry out apparently c. 1960)
is only under Fed. Hall & Patent

Fed. beams & pit saws main SIM
NOTE mortar for ± 3 1/2" wide joint. **XX**

Stringers = pit saws, ± 3" thick, pre 1860 probably. Inverted

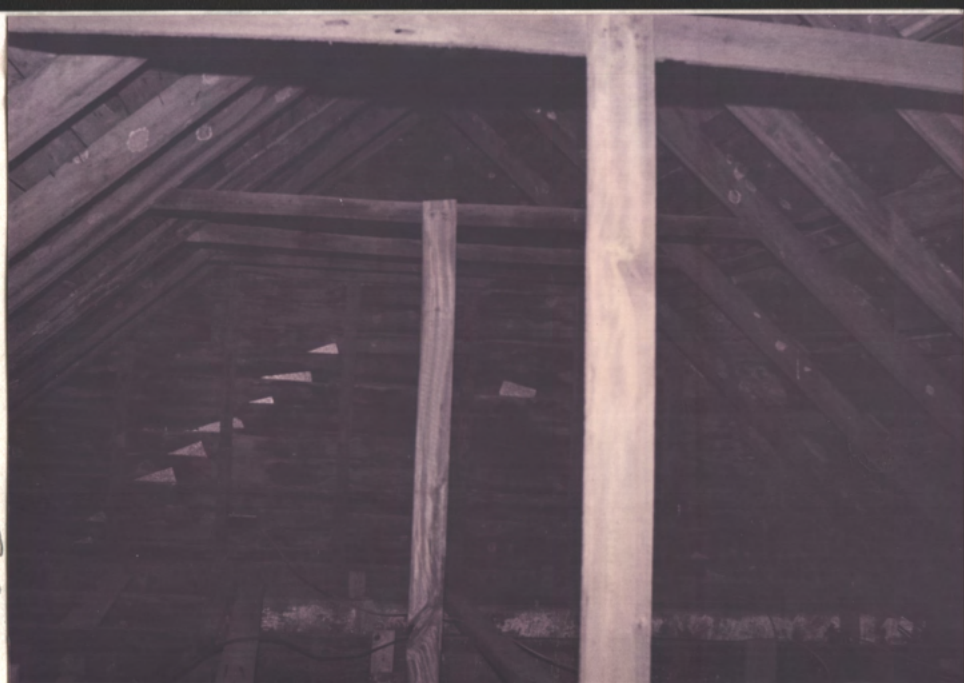
FED. PERIOD ATTIC

← Vic. rotting beams replaced →

← No ridge bt.,
half lap & peg jts (typical fed) →

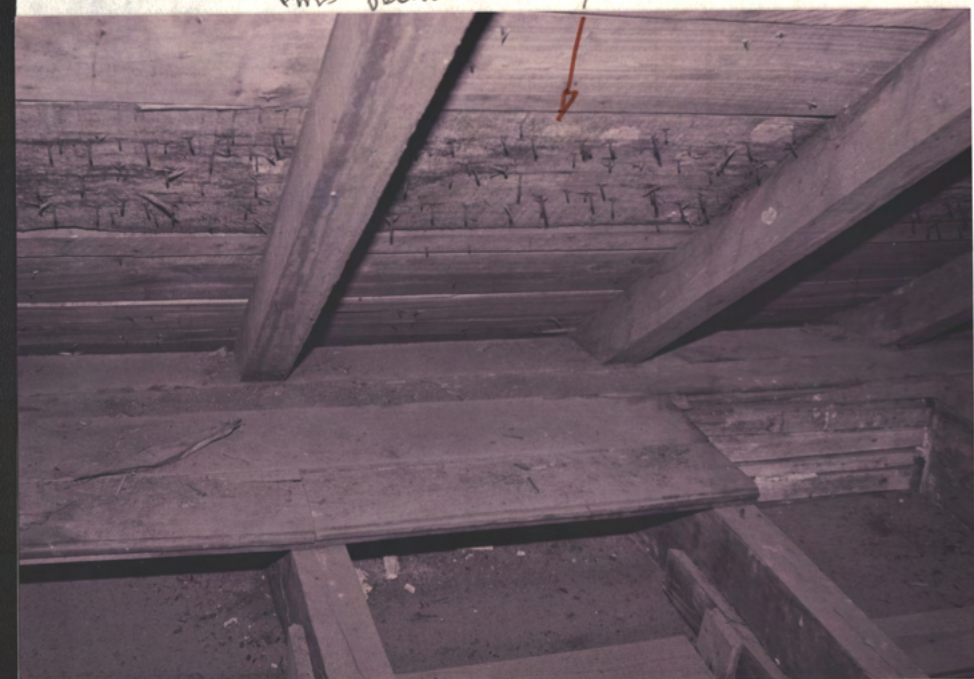
Fed.
Sash
Sash
rafters
± 3 1/2" x 5"

Note lath
(split) +
plaster, area
in "Hall"
→ below

Joist = Fed. ± 3" x 10" x ± 2" o.s.
