POST-1846
DEERING-
SWAIN HSE
TVSCHL005A

Re: Dearing-Swaim House
Tuscaloosa

HISTORICAL & RESTORATION COMMENTS:

DEARING - SWAIN HOUSE - TUSCALOOSA - 6 MAY 1980

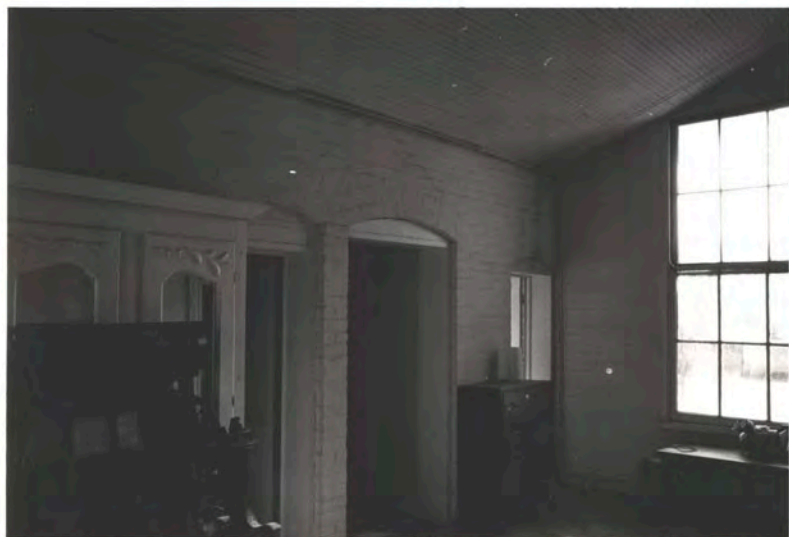
Serv. Bldg. →

→ Main
hall

"Link" between has view of serv. bldg
(also opens porch)

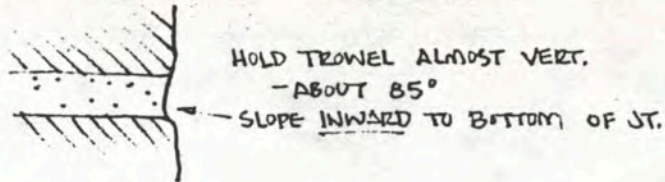
G. Joints should be troweled to match existing joints.

Do not brush-down the joints. Trowel-edge marks should show. Do not allow the masons to lay new walls with fat joints. For some reason all of them think "old brick" means 5/8" to 3/4" joints. A look at the old walls show that the joints average 3/8" wide.

H. Study the existing joints closely and carefully in all the above aspects. Go over each point with the mason who is to do the actual work (not his boss—the word never filters down). Have the mason build a + 3' square sample placed against an existing wall. Let the sample dry (to see mortar color) and clean it. Then compare with the existing wall.

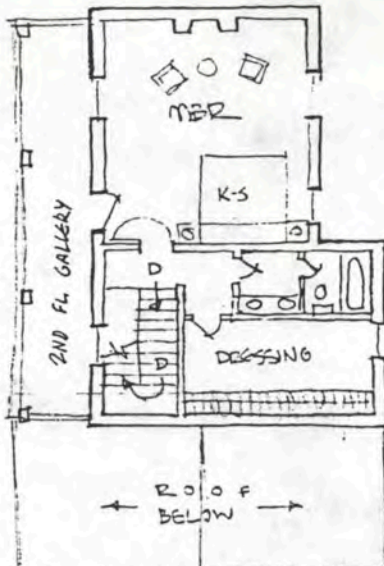
DEARING-SWAIN USE
2ND FL. SERV. WING OVERLAY

(H) Demol. Section
