August 1974

# NASA TECHNICAL MEMORANDUM

NASA TM X-64825

MSFC SKYLAB CREW SYSTEMS MISSION EVALUATION Skylab Program Office

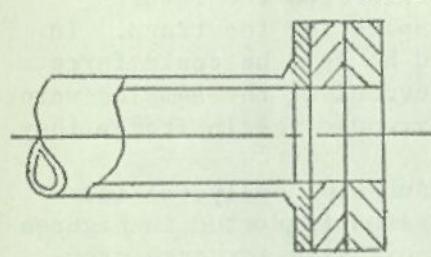
# URINE COLLECTION DRAWER NO. 3

LAUNCH CONDITION SEALS BONDED TO SUCTION LINE FLANGE BECAME DEBONDED

REPAIR TECHNIQUE STAINLESS STEEL COLLET INSERTS INTO EXISTING SUCTION LINE WITH PROVISIONS TO SEAL DRAWER MOUNTED VALVE BODY
