# DEVELOPMENT OF LOX-HYDROGEN ENGINES FOR THE SATURN A POLLO LAUNCH VEHICLES

# A. J. BURKS, Assistant Manager

June 10. 1968

NATIONAL AERONAUTICS AND SPACE ADMINISTRATION

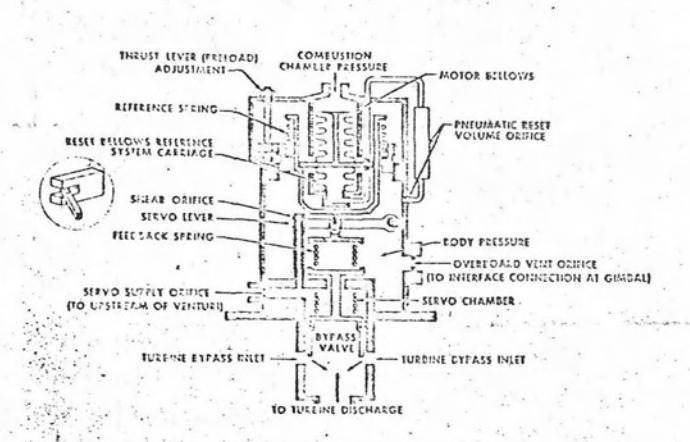
Thrust Overshoot. The Centaur vehicle was unable to accept more than 15 percent thrust overshoot. Thrust exceeding the specified limit occurred because the engine thrust control valve (Figure 6) was set to maintain a chamber pressure of 300 psi and did not by-pass any turbine drive gas until the nominal thrust level was reached. The system momentum was not retarded early enough to prevent the overshoot. Adjustments in spring pressure on the thrust control piston prevented excessive thrust overshoot, but caused the system to stabilize below the nominal thrust level.

The problem was solved by the incorporation of a "pneumatic reset" on the thrust control. The thrust control by-pass was set to open at a lower chamber pressure (approximately 270 psi), and the desired nominal 300 psi chamber pressure was reestablished by use of the pneumatic reset system.

The reference pressure on the back side of the thrust control by-pass piston is atmospheric pressure which is essentially zero psi at the engine operating altitude. When the thrust controller bypass is actuated at the lower chamber pressure level, hydrogen is vented into the thrust control body. By orificing the thrust control valve body vent, the body pressure and piston reference pressure are increased approximately 30 psi which resets the by-pass relief pressure to obtain the nominal 300 psi chamber pressure. By this method the reset pressure lags the body pressure during engine acceleration which allows the thrust control valve to return to a nominal position before the desired 300 psi chamber pressure is reached.

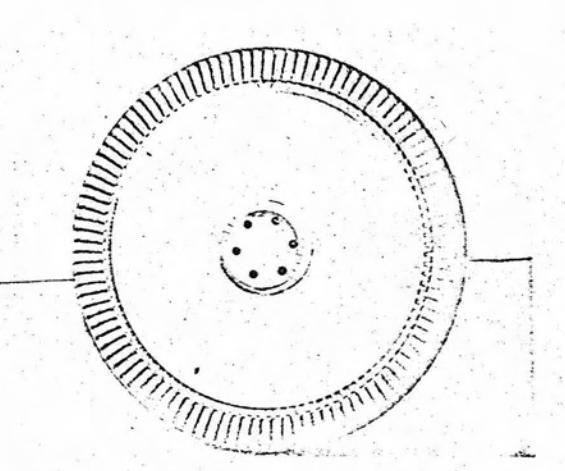
Figure 16. LOX Turbine Wheel

LOX Turbine Wheel Cracks. Cracking was detected during a routine inspection of the second stage LOX turbine wheel (Figure 16).

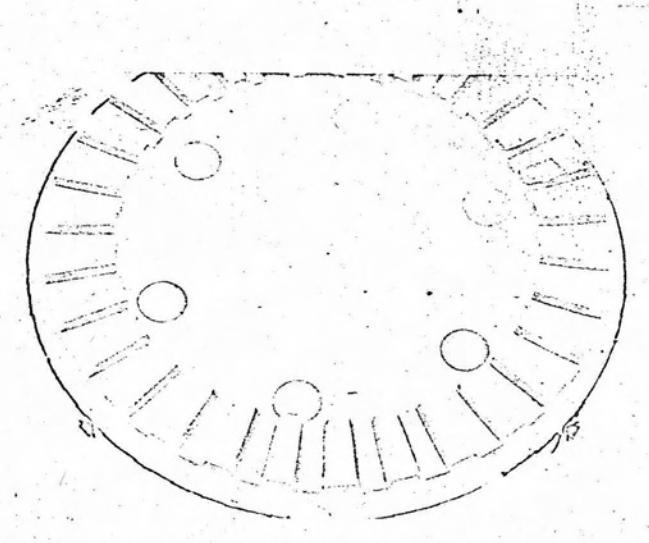
As shown in Figure 17 the wheel hub was cracked around the entire periphery. Since this wheel operated at about 8,000 rpm, the potential energy available could cause catastrophic results in case of failure. It was discovered that in going through the mixture ratio excursion on the J-2 engine, a standing wave was generated in the turbine wheel which continued to flex the metal at the hub area until fatigue occurred. By changing the web thickness and the stiffening characteristics of the wheel the destructive standing wave vibration was eliminated.

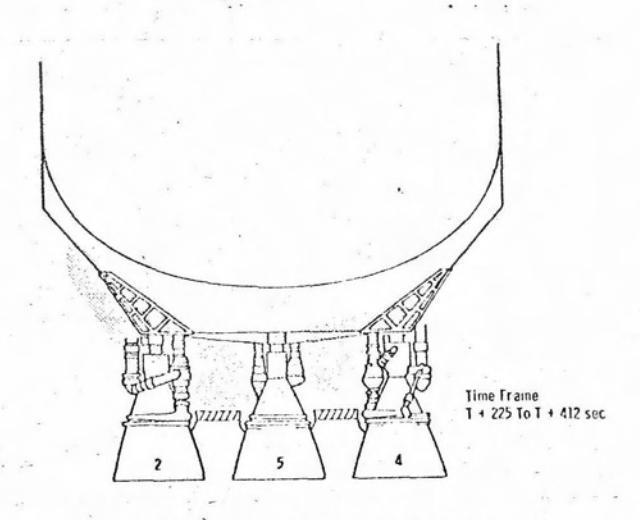
Figure 21. Side View of Area Cooled Prior to Engine Number 2 Cutoff

Cooling trends were established by 280 seconds after liftoff and were accelerated at 320 seconds. Both time intervals correspond closely with thrust shifts. Just prior to engine number 2 cutoff the engine and thrust cone area indicated hot gas impingement. Following engine number 2 cutoff there was a cooling trend in the engine 2-5 quadrant indicating a cryogenic line rupture.

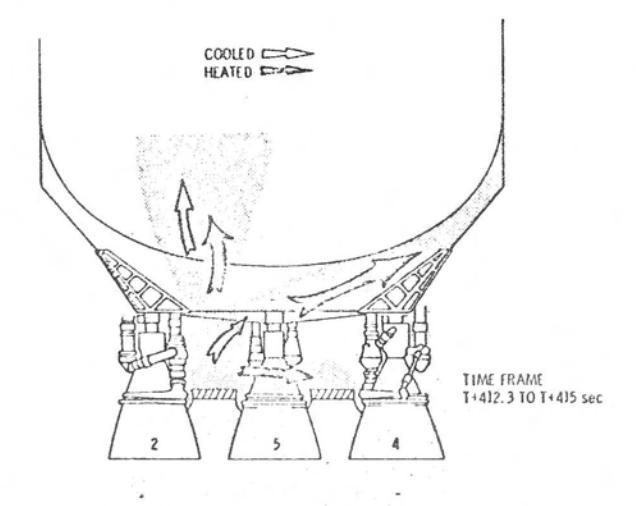
Figure 23. Side View of Areas Heated and Cooled at Engine Number 2 Cutoff

Environmental Changes. The 502 flight was normal by 501 standards until 225 seconds after liftoff. At that time temperature began to drop rapidly in sclected engine areas as shown in Figures 19, 20, and 21. Engine 2 cutoff was preceded 0.3 seconds by indications of hot gas impingement as depicted in Figures 22 and 23.

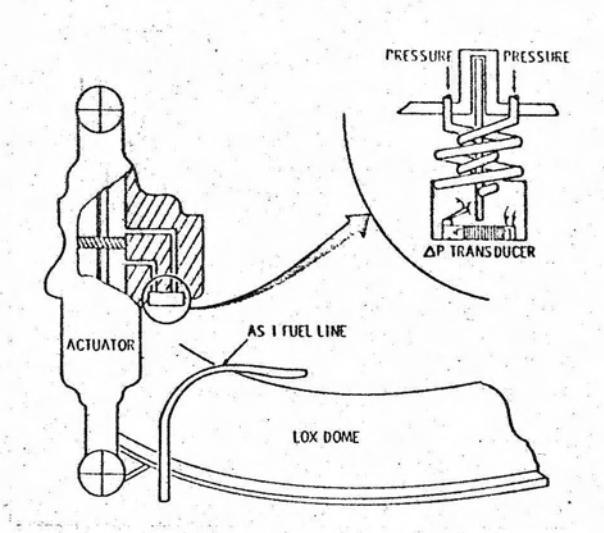
Figure 29. Pictorial Schematic of  $\Delta P$  Transducer

An actuator pressure transducer was subjected to a stream of liquid nitrogen to simulate a liquid hydrogen leak impingement. The pressure transducer (Figure 29) is composed of two concentric helix bourdon pressure tubes with one attached to the dash pot wall and the other fastened to a sliding rod. As the outer helix tube cooled rapidly it contracted faster than the inner tube and gave an indication of a differential pressure. As the inner helix tube approached the temperature of the outer one, the transducer indicated a null position. When the cryogenic source was removed, the process was reversed with the outer tube heating up faster, expanding, and giving an erroneous differential pressure. As the inner tube temperature approached the outer one a null position was again initiated. It is believed that the cryogenic spray of the actuator  $\Delta P$  transducer and/or an engine performance shift could explain all the indicated yaw actuator anomalies.
