Frances Cabaniss Roberts Collection: Series 4, Subseries D, Box 5, Folder 4
Huntsville Historic Preservation Committee Minutes and Materials, 1972 -1994

Page 2
Huntsville Historic Preservation Commission
May 23, 1972

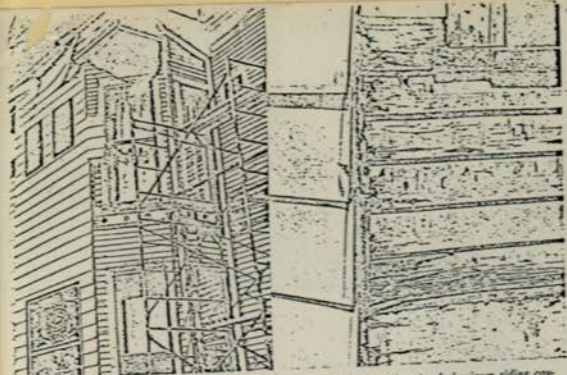
Above: It was evident that water was seeping behind the aluminum siding and causing the clapboards beneath to rot. As a result, all clapboards above the second floor windows had to be replaced. Water had also collected at the raised banding below the second floor windows, raising the clapboards there. Note the shadowlines of the bull's-eye details that had been removed to accommodate the aluminum siding.

Below: The areas where water had been trapped beneath the aluminum siding showed severe deterioration. In this case, even the studs had rotted and the interior plaster was beginning to fall.

to correct a water problem prior to installation, or damage to the siding. There were areas where water had been entering undetected, causing the original siding, sheathing, and structural studs to rot. Interior plaster was also beginning to fall due to excess moisture.

Various insects had been making their homes behind the aluminum siding. Beetles and wasps found it particularly attractive. One area was literally covered with dead wasps, another was actively infested with termites, which were busily destroying the frame structure while protected by the aluminum siding. But for the siding, the termite attack easily could have been detected.

It was also clear that the frame structure had been damaged during installation of the siding. Nails used to secure furring strips that held the aluminum siding had cracked the original wood siding. Decorative details had been removed, and the wood window sills had been cut and sections removed to accommodate the siding.

To restore the building, the owner is replacing damaged or deteriorated wood siding and trim, reconstructing missing trim and details, filling nail holes and cracks, and scraping all loose paint. He is then sanding, priming, and painting the siding with colors that match the original. This project also involves restoration of the house's porches, which had been altered when the aluminum siding was installed. The porches' original wood columns and railings were replaced with wrought iron, altering the original design and appearance of the house. Those wrought-iron fixtures appear too light and delicate to carry the roof's weight, and they may not be structurally sound. The sagging roof provided evidence that the supporting system was failing. The inappropriate wrought-iron columns and railings will be replaced with columns and railings matching the original.

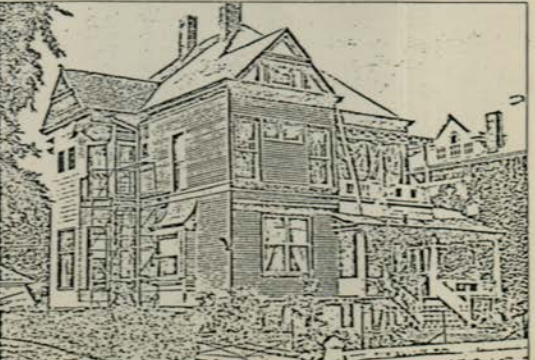
Above: Covered with aluminum siding, this 1889 house in Peoria's West Bluff Historic District lacked detail and had a flat, monotonous appearance.

Below: The same house during a preservation project partially funded by a federal historic preservation grant-in-aid administered by the Department of Conservation. The synthetic siding is being removed, rotten or missing boards are being replaced, and the surface is being painted.

Faced with periodically painting the aluminum siding and maintaining a building out of character with the rest of the neighborhood, the owner removed the siding himself, disclosing the badly deteriorated clapboards beneath. The aluminum shell was not airtight, yet there was not enough air circulation to allow moisture to evaporate. Dirt had accumulated behind the siding, and the condensed moisture that had been trapped between clapboards and siding ran down the side of the house, leaving patterns in the accumulated dirt. Most bottom boards near raised moldings or trim boards, where moisture had collected at the base of each planar surface, were rotten and required replacing. In other areas water was actually entering and being trapped behind the siding, a phenomenon attributable to any of several causes—improper installation, failure

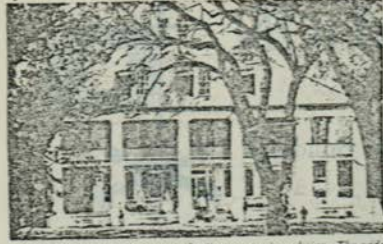
Figure 3. Southern mansions typify climate conscious design. The wide roof overhangs, exterior porches, shade trees, heavy masonry walls (painted white), and living quarters on the second floor (in each evening breezes and escape the radiant heat from the earth's surface) all are energy saving characteristics which provide reasonably comfortable living spaces without mechanical air conditioning. (Photo: Marcus Aumann Smith)

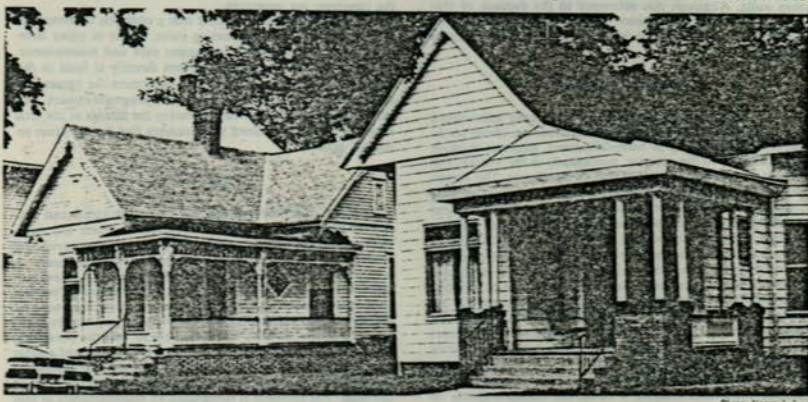
Photo: Nancy J. Long

Two originally similar houses. When aluminum was installed on the house on the right, the barge boards, scrollwork, columns and railings were removed. The distinctive shingled gable and attic vent were covered, further compromising the building's architectural integrity.

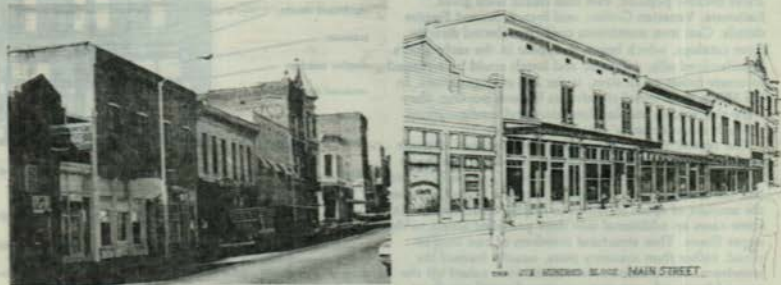
Figure 1. Inappropriate storefront alterations over the years—metal cladding, oversized signs and canopies—have detracted from the character of this historic district in Van Buren, Arkansas. A carefully considered rehabilitation plan for Main Street, including the removal of poorly designed signs, false fronts and the selection of an appropriate exterior paint color palette, serves to enhance the visual environment and preserves the district's sense of time and place. Photo above: Bob Dunn; Drawing, David Fitts

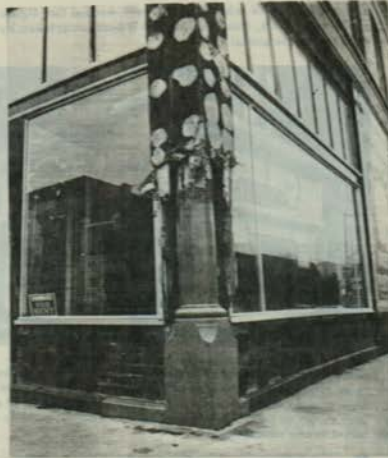
Figure 6. Storefronts of the 1940's, 50's, and 60's were frequently installed by attaching studs or a metal grid over an early front and applying new covering materials. If the existing storefront is a relatively recent addition with little or no architectural merit, begin by removing the covering materials in several places as was done here. If this preliminary investigation reveals evidence of an earlier front, such as this cast-iron column, carefully remove the later materials to assess the overall condition of the historic storefront. The black mastic visible on the lower masonry panels was used for installing pigmented structural glass. Some attachment methods for modern facings, such as mastic or metal lath, may have seriously damaged the original fabric of the building, and this must be taken into account in the rehabilitation process. Photo: Bob Dunn
