1858 Vaughn - Stacy Hsu
Pulaski, Tr.

1858 VAUGHN-STACY HOUSE, PULASKI, TENNESSEE

1858
VAUGHN-STACY
HOUSE - PULASKI, TN.
SKETCH PLAN - JULY 3 '83
HARVIE P. JONES, F.A.I.A.

photos June 1983 H.P. Jones, F.A.I.A.
Vance - Stacy - Irwin
Ford Ave - Pulaski, Tenn. - ca. 1858 - Sam Davis Ave. III
1 of 7

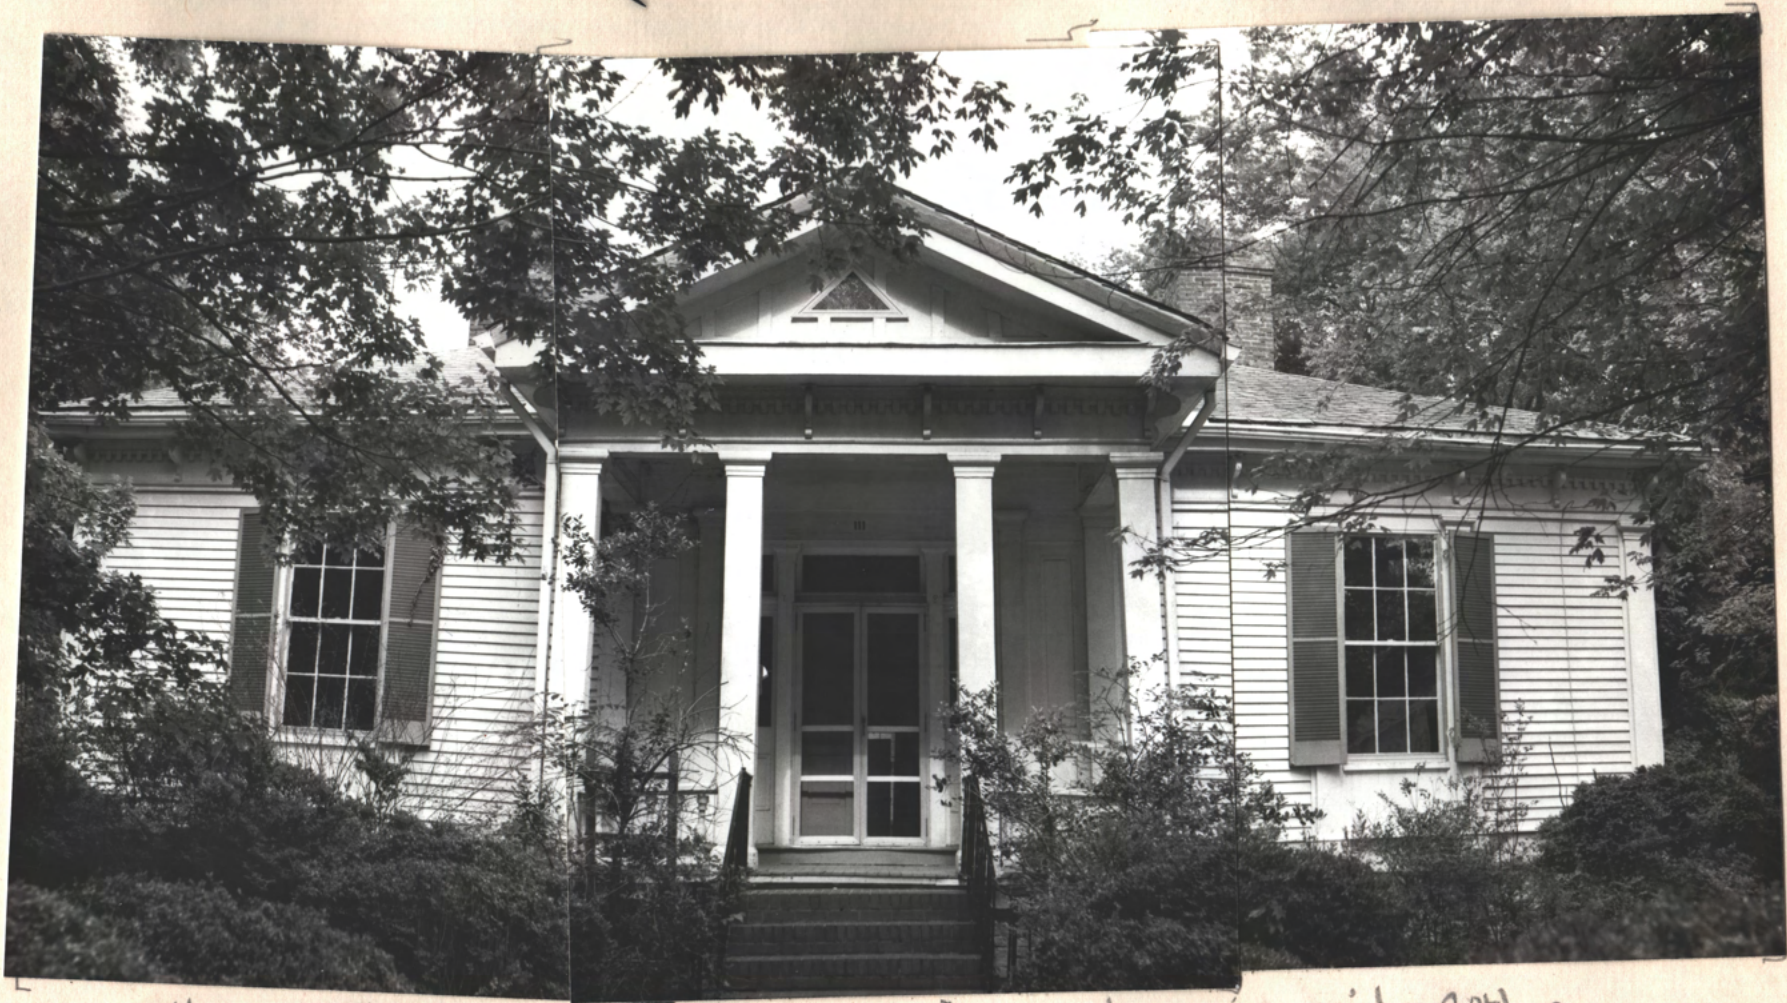
WEST PORTICO (added per attic evidence
built sometime after Civil War, per attic evidence)

gutters = 20th. c.

conc. steps + iron rail = 20th c.

Triangular vent probably early 20th c.

The two tetrastyle pedimented porticos are added, based on conclusive evidence inside the attic, and are almost identical in design except that the north one facing the secondary street (Madison) is narrower, has more slender boxed Tuscan columns, and has a steeper roof pitch. Perhaps these porticos were added in the last quarter of the 19th century, based on testimony of an 1860-1878 Chancery Court case. The tympanum of each portico has an inharmonious triangular vent screened with hardware cloth. These vents appear to have been added. Each tympanum has wide vertical boards with battens. Wide horizontal boards with flush inconspicuous butt joints is usual, but this battened typanum possibly is a result of the Victorian influence, in which battened vertical surfaces became stylish, as in Carpenter Gothic churches. The two porticos have wooden balustrades with heavy turned balusters derived from classical urn designs. The portico floors are modern narrow tongue-and-groove wood. The steps are modern brick with steel rails. Typically houses of this period had finished wooden steps with nosed treads, closed risers and skirts and latticed side-closures. Only infrequently did they have balustrades at the steps. The two entries each have four Tuscan pilasters, transoms, and sidelights. The glazing is Bohemian glass with floral designs, and are of cranberry color. The sidelights at the main west entry are clear, apparently replacement glass, the Bohemian glass now being lost (the Bohemian transom glass transom remains). The owner found broken pieces of Bohemian cranberry glass in the basement. The sidelights at the north secondary entry are "blind", a fact not evident from the exterior (see plan sketch). This observer has seen several false windows (covered with blinds) in 19th century houses, but no false sidelights until this example. The plan leaves little question but that they are originally false, as room partitions run into the back of the sidelights.

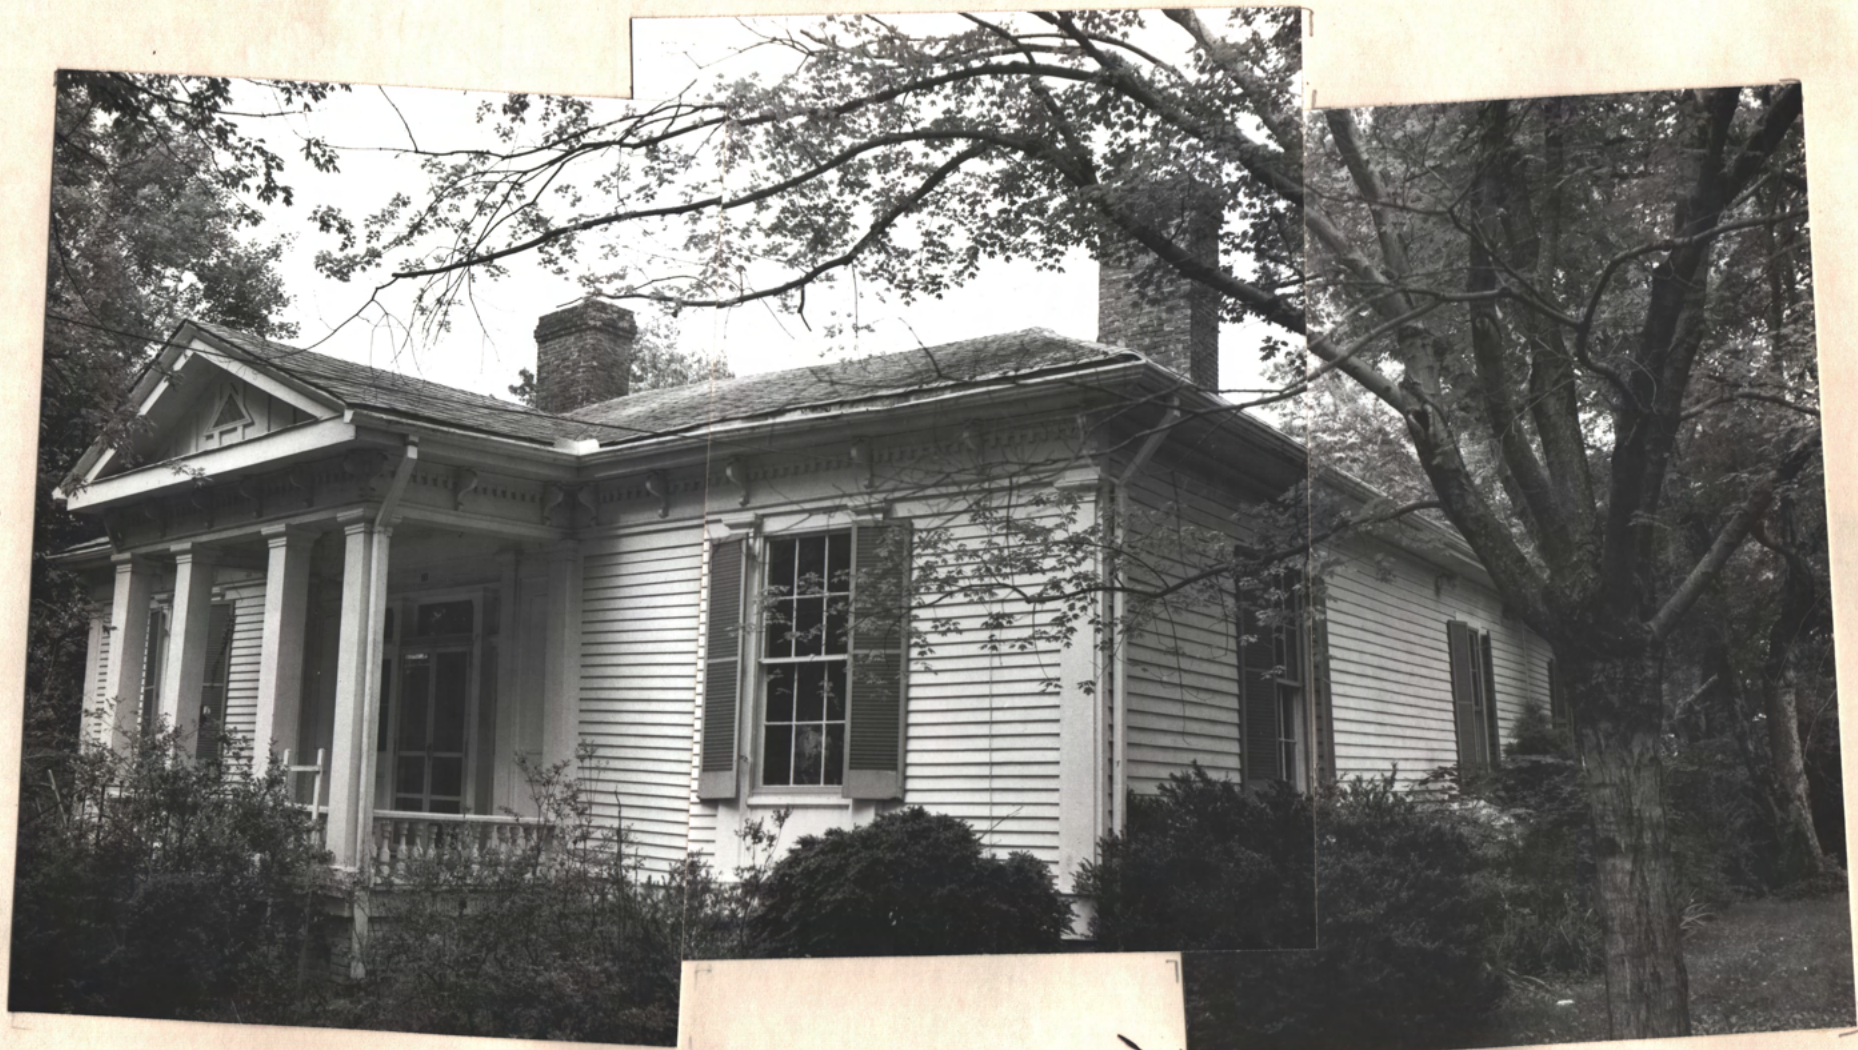
267
West Portico
(added, per
attic evidence)

Blinks not original, apparently
(thin paint, no pegs at tenons)
Gutters = 20th. cent. (orig. cornices
are removed)

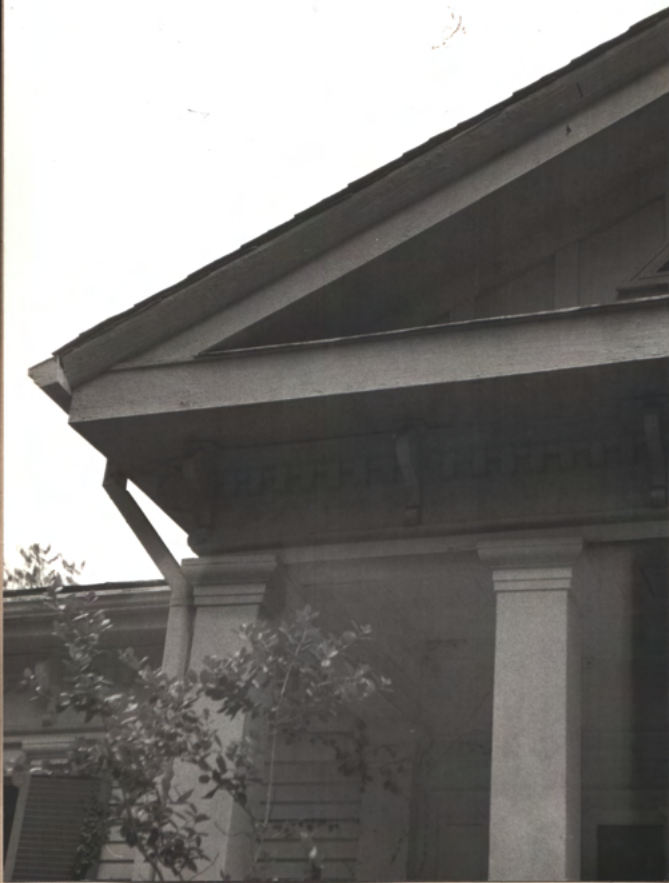
West Portico

Bohemian
Cranberry
Gl.

Clear
Gl.
probably
was
Bohemian
glass
(broken
pieces found
in basement)

We found broken pieces of Bohemian glass in the basement which seems to confirm the west sidelights were originally Bohemian glass.

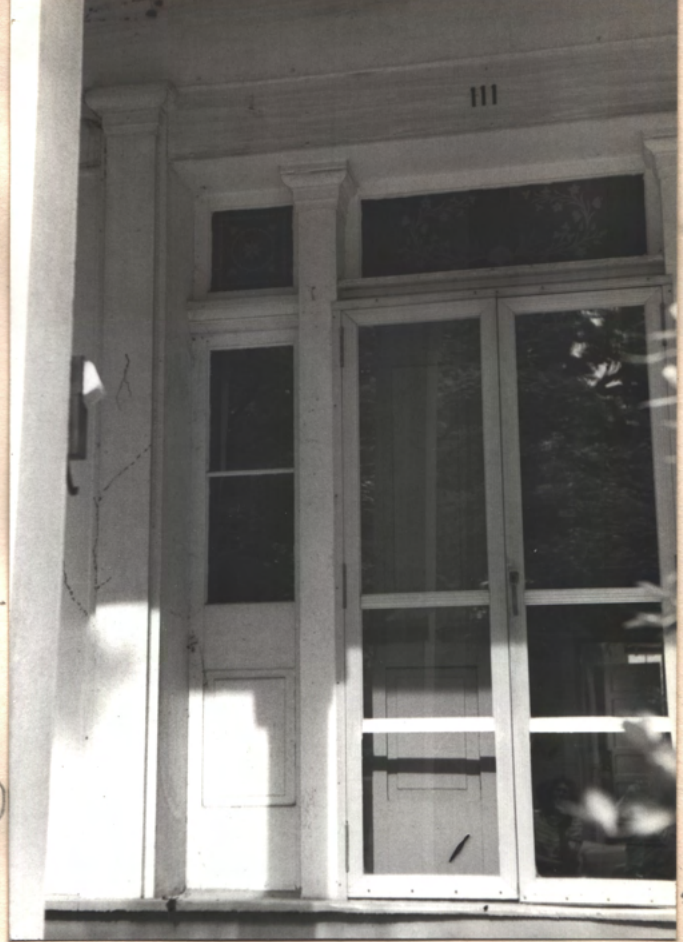
West Portico

alum. + gl. storm doors

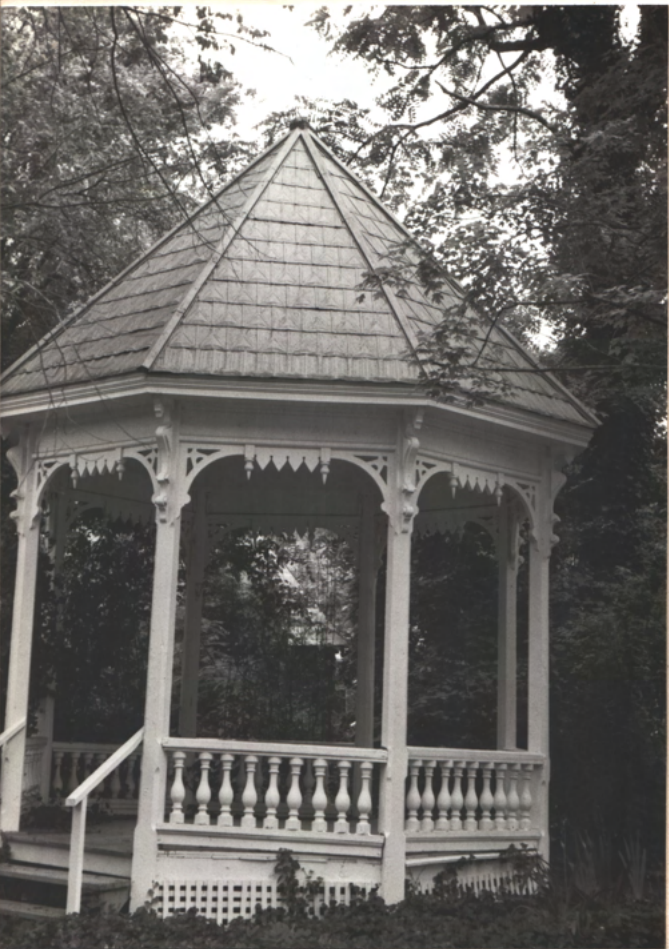
Gazebo - looks 1880-1890
based on style (?)

wood spire
rotted off
(base remains)

Surviving outbuildings consist of an octagonal, steep-roofed summerhouse, or gazebo, and a wellhouse. The bracketing and delicate jigsaw work on the gazebo seem to indicate a late-19th century date of construction, as does the previously mentioned ceiling of double-beaded T & G 1x6's. The roof is of stamped metal shingles. The tall wooden finial typically found on such structures has rotted off to its base. The wellhouse appears to also date from the late 19th century. The wellhouse is mentioned in an 1890 deed. It is hexagonal, enclosed with clapboard siding, has a jigsaw-decorated eave-fascia, and a pyramidal roof which also once had a wooden finial at the apex. The ell-shaped 1 1/2 story brick building east (behind) the main house appears not to have been a residence at first, although an original use is not apparent without more investigation. This building was once on the same lot as the main house. The present owner of this residence reports it had no front windows or dormers until this century. Local tradition refers to it as a "coach house", although carriage door traces are not readily apparent. The building now has an attractive and flamboyant bracketed Victorian front porch and other generally late 19th century embellishments. This porch is of a more elaborate character than the building it is on and is thus believed to have been moved here from a demolished late 19th century house. The roof of the building has wide unboxed eaves of a 1920's character, as do the added dormers. More study is needed in regard to this structure.

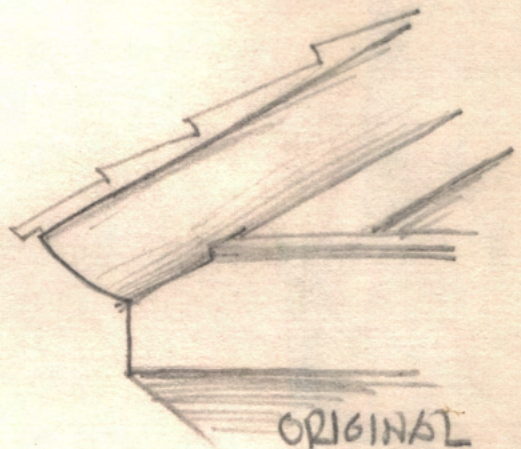
ORIGINAL
CORNICE
(now removed
for gutters)

The original roof-cornice moulds remain at the raking-cornices of the pediments. These cornice-moulds had been removed elsewhere to accommodate modern ogee guttering, and have been recently replaced to match the original moulds where previously removed. The original guttering was probably built-in, behind the wood cornices, as was usual for the period. It was also usual for these to leak and be abandoned, as was seen here. The two street-sides of the house (north and west) have wide frieze-boards under the roof-cornice decorated with dentils between Italianate-inspired cyma-reversa profile brackets. This elaborate frieze is omitted on the off-street (S. & E.) facades. The windows of the two street-facades are flanked by pilasters, but these embellishments are also omitted on the off-street facades.

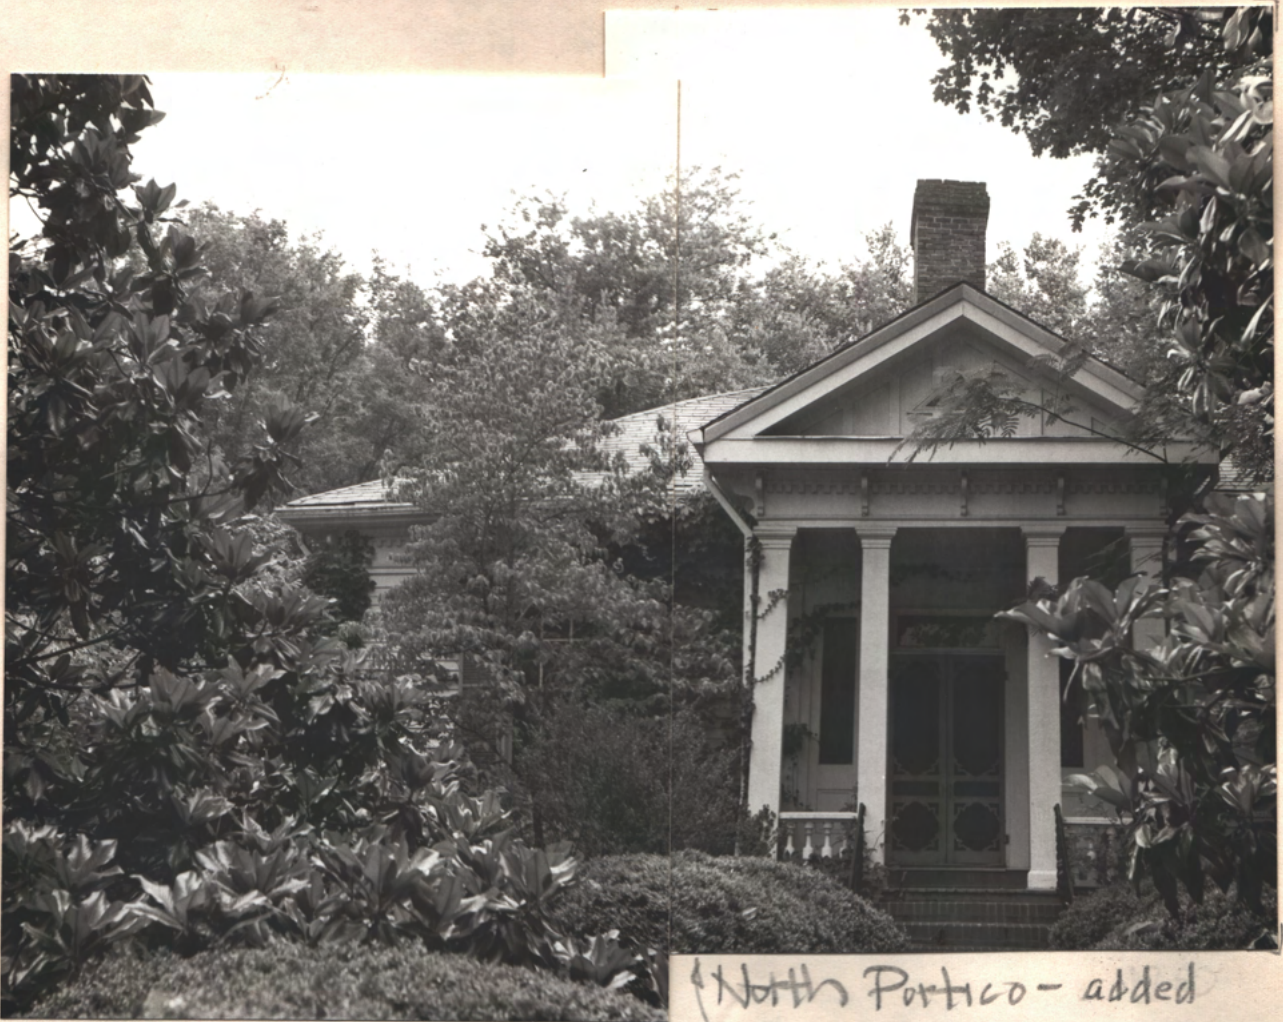
North Portico - added

triangular vent w/
"hardware cloth" is
probably 20th. cent.

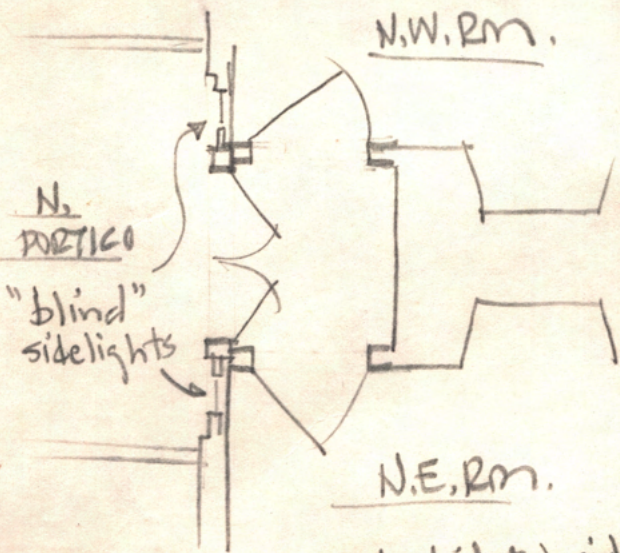
toplight & sidelights
= Bohemian
Cranberry Glass

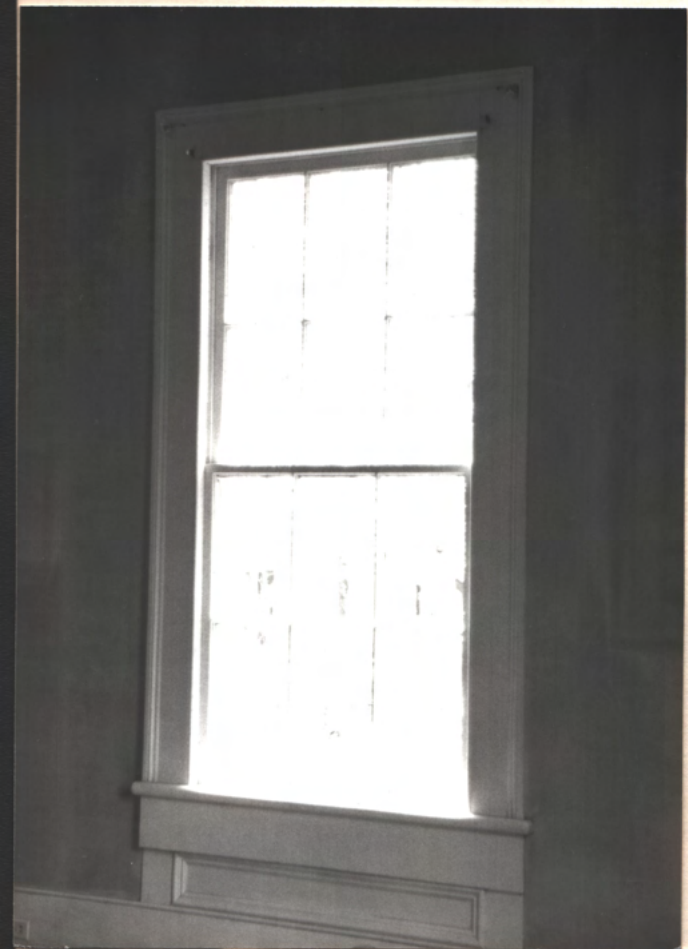
Window (typical for other main rms)

The windows in the original part of the house are large 6/6 single-sliding sashes, the bottom sash now hung on metal tapes that are presumably a 20th century improvement. The top sashes are fixed in place, as was usual for the 19th century. The window exteriors (on the two street facades) are flanked by Tuscan pilasters with caps and bases. There are spandrel-panels under the exterior window sills. The present spandrel panels may be covering an earlier panel by their appearance. An investigation should be made. The interior window trim is simple flat back-banded trim with a spandrel panel below the sill and above the baseboard. The original sash muntin-bars are of a simple wedge-section most common for the mid-19th century.

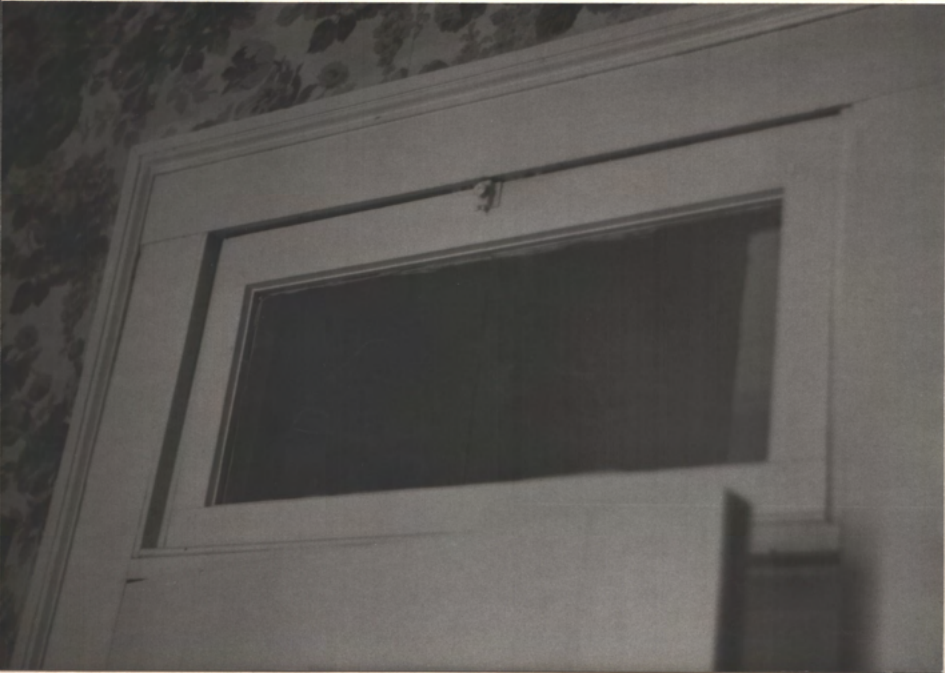
N.E. RM. DOOR + TRANSOM

← (4-panel doors)
Lock probably original →

The doors are 4-panel, most typical for this period, the panels being raised on the more prominent side and flat on the less-prominent "room side" (also typical). The doors have jack-plane marks on their surfaces, and exposed tenon-ends and pegs, typical of ante-bellum doors (the doors to the N.W. room from the hall are 20th century replacements). The iron rimlocks are vertically-proportioned rectangles and have white ceramic knobs. This was a common mid-19th century type and no traces of previous locks were observed on the doors. The hinges are a one-piece leaf cast-iron type most common in the 19th century. They were made by placing the casting for one leaf in a mould for the entire hinge. The molten iron is then poured in the mould and runs into the pin-holes of the already cast part, forming an integral pin which cannot be removed.

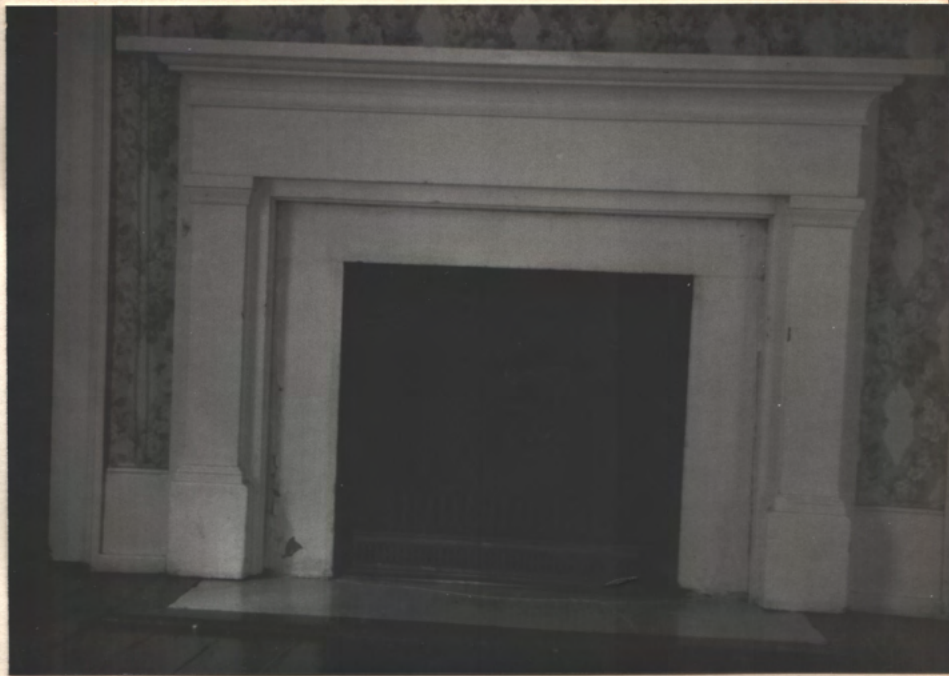
S.E. RM

Mantel

S.W. Rm. mantel not photographed— is clearly Federal Period (design, moulds, nicks, paint thick, etc) probably put here in early 20th c. in "Colonial Revival" craze. Have seen other such cases (Gov. Bibb Hse, Westmoreland in Athens, etc.)

The remaining three original mantels are of varying heavy Greek Revival types. Those in the N.E. and S.E. rooms are nearly the same, but have slightly differing moulds and proportions. A large cyma-reversa mould (one more deeply concave than the other) supports a rectangular mantel-shelf. The architraves and pilasters are unmoulded rectangles, with simple caps, bases and plinths at the pilasters. The fireplace surround is sawn limestone about 3 inches thick, as is the hearth (the fireplace floor is brick). The N.W. fireplace has later been filled in for a coal grate, as has the one at the N.E. room. The N.E. mantel is of similar design except the mantel-shelf cornice is of a simple wedge profile with a beaded bottom edge. The pilasters are tapered toward the top in a suggestion of entasis. The pilaster cap is a simple bead. The mantel in the S.W. room is of Federal period design and construction, with delicate proportions, moulded pilasters and a 4-layered flaring mantel-shelf. This mantel was probably moved here from a Federal Period house in the pre-1930's when "Colonial Revival" was the rage. The writer has seen numerous such cases.

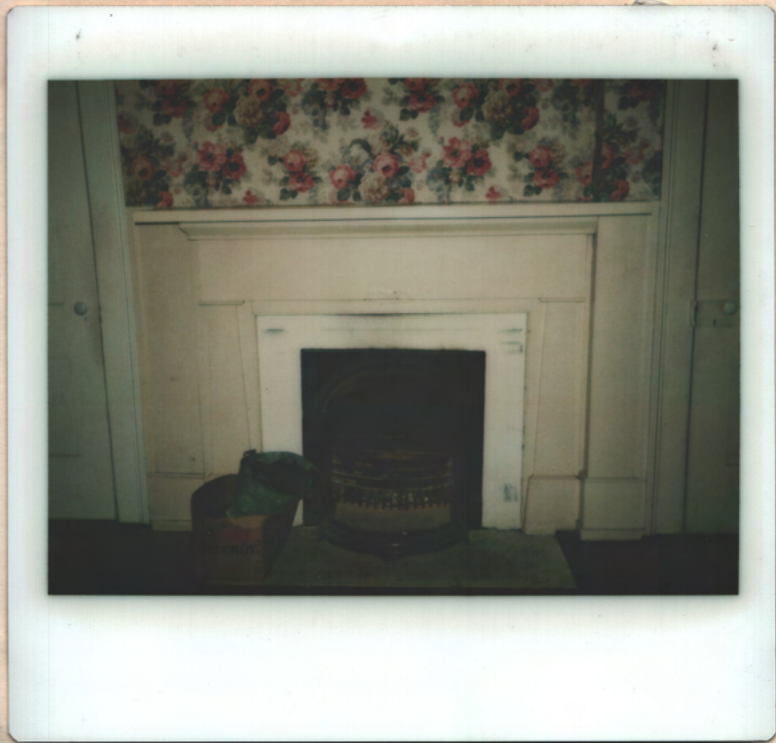
Orig. Gk. Revival mantel
in N.E. Rm

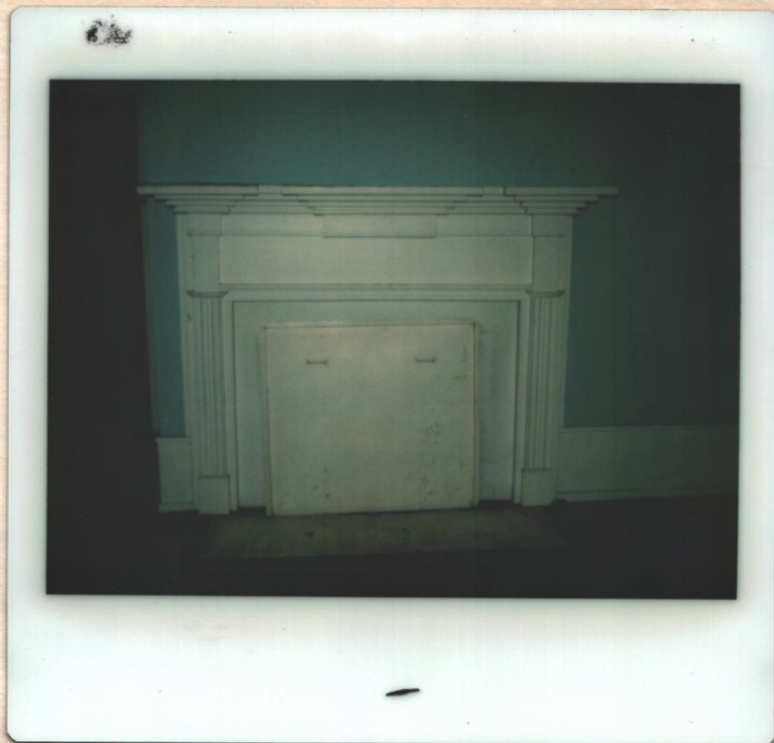
Non-original Fed. mantel
in S.W. Rm

- ③ It is common to move of tenement windows (S.E. rm). The S.W. mantel is Federal Period & probably was moved here in the Colonial Revival Period (I've seen many such examples) of the early 20th c., from a demolished house.

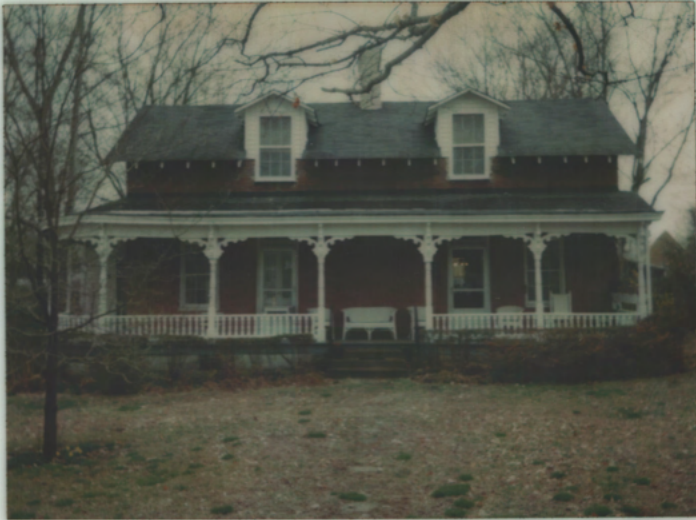
front (north side)

Former service bldg. behind 1858 Vaughn - Stacy home, Pulaski, Tex.
later converted to residence

Owner says doors & front windows added by her in 20th c.
↓
Porch presumably added (maybe reversed)

- ④ I agree with your idea on the back doors.
- ⑤ It's strange they saved the broken Bohemian glass pieces. Jim said they did.
- ⑥ The bldg. (house) behind yours is a puzzle. It has proportions like a service bldg. No windows on the front seem to clinch it. The porch may have been moved here as it is far too

flamboyant for the rest of the structure. Look for joints in the front wall indicating 6' to 7' wide carriage doors.

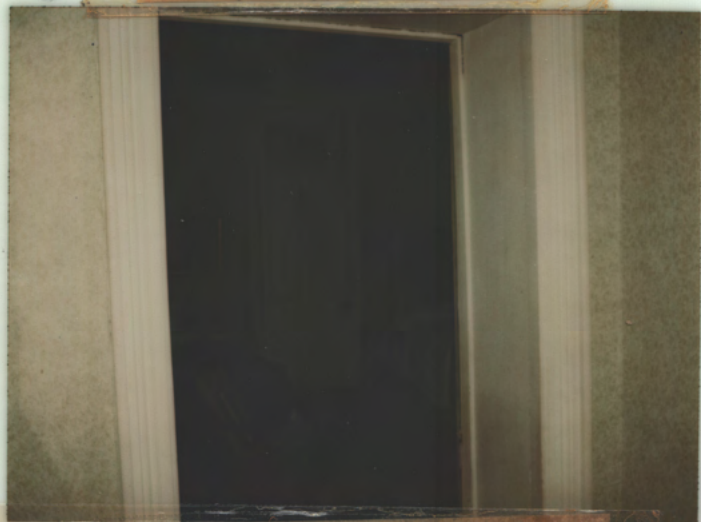
looking east

interior doorway
The door in the background was a window.
