Belle Mont, c. 1828

**RESTORATION OF THE CIRCA 1828 BELLE MONT HOUSE
Tuscumbia, Alabama**

**Belle Monte
Restoration of the circa 1828 house
Tuscumbia, Alabama**

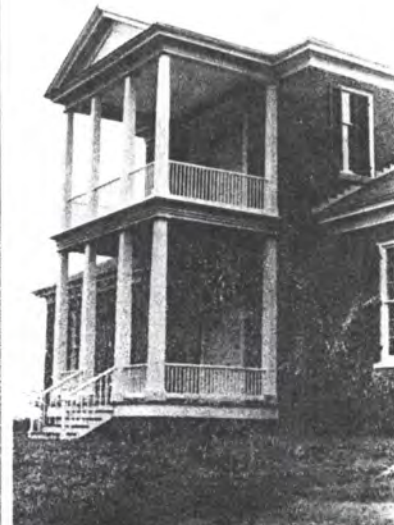
The Belle Mont portico was pulled back from the brink of collapse. Wherever possible, original material was kept — and repaired or patched as necessary.

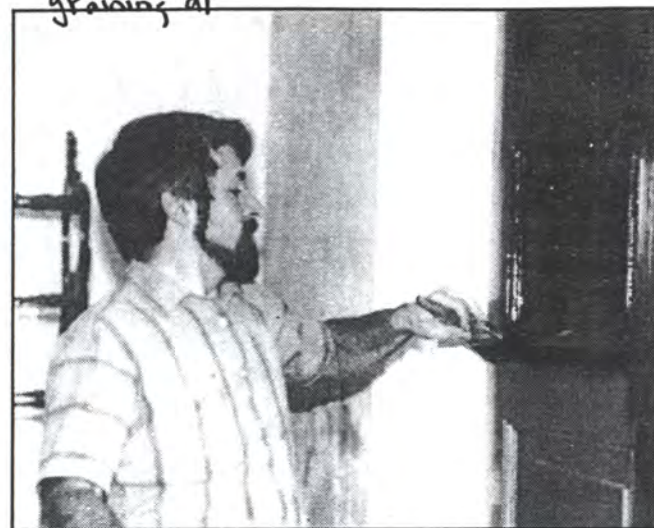
Headley applies his artistry to a door at Belle Mont.

filling in chips and cracks, sanding and priming again, two stages of graining, then varnishing.

Headley went through a systematic process of sanding the wood, priming it,

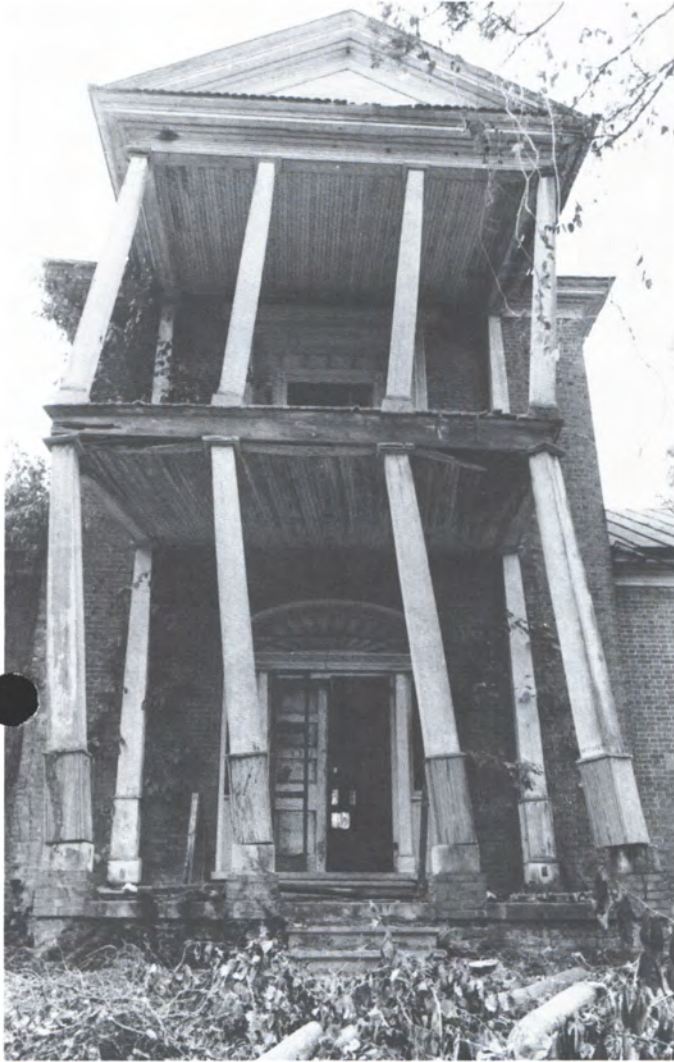
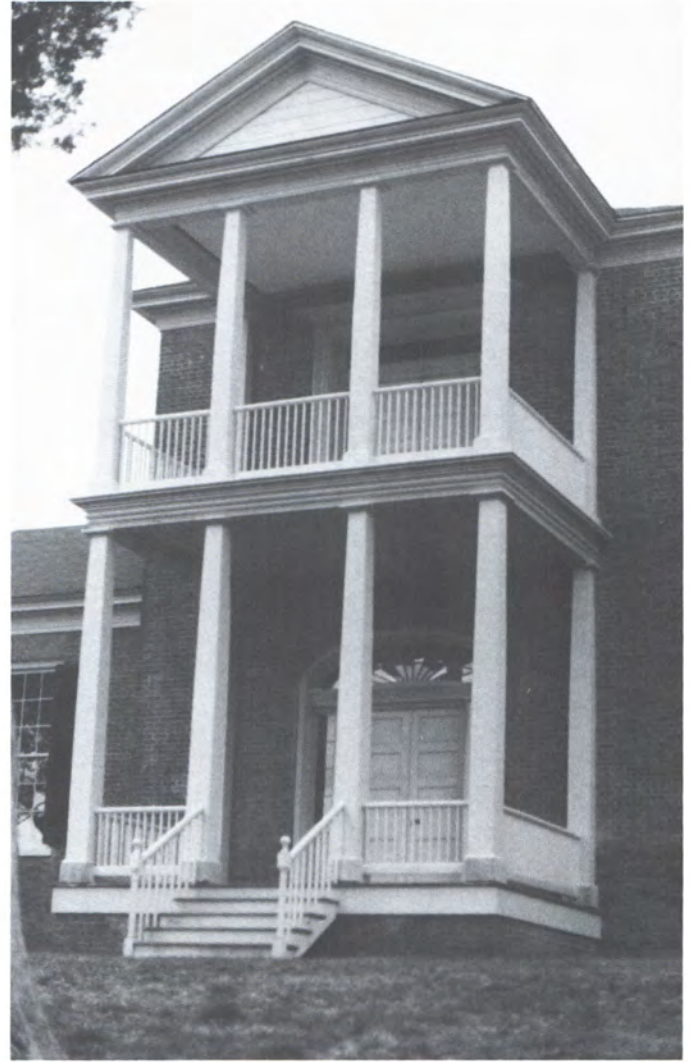
The unrestored portico was missing the second floor cornice as well as the first floor and steps. The HABS drawings and photos enabled a restoration that is at least very close to the original. The mansion now exudes the stately elegance it must have had in 1828. (Photos: Herrin & Jones, Architecture/Interior Design)

The HABS drawings and photographs were invaluable on this and other restorations executed by this office. Other elements that were completely missing at Belle Mont were chimney stacks, the elaborate moulded wood cornice at the portico's second

floor perimeter, six marble mantels (fragments remained), rimlocks, and the portico's main floor and steps. Thanks to the work of the HABS architects and photographers in 1936, Belle Mont's missing elements are at very close to the originals, if not "just like" them.

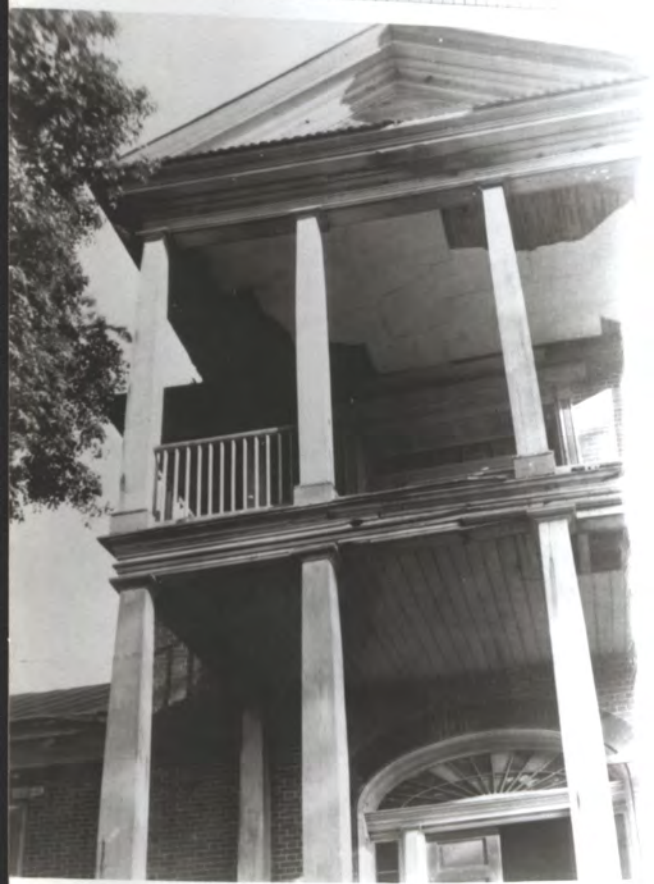
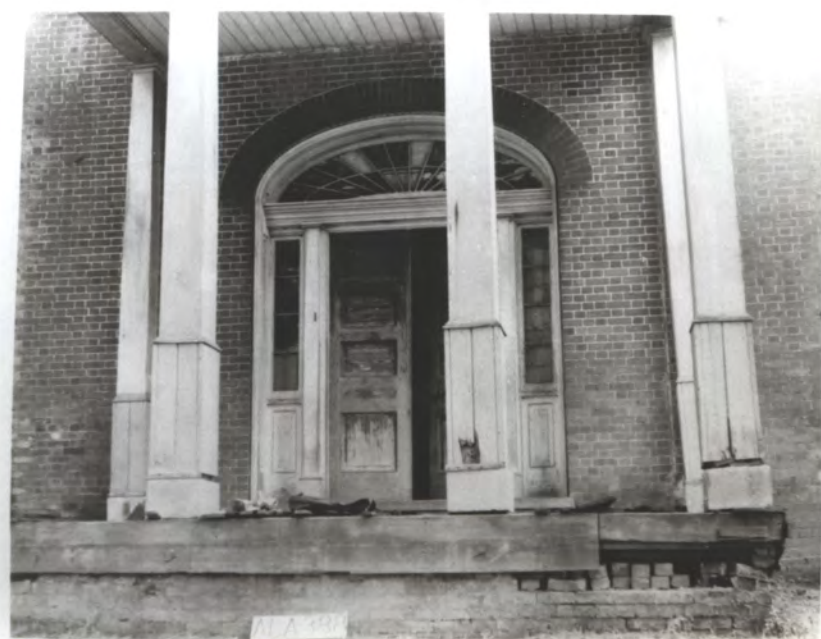
orig. wood steps gone
 orig. balustrade gone at 1st fl.
 (evidence still there)

"whingsot" at cols
 is modern
 (painted under)

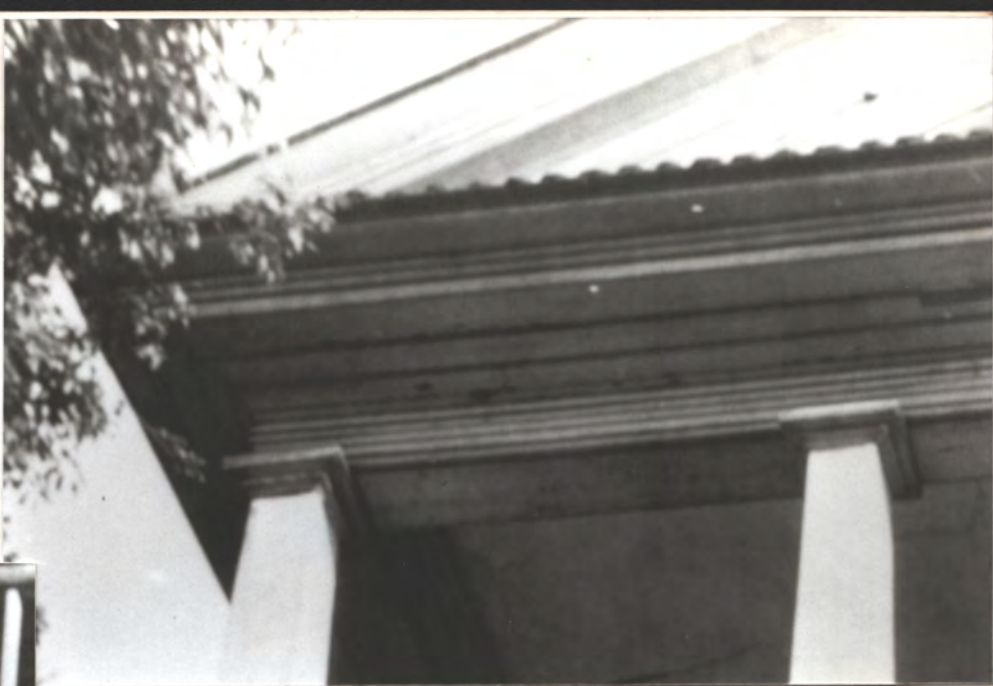
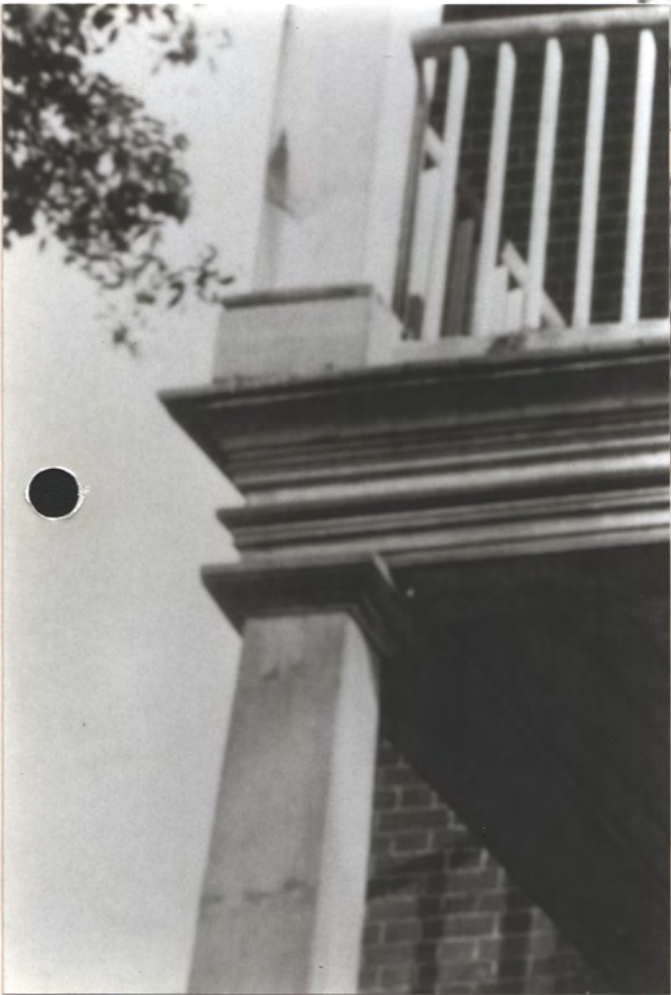
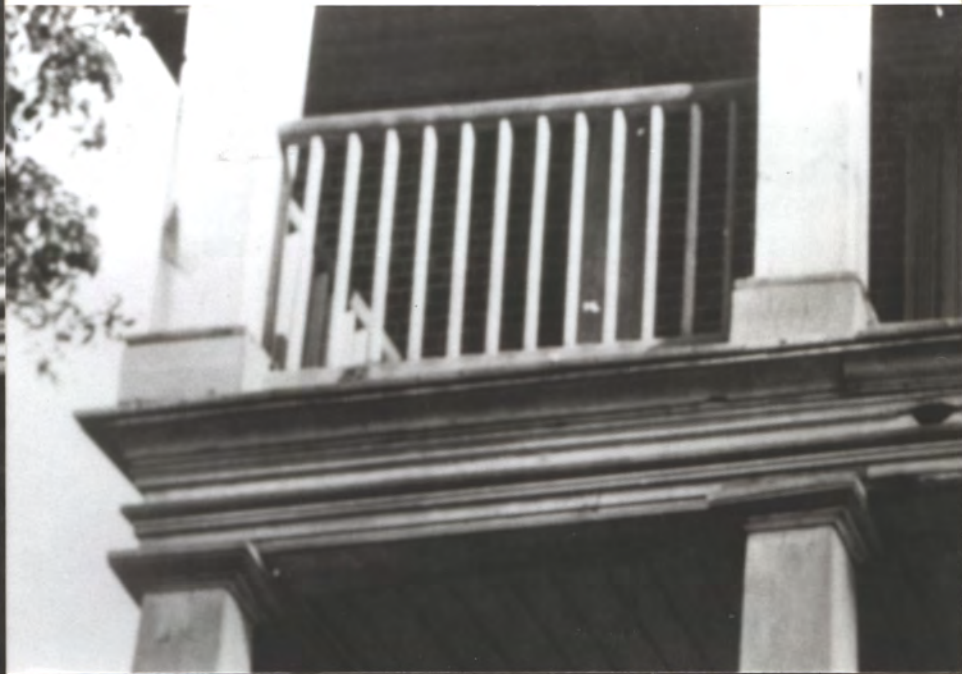
Note round-end wood shingles. Still there in 1987.
 Shingles found in attic were square-butt (1984)

Note very elaborate cornice moulds at 2nd fl. level, gone by 1963. Replanted in 1987

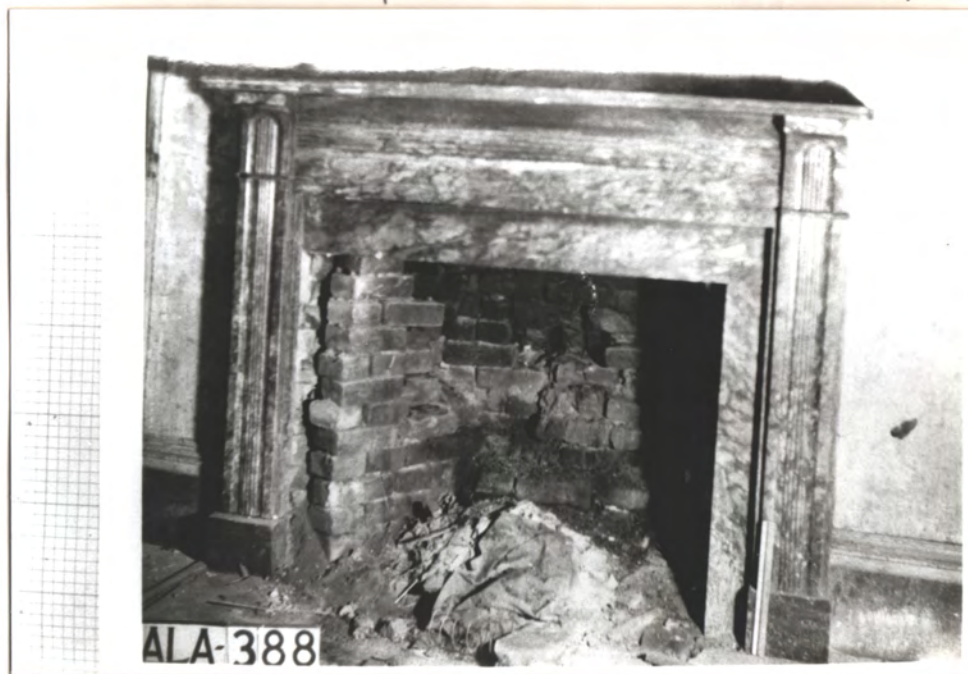
N. E. Room mantle
Marble = warm gray mottled, per chips found. (mantels gone)

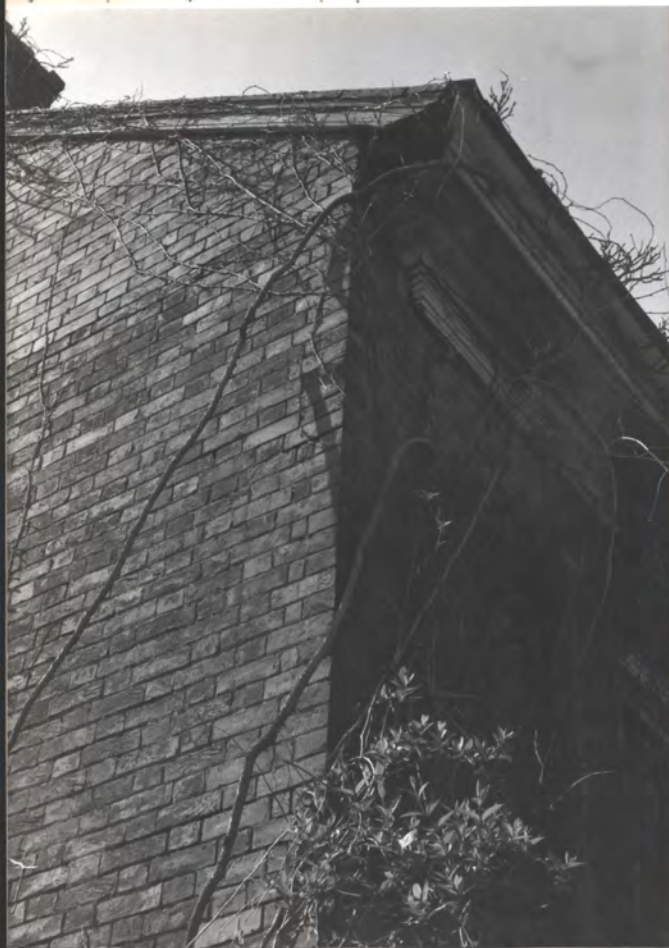
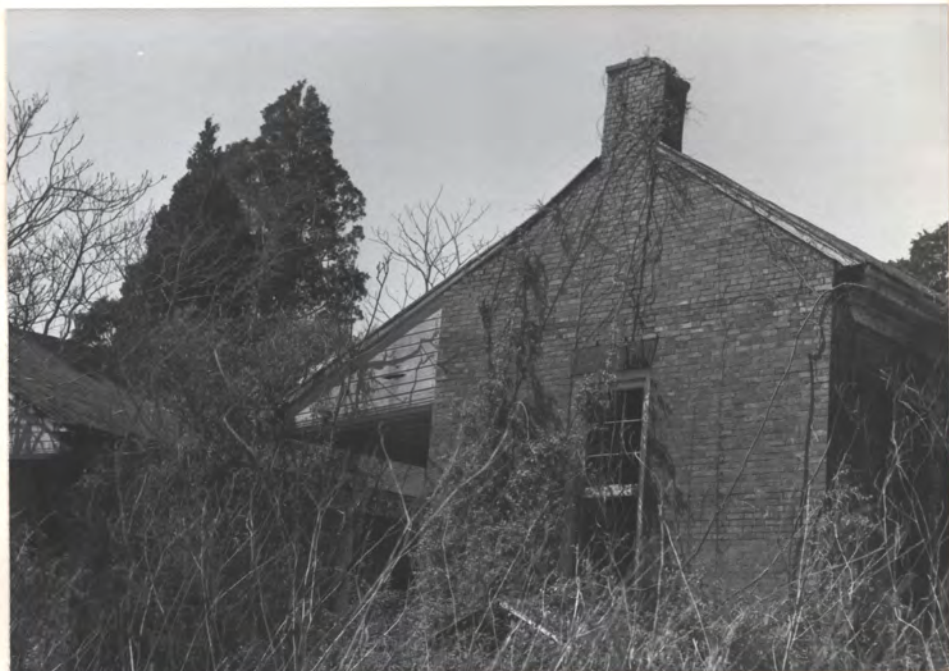
BRICK - ALL FLEMISH BOND (USUALLY
COMMON BOND ON BACK & SIDES)
NO. 2 BRICKS ON BACK 2 WALLS
NO. 2 BRICKS BELOW FL. ELEV.
RUBBED, GAGED & STAINED ARCHES

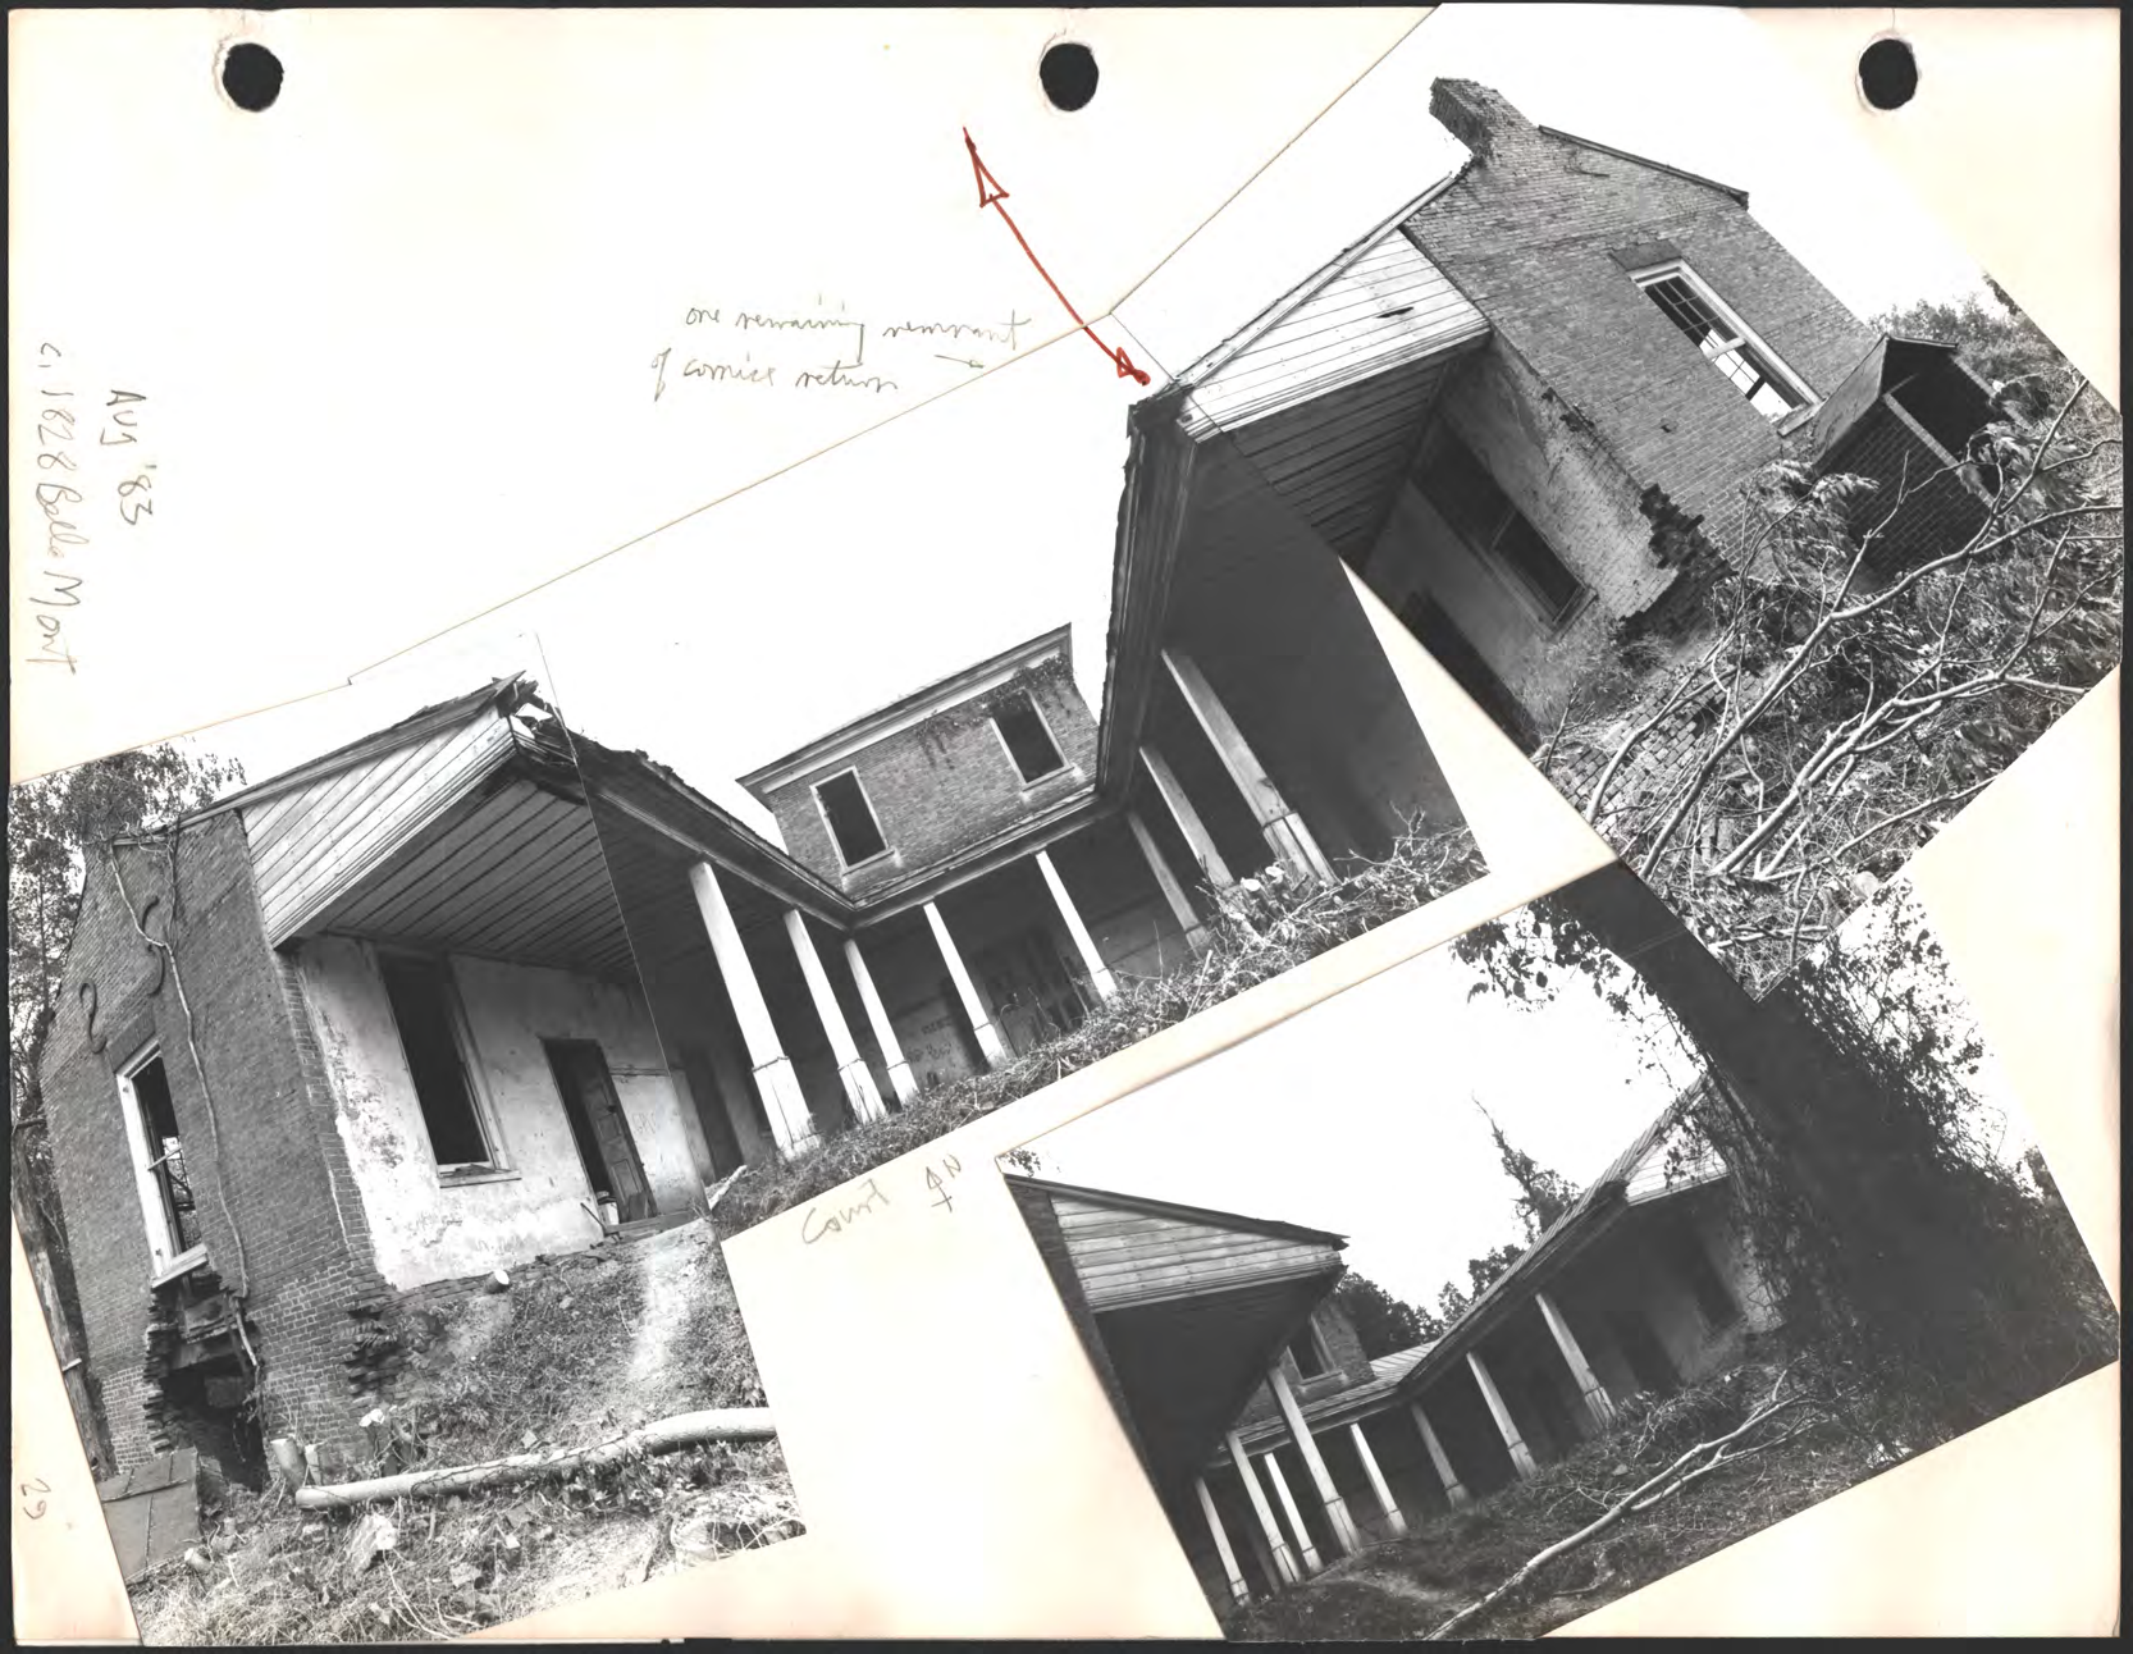
c. 1828 Belle Mont
Aug '85

one remaining remnant
of cornice return

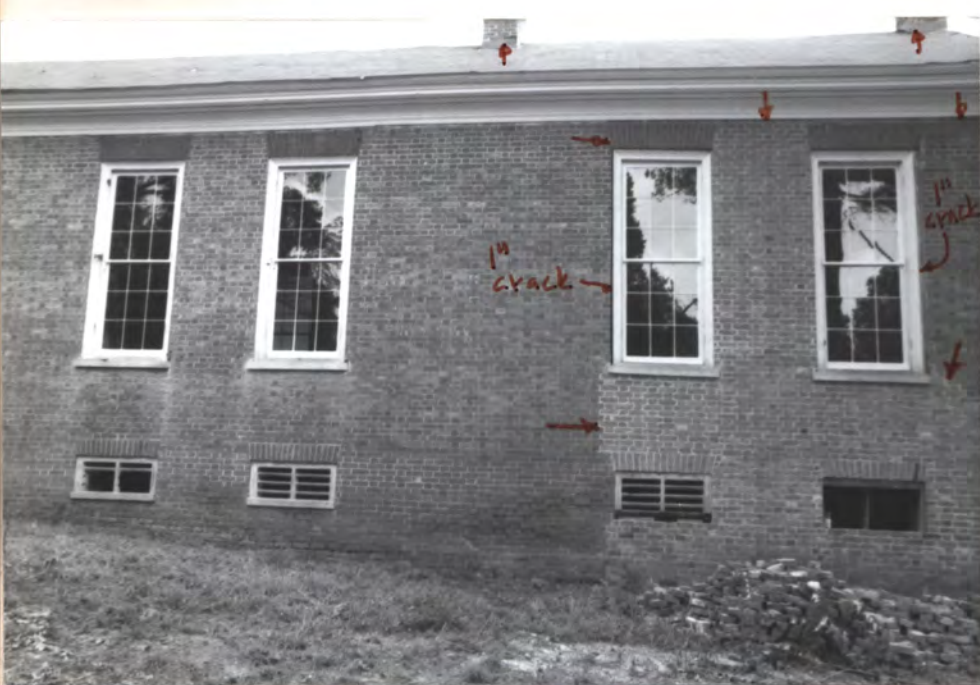
WEST ELEVATION

NOTE:
 COLLAPSED, MID 20th cent
 REBUILT IN
 1984

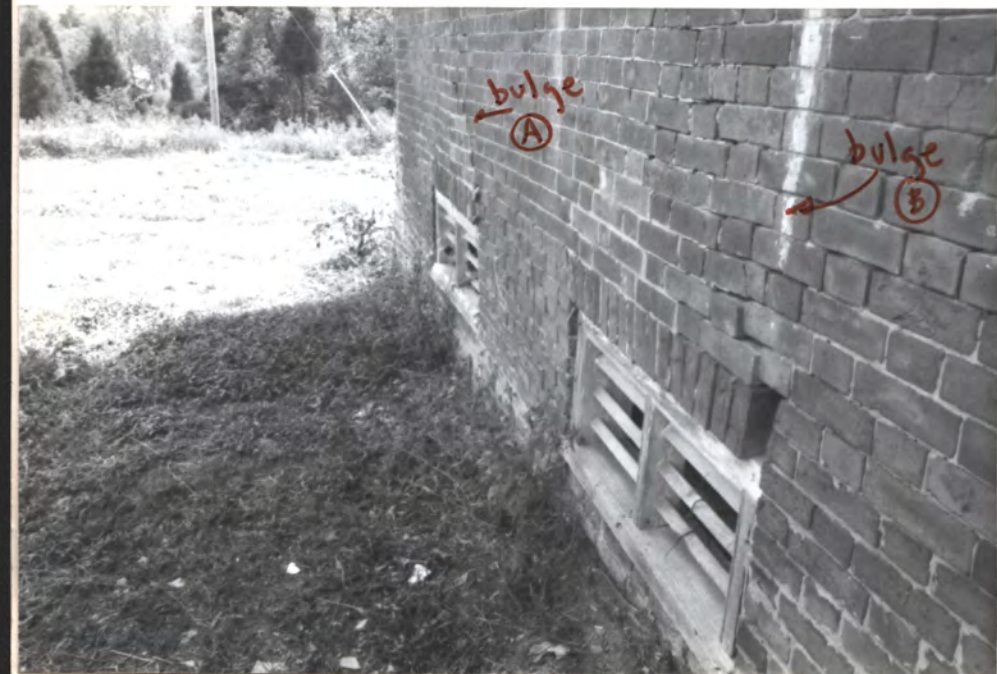
EAST WALL
(LOOKING NORTH)

bulge repaired
in 1987

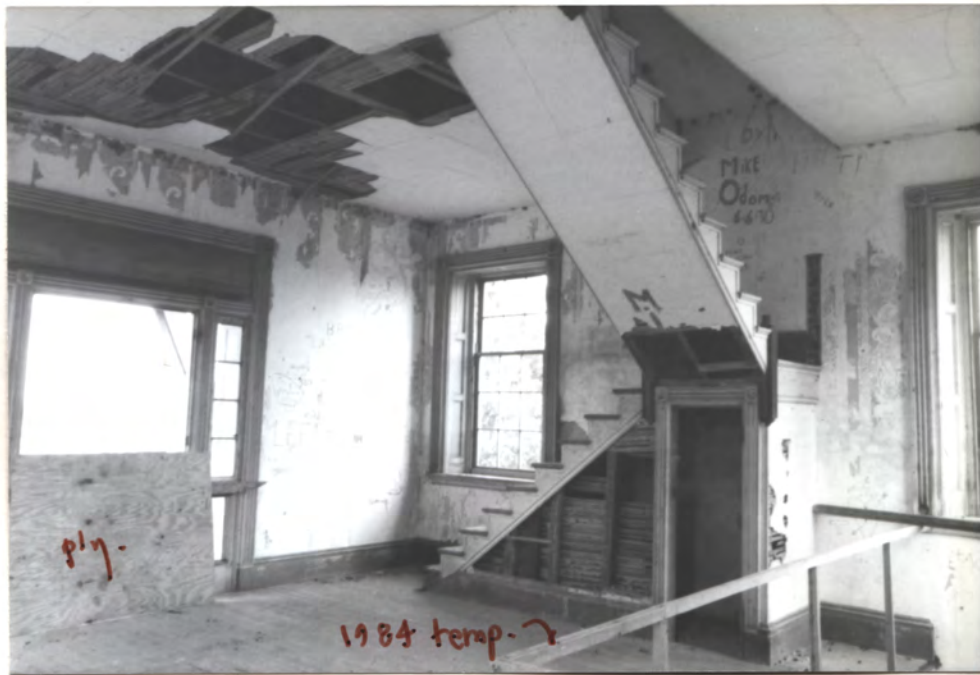
A
Temporary constr. handrails.
P.S.: balustrade was later
replaced from
HABS in 1986-87
HJ

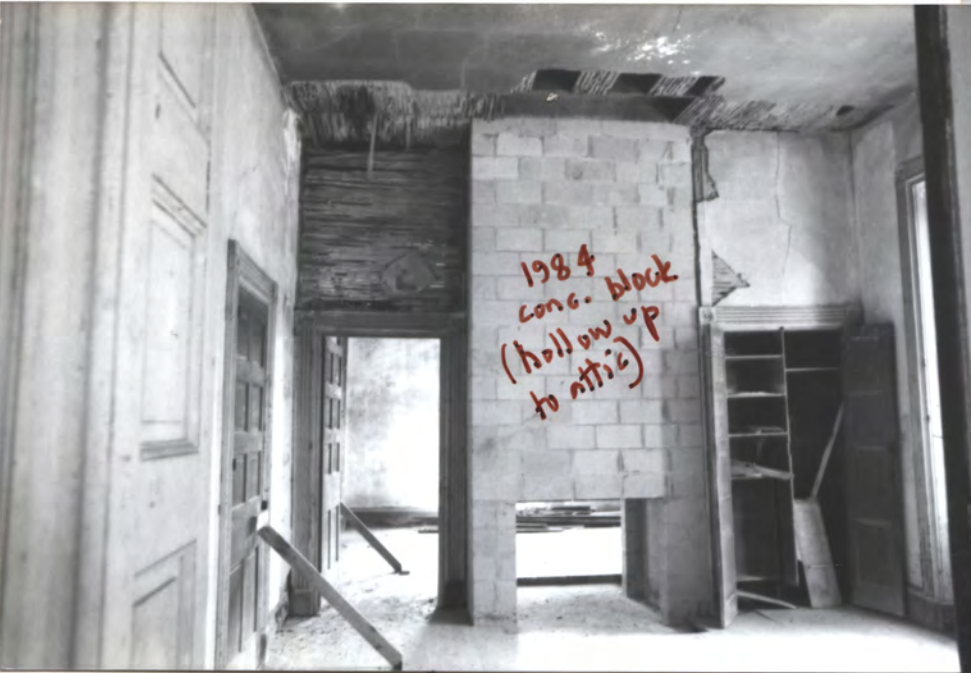
1984
conc. block
(hollow up
to attic)

Fl. hole repaired 1984
WEST CENTRAL RM

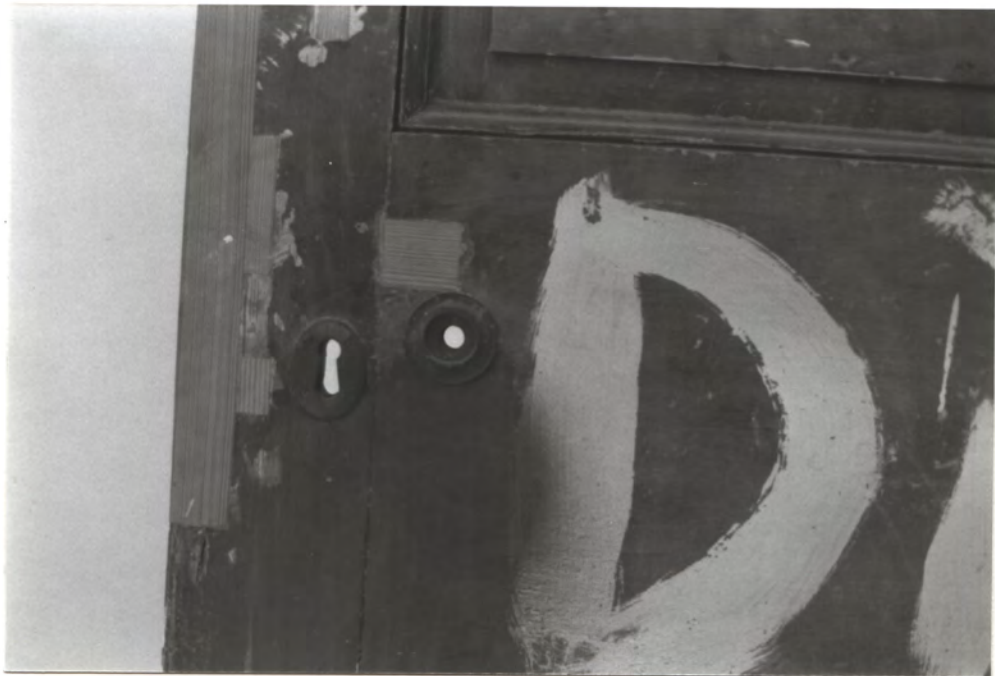
Example of care taken by Jacques Millwork of Florence in
repairing vandalized doors. Very tight, as small as
practicable set-in blocks of dense old pine

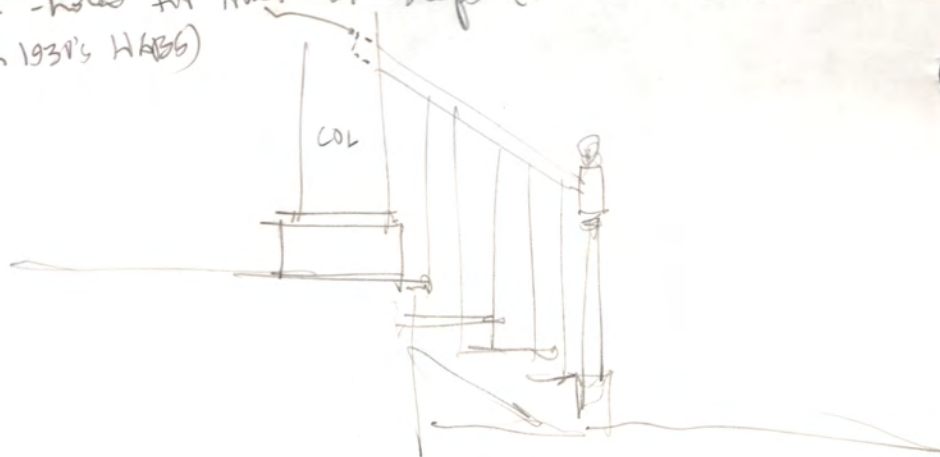
- Photos Sept '47 showing board covers removed from
porch cols
1. Multiple - plank patch bottoms
 2. Slanted mortise - holes for nail at steps (col. is rotated 90°)
(Doesn't show up on 1930's HABS)

→ repaired
Cols.

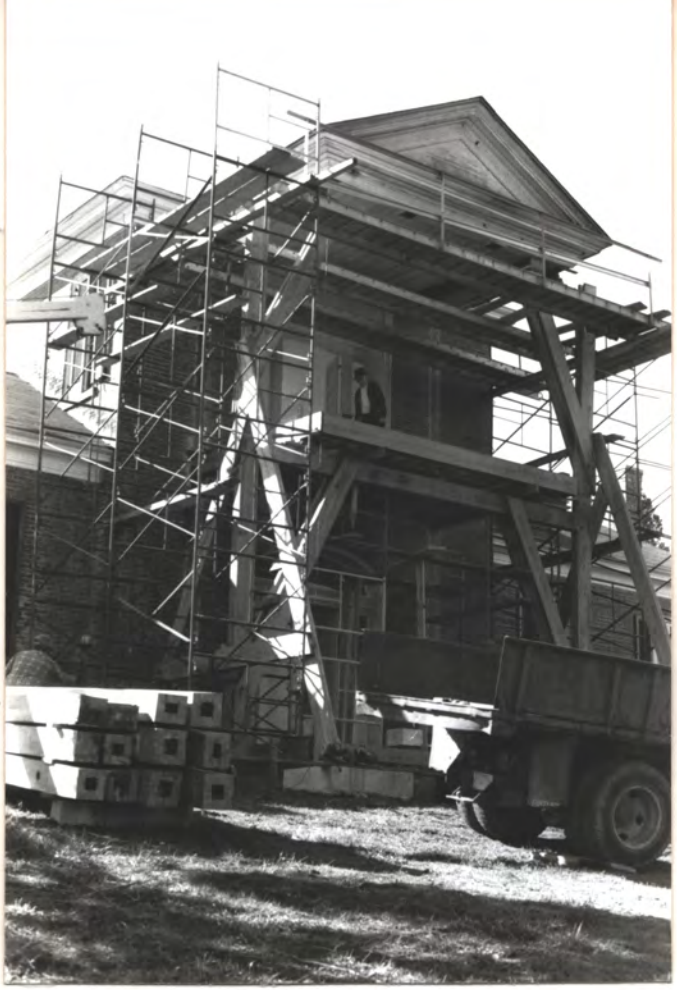
← Temporary
bracing 1983
by JH-HJ
to prevent
portico collapse
(imminent)
Cols. removed
for repair

millwork & carpentry by Buck & Larry Jaynes of
Jaynes Millwork, Florence = excellent!
Gen. Contr. = B.H. Craig, Florence. Owner = Al Hist. Commission

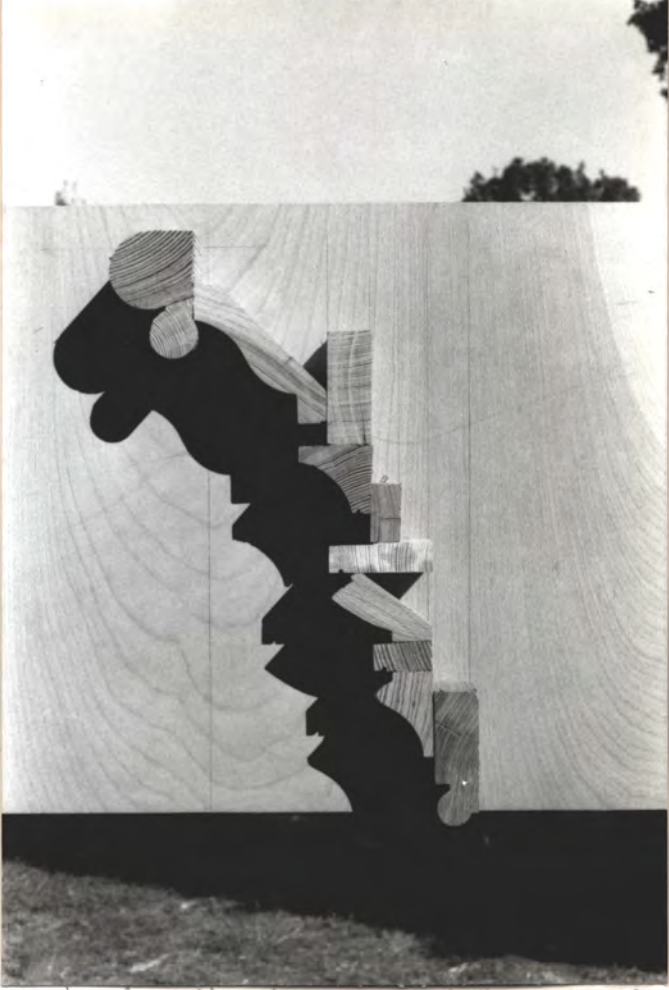
Sample of moulds at portico 2nd fl., per AABS
(all gone before 1983)

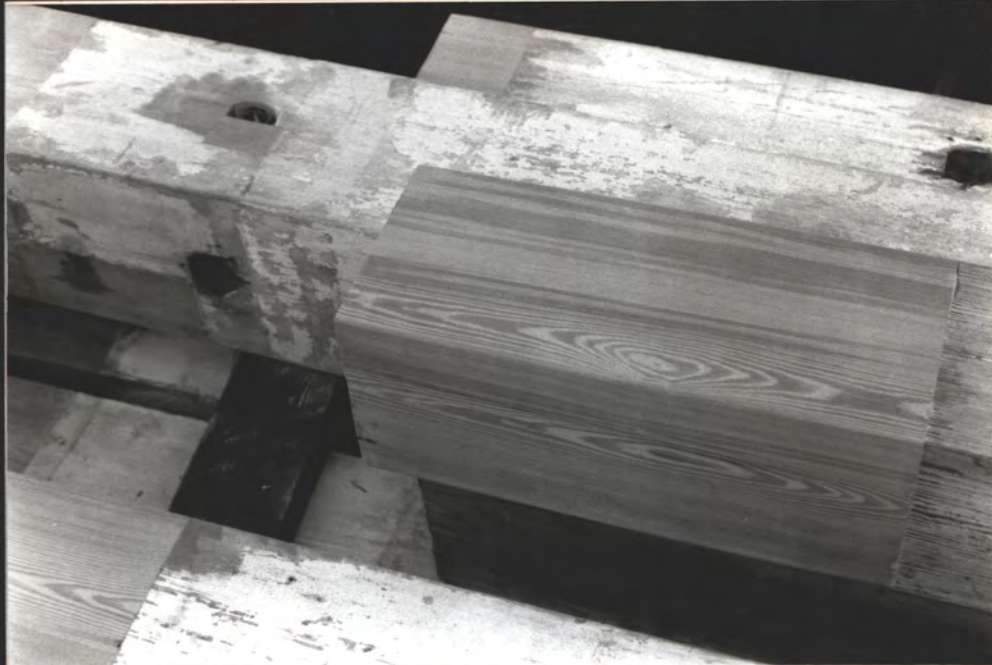
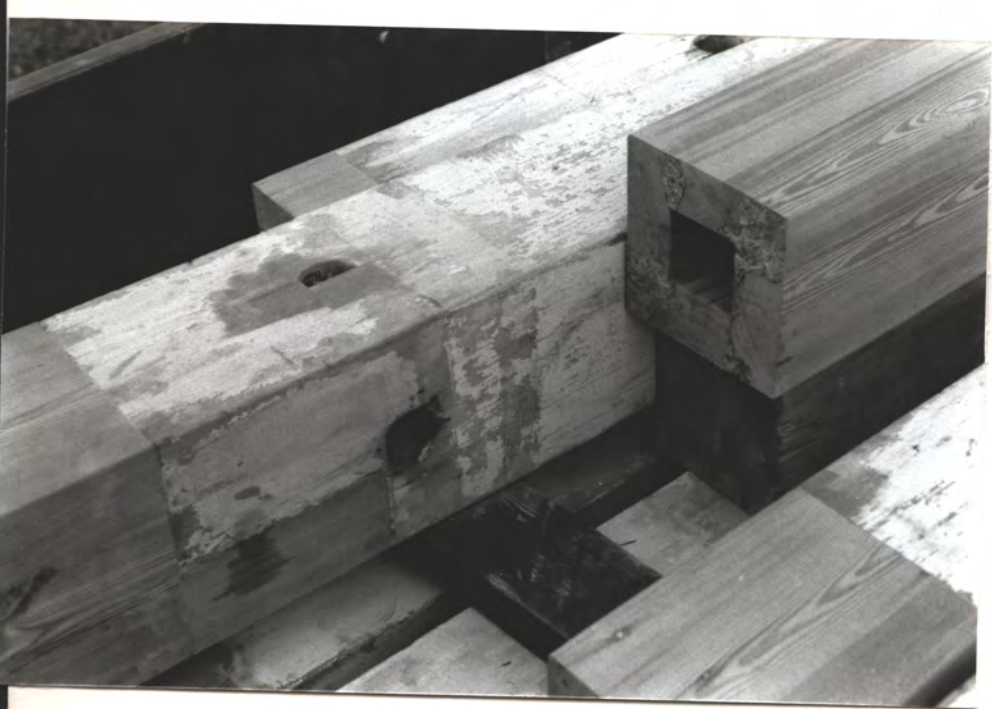
rotted bottoms of portico cols.
 repaired, using salvaged old
 resin-filled heart pine

(P.S. - Jan 1996 -
 cols. still o.k. (1996)
 NJ

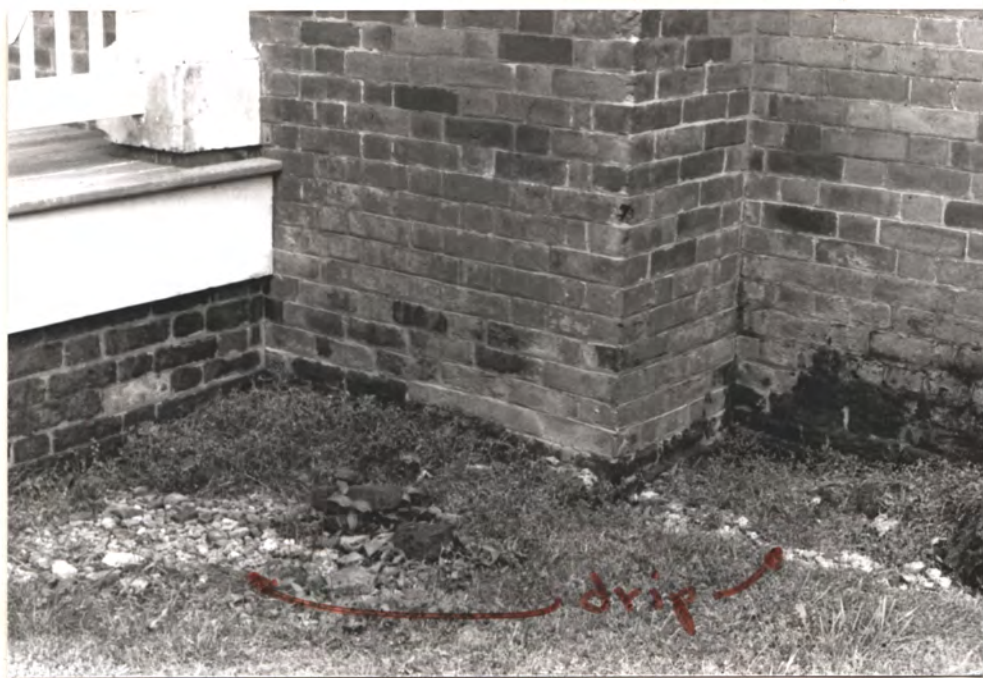
Moss near ground
 due to rain-water
 spilling off roof &
 soaking into bricks.
 Has damaged plaster
 inside due to
 "rising damp".

water spill from roof valley from N →

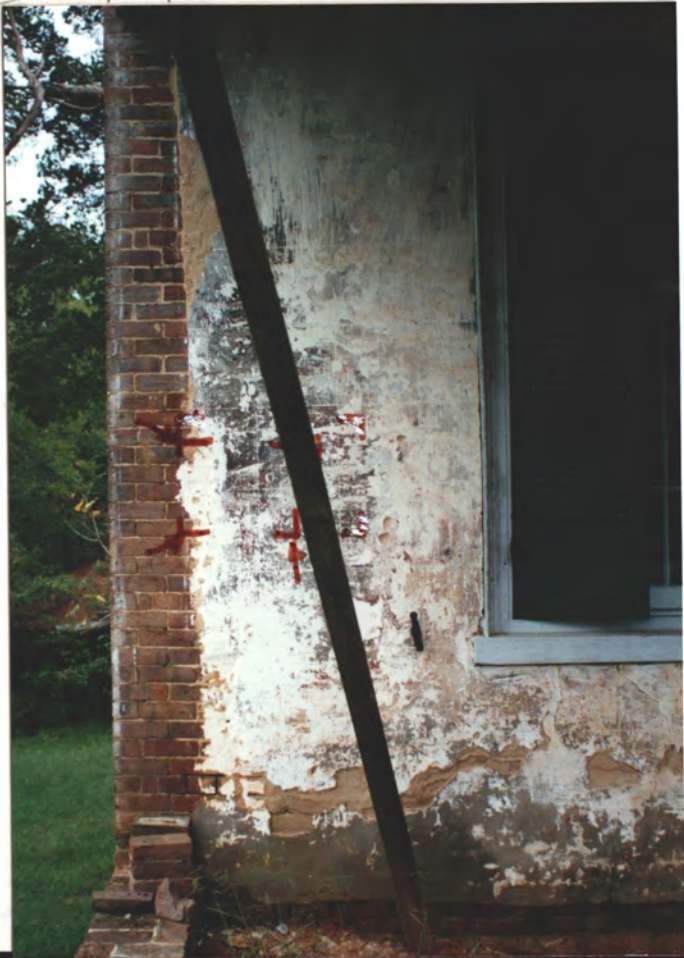
Missing
Plaster
See HBS
photo

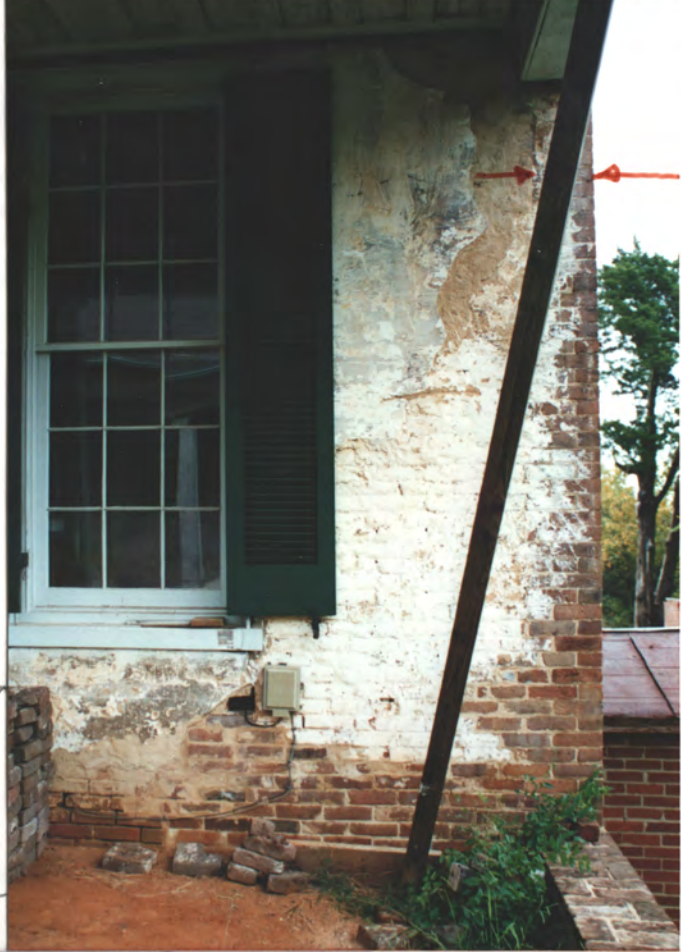
E. wall of Ct. YD

Missing
plaster -
See Abbas 1938
photos

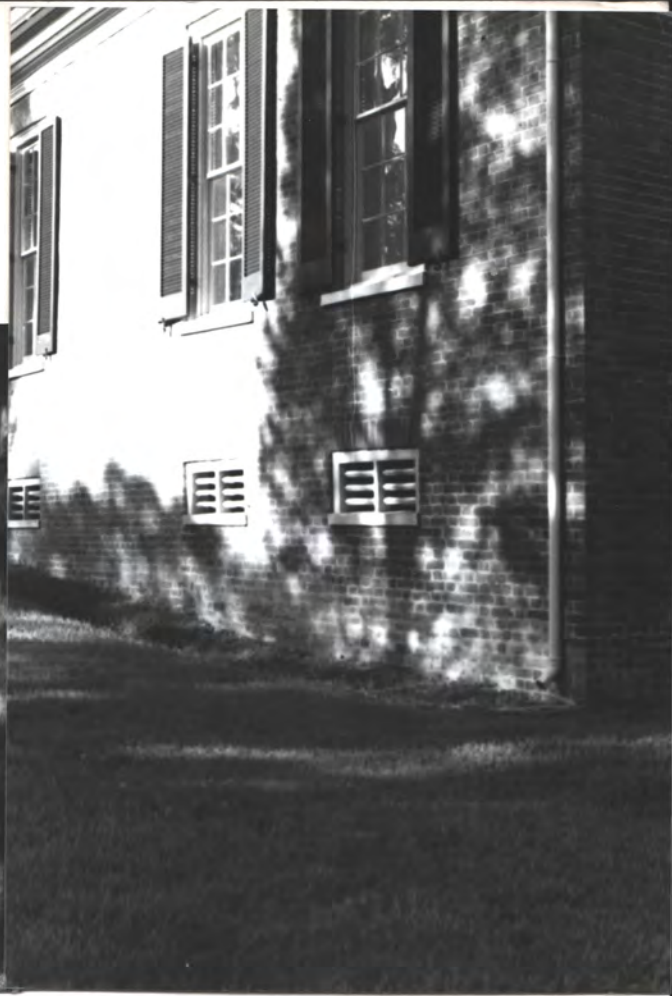
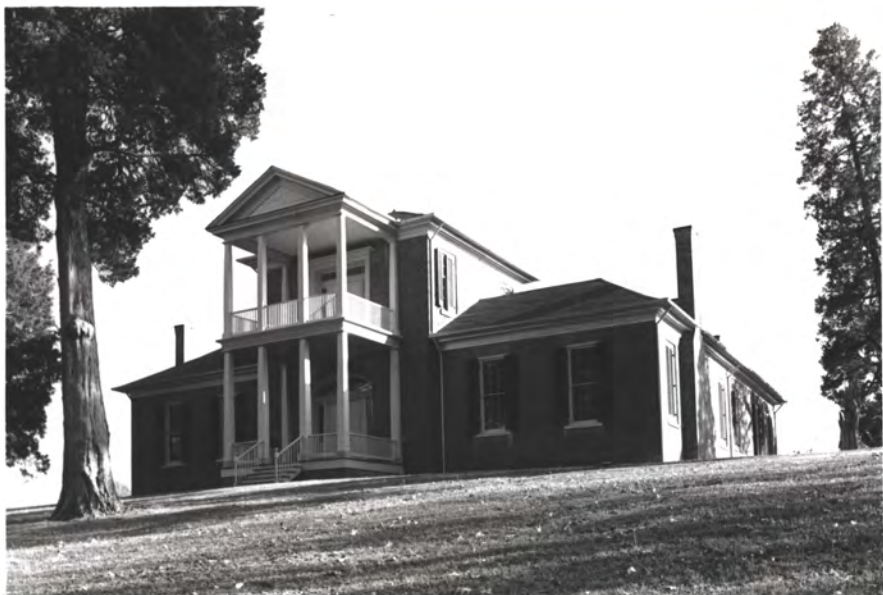
this portion of wall had completely
collapsed by 1983.
Repaired 1984 ±.
Lowered footings ± 2' to get to good soil
("plastic" soil was cause of settlement
& collapse)

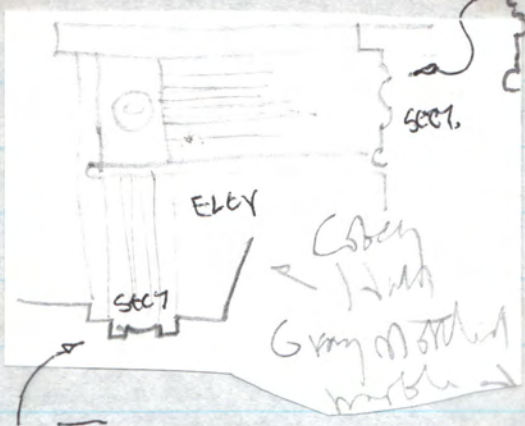
like gildaste
 Mantels in c.1840's Cobey Hill
 in Florence, Al.
 = same mottled warm-gray
 Philadelphia-area marble
 found at Belle Mont (1828)
