1827 1st Pres.  
Ch. Tusculum, AL

Photos April 1991 H.P. Jones FAH  
 1st Presb. Church, Tusculum, AL.  
 orgm. 1824, built 1827.  
 Gothic windows most unusual for Fed.  
 but appear orig. (not brick modif.)

Re: 1827 First Presbyterian Church  
Tuscumbia, Alabama  
Project No. 95025

Re: 1824 First Presbyterian Church  
Project No. 94022

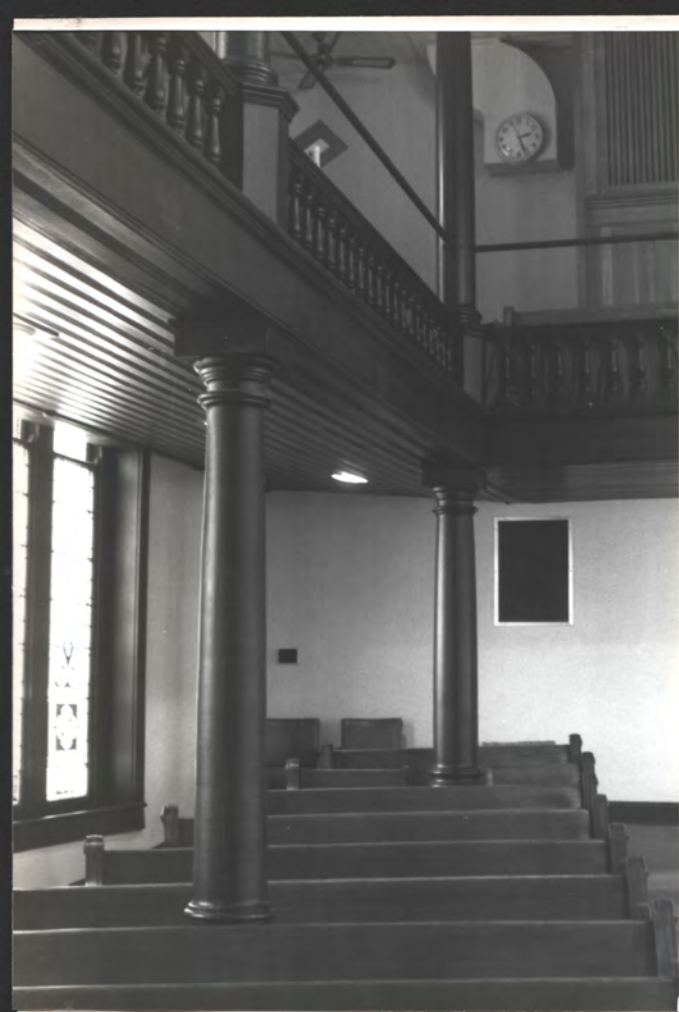
Looking  
east  
to  
rear

Organ =  
recent

Since the  
col. bases  
"rise" w/  
the fl.,  
the fl.  
must have  
always  
been  
sloped =  
unusual

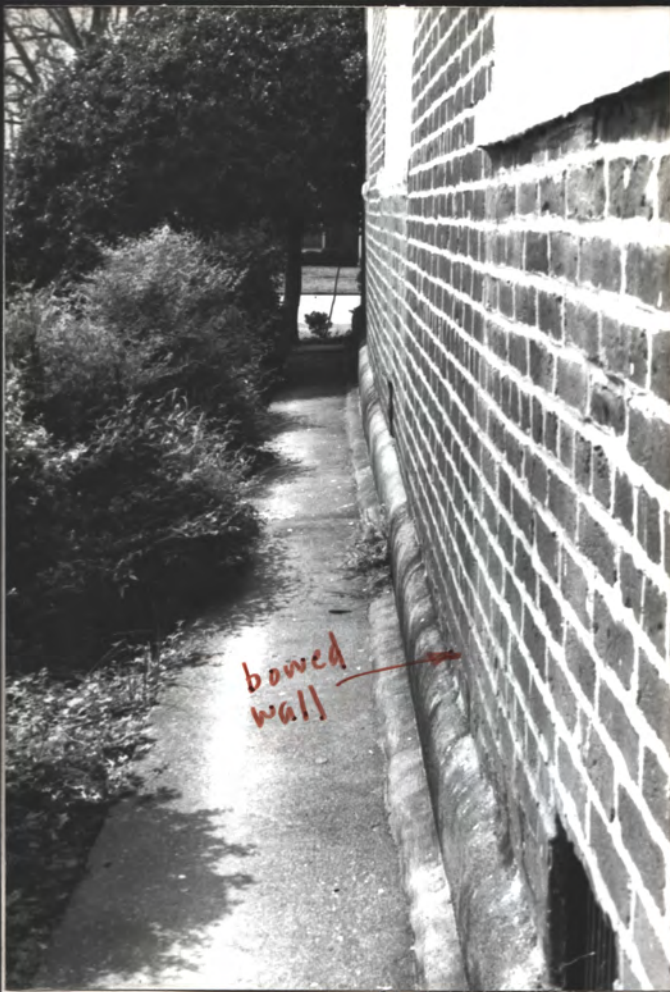
South wall

Wall bowing is due to no widening of the wall at the bottom to distribute the load on the soil

later conc. to shed water away from wall

later conc. water-shed (3 staged)

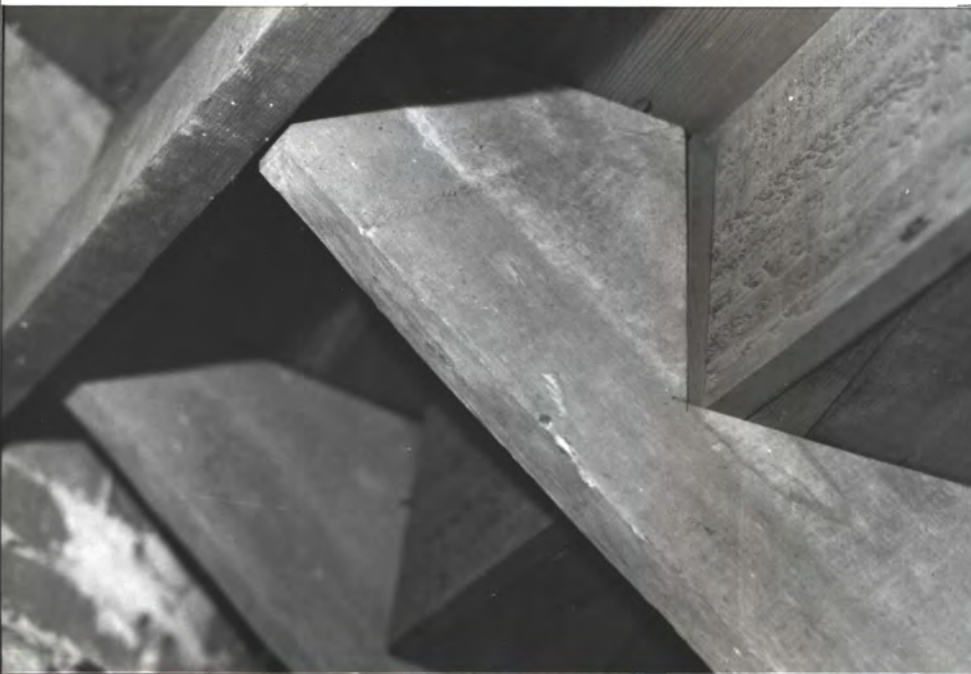
South stair at Fl. 2 level.

South stair (Sash-sawn Imbr.) orig. constr.

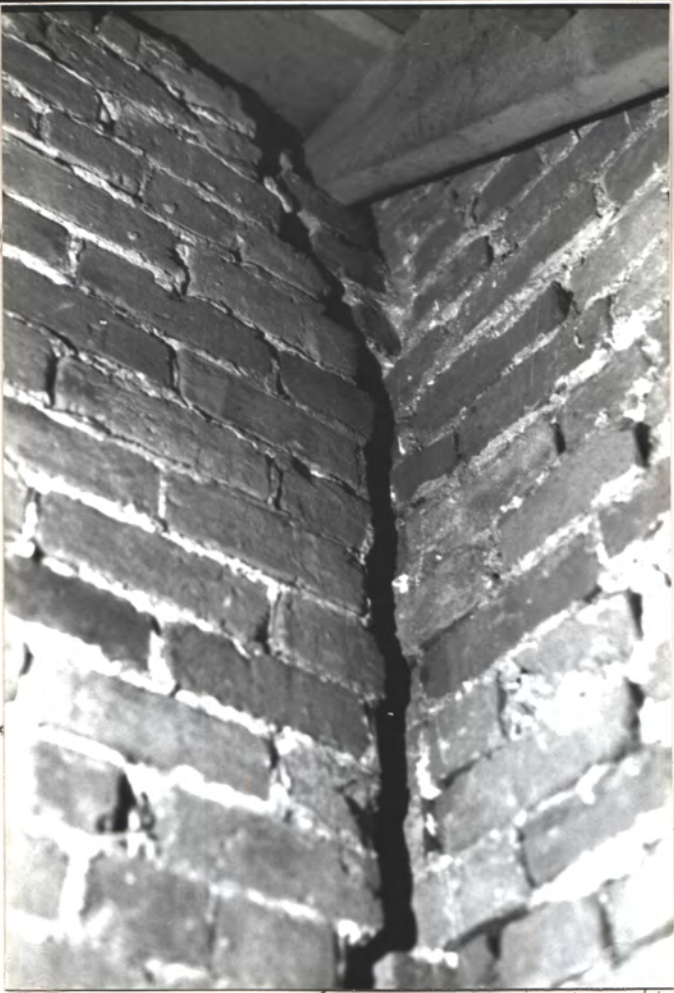
S. wall of entry \* \* \* north wall  
 1" + separ. (with arrows pointing to the crack)

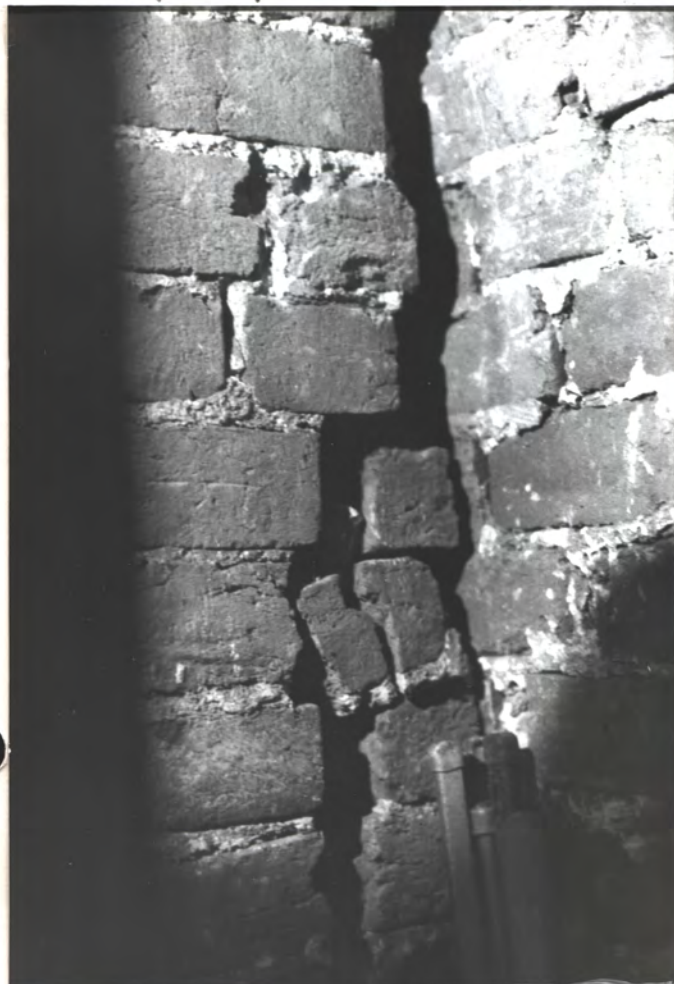
S. Wall, S.W. window \* \* ± 1/2" separation

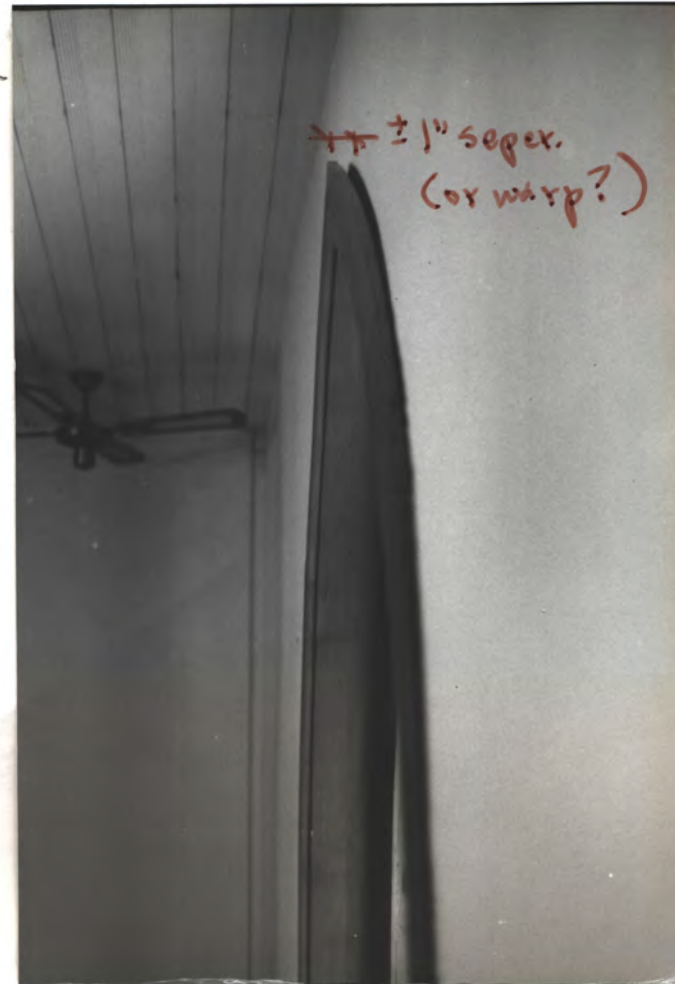
\* \* ± 1" separ. (or warp?)

wall color  
 "Sant-appe"  
 green  
 (modern)  
 trim was  
 originally  
 of white

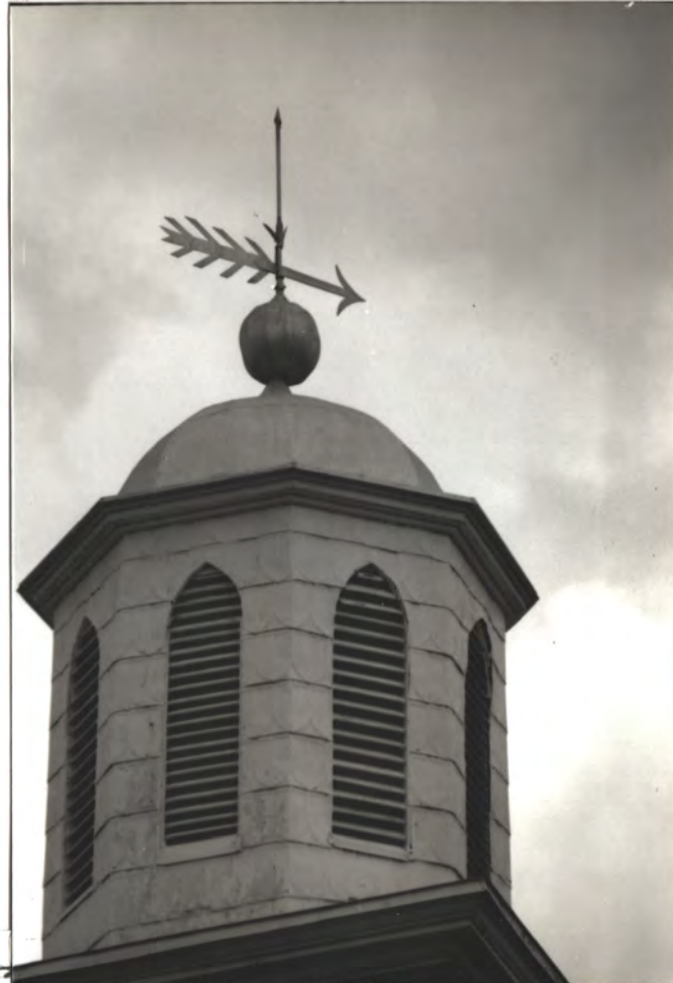
WEST  
FRONT

→ later  
metal  
shingles on  
sides,  
perhaps 1880-1910

No snow falling.  
Water running  
into corner  
dropping it  
(all corners)

Flemish band  
typical of  
1820's

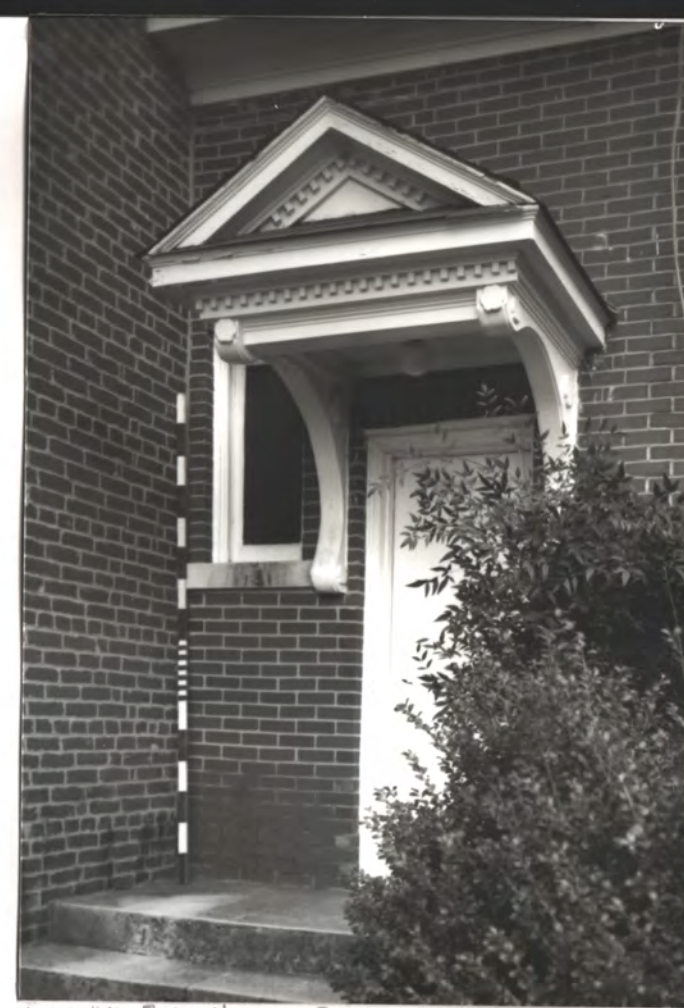
S. WALL

Original windows =  
vert. slat.  
scrub, clear  
glass, &  
blinds  
(HBS)  
These are  
1904

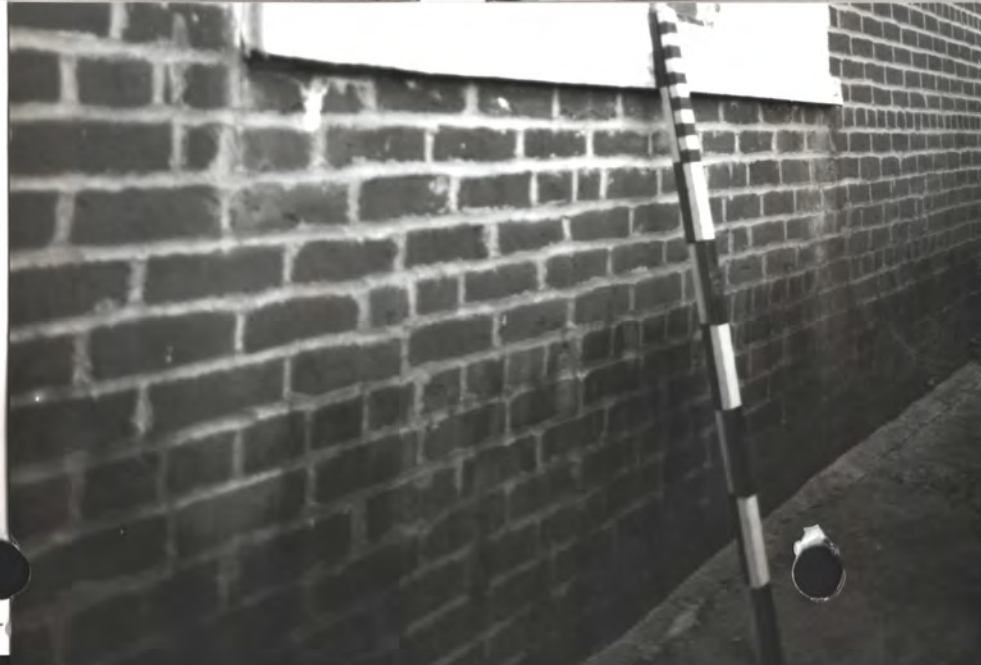
← S. ENTRY TO FELLOWSHIP HALL  
1924 (HBS)

BULGE AT N. WALL (S. = SAME)

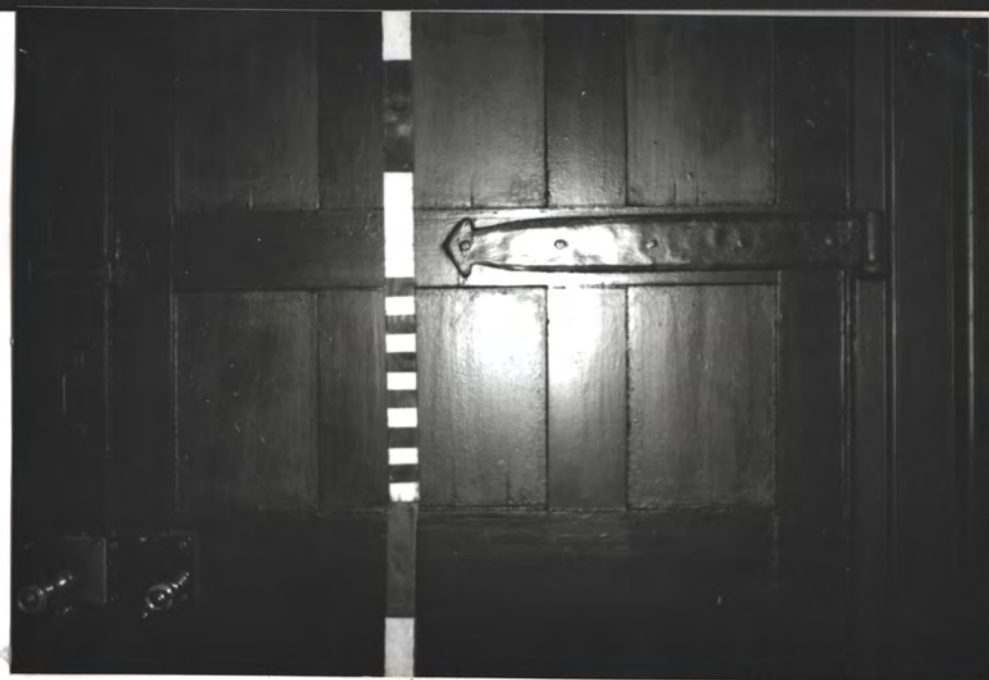
→ N  
WEST FRONT DOORS (orig.)

Mod. looks

hinges look orig.

Attached is a detail sheet of improved weather-stripping at the front entry doors. Properly installed by a skilled and careful finish carpenter, it is likely that this will reduce wind-blown rain entry to an acceptable minimum. Some water will enter when the doors are opened during rains and when water is tracked-in. For this we suggest a method we have used on other churches: Make an insert in the vestibule carpet of the width of the doors and about 5 feet east-to-west. Seam the edges of the carpet, and also seam the edges of two carpet pieces that fit the insert opening. The inserts can be held down by Velcro strips on the bottom edges. In this way, a soiled or damp insert can be removed for cleaning and the alternate insert immediately put in its place.

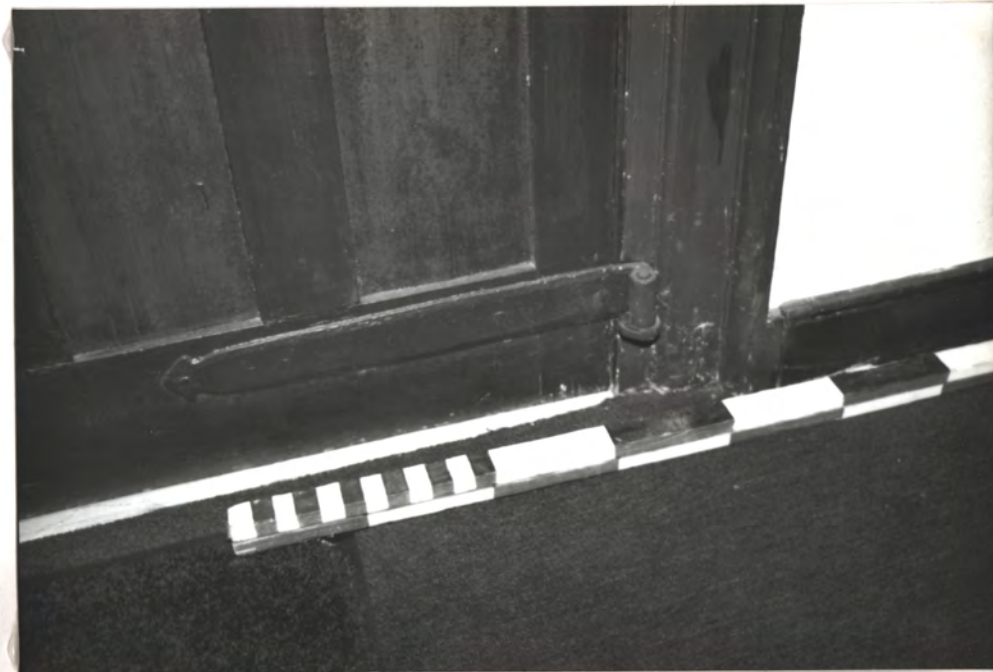
N. Clos.  
 (N. wall  
 brick is  
 damp  
 up to ±4)

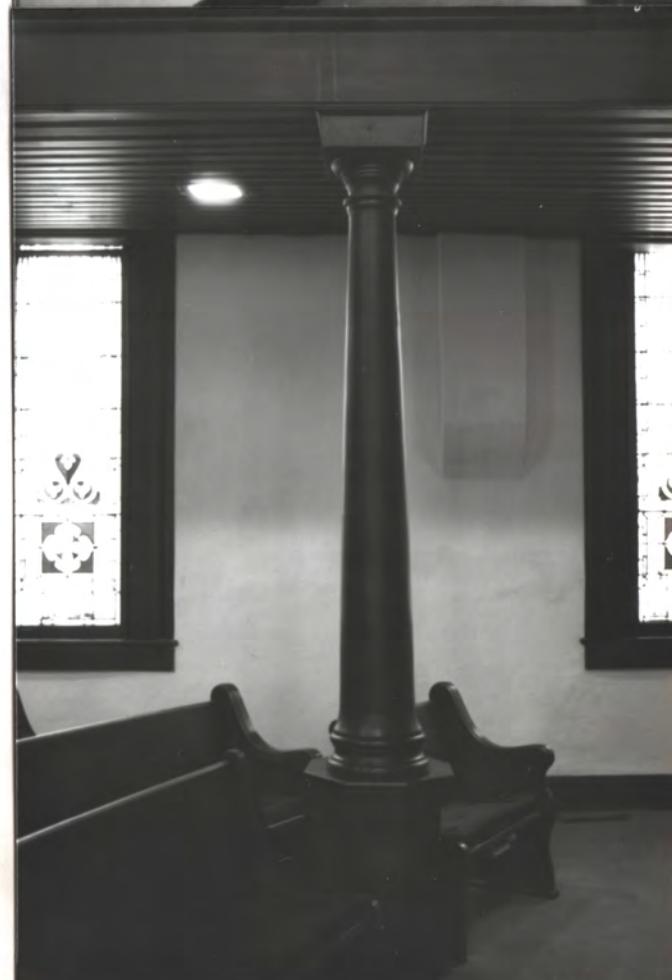
S.W. WALL  
SANCT. at front  
of pews

modern  
cement-plaster  
patching of  
walls due to  
rising damp  
2' to 4' h.

The oldest method of blocking rising damp is to insert (a piece at a time) a layer of sheet-lead or slate completely through the solid brick wall (the walls are probably 17 inches to 21 inches thick at the soil line). This method would be extremely costly and would necessitate the phased removal and replacement of a  $\pm$  2 foot high bank of brick on three walls of the Sanctuary. It is unlikely that this could be done without visually harming the brick wall bases. An alternative is to inject a material into the walls just at the soil line which would block or greatly reduce the capillary action. While this method would be much less costly (still not inexpensive) and less disruptive of the 1824 brickwork, its durability in decades is unknown. This method has been in successful use for several decades and was used several years ago at the 1819 Weeden House in Huntsville with

good results. It is necessary to drill small holes in the brick at the soil line at every 8 inches in order to pump in the fluid material, which drilling must be carefully done and repaired to minimize disfigurement of the brick wall. The material and technique used at the 1819 Weeden House is "Pro-So-Co Conservaire Damp-Course Fluid". Some technical information is attached. Also attached is information on lead-shield moisture-barriers.

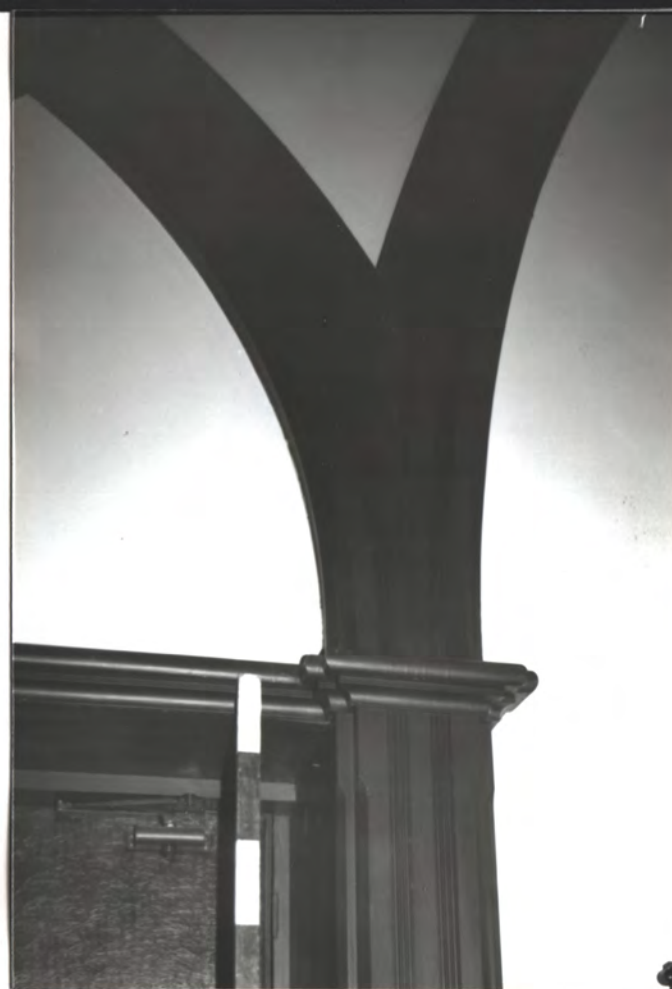
Detail of photo at left

plastic "leather"  
on fed. 6-pnl.  
doors, this face only.  
Attempt at sound-reduction  
(doesn't help)

The two pairs of doors leading from the Vestibule to the Sanctuary are modern. They appear to be standard flush-panel hollow core doors, too small for the 1827 frames, and covered with plastic in imitation of padded leather. They may have been installed in the hope of reducing sound transmission from the Vestibule to the Sanctuary but the light construction and the 30 linear feet of cracks at each door pair would negate any such acoustical effect. It would be desirable to have a skilled and knowledgeable millwork company replicate the original paneled doors (in the original size) that would have been here. The best historical millwork company I have worked with is Jaynes Millwork of Florence. The panel divisions would probably be a variation on the front doors, except to fit the smaller openings.

The thickness and moulds of the doors would likely match the north closet door. When the modern casings are removed, there may be paneled jambs that will confirm or revise these details, for it was typical in the 1820's that jamb-panels would match the door panels, as they do at the historic front doors.

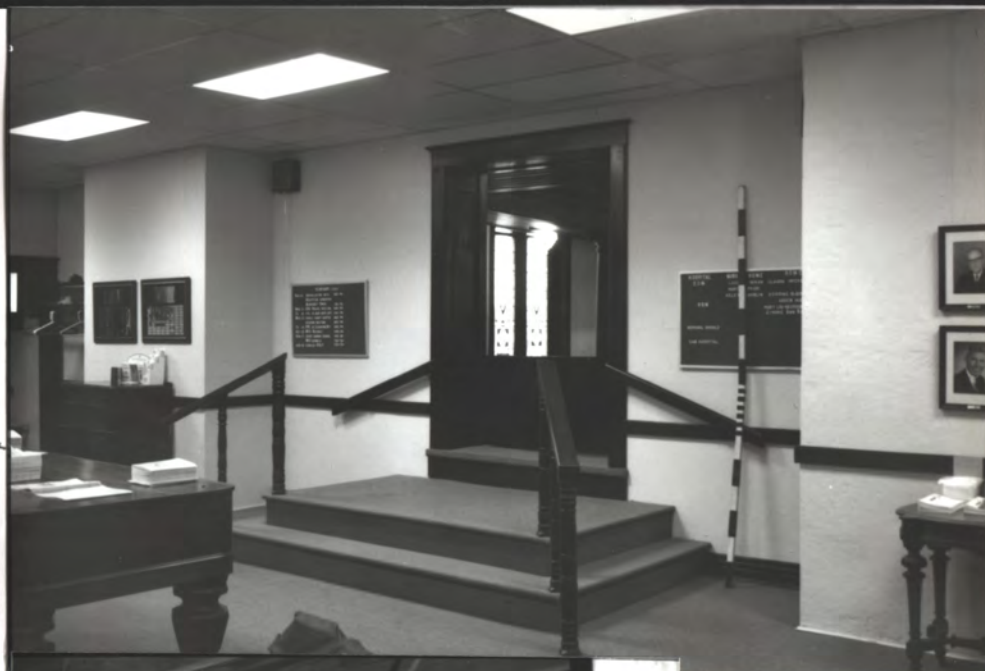
Fellowship  
Hall  
(built  
1924  
per HABS)  
Ceil =  
c. 1972

There is a  
beautiful wood  
beamwork above  
this ceiling.  
The original  
photo cell, is  
± 3'-4' above  
the structural  
tbl.

The beauty of the Fellowship Hall will be greatly enhanced by removing the cheap dropped-ceiling of 2'x4' "supermarket" acoustical tiles and glaring fluorescent lights that is dropped about 3 or 4 feet below the original plaster ceiling of the Fellowship Hall. This unattractive ceiling conceals the beautiful turned-wood balustrade that is on three sides of the upper part of the Fellowship Hall, and chops the height of the room to an uncomfortable shortness. Perhaps this ceiling was installed with the thought of reducing utility cost, but mechanical engineers (and our experience) say that such dropped uninsulated ceilings do virtually nothing to reduce utilities.

The original Victorian-era plaster-on-wood-lath ceiling remains above the acoustical tile. A section of about 5 feet square is off, at the southwest corner. Some more may possibly be not well-keyed to the lath, and a few tight cracks are apparent. However, these conditions are typically easily repaired without removing the original plaster. We have re-secured loose plaster and repaired plaster in many cases, usually more cheaply than the "sheetrock" solution. Plaster that is not well-keyed (but not "friable") can be easily re-secured with "plaster-washers", the cracks repaired, skim-coated and painted. One such case is Belle Mont, where the ceilings were in a much more fragmented condition than in this room. Attached is information on such repairs. There are several plasterers in north Alabama. The names of two follow. B. H. Craig can give you the name of the one who did Belle Mont.

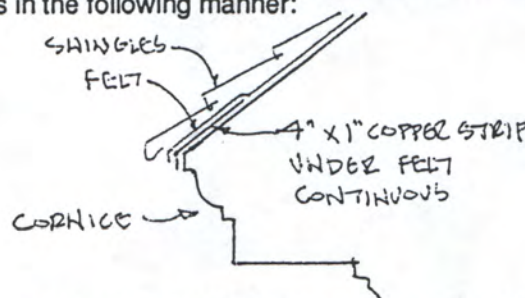
It was noted that both the N.W. and S.W. and perhaps the S.E. and N.E. corners of the composition shingle roof of the Sanctuary have worn away to the point that water is running into the 1824 wooden roof cornice. This is rapidly rotting the historic wooden cornice and needs to be repaired immediately. Composition shingle roofs always erode at their eaves first, causing such serious damage before anyone is aware of it. Therefore, shingle roofs should always have a strip of copper flashing installed along all the drip and gable eaves in the following manner:

The flashing will prevent water from entering the cornice when the shingle edges erode, or when the shingle edges are cut too close to the cornice edge upon installation, as frequently happens.
