The 1896 Hundley Building at 128 South Side (Court House) Square in Huntsville, Alabama, is listed in the 1979 Huntsville Multiple Resources downtown historic district. Historic photographs of the building date from 1904, c. 1900, the 1950's and 1960's, and other periods. In 1966 the Italianate commercial building was leased by the American National Bank. The bank altered the original shop-front and upper front sashes to a "colonial" version, as seen in the 1979 photograph.

13 Mar 1998 by HPL/moo  
for grant applic. to AHC  
by HHF

C. 1836 HARRISON'S BLDG.  
± 1896 HUNDLEY BLDG.  
S. SIDE SQ. - HUNTSVILLE, AL.  
HIST. HVILLE FOUNDATION  
27 DEC. '97 H.P. JONES, P.A.I.B.

1896+1922+1963  
 Hundley Bldg.  
 128 S. Side Square  
 Huntsville, AL  
 Ugly shopfront  
 & 10/10 stakes  
 installed 1963 by  
 "Dm. Nat. Bmk"  
 (was Italianate)  
 - Pres. had "been  
 to Williamsburg"  
 10/13 photos  
 Dec. '97 HJw

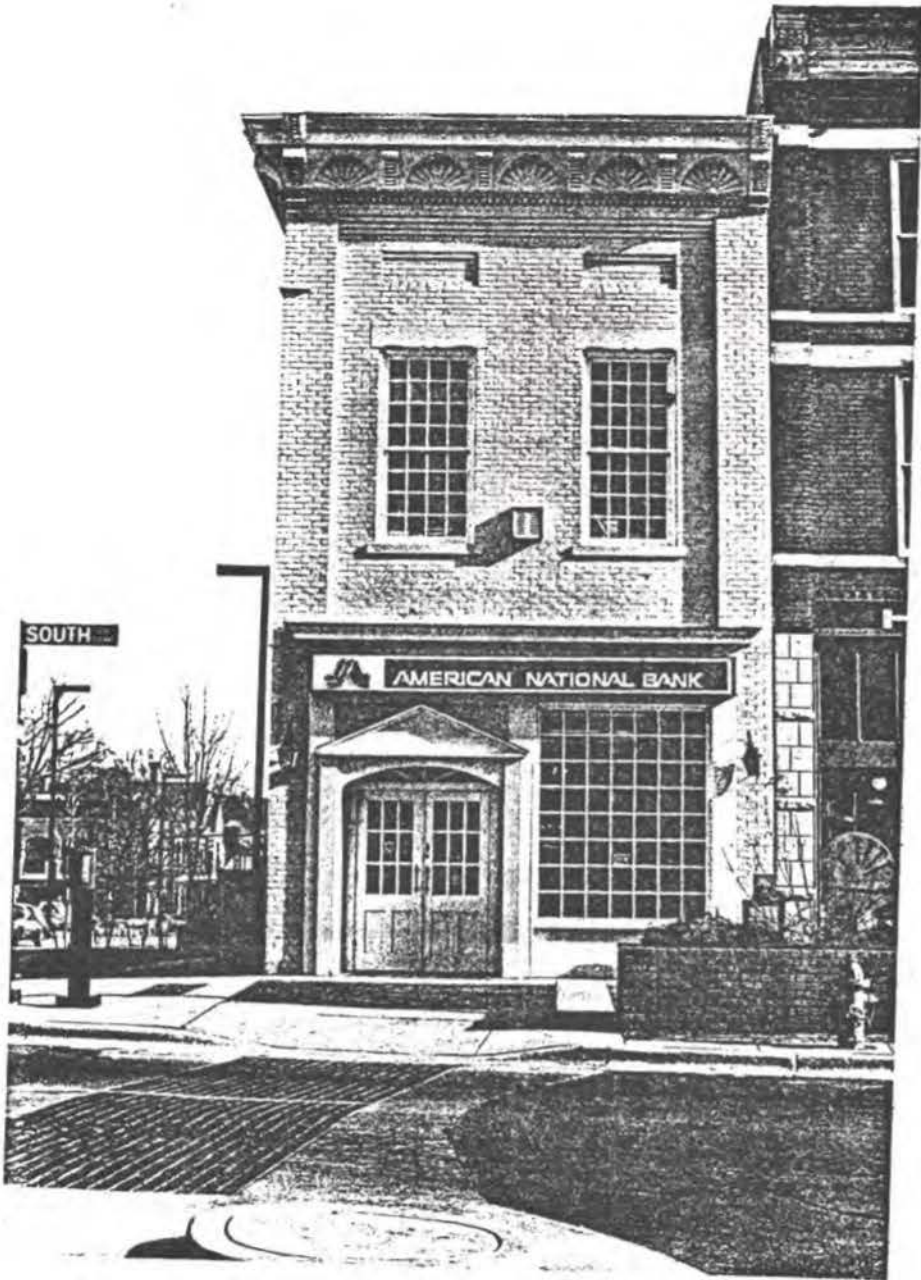
1979 photo - Linda Boyer Allen

This building is a two-story, brick structure on a corner lot. Although it has been remodeled several times, it still retains the pressed metal cornice of sunburst patterns, the carved lintels, and a small iron balcony on the side street. The first floor facade has been remodeled with a large multipaned window and a Colonial Revival doorway. It now serves as a bank.

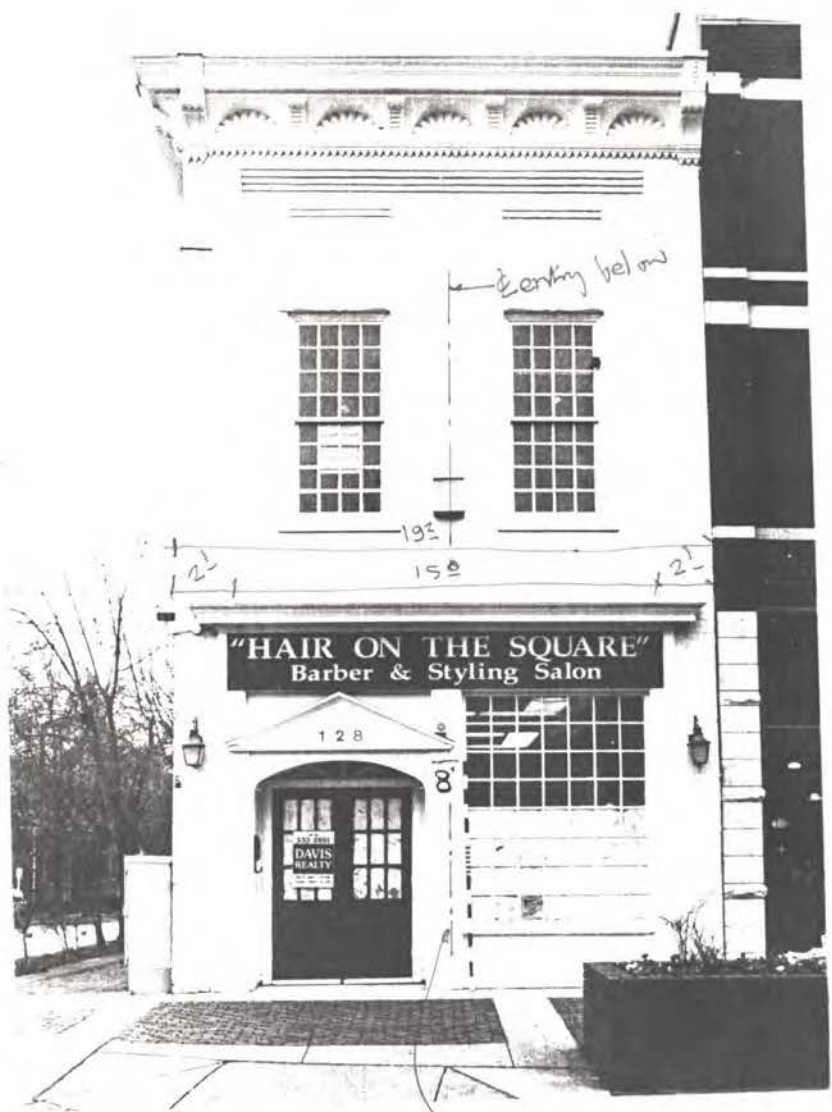
More - this offset appears on the c.1900 photo

stops typical of the period

1. More - in carefully studying the several old photos, it seems to be this, except the fl. has been lowered, of course.
2. Plans of glass must be reviewed by the Ol. Historical Commission in Mont. Contact is via Hist. Fndn.
3. I think plans must be bid. Verify. AHC rep. is due here ±15 Sept, to be confirmed. Bids can be limited to pre-qualif. contractors. I have a good list.
4. Use 4x4 painted hinges, ball-bearing w/ square corners on plates ±4\"/>

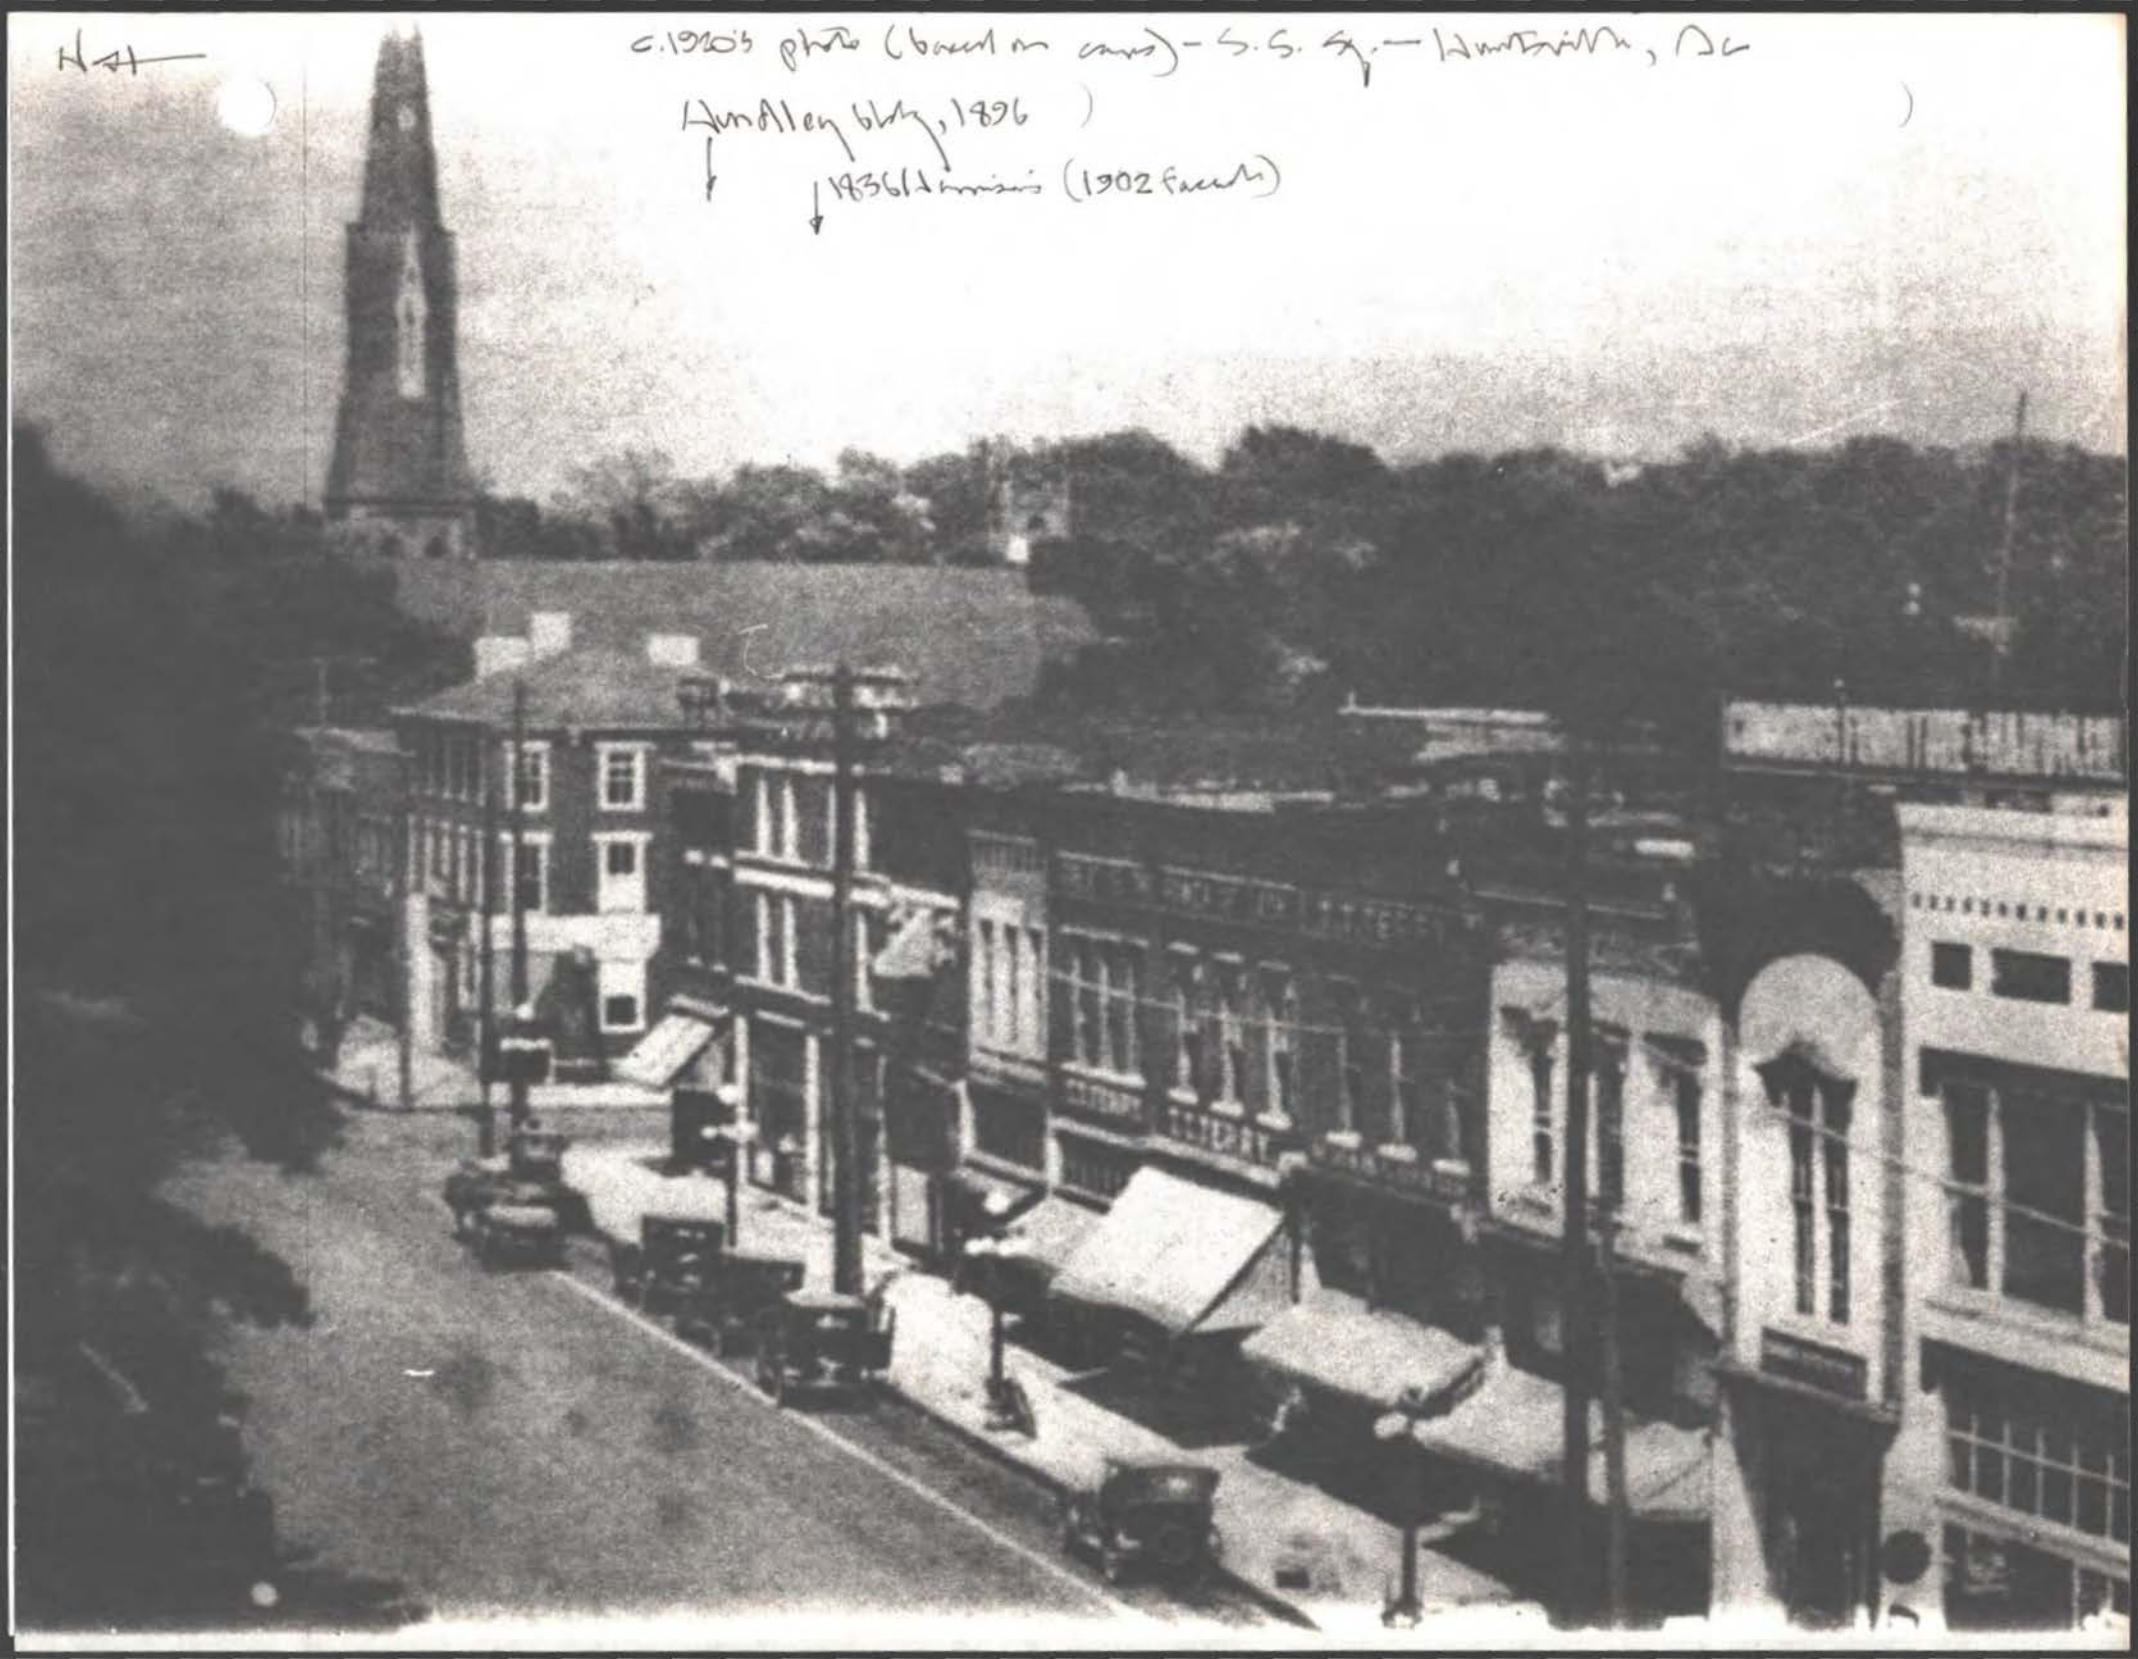
ledges apparently for exposing photo prints of Harrison's  
blue-print paper. This technique used by G.W. Jones Eng. in early 20th c.

Harrison's front is pre-1902 configuration (recessed entrance)  
→ N ← N  
c. 1900 (?) photo.  
Sts. are still dirt.

Large windows are on both the porch

"Photog." said to be Judd's studio (at base) & in 1900

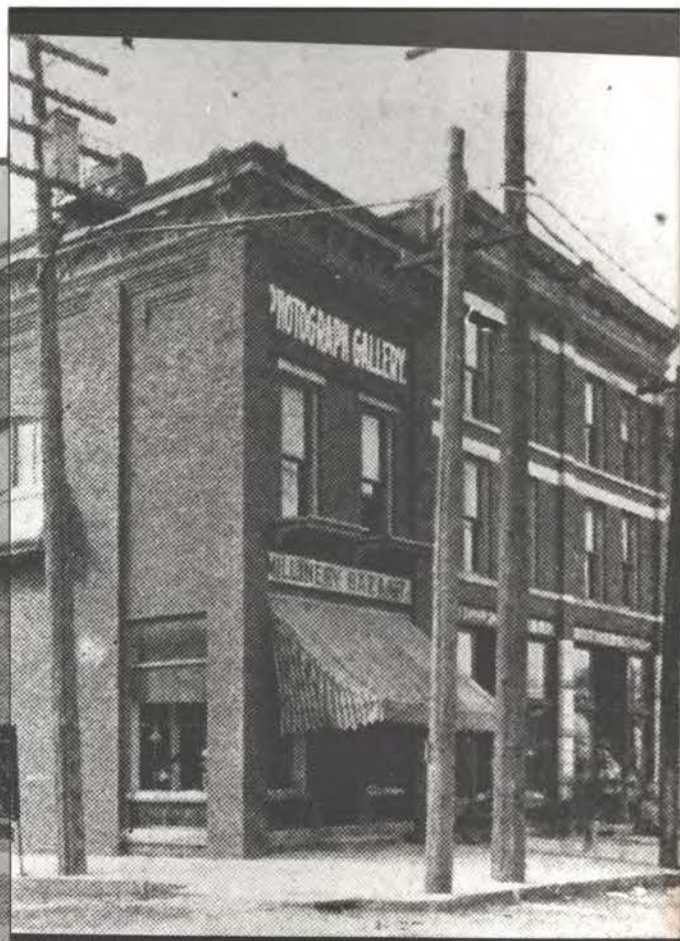
1896 Hundley Bldg.  
128 S. Side Square  
Huntsville, AL  
photo 12/15/1904 from  
"The Morning Mercury"  
newspaper

← "Photograph Gallery" (may be Judd. Ok. City Directory of 1904)

← "Millinery Bazaar" (hat shop)

2 story  
by mid  
20th c.  
Apparent  
photo  
studio  
(big  
windows)

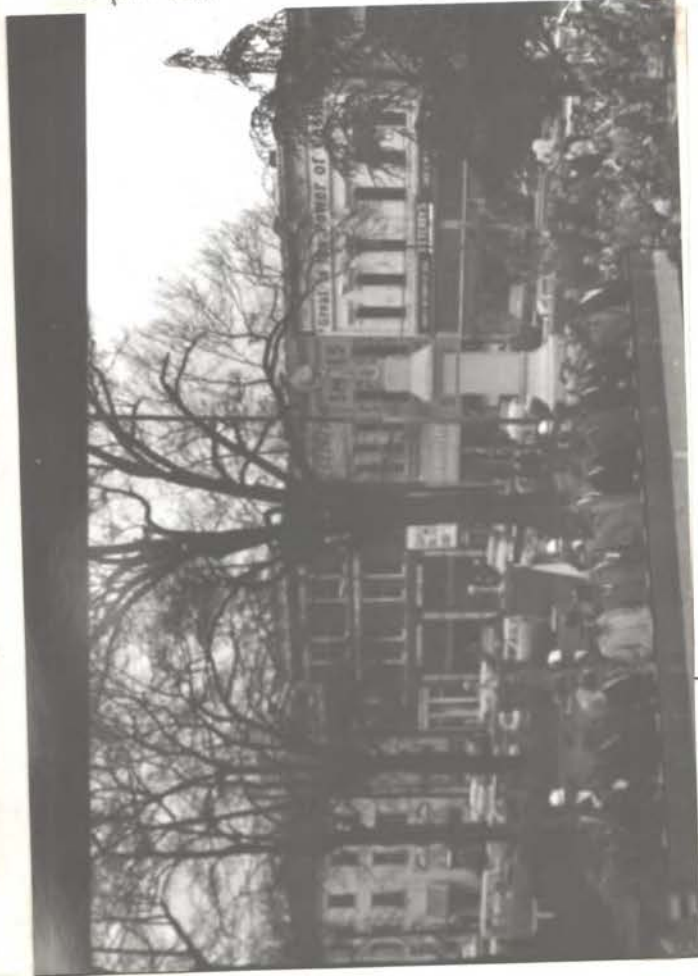
1896 + 1963 steel beams  
 c.1920 metal cornice + coil

trace of 1996 support post (no paint on steel)

c.1960 panels

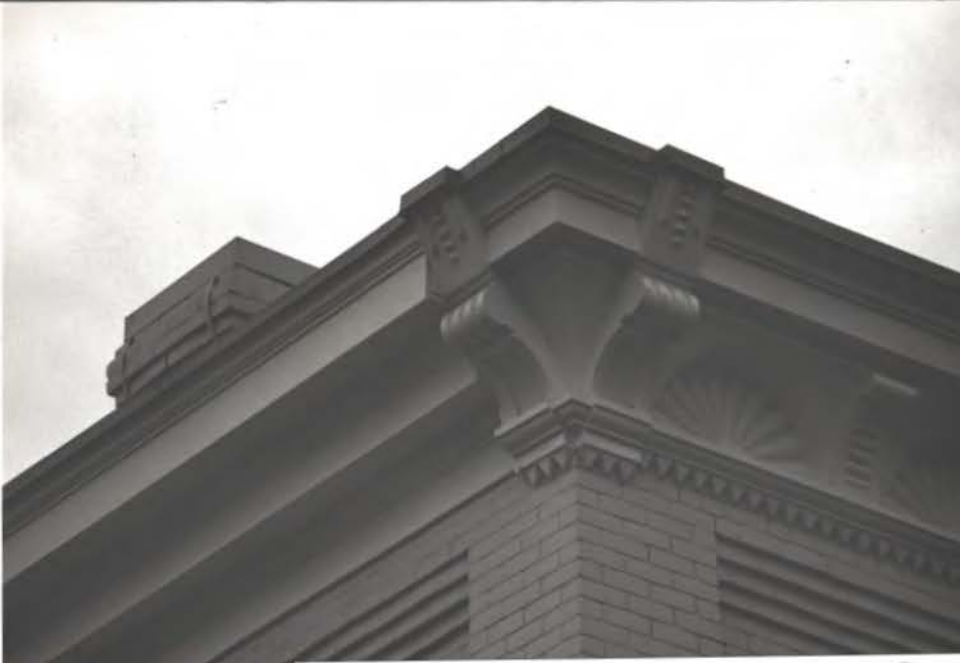
↗ N  
 N.E. Corner  
 (Least wood cornice replaced metal cornice like on front in c. 1980 when storm blew down the metal cornice.)

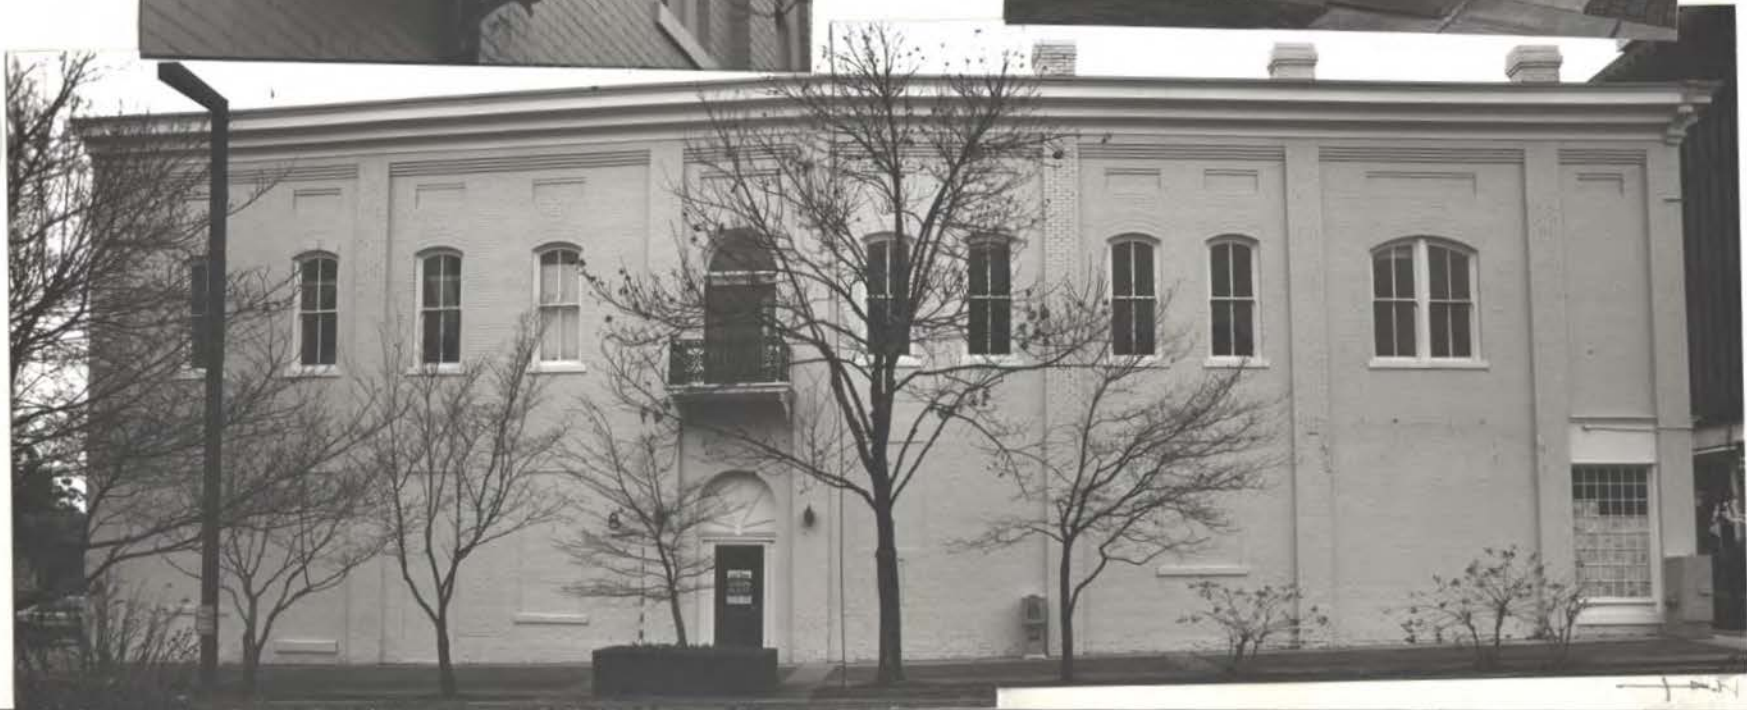
Note several windows & doors  
bricked-up in 1963 by bank  
↓

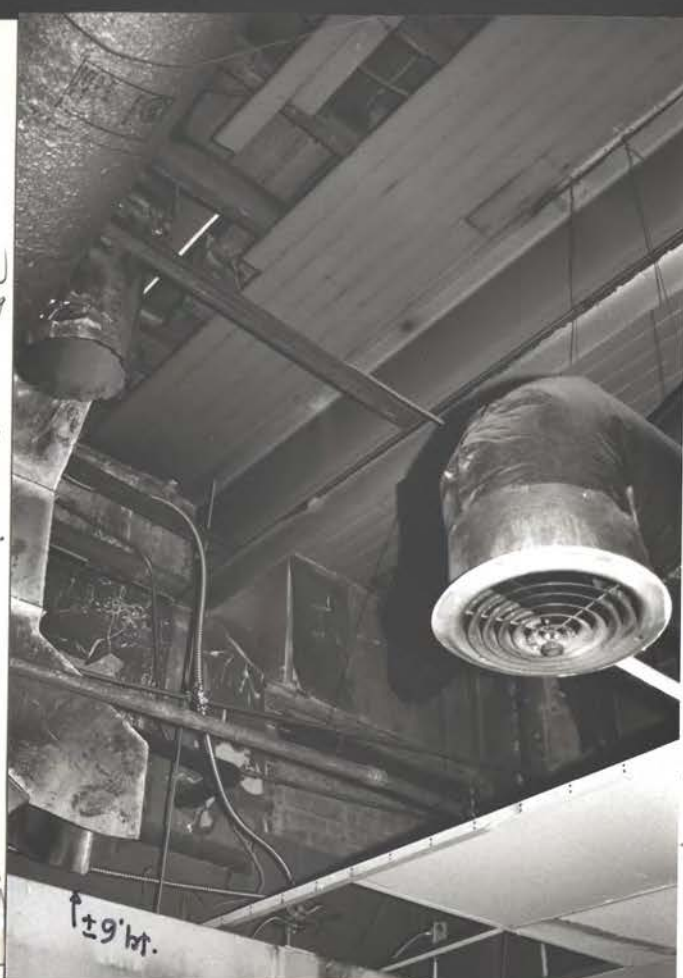
1960's  
-80's  
ducts

1980's  
Furred  
gypsum  
wall

original  
board  
ceiling

1980's  
acous. tile  
ceiling

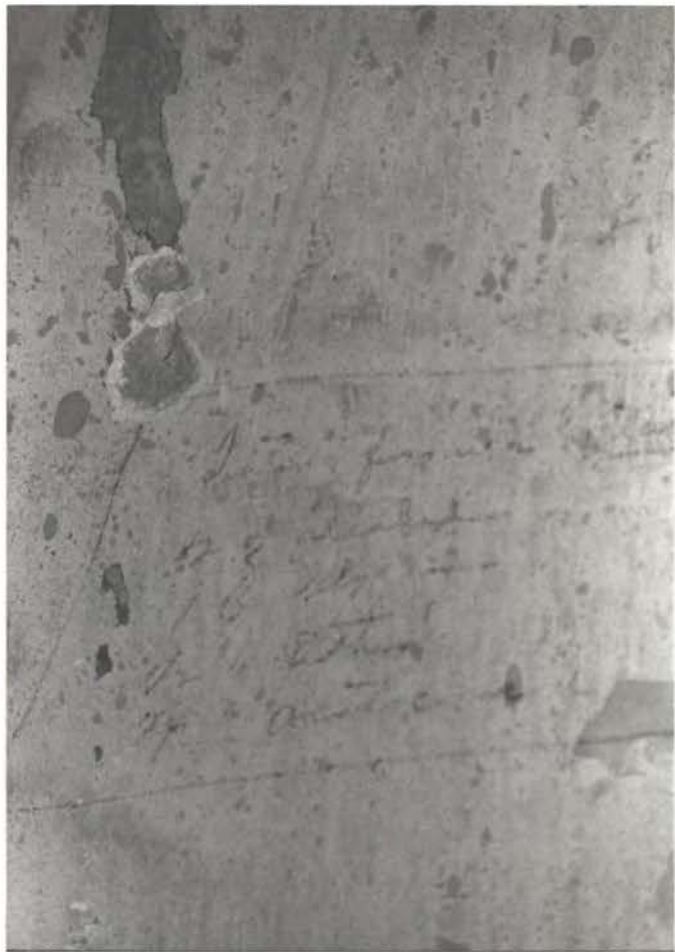
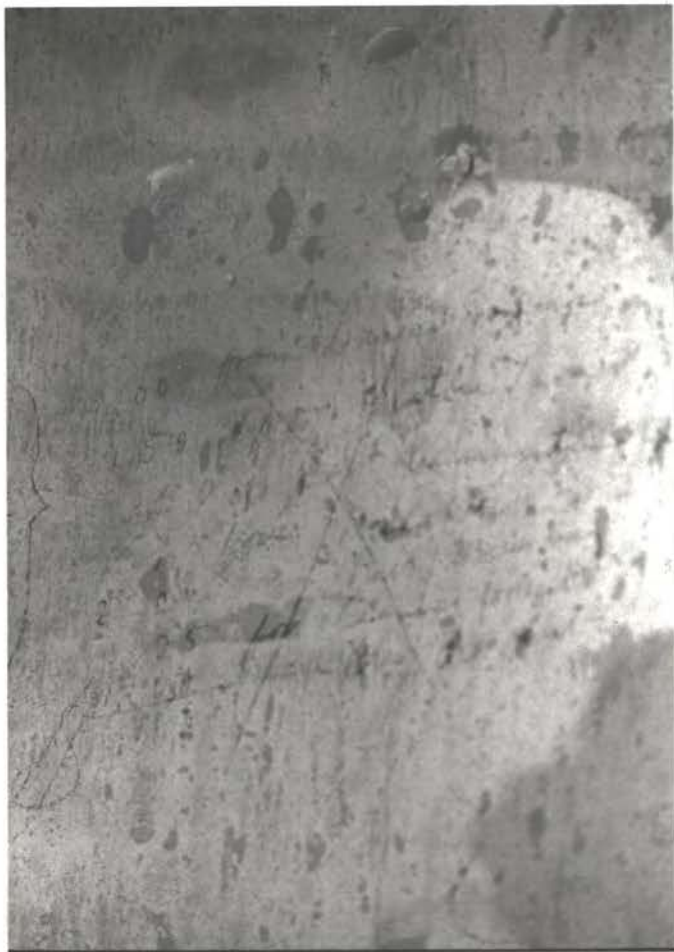
1896 Hundley Bldg.  
 S.S. Sq. - Huntsville, AL  
 pencil notations on plaster at  
 fl. 2 west wall at N.W. hall  
 - Accounts of photographer  
 (several notations are payments  
 to "KODAK", other notes are  
 charges to various clients)  
 Sanborn map of hist. photo  
 show a sign for  
 "photography gallery" here  
 on fl. 2 at turn of 20th cent.  
 photos May 98 H Jones
