in about 1970, Catherine Gillman
asked J & W Ayres, to assist in
getting a Nat. Regis. Mon. together
on this bldg. to save it from
I-565 cutting, which was then
planned to destroy the bldg.
She knew (we didn't) that Nat. Regis
listing would force the Interstate
to avoid the bldg. IF DID!

PHOTO #7
 HUNTSVILLE DEPOT - 1978
 Second Floor Hall - Looking West

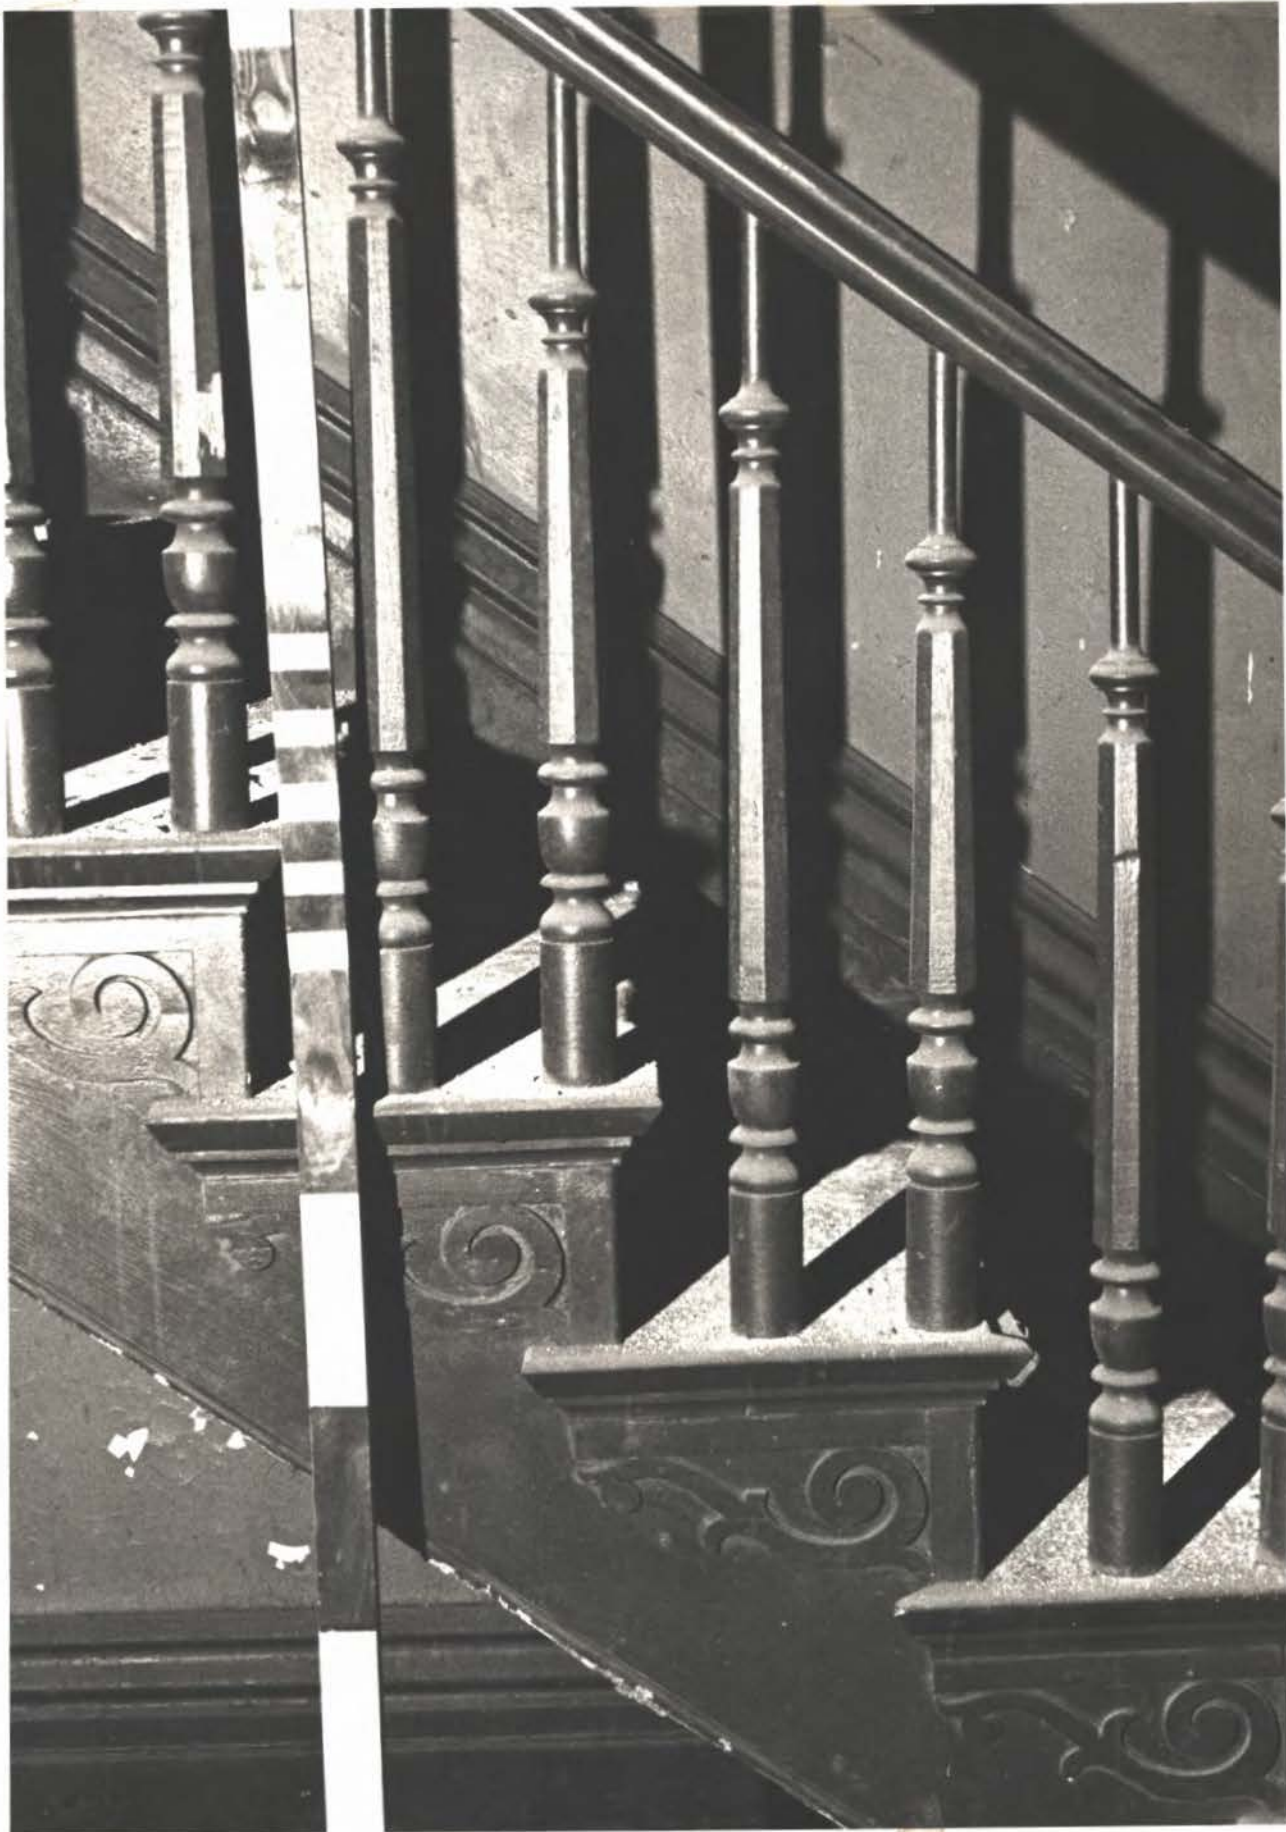
PHOTO #10
HUNTSVILLE DEPOT - 1978
Stair Detail

NOTE: Scale is in 6 inch increments

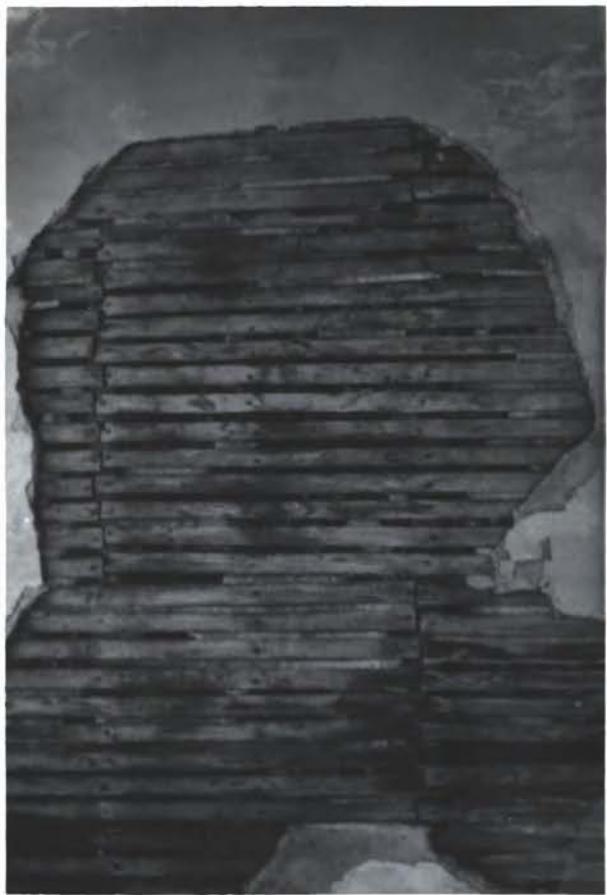
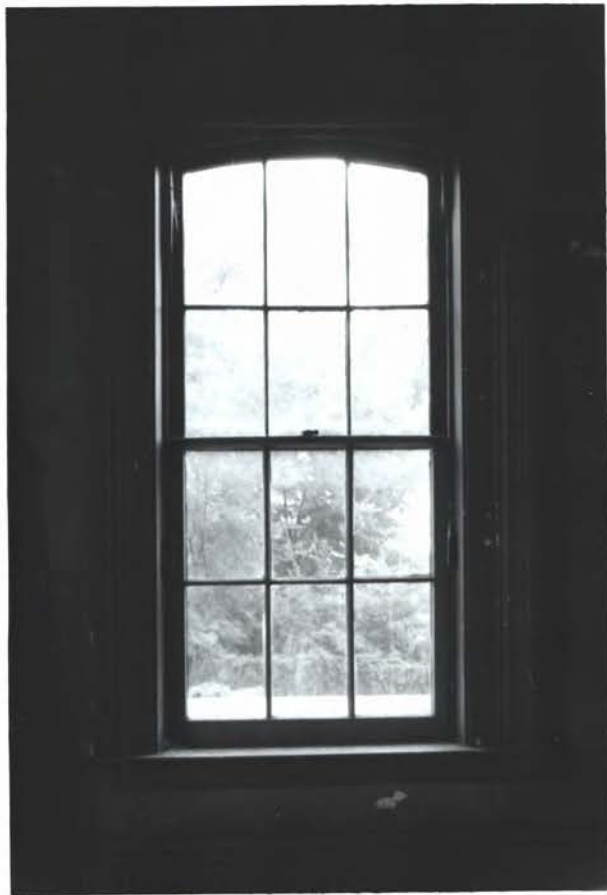
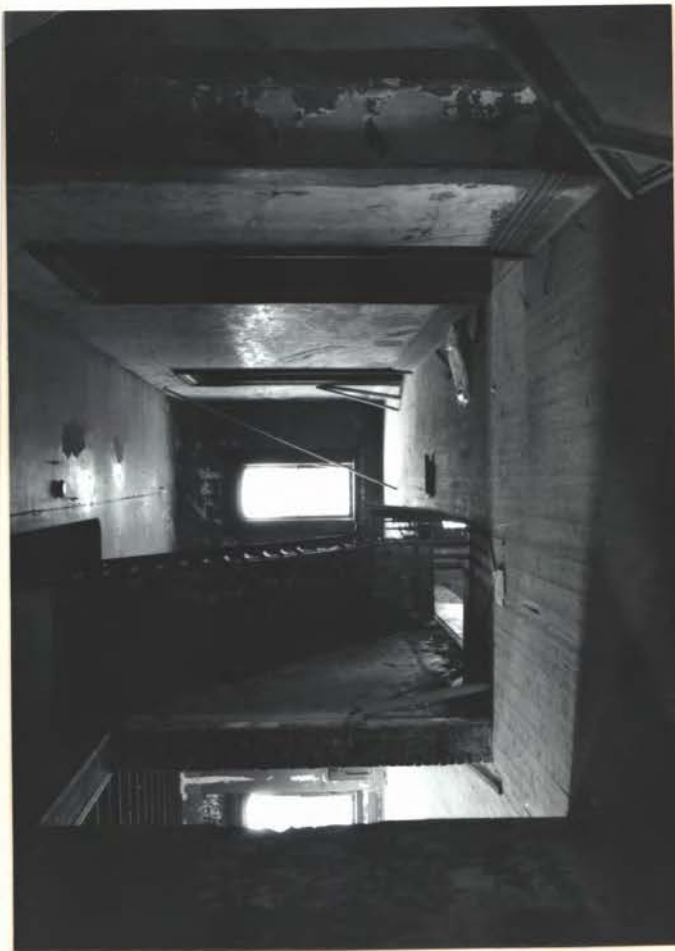
EXISTING
CENTRAL STAIR
DETAILS. STAIR
RUNS FROM
2ND FLR TO 3rd
FLR

EXISTING
CENTRAL
STAIR DETAILS
STAIR RUNS
FROM 2ND FLR
TO THIRD FLR

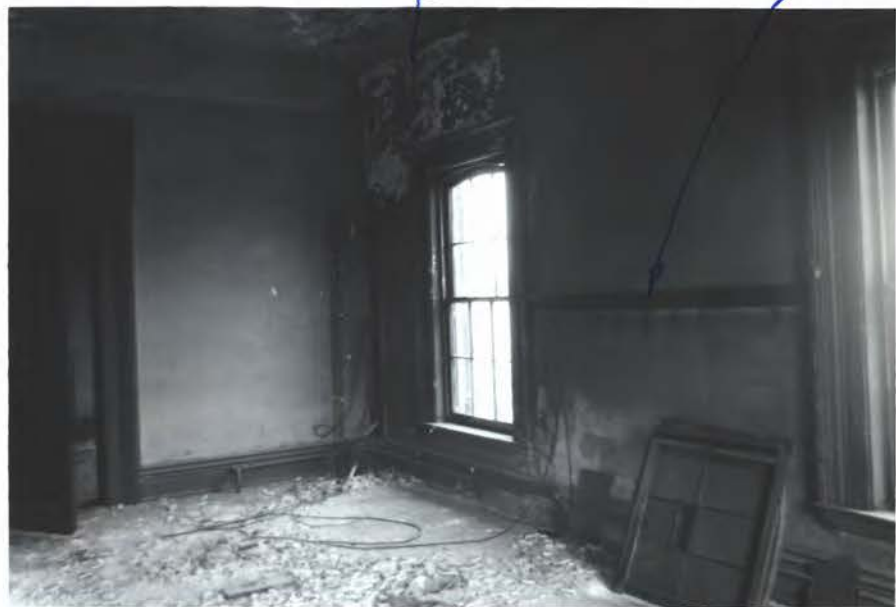
PHOTO #29
HUNTSVILLE DEPOT - 1978
Business Office One - Looking NW

Exposed Lath at ceiling

Note Brick in Firebox
to be removed.

Note debris at Floor to
be removed.

Place all stove parts
and miscellaneous building
parts in "Storage Area".

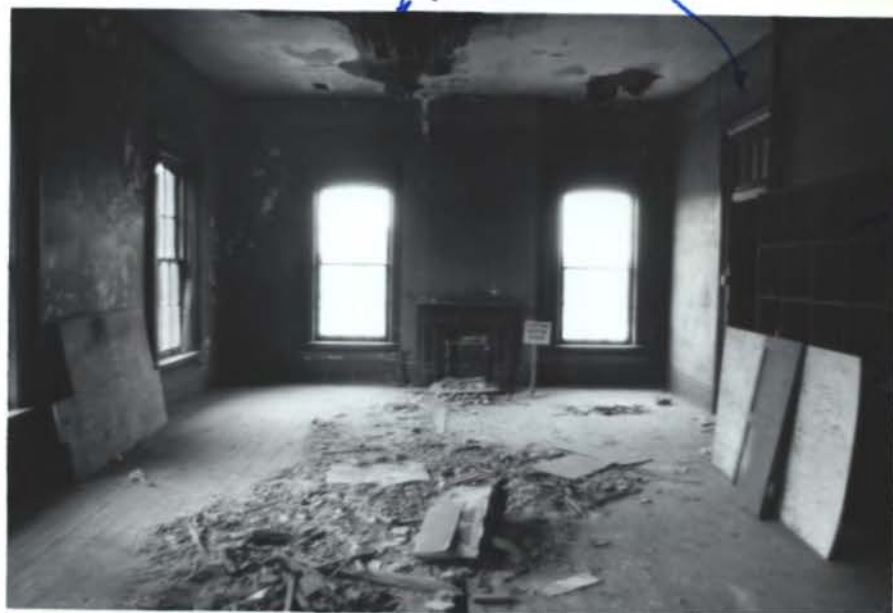
PHOTO #31
HUNTSVILLE DEPOT - 1978
Board Room - Looking West

Note brick in Firebox
to be removed.

Note existing debris
to be removed.

Extensive ceiling
damage (see "Finish
Removal Schedule")

Note debris at floor to
be removed.

See "Plan" for floor damage
areas.

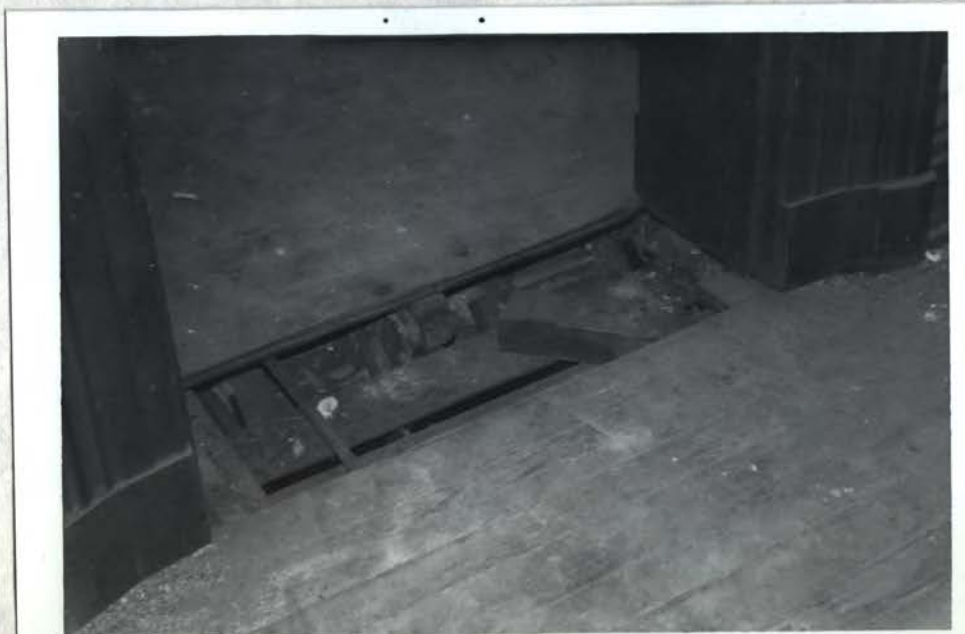
PHOTO #38

Note damaged floor to be repaired.

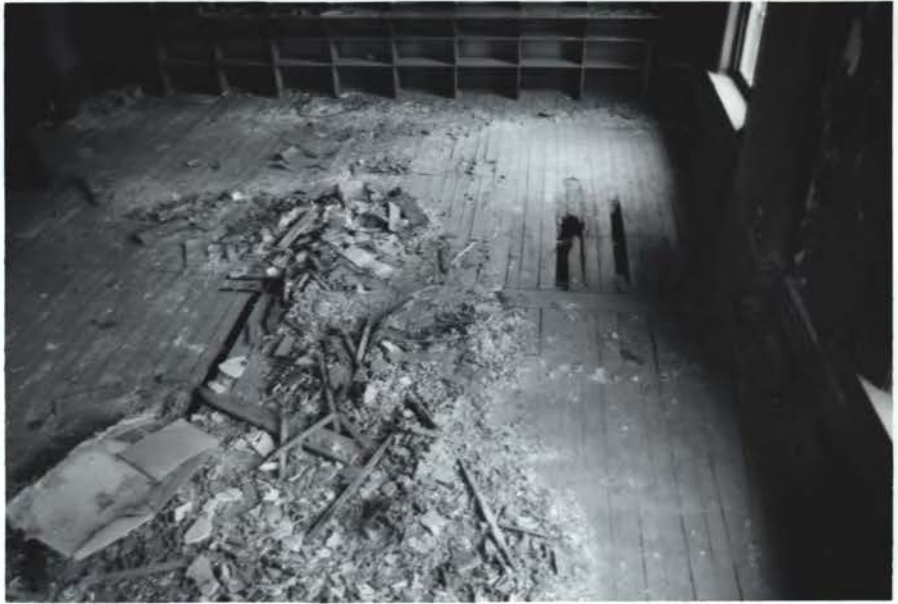
PHOTO #39
HUNTSVILLE DEPOT - 1978
Board Room - Looking East

Note damaged floor to be repaired.

Place all stove parts and miscellaneous building parts in "Storage Areas".

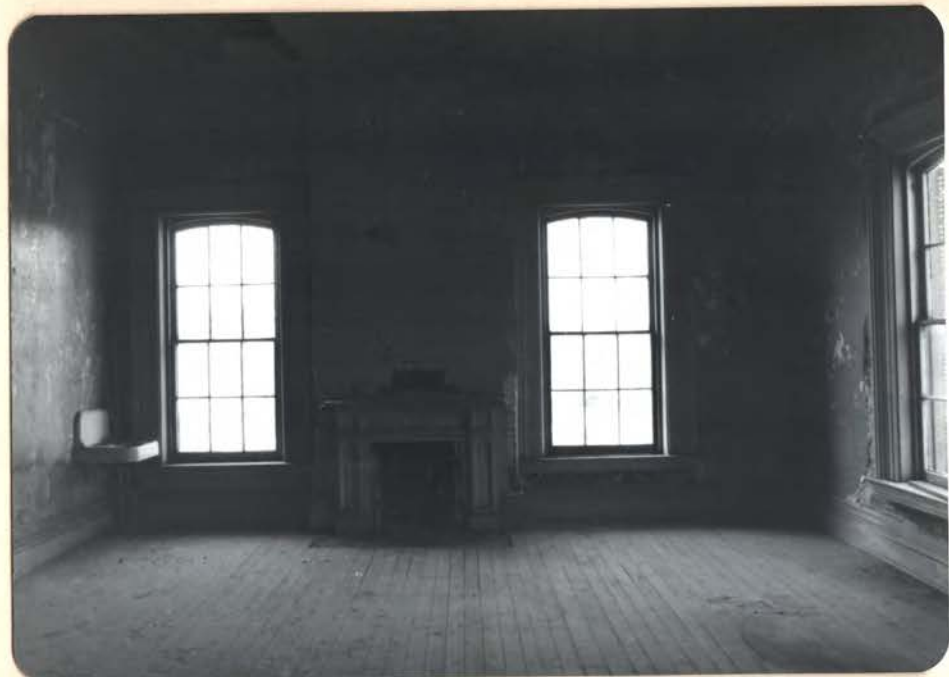
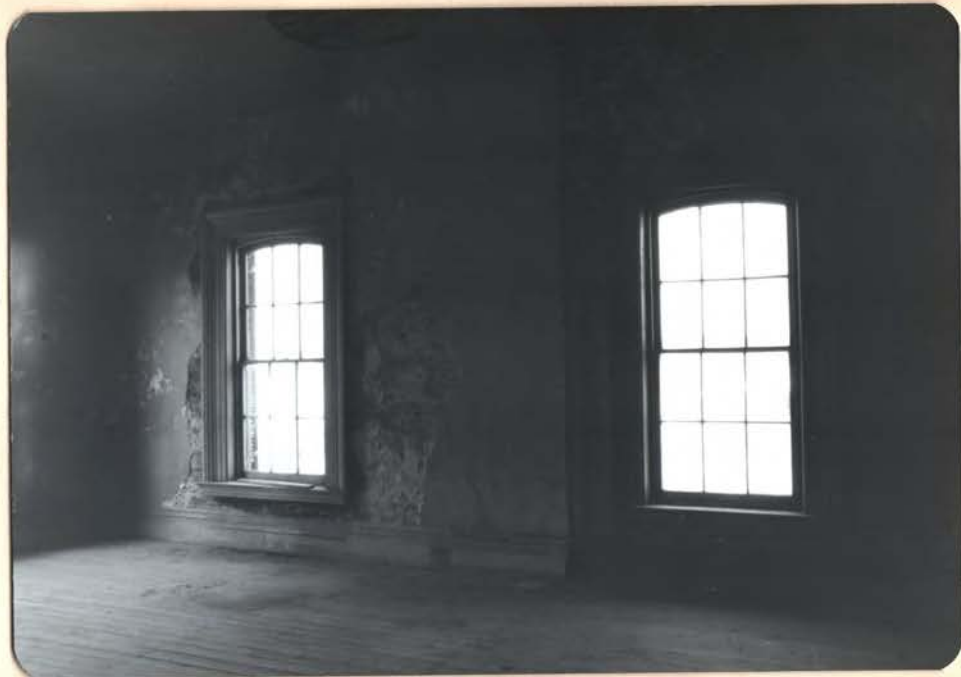
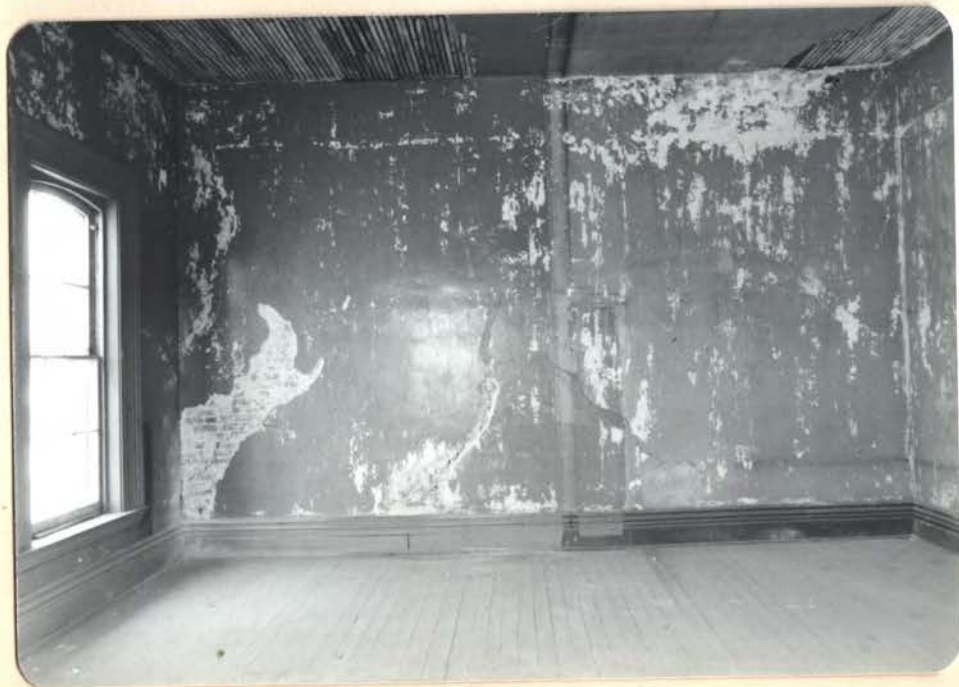
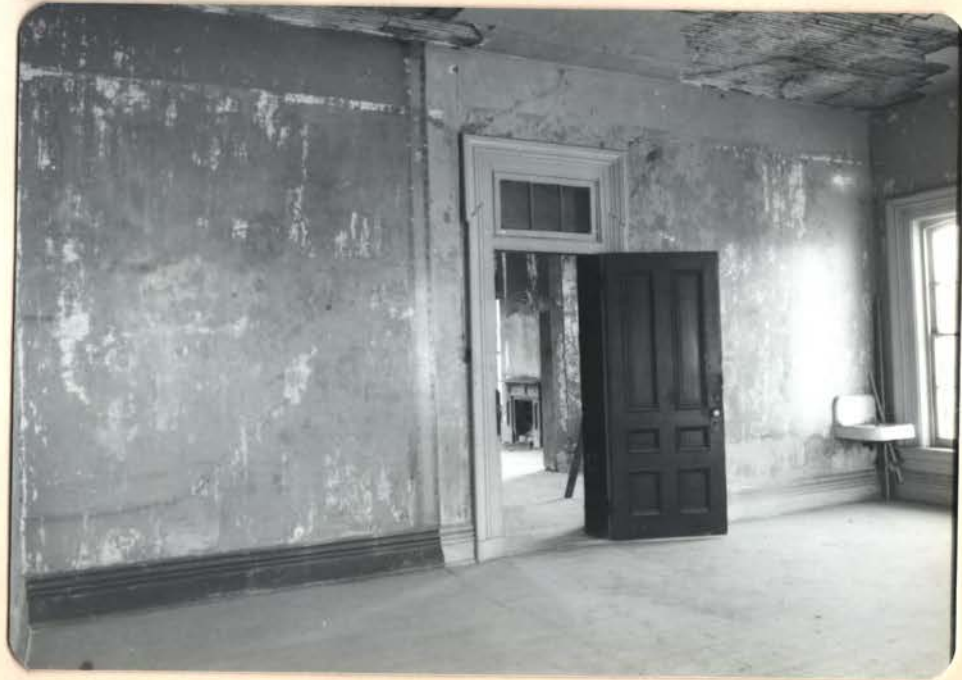
2ND FLOOR
SOUTH SIDE
CHIMNEY

offset is original
(note framed hole in roof)
flue thru roof reconstructed
in 1977

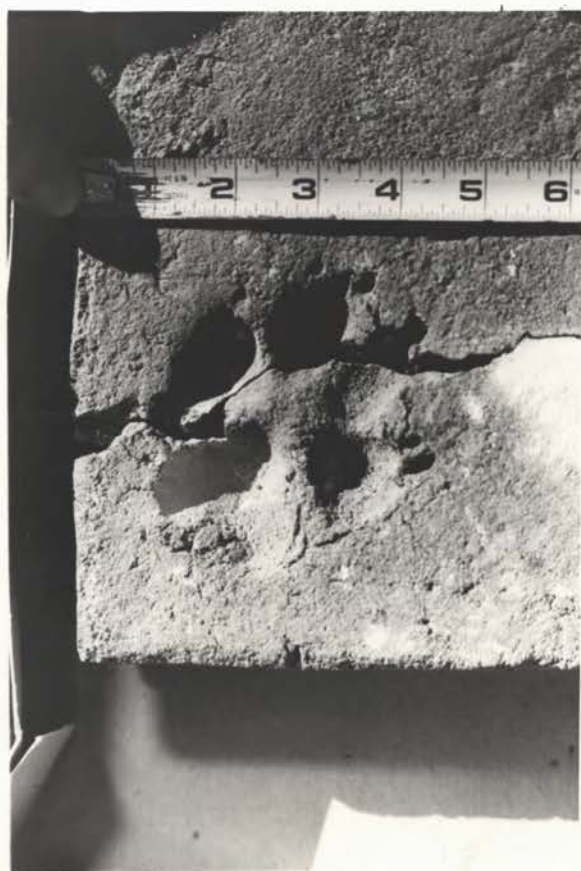
Brick w/ animal print.
Found in hearth @ Huntsville Depot
May, 1981
2nd fl. south east.
