c. 1830's  
Chadwick  
Hse  
N.W. corner  
Randolph & Lincoln

Sprague - Chadwick  
ca. 1832 + vic. others  
4 photos in 1970 - H Jones

CIRCA 1835 SPRAGUE-CHADWICK HOUSE, 307 RANDOLPH AVENUE (FEDERAL PERIOD)

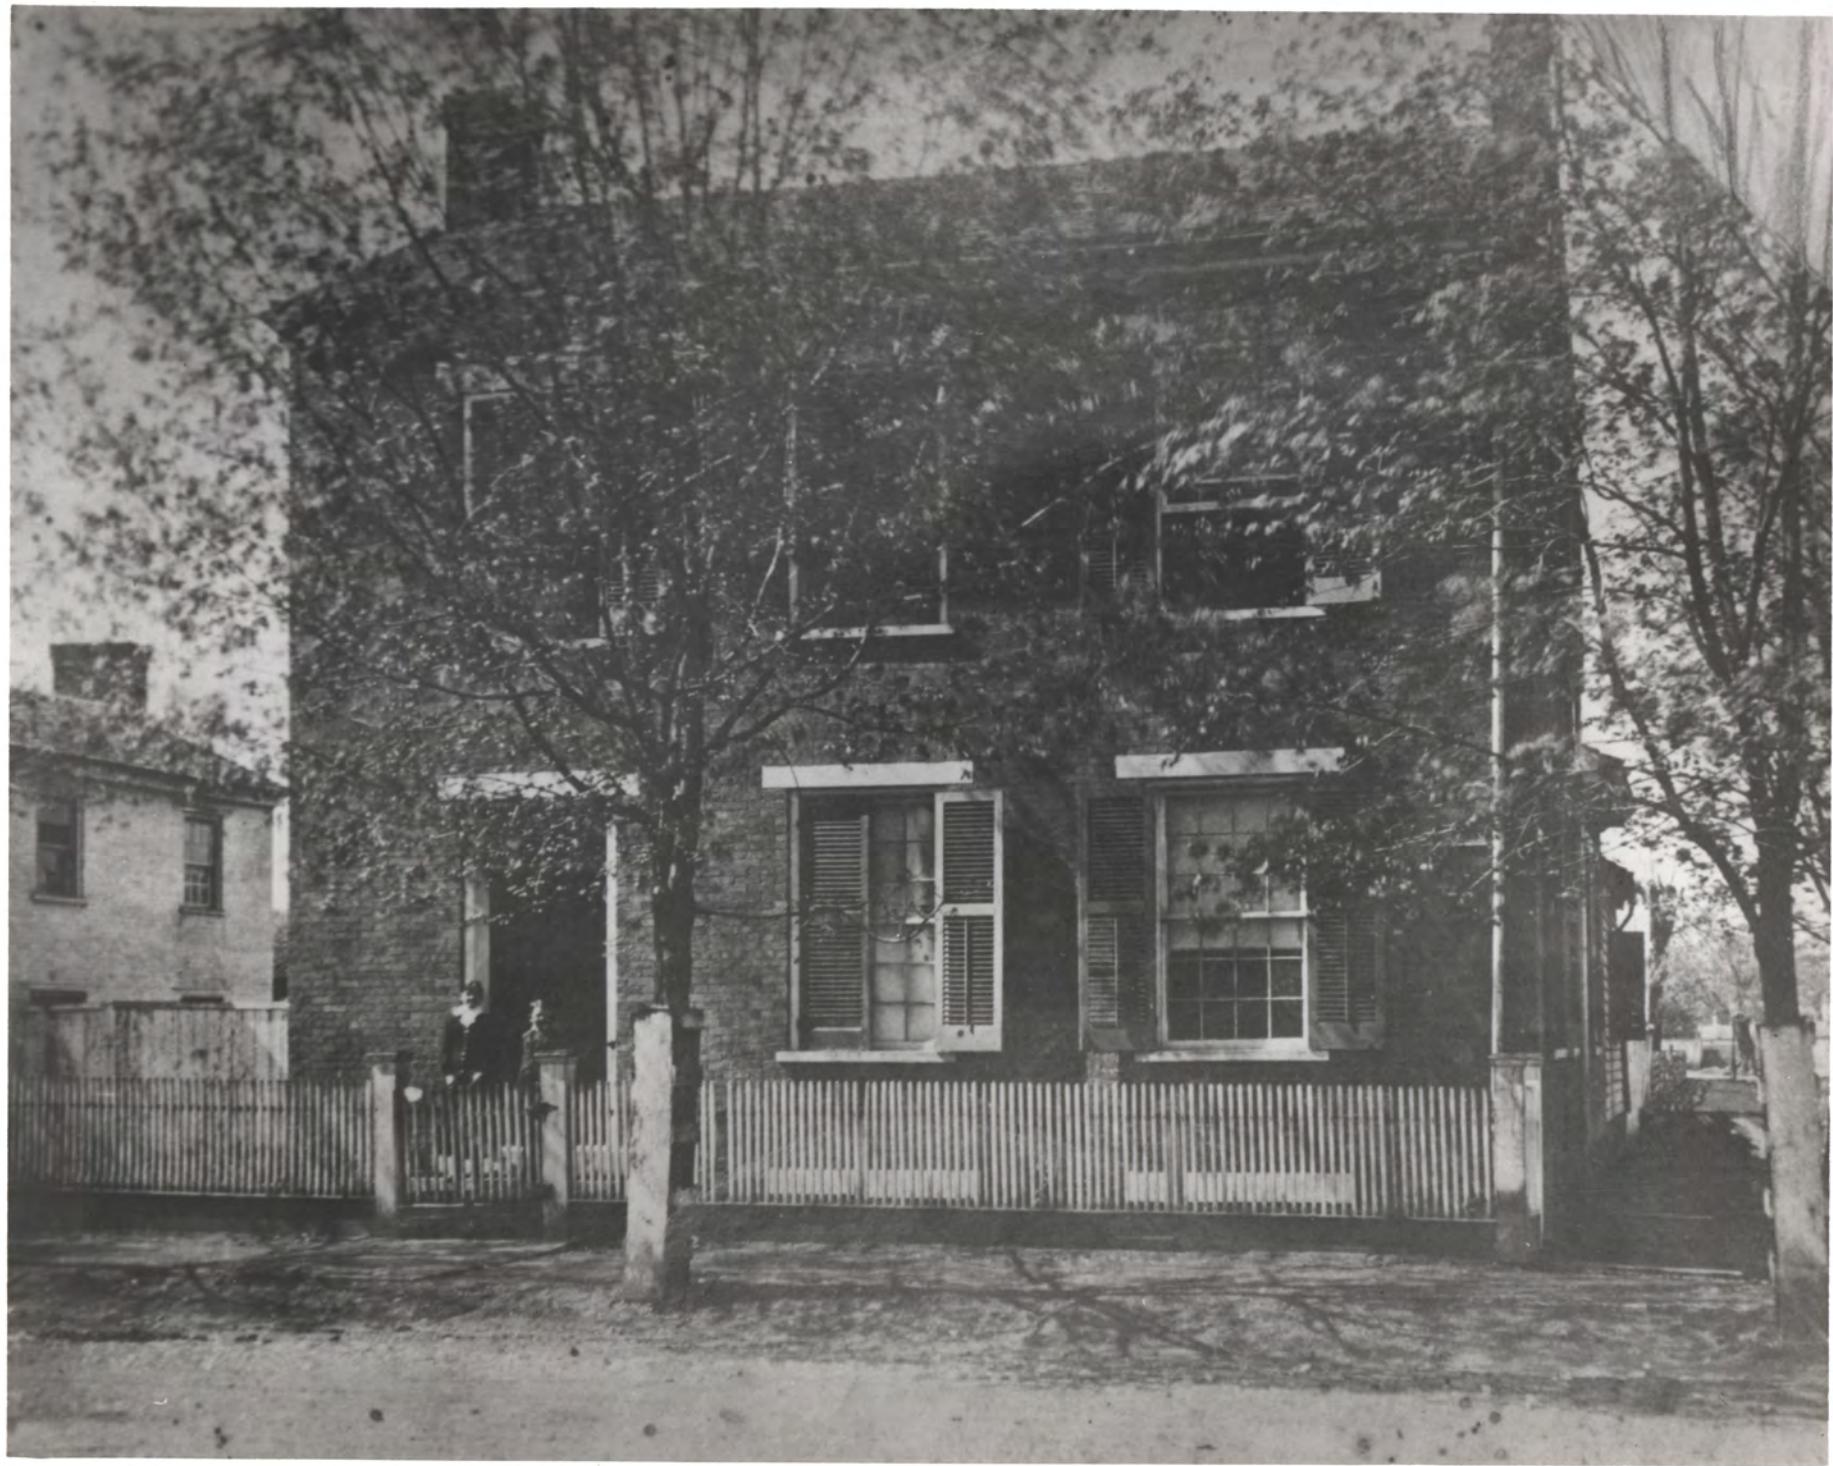
orig. photo  
ca. 1860-1880?  
Copy 1976 ±

Late 1800's photo of  
Sprague - Chadwick Hse, built ca 1832

Shakes are now late 1800's

2 over 2 (see overleaf)

Vic. Add. to west of to north (see overleaf)

Note no entry porch. Most Fed Hses had none

Door appears dark color

Trim appears white

Appears to have built-in gutter (Most Fed. Hses did)

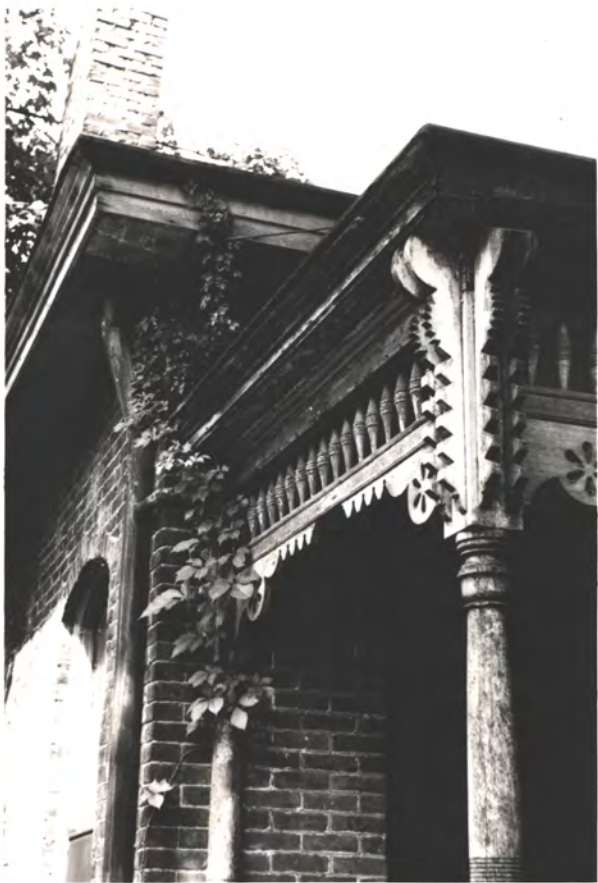
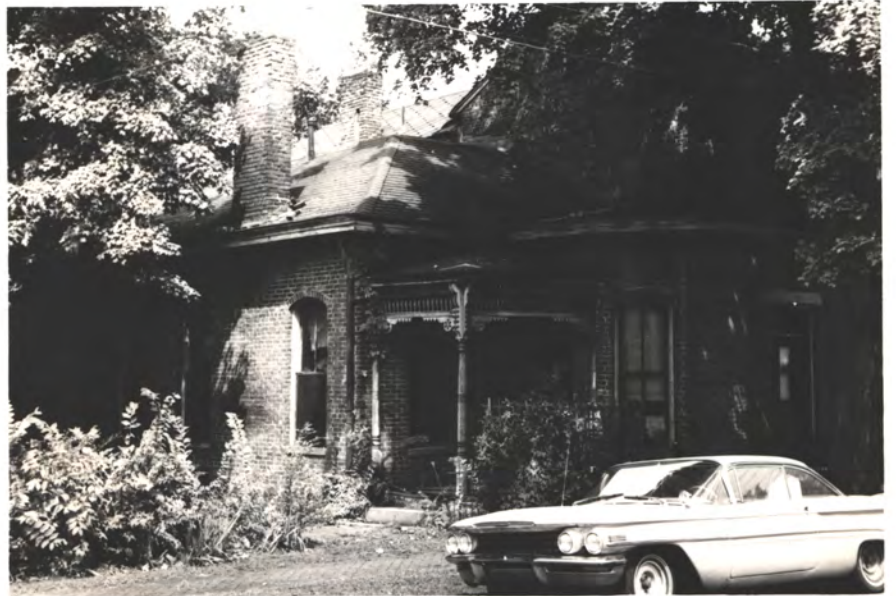
vic. →

late 1800's original  
KIT.  
Demol. ca. 1973

vic. west wing →

In 1970 the Sprague-Chadwick House had been long empty and in disrepair and was known to local children as "the haunted house". Its owner offered to donate its bricks to the proposed Constitution Hall Village since it was assumed the late-Federal Period house was of no value. The front porch was rotted and collapsed, windows were broken, paint peeled, etc.

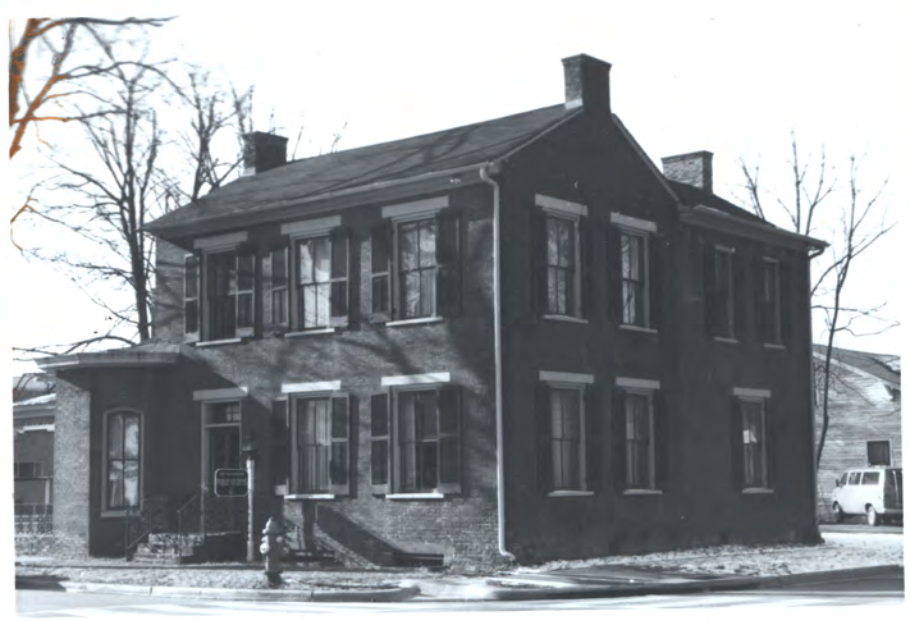
False chimney →

tapered roller fascia →

one type of Typical Fall  
 2/2 late 1800's sashes →  
 some terminations →

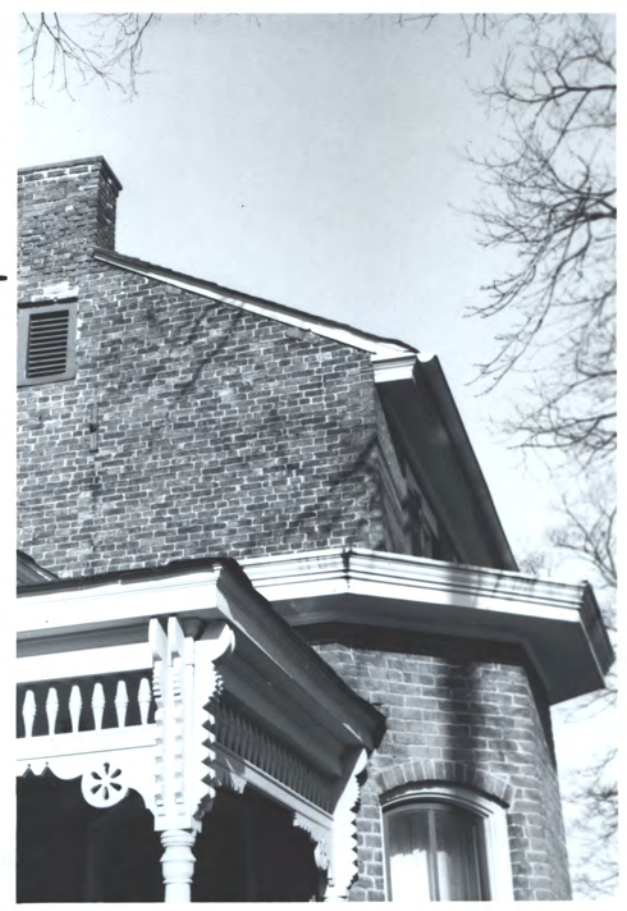
Sprague - Chadwick Hse  
 photos ca. 1978 - H. Jones

These blinds not orig. to house - are from houses demol. in 1960's by "Urban Renewal" on west Holmes Ave - are was 1820's

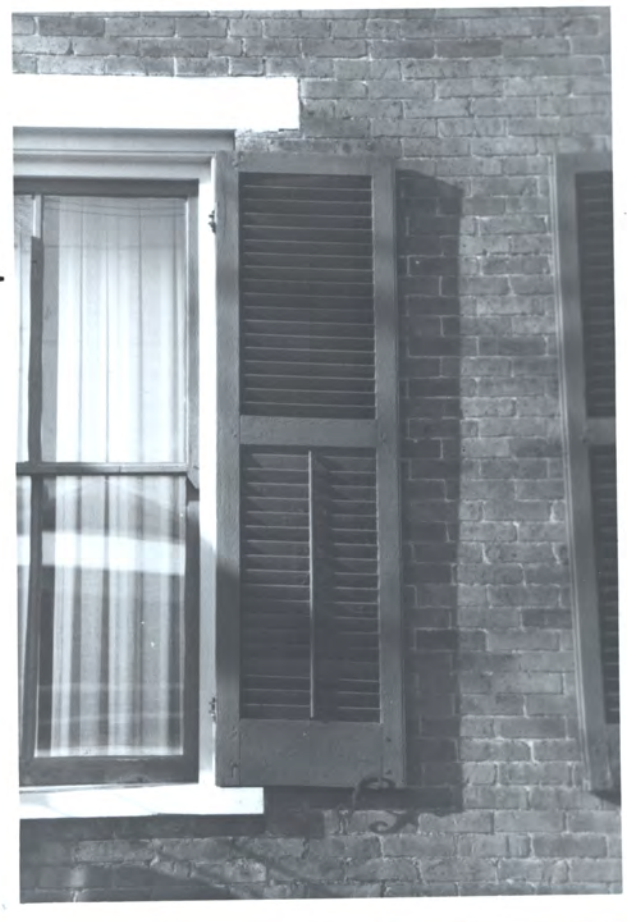
Note high-quality brick in all-running bond on public face - & cheap brick in common bond on other faces (typical of the early 19th cent.) →

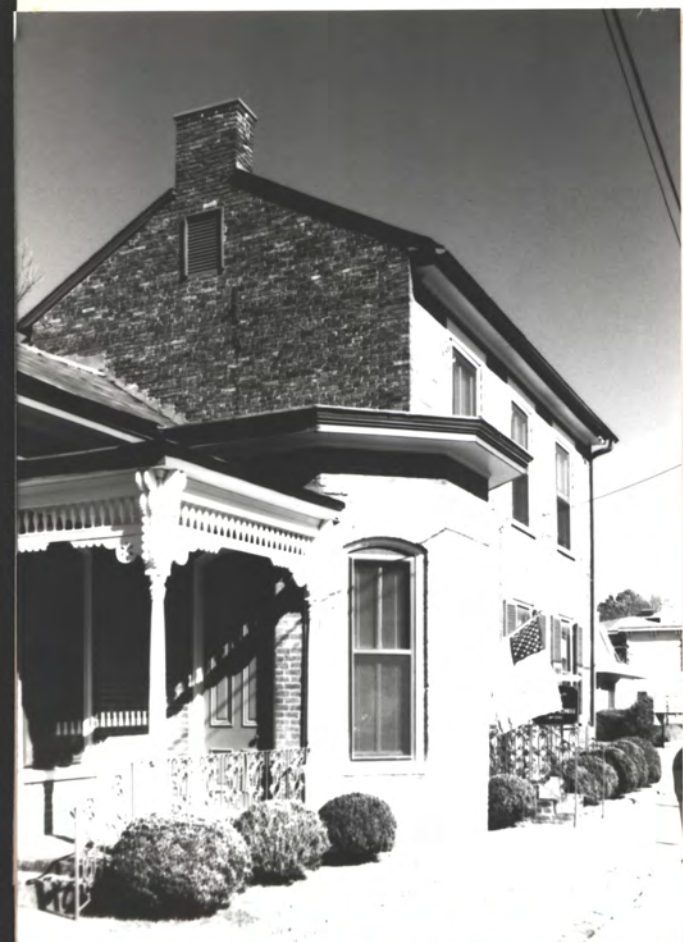
ORIGINAL PLAN

see c. 1880  
 photo +  
 Sanborn  
 maps  
 + 1860 map

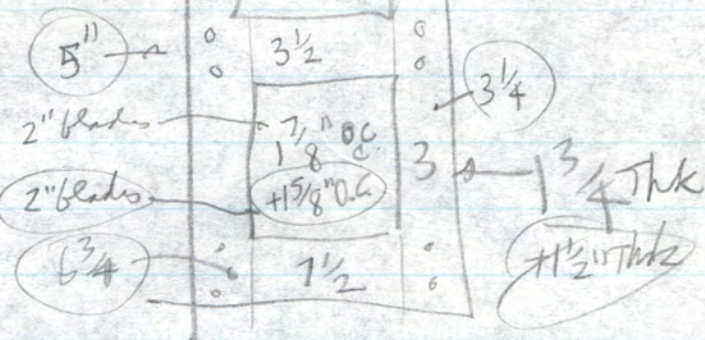
Blinds at

Leads - 5" = S. blinds  
 (5") = E. blinds

$\frac{1}{4}$ " blades

(Originally were on c. 1820 house  
 on west side of west Clinton,  
 demolished in 1960's "Urban Renewal"  
 program)

Measured 18 Jan. 1990 H. Jones
