**ARCHITECTURAL COLLECTION
OF
HARVIE P. JONES, F.A.I.A.**

SERIES 4---PHOTOGRAPH NOTEBOOKS

BOOK 51

**c. 1840 James Meals
Log House
Burritt Museum**

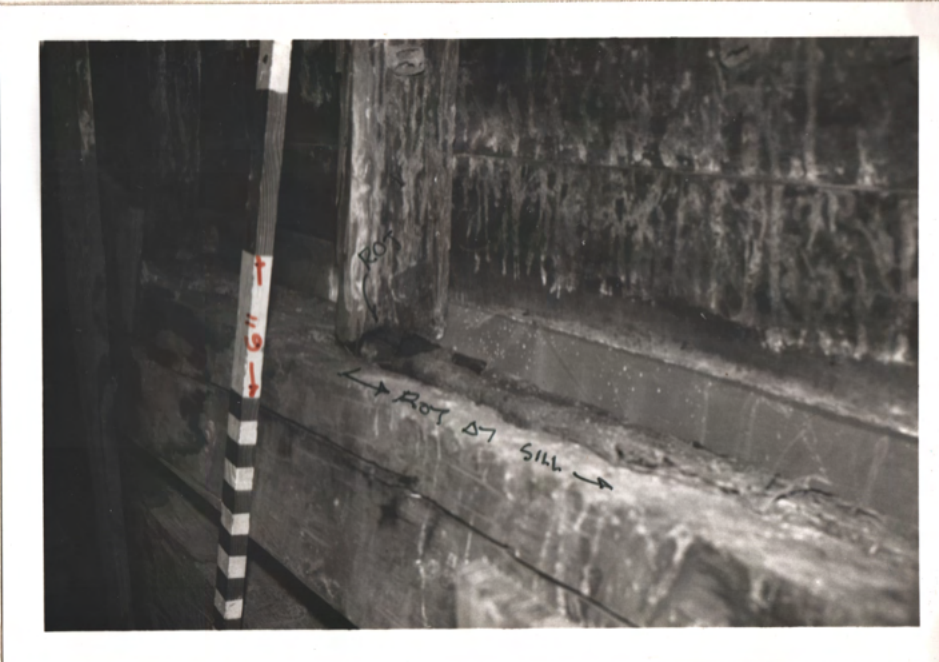
E. Pan left, east wall -
TRACES OF 2 WINDOWS. THIS IS N.E. WINDOW
 (CURBS ARE ROTTED - SEEN VICTORIAN) + SEE OVER

Rot below missing sill (only) confirms such loc.

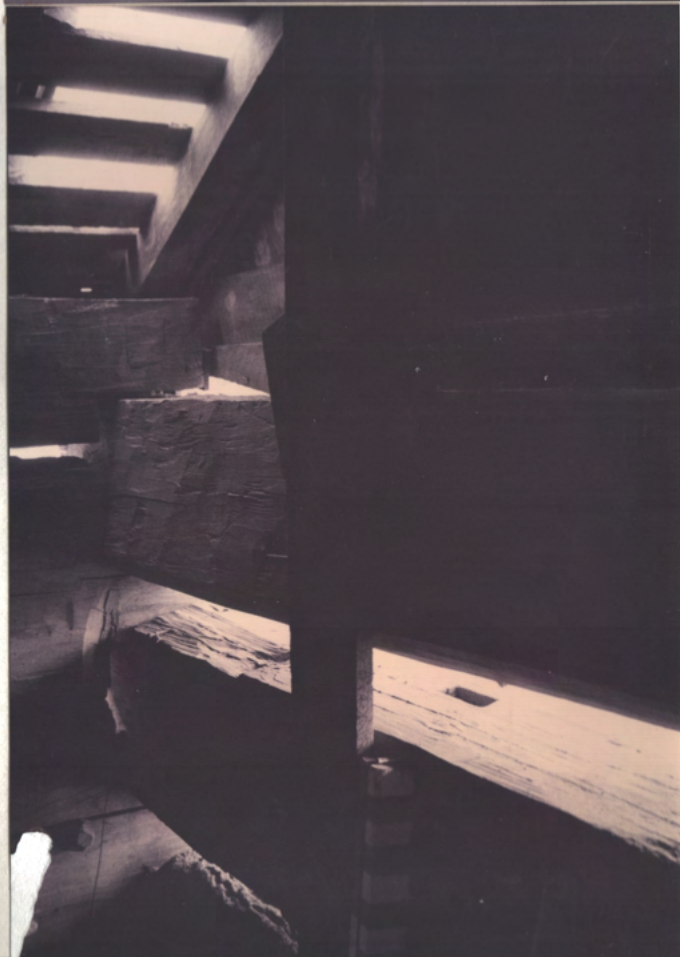
565h loc.
(ROT WOOD ONLY AT SILL
↓ STD-TENONS CONFIRMS
FORMER LOC. OF 565h)

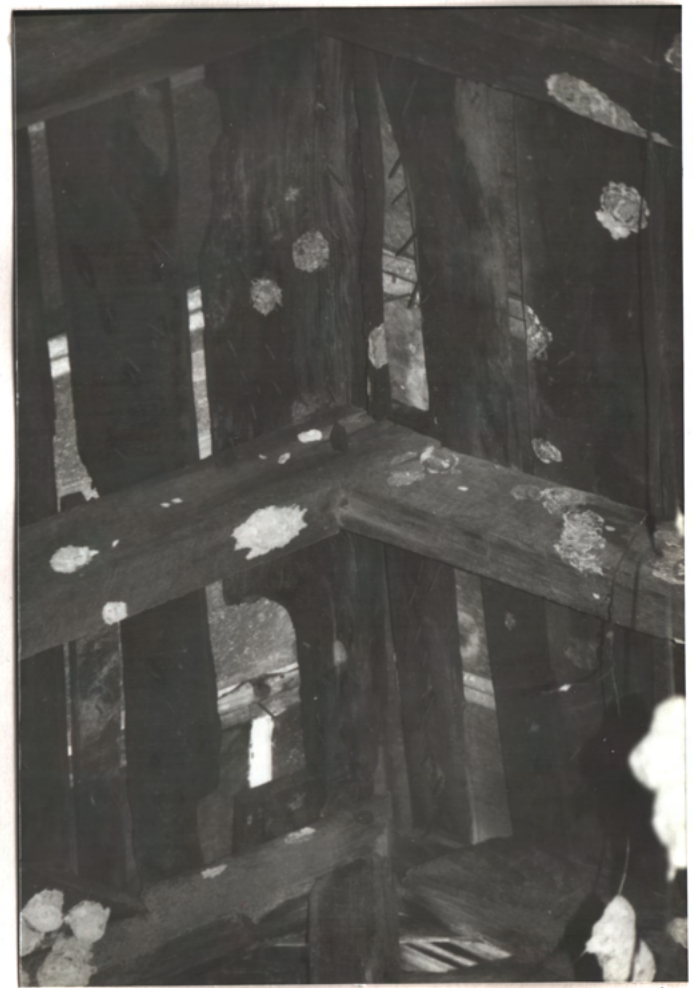
W. PEN

- by pin
- 1. half-log of peg ft. at rafters
 - 2. rot - some rafters
 - 3. wide "slab" planks at dark

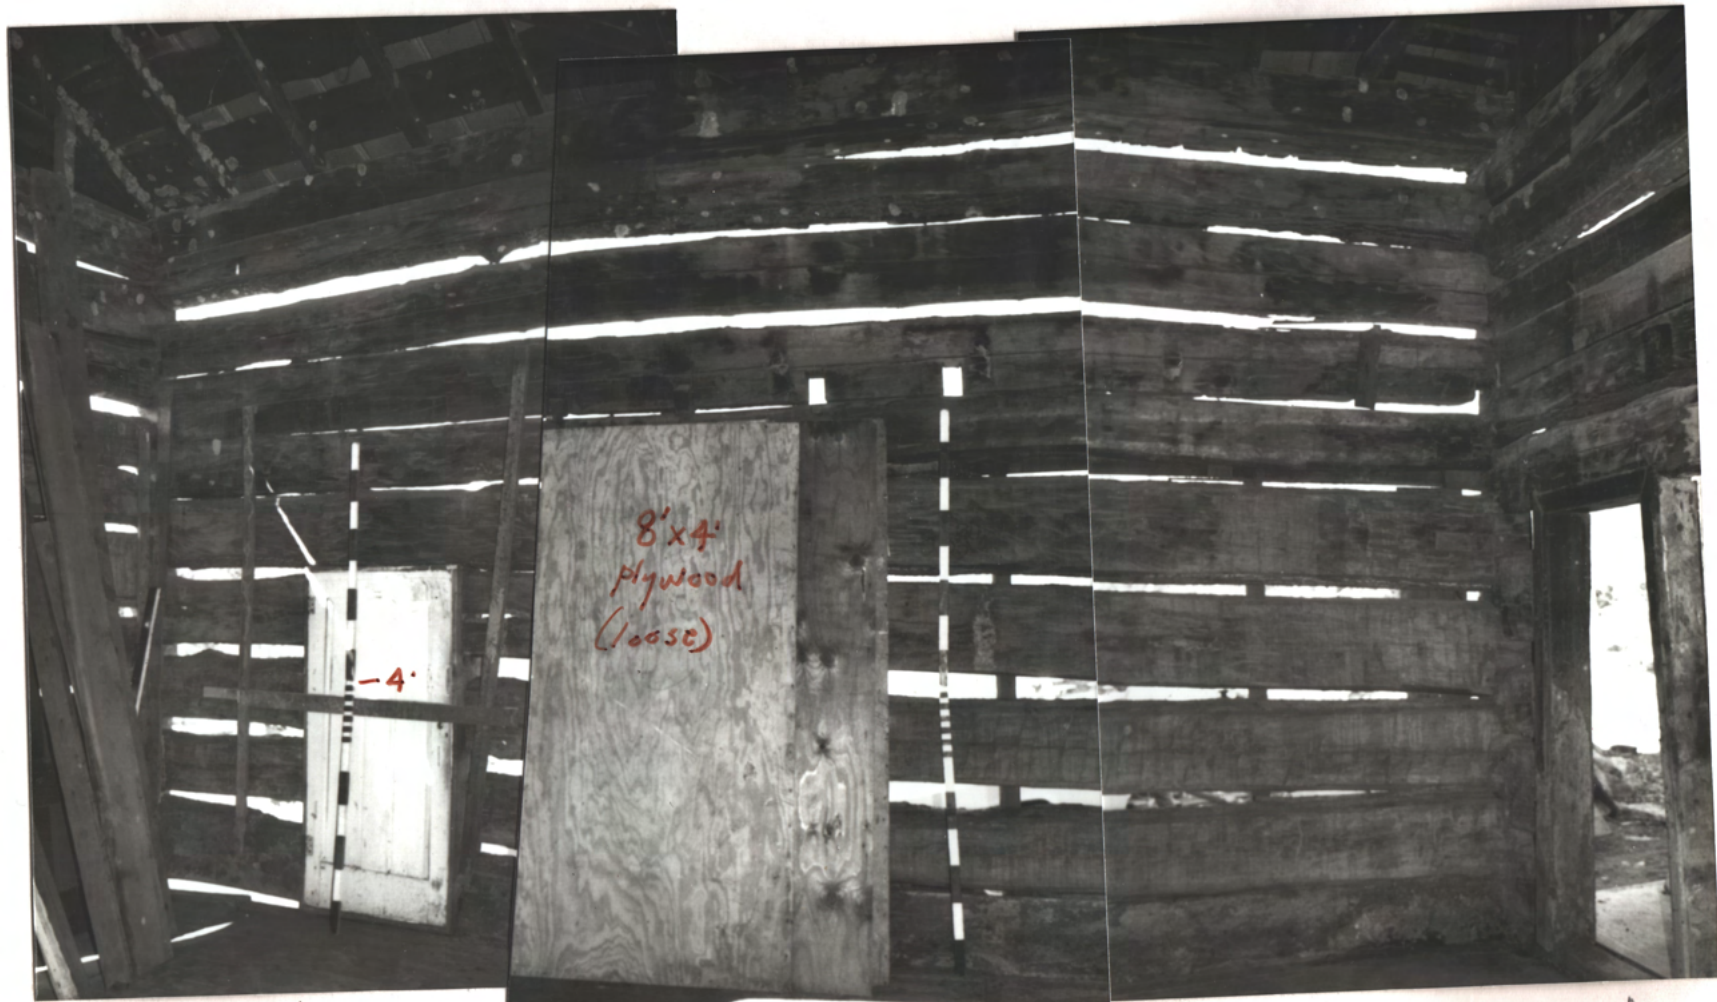
Removal class. last,
Greek Revival 2nd prd.
Not orig. to this place
Battery. Same frame

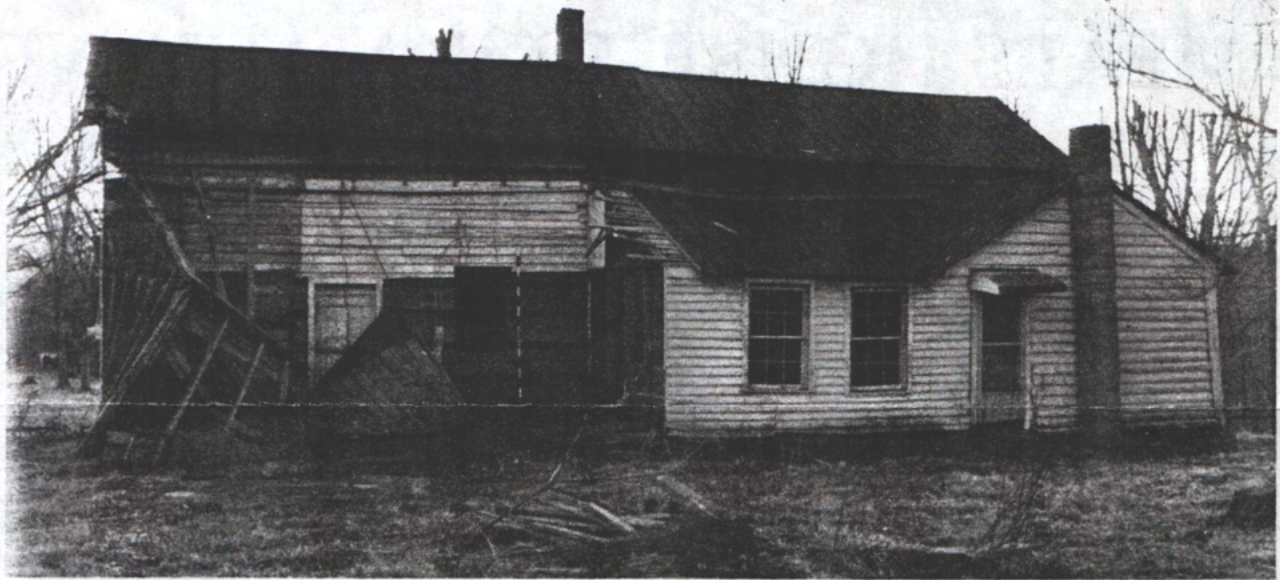
Rear view, February, 1993. The earliest addition, ca. 1860, has fallen down at left.
Photograph by Harvie Jones, architect.

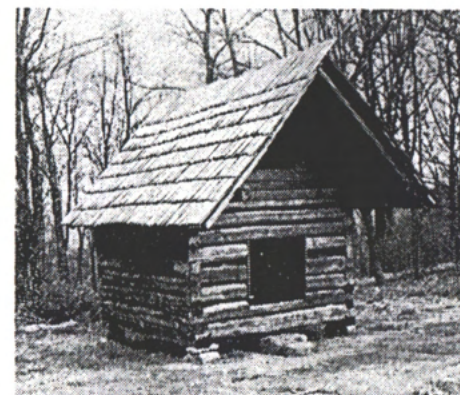
The finished corn crib, built by volunteer staff. Note the hand-riven oak roof boards. January, 1994.

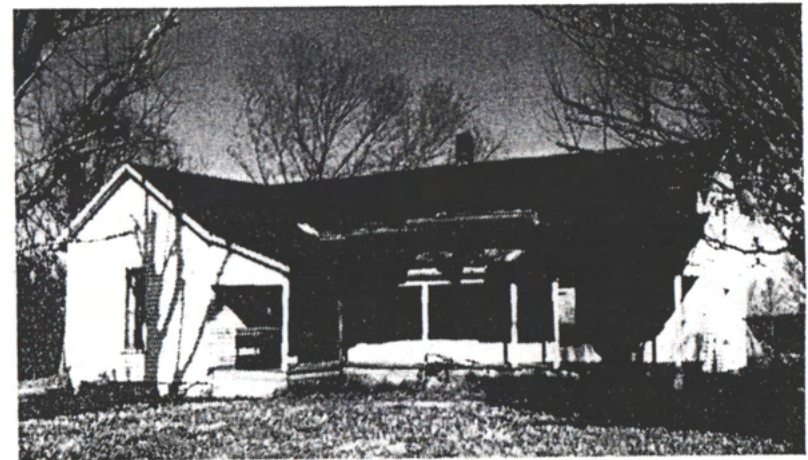
The James A. Meals house in its original location, Lester, Alabama. November, 1992

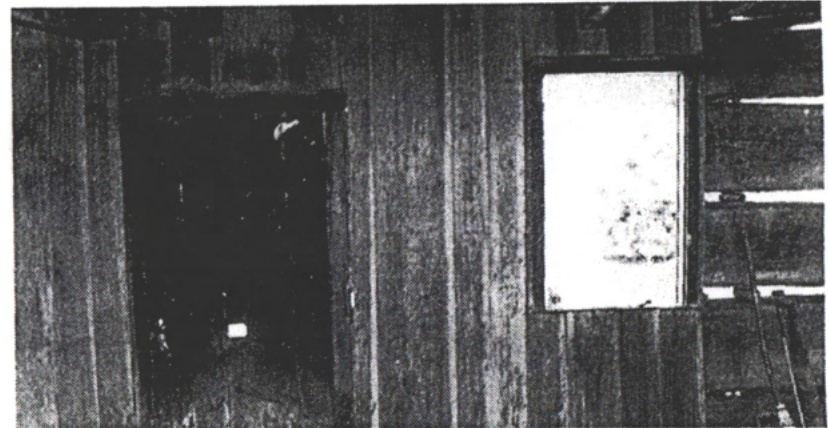
Paneling in the parlor of the Meals house after cleaning. Note the original door and window as well as board and batten door with cut-out for electricity hookup. The window sash and glass have been removed during the restoration. All paneling is tongue-in-groove with a double-beaded edge on each side. 1994

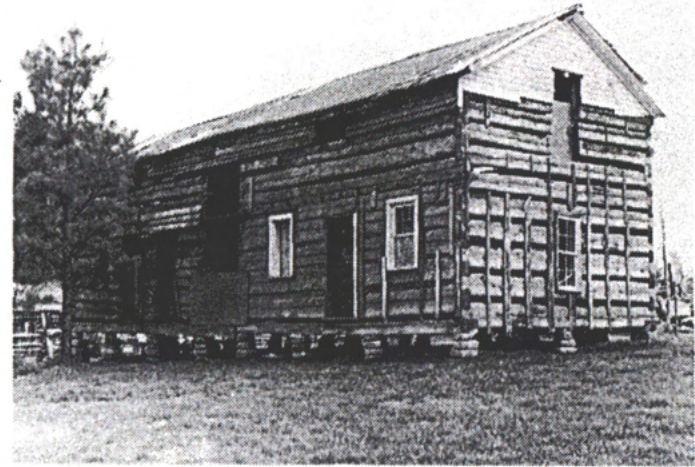
Above: James A. Meals house on site at Burritt Museum. The clapboard siding has been removed to determine which logs need to be replaced. 1994.

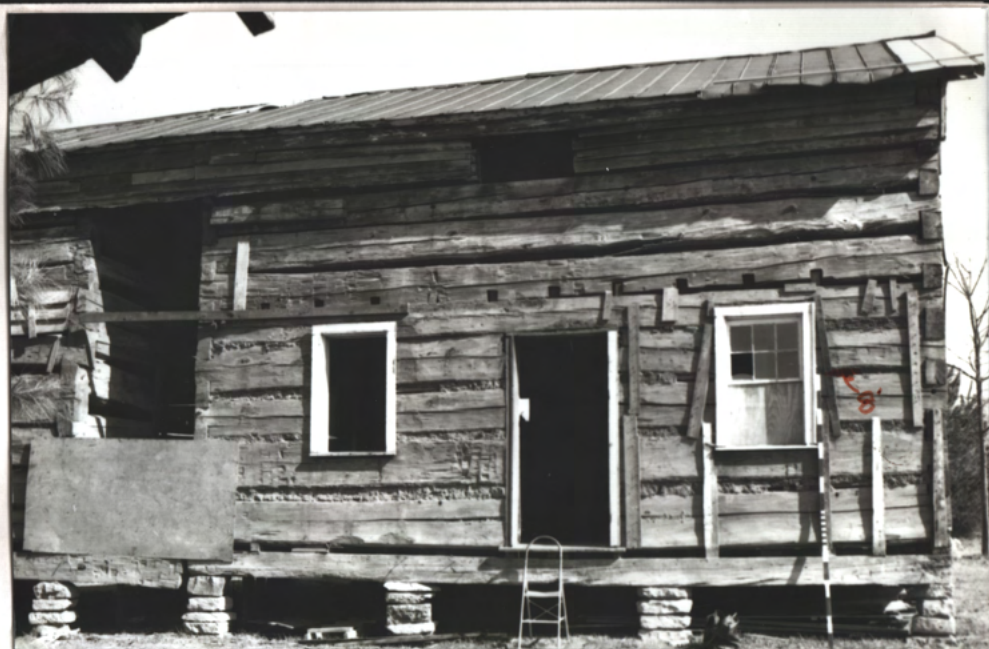
S.W.M.
 Orig.
 E. Pan

Mud & hair
 staining →

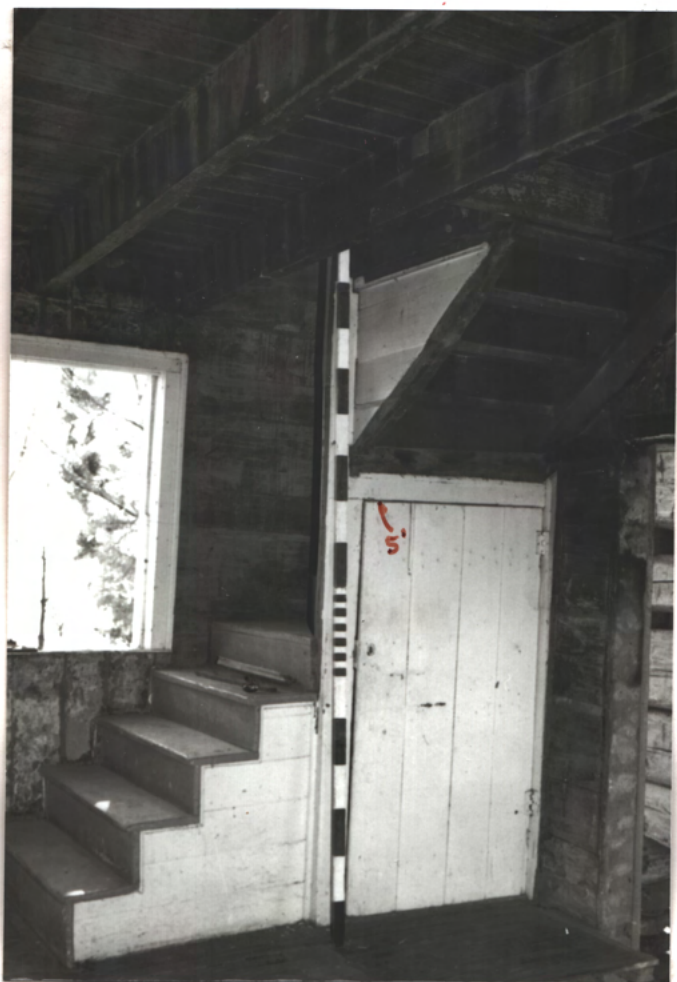
- *Construct all board and batten doors.
- *Install "dutchmen" in original back door.
- *Provide door hardware.
- *Construct reproduction window sashes to match originals and repair originals.

- *Replace missing trim boards between beams in parlor.
- *Install "dutchman" in paneling.
- *Remove paint from flooring in loft and parlor.
- *Remove paint from staircase.
