NASA TECHNICAL
MEMORANDUM

NASA TM X-64844

MSFC SKYLAB NEUTRAL BUOYANCY SIMULATOR

14. SPONSORING AGENCY CODE	
15. SUPPLEMENTARY NOTES			
16. ABSTRACT Presented in this report is the role of the Neutral Buoyancy Simulator in the development, crew training, and flight operational aspects of Skylab.

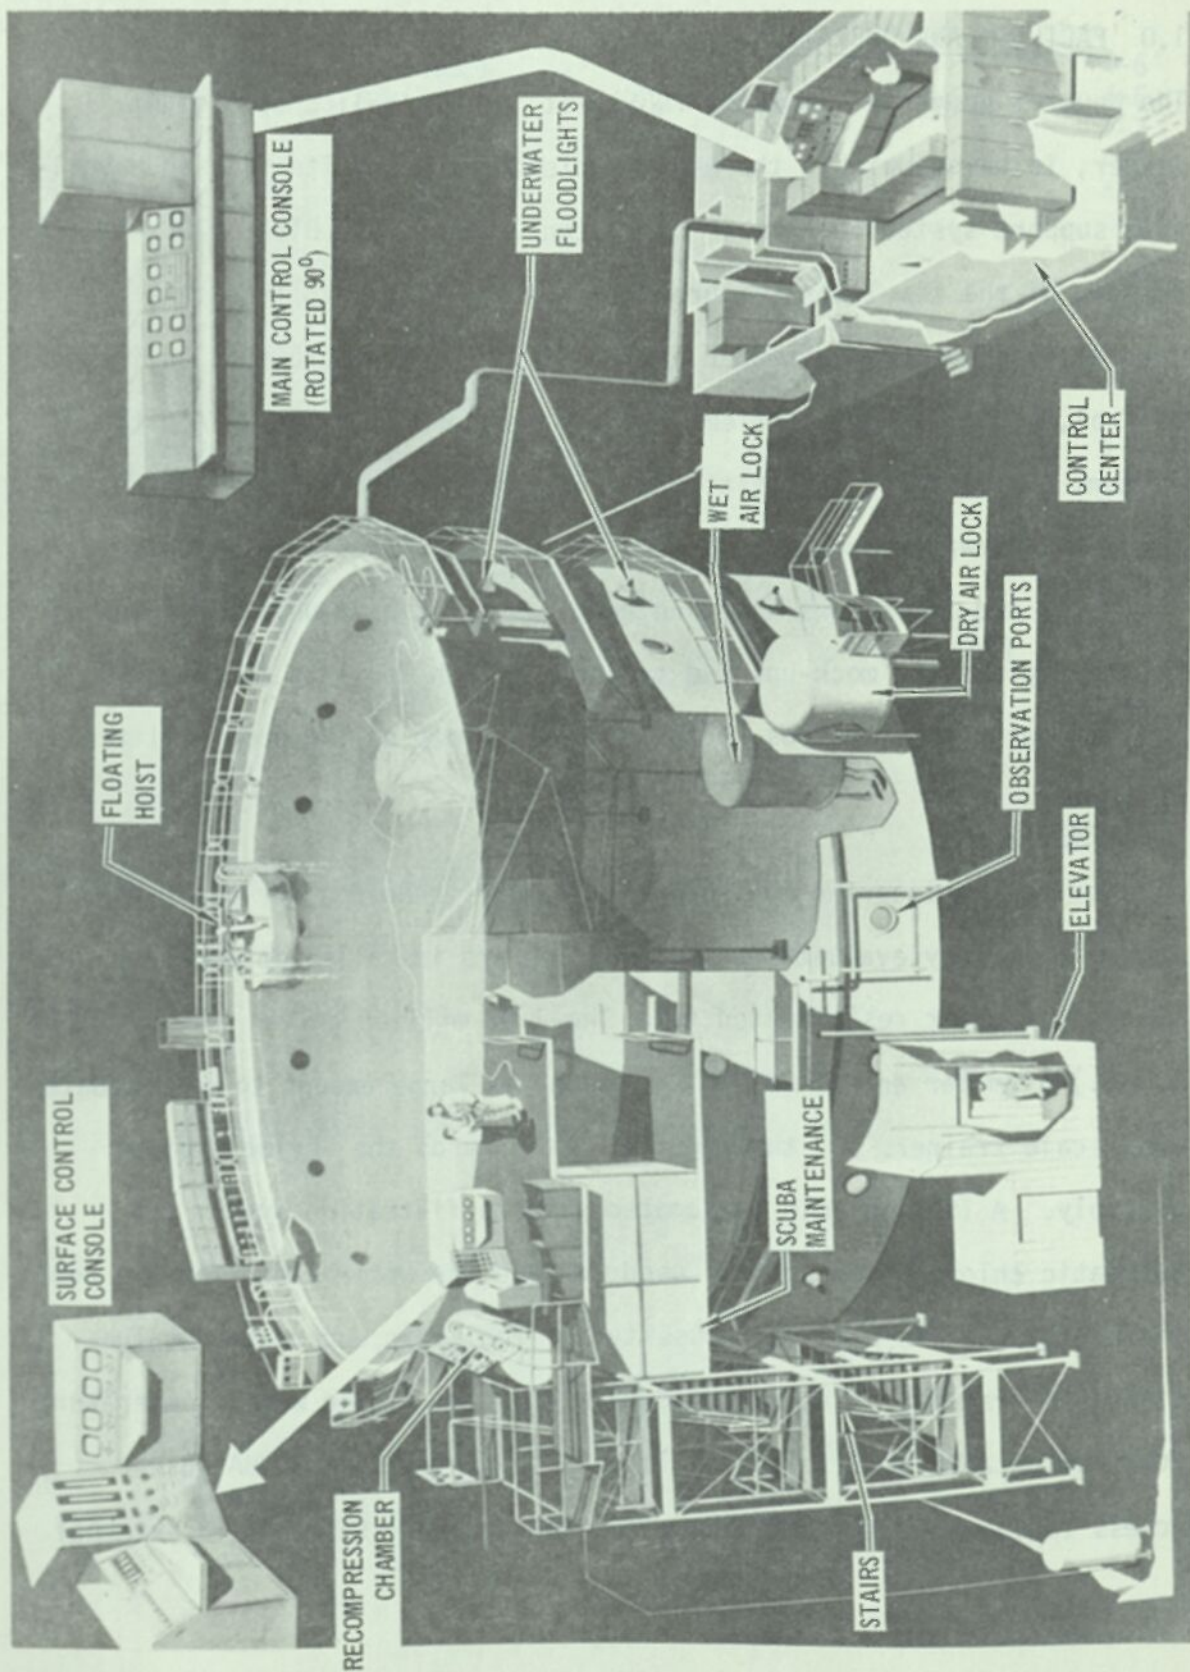
FIGURE 1-1 NEUTRAL BUOYANCY SIMULATOR

The various engineering mock-ups and trainers required for underwater Neutral Buoyancy evaluations and training are installed in a welded steel, polyester resin coated tank. The 1.32 million gallon tank of 22.8m (75ft.) diameter and 12.2m (40ft.) depth, is large enough to accommodate full scale trainers for the required elements of the Skylab orbital assembly. A 1500 gal/min diatomaceous earth filtration system and automatic chlorination unit is used to keep the water clean for the good visibility that is a prime necessity for realistic underwater evaluations and training. Steam heat exchangers control the water temperature to a comfortable 86°F, allowing long term shirt sleeve SCUBA work. Access to the tank is provided by an elevator and stairways to external

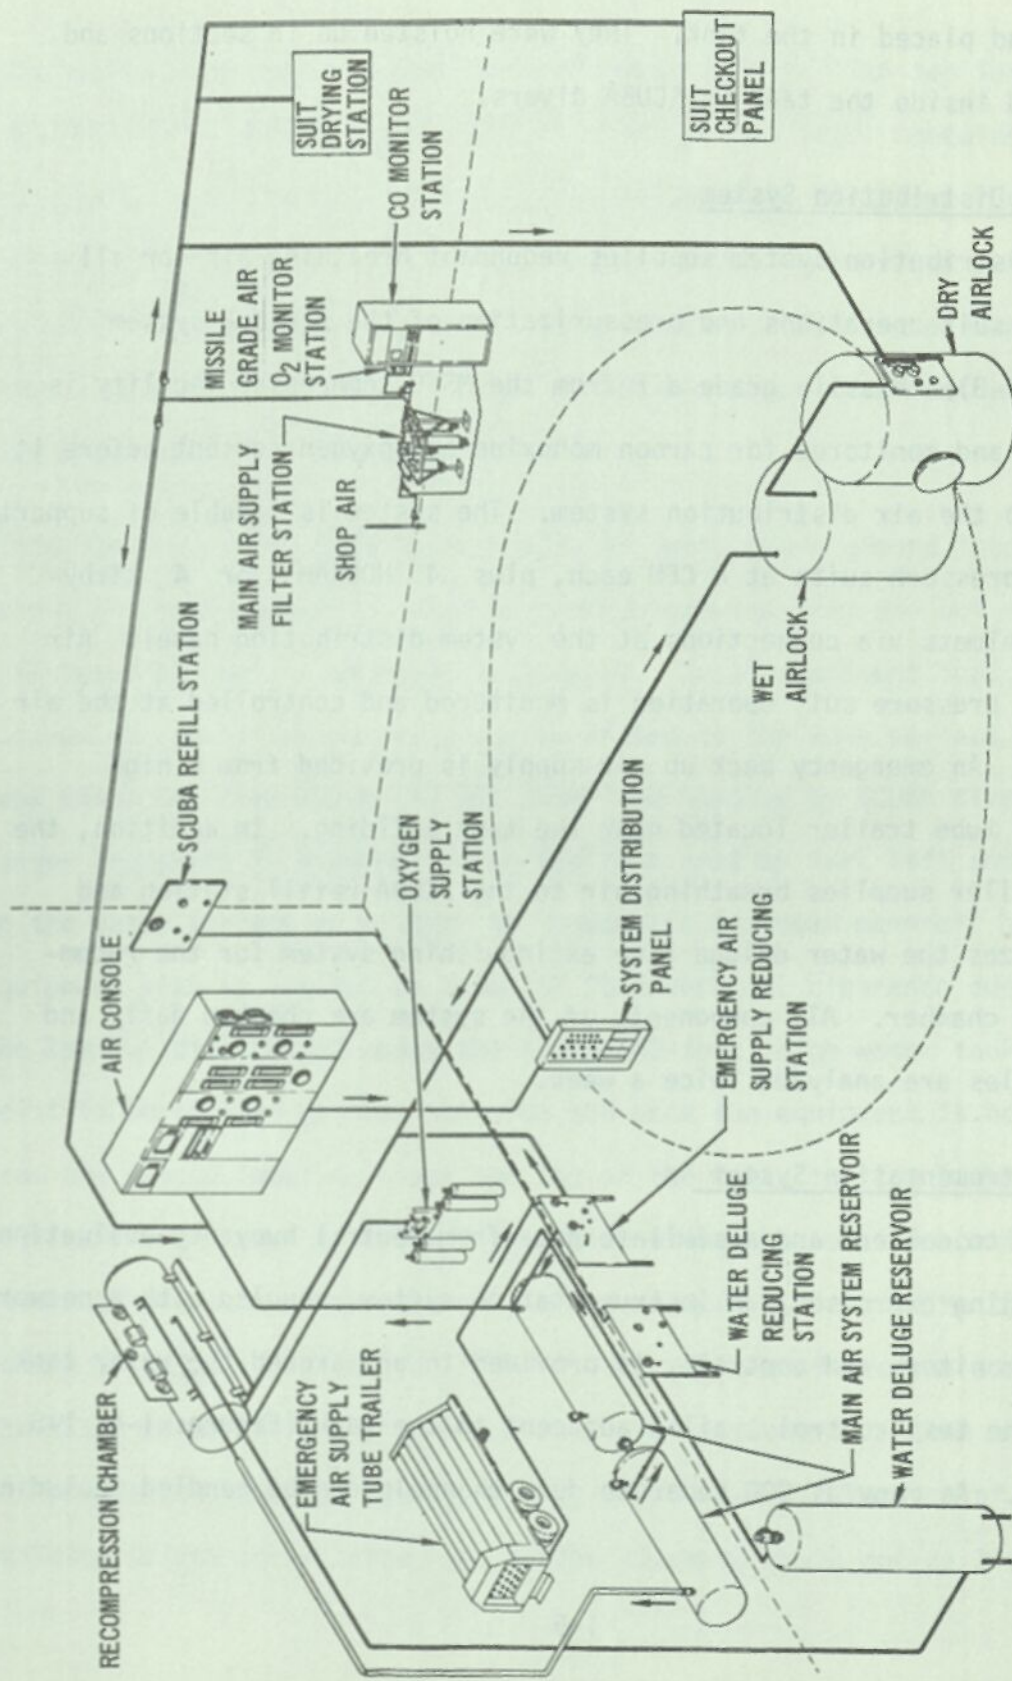
FIGURE 1-3 NBS AIR DISTRIBUTION SYSTEM

An air distribution system supplies redundant breathing air for all pressure suit operations and pressurization of the Airlock system (Figure 1-3). Missile grade air from the MSFC compressor facility is filtered and monitored for carbon monoxide and oxygen content before it goes into the air distribution system. The system is capable of supporting 4 pressure suits at 6 CFM each, plus 4 HOOKAH's or 4 Kirby-Morgan helmets via connections at the system distribution panel. Air flow for pressure suit operation is monitored and controlled at the air console. An emergency back up air supply is provided from a high pressure tube trailer located near the tank building. In addition, the tube trailer supplies breathing air to the SCUBA refill station and pressurizes the water deluge fire extinguishing system for the recompression chamber. All components of the system are checked daily and air samples are analyzed twice a week.

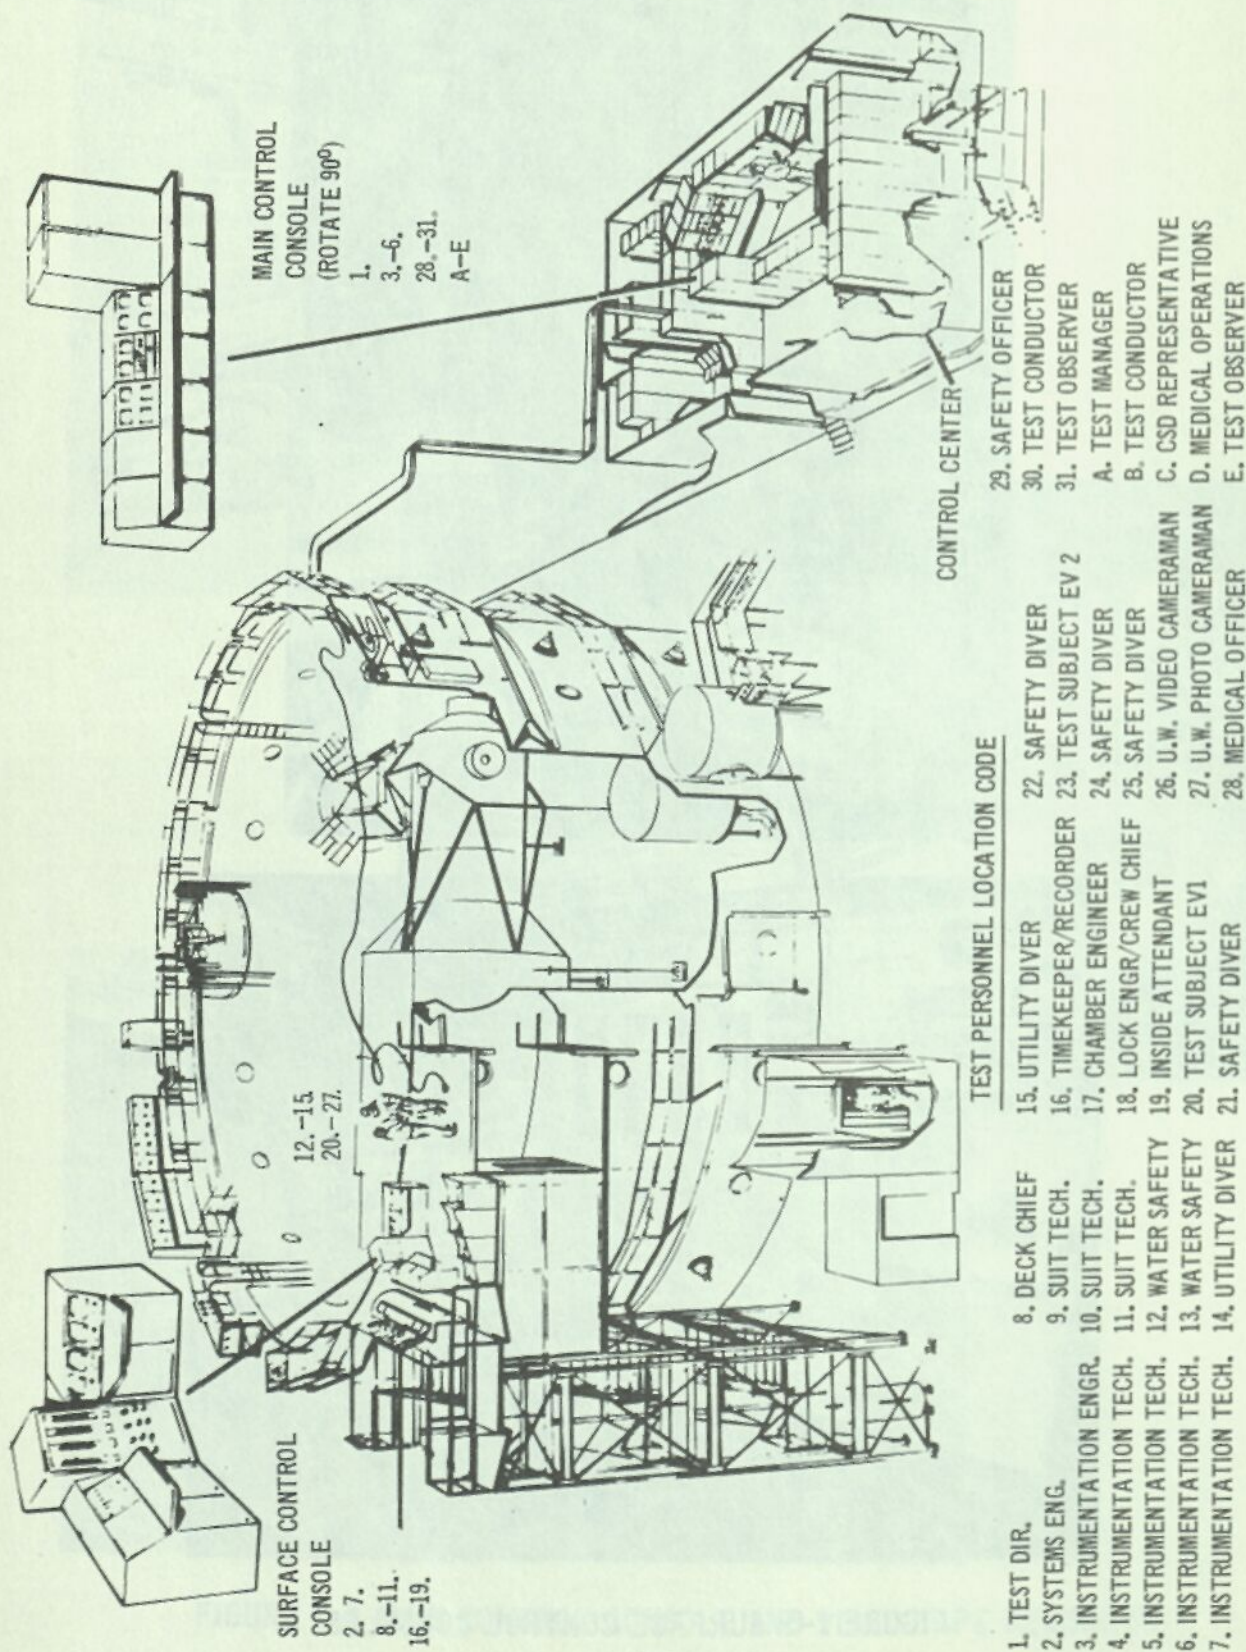
FIGURE 1-4 INSTRUMENTATION AND TEST PERSONNEL LOCATIONS

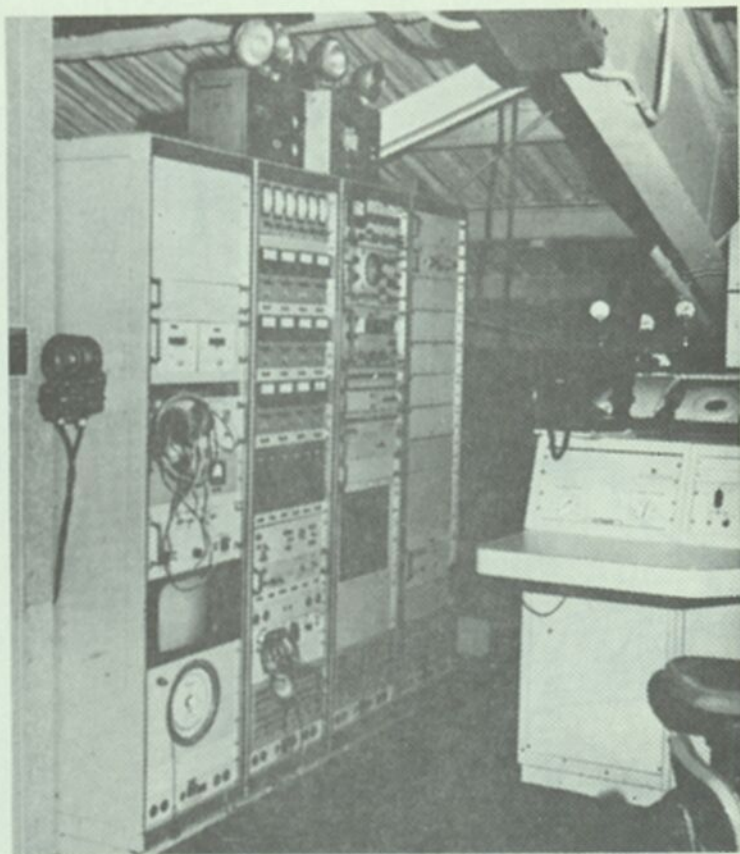
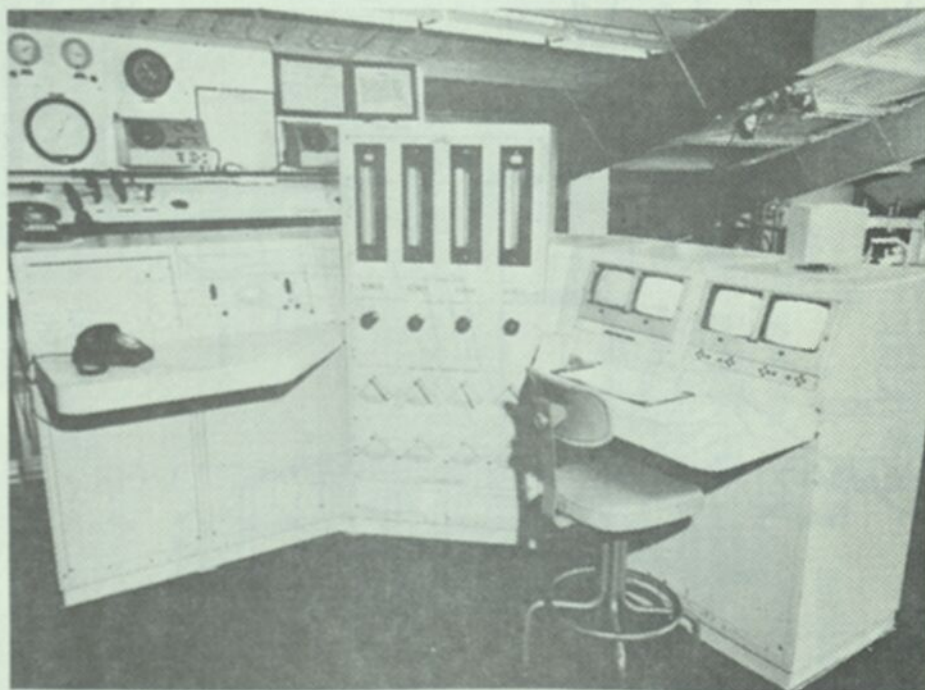
FIGURE 1-5 SURFACE CONTROL CONSOLES

In order to collect and assimilate data from neutral buoyancy evaluations and training exercises, an instrumentation system, coupled with a network of test monitors and controls, is provided in and around the water tank and at the test control trailer adjacent to the tank (Figures 1-4, 1-5, and 1-6). As many as 200 separate data channels can be handled including

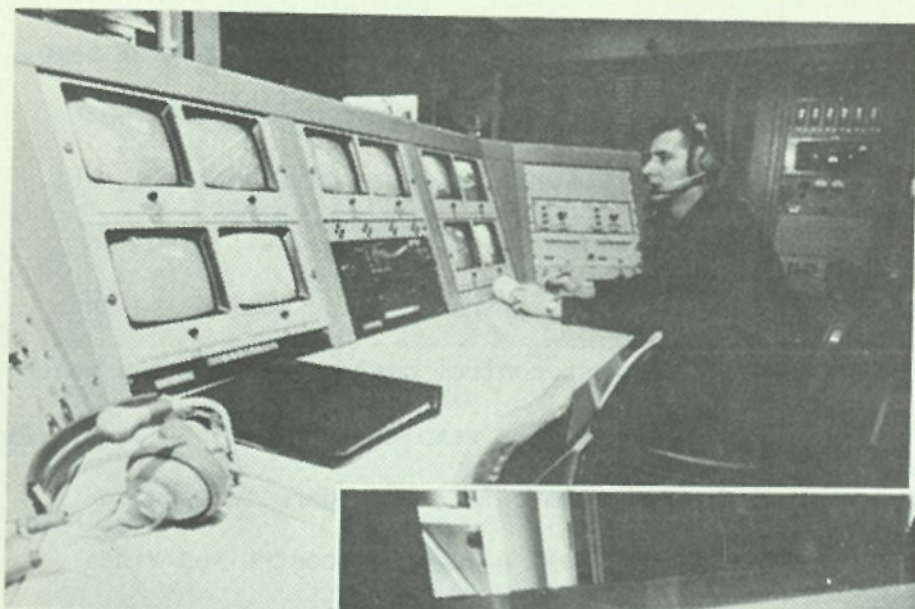
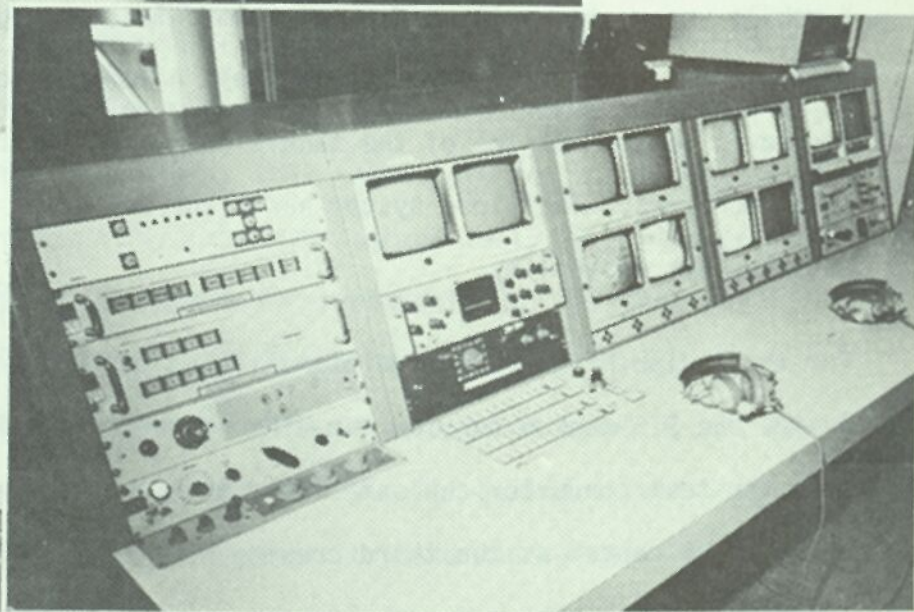
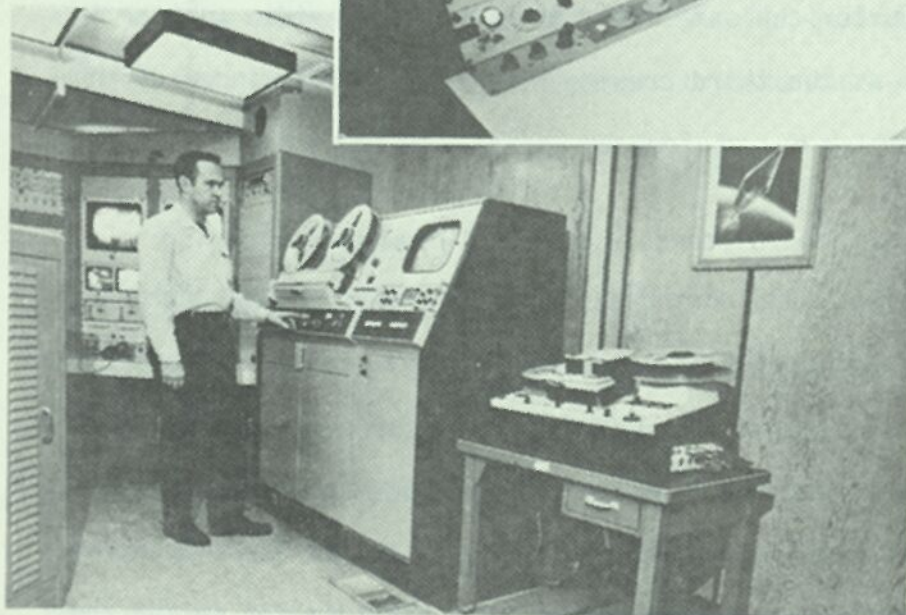
FIGURE 1-6 MAIN CONTROL CONSOLE AND VIDEO TAPE RECORDER

video, audio, EKG, heart rate, LCG flow, LCG inlet temp, LCG outlet temp, air flow to suit, inlet air temp, outlet air temp, respiration rate, differential suit pressure, depth pressure, absolute suit pressure, etc. The signal conditioning equipment, meters, and pressure suit junction panels are located at the tank with the instrumentation monitoring and recording equipment located in the test control center. Inside the water tank during an NBS exercise, there are nine remotely controlled TV cameras, a mobile underwater color video swim cameraman, an underwater photographer, and an underwater speaker system. A remotely controlled video camera is located on top of the tank along with test consoles containing video monitors. The video system has black and white or color recording and playback capability.

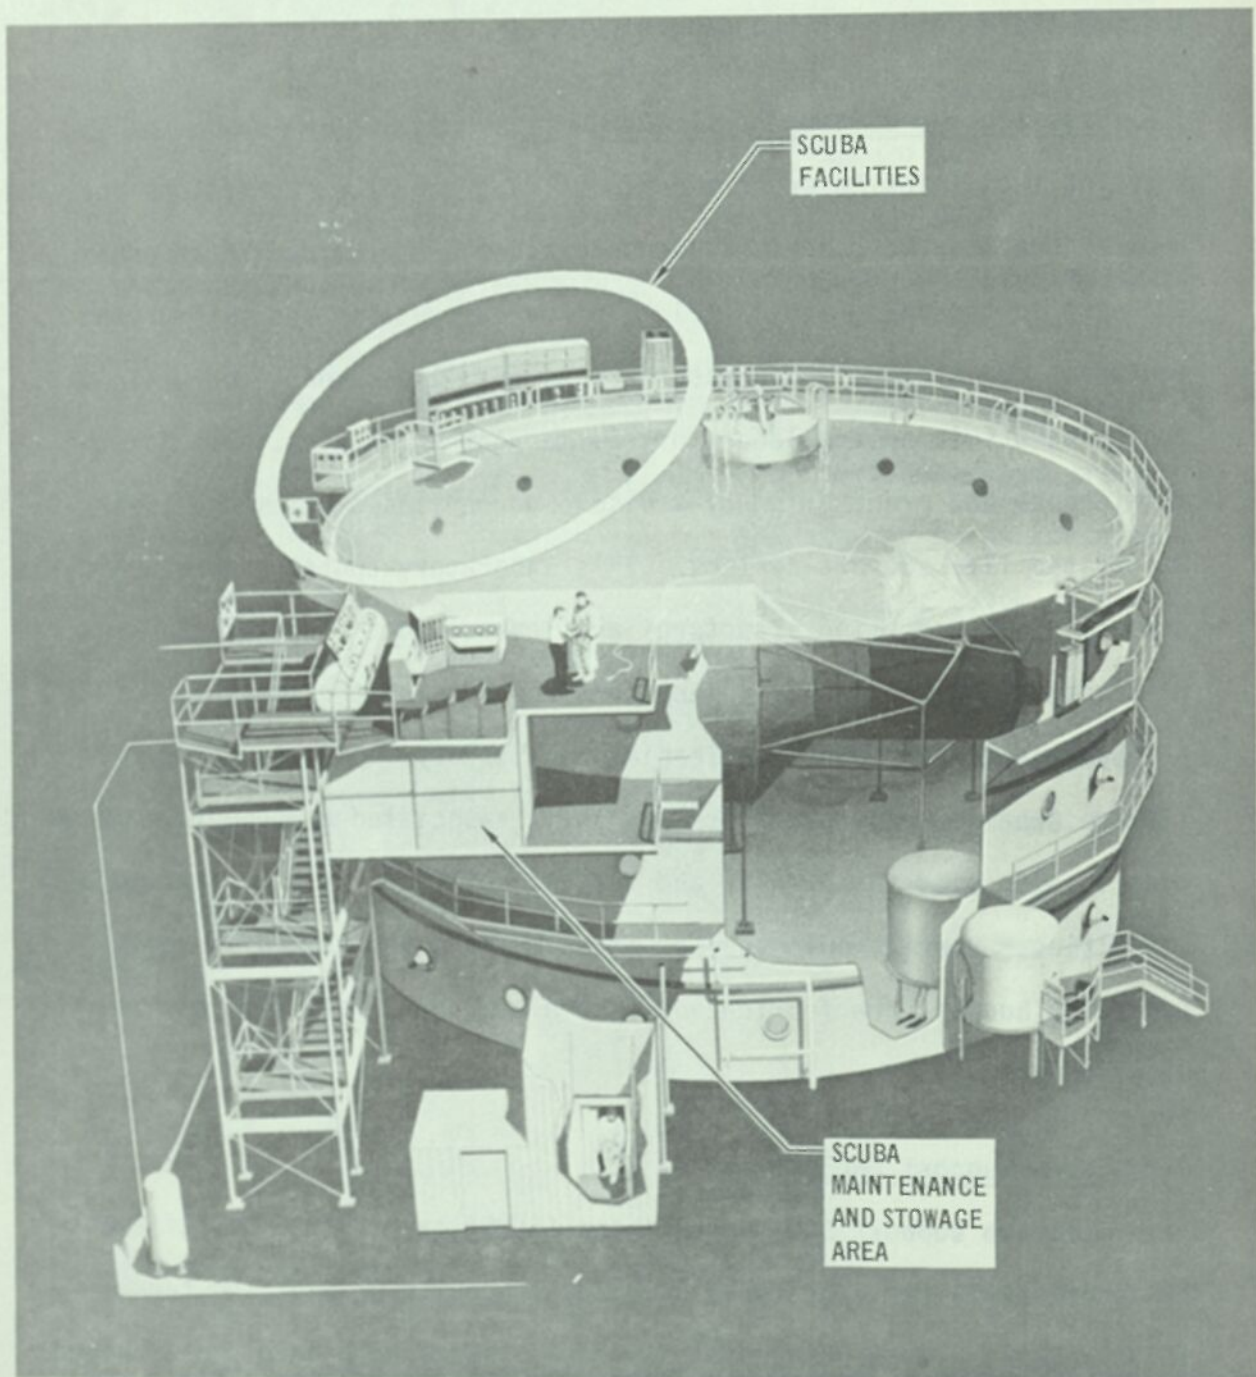
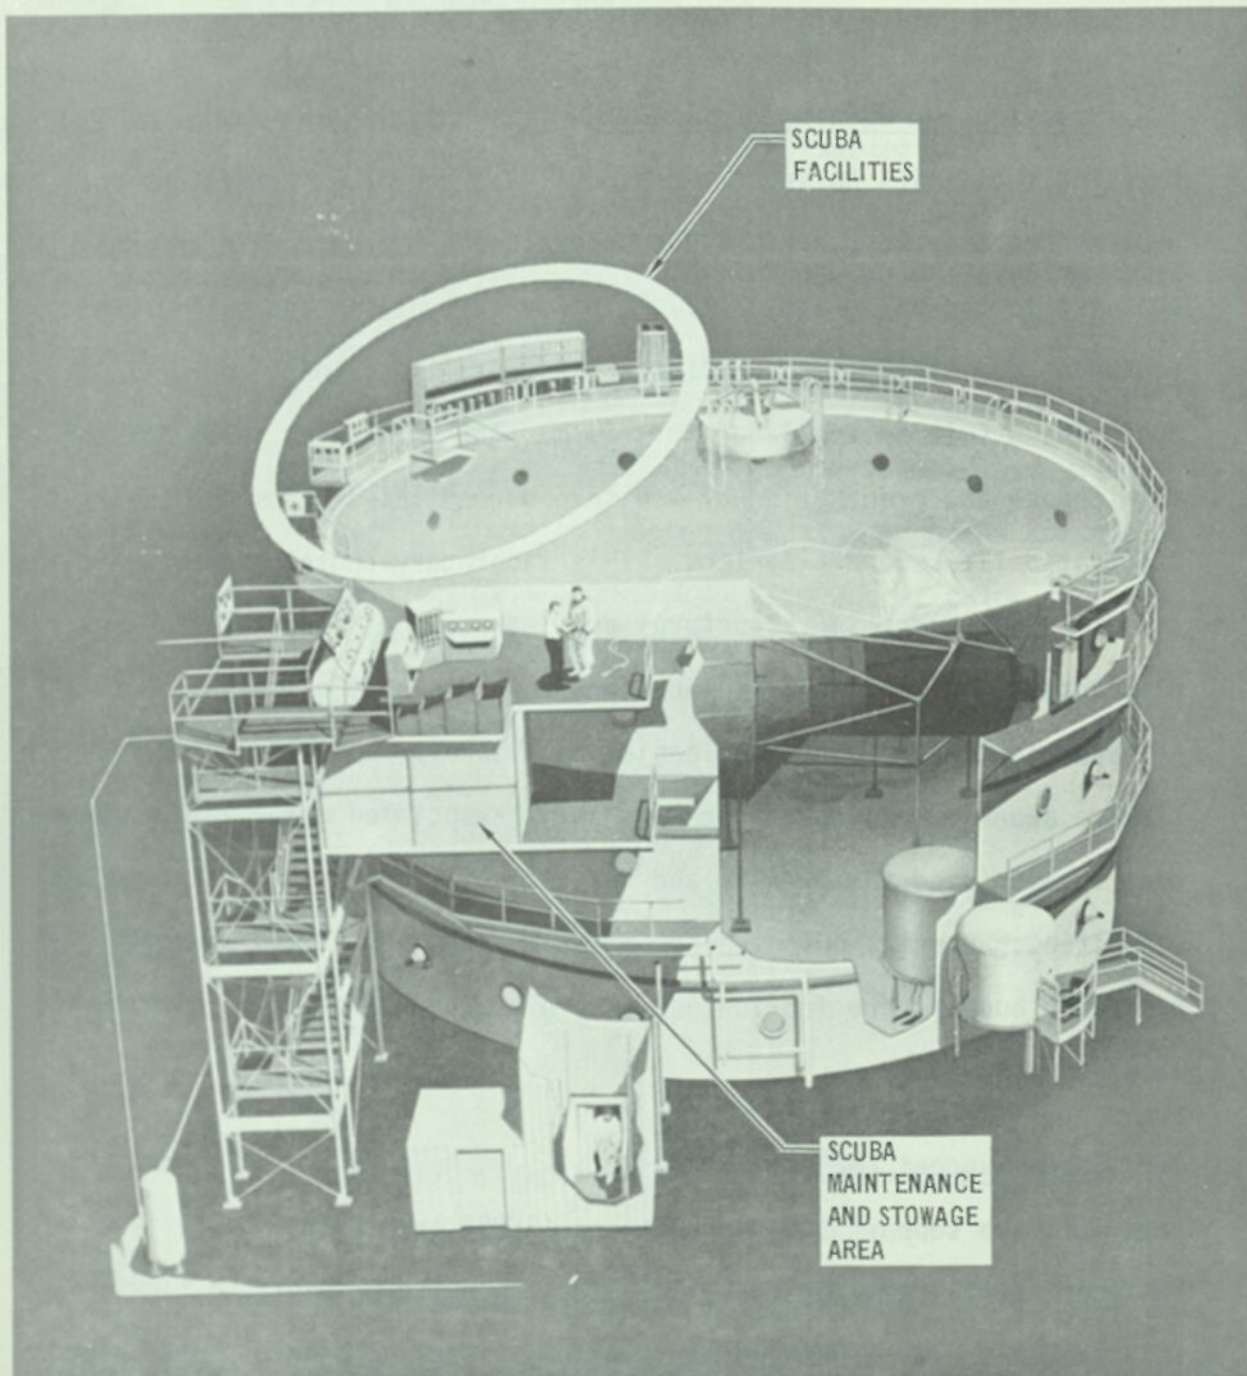
FIGURE 1-7 NBS SCUBA SUPPORT FACILITIES

Facilities to support SCUBA operations (SCUBA tanks, wet suits, fins, cylinder refill station, etc.) are located on top-side of the tank (Figure 1-7). The SCUBA refill station consists of a panel containing supply, delivery, and SCUBA cylinder pressure gauges with delivery and vent valves (Figure 1-8). The high pressure air (2,250 psi max) is

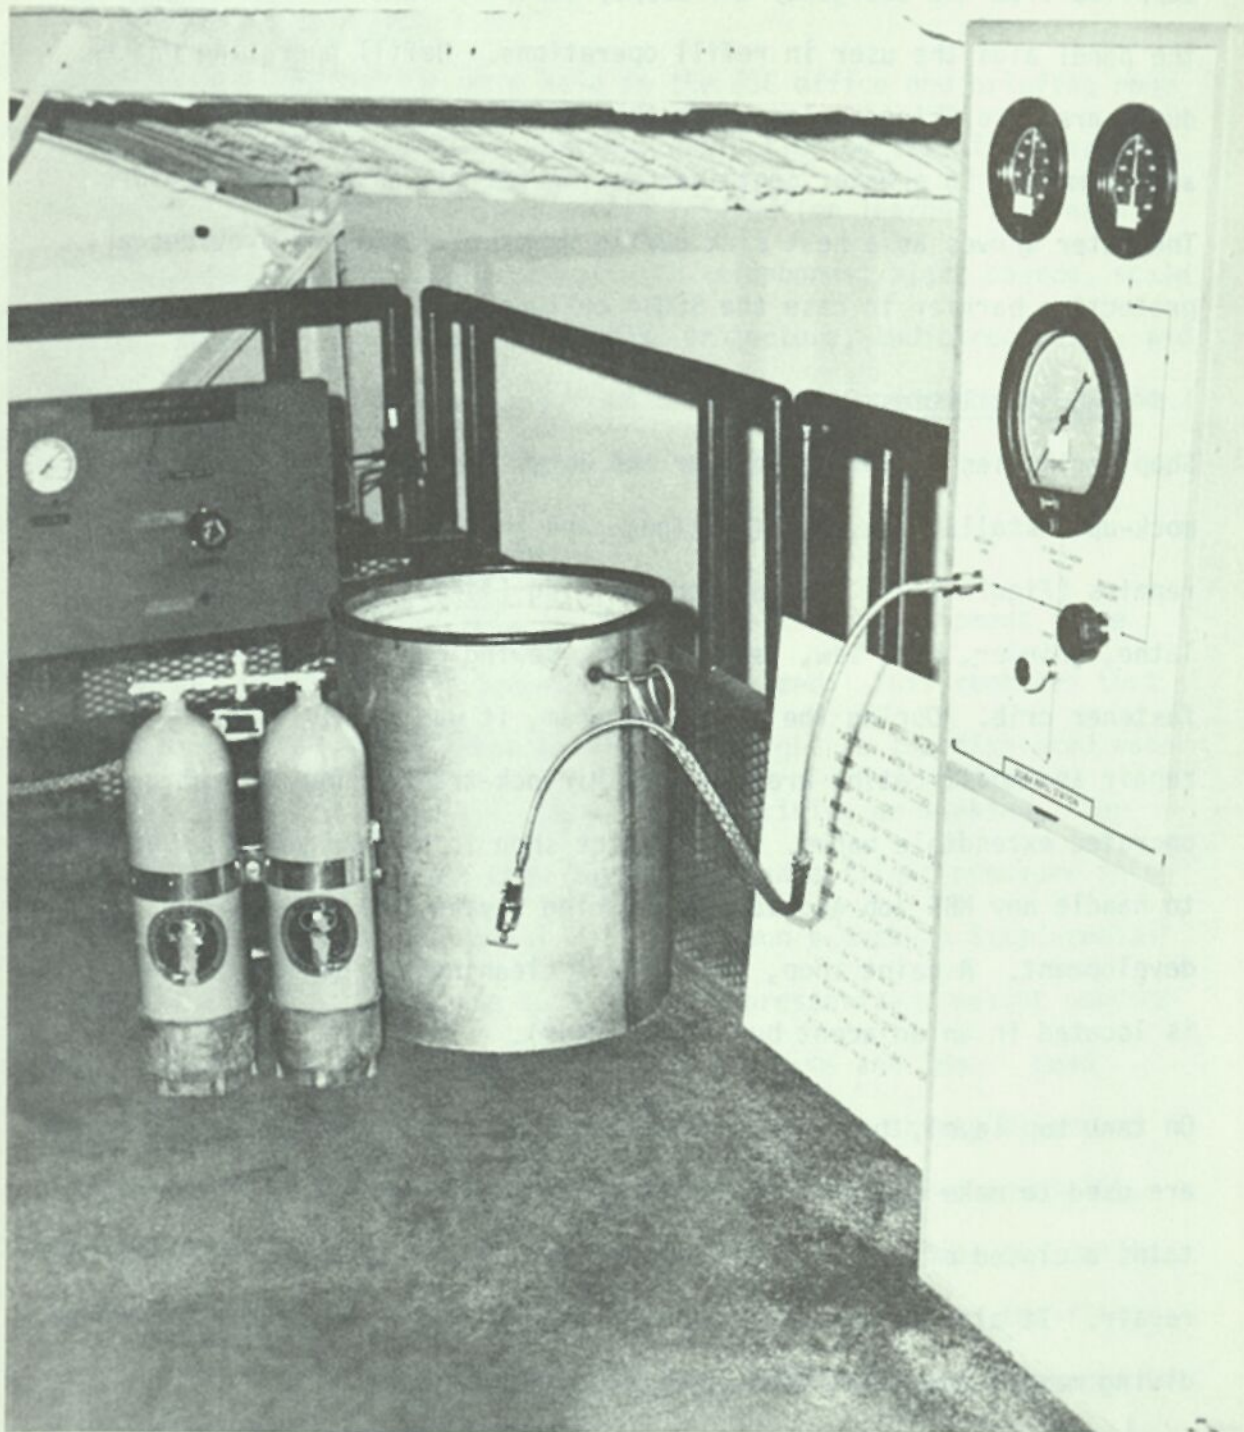
FIGURE 1-8 SCUBA REFILL STATION

supplied from the emergency air supply tube trailer. A flow diagram on the panel aids the user in refill operations. Refill operating procedures are also printed along side the refill panel. The SCUBA cylinders are submerged in a water container during refills as a safety measure. The water serves as a heat sink during pressurization and provides a protective barrier in case the SCUBA cylinder ruptures.

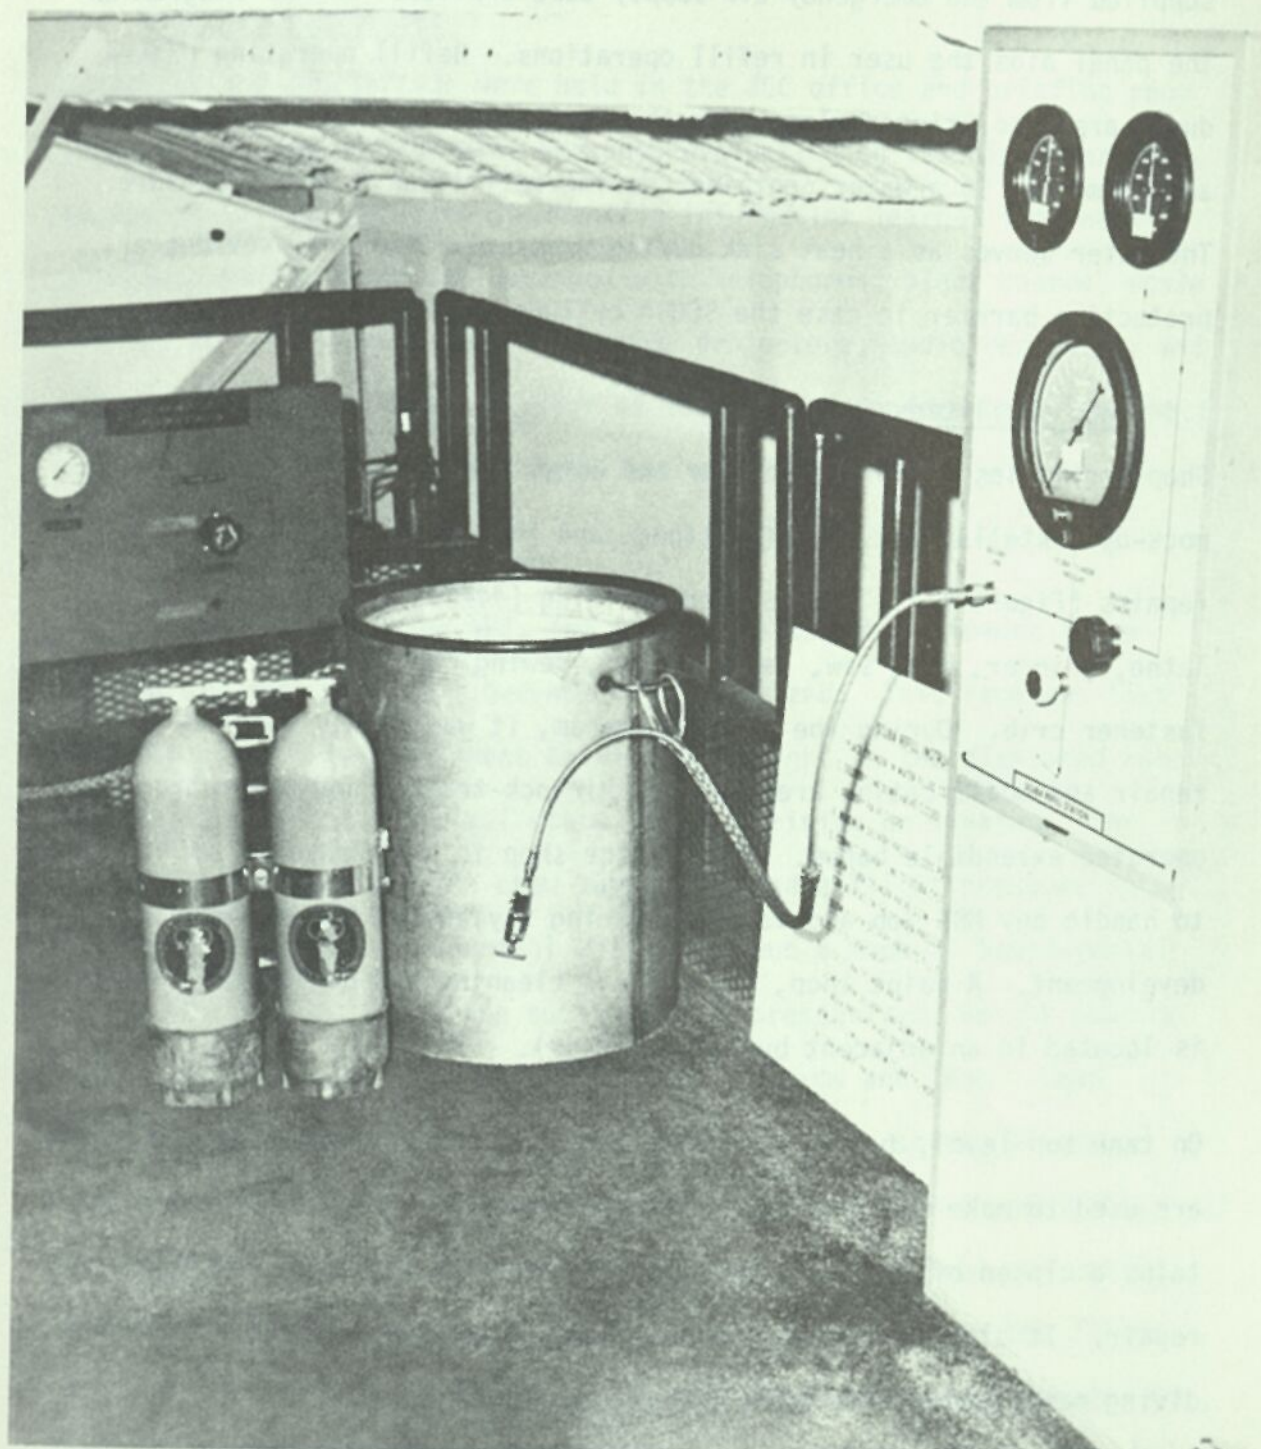
FIGURE 1-8 SCUBA REFILL STATION

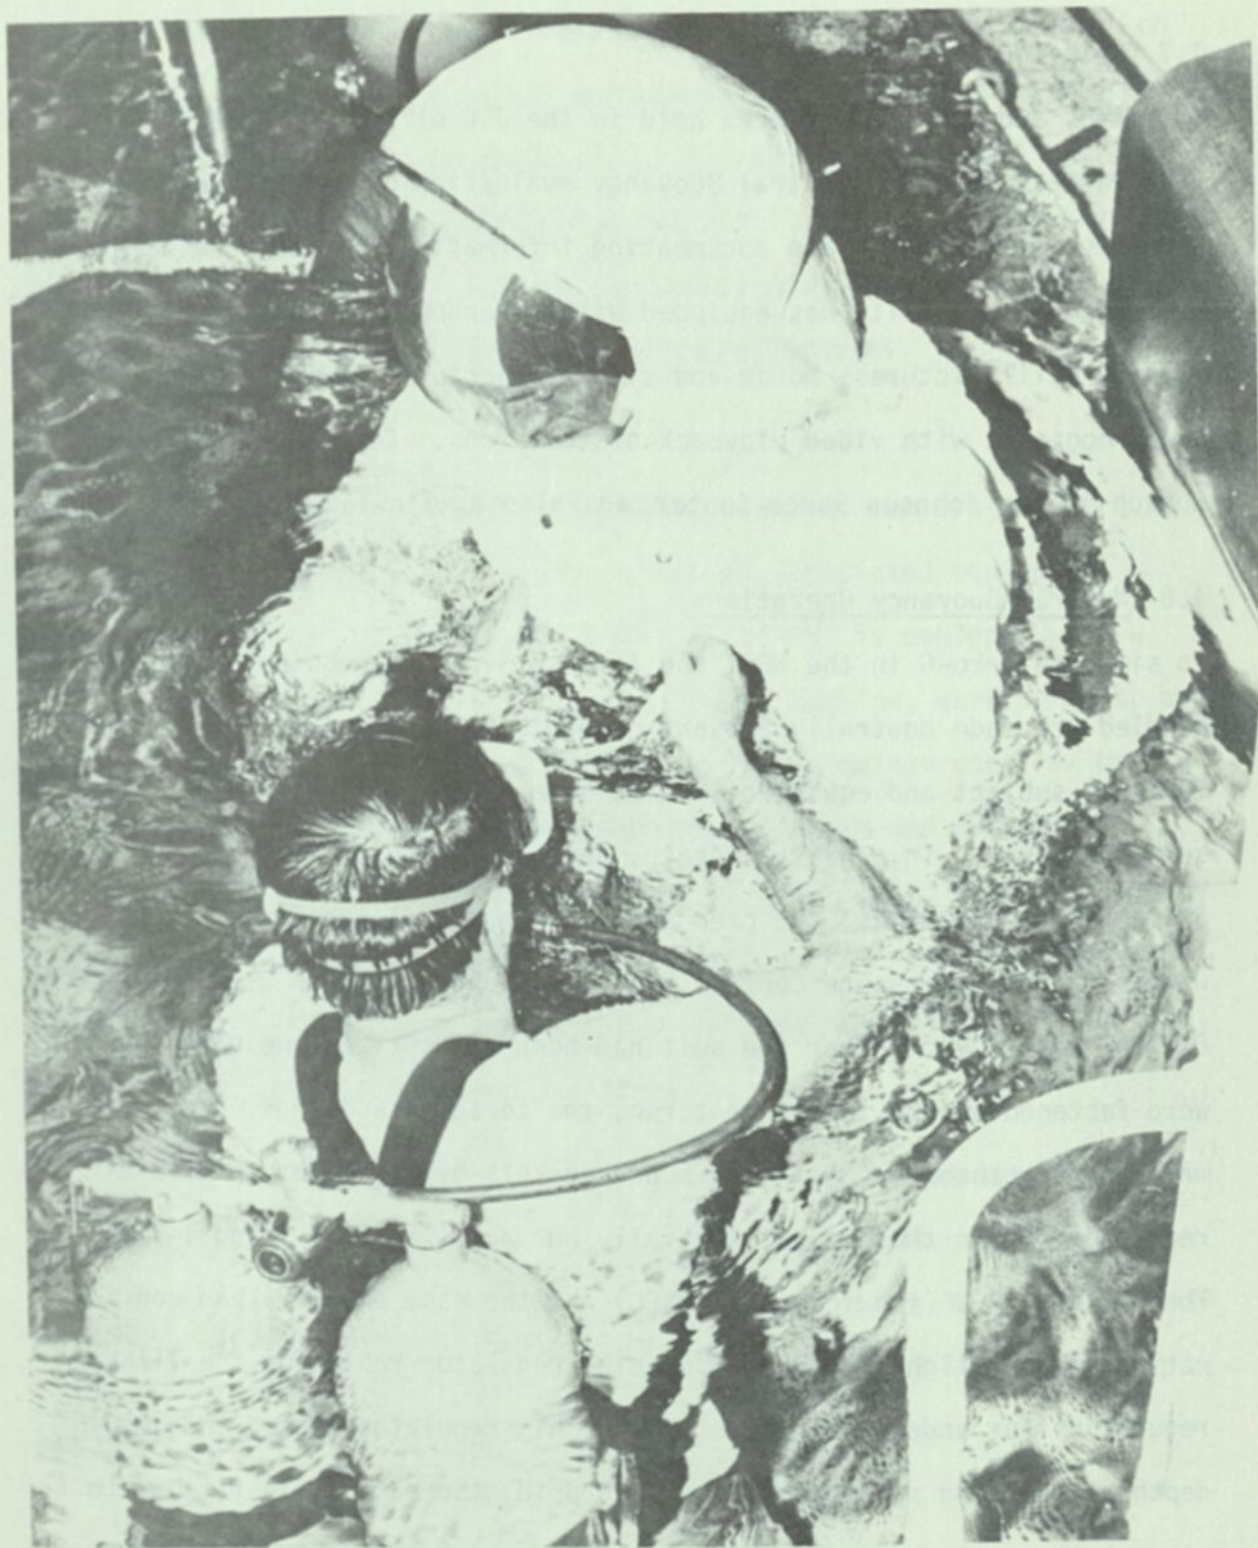
To simulate zero-G in the NBS, the test subjects and equipment to be handled are made neutrally buoyant or neutralized. This requires that the test subject and equipment be the same weight as the displaced water so that they are in a neutral state, neither rising or sinking. For Skylab EVA evaluations, the crew subject donned a flight pressure suit with a training Pressure Control Unit (PCU) and a mock-up Supplemental Oxygen Pack (SOP). After the suit had been pressurized, weight pouches were fastened around the upper torso, the forearms and legs. Lead weights were then placed in the pouch pockets by the safety divers as required to make the subject neutrally buoyant (Figure 1-9 and 1-10). The training PCU (fabricated by MSFC) was the same envelope and configuration as the flight PCU with a special regulator replacing the flight regulators for underwater operations. This regulator sensed changes in depth maintaining suit pressure at 3.6 psid, the same as in flight, to give similar suit mobility. Since the PCU was located at mid-waist,

FIGURE 1-9 SAFETY DIVER ATTACHING WEIGHT POUCHES TO SUITED CREWMAN

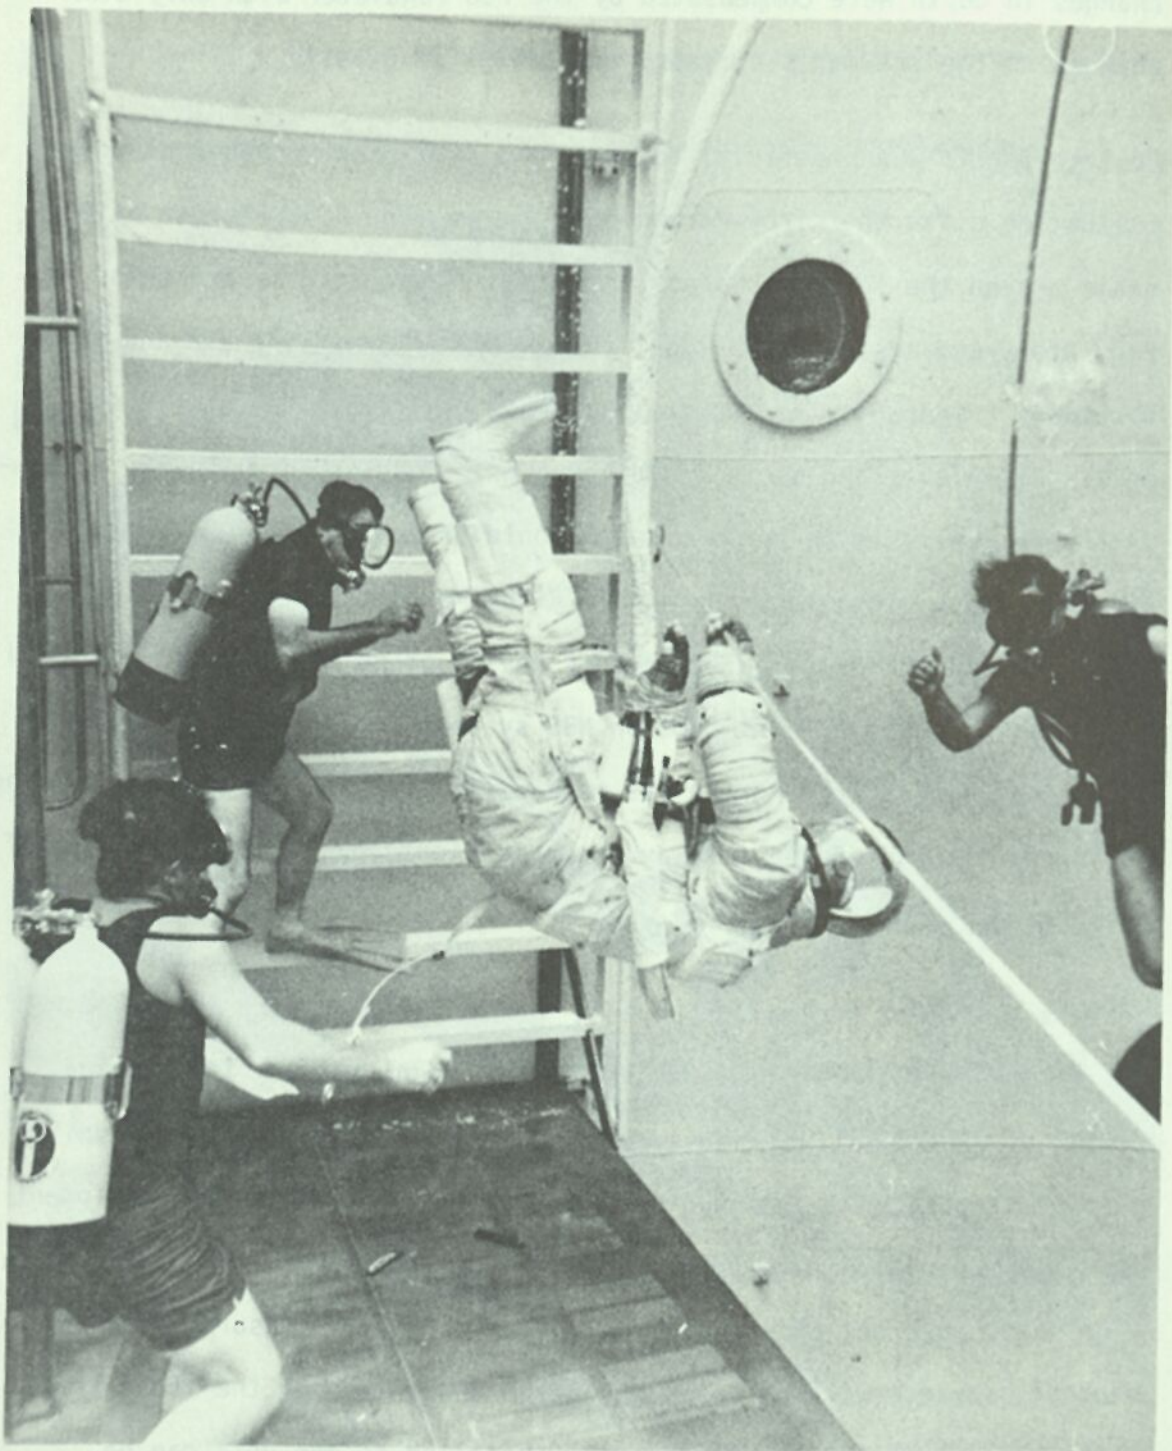
FIGURE 1-10 NEUTRALIZING SUITED CREWMAN USING LEAD WEIGHTS

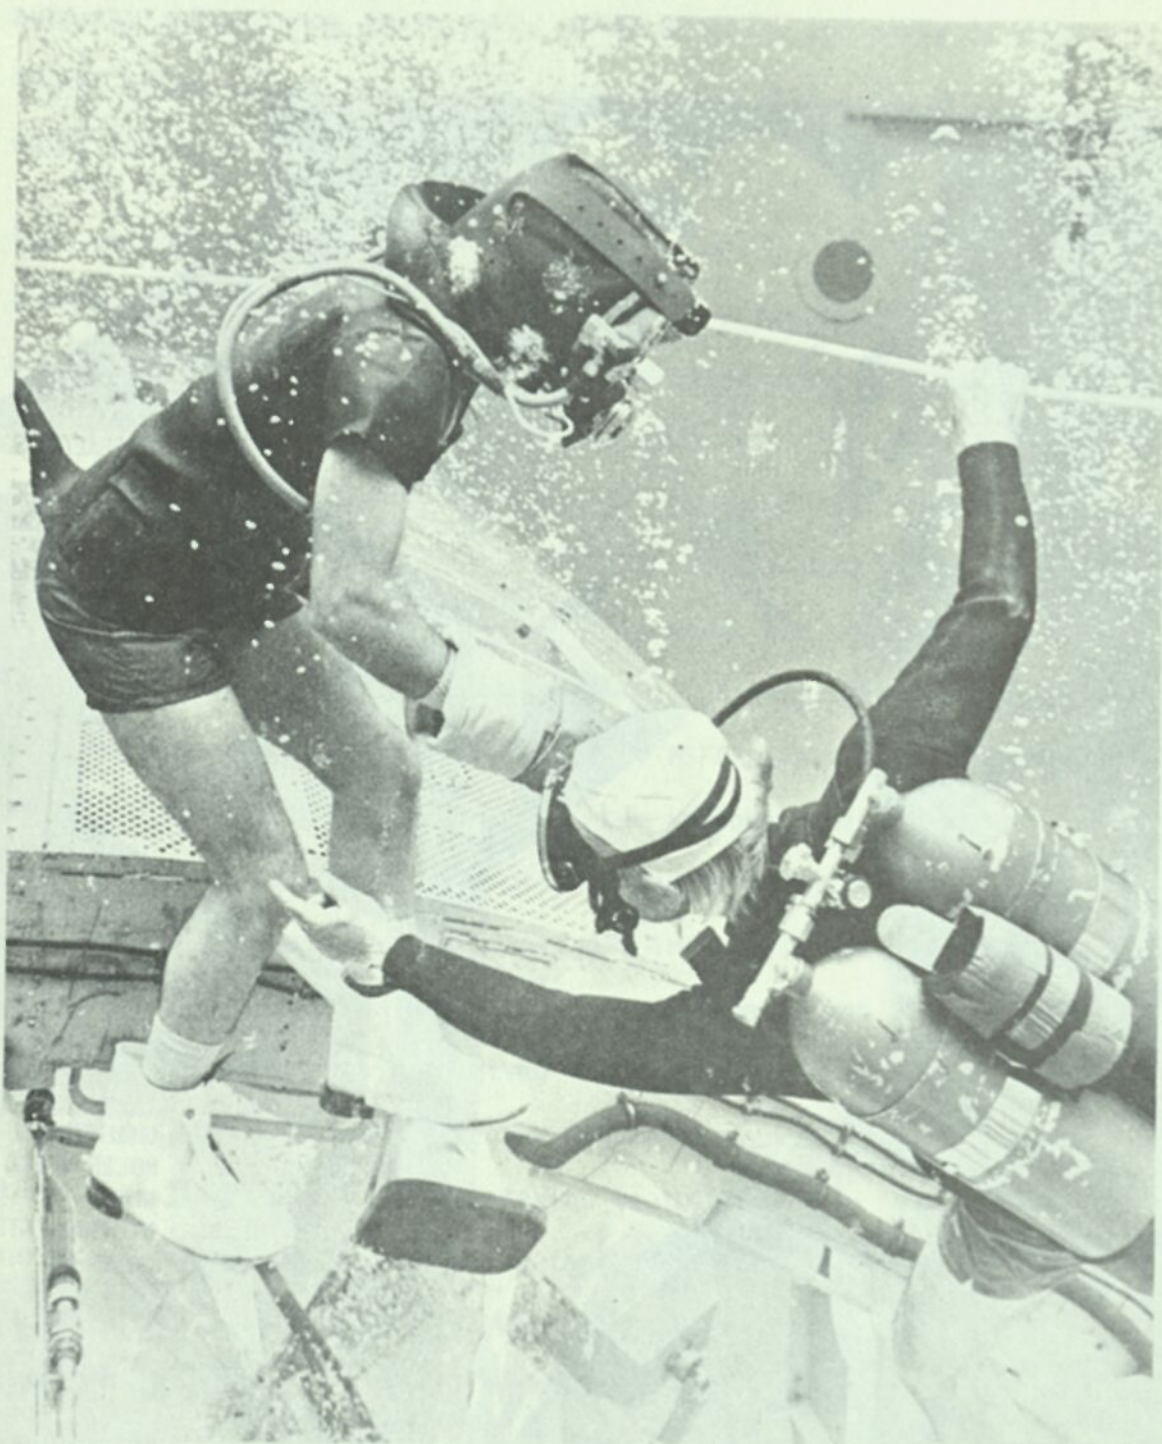
Quite often it was beneficial to perform a preliminary suited exercise evaluation using the Kirby-Morgan head piece. The Kirby-Morgan helmet seals around the face and is equipped with viewing glass, breathing regulator, and a single umbilical that provides breathing air and communications (Figure 1-11). Neutral buoyancy is achieved by a weighted belt. EVA gloves and boots could be worn to make the preliminary evaluation more realistic in terms of what could or could not be accomplished in an EVA task situation. Using the Kirby-Morgan helmet provided the capability to perform a quick cursory review of hardware orientation and EVA tasks with a minimum impact on NBS systems and personnel. In addition, use of the Kirby-Morgan was more effective than use of SCUBA diving equipment because of the two-way communication capability and absence of bulky air cylinders.

FIGURE 1-11 PRELIMINARY EVALUATION EXERCISE USING KIRBY-MORGAN HELMET
