NASA TECHNICAL
MEMORANDUM

NASA TM X-64844

MSFC SKYLAB NEUTRAL BUOYANCY SIMULATOR

14. SPONSORING AGENCY CODE	
15. SUPPLEMENTARY NOTES			
16. ABSTRACT Presented in this report is the role of the Neutral Buoyancy Simulator in the development, crew training, and flight operational aspects of Skylab.

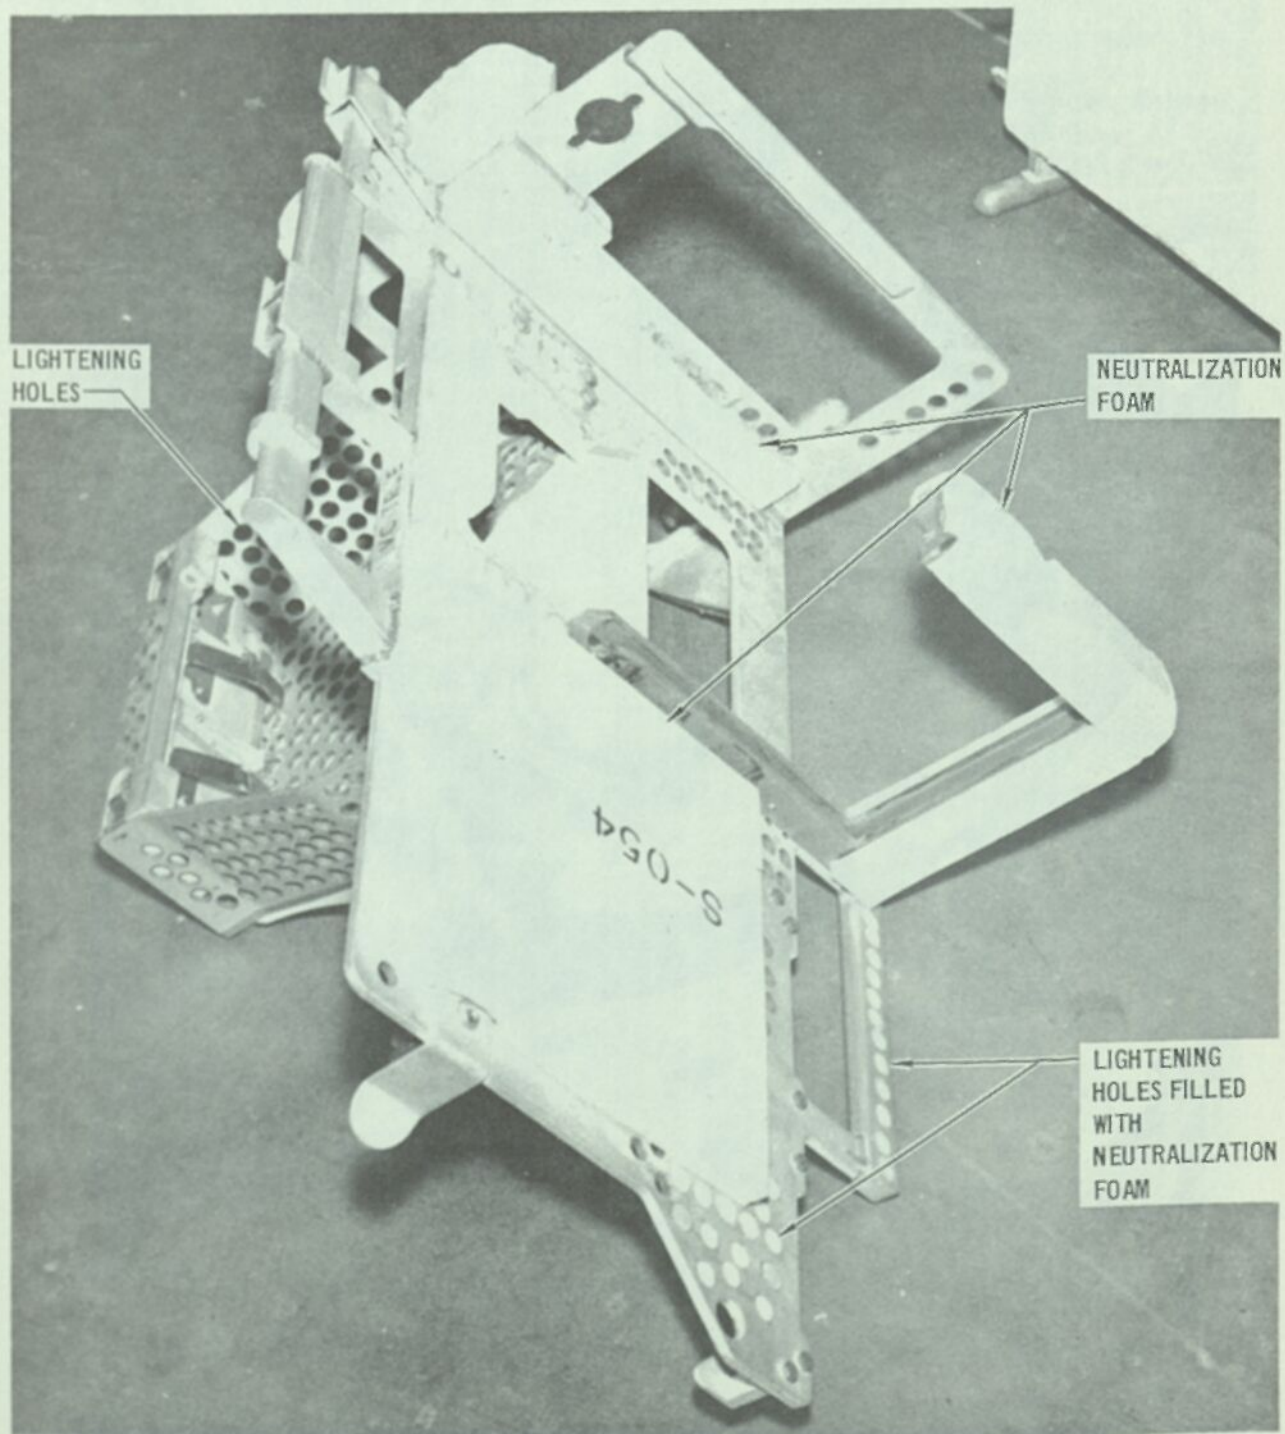
FIGURE 1-12 NEUTRALIZED VC ATM FILM TREE

To make equipment neutrally buoyant, flotation units are installed inside the hardware and located so the equipment retains its original center of gravity (CG) (Figure 1-12). Additionally, flotation units must be strategically located so they will not interfere with equipment mechanism operation or disturb the equipment envelope. Also, the flotation units must not change due to changes in water pressure, or the neutral buoyancy will be lost. Location and volume of the flotation units are calculated and temporarily installed so the unit can be "trimmed out" underwater by SCUBA divers. CPR-200-8 styrofoam with

6-8 lb/cu ft density was found to be the best material for flotation units. It was easily shaped to obtain the desired volume for neutral buoyancy and was easy to install. After shaping, and prior to final installation, it was coated with epoxy resin (Crest 3135) to prevent water absorption.

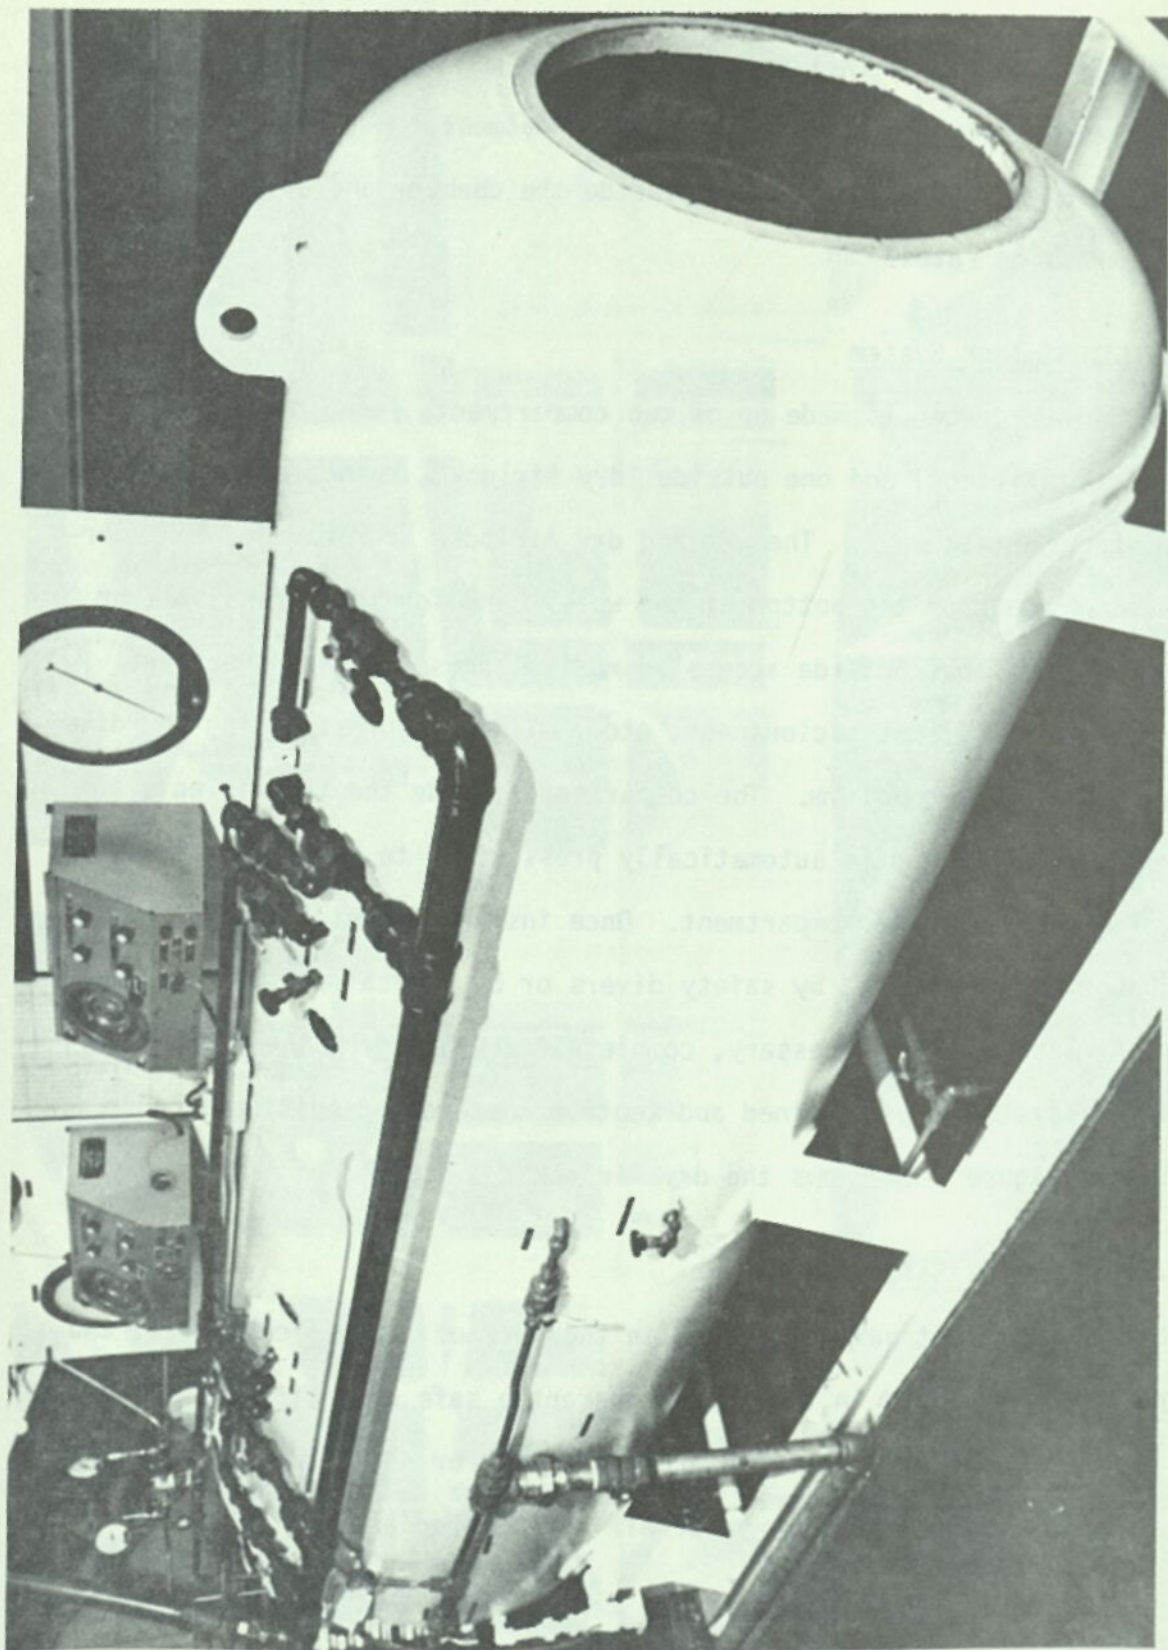
FIGURE 1-13 RECOMPRESSION CHAMBER

A recompression chamber (Figure 1-13), used for treatment of air embolism or the bends, is located on the operations deck. These two serious illnesses associated with diving can only be treated by quick recompression and controlled decompression. The recompression chamber consists of two compartments referred to as a chamber and a lock. The lock provides the capability of moving personnel and/or supplies from outside ambient pressure to depth pressure in the chamber without depressurizing while the patient is undergoing treatment. Both compartments have viewing portholes for observation by the chamber crew. The chamber is manned for all neutral buoyant tests by a chamber engineer, lock operator, inside attendant, and timekeeper-recording engineer. They are trained and certified under the Air Force training program conducted at JSC. The timekeeper-recorder is in charge of the overall recompression chamber operation. He provides the chamber dive profile to the chamber engineer and keeps track of all chamber times. The chamber engineer is the operator of the recompression chamber, controlling the chamber pressurization as directed by the timekeeper-recorder and maintaining communication with inside crew members. The lock operator is responsible for operating the lock section of the recompression chamber. He also notifies the NASA medical center of the accident via the "hot line". As a matter of precaution, the lock is pressurized down to a level slightly less than the chamber so the lock can be used immediately if trouble should develop

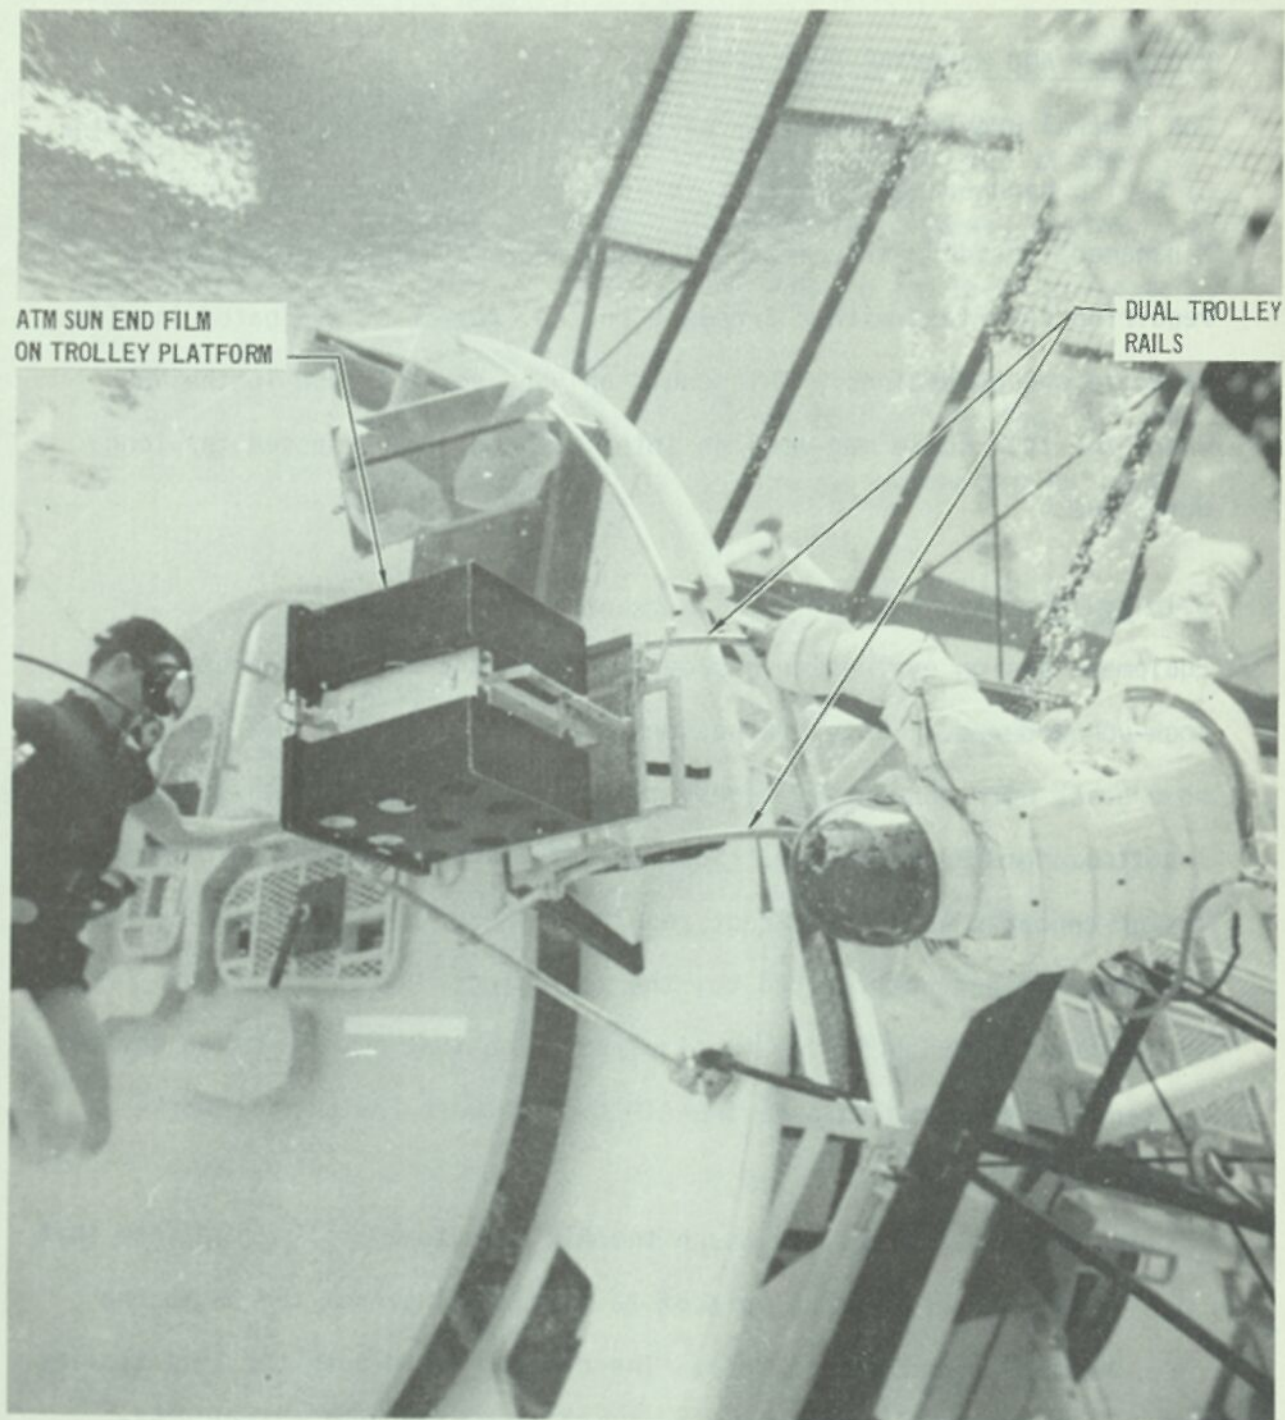
FIGURE 2-1 TRANSLATION OF ATM FILM TO SUN END WORKSTATION
USING PRELIMINARY "TROLLEY" CONCEPT

- o Early Skylab NBS evaluations revealed that a translation device was required to move the ATM film between FAS and ATM work-stations.
- o One concept was to attach the ATM film to a trolley platform that was connected to a pair of rails extending from the DA to the ATM Sun End(Figure 2-1). The crewman would push the film trolley in front of him as he translated along the dual rails. This concept was tried and proved more complex than methods later developed.

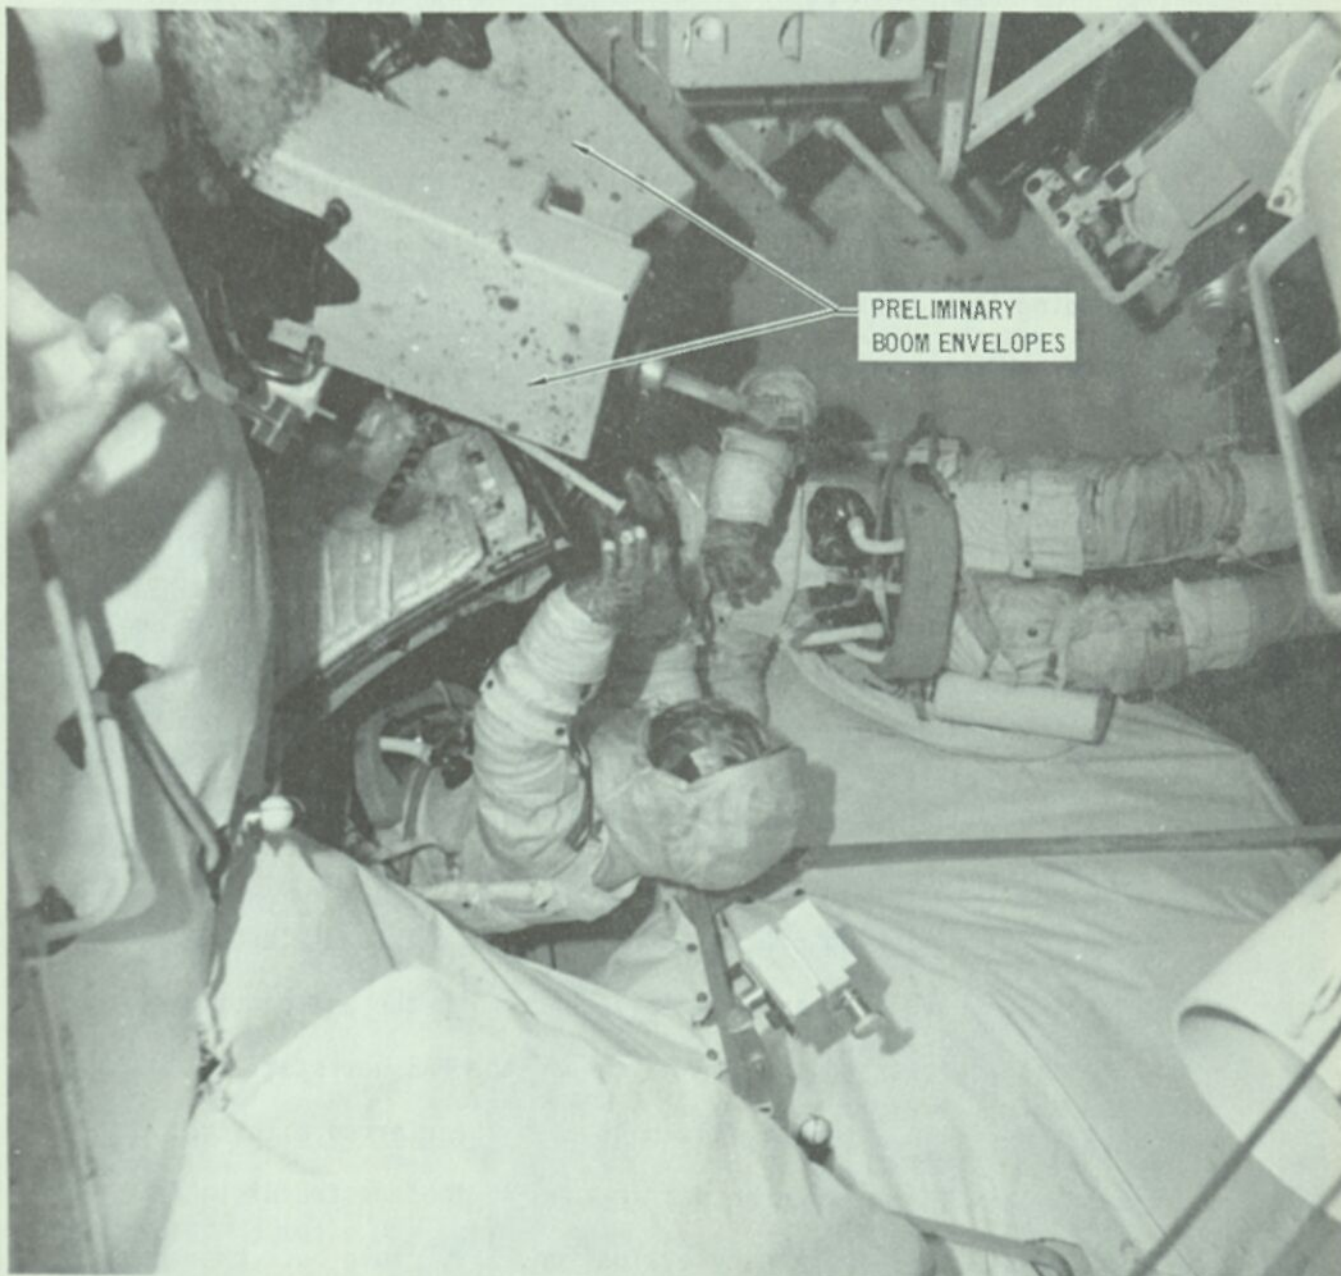
- o Preliminary mock-up of the Fairchild Hiller extendible boom envelope showed excessive interference with the astronaut when translating between the EVA hatch and the FAS workstation (Figure 2-2). The boom film hook also interfered with the astronaut's helmet when he was in the FAS foot restraints. As a result of this preliminary evaluation, a 90° fold back boom hook was designed and the boom housing was shortened approximately .14m (5 inches) and tapered to a smaller profile.

FIGURE 2-2 EVA 1 AT FAS WORK STATION (VF)
EVA 2 EGRESSING FROM EVA HATCH

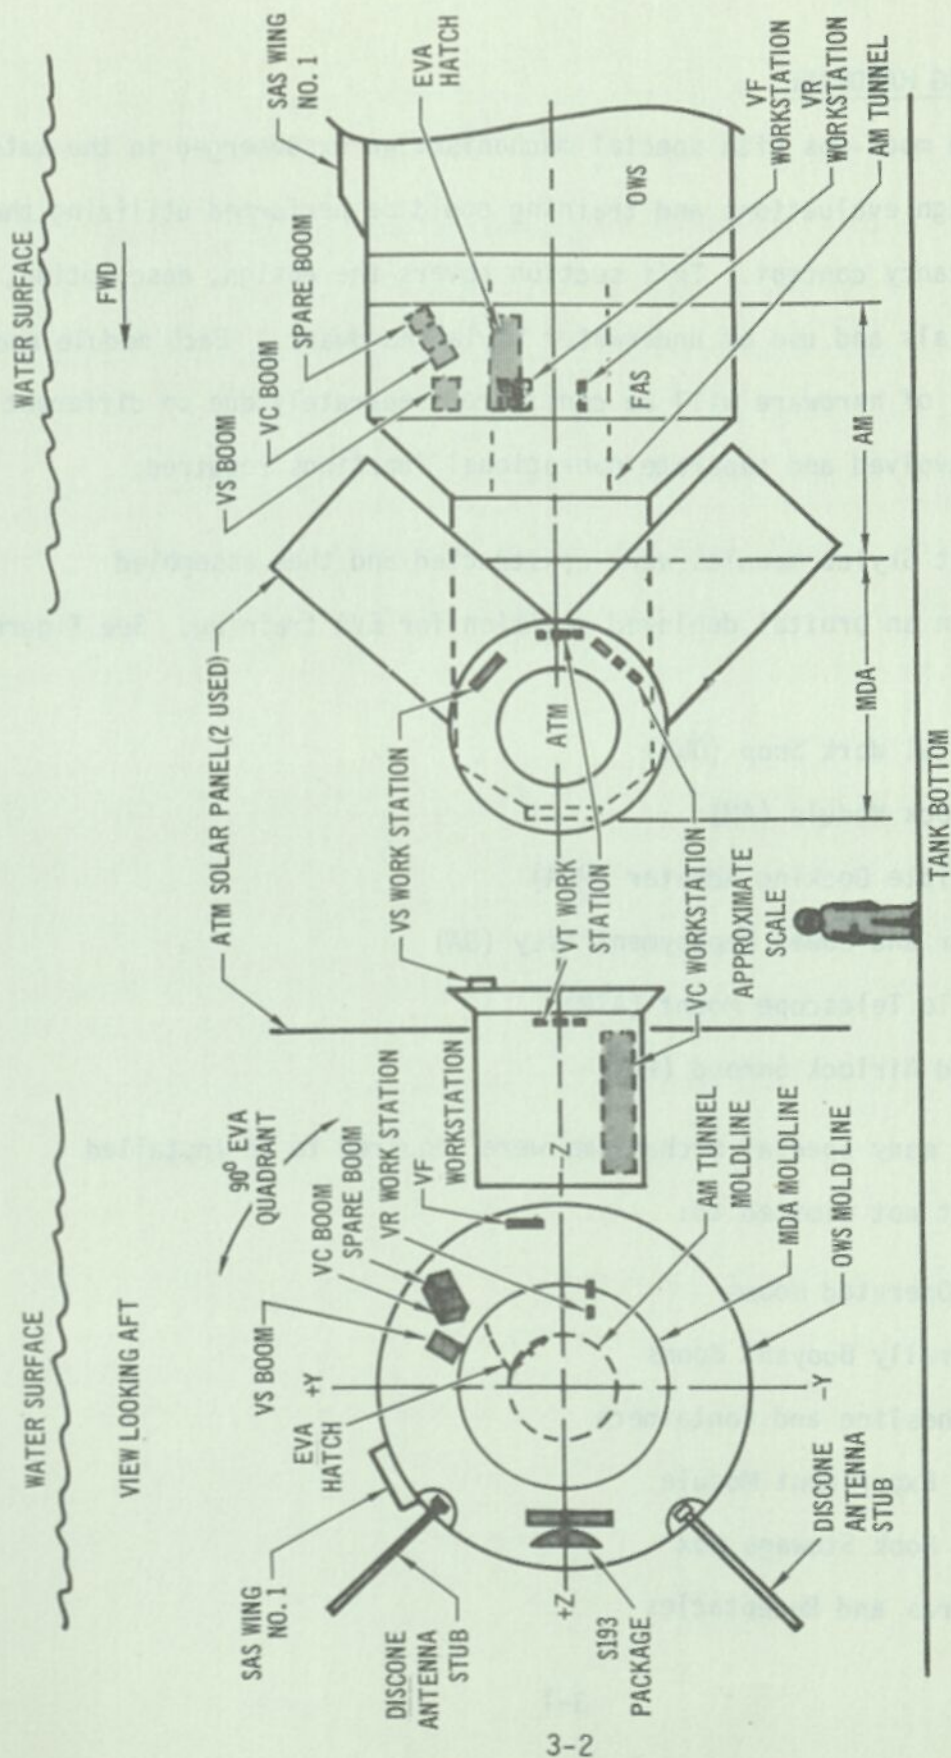
FIGURE 3-1 SKYLAB NEUTRAL BUOYANCY TRAINER ELEMENTS

Six different Skylab modules were constructed and then assembled underwater in an orbital deployed position for EVA training. See Figure 3-1.

NOTE: UPPER AND LOWER DEPLOYMENT ASSEMBLY NOT SHOWN

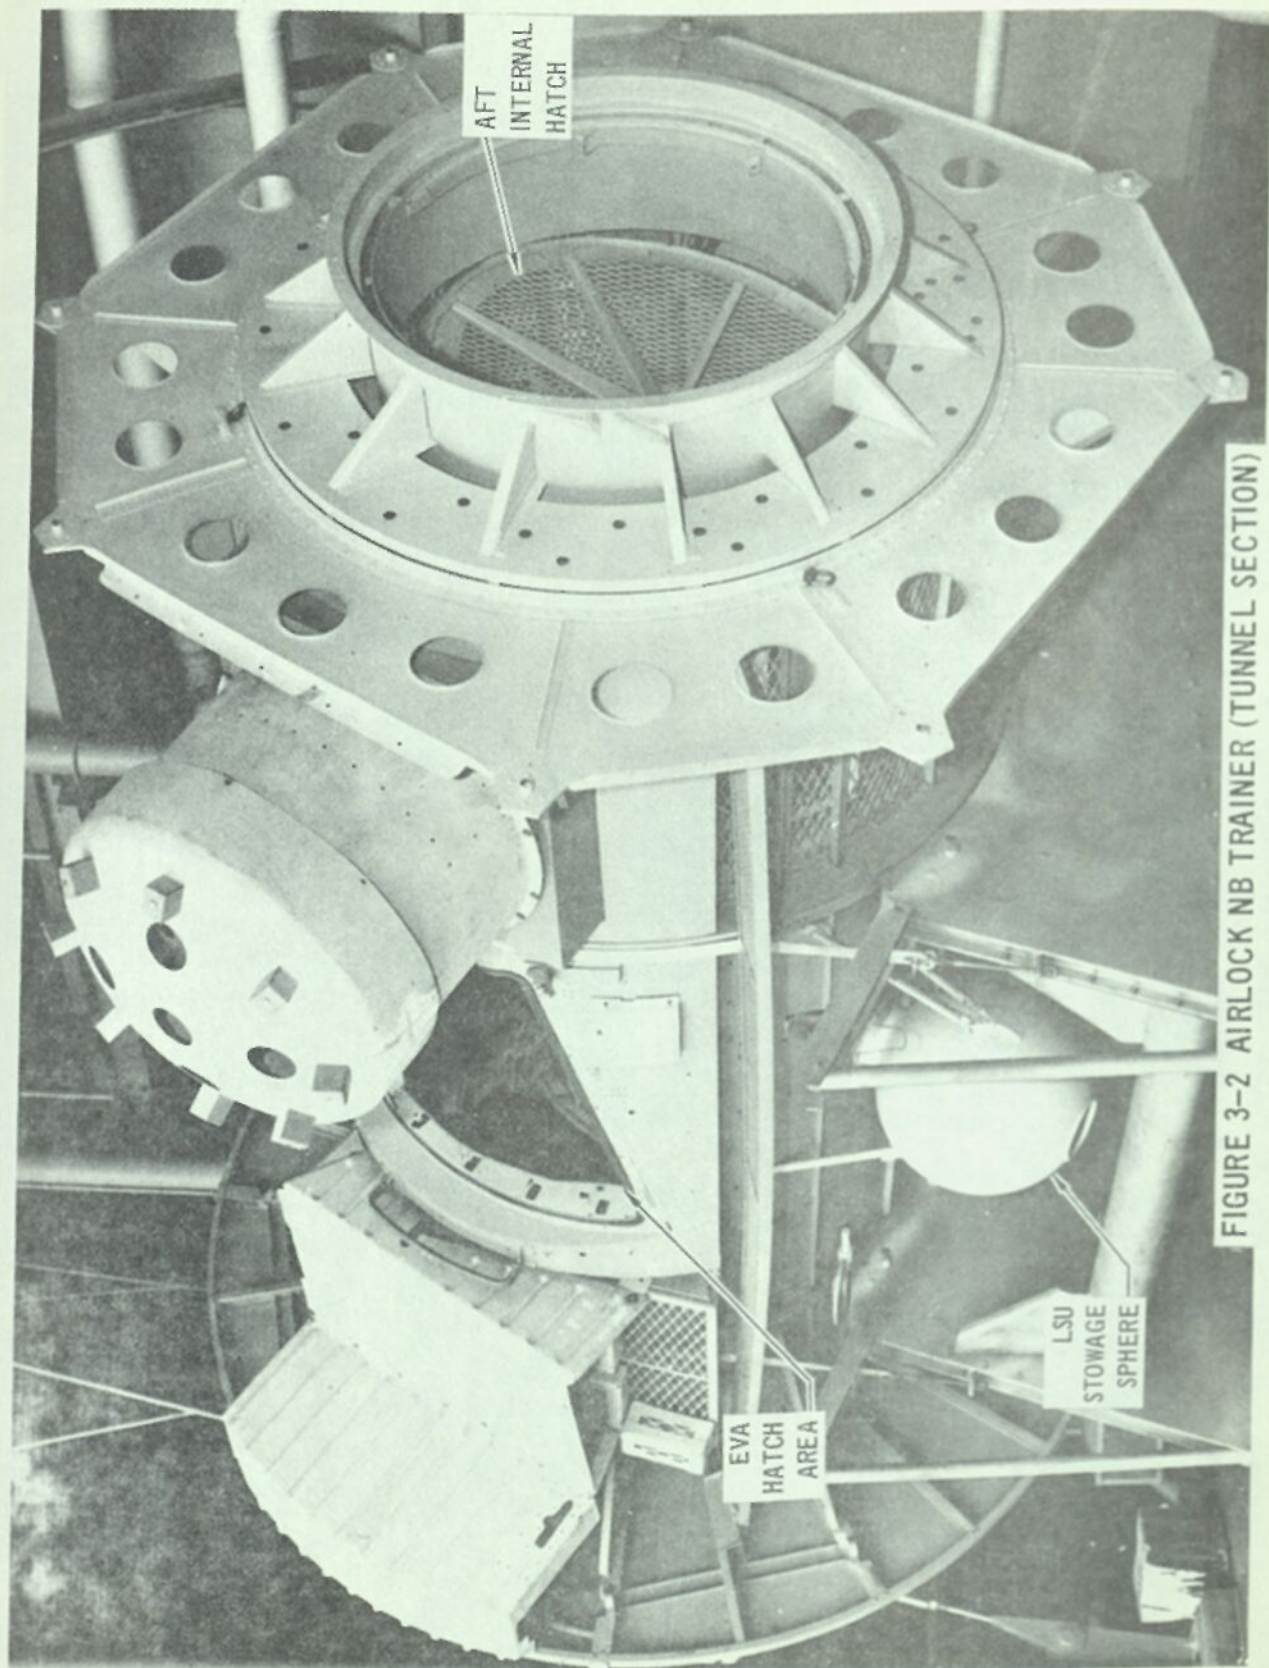
AFT
INTERNAL
HATCH

EVA
HATCH
AREA

FIGURE 3-2 AIRLOCK NB TRAINER (TUNNEL SECTION)

rings and channels, riveted to the skins. Original skins were expanded metal 3003-H14 aluminum .003m (.12 in.) thick; these were later replaced with solid 2024-T3 aluminum rolled sheets. Truss structure was .1m (4.0 in.) square 6061-T6 tubing with smaller diameter structural 6061-T6 aluminum tubing welded. See Figures (3-2, 3-3, 3-4, and 3-5).

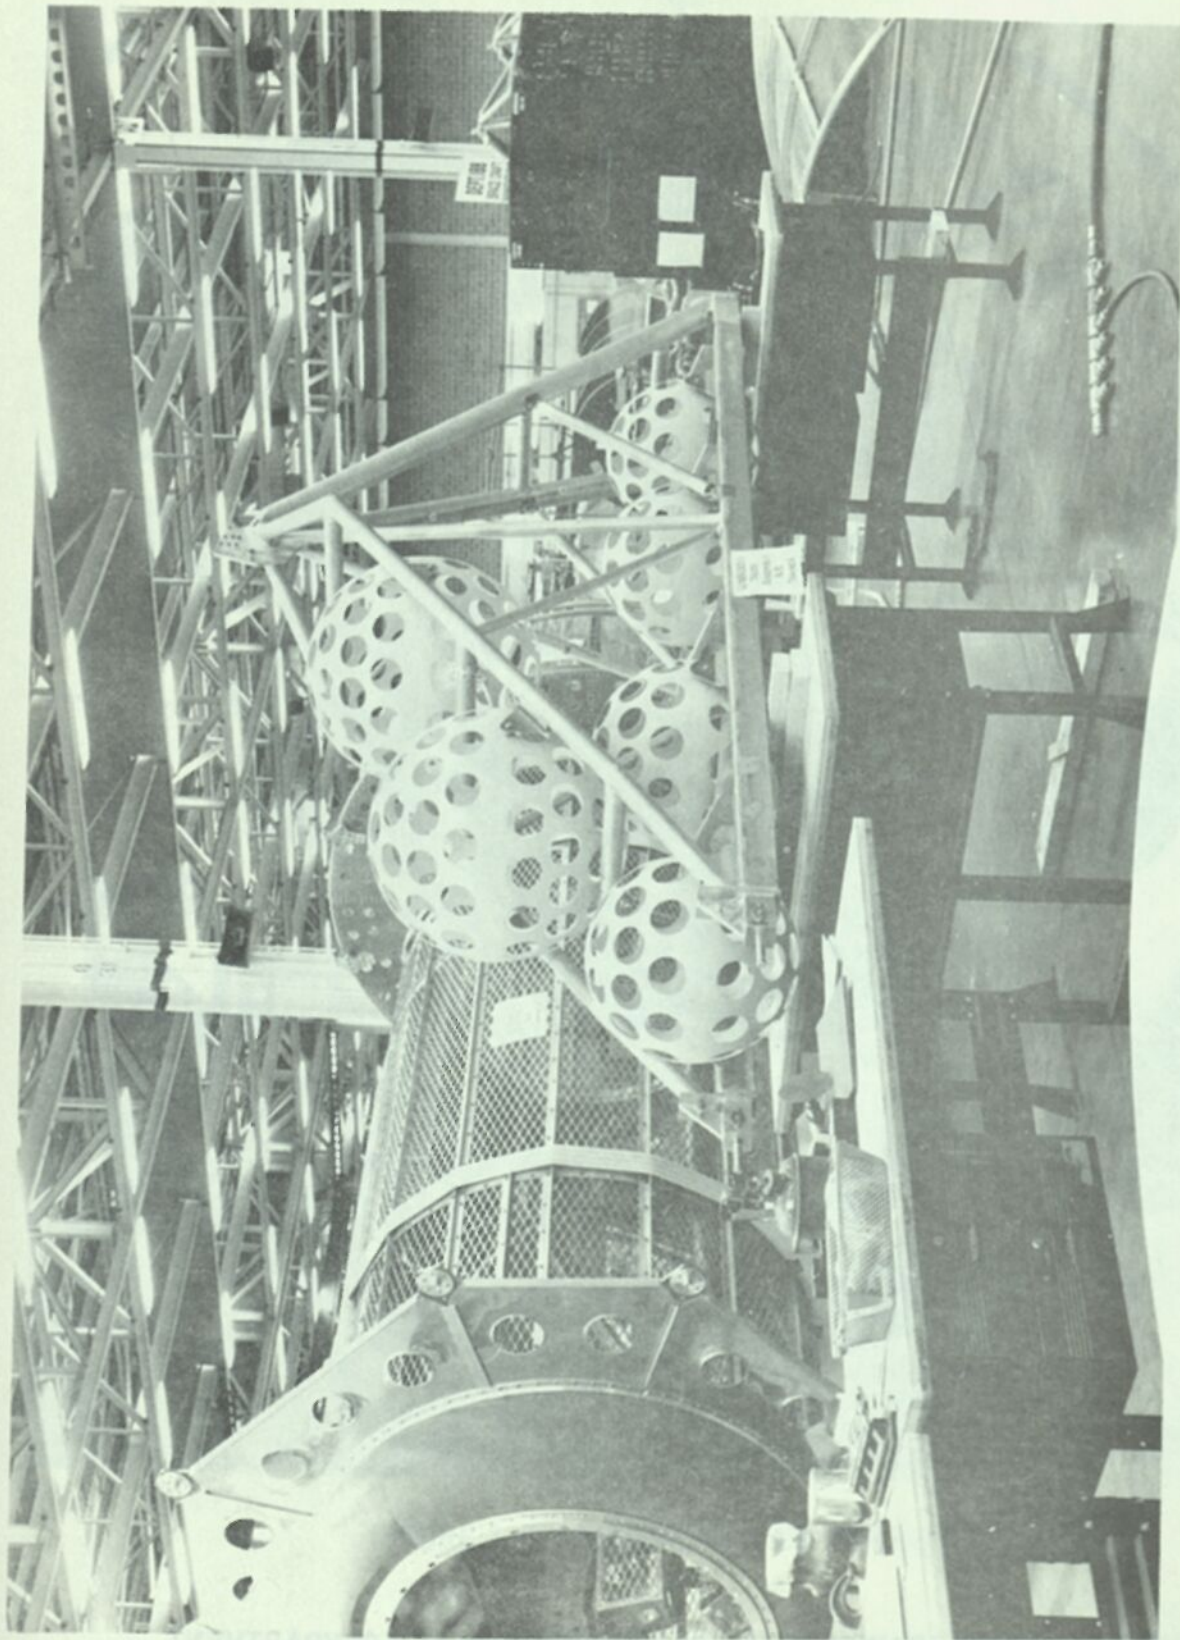
FIGURE 3-4 EARLY NBS AM TRUSS CONSTRUCTION WITH NITROGEN BOTTLES (WET WORKSHOP)

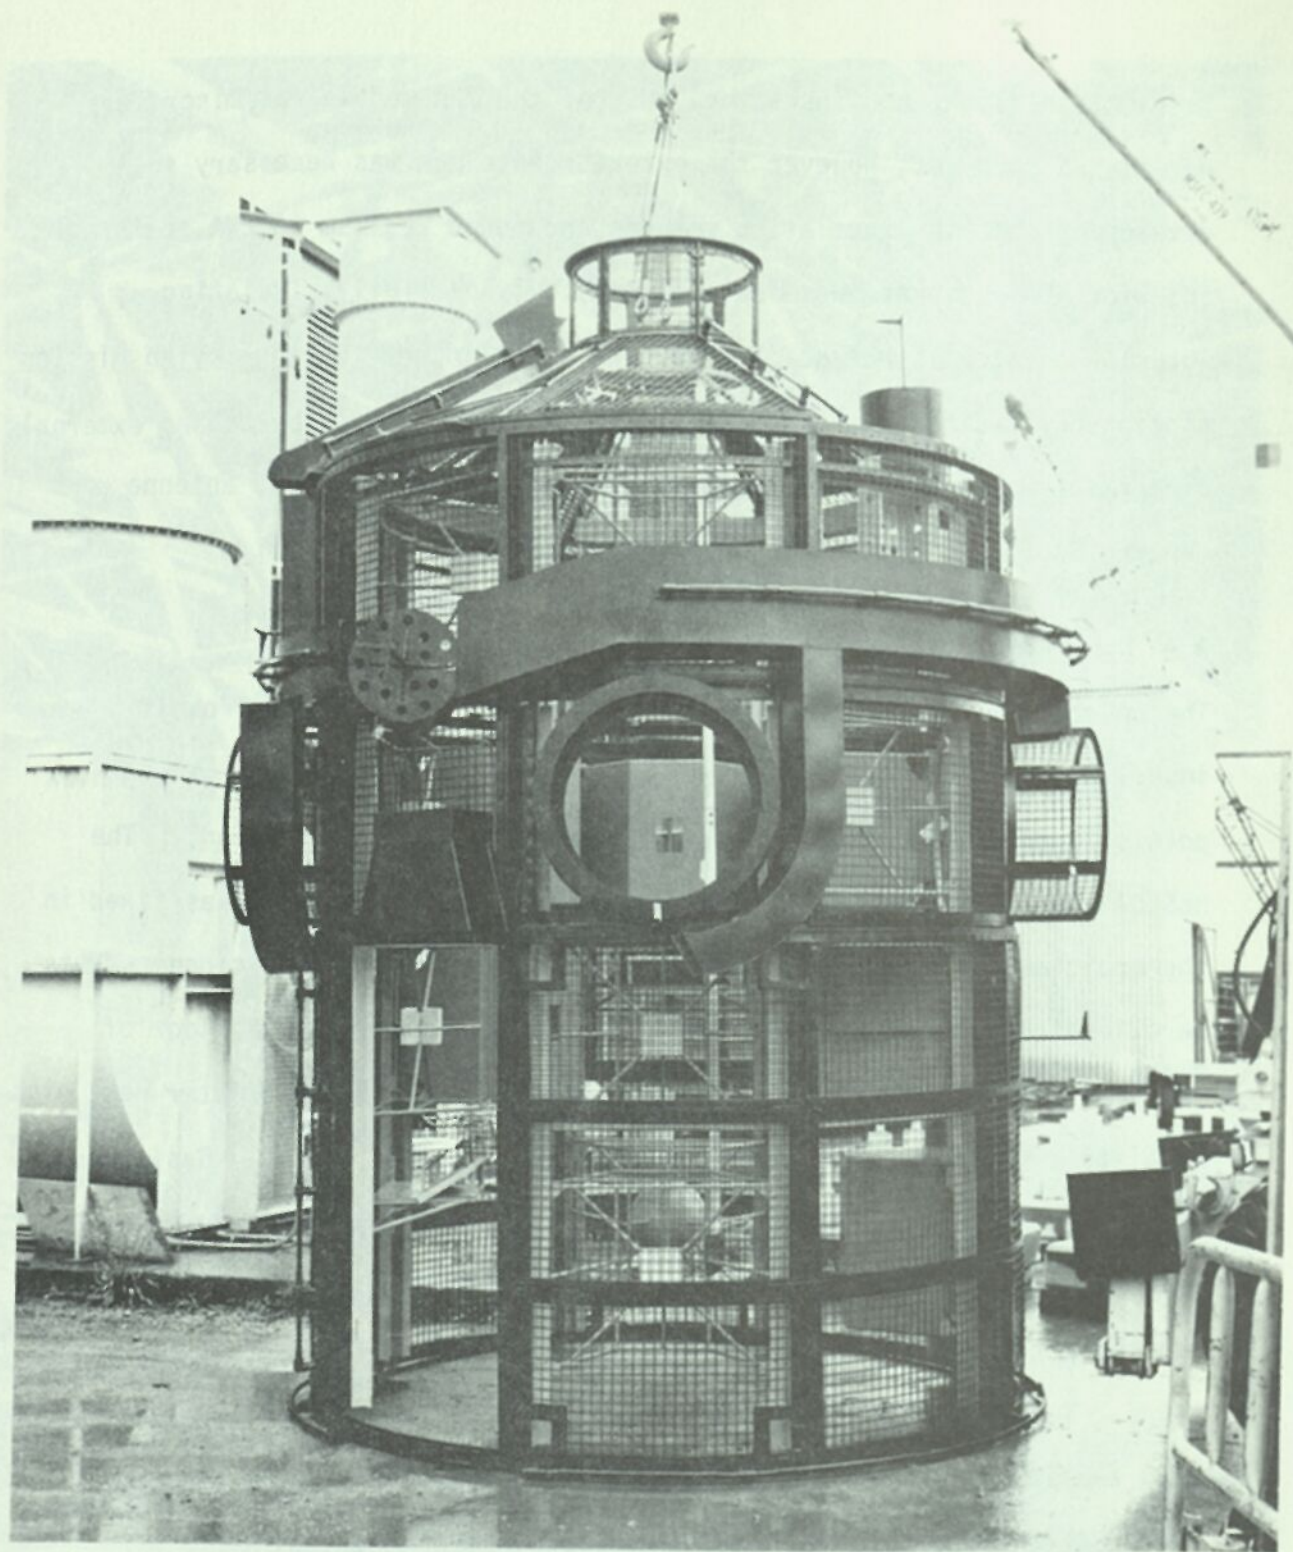
FIGURE 3-6 ORIGINAL MDA NB TRAINER

The MDA was a cylindrical structure 3.2m (126 in.) in diameter and 5.2m (204 in.) long. Fabrication was originally done by NASA-MSFC and subsequently sent to Martin Marietta Corporation (MMC) for update. Original version had five docking ports which were reduced to two during later revision (Figure 3-6).

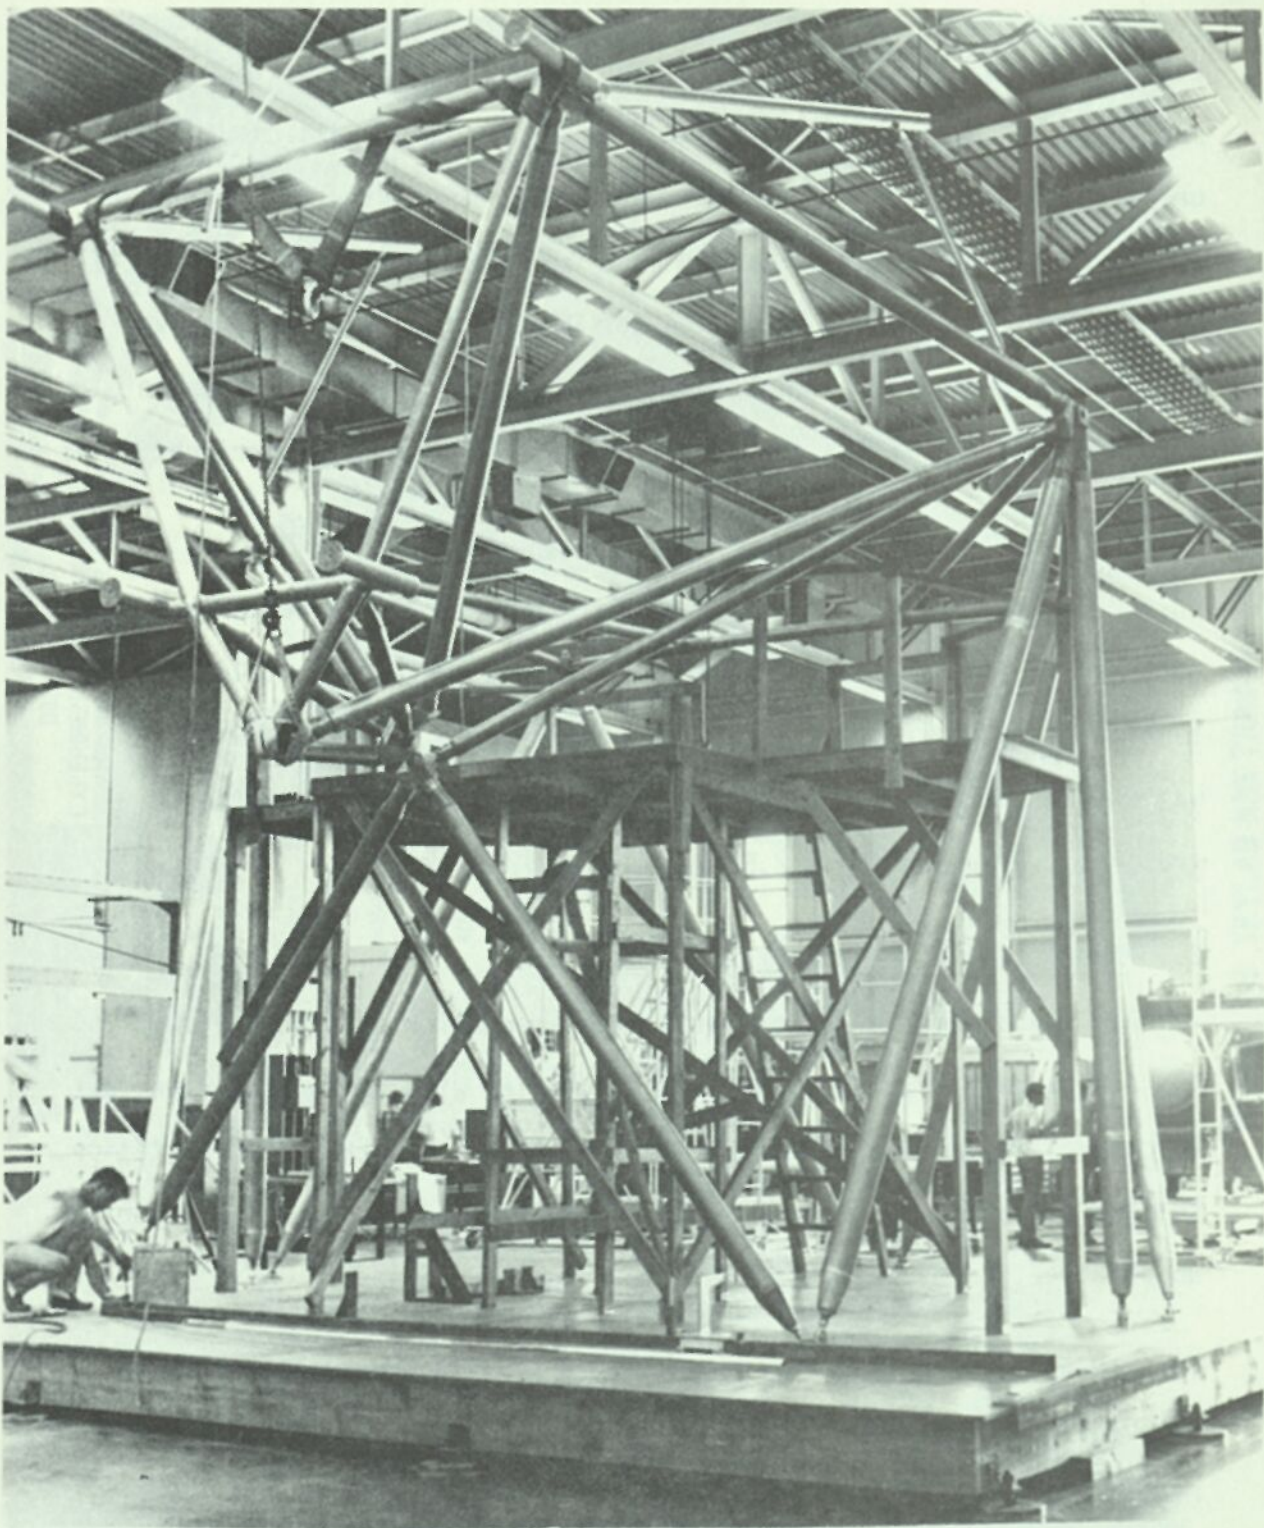
FIGURE 3-7 NBS DEPLOYMENT ASSEMBLY (DA)

The DA consisted of an upper and lower truss assembly. After orbit insertion, the upper DA truss was deployed 90 degrees around two trunnion points at the +Y and -Y axis, toward the -Z axis (sun direction). The NBS DA was a duplicate of the flight article, except that it was fixed in the orbit deployed position (see Figure 3-7). Also two additional struts were installed on the NBS DA for structural support from the floor of the tank. Original NBS units were fabricated by NASA-MSFC; later new, high fidelity assemblies were fabricated and installed by MDAC-E. Basic structure was welded bipods of 6061-T6 aluminum tubing. The lower truss assembly was attached to the FAS with welded 6061-T6 aluminum fittings. The upper truss was attached to the ATM with welded fittings and adapter rings. The two assemblies were joined together in the orbit position, with two stainless steel trunnion bolts and brass nuts. The DA contained high fidelity handrails that were essential in

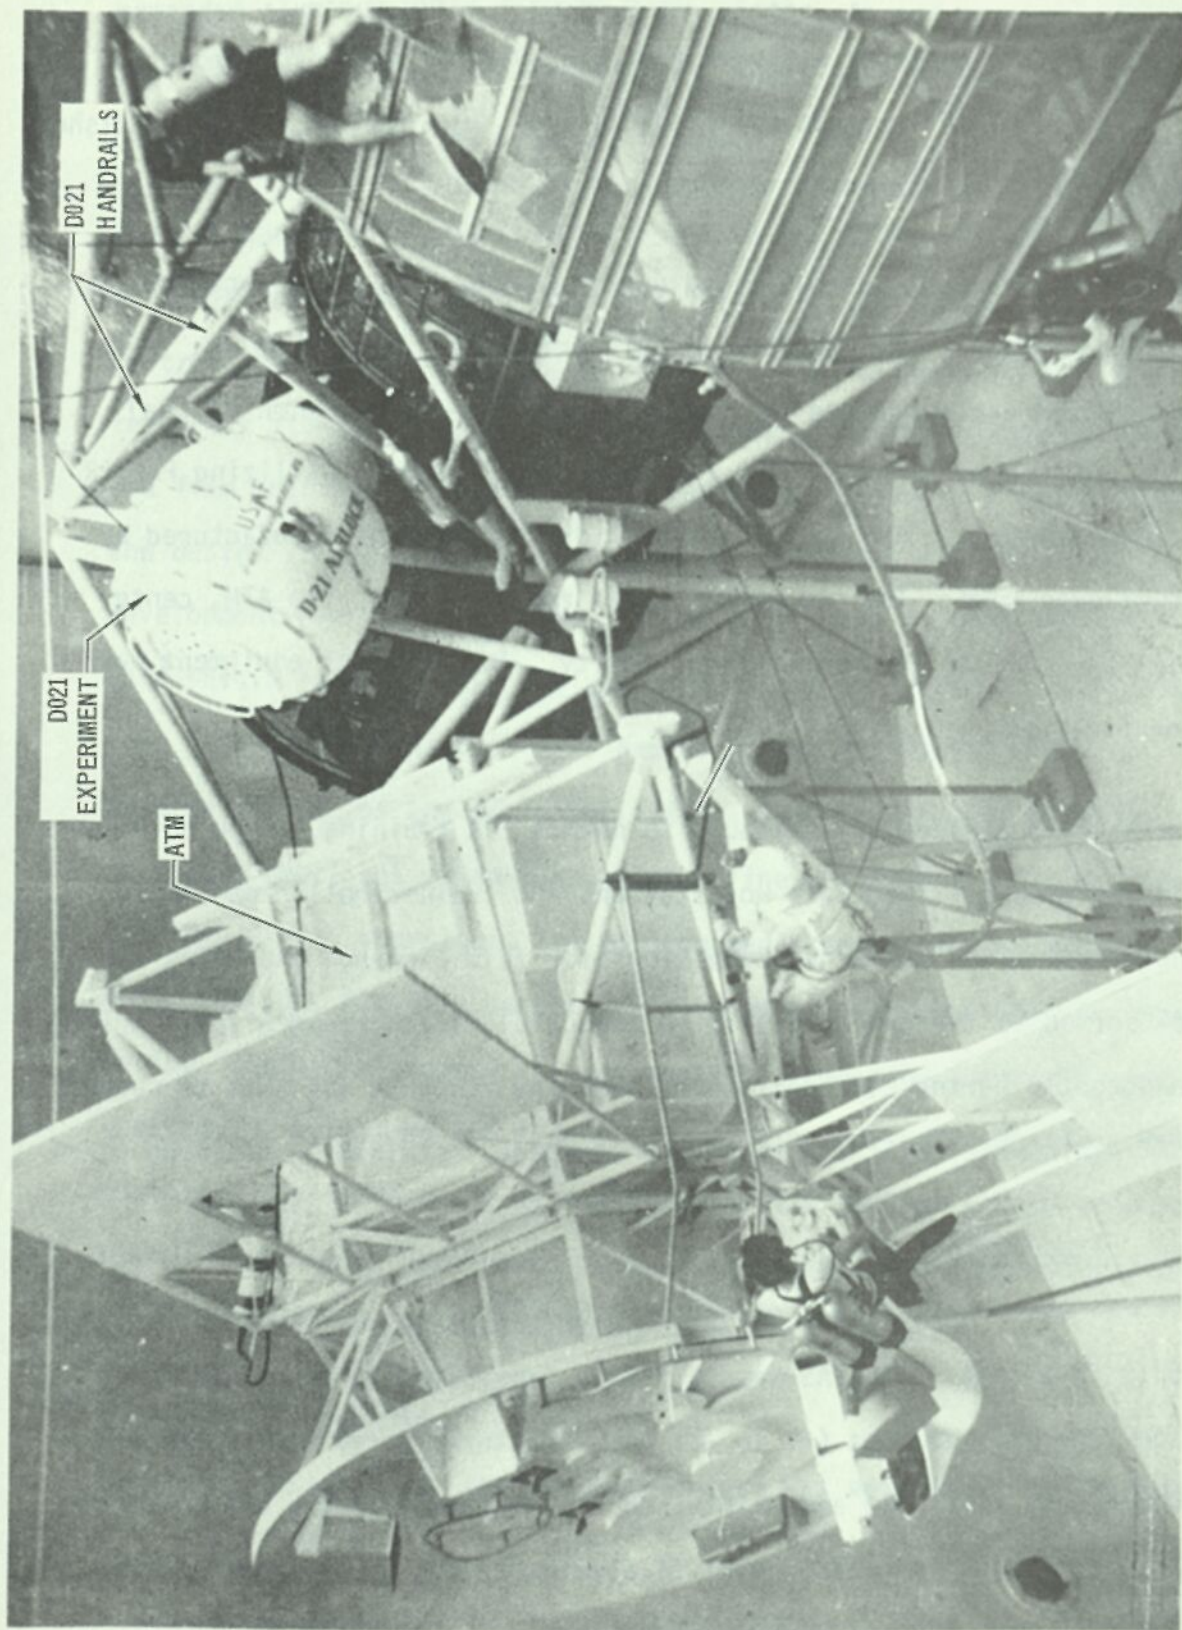
FIGURE 3-8 SKYLAB NBS TRAINING EXERCISE

The ATM was an octagonal structure 3.35m (132 in.) across and 3.66m (144.0 in.) long (Figure 3-8). An experiment canister, 2.13m (84.0 in.) in diameter and 3.0m (120.0 in.) long, was inside this octagonal structure.

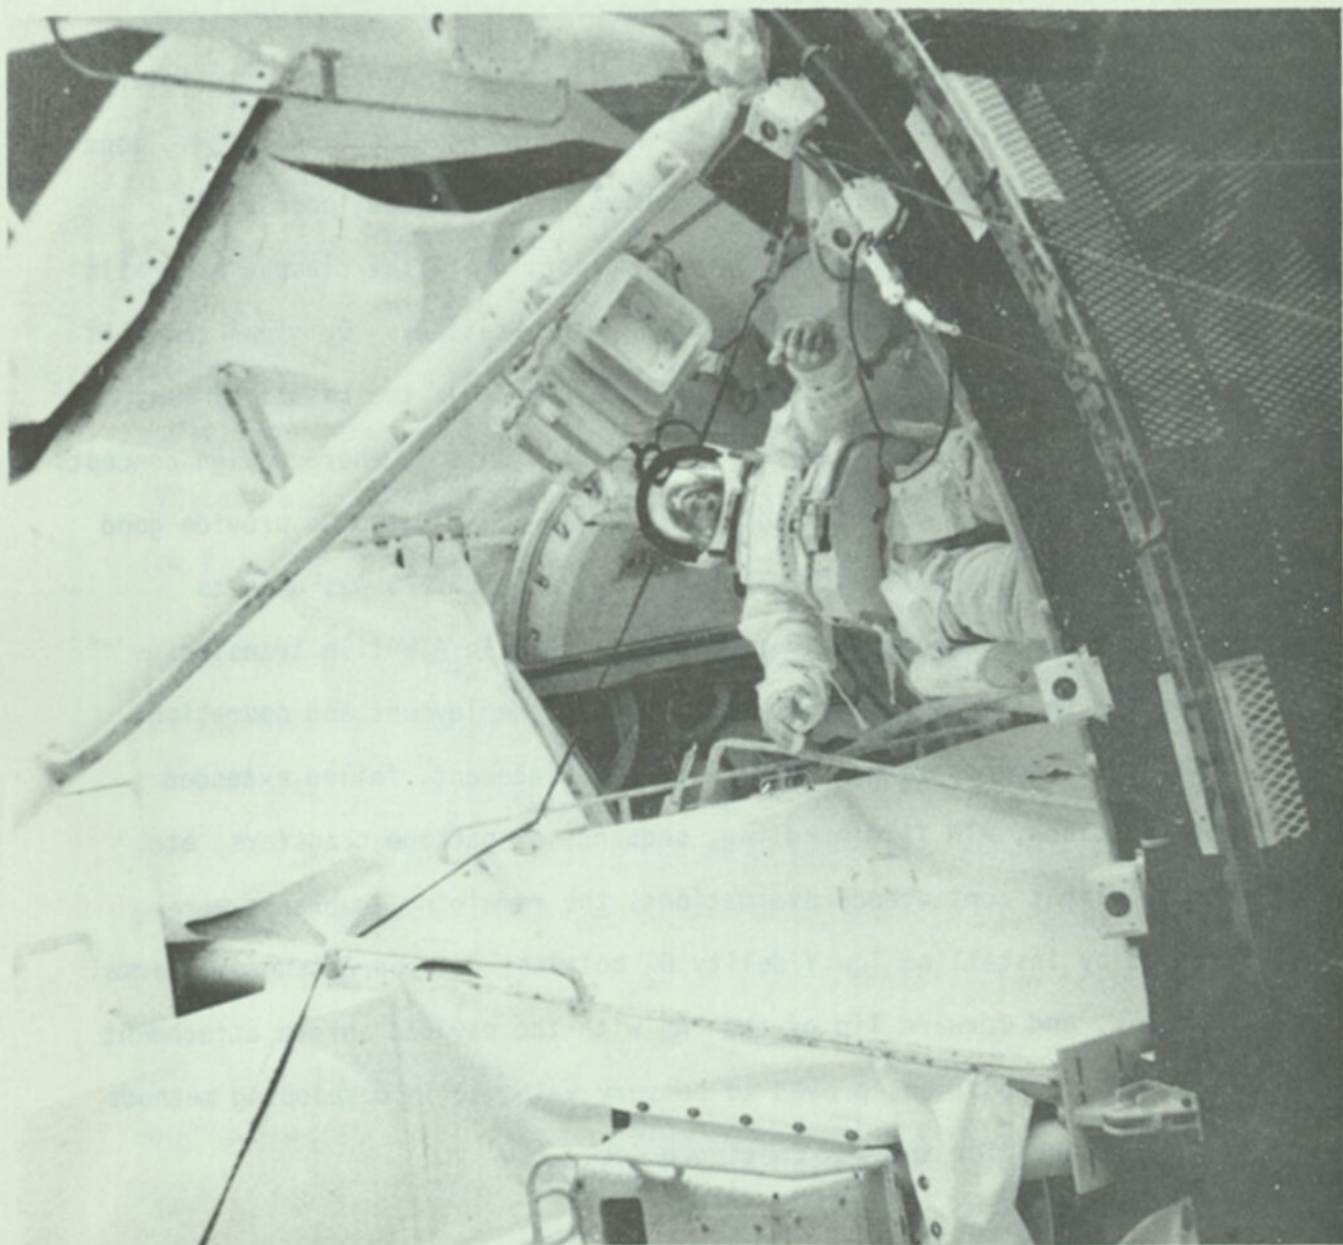
expanded aluminum skins (Figure 3-9). Later, to add a more "realistic feel" to training in the EVA quadrant, solid 2024-T3 aluminum skins were installed on top of the expanded aluminum.

FIGURE 3-9 FAS EVA QUADRANT - ASTRONAUT AT FAS WORKSTATION (VF)

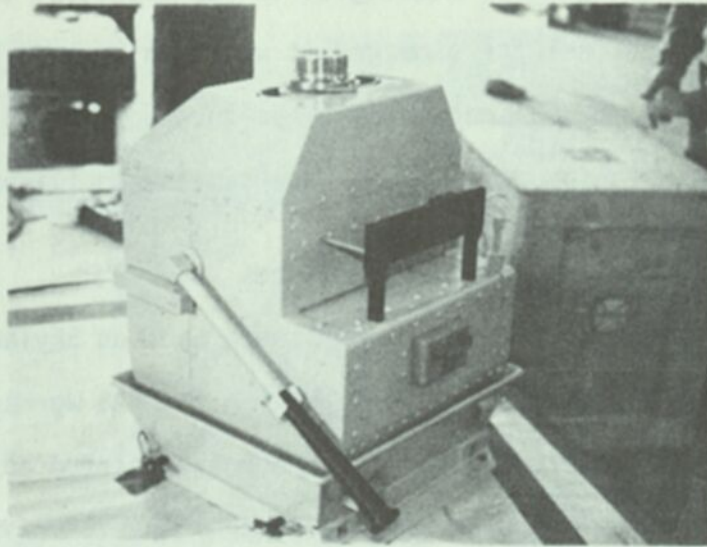
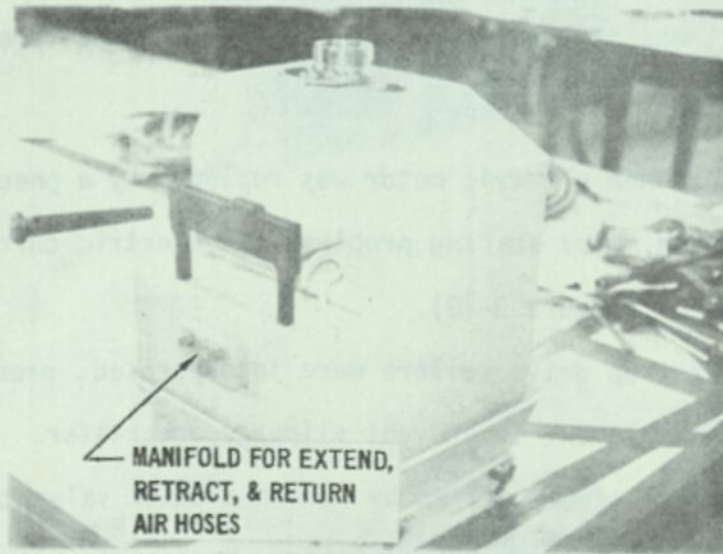
FIGURE 3-10 NBS PNEUMATIC EXTENDIBLE BOOMS
