NASA TECHNICAL
MEMORANDUM

NASA TM X-64844

MSFC SKYLAB NEUTRAL BUOYANCY SIMULATOR

14. SPONSORING AGENCY CODE	
15. SUPPLEMENTARY NOTES			
16. ABSTRACT Presented in this report is the role of the Neutral Buoyancy Simulator in the development, crew training, and flight operational aspects of Skylab.

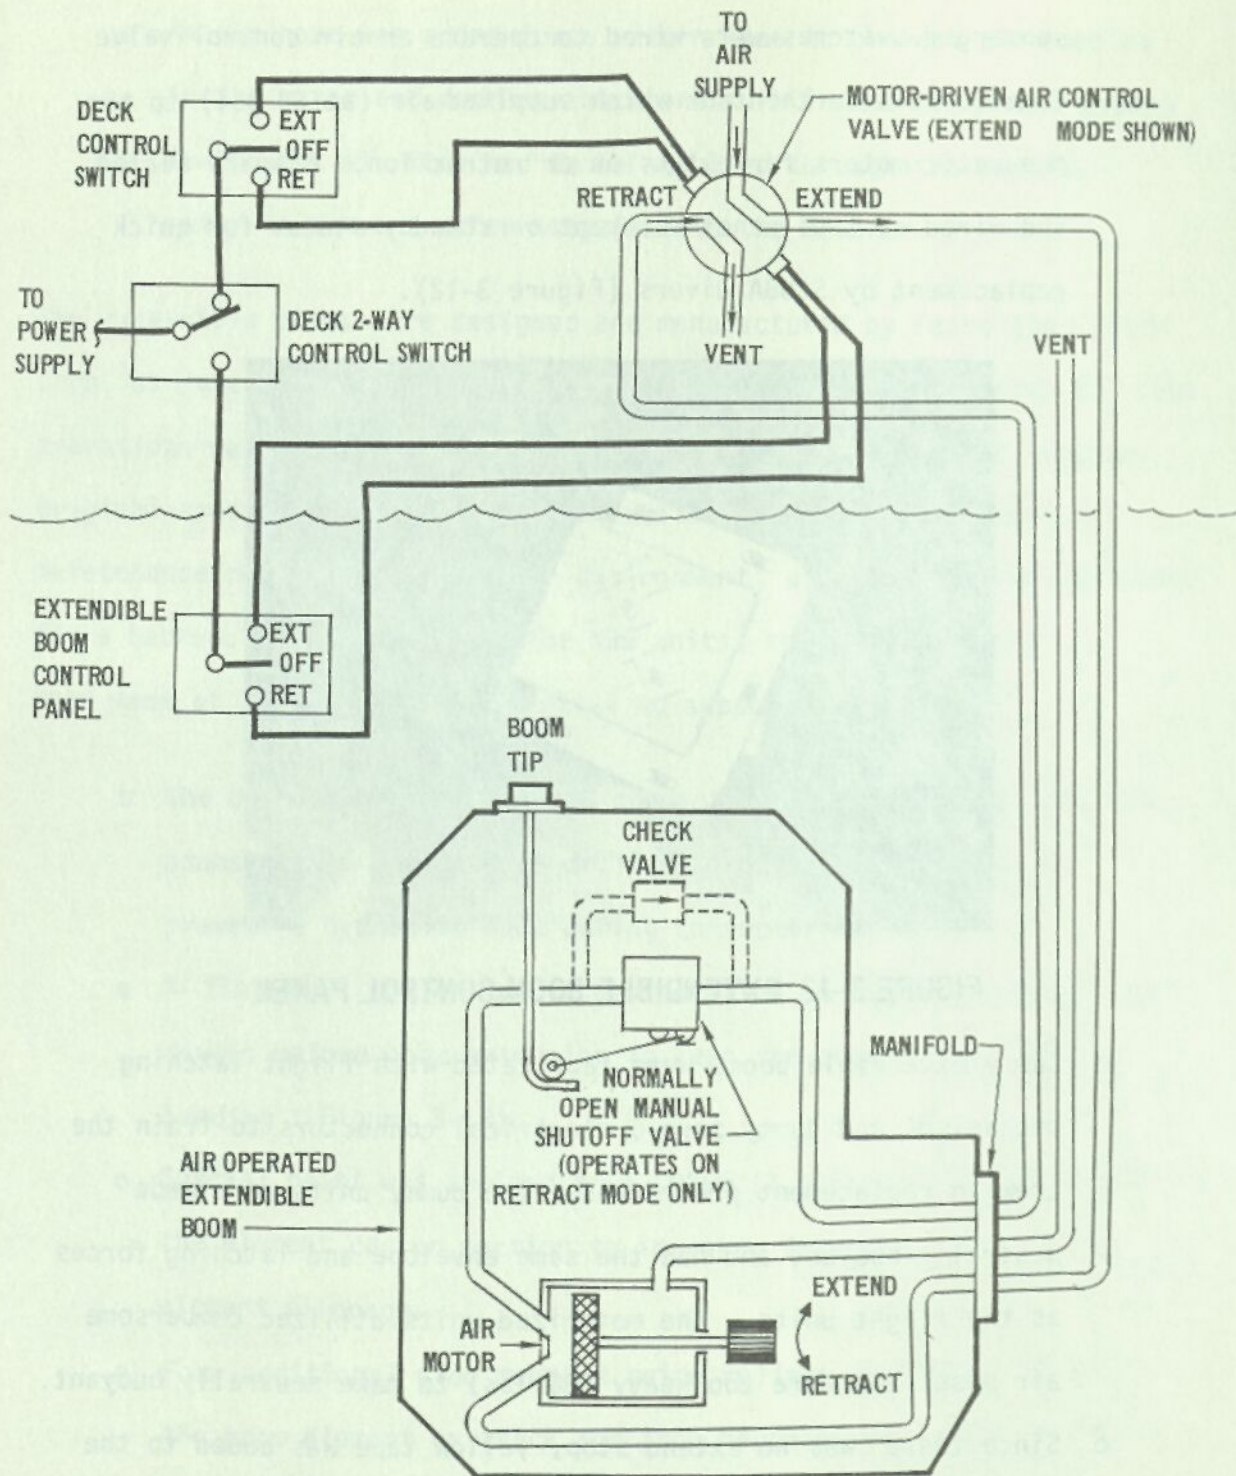
FIGURE 3-11 SCHEMATIC OF NBS AIR OPERATED EXTENDIBLE BOOM

submerged switches were wired to operate an air control valve located outside the tank which supplied air (at 80 psi) to the pneumatic motors for extension or retraction. A spare sealed and wired control panel was kept on standby status for quick replacement by SCUBA divers (Figure 3-12).

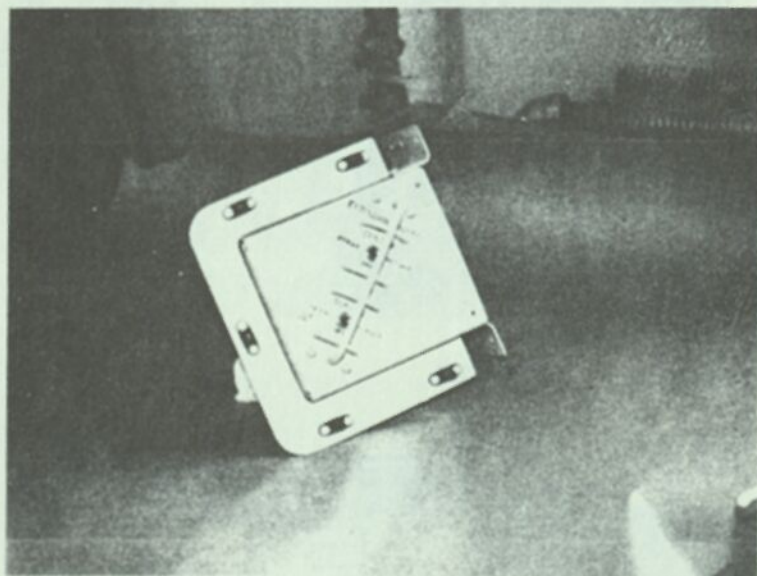
FIGURE 3-12 EXTENDIBLE BOOM CONTROL PANEL

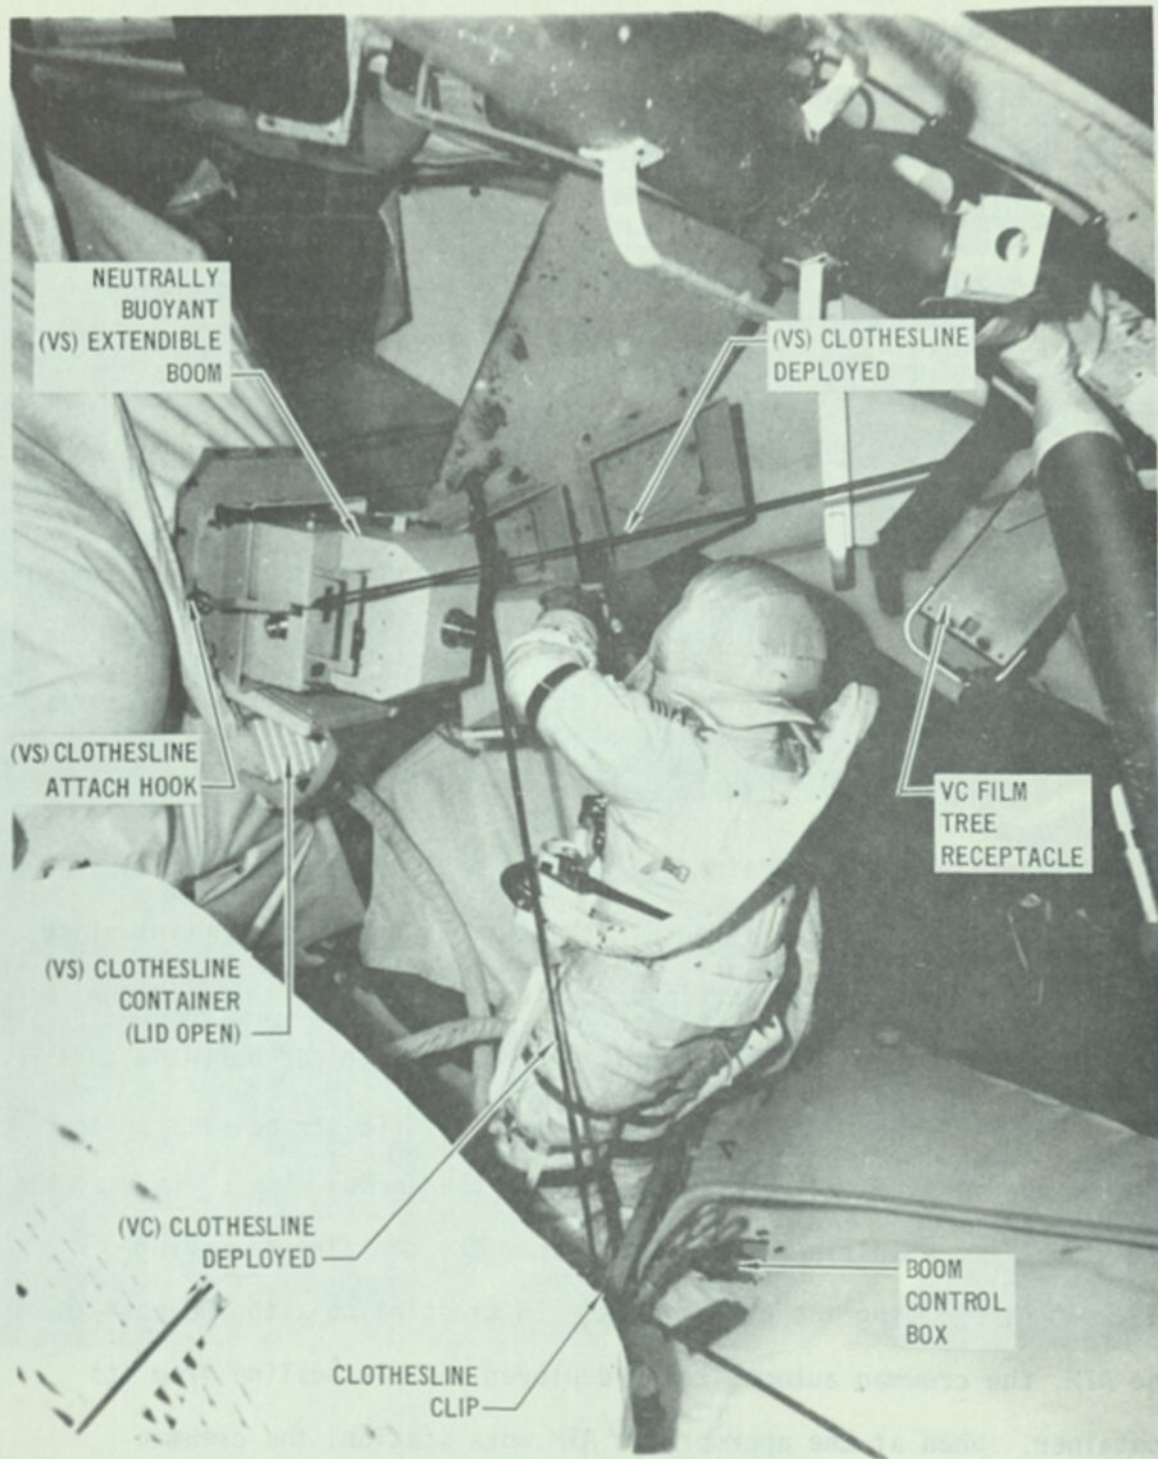
Two clotheslines of different lengths were provided as a backup ATM film transfer system. The VC clothesline was the shorter unit and was stowed adjacent to the VC boom. The VS clothesline was stowed adjacent to the VS boom (Figure 3-14). The clotheslines were endless ropes with two package hooks tied directly into the rope approximately 1.0m (40.0 inches) apart.

FIGURE 3-14 ASTRONAUT IN THE REPLACEMENT WORKSTATION (VR) PERFORMING EXTENDIBLE BOOM REPLACEMENT

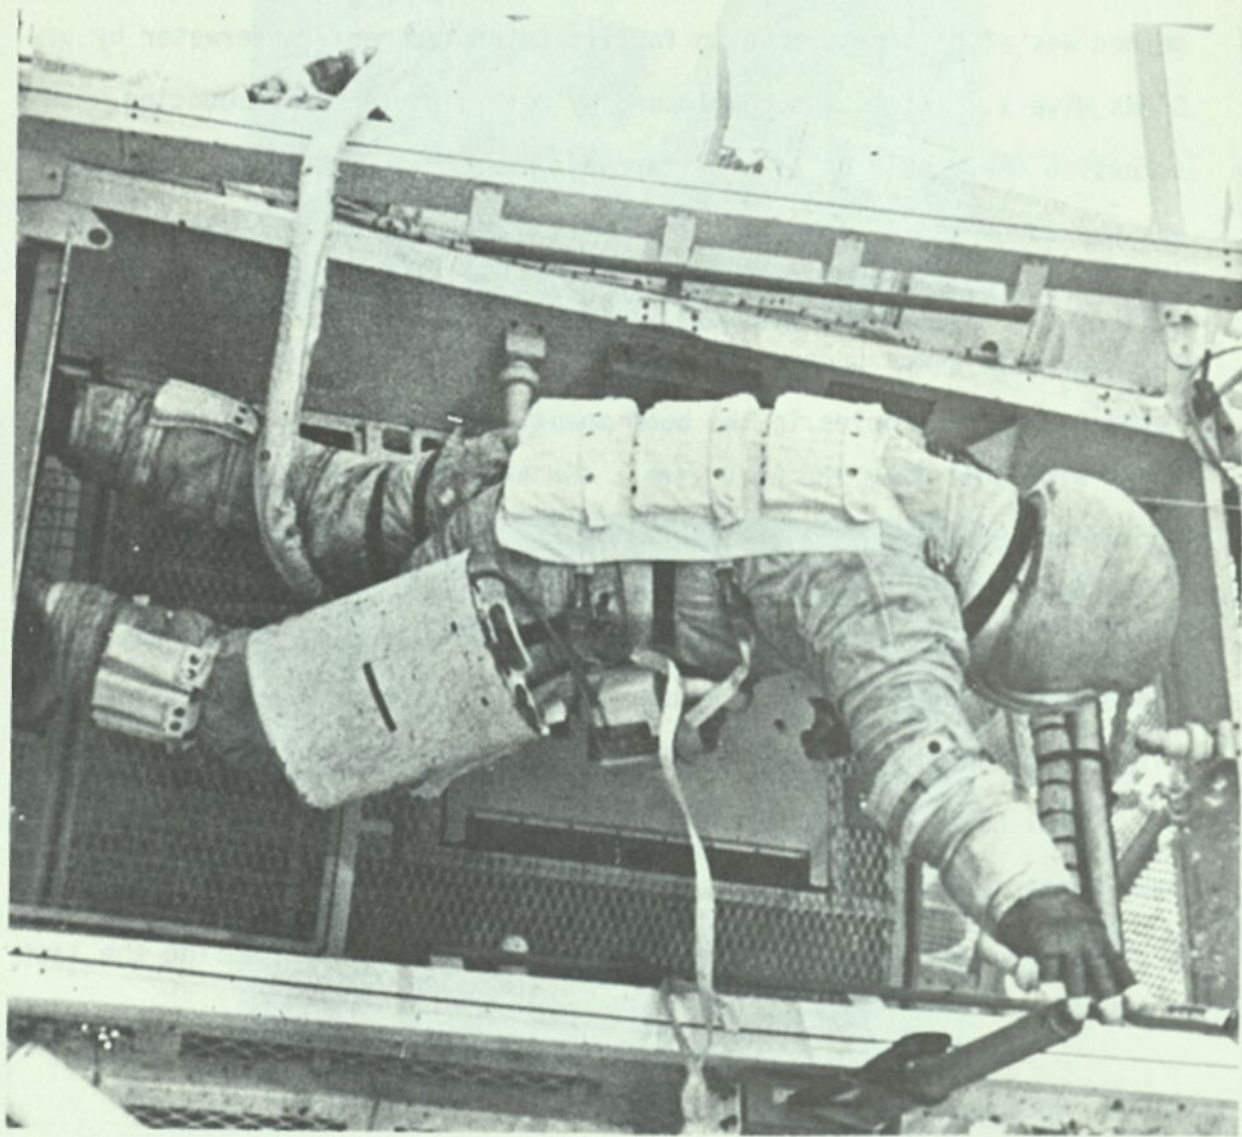
FIGURE 3-15 ASTRONAUT AT ATM WORK STATION (VC) UNFOLDING VC CLOTHESLINE DEPLOYMENT ARM

Each clothesline also contained two swivel eyelet attachment hooks. One hook was connected directly to the structure of the boom mounting plate and the other hook was stowed in a special fiberglass container along with the clothesline. The clothesline ropes were folded back and forth in the container and held at the folds with elastic straps similar to the method used in parachute packing to retain the shroud lines. In use, the crewman pulled a velcro strap which opened the container's spring loaded lid, exposing the eyelet hook. In translating with the hook to the ATM, the crewman automatically deployed the clothesline from its container. When at the appropriate ATM work station, the crewman attached the hook to the clothesline deployment arm (Figure 3-15).

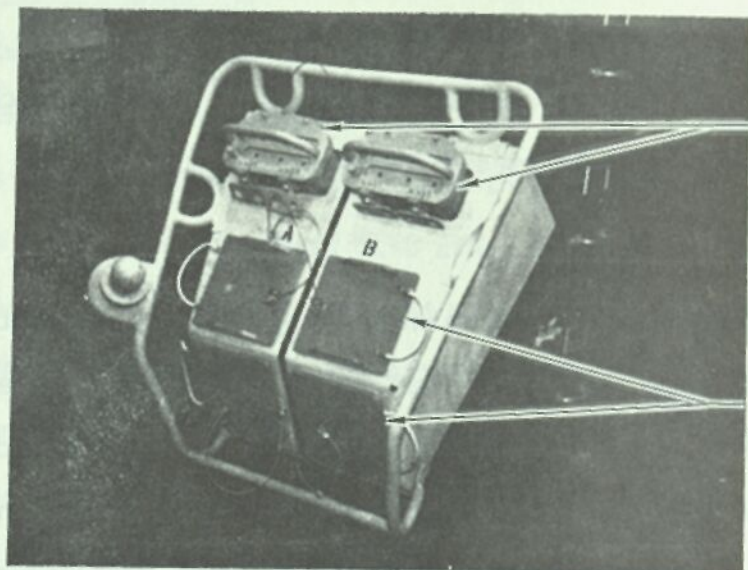
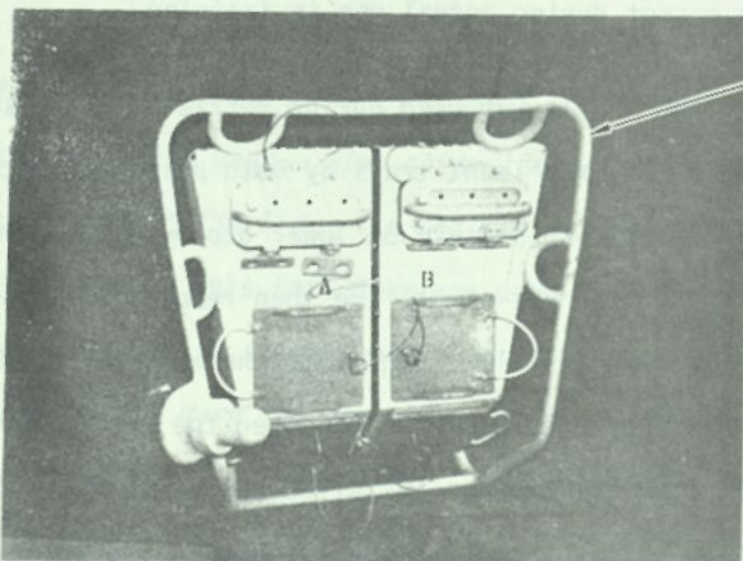
FIGURE 3-16 NBS D024 MODULE

The D024 experiment module was a rectangular box with a guard rail extending around three sides (see Figure 3-16). One end of the module

RETURN
CONTAINERS

EXPERIMENT
TRAYS

GUARD
RAIL

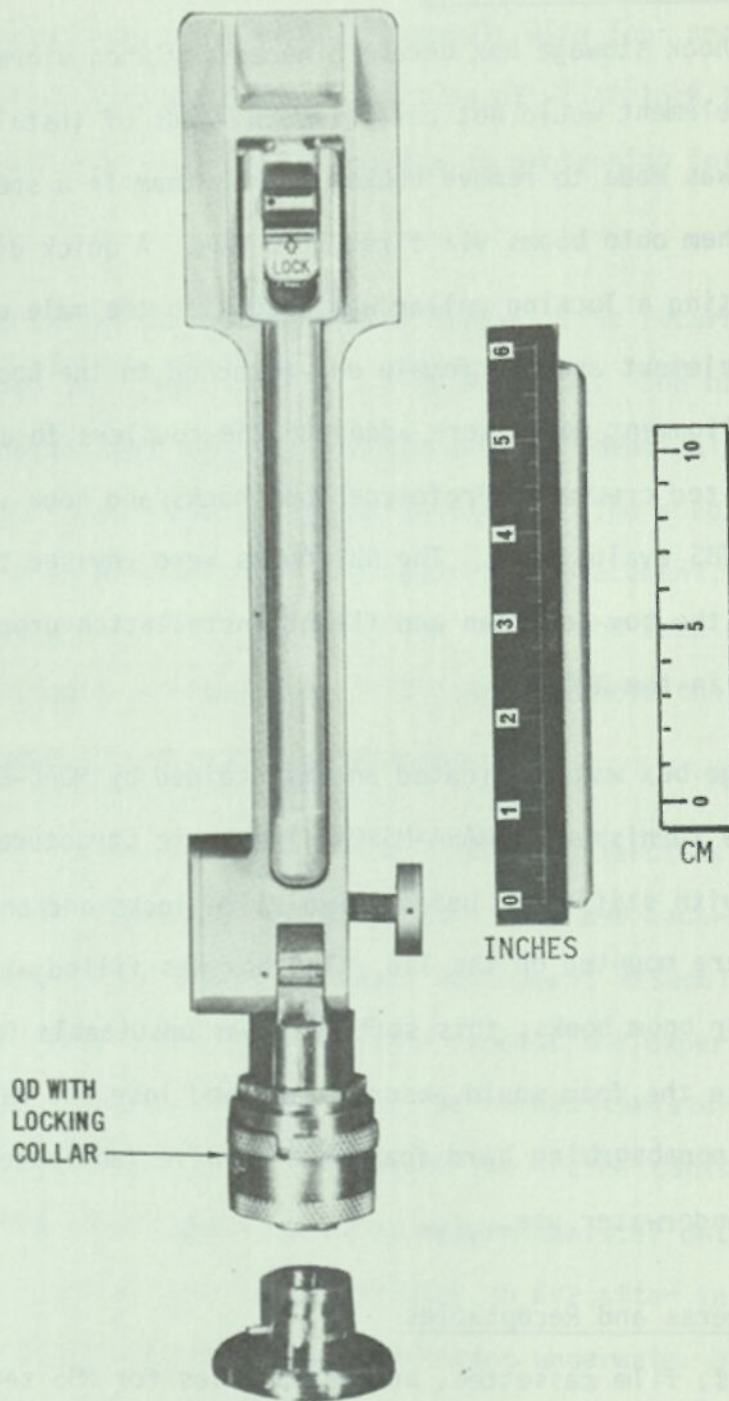
FIGURE 3-17 QUICK DISCONNECT BOOM HOOK

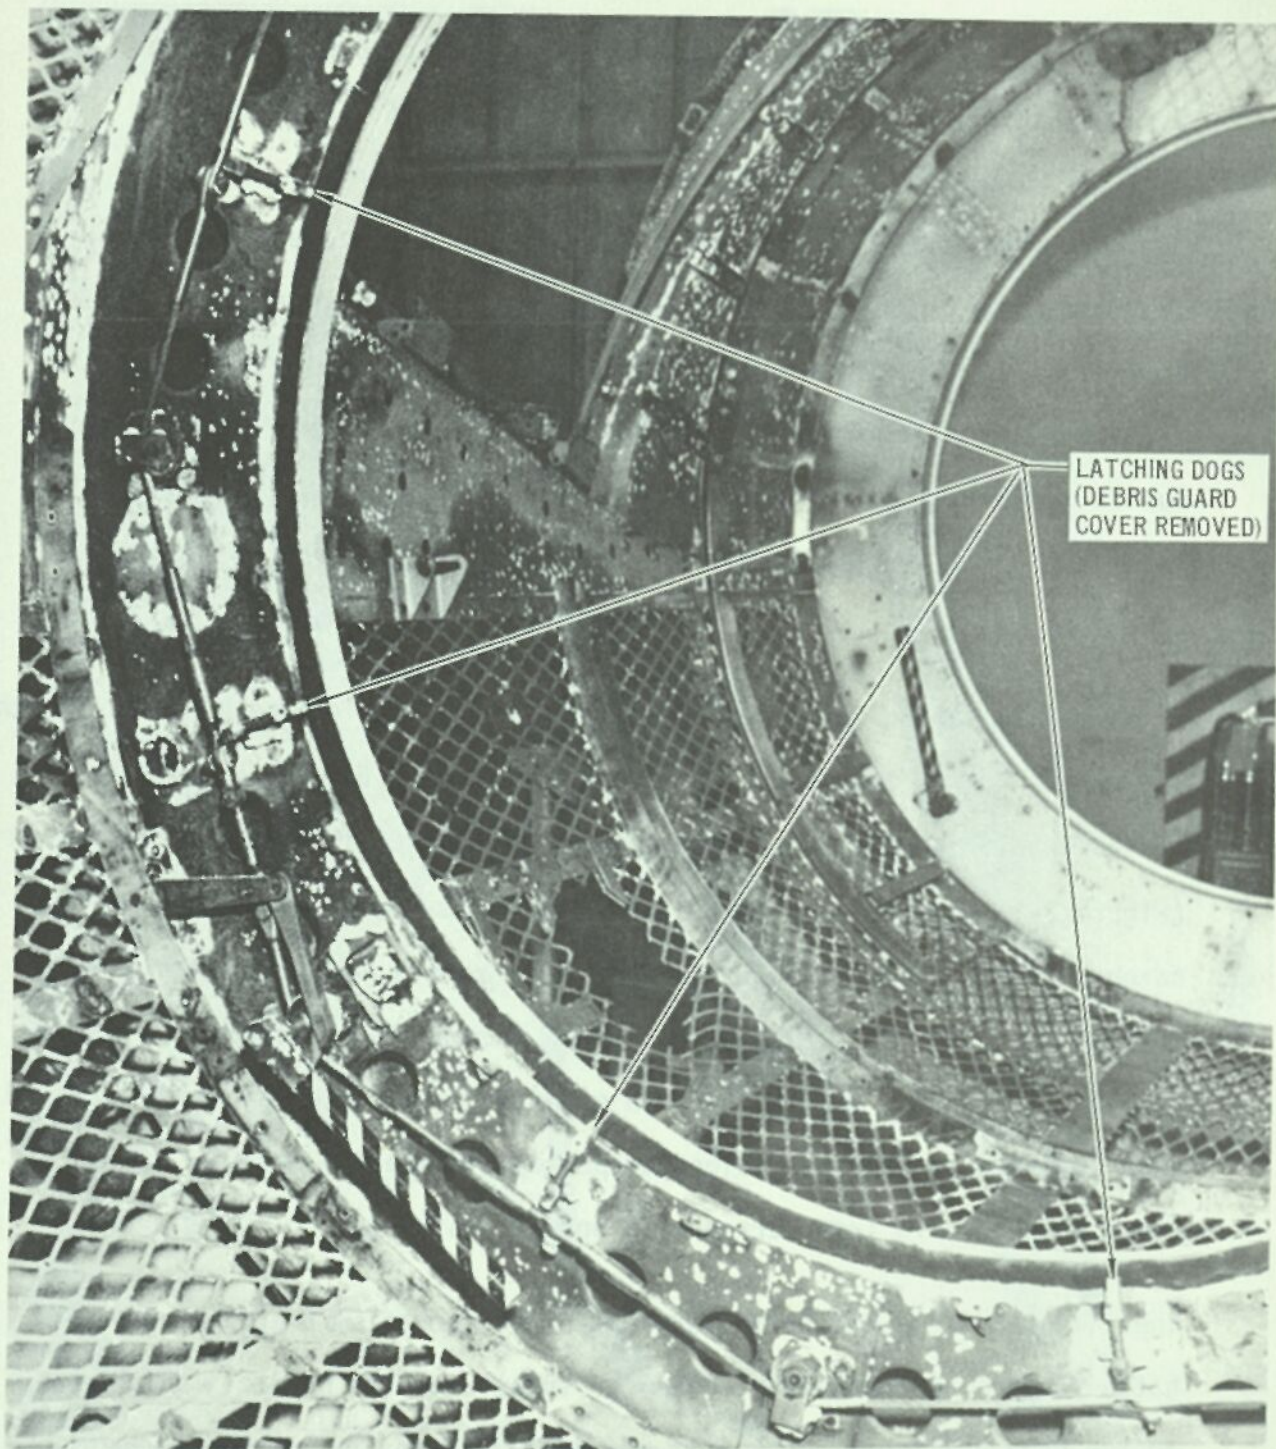
FIGURE 3-18 AM HATCH LATCHING MECHANISM

Internal hatches were low fidelity trainer articles and did not contain a sealing bead that compresses into the seal as on the flight article. Therefore a different type seal of slightly porous neoprene rubber was used. These seals presented load problems with internal hatches because the neoprene rubber continually absorbed water and swelled, which increased latching forces. A portion of the seal that protruded beyond the sill was trimmed completely off except for four pads approximately .072m (3.0 inches long). These pads closely simulated flight latching forces until water was absorbed in the open cell neoprene rubber seal. In approximately 60 days underwater, the latching force was out of spec. During the majority of training exercises, internal hatches were placed in the correct flight position by utility divers prior to beginning EVA procedures.

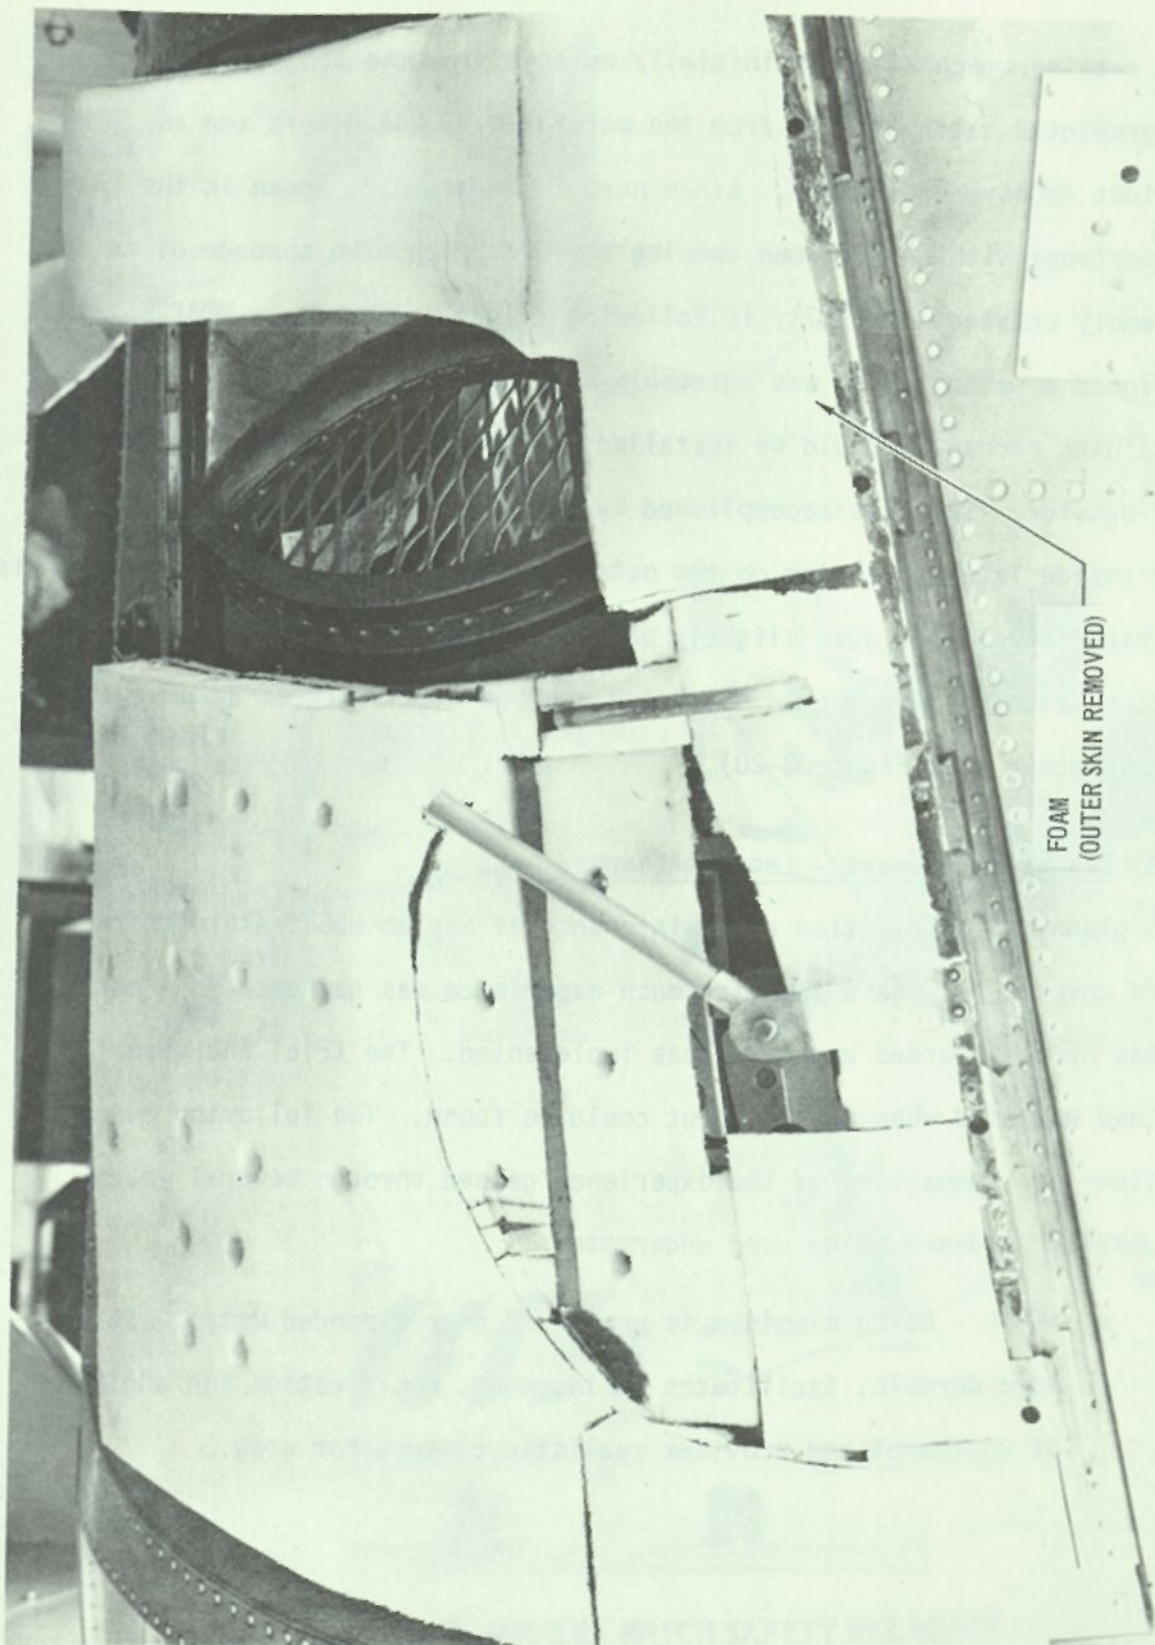
FIGURE 3-19 NBS EVA HATCH

The flight article EVA hatch had a retainer mechanism that allowed the hatch to open approximately .018m (.7 inch) when the handle was placed to the open position. This unit was installed to insure the hatch would not be blown open by lock residual pressure vented from the pressure suits.

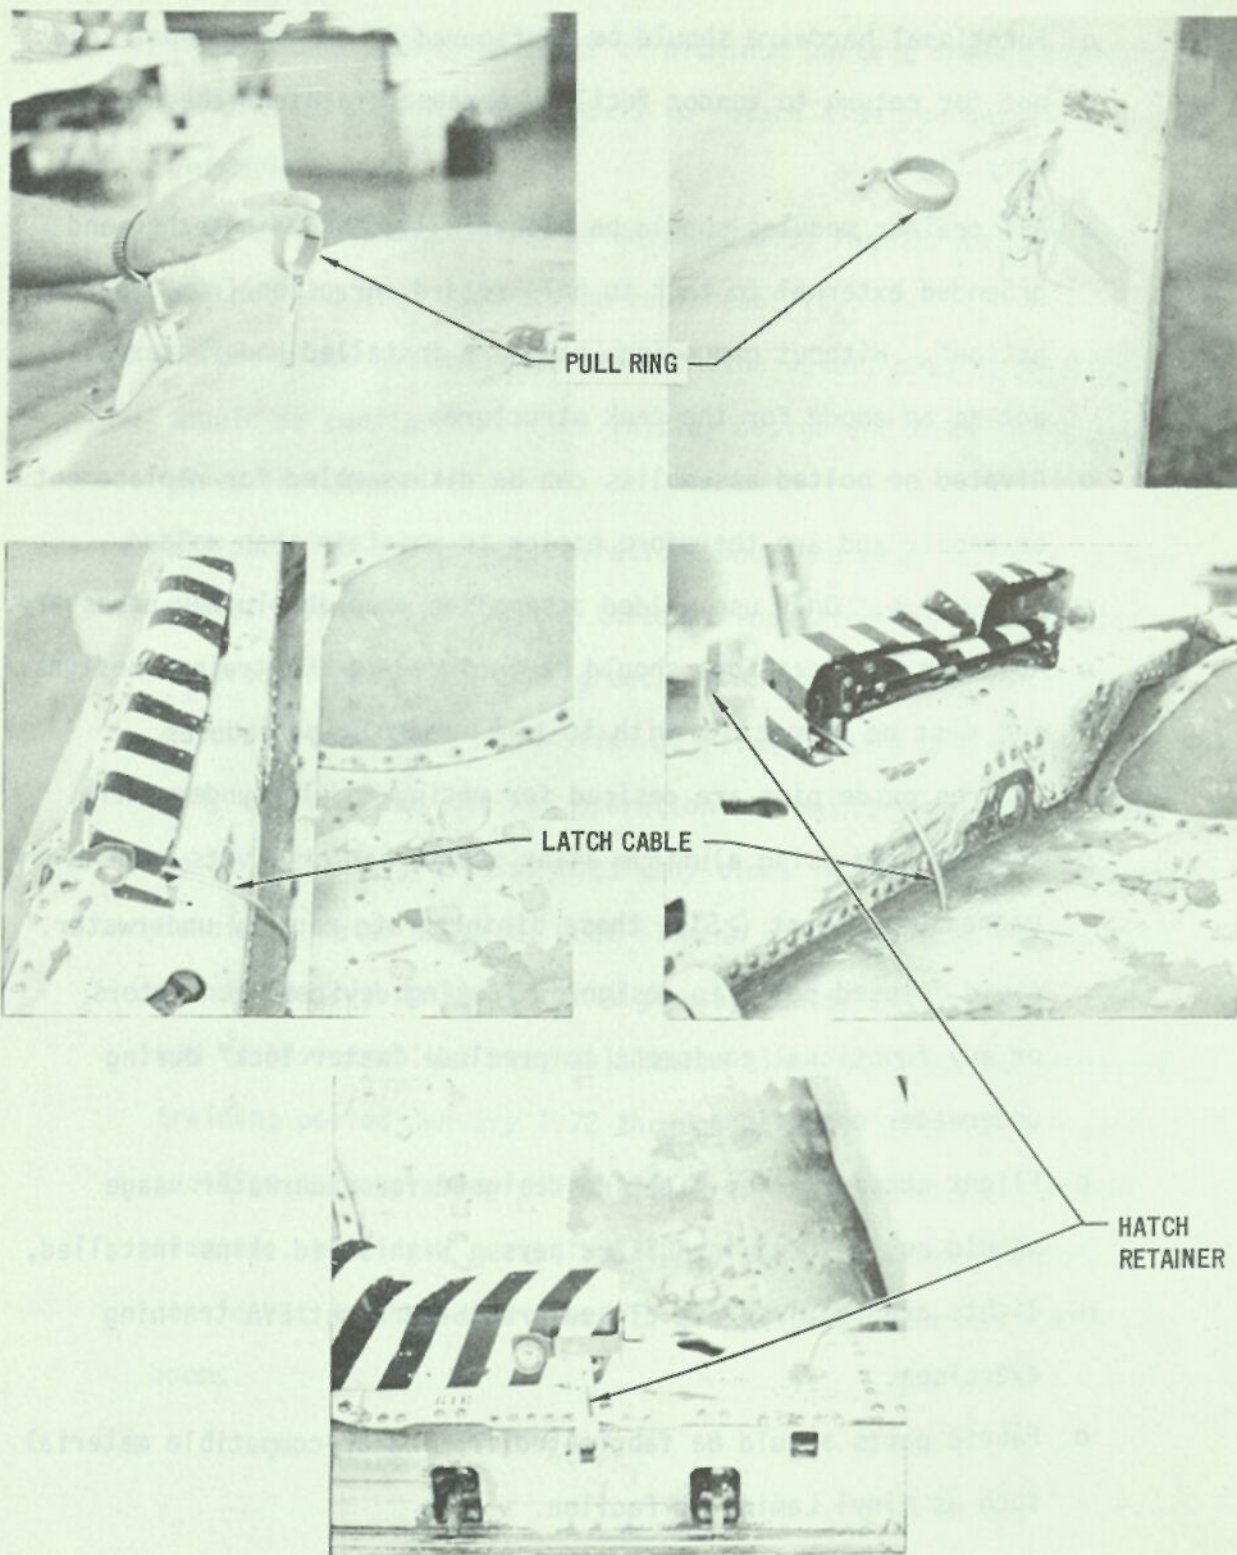
FIGURE 3-20 NBS EVA HATCH SAFETY RELREASE

The retainer mechanism was initially omitted from the NBS hatch because it prevented hatch opening from the outside by SCUBA divers and was against safety regulations. Since normal EVA training began in the lock compartment with the crewman opening the EVA hatch, the absence of this assembly created difficulty in following flight procedures. MDAC-E then designed a method which was agreeable with MSFC safety office where the retaining mechanism could be installed and the hatch could be opened from the outside. This was accomplished by a cable arrangement that connected the inside latch to a ring on the outside of the hatch. With this installed, safety divers could push slightly on the outside of hatch, pull the ring so the latch retainer would not catch and open the hatch if an emergency should occur (see Figure 3-20).

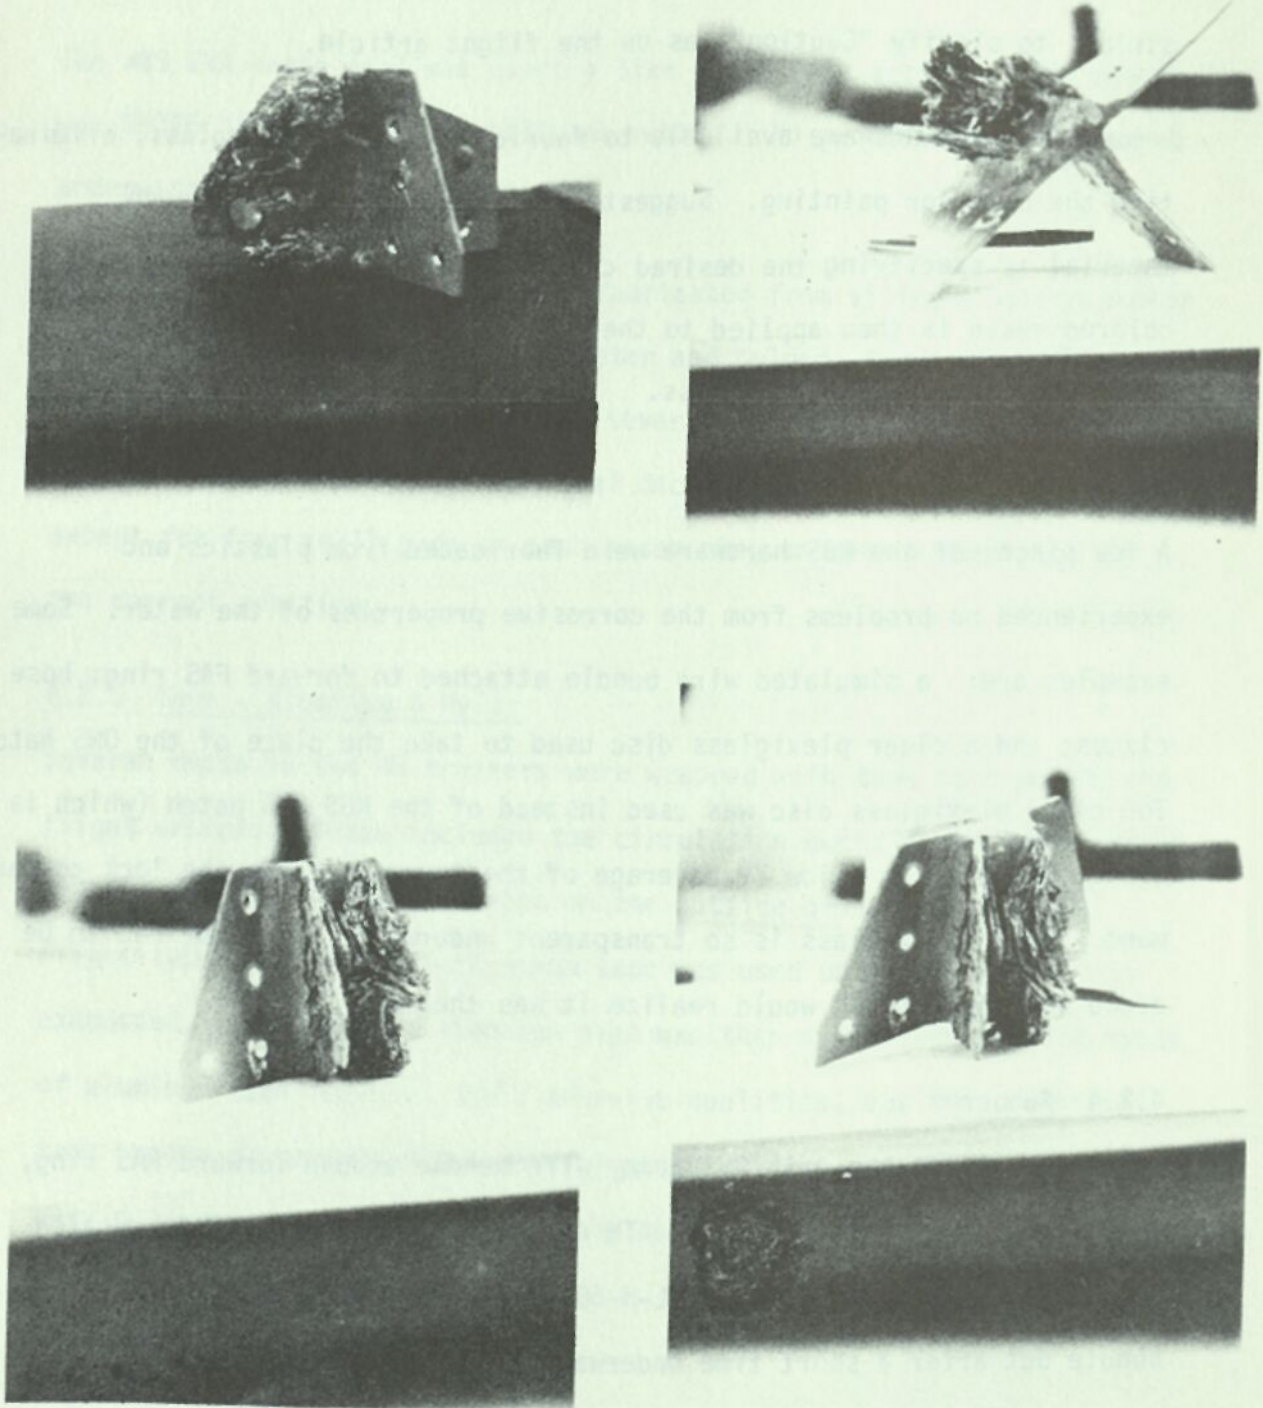
FIGURE 4-1 TM673 ALUMINUM FITTING EXFOLIATION

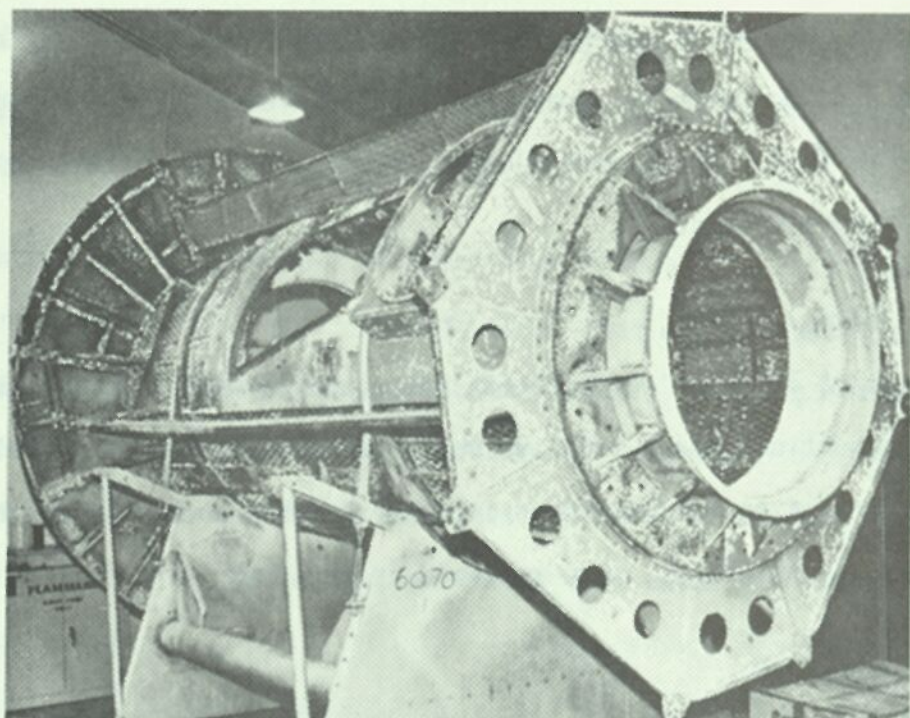
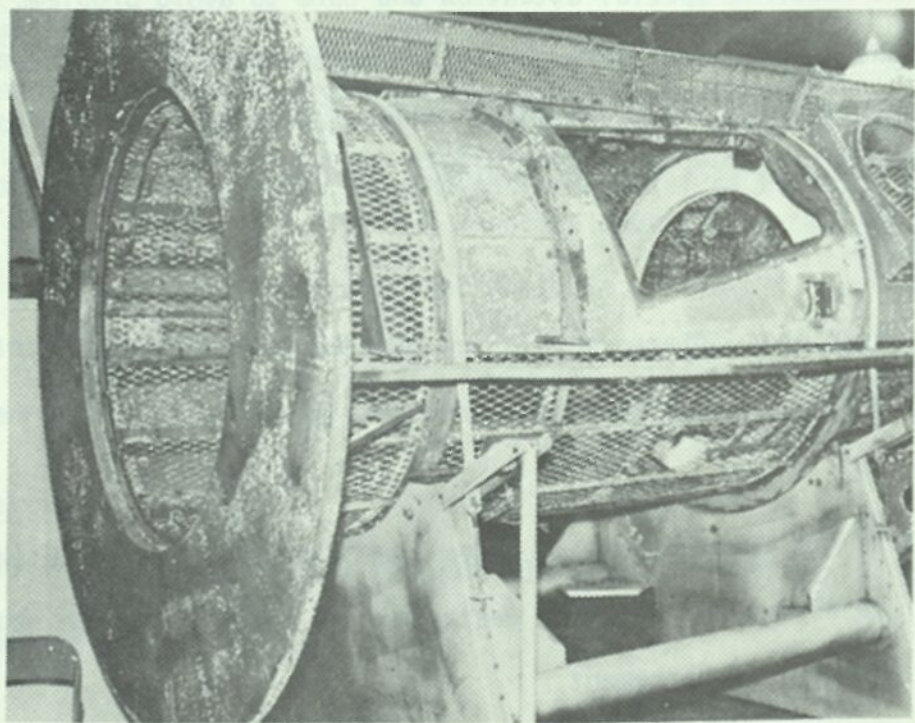
FIGURE 4-2 FASTENER CORROSION

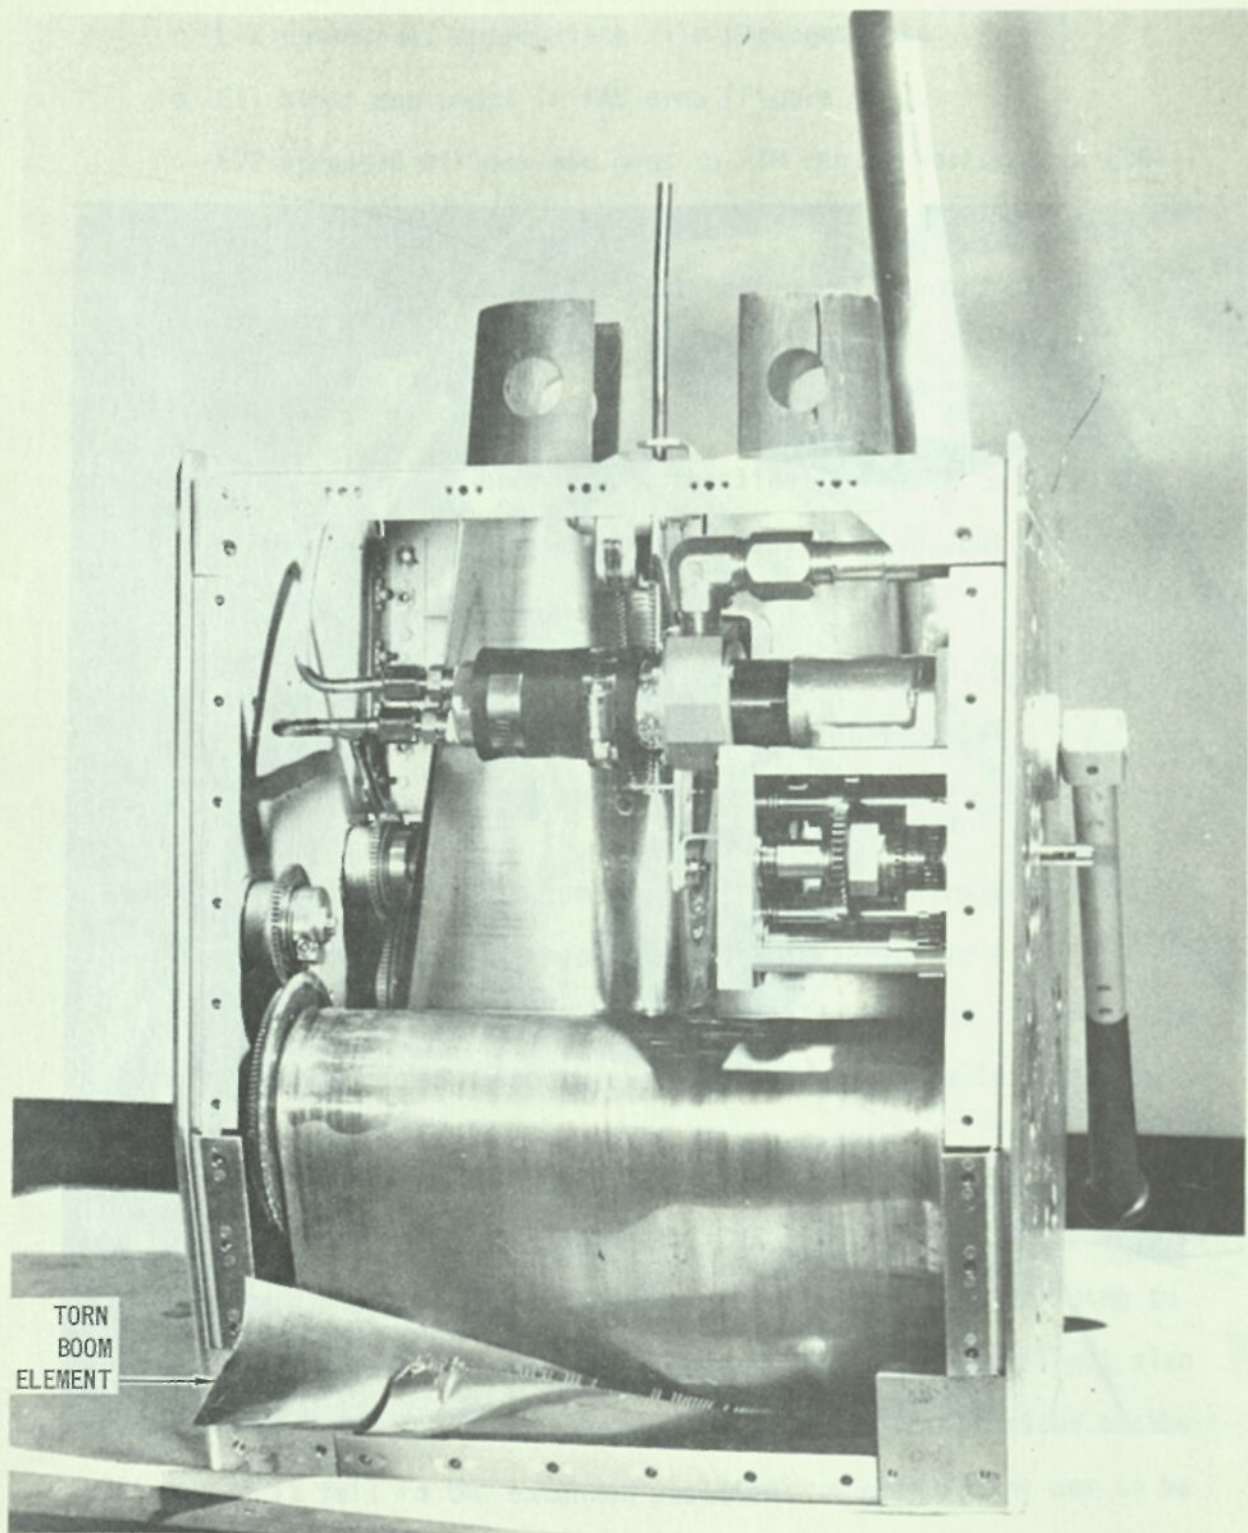
FIGURE 5-3 NBS EXTENSIBLE BOOM (COVER REMOVED)

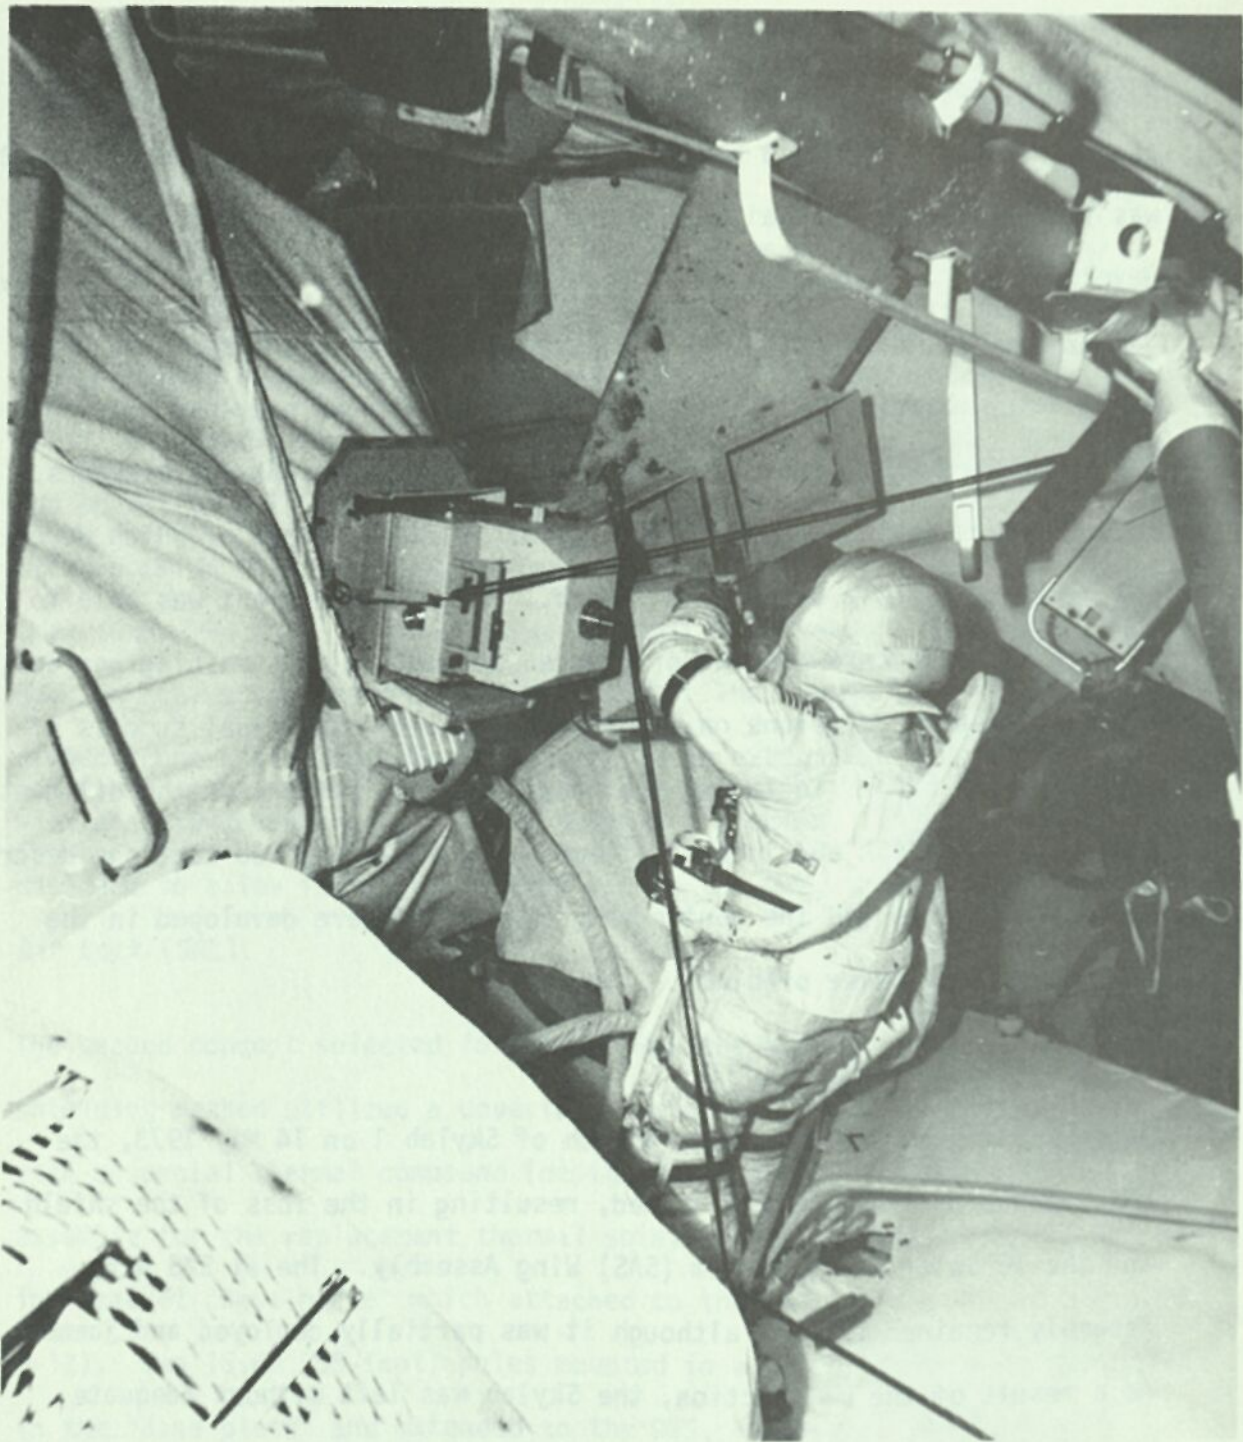
used in the event that both booms failed. The procedures for these operations were incorporated into normal NBS film transfer exercises and improved upon as zero-G techniques were developed. Figure 5-11 depicts a boom exchange procedure in progress.

FIGURE 5-11 ASTRONAUT REPLACING EXTENDIBLE BOOM
AT THE REPLACEMENT WORK STATION (VR)

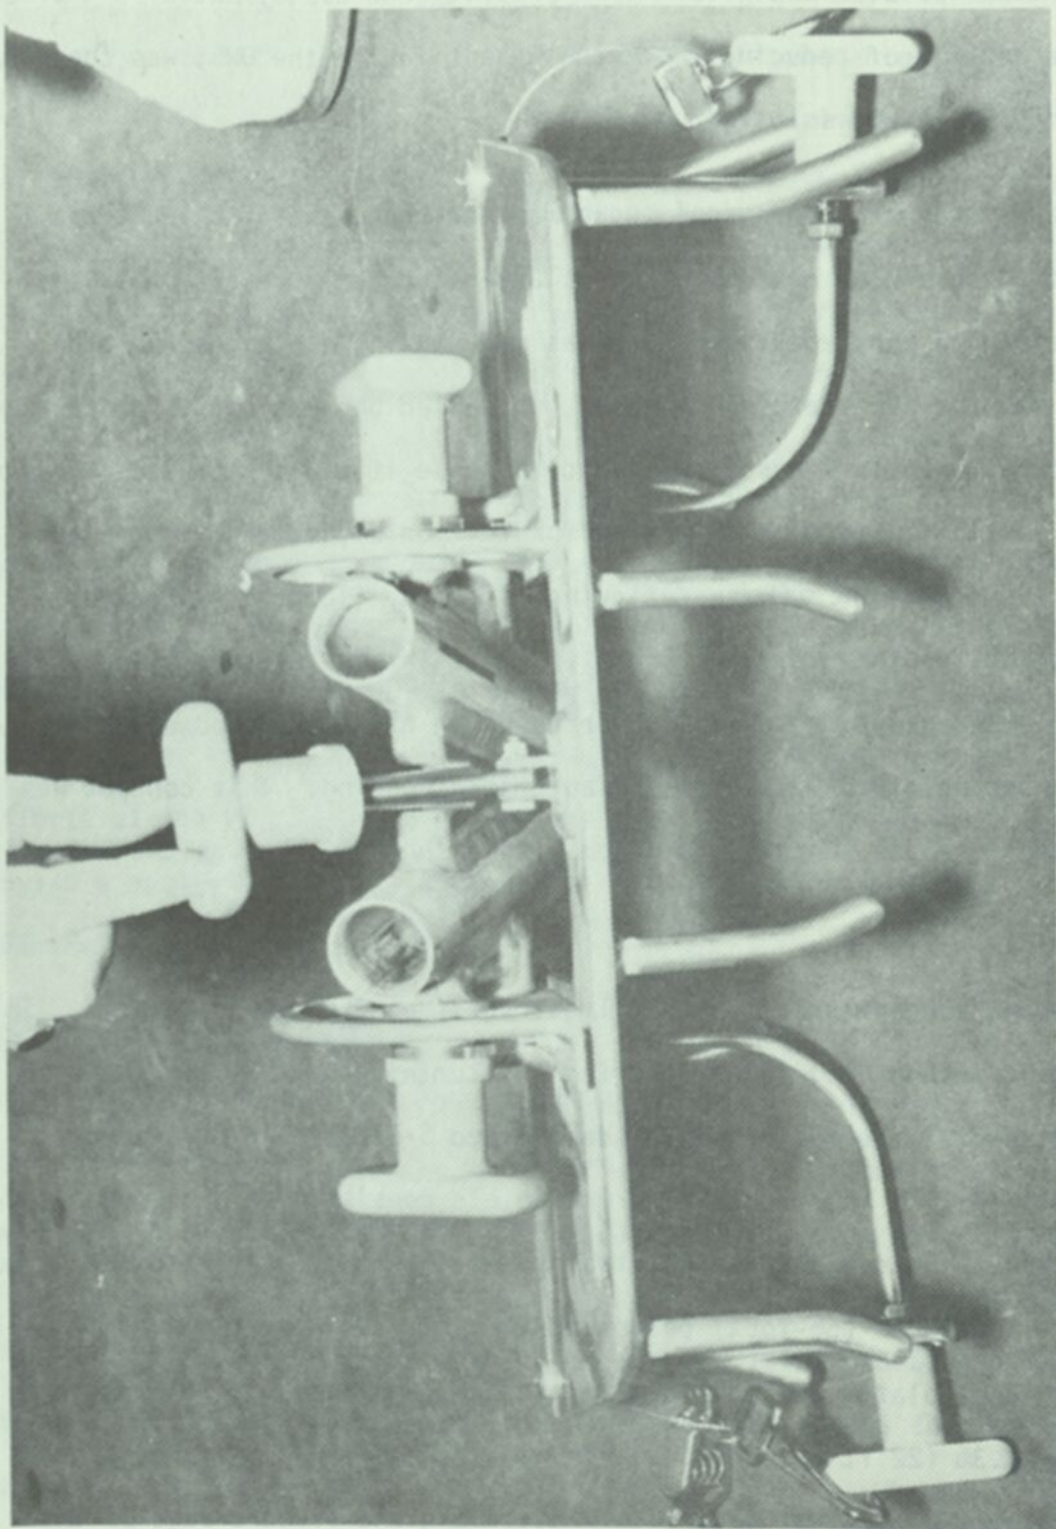
FIGURE 5-12 MSFC TWIN-POLE SAIL "BASE PLATE"

The second concept selected for flight was the MSFC twin-pole sail. This shielding method utilized a covering of aluminized mylar film, coated with a special thermal compound (designated S-13G). The deployment/assembly for the replacement thermal shield consisted of a simple mounting bracket "Base plate" which attached to the ATM A-frame trusses (Figure 5-12). Two 16.6m (55-foot) poles mounted in a "V" position were installed in the "Base plate" and extended to the OWS. A Thermal Shield (sail) 6.7m by 7.3m (22 ft by 24 ft), which was packaged in a large retaining bag, (Figure 5-13), was unfurled by attaching the forward edge of the
