NASA TECHNICAL
MEMORANDUM

NASA TM X-64844

MSFC SKYLAB NEUTRAL BUOYANCY SIMULATOR

14. SPONSORING AGENCY CODE	
15. SUPPLEMENTARY NOTES			
16. ABSTRACT Presented in this report is the role of the Neutral Buoyancy Simulator in the development, crew training, and flight operational aspects of Skylab.

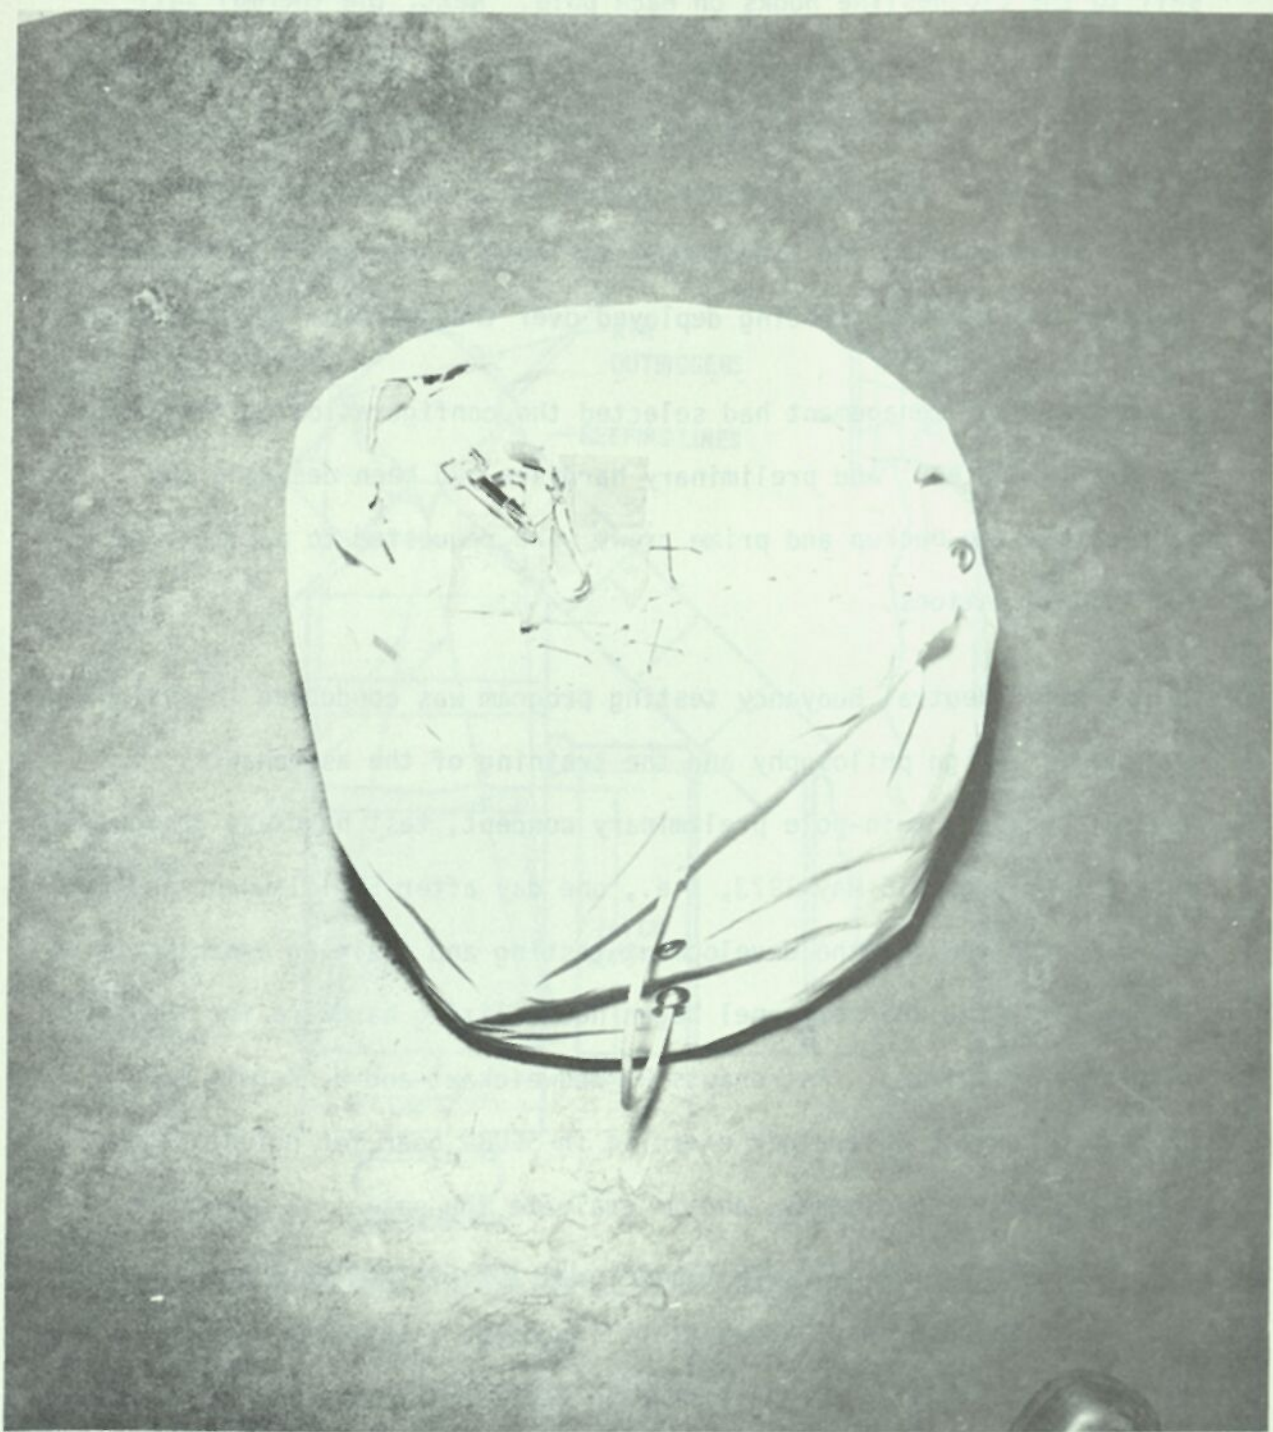
FIGURE 5-13 THERMAL SHIELD (SAIL) BAG

The second concept selected for flight was the MSFC twin-pole sail. This shielding method utilized a covering of aluminized mylar film, coated with a special thermal compound (designated S-13G). The deployment/assembly for the replacement thermal shield consisted of a simple mounting bracket "Base plate" which attached to the ATM A-frame trusses (Figure 5-12). Two 16.6m (55-foot) poles mounted in a "V" position were installed in the "Base plate" and extended to the OWS. A Thermal Shield (sail) 6.7m by 7.3m (22 ft by 24 ft), which was packaged in a large retaining bag, (Figure 5-13), was unfurled by attaching the forward edge of the

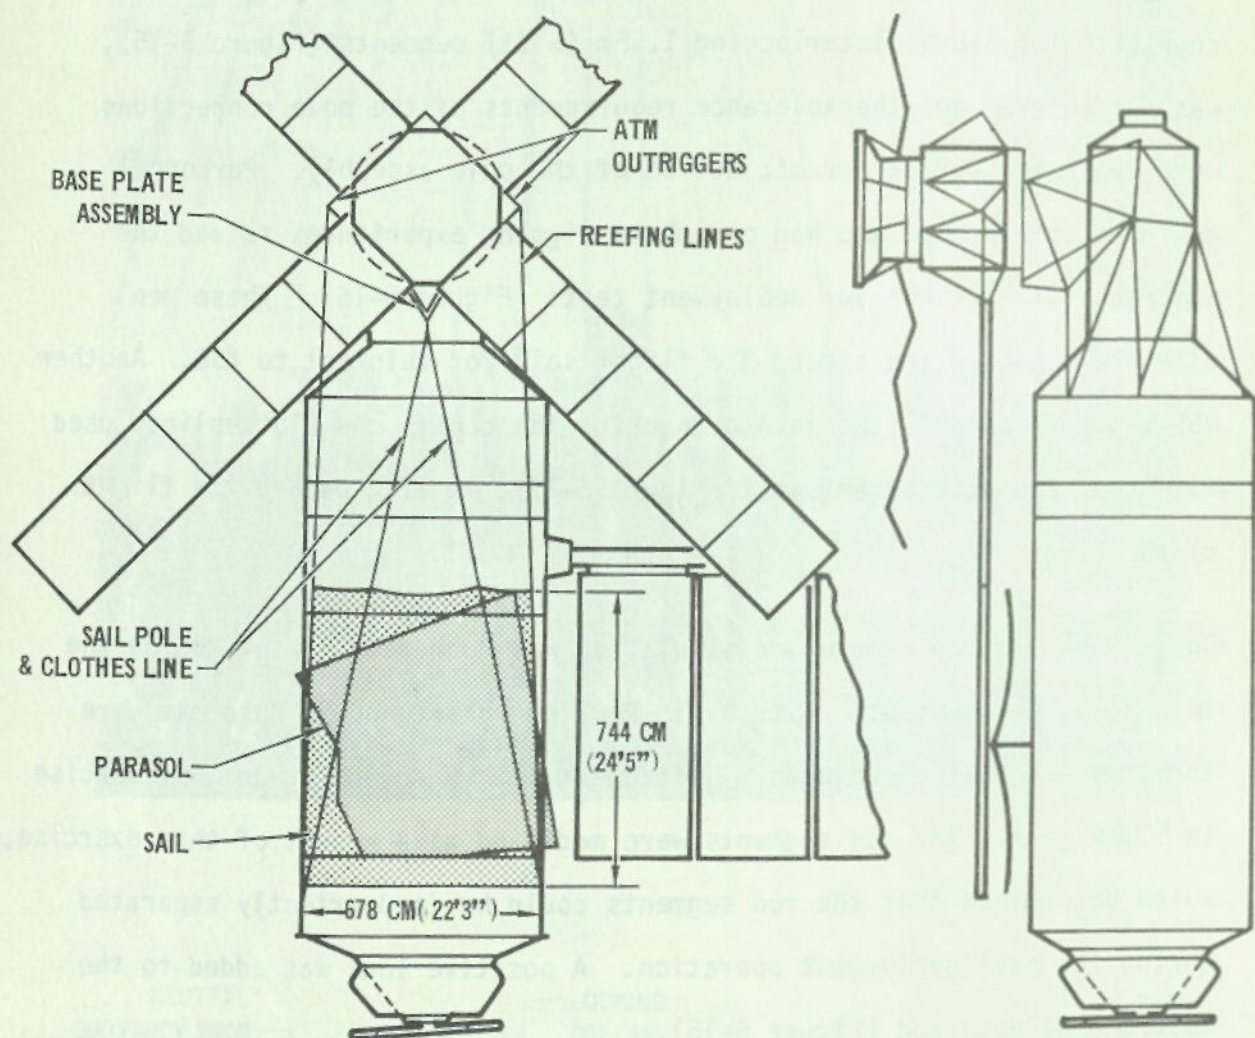
sail to the clothesline hooks on each pole. Next, the thermal sail was positioned by drawing the ropes (i.e. endless clothesline) until the leading edge of the sail was positioned against the far end of the extended poles. The trailing end of the sail, with attached reefer lines, was stretched and tied tautly to the ATM outriggers (Figure 5-14). The sail was capable of being deployed over the "Parasol", if required.

FIGURE 5-14 THERMAL SHIELD DEPLOYMENT CONFIGURATION "TWIN-POLE"

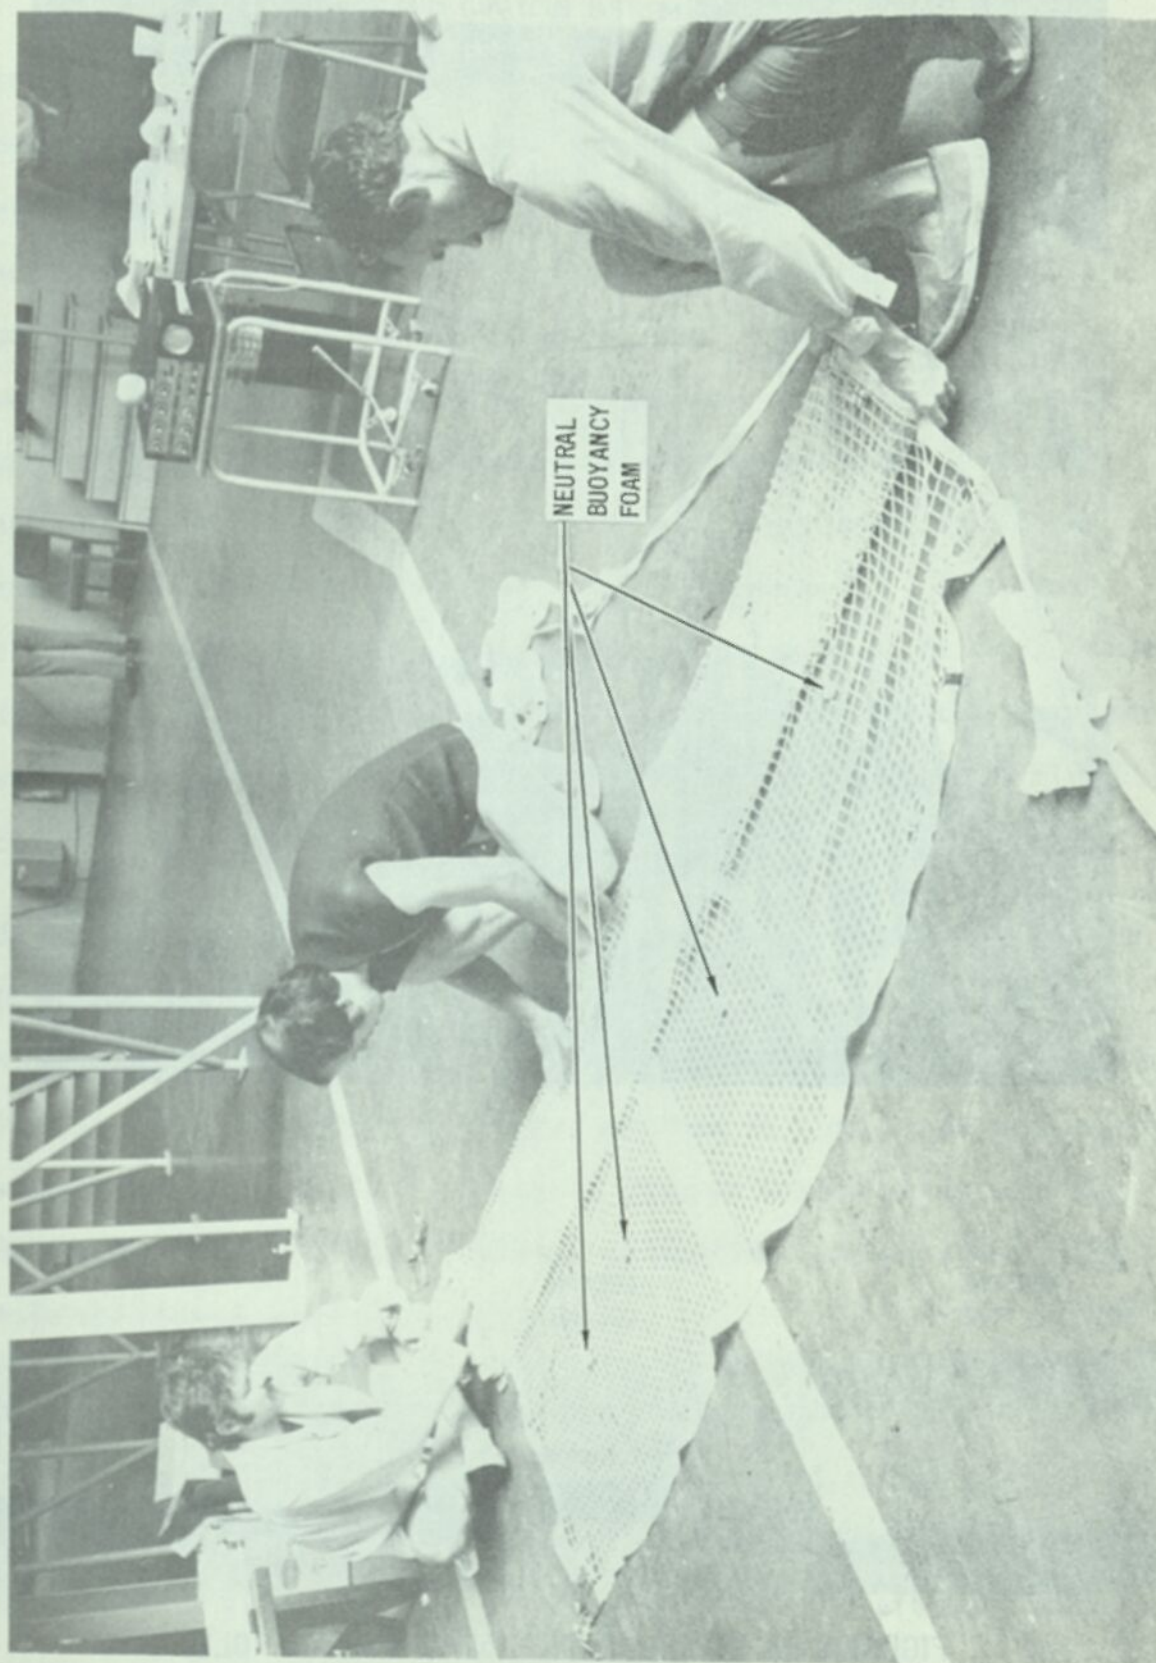
FIGURE 5-16 FOLDING THE NBS TWIN-POLE SAIL

NEUTRAL
BUOYANCY
FOAM

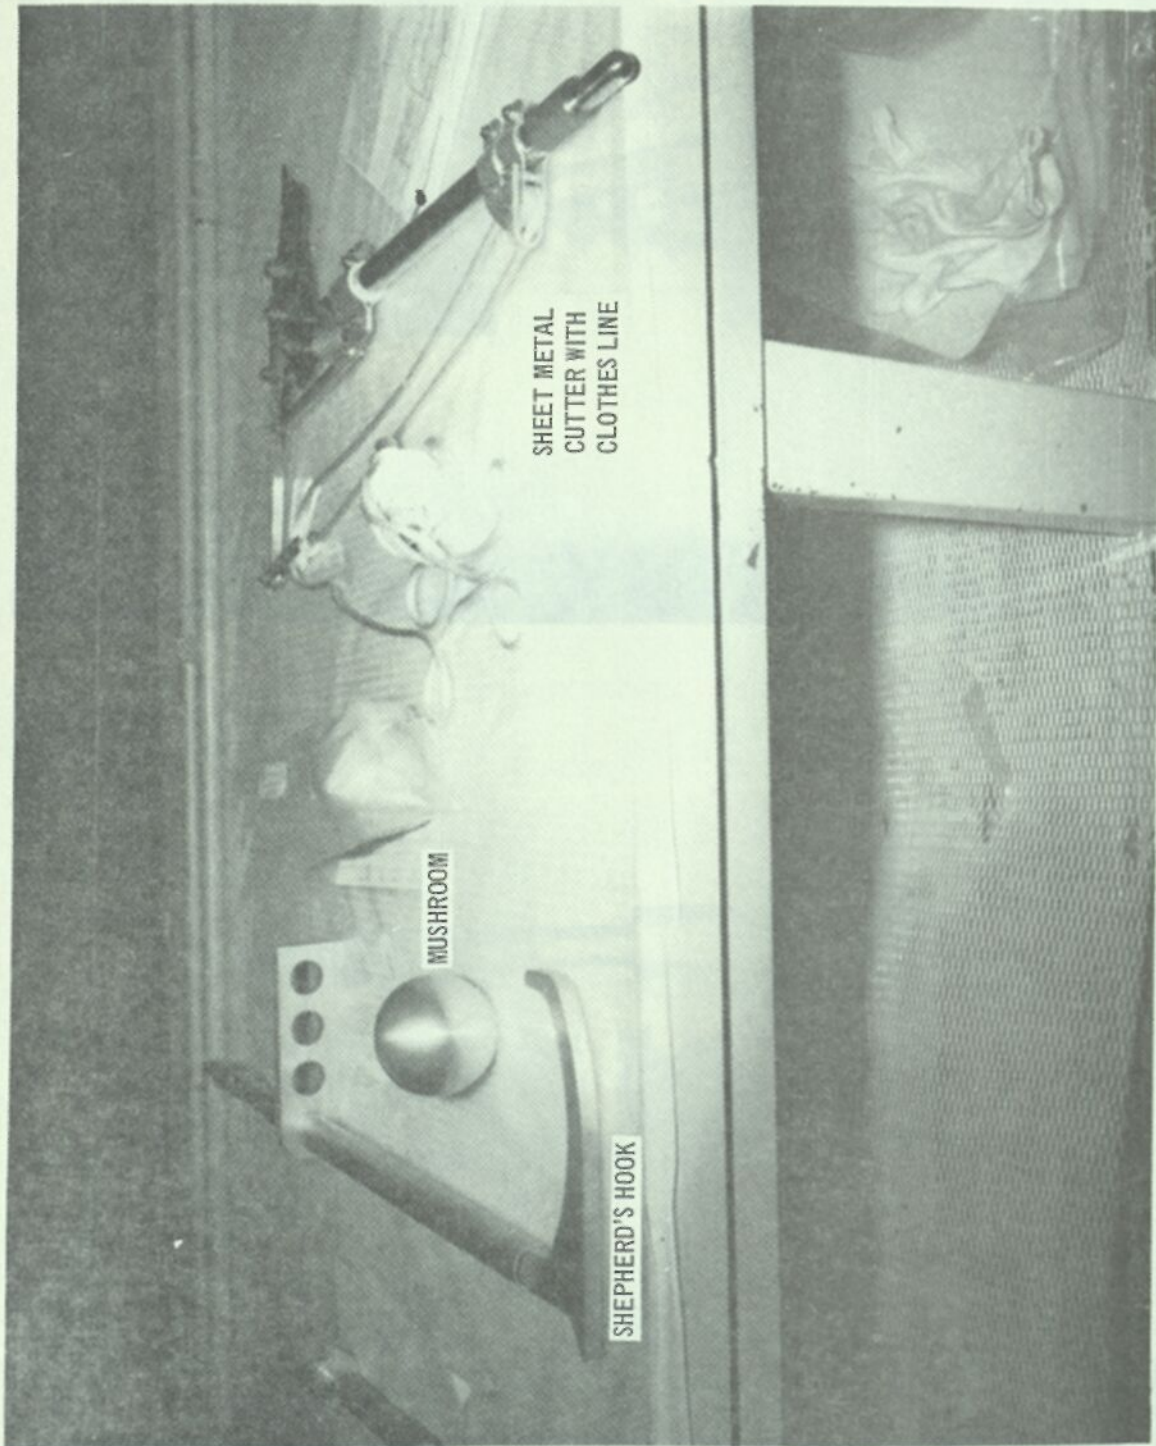
FIGURE 5-19 DEBRIS REMOVAL TOOLS

SHEET METAL
CUTTER WITH
CLOTHES LINE

MUSHROOM

SHEPHERD'S HOOK

- 9:00 A.M. NB Hardware Bench Review (Figure 5-19)
- 10:00 A.M. Thermal Sail Contingency EVA Training in NBS - Astronauts C. Conrad and J. Kerwin
- 2:00 P. M. SEVA, Debris Removal and SAS Deployment - Astronaut P. Weitz
- 3:00 P. M. Flight Hardware Bench Review
- 4:15 P. M. Sail Pole Stability Test, Building 4619 (One-G)

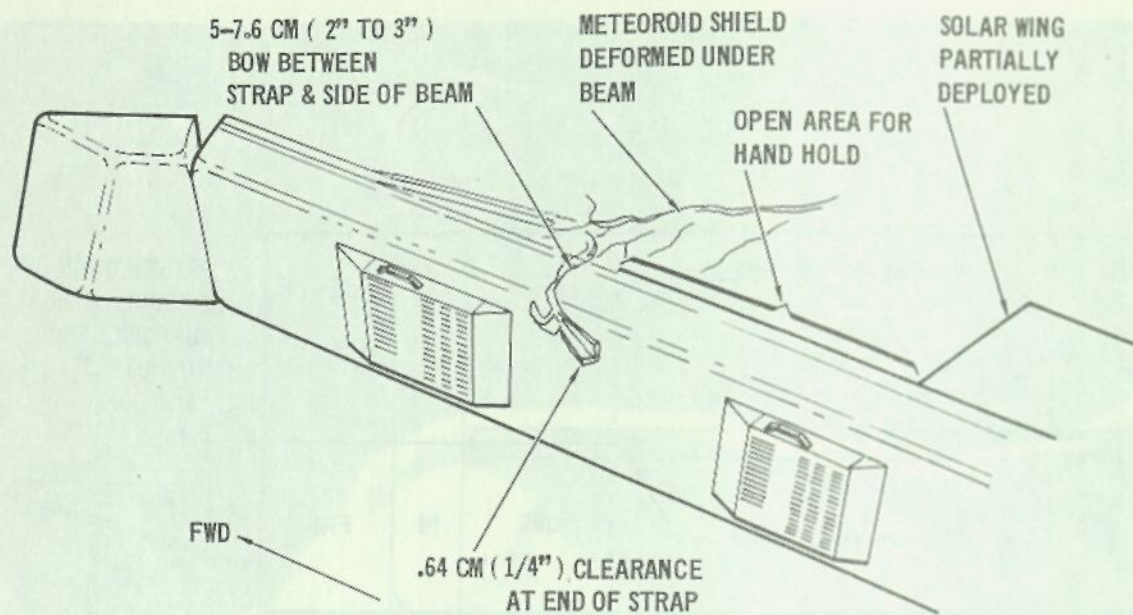
FIGURE 5-24 CONFIGURATION OF SAS WING NO. 1 PER TELECON WITH CREW - CDT 1430 6/1/73

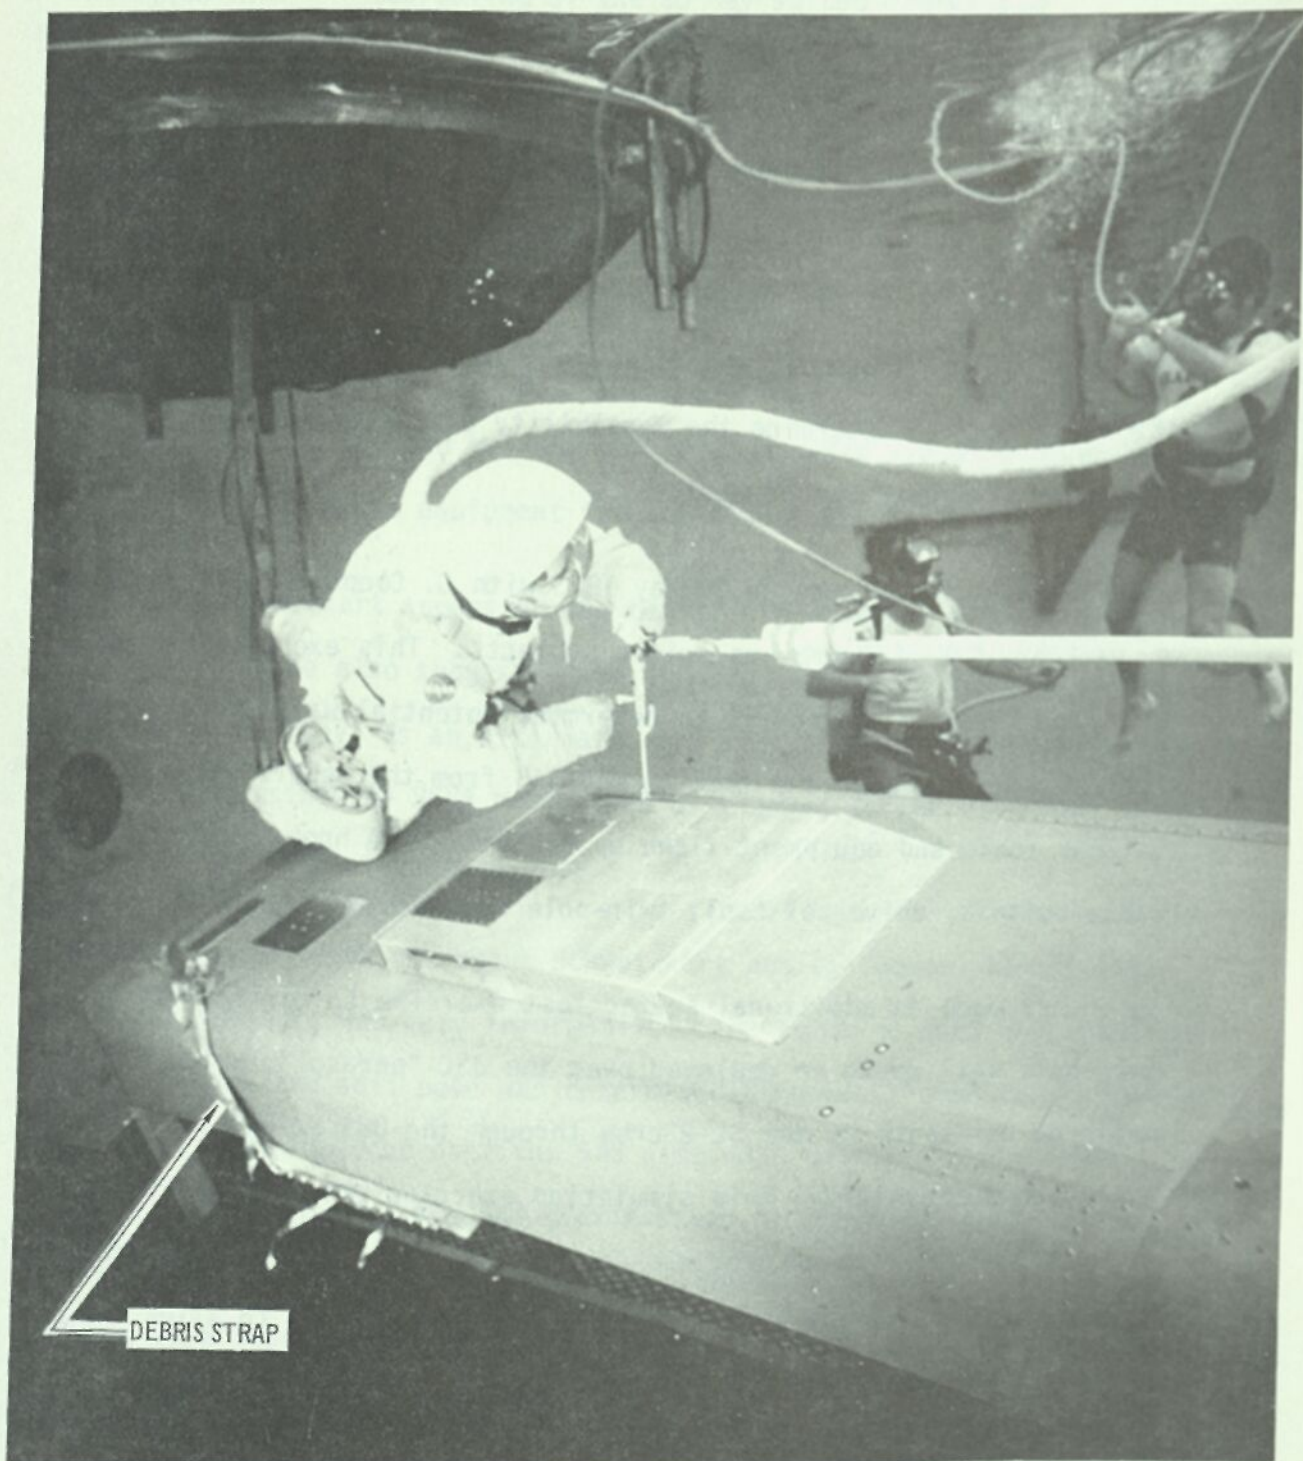
FIGURE 5-27 NBS SAS WING MOCKUP WITH DEBRIS STRAP

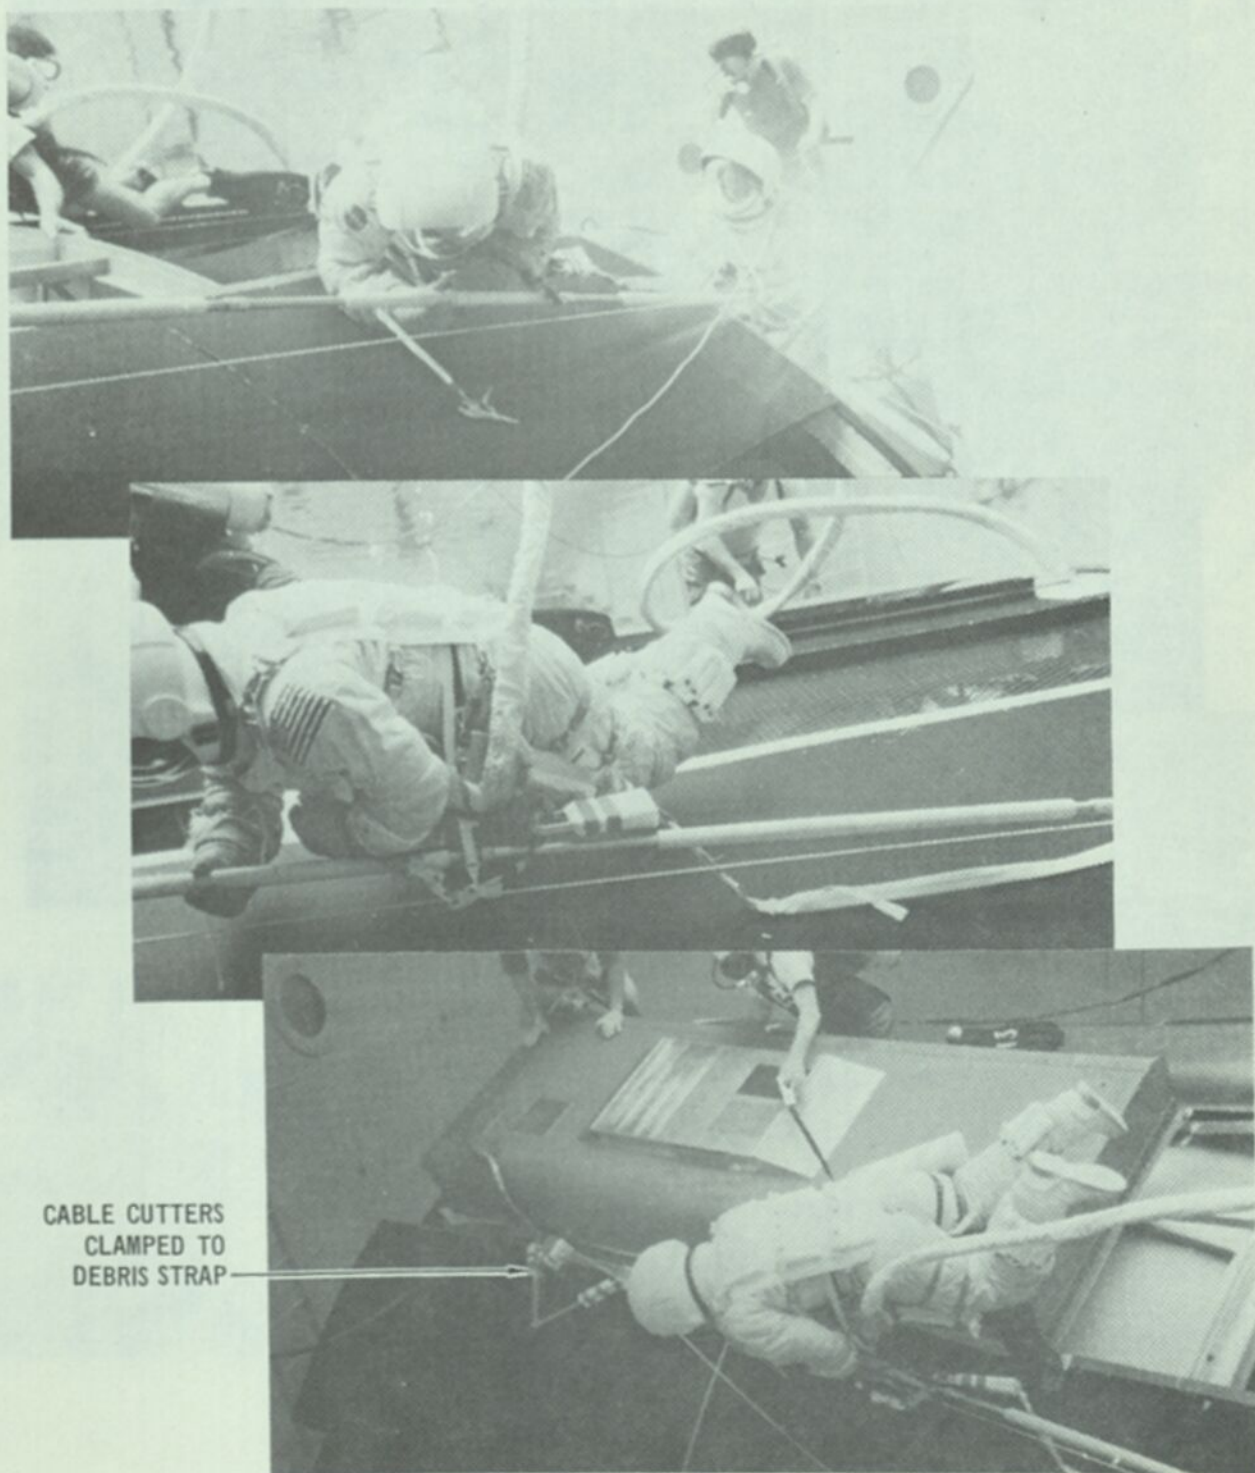
FIGURE 5-33 ASTRONAUTS TRANSLATING OUT TO THE SAS WING USING FIVE
SAIL POLE SEGMENTS WITH CABLE CUTTER CLAMPED TO DEBRIS STRAP

CABLE CUTTERS
CLAMPED TO
DEBRIS STRAP

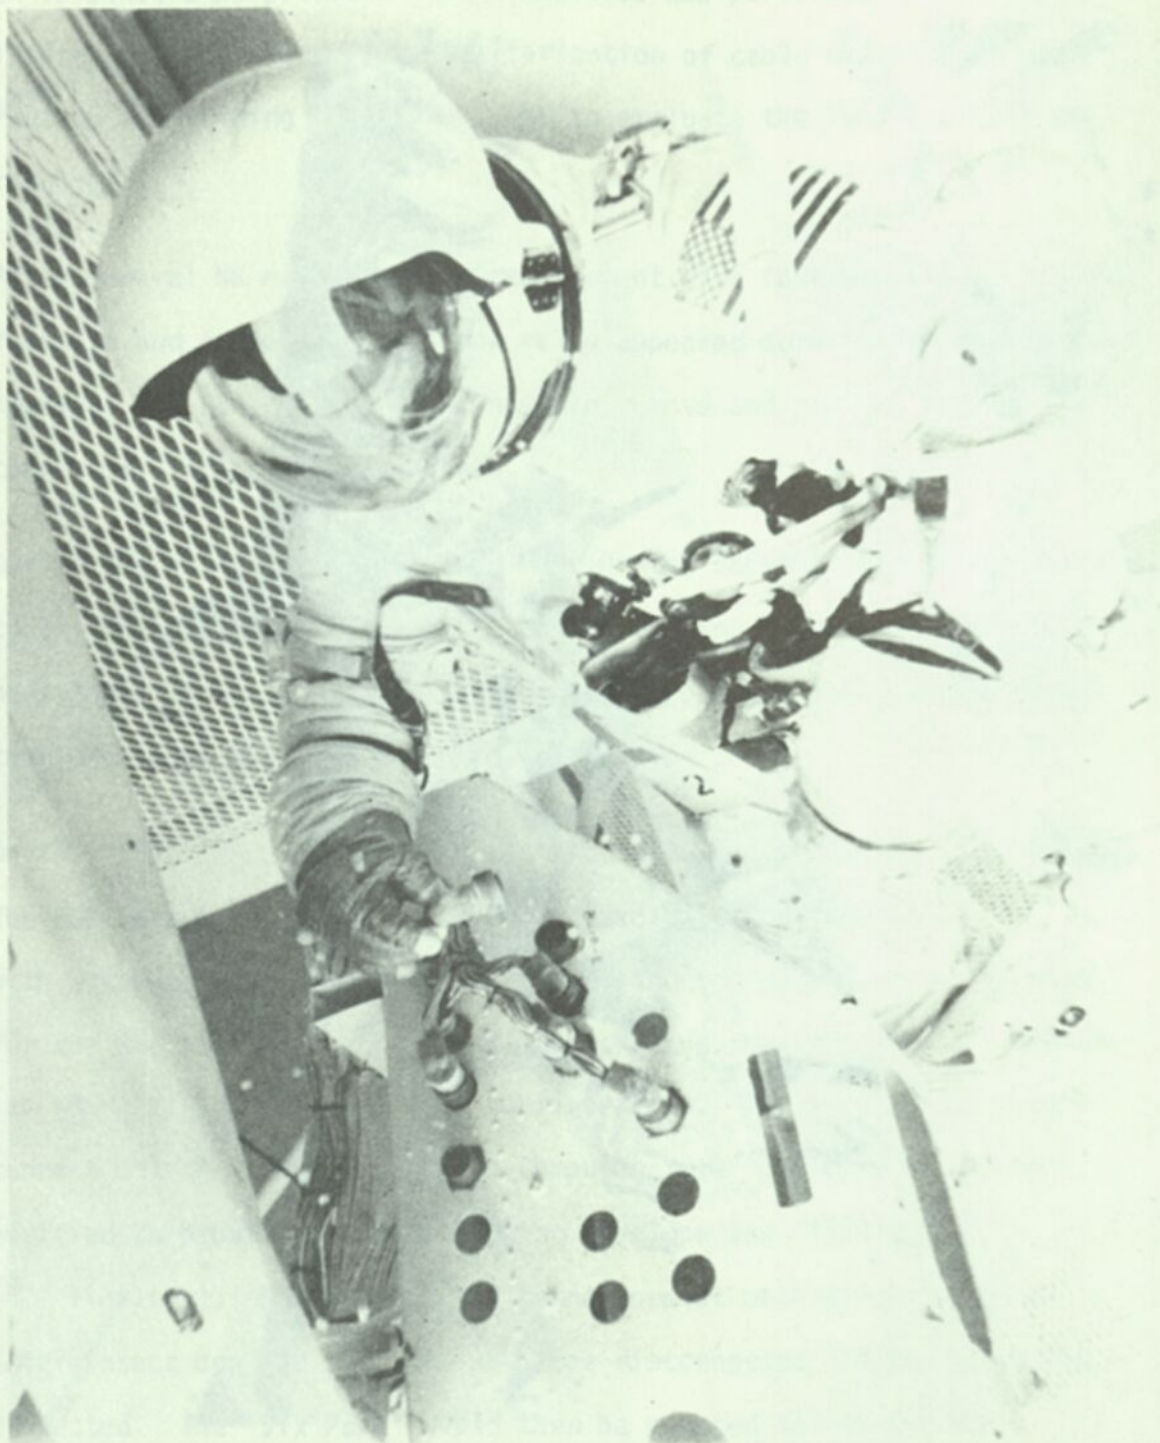
FIGURE 5-41 NBS ELECTRICAL CONNECTOR
PANEL AT UPPER DA FOR
RATE GYRO REPAIR

A meeting was held 13 June to define these repair techniques and the NB hardware required for the evaluation and training. The NB cabling and connector hardware was prepared by the S&E-ASTR Laboratory, which worked closely with the NB personnel in fabricating the hardware for underwater use (Figures 5-41 and 5-42).

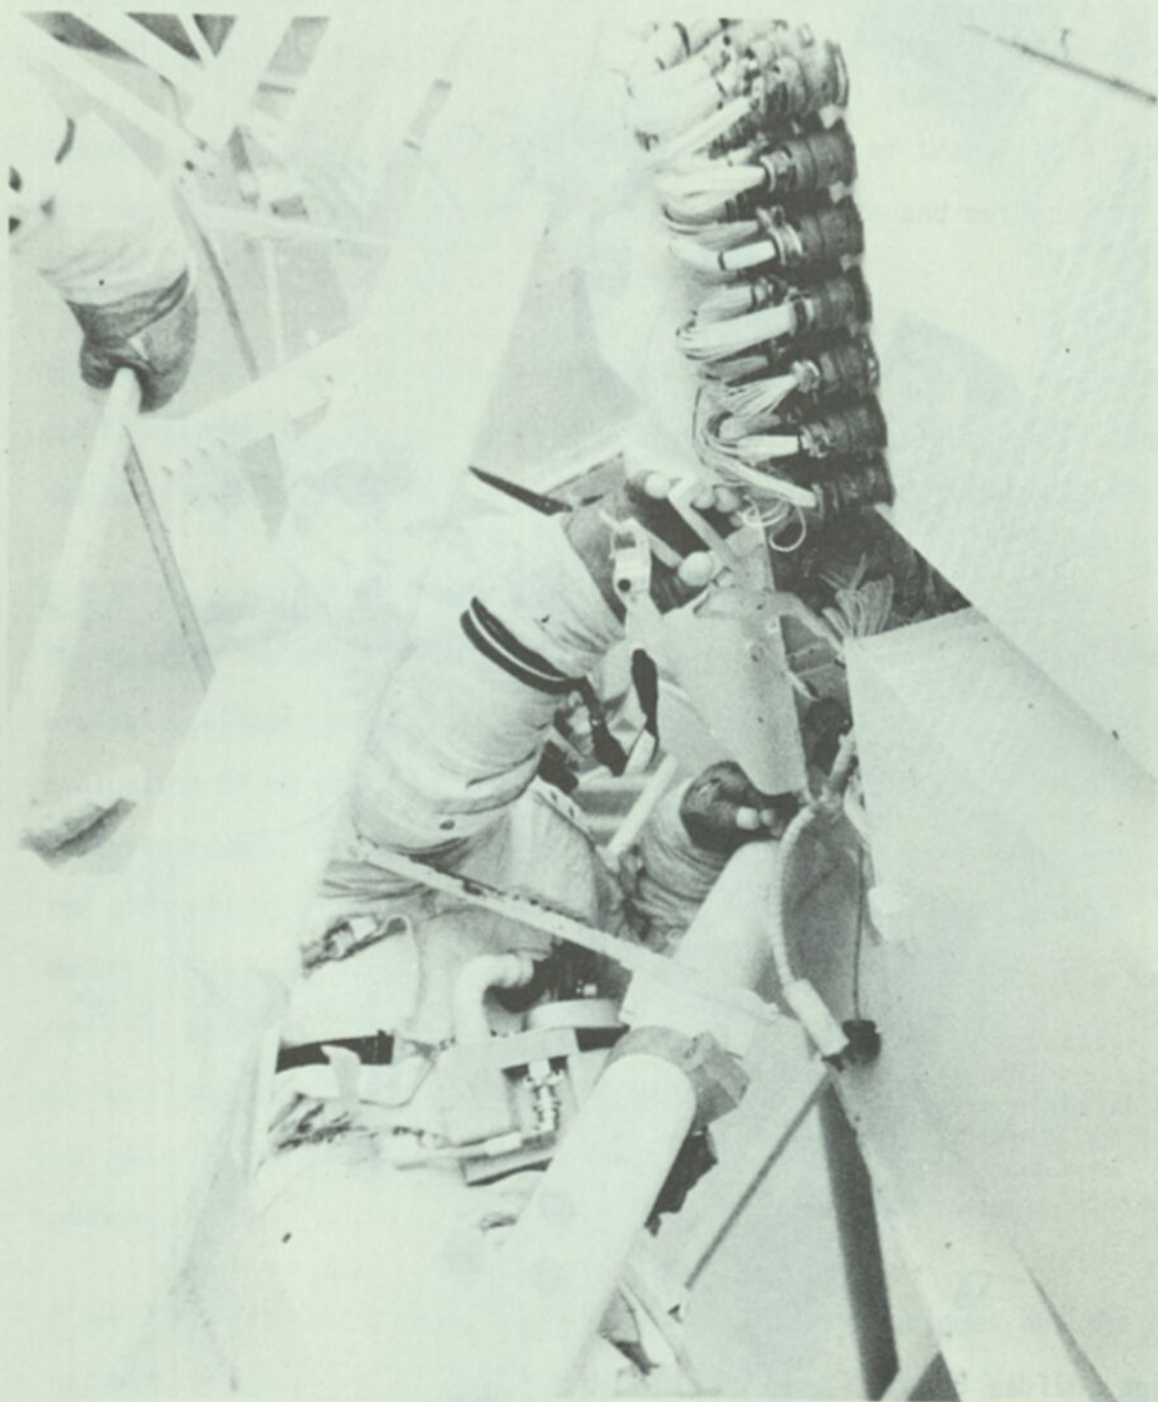
**FIGURE 5-42 NBS ELECTRICAL CONNECTORS
AT ATM FOR RATE GYRO
REPAIR**
