EFFECTS OF HIGH-PRESSURE HYDROGEN ON STEELS

W. T. Chandler and R. J. Walter

Rocketdyne
A Division of North American Rockwell Corporation
Canoga Park, California

North Alabama Chapter
American Society for Metals
Huntsville, Alabama
16 November 1967

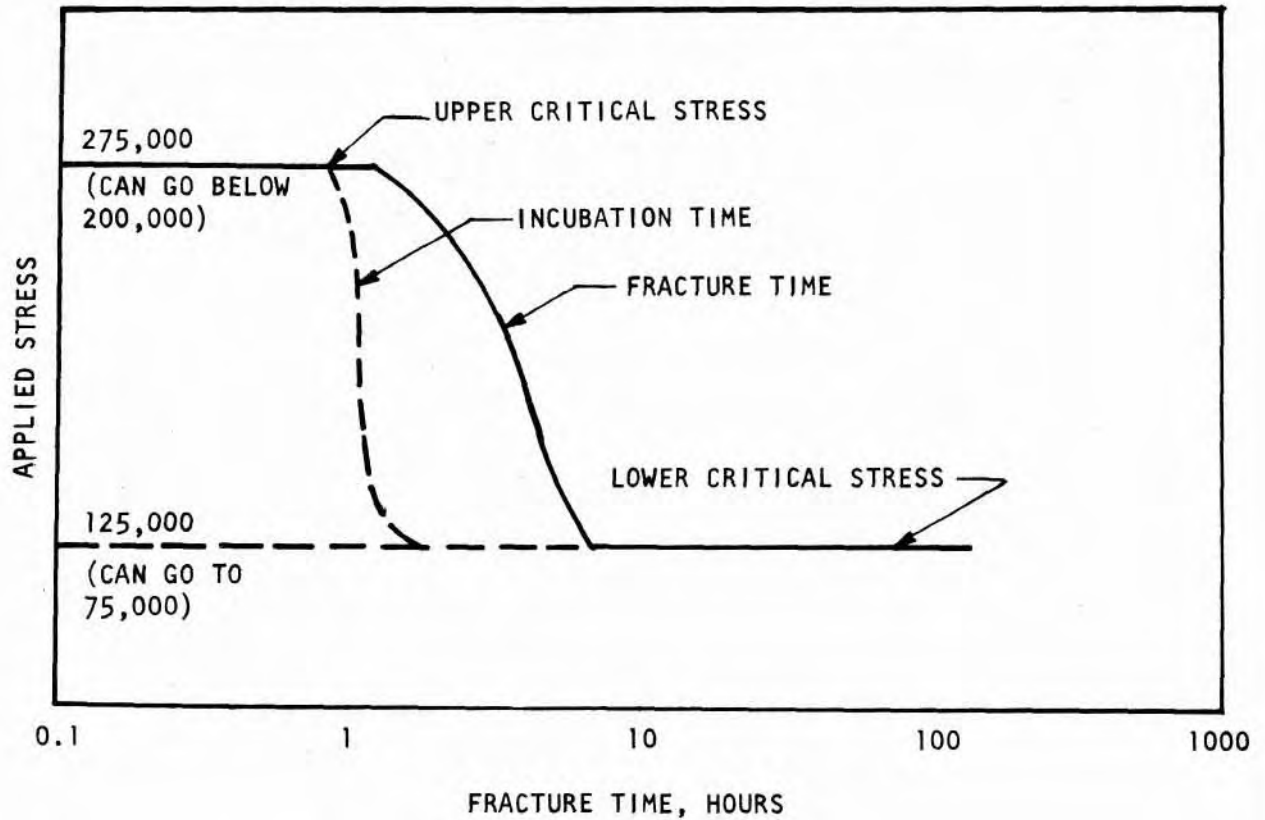
NORMAL NOTCH STRENGTH 300,000 PSI (230,000 PSI STRENGTH LEVEL STEEL)

ELECTROLYTICALLY CHARGED BAKED 7 HOURS AT 300 F

Figure 2. Delayed Failure in Steel

The nature of the delayed failure caused by hydrogen is shown in Fig. 2. The characteristics of this delayed failure are:

1. Notch tensile strength may be less than normal and directly reflects loss of ductility due to hydrogen.
2. Delayed failure may occur over wide range of applied stress.
3. There is only a slight dependence of time to failure upon applied stress.
4. There is a minimum critical stress value below which failure does not occur.
5. Notch strength, rupture time, and lower critical stress increase with decreasing hydrogen concentration.
6. Rupture and lower critical stress increase with decreasing crack severity. It is believed that there is no effect of crack severity per se but gives required critical stress for given hydrogen concentration.
7. Lower critical stress decreases as strength level of steel increases. The lower strength steel blunts the notch.

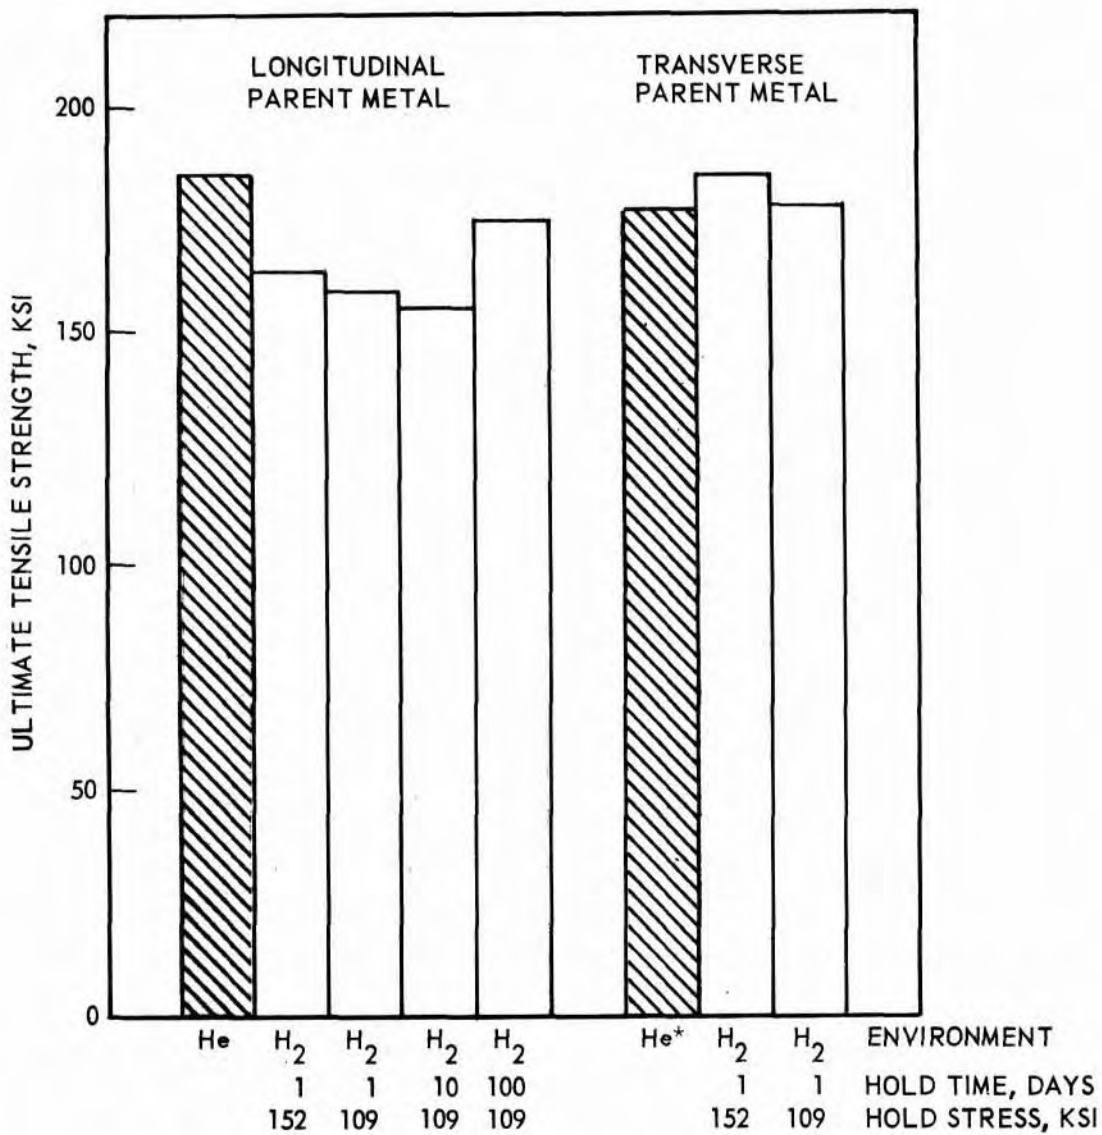
* AS DETERMINED ON UTM MINUS 18,000 PSI TO ADJUST FOR TESTING IN SPRING-LOADED DEVICE WITH 10,000-PSI PRESSURE

Figure 11. Ultimate Tensile Strength of A-302-56 Gr. B Modified With Nickel Notched Parent Metal Specimens in 10,000 psi Hydrogen and Helium

The two notched parent metal specimens that were tested in 10,000 psi hydrogen after holding unstressed for 15 minutes in the hydrogen atmosphere had a 24 percent average reduction of strength. This is a greater degree of embrittlement than was encountered for the specimens held in hydrogen under load.

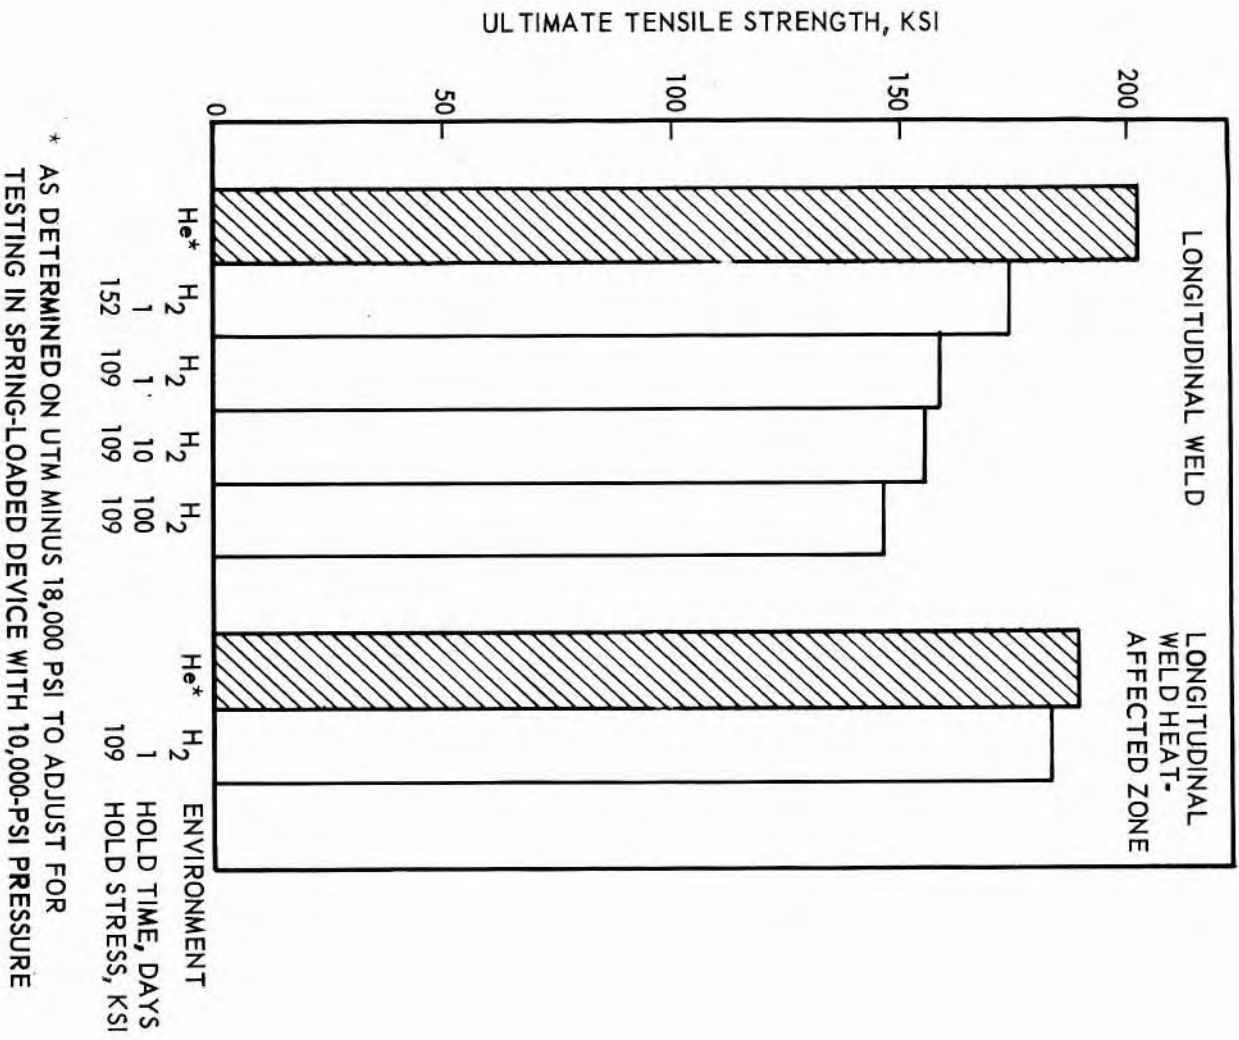
Figure 12. Ultimate Tensile Strength of A-502-56 Gr. B Modified With Nickel Notched Longitudinal Weld Specimens in 10,000 psi Hydrogen and Helium

The notched parent metal specimens oriented in the transverse direction had no significant reduction of strength from the 10,000 psi hydrogen. The ultimate strengths of the notched longitudinal weld specimens are shown in Fig. 12. Specimens with the notch in the longitudinal weld metal were significantly affected by the 10,000 psi hydrogen, and the longer the exposure to hydrogen (with the 109,000 psi hold stress), the greater the reduction of strength. The ultimate strength after the 100-day exposure averaged 145,000 psi which corresponds to a 28 percent average reduction of notched strength. Again, holding at 152,000 psi for 1 day resulted in a lower reduction of notched strength than holding 1 day at 109,000 psi. Specimens notched in the longitudinal weld heat-affected zone were not as embrittled as specimens notched in either the parent metal or the longitudinal weld metal.

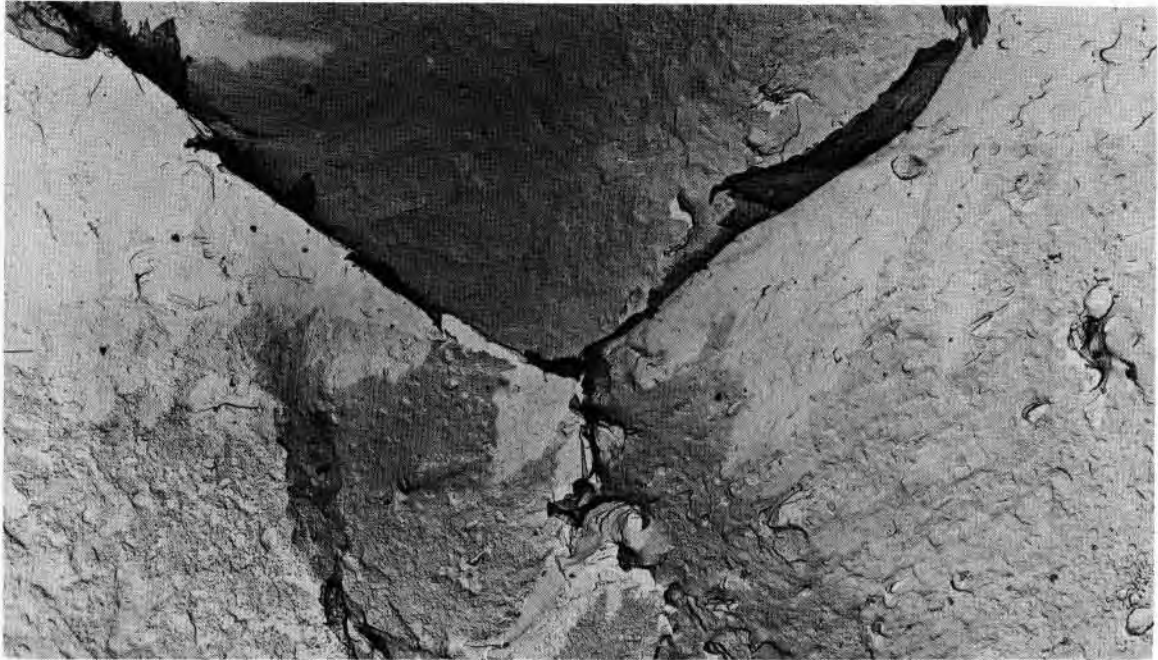
493-B

Figure 18. A-302 Notched Longitudinal Weld Metal Specimen Tested in 10,000 psi Hydrogen; 1-Day Hold

Electron fractographs of A-302 indicate that exposure to 10,000 psi hydrogen affected the fracture mode in the following ways:

1. Exposure to high-pressure hydrogen considerably increases the proportion of the fracture surface which appears brittle.
2. There is evidence that high-pressure hydrogen causes cracking in the fracture surface and the amount of cracking increases with duration of exposure to hydrogen. Figure 18 shows intergranular cracks and Fig. 19 shows transgranular cracks on the fracture surface of a notched A-302 specimen.
3. Exposure to high-pressure hydrogen results in a brittle fracture mode at the fracture surface-machined surface interface of notched specimens (Fig. 20). In contrast, this interface in notched specimens tested in air or 10,000 psi helium was quite ductile (Fig. 21). Also, this interface in notched, hydrogen-charged specimens is ductile, Fig. 22 (Ref. 27).

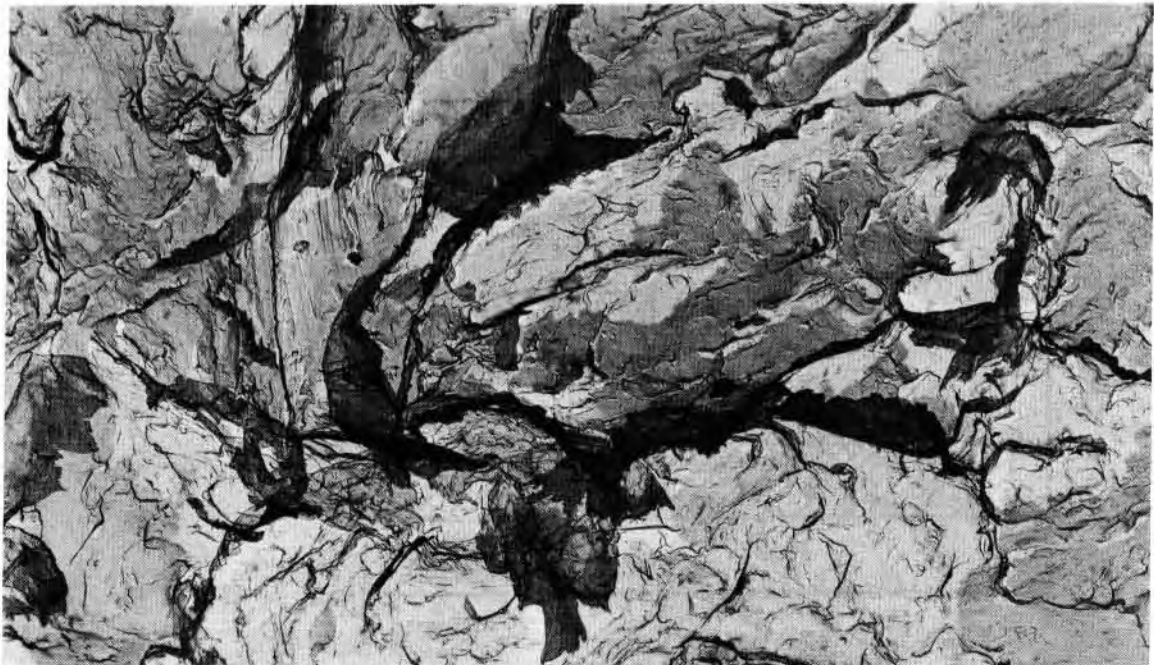
Electron Fractograph

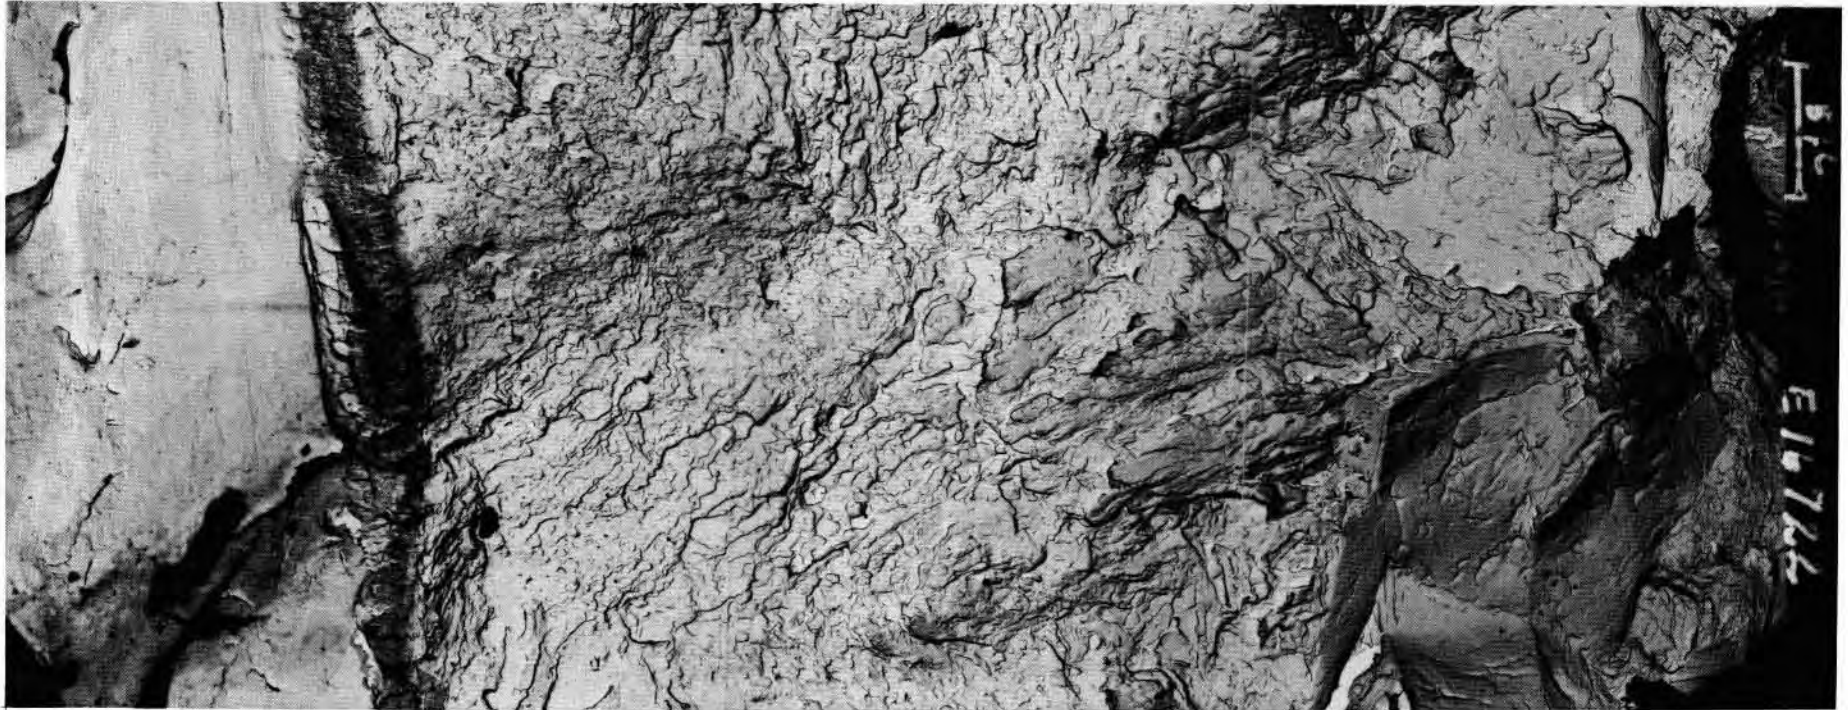
Machined Surface

Ductile

Brittle (Fracture Nucleus)

Figure 22. Notched 300M Specimen, Cd Plated and Baked Failed After 75 Minutes at 124 ksi (50 Percent of Yield)

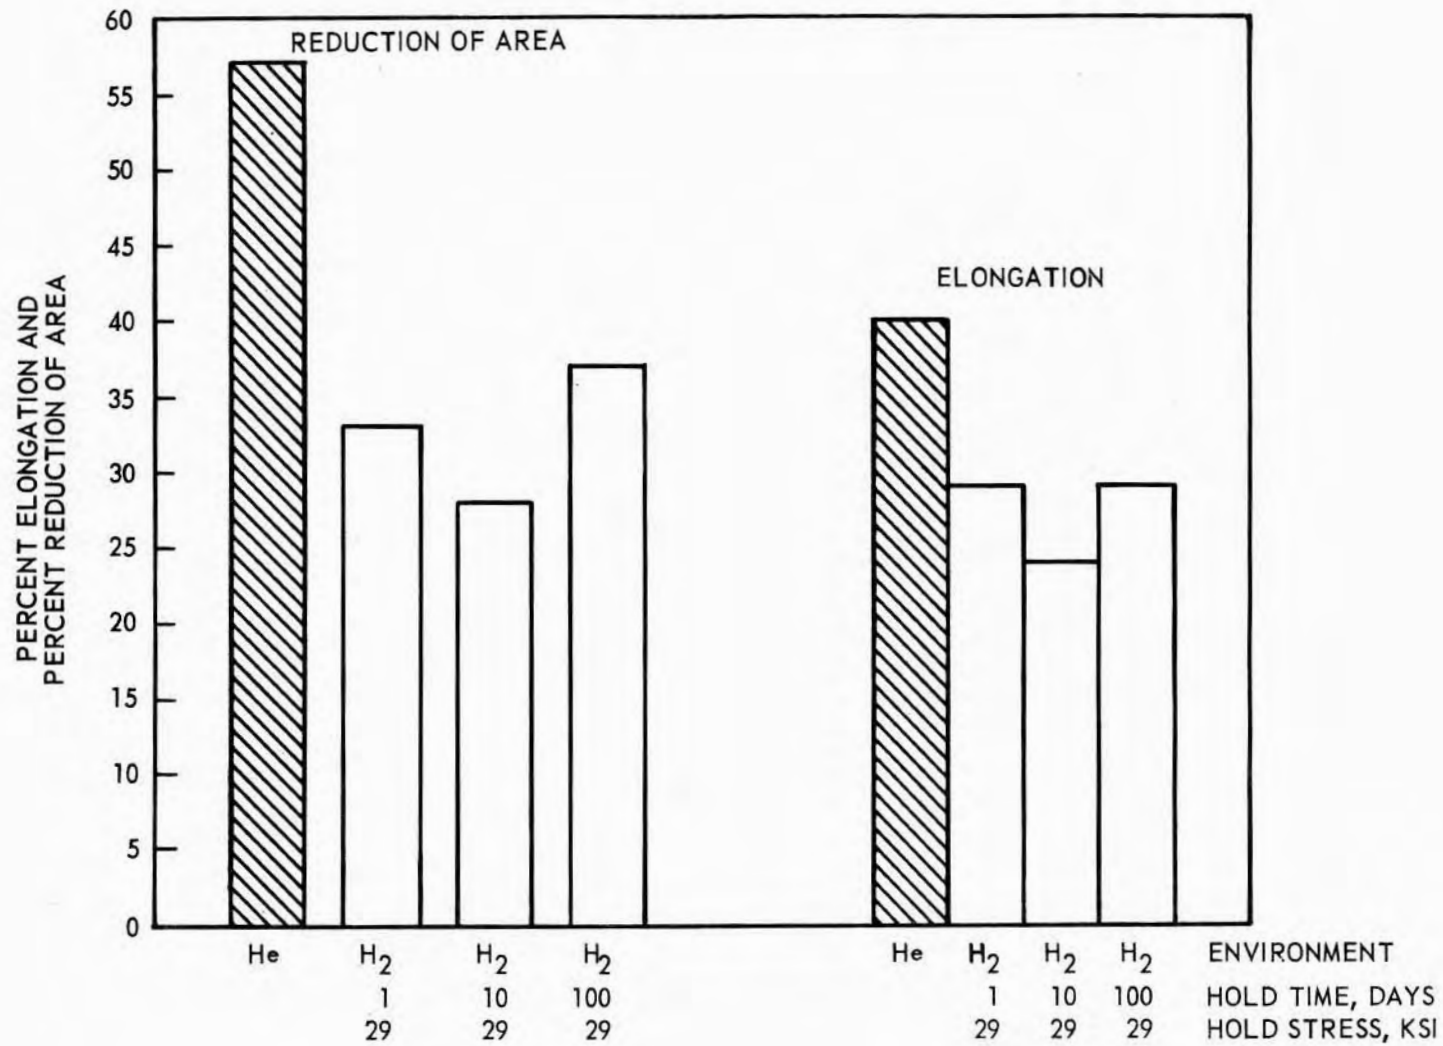
Figure 23. Reduction of Area and Elongation in 10,000 psi Hydrogen and Helium of A-212-61T Gr. B-FB Unnotched Parent Metal Longitudinal Specimens

A-212. In general, the strength of the unnotched specimens was unaffected by the 10,000 psi hydrogen environment.

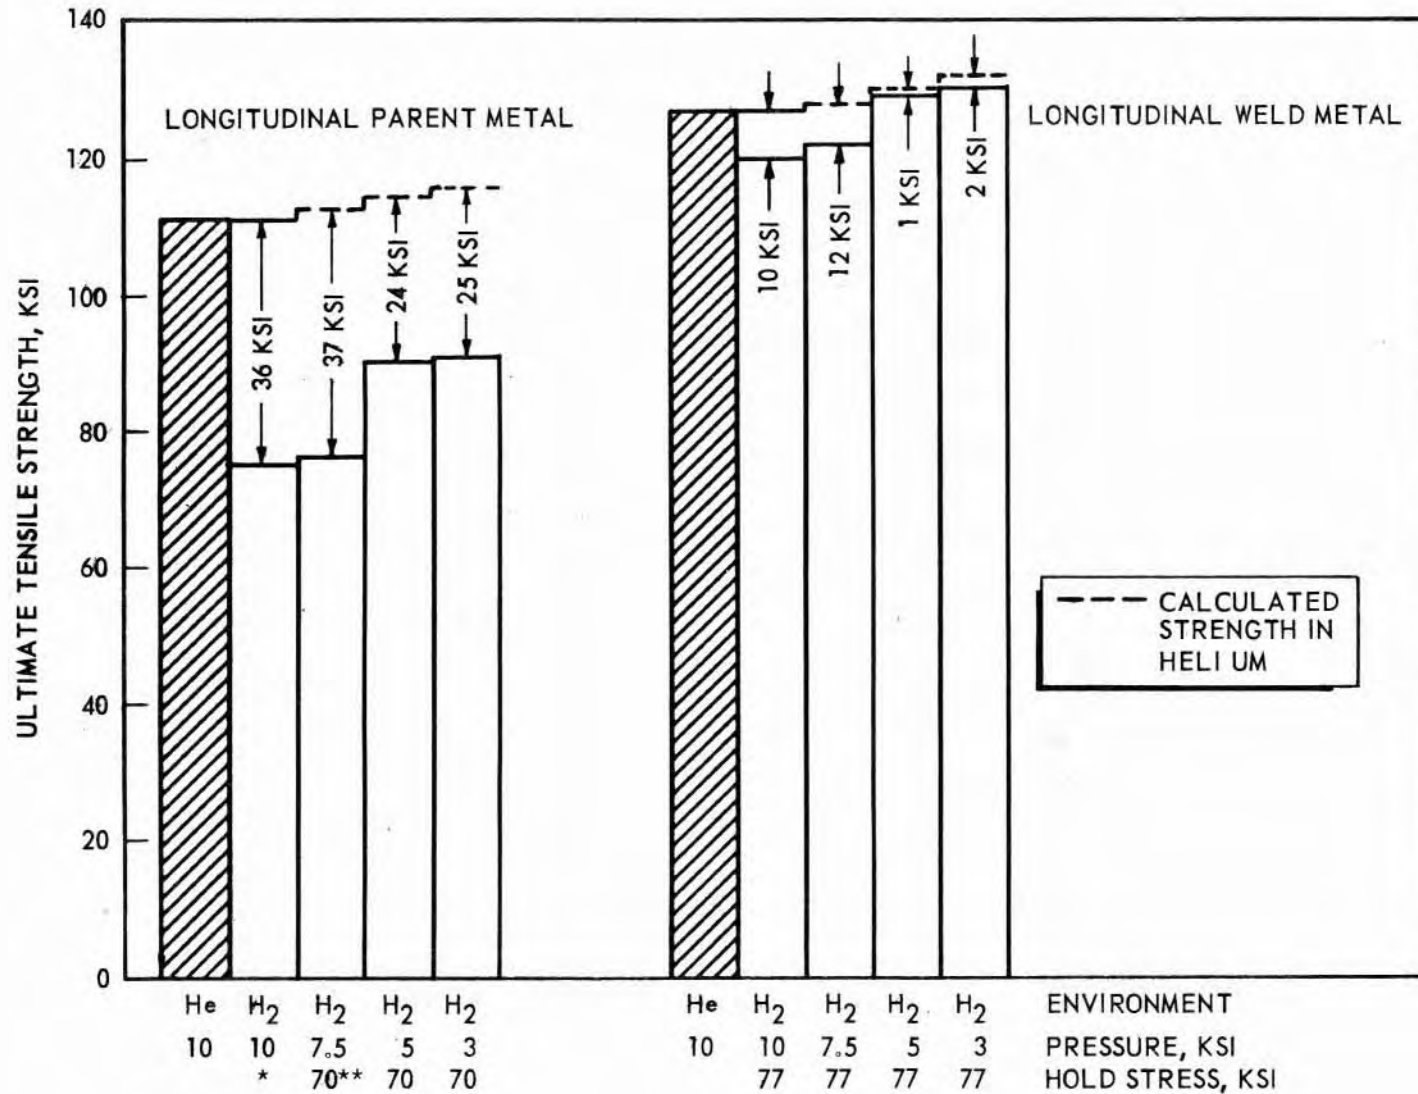
Figure 26. Effect of Hydrogen Pressure on the Ultimate Tensile Strength of A-212-61T Gr. B-FB Notched Longitudinal Parent Metal and Longitudinal Weld Metal Specimens; 1-Day Hold

The results of the tests conducted at various hydrogen pressures on the notched longitudinal parent metal and longitudinal weld metal specimens of A-212 are plotted in Fig. 26 and 27 for the ultimate strength and ductility, respectively. It can be seen for both types of specimens that when the test pressure was reduced from 7500 to 5000 psi, there was a sharp decrease in the effect of the hydrogen environment on strength.

For hydrogen pressures of 3000 and 5000 psi, the strength of the weld metal specimens was about the same as the calculated strengths in helium at the same pressures, i.e., there was no decrease of strength due to exposure to hydrogen for pressures of 3000 and 5000 psi. However, there was an appreciable decrease of strength of the parent metal specimens at 3000 and 5000 psi hydrogen pressure. At 3000 psi, there is about an 18 percent reduction of strength from that in 10,000 psi helium and about 22 percent reduction of strength from the calculated strength in 3000 psi helium.
