SKYLAB SILHOUETTED AGAINST EARTH, DARK SKY, AS VIEWED FROM COMMAND/SERVICE MODULE

NATIONAL AERONAUTICS AND SPACE ADMINISTRATION

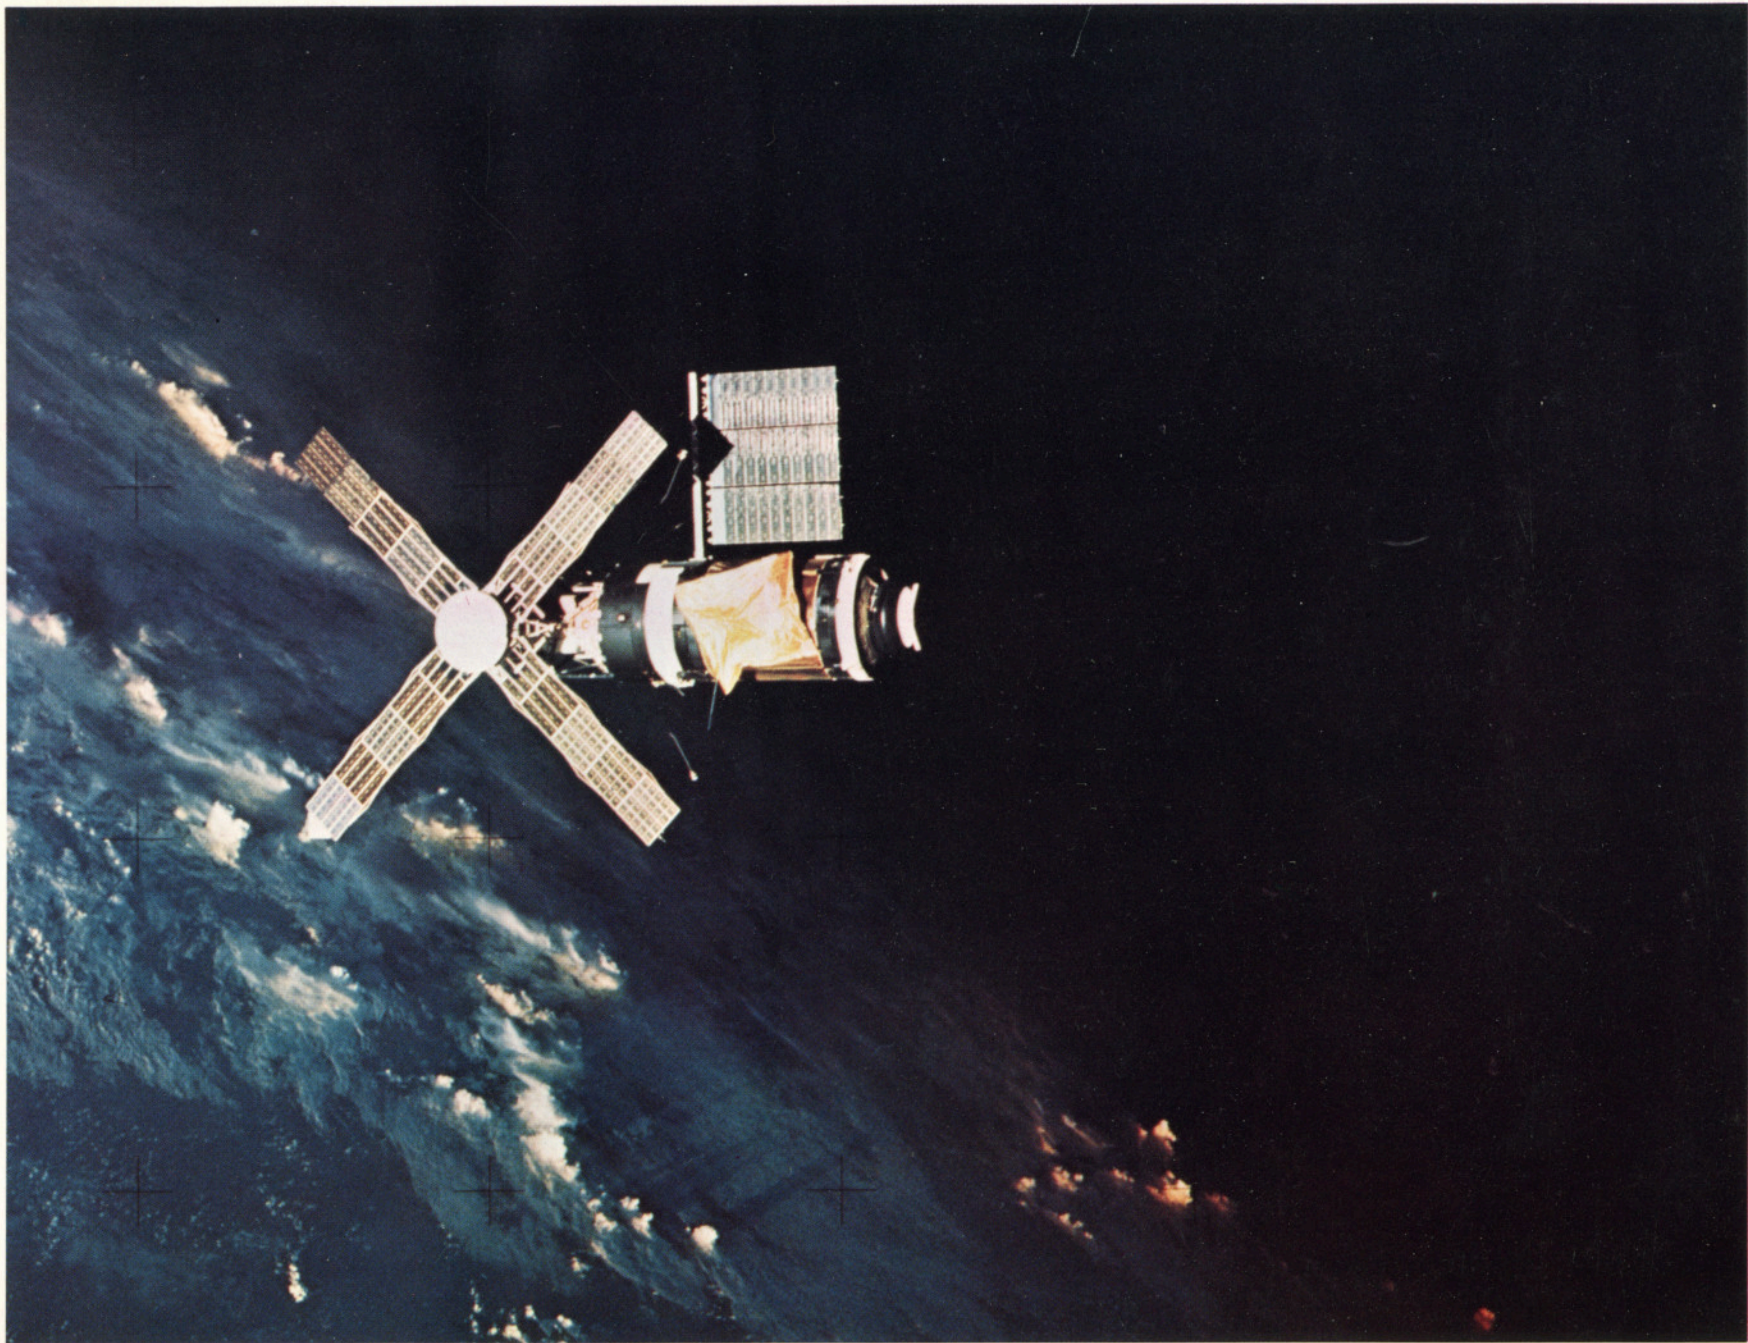
SKYLAB CLUSTER IN EARTH ORBIT—This excellent view of the Skylab 1 space station cluster in Earth orbit was photographed from the Skylab 2 Command/Service Module during the final “fly around” inspection by the CSM. Clouds cover much of the Earth in the background. Sun reflection on the clouds at bottom right gives off an interesting coloration. This is a good view of the Earth’s terminator. The gold-colored diamond-shaped material on the Orbital Workshop (OWS) shields the vehicle from the powerful rays of the sun. The parasol covers the area where the OWS’s micrometeoroid shield is missing. The one remaining OWS solar array system wing has been fully deployed successfully, because of efforts by the astronauts to free the previously stuck solar array beam. The solar panel on the opposite side of the OWS is completely missing.
