Founders' Hall
Athens State College, c.1840, Athens, Al.

photos June 1985, H.P. Jones Falls

PARLOR — Founders' Hall
ASC.

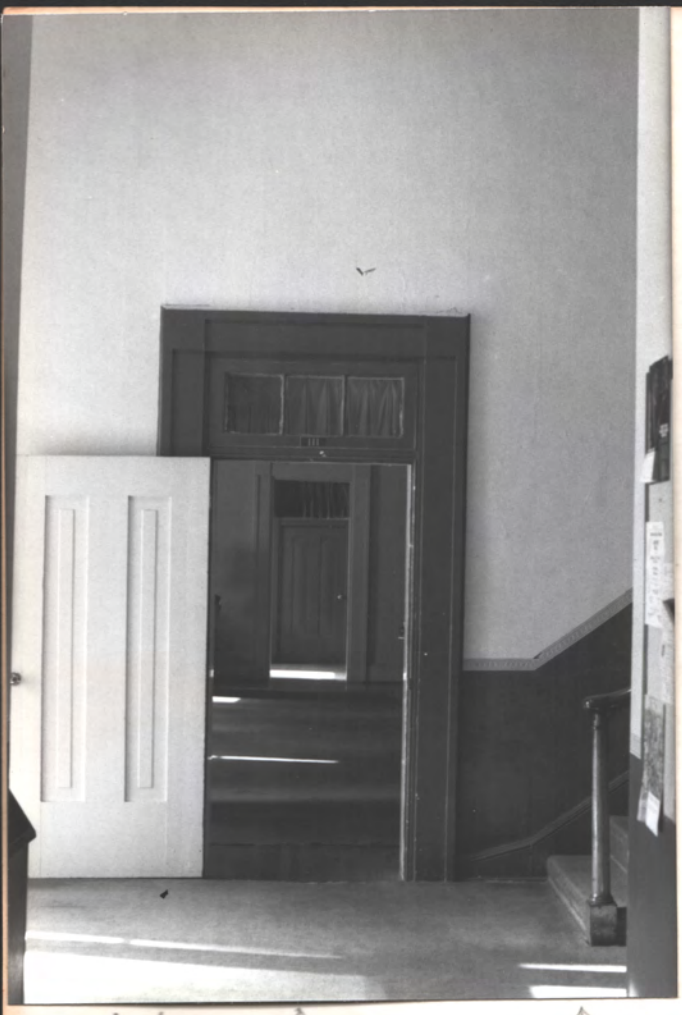
SOUTH STAIR BY PARLOR

mod. closet infill

← STAIR ALL ORIG. (c.1840)
except mod. carpet, metal brace,
& missing one baluster

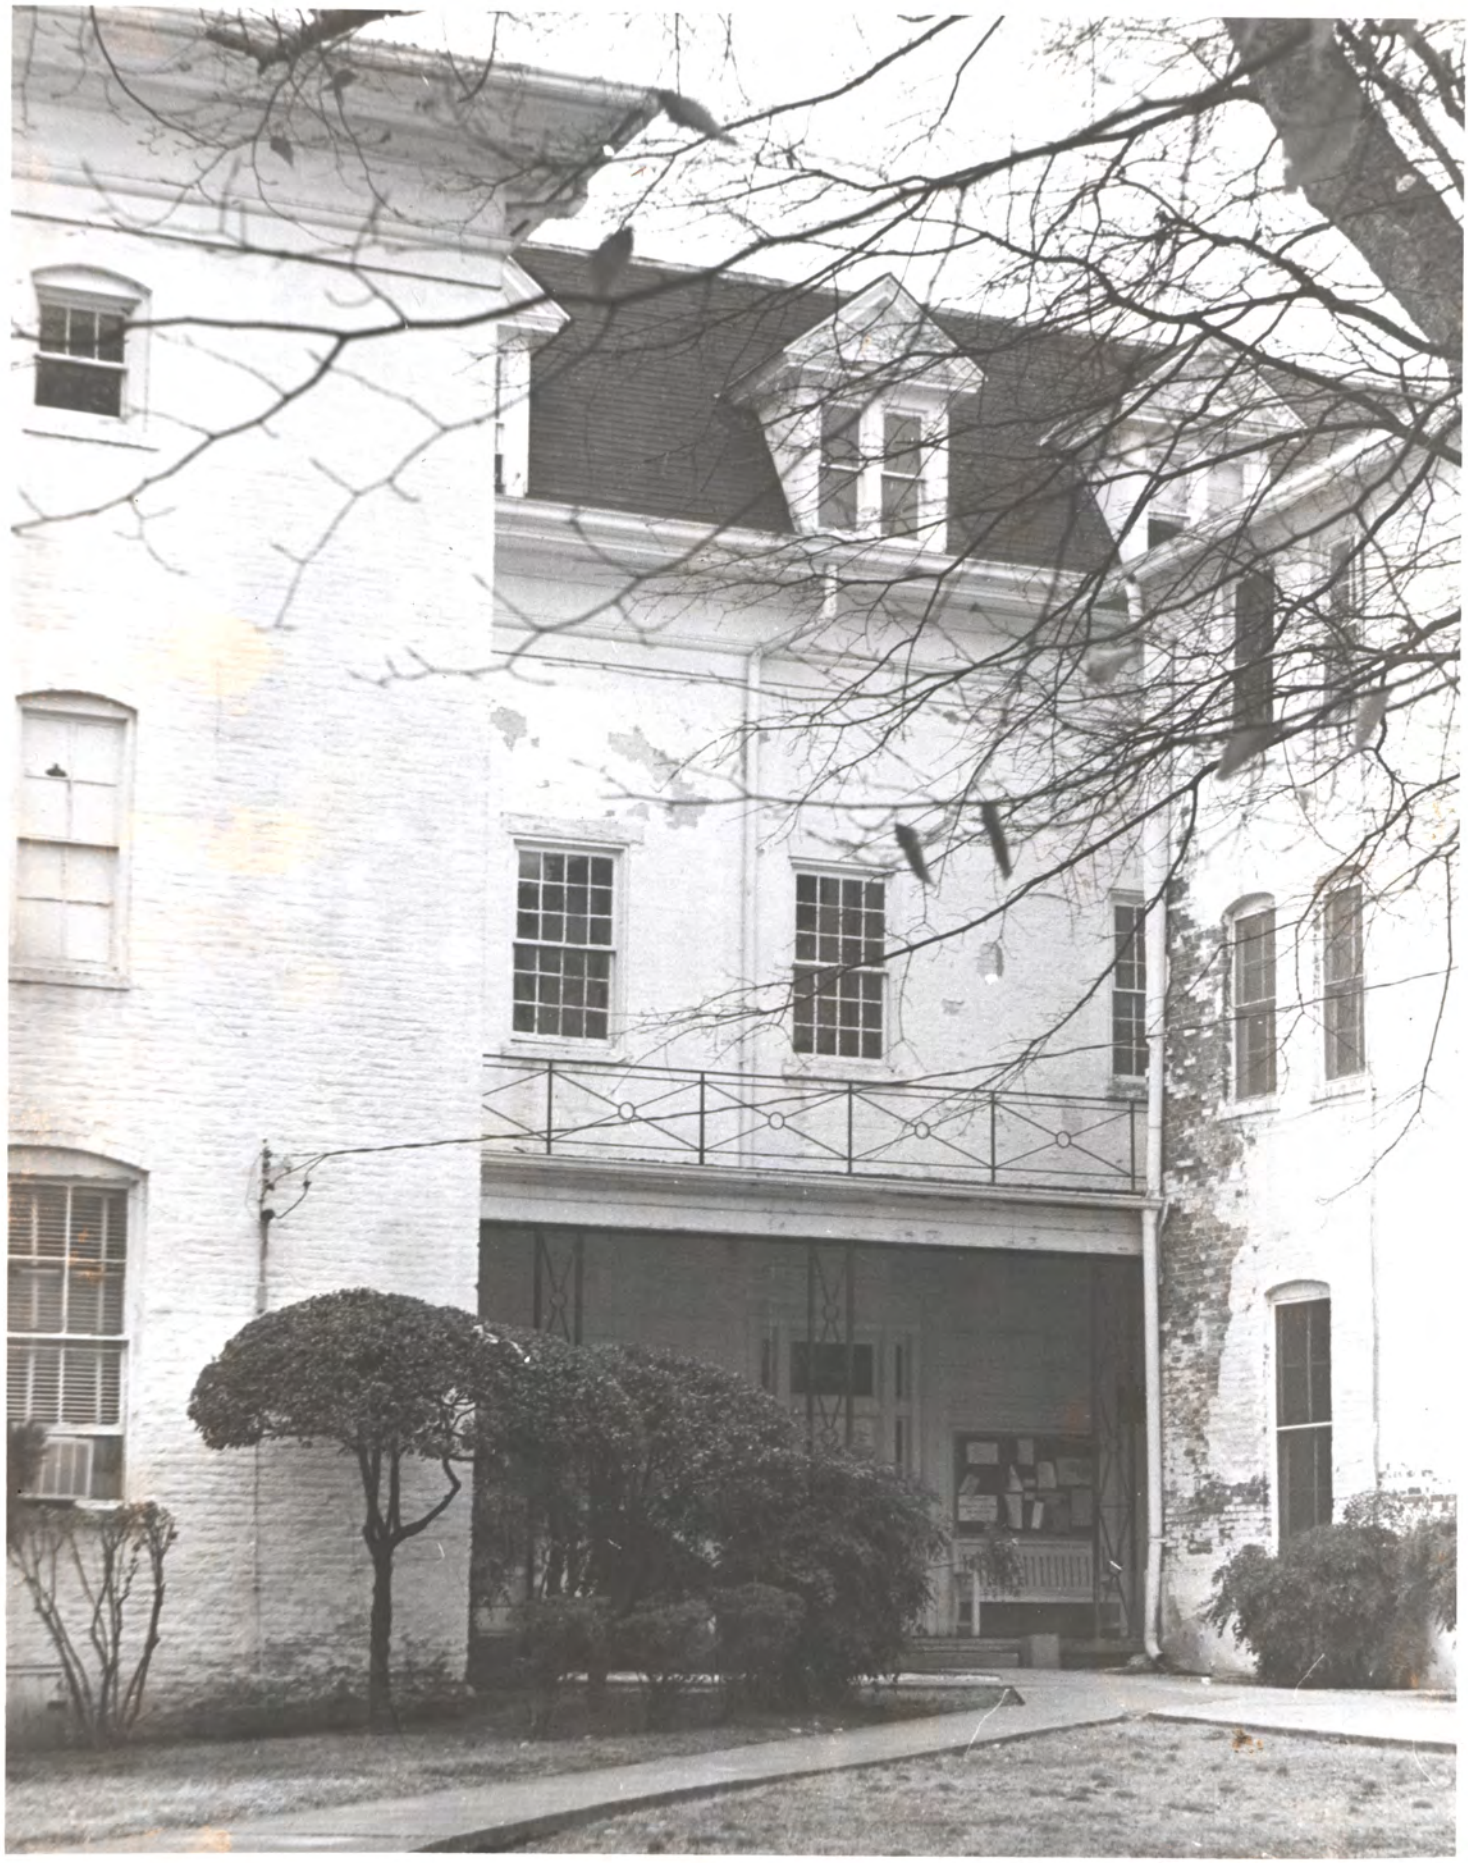
Elev. & stair added in S.W. corner of ct. in c. 1979 JdH Arch-HJ&RA

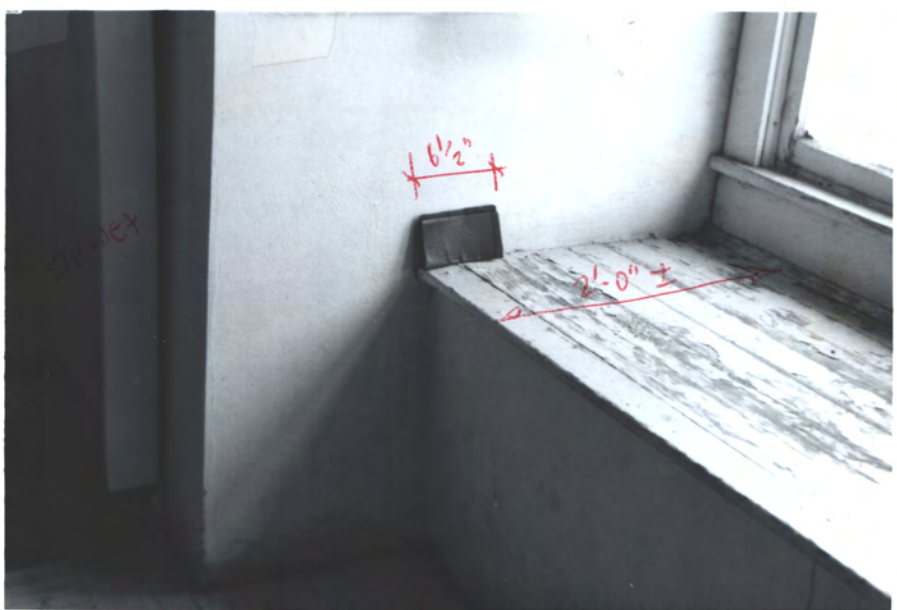
6½"
2'-0" ±
FH 3rd Cl Rest. Rm.

shower
± 6'-4" h. (?)
