CIRCA 1795 GEORGE SPENCER HOUSE
WARREN SQUARE, 22 HABERSHAM STREET
SAVANNAH, GEORGIA

Re: Mills Lane c.1795 Spencer House
Project No. 92013

Re: Stone and Spencer Houses
Project No.(s) 92012 & 92013

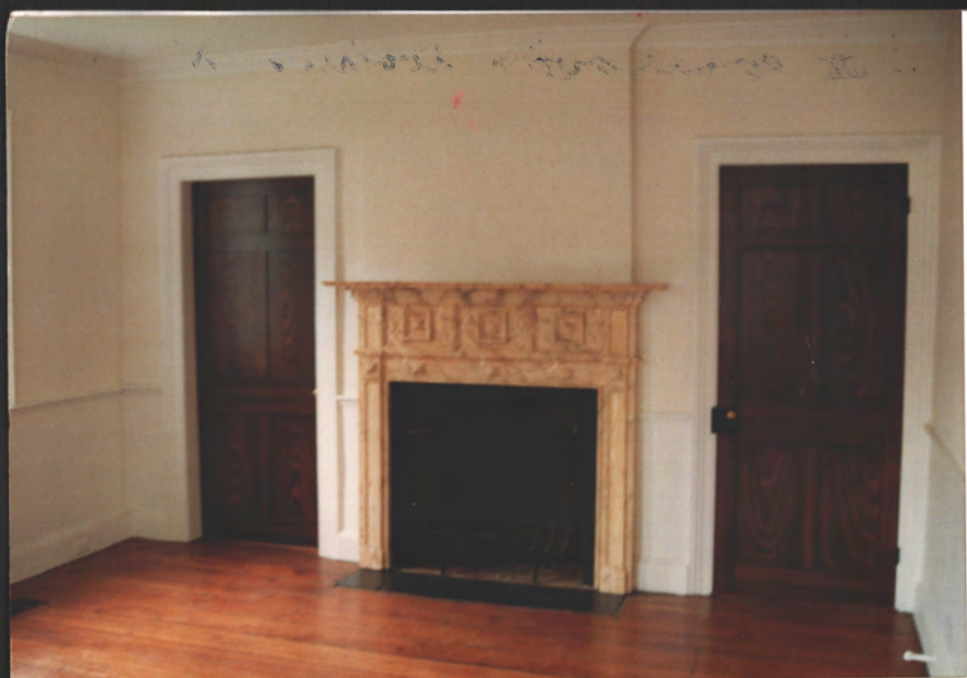
11 ← 1st fl. N.W. Rm., orig. mantel
 (2 doors = 1993 replace. of Vic. doors & trim
 per ML)

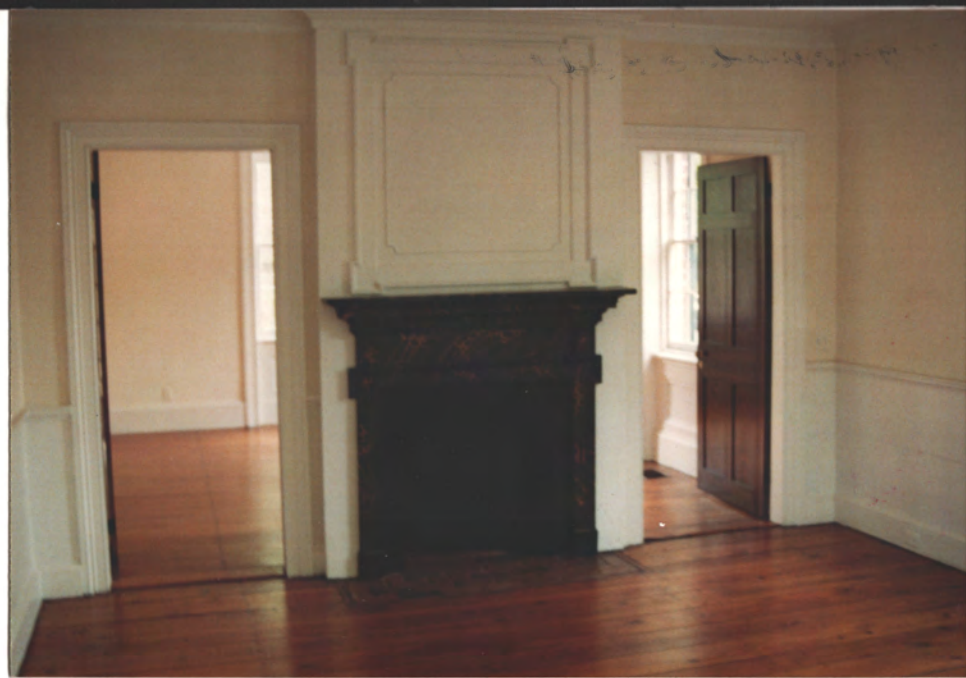
11 ← 1st fl. S.W. Corridor (c.1795) mantel & overmantel
 2 doors = 1993 replace. of 2 Vic. doors & trim.

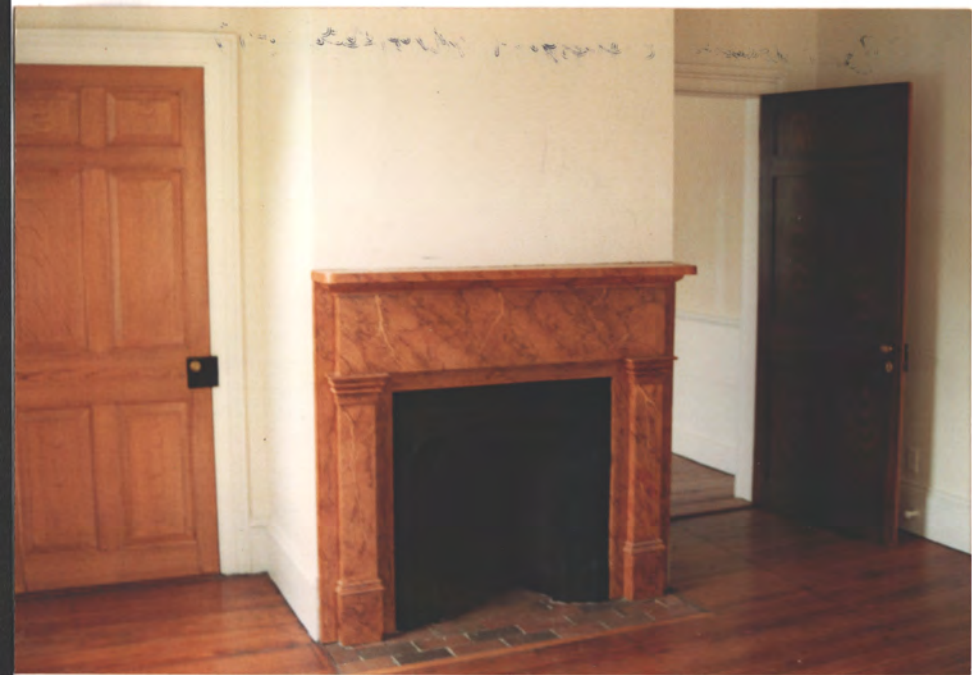
Fl. 1, SE. Rm, 1850's mantel.
Door = 1993 replace. for vic. doors
