## Borders-Blackmon House Offers Important Record of Slave Artistry

CIRCA 1840 BORDERS - BLACKMAN HSE, ANNISTON, AL.  
 H.A.B.S. RESTOR. + ADDN. 1990 DR. GEORGE & SUSAN GIBBS.  
 JONES & HERRIN, ARCHITECTS - H.P. JONES, F.A.I.A. - HUNTSVILLE, AL.

c.1840 Borders - Blackman Hse, Anniston, AL (HABS)  
after restoration in 1990 by Jones & Kerrin, Arch.  
Harrie P. Jones, FARA, Huntsville, AL  
Owner - Dr. George Gibbins, Anniston  
Photos H. Jones, June 1993

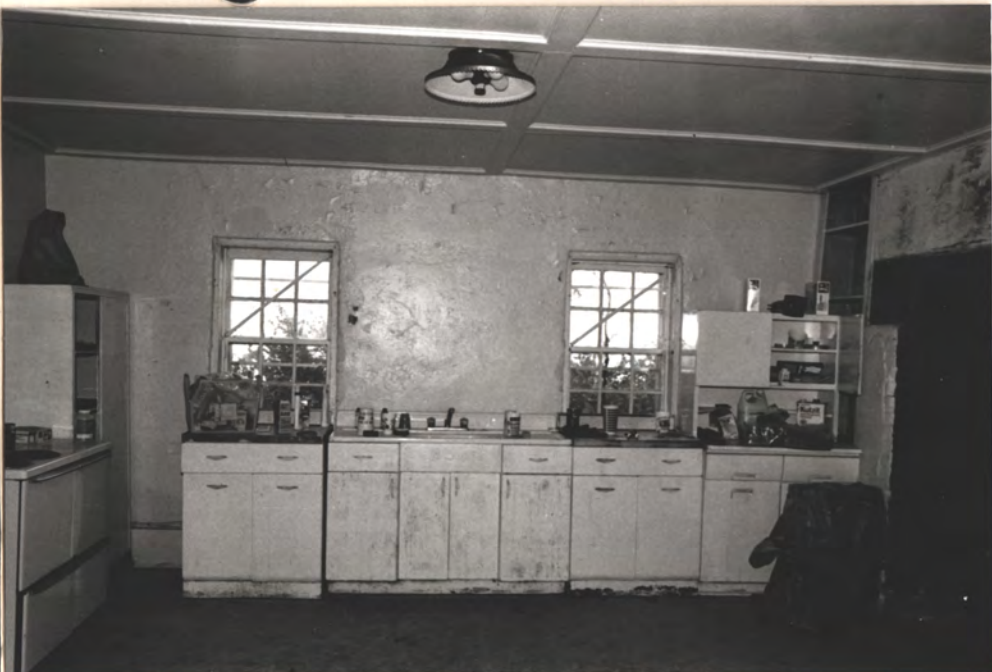
N. WALL  
 steel cabinets probably 1950's

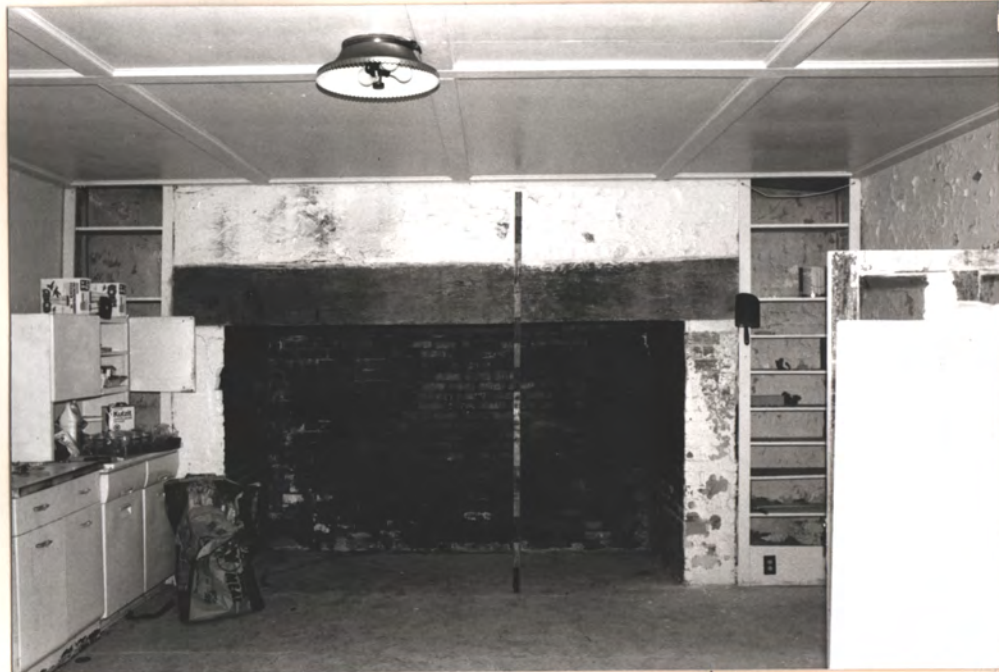
ORIG. KIT

E. WALL (F.P.)  
 original cooking fireplace 25 1/2 h. x 5' + w.

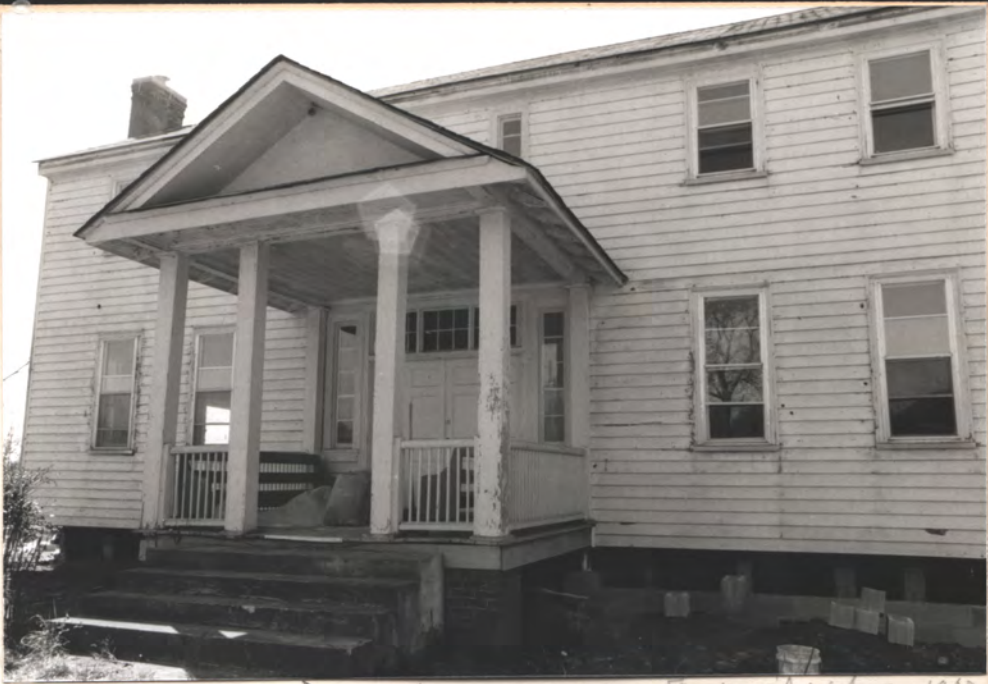
Portico = original, except  
pitched roof is an early mod.  
(was flat)

Therefore the pitched roof  
was apparently put on within  
5 to 15 years of the house's  
constr. Flat roof probably  
leaked.
