**ST. MICHAEL'S AND ALL ANGELS CHURCH
(EPISCOPAL)**

ANNISTON, ALABAMA

PROJECT NO. 93049

PRESERVATION & RESTORATION PRELIMINARY OUTLINE NOTES

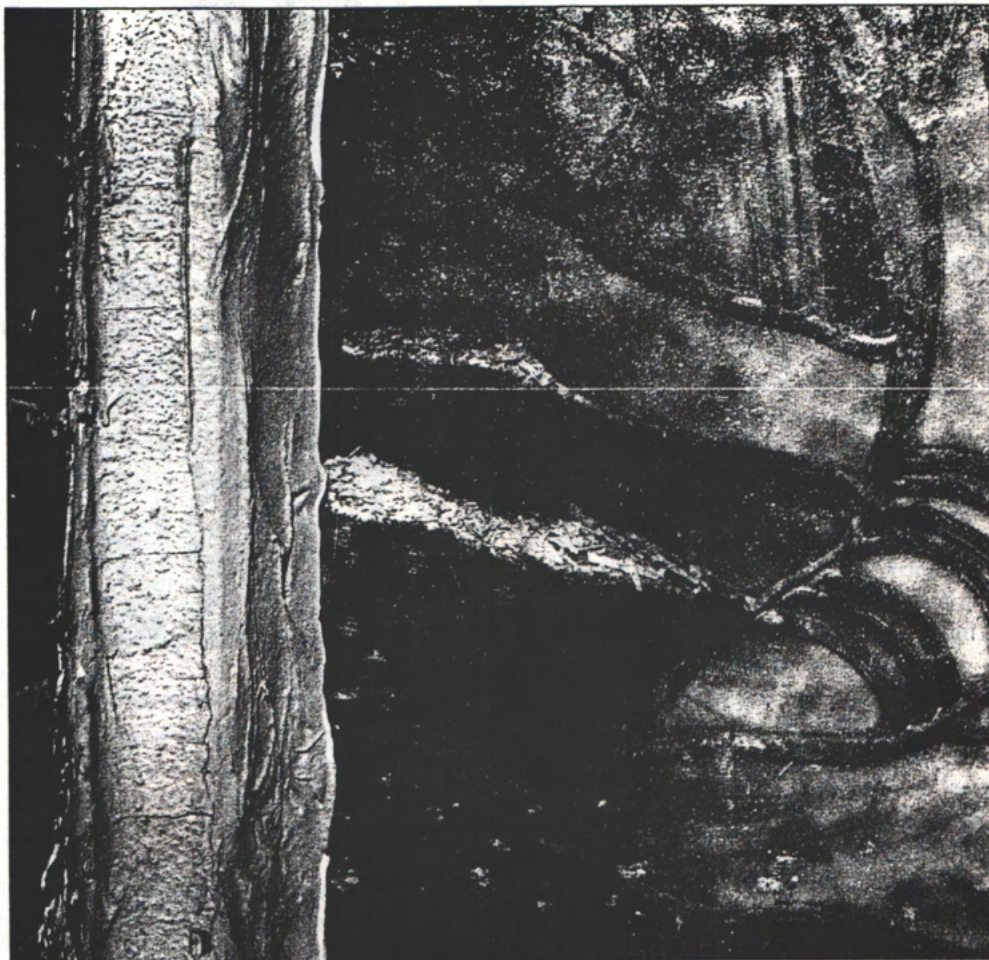
The white smudge at the left center of this panel used to be a lead came. When the protective glazing was installed, it was placed flush against the stained glass. Since the stained glass could not be sealed, water vapor infiltrated the cavity. In cold weather, it condensed on the lead and, in a period of less than ten years, turned the lead to powder.
