Re: Church of the Nativity Administration Office
Project No. 95075

Re: Circa 1870 Building at 208 Eustis Avenue
(Church of the Nativity Administration Building)
Project No. 95075

NATIVITY ADMINISTRATION BUILDING
PROJECT NO. 95078

CHURCH OF THE NATIVITY ADMIN. BLDG.

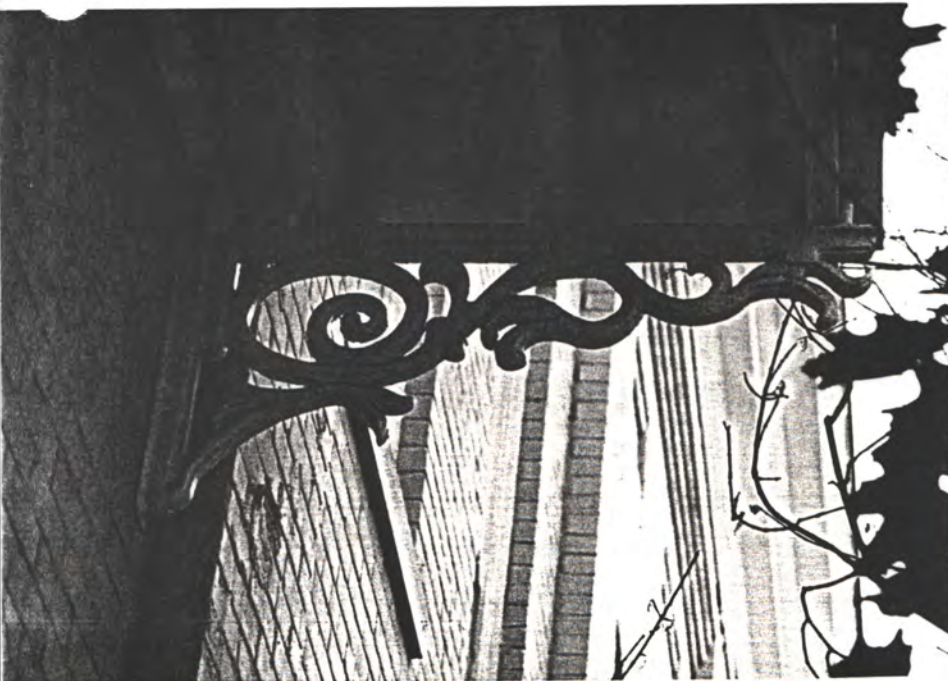
Late Vic. Commer. Bldg.
S.W. corner of Knott & Franklin
Huntsville, AL,
photos June 1995 HPS/James FAIB

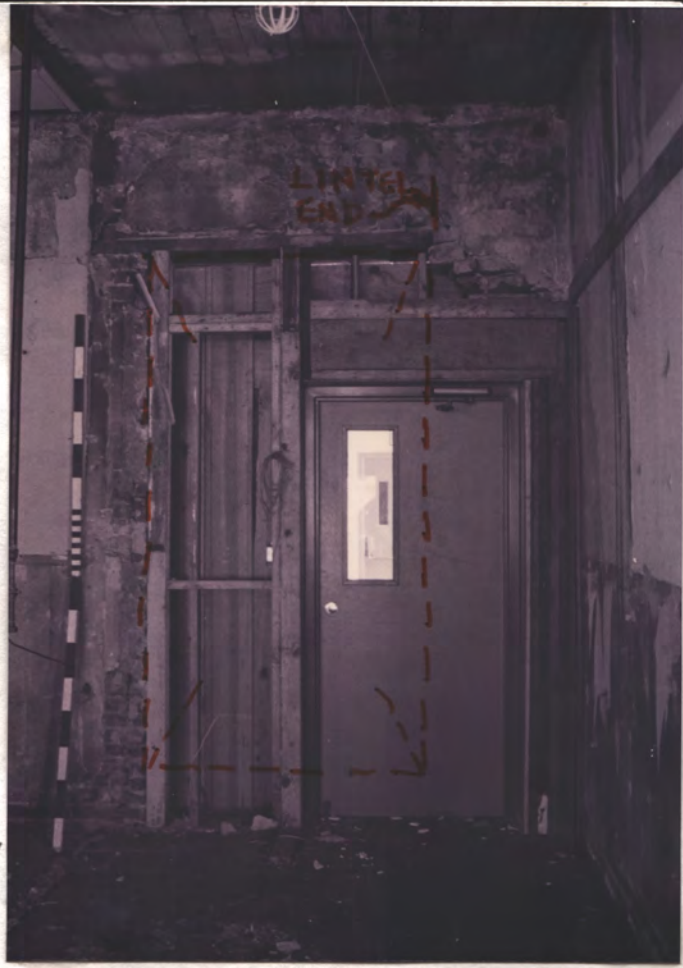
S.W. of M, W. Window (modif. c. 1975 for address by Tom Jones, Arthur)

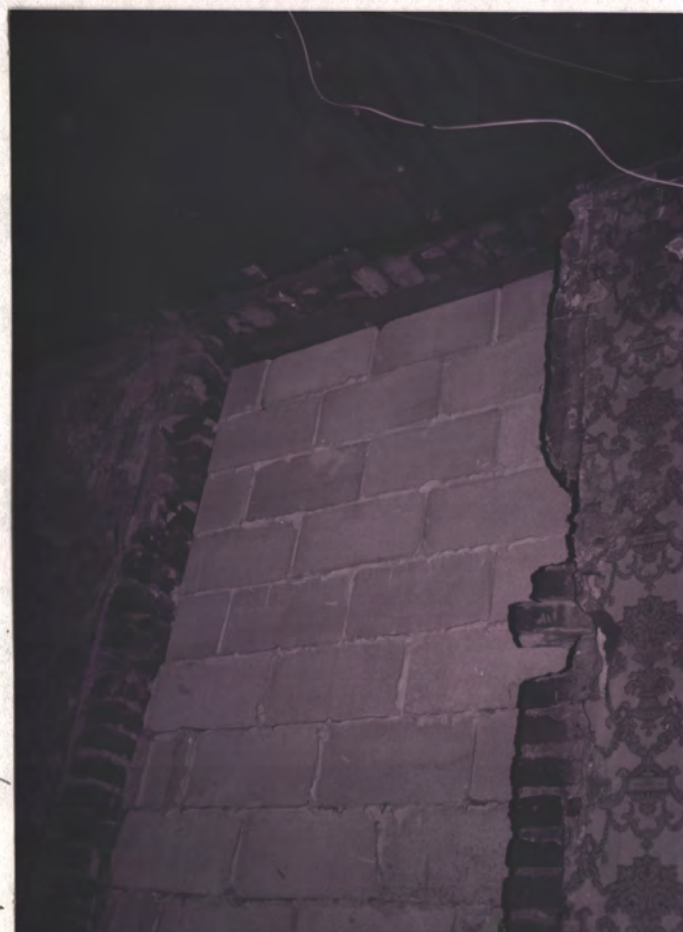
orig. window
made into
a door

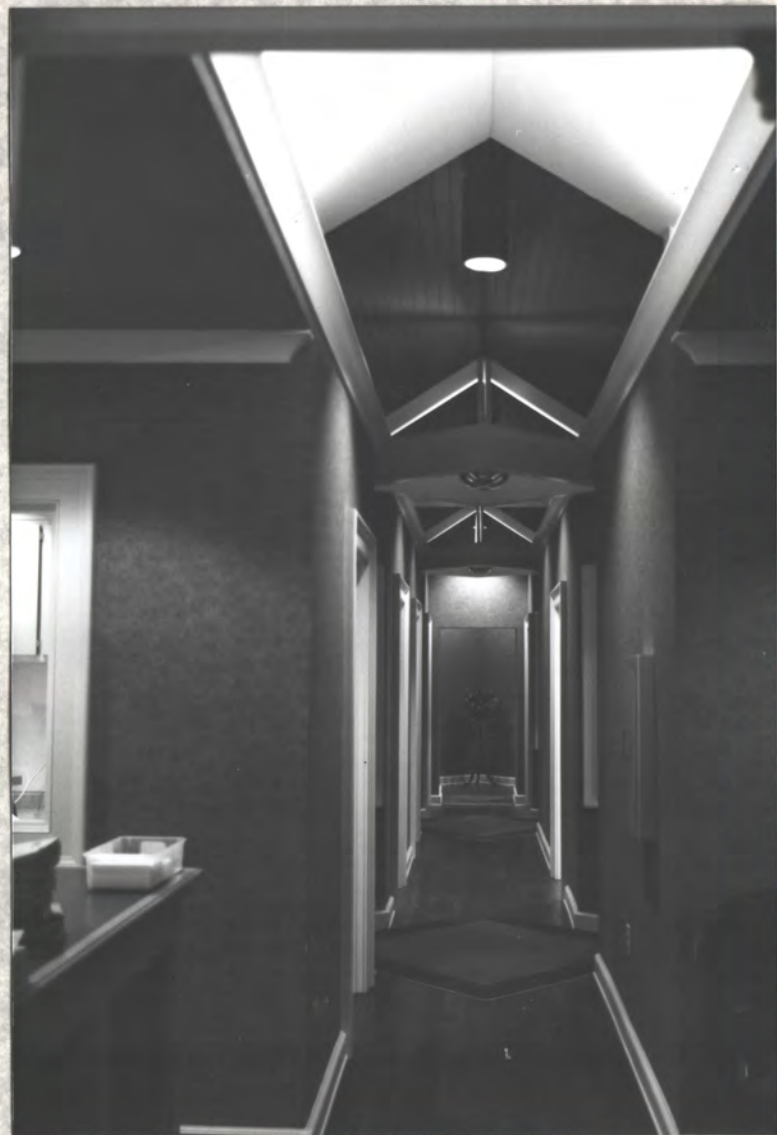
W ↙ Fl. 1 off. wing - Lori Bates, I.D., J & W
(trim details by AD per 1970's designs)
